STUDY OF CHANNELIZED TRAFFIC

TECHNICAL MEMORANDUM NO. 3-426

WATERWAYS EXPERIMENT STATION

FEBRUARY 1956

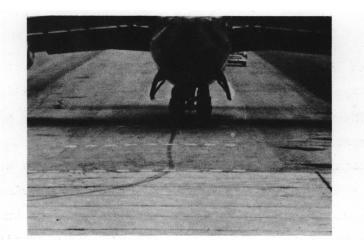
Photograph 1. Transverse reference lines used to determine position of wheels

5. Movie cameras were placed at strategic locations along straightaways and curves as shown on plates 1, 2, and 3 and trained to photograph the relative position of the pavement stripes and the landing gear of the aircraft during taxiing operations. The cameras were placed on stands to provide sufficient elevation and were generally operated at 8 frames per sec while the plane was in the immediate vicinity. Transverse reference lines were painted across the taxi stripes at strategic locations (fig. 1). These lines were broken at 1-ft intervals so that lateral distribution could be determined. Subsequently, the movie film was projected by individual frames and the distribution of the landing gear at specific reference lines was scaled from the projected image.

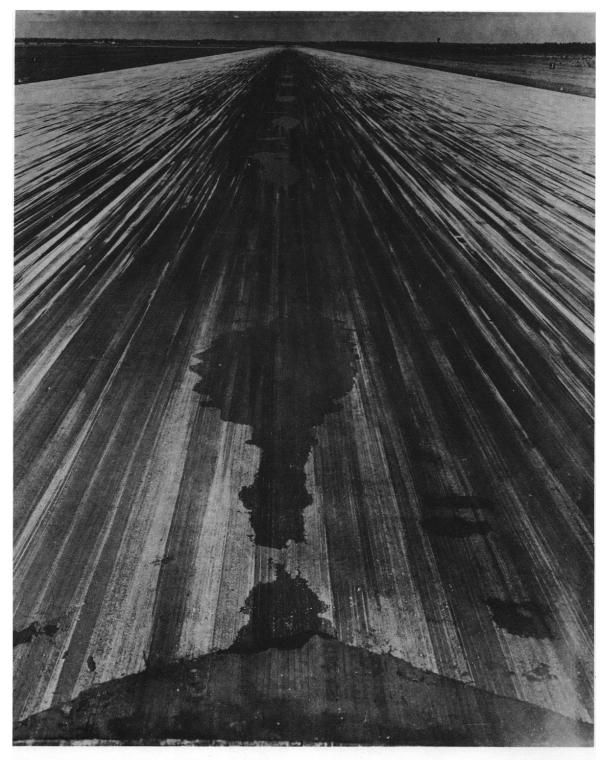
Fig. 2. Effects of concentration of traffic in the central 20 ft of runway at Pinecastle AFB

12. Fig. 2 is a photograph which was taken from the juncture between the rigid and flexible pavements on the runway at Pinecastle AFB. At the joint the flexible pavement was 1-2 in. lower than the rigid pavement causing "porpoising" of the B-47 aircraft on take-off. The "birdbaths" shown in the picture have been caused by bouncing of the planes. The depressions are restricted to an area about 20 ft wide in the center of the runway.

19. <u>Runways.</u> The photographic procedure of measuring lateral distribution of traffic could not be applied to runways because the cameras would have interfered with landing operations. However, visual observations of plane positions at the time of take-off, blast effects of B-47 motors, and pavement conditions provide information on the lateral position of B-47 planes at take-off. Longitudinal lines are painted on most runways at a distance of 15 ft on either side of the center line. It was observed at Lake Charles and Pinecastle that the take-offs were made from between these lines. The runway at MacDill was wider than the others and the distribution was found to be wider. Blast effects substantiated these observations. As discussed previously the Lockbourne data indicated that the most intensive loading was over a width of less than 50 ft. Fig. 2 (taken at Pinecastle) indicated a concentration of traffic in the central 20 ft. No such concentration was observed during taxiing after landing.

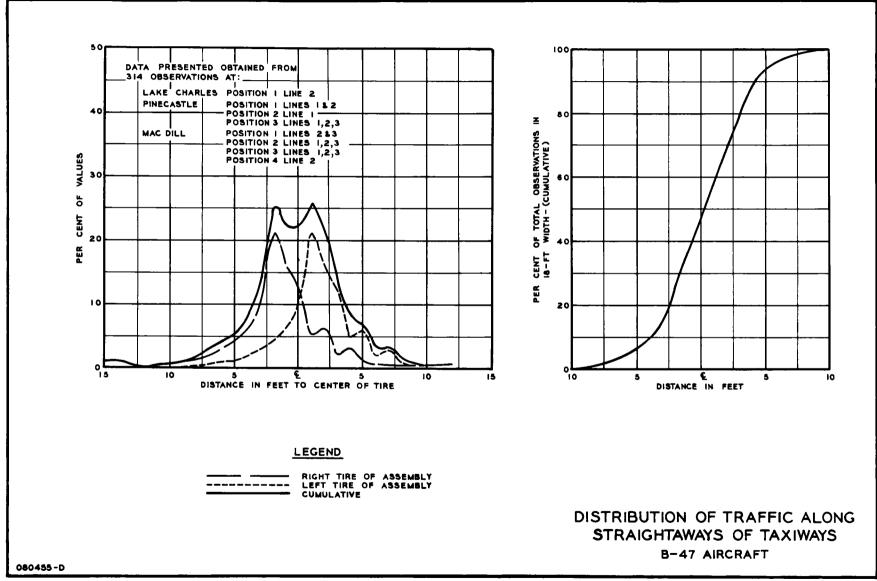
PLATE 4

16. The results of 314 observations of the distribution of B-47 planes on taxiway straightaways are shown on plate 4. In the plot on the left the distribution of each wheel of a dual assembly over the central portion of the taxiway is shown by the two dashed lines, and the distribution of the entire assembly by the heavy solid line. The righthand graph shows a cumulative plot of the distribution starting at a point about 10 ft from the center line. The cumulative curve shows that about 75 per cent of the traffic falls into a lane about 7.5 ft wide, spaced symmetrically about the center line.

26. The traffic distribution curves for B-47 aircraft discussed previously showed that on taxiway and taxilane straightaways about 75 per cent of the traffic occurred in a width of 7.5 ft. Tire contact width for the B-47 tire averages 13.2 in. Assuming uniform distribution of traffic across the 7.5-ft center of a main taxiway, cycles of operation for a one-runway field can be converted to coverages on the taxiway as follows:
