ORNL-2217
C-84 - Reactors-Special Features
of Aircraft Reactors

METALLURGY DIVISION
SEMIANNUAL PROGRESS REPORT
for Period Ending October 10, 1956

OAK RIDGE NATIONAL LABORATORY
Operated by
UNION CARBIDE NUCLEAR COMPANY
A Division of Union Carbide and Carbon Corporation
Post Office Box X
Oak Ridge, Tennessee

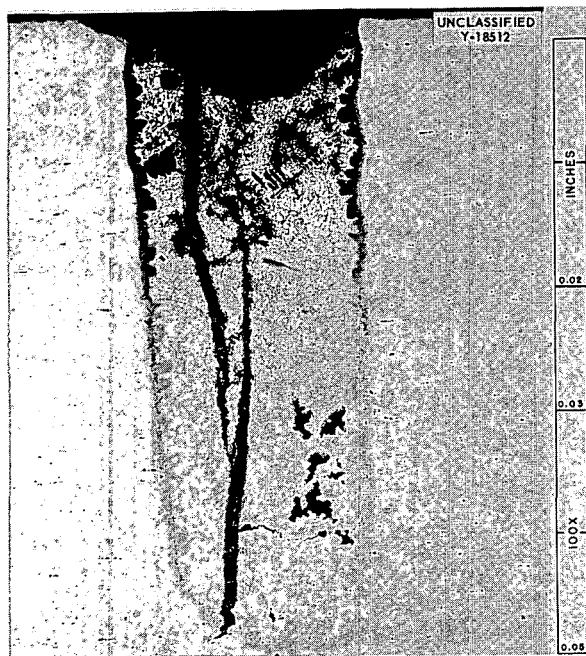
Fig. 27. Large-Type Crack Found in Brazed Joints in the Inconel-NaK Loop. Etchant: 10% oxalic acid. 100X. Reduced 34%.

which extended halfway through the tube wall were found in some of the brazed joints (Fig. 27). It is not known whether these cracks are caused by thermal stress or shrinkage, since no as-received joints were available for examination. NaK samples from this loop showed 1160-ppm oxygen content after test. This is admittedly high, but no efforts were made to purify the NaK since it is received in container lots.

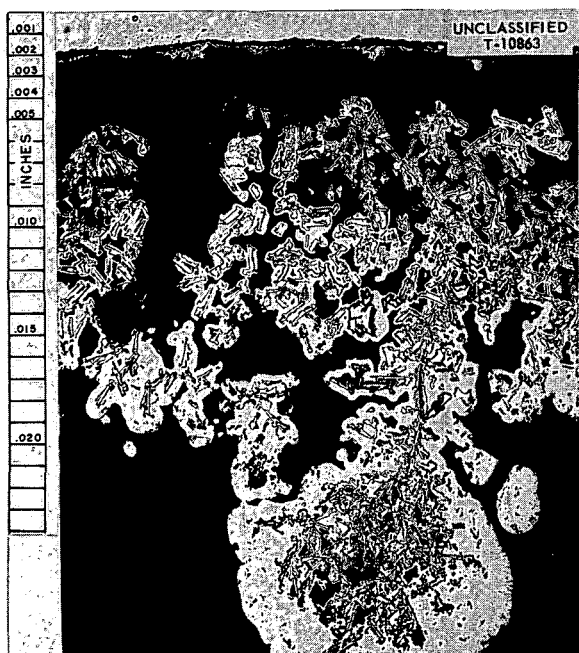
Fig. 55. Deposits Found in Inconel Pump Loop 7426-12 Operated with Sodium at 1500°F. 150X. Reduced 22%.

A relatively heavy deposit, also predominantly nickel, was found in Inconel loop 7426-12, operated at 1500°F with a temperature gradient of 400°F. The loop included a cold trap identical to that mentioned above. Deposits appeared predominantly in the economizer section of this loop, reaching thicknesses of 20 mils, as shown in Fig. 55. Intergranular attack in the hot zone was 2 mils. When scraped from the loop walls, the deposits were measured to be 21 g. This value is substantially higher than the value of 15 g reported above and would indicate temperature drop to be a more significant variable than found in earlier 500-hr tests.⁶ In the case of both the above loops,

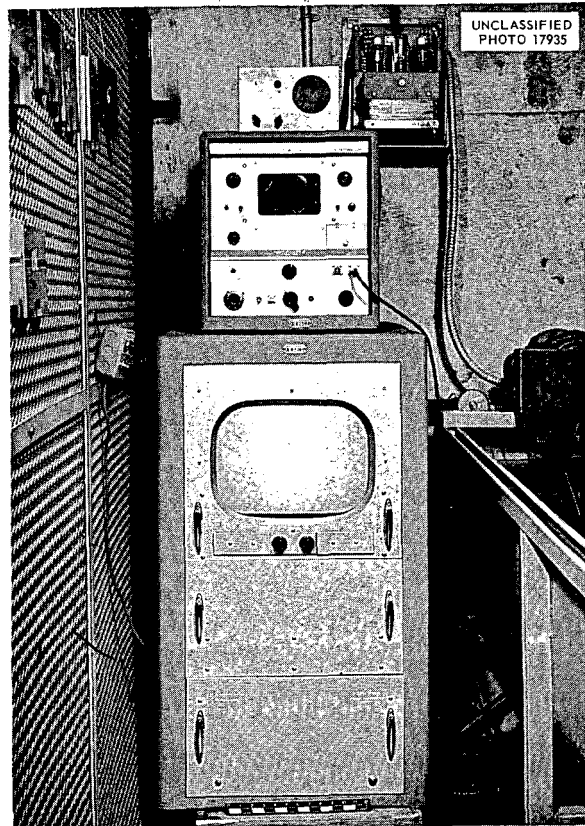
UNCLASSIFIED
PHOTO 17935

Fig. 94. Instrumentation for the Immersed Ultrasonic Inspection of Pipe.

Instrumentation shown in Fig. 94 consists of the model 424A Immerscope (Curtiss Wright Corp., Caldwell, New Jersey); the B-scan, the large console under the Immerscope; and a small audible alarm, the small upper box, designed at ORNL. The Immerscope excites a lithium sulfate crystal, causing it to emit high-frequency sonic vibrations. This ultrasonic beam is transmitted into the water bath and into the pipe wall. Any discontinuity of the pipe wall reflects the sound beam which

is received by the crystal, amplified by a wide-band amplifier, and presented as a time-amplitude plot on the small oscilloscope. The "B-scan" takes the same data plus a signal for rotation of the pipe and plots pipe rotation against time of travel on a larger oscilloscope. This latter plot is easier to interpret because the oscilloscope utilizes a persistent phosphor, and information being plotted may be compared with information of the past several seconds. This is more easily understood than the instantaneous plot shown by the Immerscope or "A-scan." The audible alarm calls the attention of the operator to indications which might otherwise be missed.

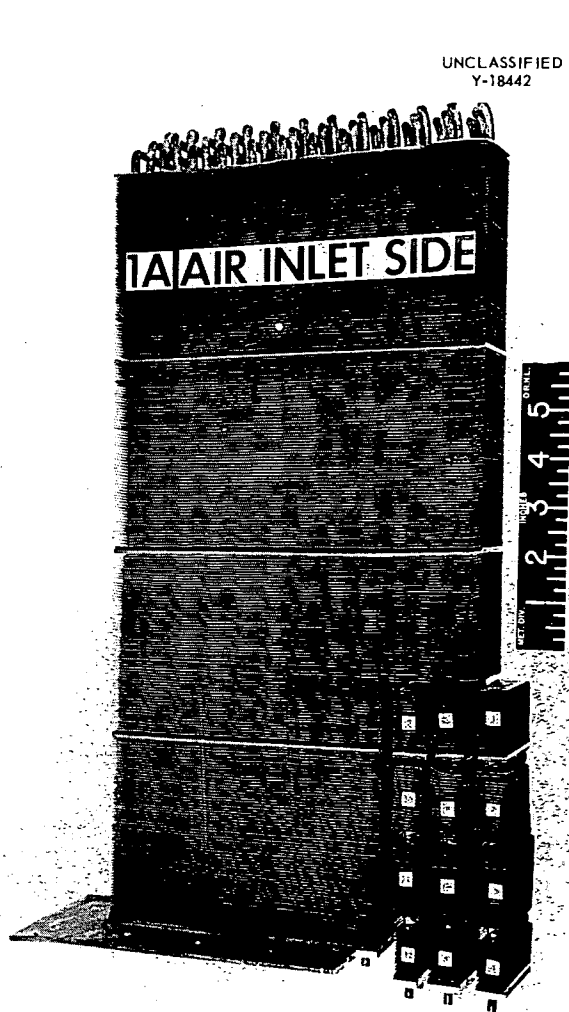
Fig. 125. York HCF Radiator No. 4.

Twenty-four specimens were cut from the radiator, as shown in Figs. 125 and 126. Each specimen contained a portion of three tubes, each joined to 15 or more fins. The specimens were cross-sectioned to reveal two opposed joint areas and were then mounted and examined at 80X.

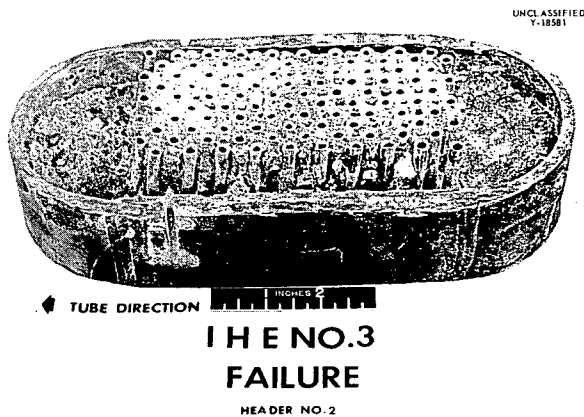
Fig. 133. Bottom Side of IHE No. 3, NaK Outlet Head, Showing Bending of Tubes.

seen in Fig. 133, a photograph of the NaK outlet head.

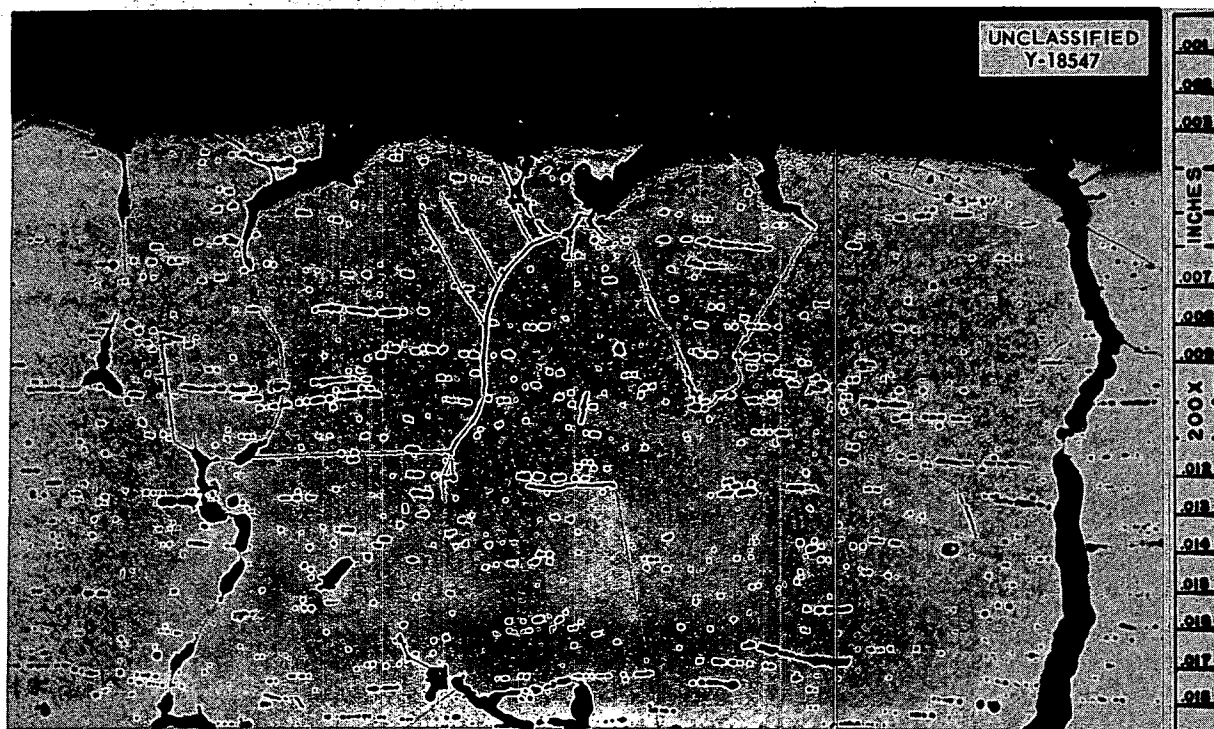
Fig. 138. Inner Surface of Tube 17. Cracking and corrosion from the outer surface are evident. Etchant: electrolytic oxalic acid.

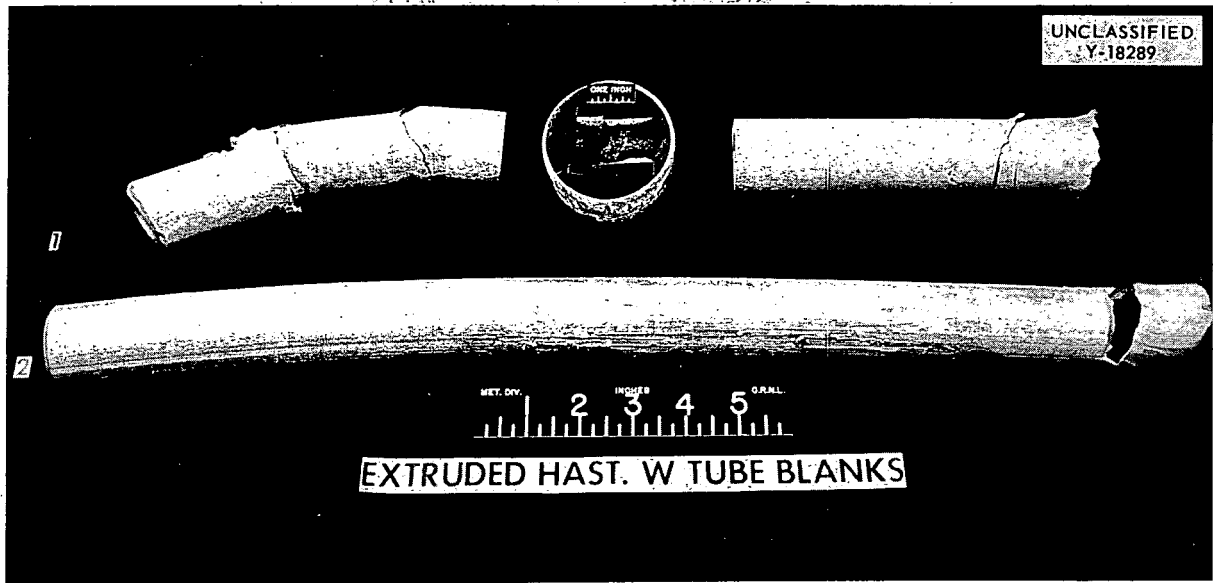
Fig. 151. Seamless Tube Blanks Extruded from Forged Hastelloy W Billets Canned in Inconel. Tube 1 was extruded at a fast rate at 2100°F. Tube 2 was extruded slowly at 2200°F.

It was concluded from this work that Hastelloy W could be extruded on a laboratory scale by raising the extrusion temperature and reducing the extrusion rate so as to allow time for metal flow and to minimize the deleterious effects of generated heat. The successful and unsuccessful tube-blank extrusions are illustrated in Fig. 151.

Results of processing the successful tube blank of Hastelloy W, shown in Fig. 151, to 0.187-in.-OD, 0.025-in.-wall tubing by the Superior Tube Co. indicate the feasibility of producing small-diameter seamless tubing of Hastelloy-type alloys. This extrusion yielded 25 ft of tubing, which was examined by non-destructive testing techniques and was determined to be of the high quality required for heat-exchanger applications. Longitudinal and transverse sections of the tube wall are shown in Figs. 152 and 153, respectively.

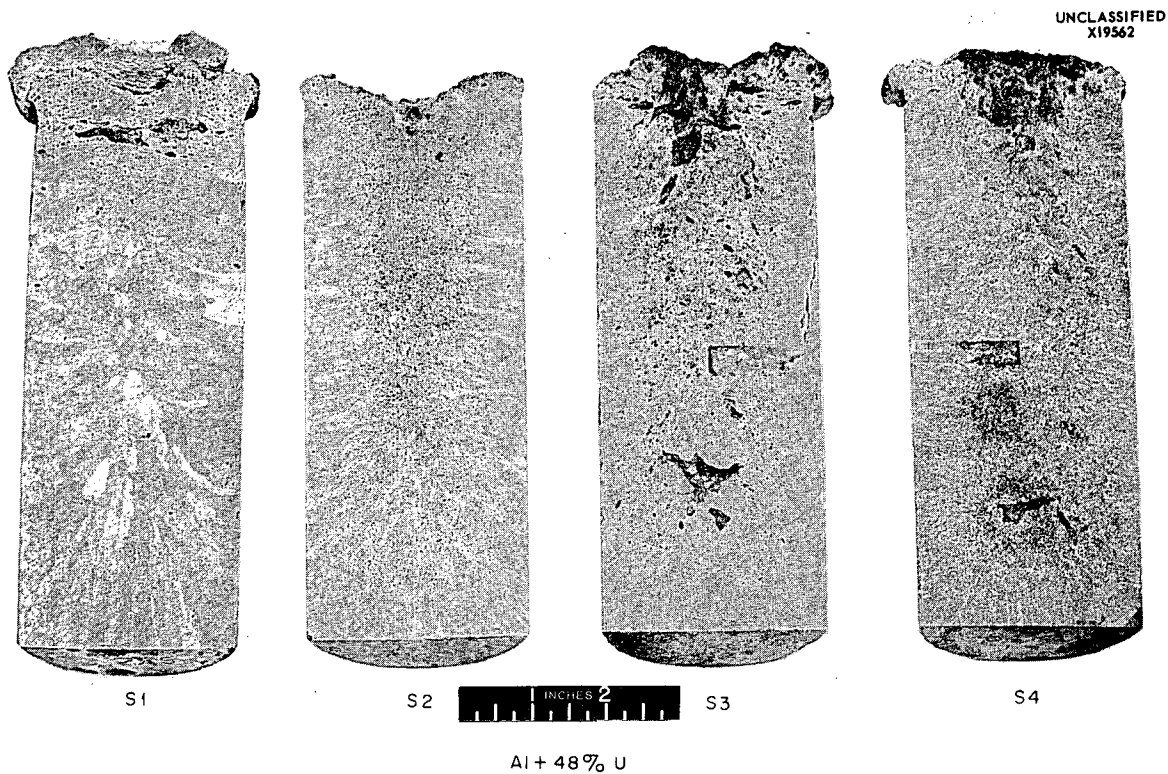
Fig. 180. Microstructures of Sectional Cylinders Produced in Molds of Dimensions as Given in Table 72.

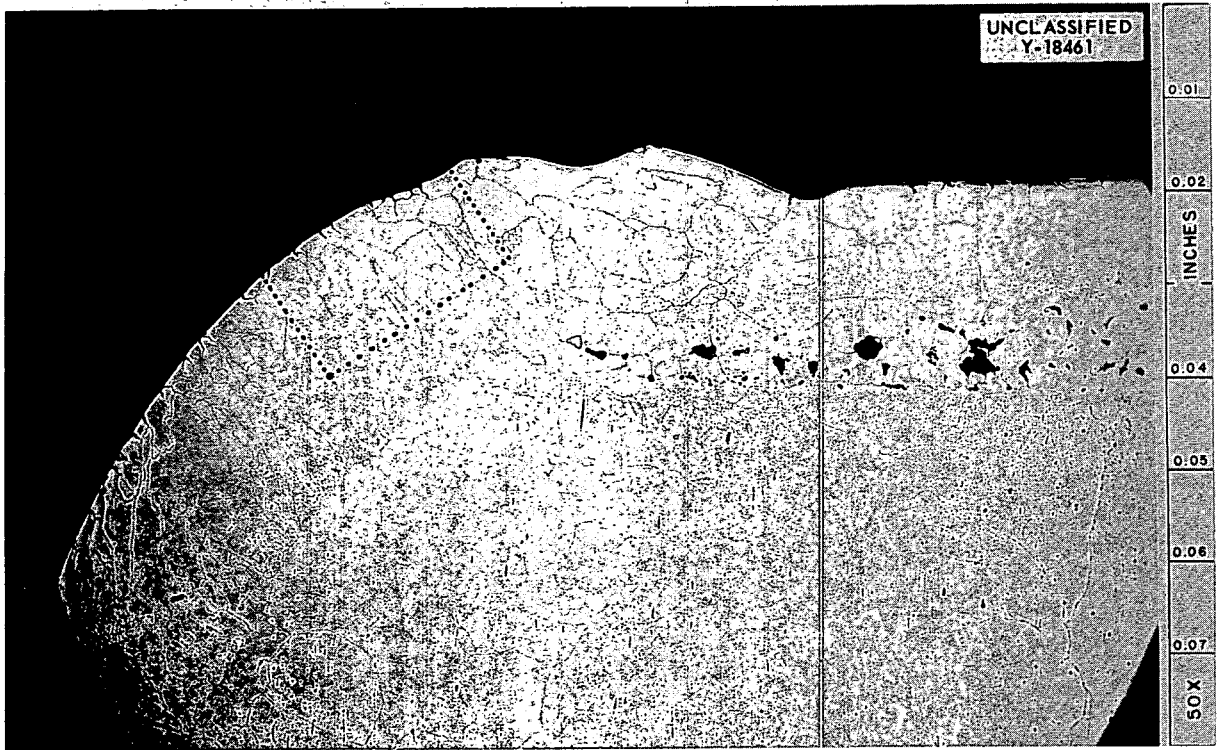
Fig. 193. Tube-to-Header Weld from Area A. Dark areas in the lower corners are due to field limitations of microscope.

Fig. 193. A photomicrograph at a higher magnification is shown in Fig. 194. It is evident that the depth of intergranular attack is not so deep as in the tubes and that there is no indication of selective attack in the cored structure typical of a weld.

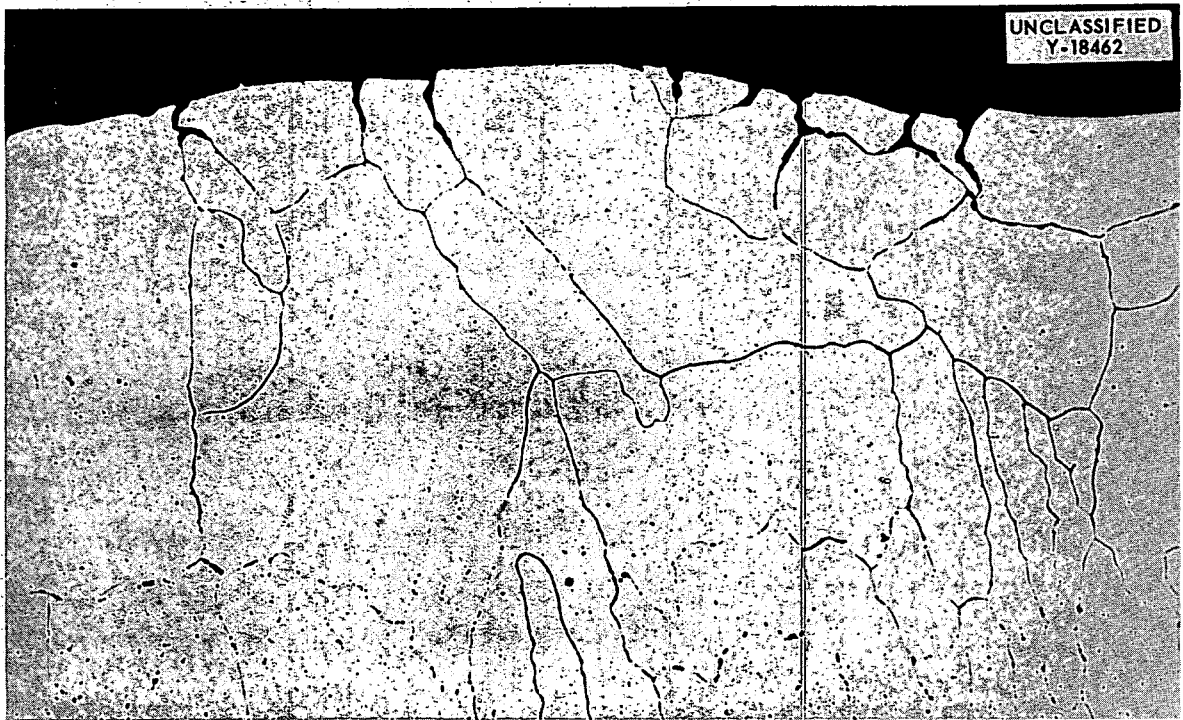
Fig. 194. Tube-to-Header Weld from Area A. Photomicrograph of area indicated in Fig. 193 at higher magnification. 250X.

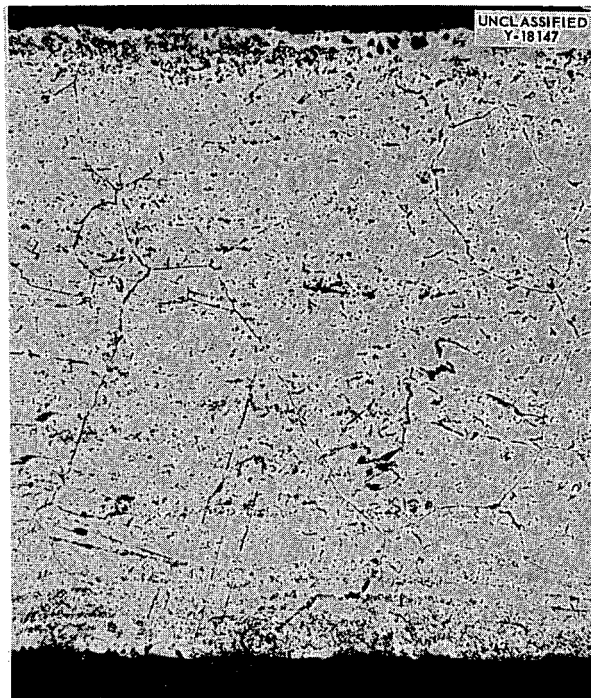
Fig. 198. Inconel Tube Wall in Area C. Note small amount of subsurface voids on fuel side (top of photomicrograph) and absence of intergranular attack on NaK side (bottom). Note uniform distribution of precipitate. 250X. Reduced 26.5%. (Confidential with caption)

The fuel outlet and NaK inlet header is shown in Fig. 197, with the examination areas C, D, and E indicated. A longitudinal examination at the first bend near the fluoride outlet is shown in Fig. 198 (area C). A comparison with the micro-

structures from areas B and A shows a heavier precipitate in the microstructure across the entire tube wall in area C, with no attack on the inner wall exposed to the NaK and a small amount of subsurface voids on the fuel side.

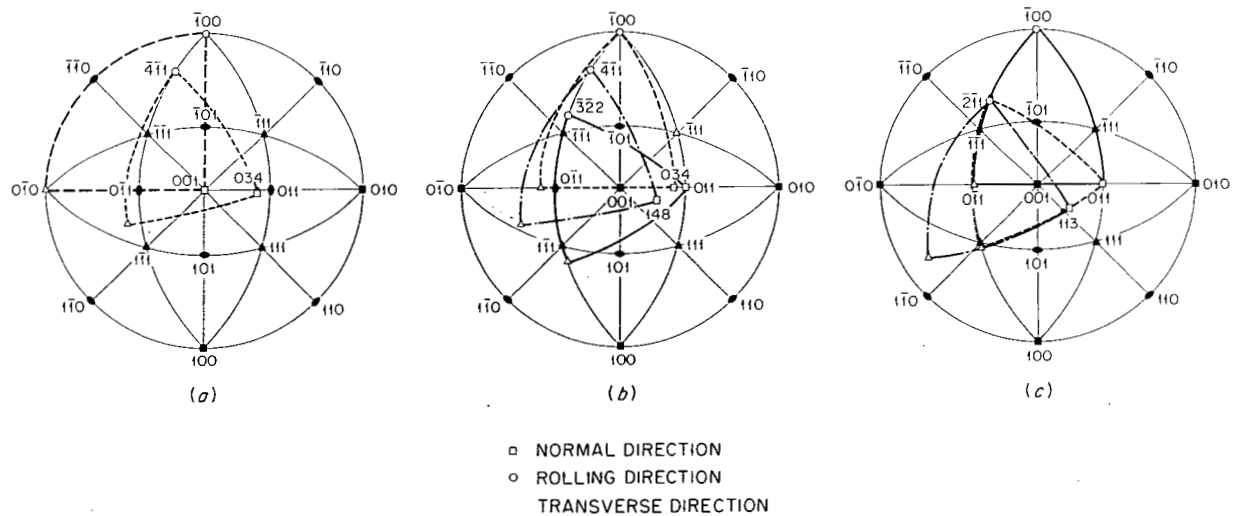
Fig. 224. Standard Stereographic Projection Illustrating the Components of the Sheet Textures of Thorium. (a) As-extruded 1 x 2 in. bar, near {034} $\langle \bar{4}11 \rangle$, {001} $\langle \bar{1}00 \rangle$. (b) Cold-rolled 75%, {011} $\langle \bar{3}22 \rangle$, {034} $\langle \bar{1}00 \rangle$, {148} $\langle \bar{4}11 \rangle$. (c) Cold-rolled 95%, {011} $\langle \bar{1}00 \rangle$, near {113} $\langle \bar{2}11 \rangle$, near {011} $\langle \bar{2}11 \rangle$.
