GEAP-10066
AEC RESEARCH AND
DEVELOPMENT REPORT
JULY 1969

**MECHANICAL PROPERTIES EVALUATION
OF AUSTENITIC STAINLESS STEELS
IRRADIATED IN EBR-II**

BREEDER REACTOR DEVELOPMENT OPERATION
GENERAL   ELECTRIC
SUNNYVALE, CALIFORNIA

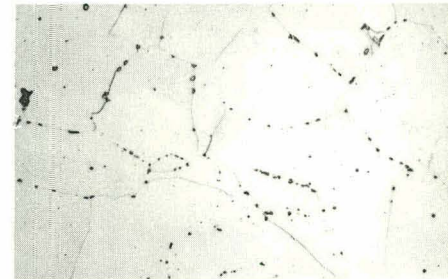
SECTION: LONGITUDINAL
MAGNIFICATION: 500X

Figure 4-6. Microstructure of Type-316 Stainless Steel, Carbide Agglomerated. Etchant: Modified Glyceregia (Reduced to ~ 75% for reproduction purposes)

TUBULAR COUPON
SECTION: TRANSVERSE
MAGNIFICATION: 100X
ATSM GRAIN SIZE NO. 10

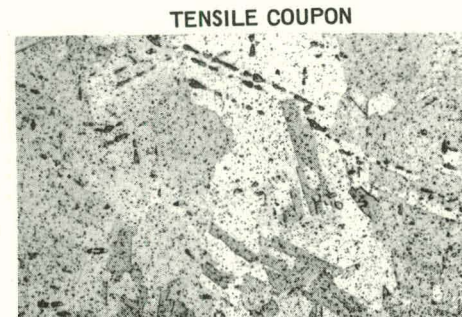
TENSILE COUPON
SECTION: LONGITUDINAL
MAGNIFICATION: 500X

Figure 4-9. Microstructure of Type-347 Stainless Steel, Mill Annealed. Etchant: HCl + H₂O₂ (Reduced to ~ 75% for reproduction purposes)

structure is apparent in the tensile coupon section. This structure also appears in tensile coupons of Types 321 (Figure 4-7 and 4-8), 347 (Figures 4-9 and 4-10), and Incoloy-800 (Figures 4-11 and 4-12). Consistently large grains are at the outer surfaces, with a fine-grain structure near the centroid. The outer and inner fibers are regions of maximum strain (during the flattening and stamping operation), and the middle region is one of minimum deformation. It is possible, therefore, that the 1800°F anneal caused recrystallization and grain growth to occur at the regions of maximum strain. The center region was unaffected because of the lack of appreciable cold work.

A very fine grain size (ASTM 10) was observed in both structural conditions of Type 321 (Figures 4-7 and 4-8), and the weld region was fully recrystallized. Type 347, in both the mill-annealed (Figure 4-9) and carbide-agglomerated (Figure 4-10) structures, was nearly identical in grain size to Type 321. The weld area in Type 347, however, was not fully recrystallized. Types 321 and 347 did not respond to the carbide-agglomeration heat-treatment to the extent shown by Types 304 and 316. In these specimens, stabilized carbides were uniformly distributed throughout the structure.

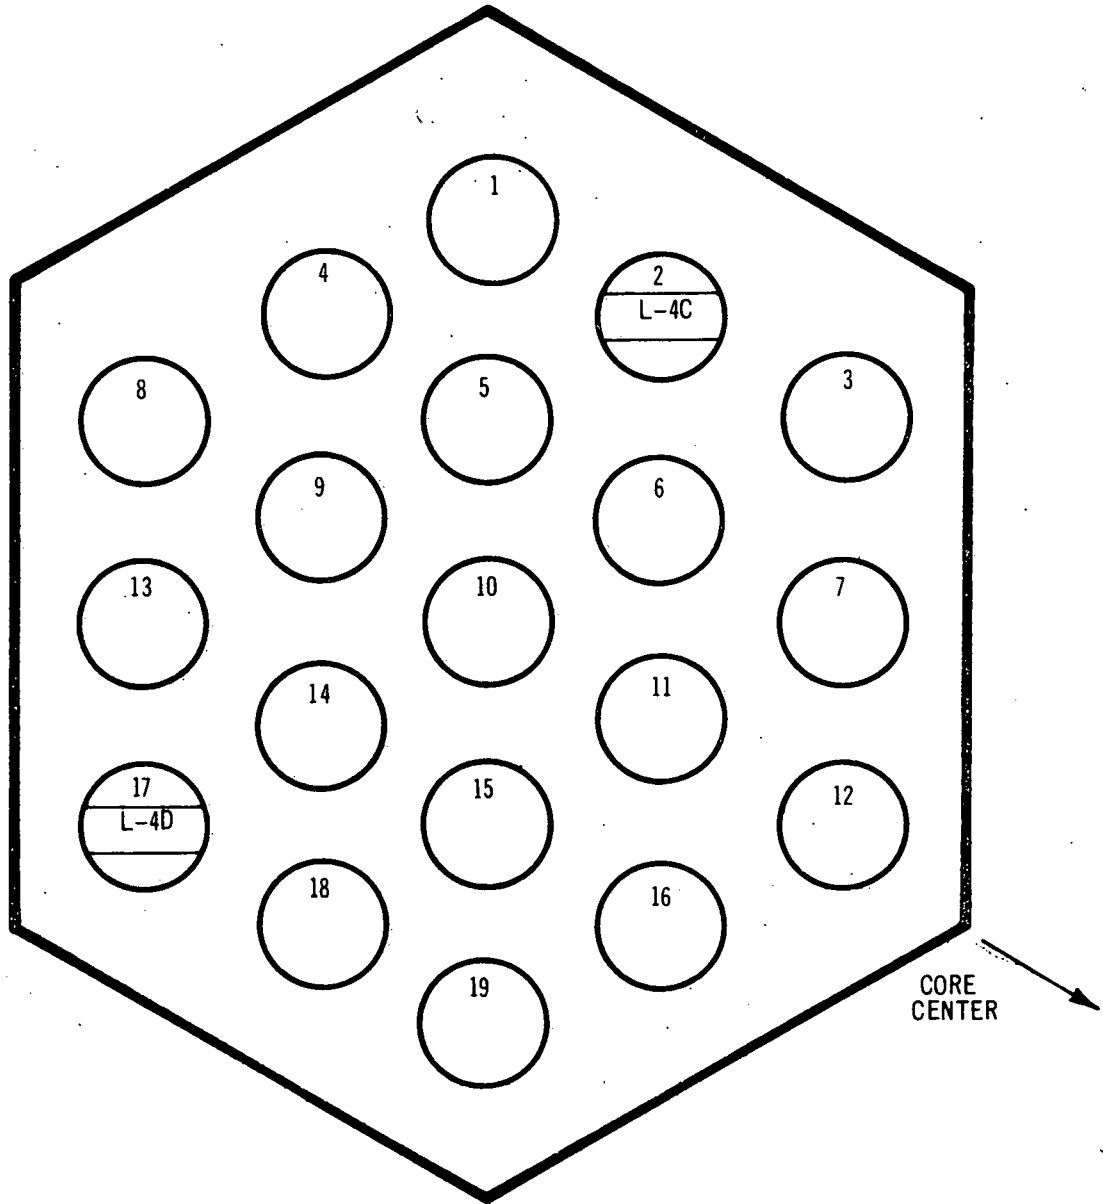
SUBASSEMBLY NO. X 009
CORE LOCATION 4A2

Figure 4-21. Subassembly Diagram, X009

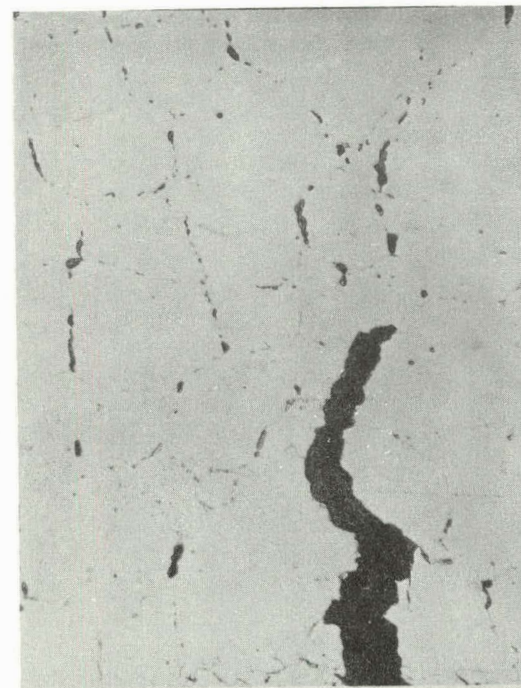
(c) ETCH: MURAKAMI 500X

Figure 5-3. Photomicrographs of Failed Tubular Test Section L-4C-4 (Type 316) Transverse Section

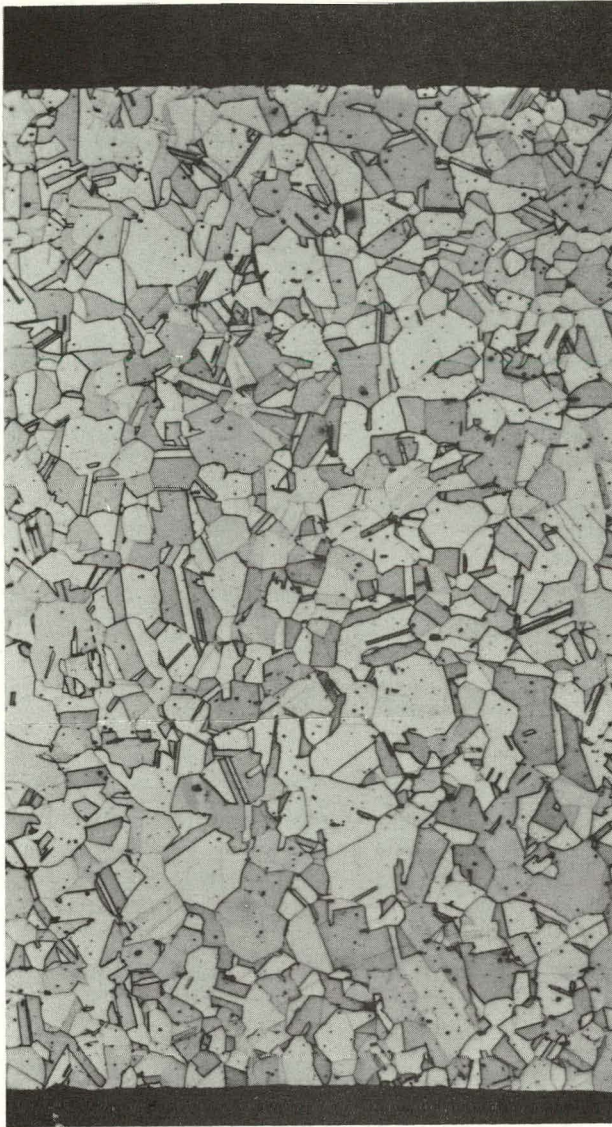
AS-RECEIVED TUBING,
MODIFIED GLYCEREGIA ETCH, 250X

IRRADIATED TUBING
OXALIC ACID ETCH, 250X

IRRADIATED SPECIMEN IS FROM THE
CAPSULE TUBE OF PIN F2Q

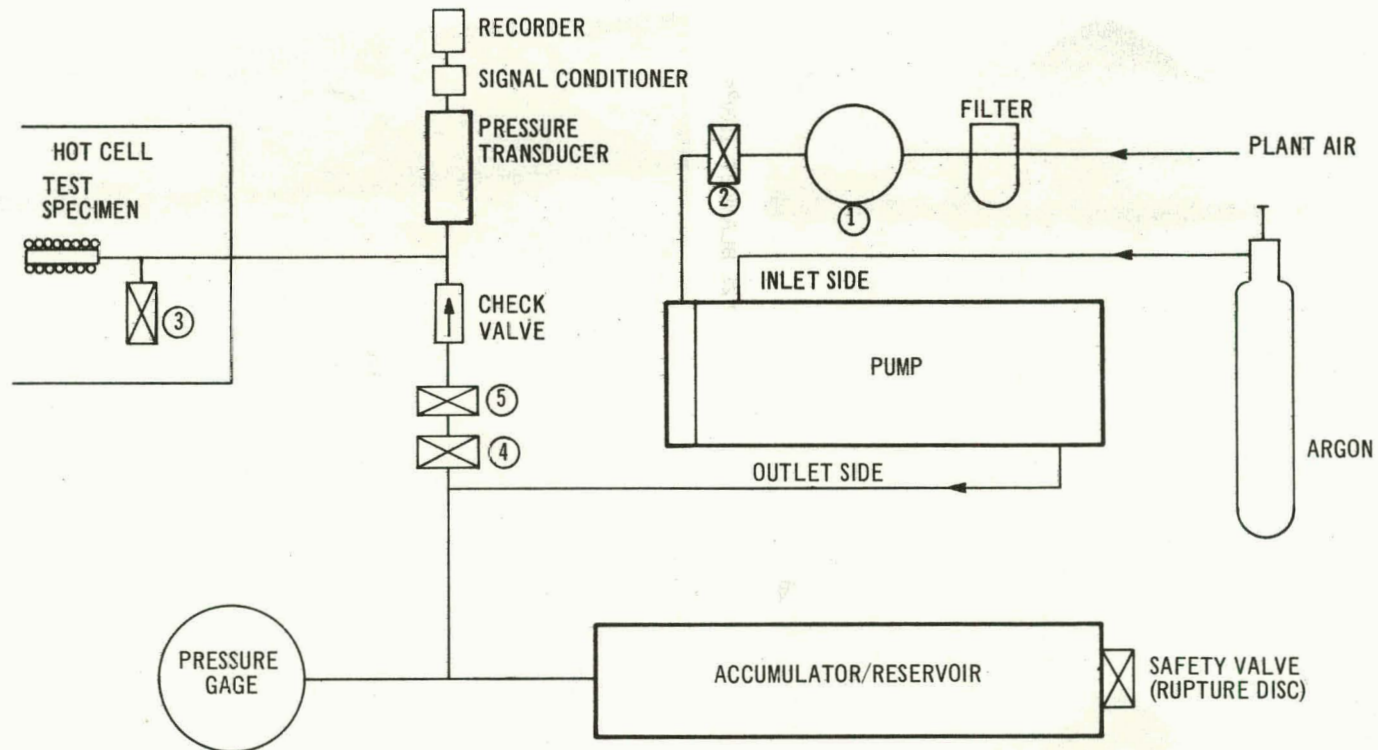
- ① PLANT AIR REGULATOR AND GAGE
- ② PLANT AIR SHUTOFF VALVE
- ③ SYSTEM VENT VALVE
- ④ SYSTEM SHUTOFF VALVE
- ⑤ METERING VALVE

Figure 5-7. Dynamic Burst Apparatus

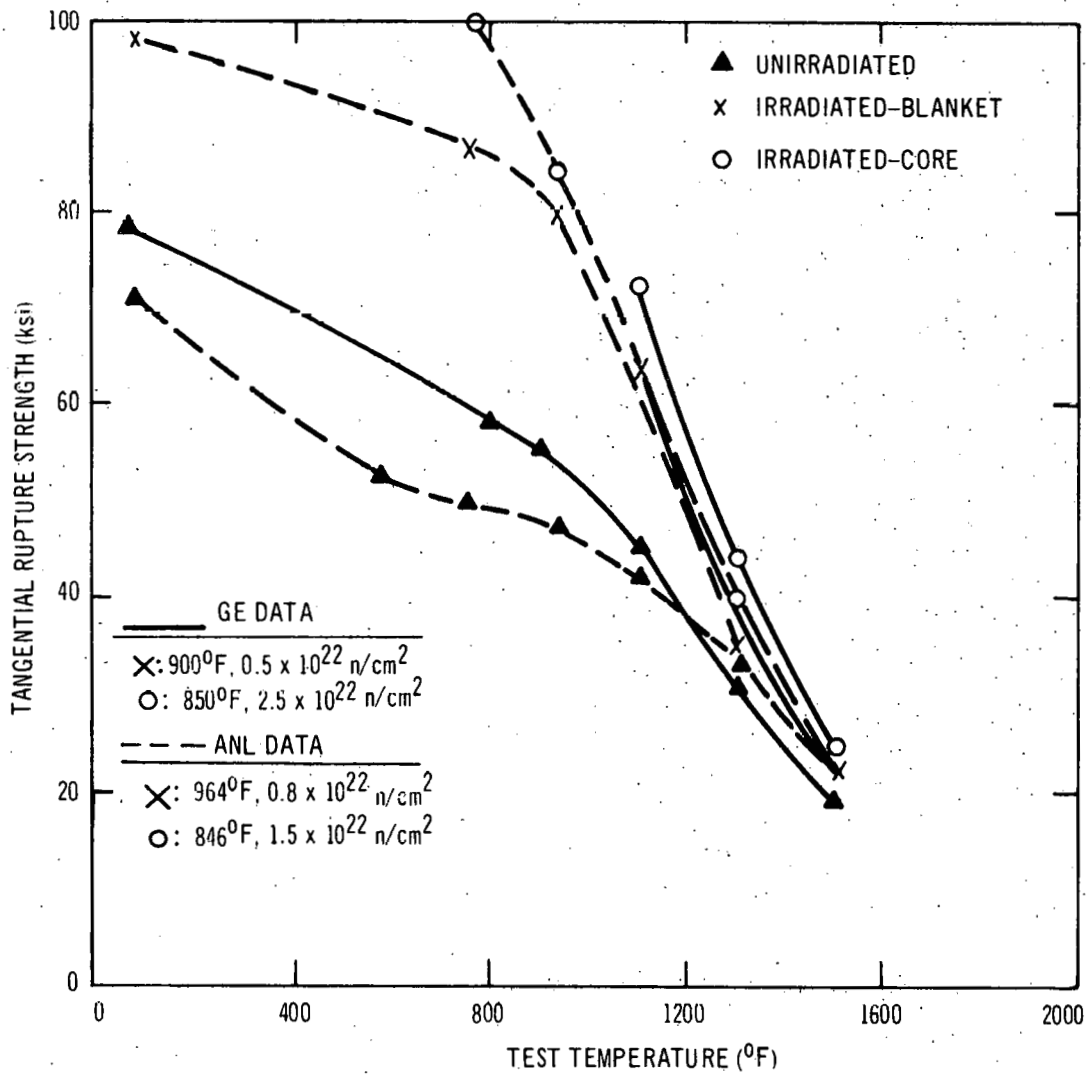
Figure 5-12. Effect of Irradiation on High Temperature Rupture Strength of Type-304 Tubing. Comparison with other data.

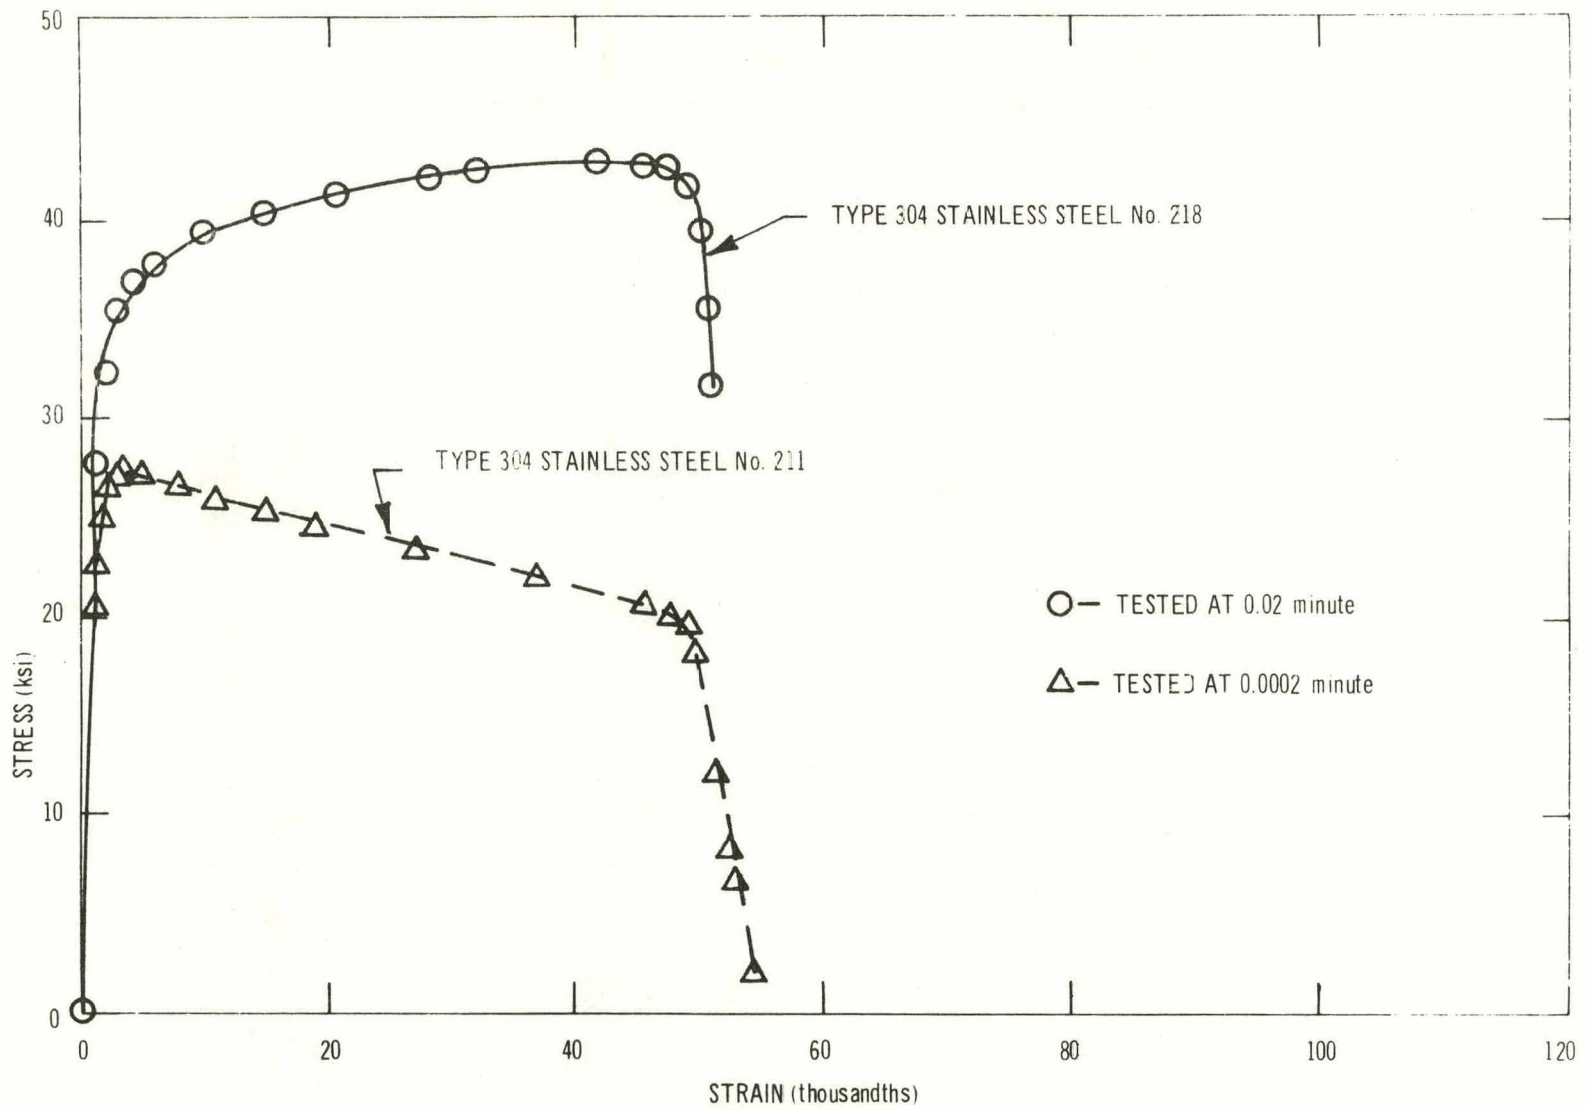
Figure 5-28. Effect of Strain Rate on the 1300°F Flow Curves of Mill-Annealed Type 304, Irradiated at $> 6.2 \times 10^{21}$ ($E_n > 1 \text{ MeV}$)
