DWR-12456 BAW-3809-6
August 1969
TID-4500
UC-25

EXAMINATION OF STAINLESS- STEEL-CLAD $\text{ThO}_2\text{-UO}_2$ FUEL RODS AND ZIRCALOY-2 CAN AFTER OPERATION FOR 442 EFPD IN THE INDIAN POINT REACTOR

RESEARCH & DEVELOPMENT
DIVISION
NUCLEAR DEVELOPMENT
CENTER
Lynchburg, Virginia

FINAL REPORT

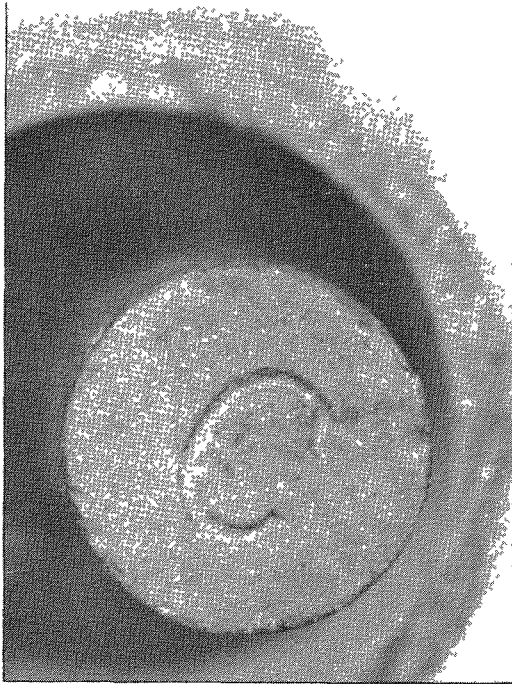
Figure 5-2. End and Side Views of Irradiated Thoria-Urania Pellet

End View

(Tubular piece is a support, not the cladding.)

The sectioning of the rods proceeded without any difficulty. In some instances, however, entire fuel pellets came out of the rod segments. Figure 5-2 shows two views of a fuel pellet removed from rod 105C; this pellet achieved an estimated burnup of 15 GWd/T. Irradiation altered neither the shape of the pellet nor the enrichment identification mark ("C").
