IN SITU DECOMMISSIONING SENSOR NETWORK, MESO-SCALE TEST BED – PHASE 3 FLUID INJECTION TEST SUMMARY REPORT

September 2013

SRNL-STI-2013-00569

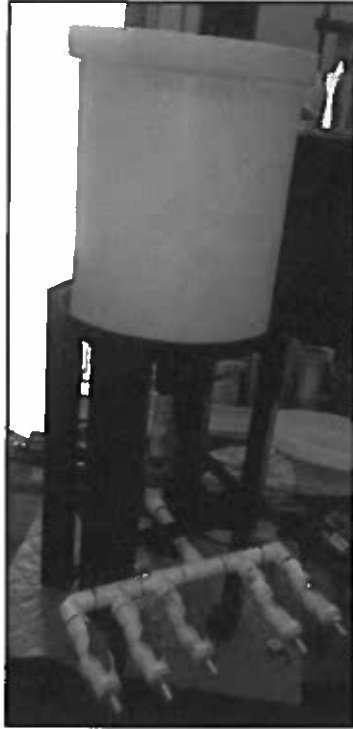
The injection fluid used was a non-hazardous inert solution of potassium chloride 5% by volume (KCl) and deionized (DI) water. The fluid injection delivery system was designed and fabricated at FIU, which allows fluid to be injected into any of the five wells at the same time or independently. The system consisted of a 5-gallon tank connected to a PVC pipe manifold; (Figure 4). Plastic tubing was connected to the manifold and injection wells to convey the fluid.

Figure 4. – Fluid Injection Delivery System

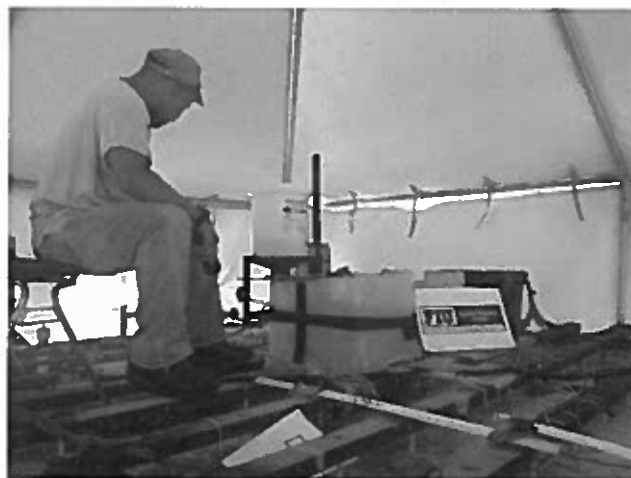
Figure 5. -- FIU Researcher Monitoring Well Levels.

Fluid injection was conducted over a 3 day period from August 27 – 30, 2013. The first day consisted of injecting a 5% KCl solution into all of the injection wells, while during the remaining two days only deionized water was injected. At the beginning of the first day of injection (8/27/13), all the wells were filled to the top with 5% KCl. Throughout the day; each well was monitored and topped off whenever the fluid level dropped by more than a 0.25 in. (0.63 cm) from the top; see Figure 5.

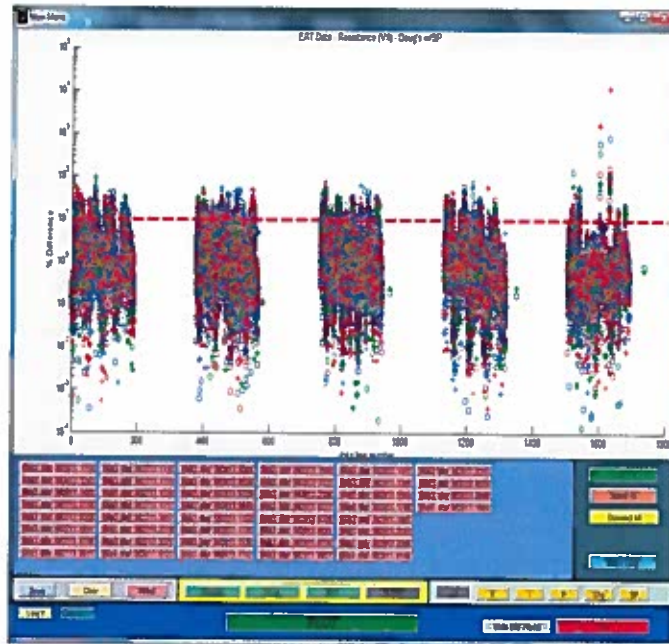
Figure 7 shows an example of the percent difference for some of the reciprocal measurements from these data sets. This data set showed good reciprocal behavior with the vast majority of reciprocal error being less than 10% (red dashed line). This indicates acceptable data quality and little systematic change between measurements.

Figure 7. – Example of ERT-T Reciprocity Results

Data quality in ERT-T surveys is measured by conducting a reciprocal measurement. This is a measurement where the transmitting electrode pair and receiving electrode pair, from an earlier measurement, are repeated with the pairs switched. The two different measurements are compared, and assuming the system is linear and constant, the reciprocal measurements should match. The degree to which they don't match is a measure of a non-linear or changing system which will invalidate some of the main assumptions underlying geophysical processing and inversion techniques. The reciprocal measurements for these data collection schedules had measurements being performed after 200 of the 'regular' measurements. This meant that only a few minutes had passed before reciprocals were measured, thus ensuring a 'constant' system in the event of rapid infiltration.

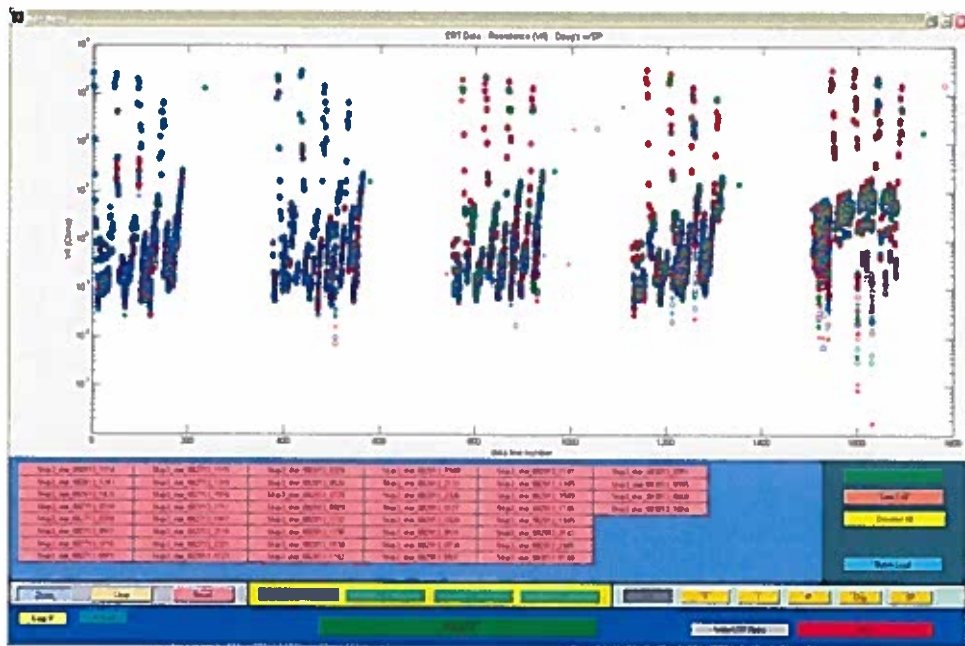
Figure 9. - Raw ERT-T Data from the 5-Spot (star) Data Set (Arrays 1 through 5, Vertical) for August 27th - 30th.

ERT Data was collected continuously from mid-day August 26th through mid-day August 30th. A system error occurred on August 30th and data collection was not started again until September 3rd. However, the initial data was sufficient to bound the infiltration periods. After downloading the ERT-T files, the data was imported into an INL developed program for inspecting and eventually writing the data to Universal Resistivity Format (URF) type inversion input files. The data is inspected for quality (reciprocity) and in this case the degree of change to estimate if inversion was a reasonable next step. Figures 8 through 10, the base data set (Arrays 9 through 12, Horizontal), 5-spot data set (Arrays 1 through 5, Vertical) and the 3-spot data set (Arrays 3 through 5, Vertical) respectively, show data collected over the periods of injection, roughly August 27th-30th. The data sets show little change with some variation seen in the lower values, a typically noisy area. These trends in the data observed were not consistent, with successive points randomly varying within the range. This result indicated the observed changes were probably due to a source of noise in the system.

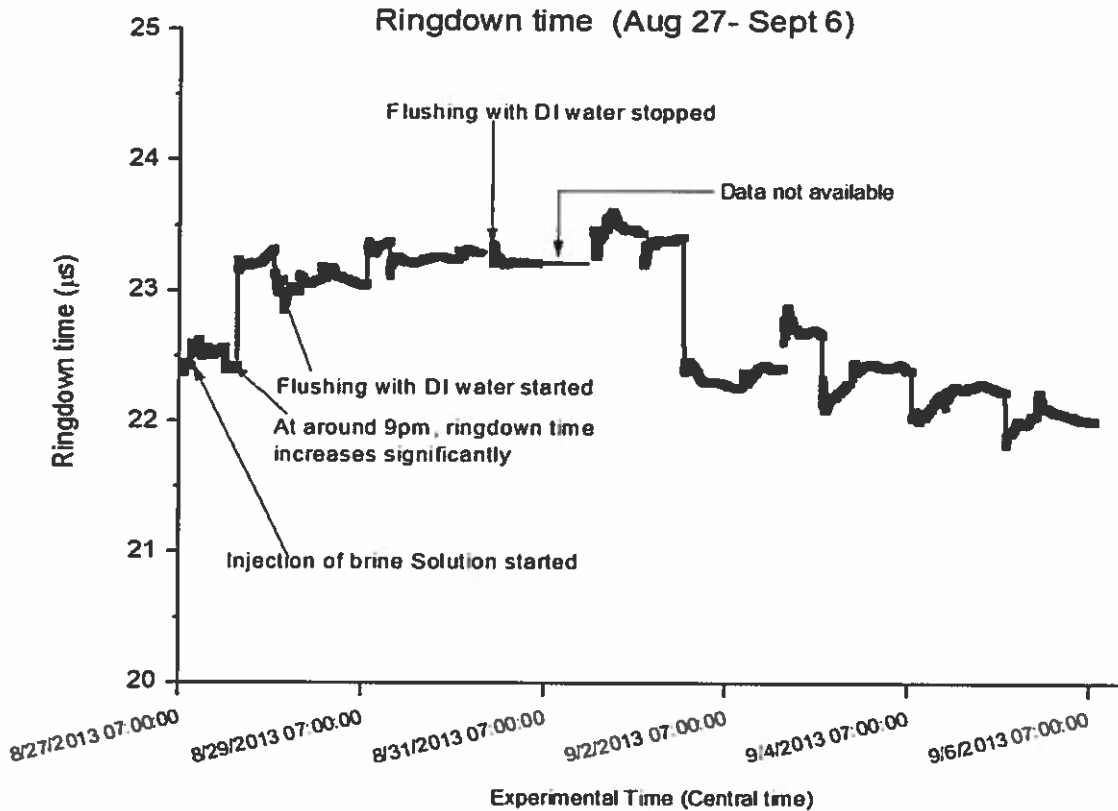
A composite plot for the entire testing period was developed by adjusting the baseline response time to 23.3 μs . The FLRD response time data showed an increase in signal response when moisture level increased and a decrease in signal response as moisture level decreased; (Figure 15). After reviewing the composite plot (Figure 15), fluid quality during the entire fluid injection period (KCl – DI water injection) influenced the FLRD ringdown response time. It is speculated a wavelength shift occurs when the light travels through differing fluid quality. The FLRD ringdown response time slightly decreased when injection fluid transitioned from KCl (average ringdown response time – 23.4 μs) to DI water (average ringdown response time – 23.2 μs). Technical discussion regarding this influence is discussed in Sensors and Actuators B Journal, 2013, “*Reproducibly Reversible Fiber Loop Ringdown Water Sensor Embedded in Concrete and Grout for Water Monitoring*” [10].

Figure 15. – Composite FLRD Fluid Sensor Signal Response for Fluid Injection Test

The FLRD fluid sensors detected moisture level changes during the fluid injection test. The sensor system was able to be re-activated after 15 months and functioned satisfactorily. FLRD data showed after about 10 hours of the initial fluid injection (KCI), the ringdown response time indicated the fluid had reached the sensor location. Adjusting the sensor trigger level from 0.06 V to 0.05 V increased the average ringdown time of 31.5 µs (at trigger level of 0.05 V) as compared to 28.8 µs (at trigger level of 0.06 V) which supplied a continuous data stream indicating the presence of fluid in the grout. The FLRD response time data showed an increase in signal response when moisture level increased and a decrease in signal response as moisture level decreased. Further refinement of the data collection software capacity is recommended. The FLRD fluid sensor data also indicated fluid quality can influence the ringdown response time, but further investigation is needed to confirm this observation.

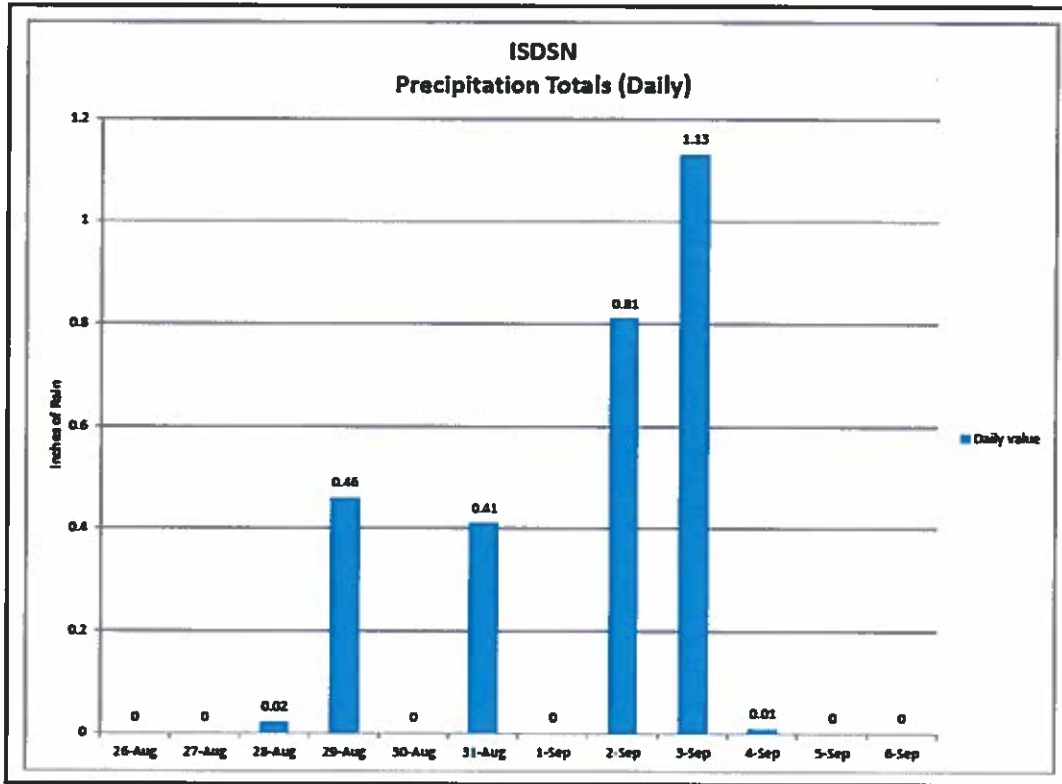
Figure B-3. Daily Precipitation during Fluid Injection Testing Period.

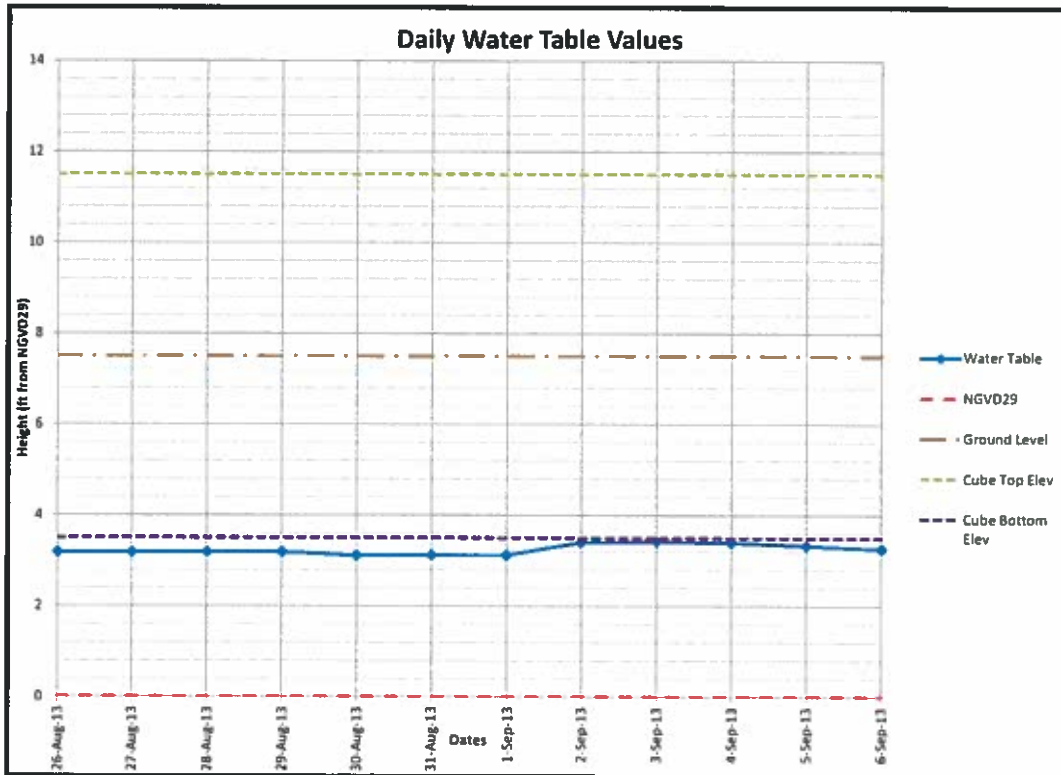
Figure B-5. - Groundwater Level in Reference to the ISDSN-MSTB Test Cube Location
