Development of Permanent Mechanical Repair Sleeve for Plastic Pipe

Final Report

D.O.E. Contract No. 03-NT41880

GTI Project No. 15446

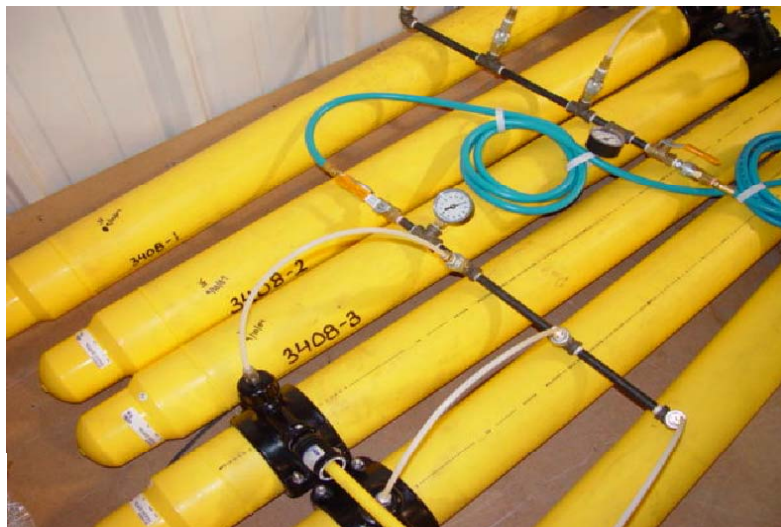
Figure 6. SCG Test Setup

then placed inside the 4-inch pipe assemblies. Plastic tubing (1/4 inch) was inserted through each of the tees and connected to the whip extensions of each of the 2-inch pipe samples with compression fittings. 4-inch SDR 11 end caps were heat fused onto the 4-inch pipe and the entire assembly was connected to individual pressure gauges and connected to a pressure manifold. The test set-up is shown in Figures 4-6.

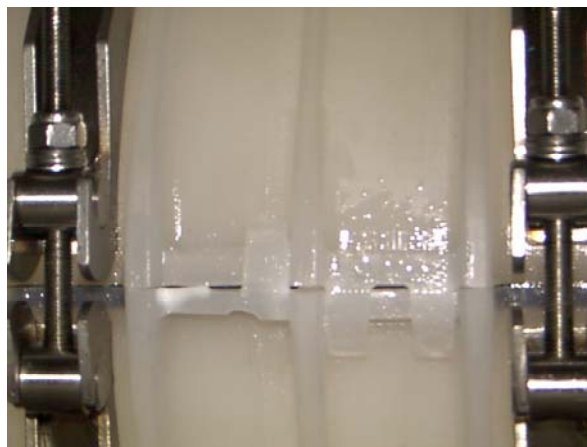
The results of the testing demonstrated that these prototype fittings could not hold water. Due to anomalies in the machined parts and the seals, there were several leak paths that were observed at pressures above 20 psig at the interface of the two fitting halves. Small scale changes were made to the seal and the prototypes were re-tested at higher pressures – 60 psig. Six Belleville washers were placed in series on the stud and compressed by a ¼-28 nut to produce a minimum pre-load on the bolt of \approx 800 lbs. Even with the greater pre-load, both prototype fittings leaked and a slight separation was noted, see Figure 10.

Figure 10. Sustained pressure testing to verify leak tightness of proposed seal design at 60 psig internal pressure

From Figure 10, in addition to the leaks, it was observed that the fitting began to separate between the clamps with the greatest separation occurring on the outer most edge of the rib centered between the two clamps.

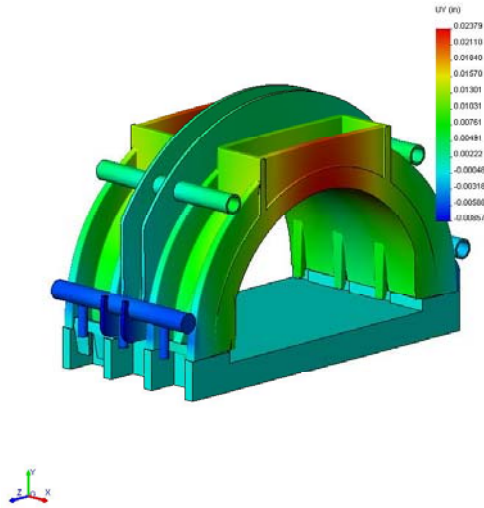
Model name: Collar Clamp analysis half new 4
Study name: PreLoad with 125 PSI
Plot type: Static displacement - Plot2
Deformation Scale: 5

Figure 15. Displacement as viewed from the hinge side (Scale = 1.0)

Figure 15 illustrates the displacement of the fitting in the “Y-axis” as viewed from the hinge side of the fitting with a deformation scale of 1. Figure 16 illustrates the displacement of the fitting in the Y-axis as viewed from the latch side of the fitting with a deformation scale of 5. These plots show separation of the fitting at the inside edge in the range of 3 mils to 7 mils per side or a total of 6 mils to 14 mils. The greatest amount of separation is at the corners of the model shown which would correspond to the center of the bulge in the previous models. It was observed that through the proposed design enhancements, the outside edge of the fitting is holds together preventing extrusion of the seal. The stress appears to be reasonable and the strain will well within the limits of the PA11 material (4%), as shown in Figures 17 and 18, respectively.

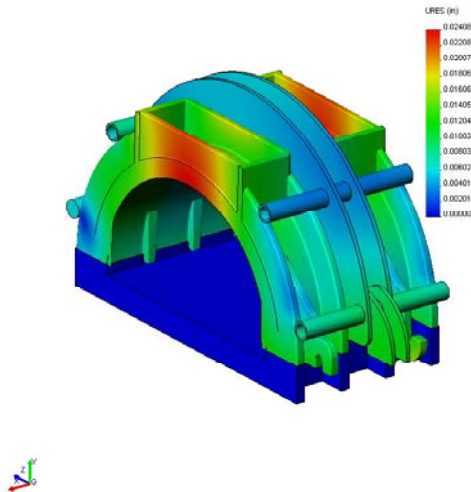
Model name: Collar Clamp analysis half new 4
Study name: PreLoad with 125 PSI
Plot type: Static displacement - Plot1
Deformation Scale: 1

Figure 16. Displacement as viewed from the latch side (Scale = 5.0)

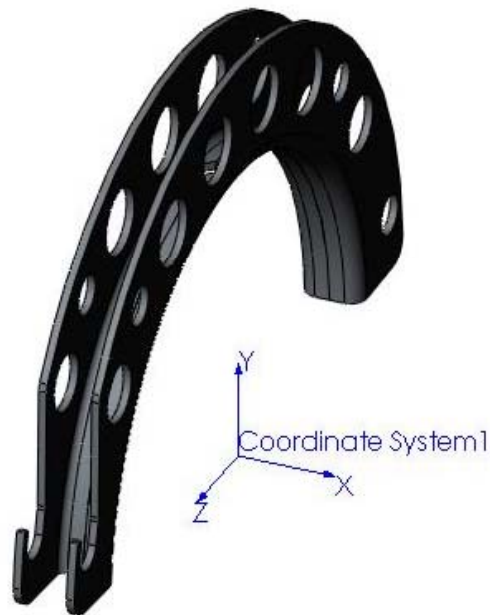
Based on the positive results of the FEA modeling, the clamping structure design was fixed and prototype clamping assemblies were fabricated. The entire clamp structure was constructed from 316 CRES (Stainless Steel). Each collar clamp half was made in two pieces by piercing and blanking the outline of the collar channel and then forming the perpendicular surface. For the prototype, the blanks were laser cut in their flat form to represent a part that would be produced on a pierce and blank die. Two simple tools, one for the small collar clamp and one for the large collar clamp, were built that could be loaded in a hydraulic press brake for forming the perpendicular radial surface. Two blanks were loaded in the forming tool where one cycle of the tool produced a left and a right version of the part. Laser cutting the blank allowed for easily changing and optimizing the shape of the blank to produce a formed part needing only minimal cleanup before the welding process. The formed left and right parts were then placed into a welding fixture where a stitched seam weld was placed on the inside of the channel making the two pieces into one half of the collar clamp as shown in Figure 19.

Figure 19. Small collar clamp
