# Design, Fabrication and Testing of An Infrared Ratio Pyrometer System for the Measurement of Gasifier Reaction Chamber Temperature

## FINAL REPORT

Period of Performance: October 1, 1999 through September 30, 2006  
Report Issued: September 2006  
DOE Award No. DE-FC26-99FT40684

GE Energy  
1333 West Loop South  
Houston, Texas 77027

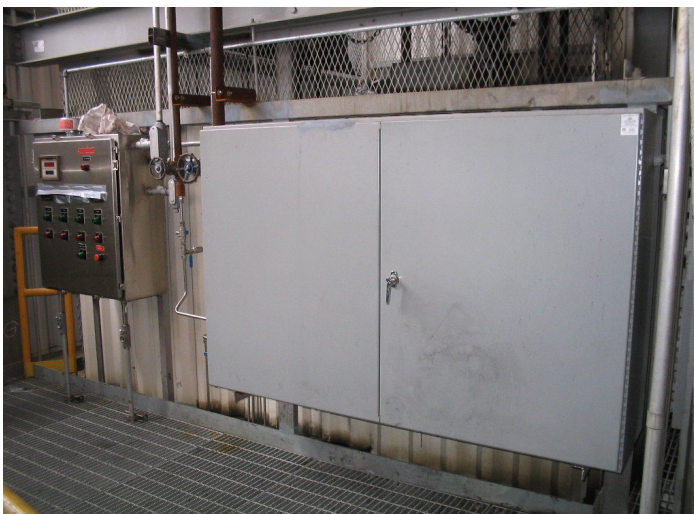
Figure 1 shows the equipment that was shipped to the test site in Polk County, Florida. It consisted of two control boxes and a series of items that bolt directly to the gasifier to form the pyrometer optical train. One of the control boxes contained electrical components, including the pyrometer transmitter and the Programmable Logic Controller (PLC) that ran the entire system. The second control box contained all of the pressure and flow control valves and instrumentation for the sight tube purging and sight glass safety systems. The two control boxes were sent first so that field installation of utilities and instrument connections could begin as soon as possible. The elements of the optical train were shipped shortly before actual testing began. All components for the entire system arrived safely and in good condition at Tampa Electric's Polk County Power Station.

Figure 1a. Equipment Shipped to Test Site – Control Boxes

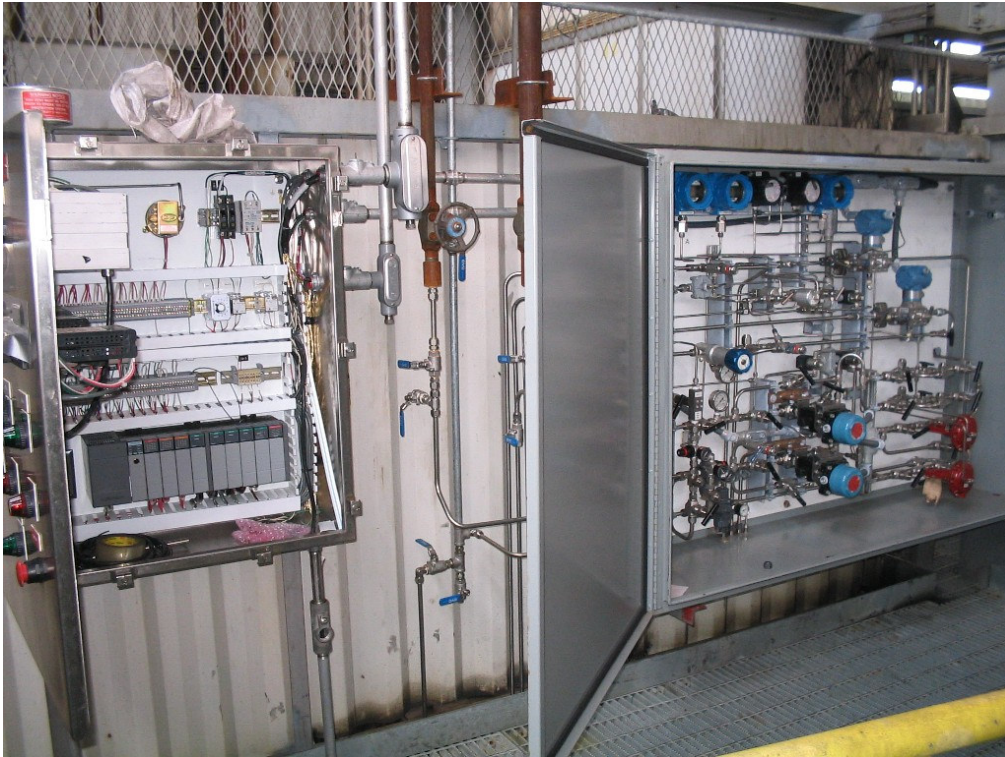
Mechanical installation occurred in two phases. First, the two control boxes were installed in close proximity to the connection point on the gasifier where the pyrometer would be located. Later on, the pyrometer optical train was bolted onto one of the flanges on the sidewall of the gasifier that normally was used for a gasifier thermocouple. The insertion point on the gasifier was prepared by removing the existing thermocouple, redrilling the hole through the refractory lining of the gasifier to a diameter that was large enough to accommodate the pyrometer sight tube and then installing the sight tube and the rest of the optical train equipment. This installation procedure, as well as the optical alignment procedure, were described in the final report for Phase 1. Figure 2 shows the interior of the two control boxes installed on site. Figure 3 shows the pyrometer optical train installed on one of the gasifier thermocouple nozzles.

Figure 2. Interior of Installed Control Boxes Installed Near Pyrometer

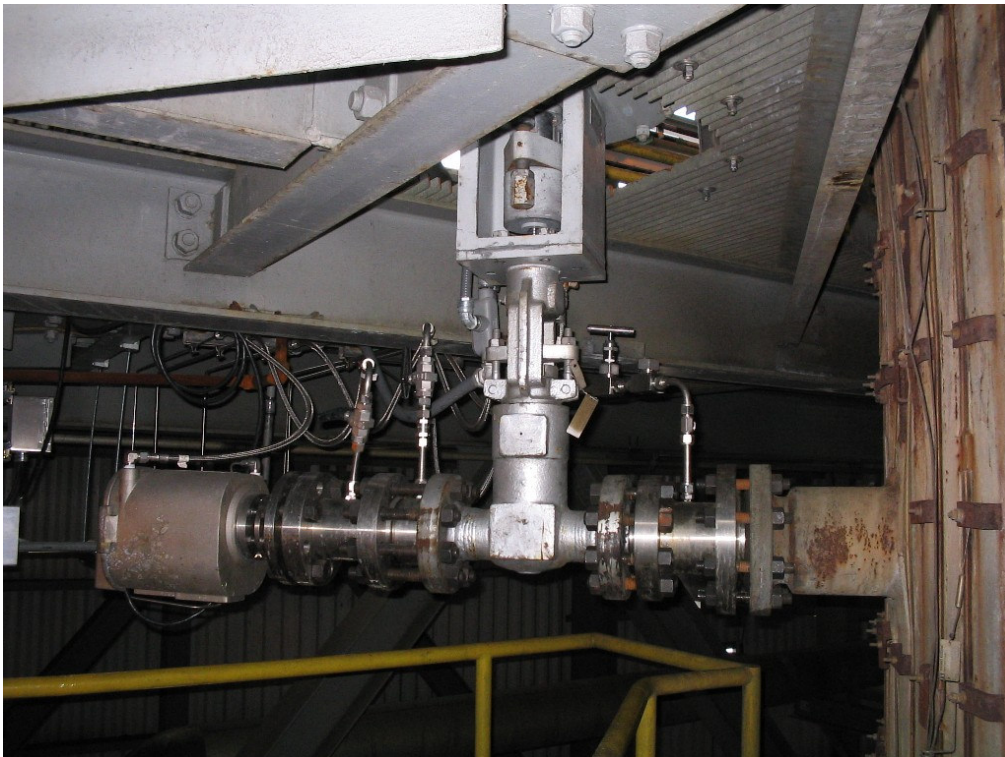
Figure 3. Pyrometer Optical Train Installed on Gasifier Nozzle
