ANL-6059
Metallurgy and Ceramics
(TID-4500, 15th Ed.)
AEC Research and
Development Report

EXAMINATION OF IRRADIATED EXPERIMENTAL
NRU FUEL RODS

Final Report of Metallurgy Division
Program 6.1.25

November 1959

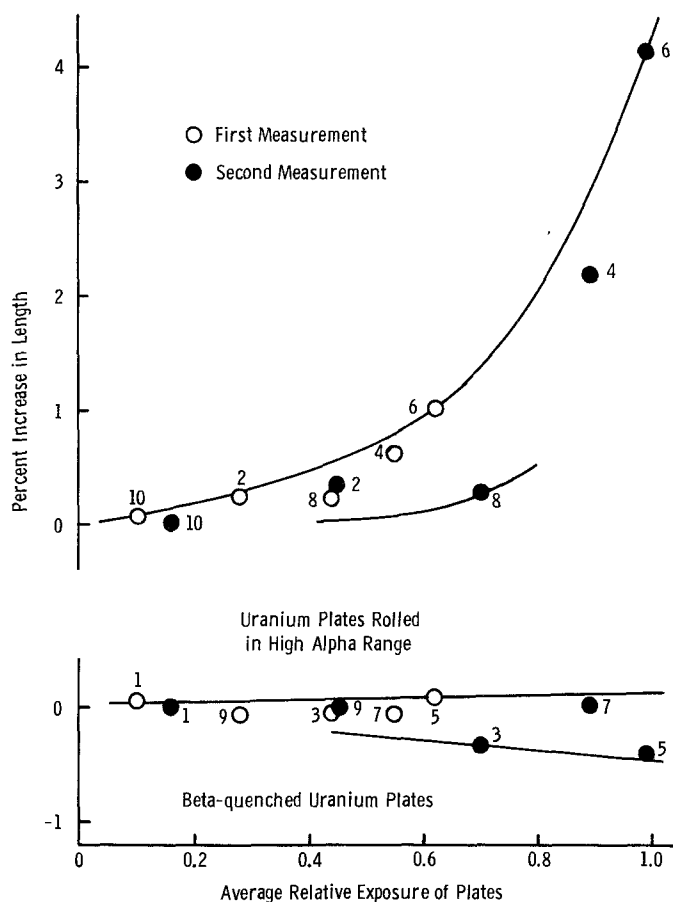
Figure 2 Elongation of Flat Plates as a Function of Relative Exposure

A typical difference between the dimensional stability of as-rolled and beta-quenched materials is shown by the group of flat plates. If it be assumed that buckling of the reactor flux is essentially a cosine function falling off to zero at the ends of the composite rod, the relative exposures of the various plates may be computed and dimensional changes may be plotted as a function of a burnup ratio. The data which result from these assumptions are given in Table I and have been plotted in Figure 2. It will be seen at once that the as-rolled material, after an initial low-growth exposure, tends to elongate rapidly, whereas the beta-quenched material either remains nearly unchanged or tends to a slight shrinkage. This relative behavior is to be expected from the

metallurgical history of the materials, (7,8) but, in the test under consideration, the sheath has apparently provided considerable restraint to the as-rolled specimens so that the elongation is initially retarded. The reactor flux probably is not exactly defined by a cosine function. However, so interrelated are the data from the various plates (plate numbers are shown on the graph) that reducing the scatter of the points would accentuate the restraining effect just mentioned.

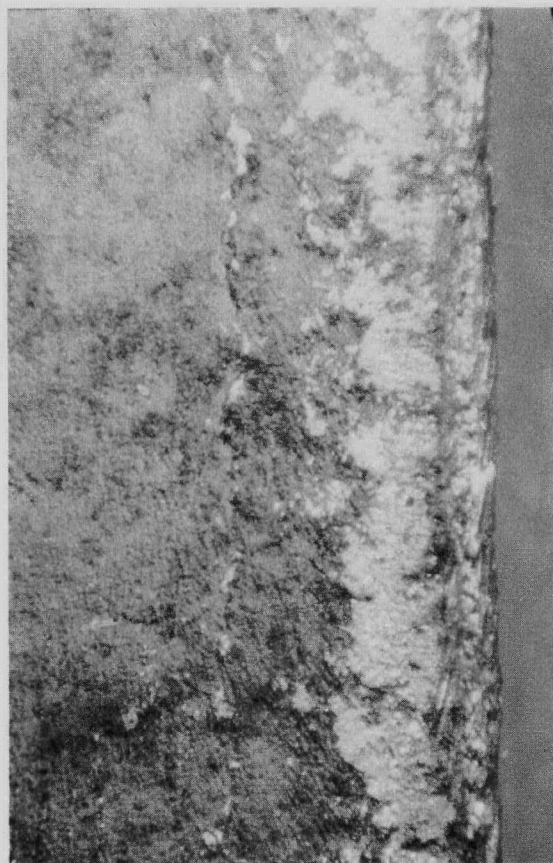
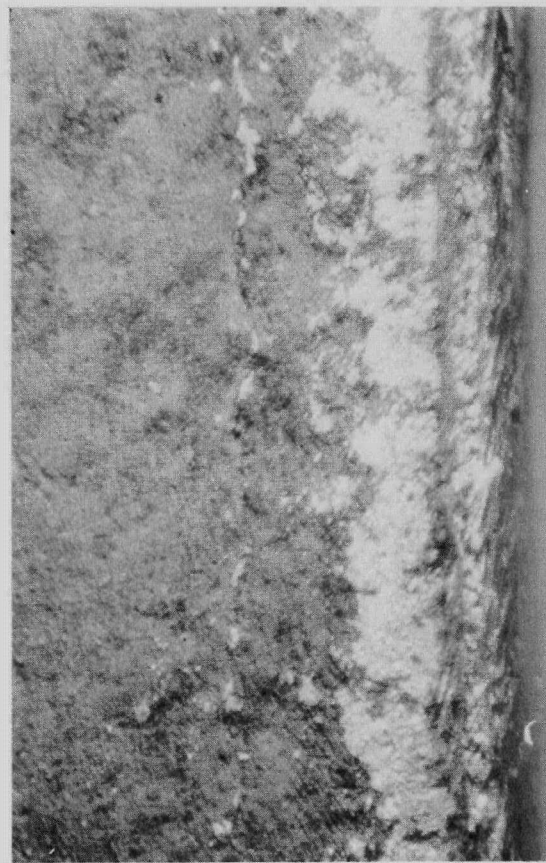
17254

Figure 4. Magnified View of Plate No. 2 at Edge. Raised edge, parallel fissure, and adhering aluminum are seen clearly in this stereo.

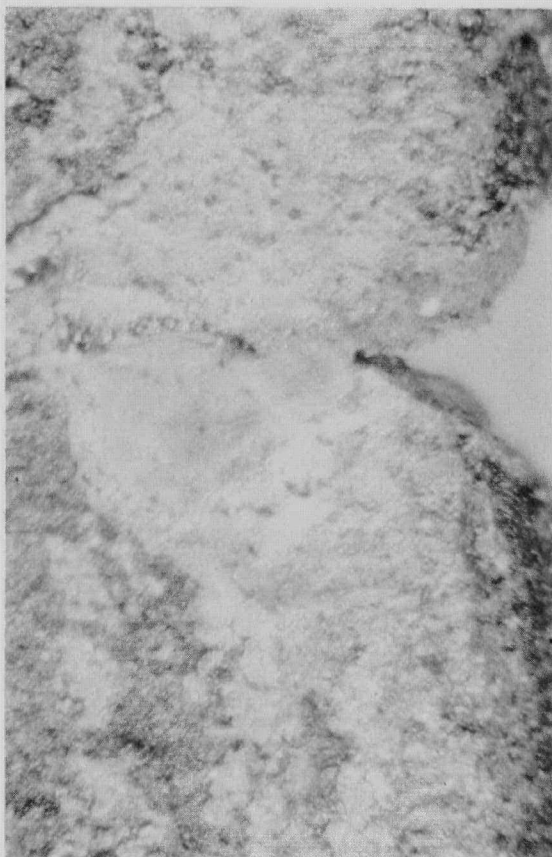
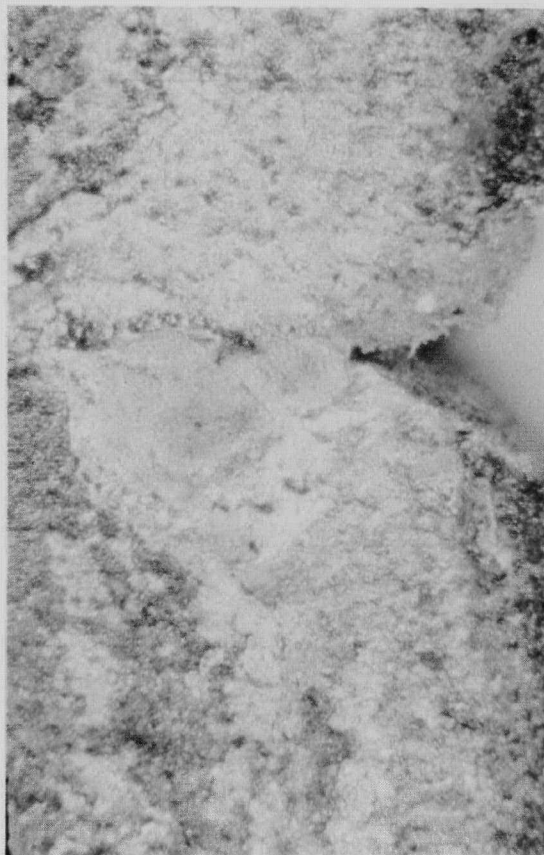
17252

Figure 6. Greatly Enlarged View of Aluminum Fused to Edge of Plate No. 2. Notch is fiducial mark used for radiographic dimensioning of plate before removal of sheath.

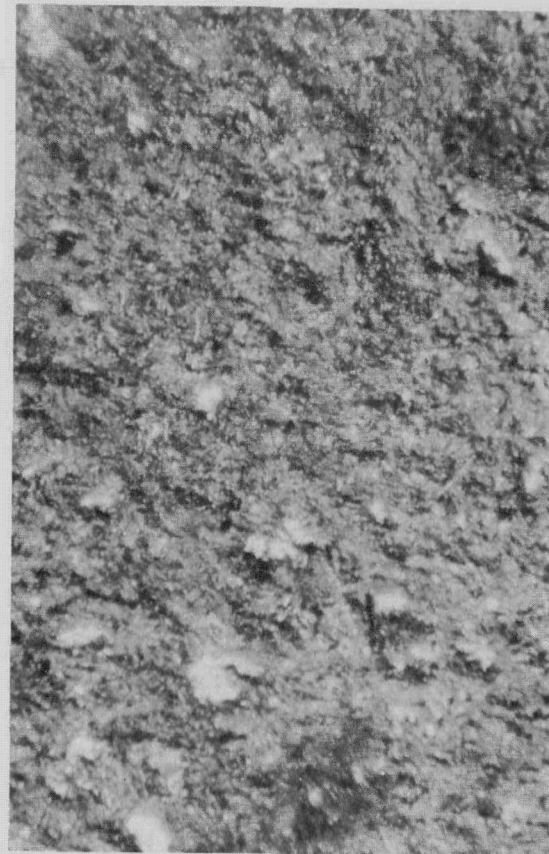
17251

Figure 9. Typical View of Surface near Middle of Plate No. 5. Note evidence of poor contact between sheath and core.

On the basis of initial examination it was reported that there was no visible deterioration of the sheath, and that the sheath uranium contact appeared to be very good on those specimens which were stripped.⁽⁶⁾ Additional examination indicates that this view may be overoptimistic. That contact was very good at the edges of the plates is evident from an examination of Figures 4 and 8, for here a fairly general metallurgical bond had formed between core and clad. However, contact away from the edges was evidently not so good (Figures 5 and 9), especially as surface roughness increased with irradiation time.

Judging from Figure 9 and applying a proper scaling factor, the peak-to-valley relief on the surface of the beta-quenched specimen (No. 5) is approximately 0.020 in. The thickness data in Table III indicate that nearly half of this relief was produced during irradiation. The Canadian report⁽⁶⁾ mentions that surface roughness was slightly increased at the end of irradiation. Only the highest peaks were apparently in metallurgical

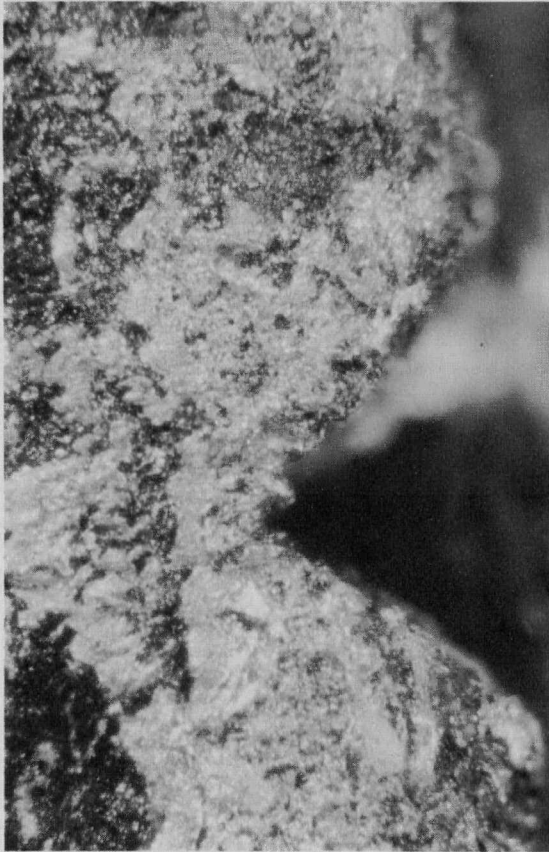
17253

Figure 10. Greatly Enlarged View of Aluminum Fused to Edge of Plate No. 5 at Fiducial Notch

contact with the cladding, judging from the appearances of the specimens as shown in Figures 7 and 8. Thus, even for the dimensionally stable beta-quenched material, progressive worsening of the flat surface contacts would tend to increase the heat flux and the temperature at the edges. There are quite definite indications that incipient eutectic melting between clad and core had occurred (Figure 10).
