DOE/NV--1075

Post-Closure Inspection and
Monitoring Report for Corrective
Action Unit 110: Area 3 WMD
U-3ax/bl Crater, Nevada Test Site,
Nevada For the Period July 2004 -
June 2005

August 2005

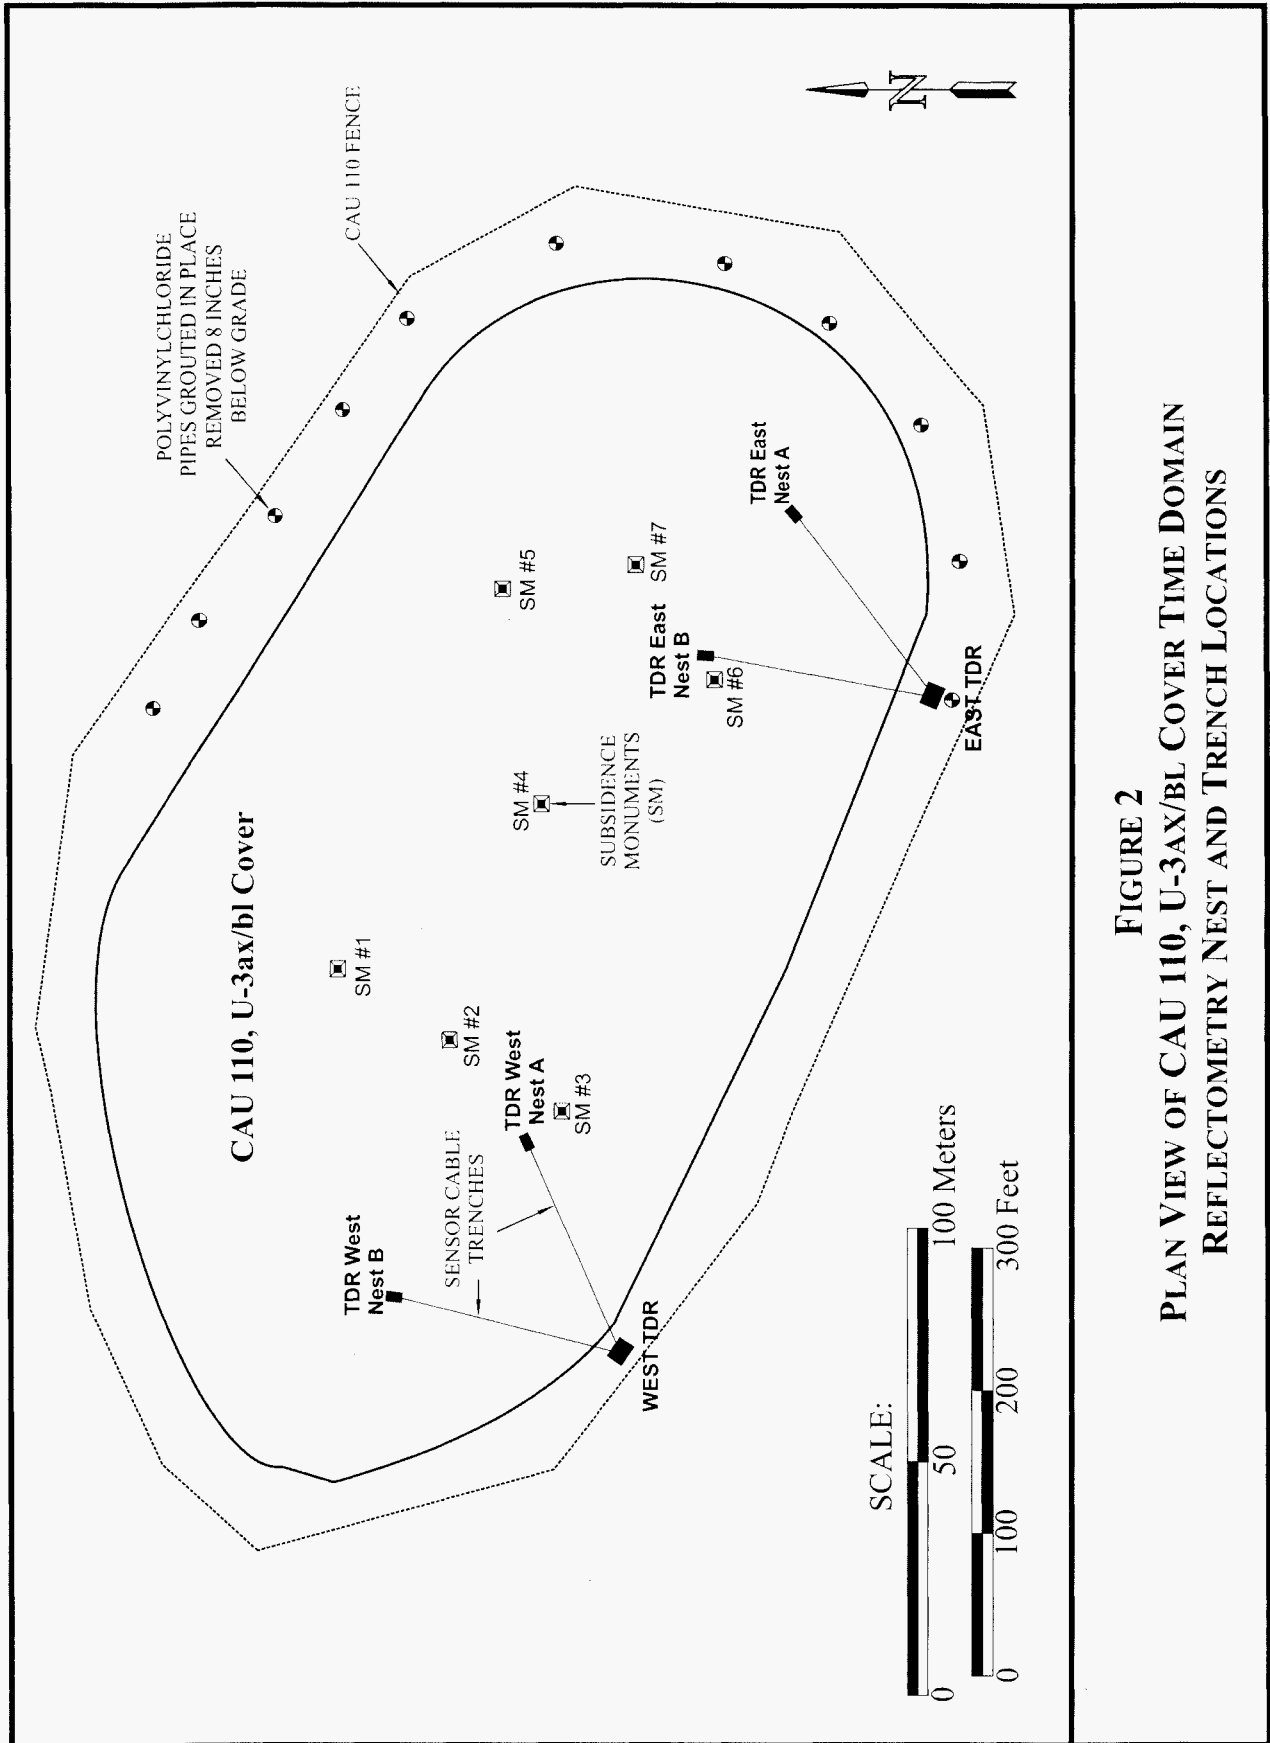
FIGURE 2
PLAN VIEW OF CAU 110, U-3AX/BL COVER TIME DOMAIN
REFLECTOMETRY NEST AND TRENCH LOCATIONS

The CAU 110 cover is designed to limit infiltration of precipitation into the disposal unit by evapotranspiration of vegetation on the cover. The cover performance is monitored using Time Domain Reflectometry (TDR) soil water content sensors that are buried at 0.3 m (1 ft) depth intervals up to 2.4 m (8 ft) within the waste cover to provide water content profile data. TDR probes are installed at a distance of 50.3 m (165 ft) from the southern edge of the cover. A profile of eight probes (a stack) is repeated at four locations across the cover (Figures 2 and 3). The soil water content profile data are used to determine whether the cover is functioning as designed. Soil moisture content data from the TDR moisture probes are recorded daily and stored on a datalogger. The data are downloaded remotely over a radio/telephone link.

The CAU 110 cover boundary is defined by the fence installed around the cover, which is approximately 3.0 hectares (7.5 acres). The point of compliance is at the deepest TDR soil moisture probe (2.4 m [8 ft] below the cover surface). Compliance will be set based on soil moisture content; however, the specific criteria will not be established until enough data have been collected during average site conditions to establish a realistic compliance level. Once the soil moisture content within the cover reaches equilibrium under normal or above average precipitation conditions, soil moisture compliance values will be agreed upon with the NDEP. During this monitoring period, the response of the cover under above average precipitation conditions was observed and compared to predicted performance. Once the cover reaches equilibrium, which is expected to occur during the next reporting period, a compliance level can be set.

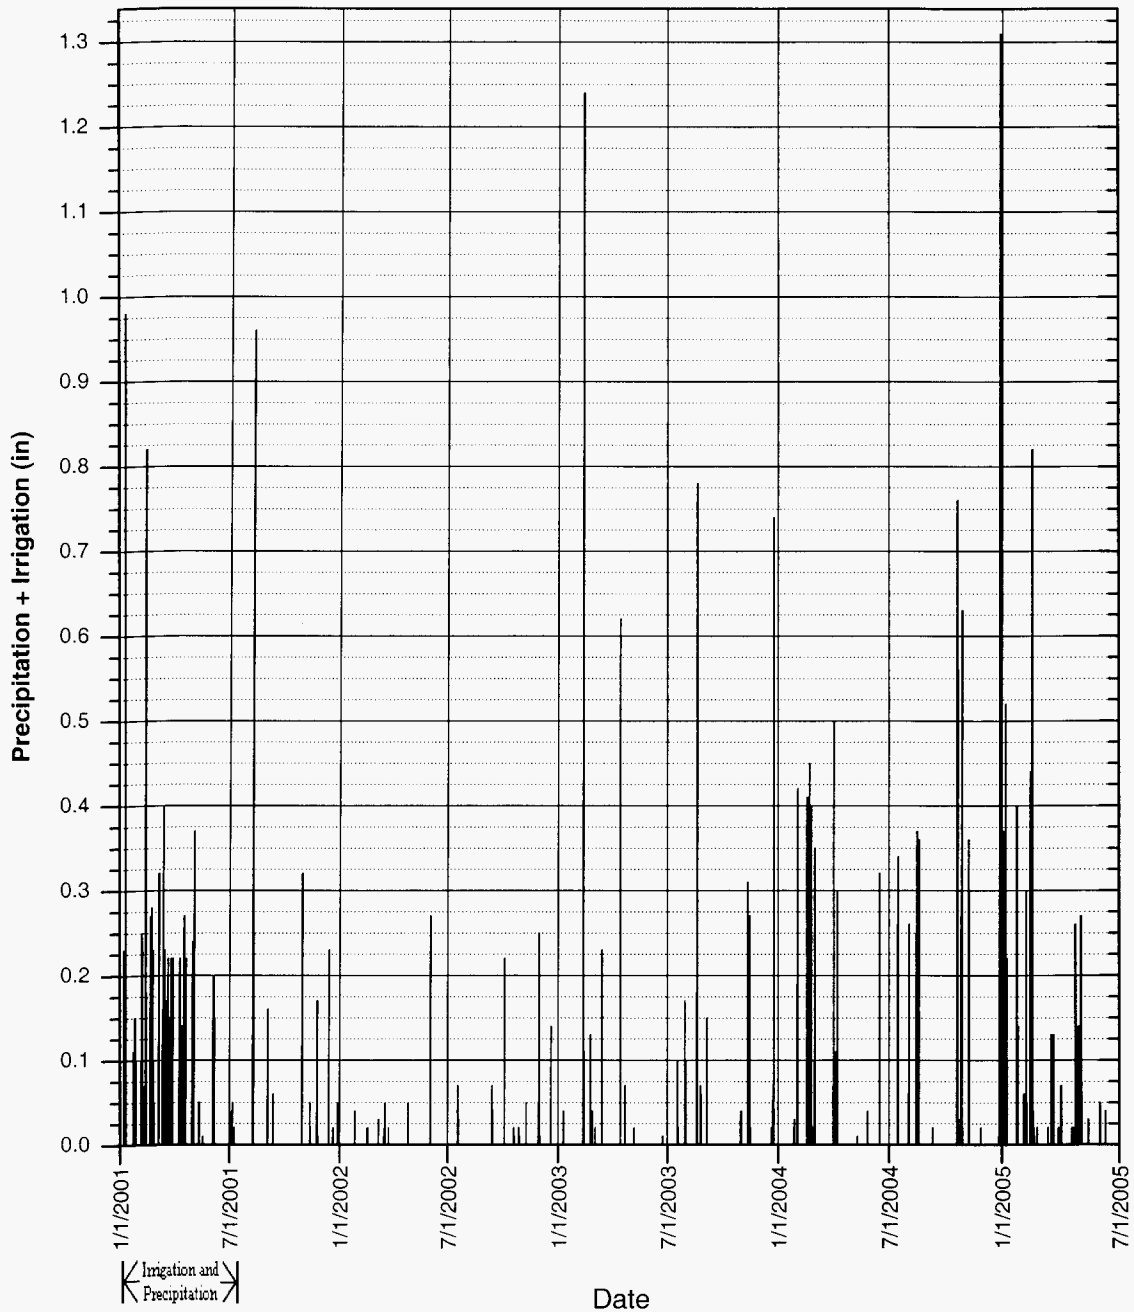
FIGURE 4
PRECIPITATION DATA FOR METEOROLOGICAL
STATION BUSTER JANGLE Y

During this reporting period, the cover has been subjected to above average precipitation and is currently reaching equilibrium from these events. It is expected that by the end of the next reporting period the soil moisture compliance level can be established.

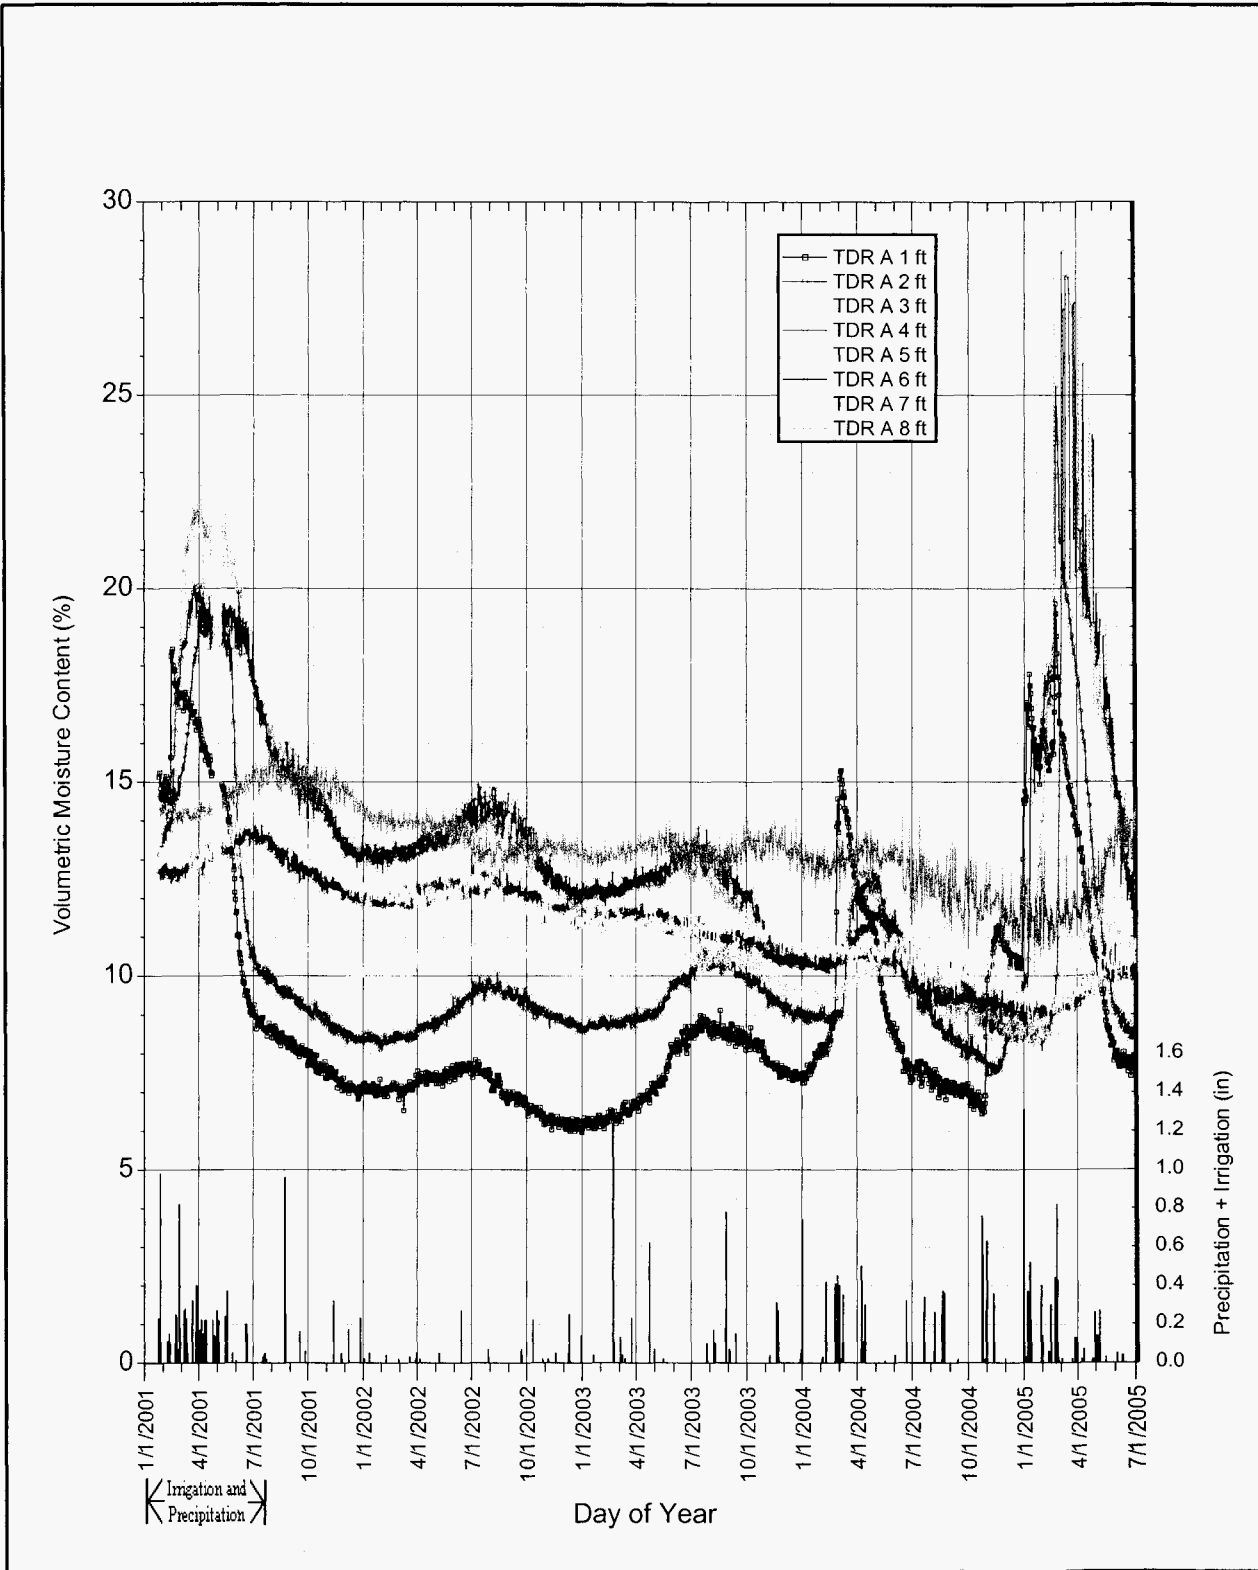
FIGURE 5
EAST TDR NEST A SOIL MOISTURE CONTENT

The soil moisture graphs, Figures 5 through 8, show several responses: the initial conditions, the irrigation wetting event, infiltration, and the trend to steady-state conditions. The initial conditions at the beginning of the data collection reflect the disturbed soil's intrinsic moisture conditions. The installation of the TDR probes is described in detail in the CAU 110 Closure Report (NNSA/NV, 2001). Health and safety considerations required that hazards caused by dust be minimized during the TDR probe installation; the trenching and compaction of each of the soil lifts required some water to be added to the soils prior to handling. The amount of water added to the soil, while kept to a minimum, was variable and resulted in a vertical moisture content profile that is not necessarily monotonic with depth as would be expected with a natural profile. Consequently, some depths appear wetter than others and will remain so until the system fully equilibrates.

The TDR data indicate that the soil moisture content in the CAU 110 cover had been approaching steady-state under the prior drought conditions. A small amount of infiltration from the January through March 2005 precipitation events has reached down to 2.1 m (7 ft) in the cover at some of the TDR nests, and can be seen as a 2 percent increase in soil moisture content at 2.4 m (8 ft) in the East TDR Nest A data. Soil moisture content values on the TDR nests at depth are generally between 10 and 15 percent VMC, while moisture content on near surface probes increased significantly due to the heavy precipitation received between January and March 2005. Moisture content values between 25 and 30 percent VMC extended to 1.5 m (5 ft) on all the TDR nests and then showed progressive drying in the near surface to less than 10 percent VMC by the end of June. The wetting front on the West TDR Nest A has caused a loss of signal due to the high moisture content (greater than 30 percent VMC) at the 1.5-m (5-ft) depth in conductive soil. It is expected that data for this probe will recover as evapotranspiration lowers the soil moisture content and the VMC returns to the normal operating range.

The general increase in soil moisture content that occurred after April 2002 at the East TDR Nest B noted in the previous report was not the result of an instrumentation problem but is due to the soil in that nest reaching equilibrium.

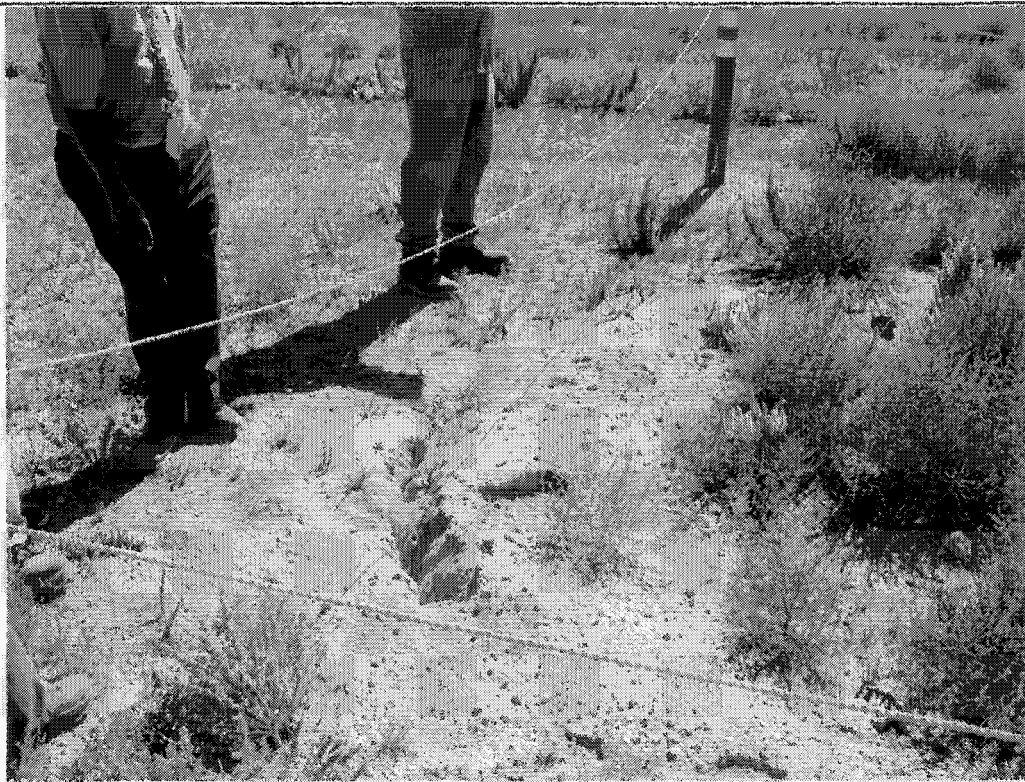
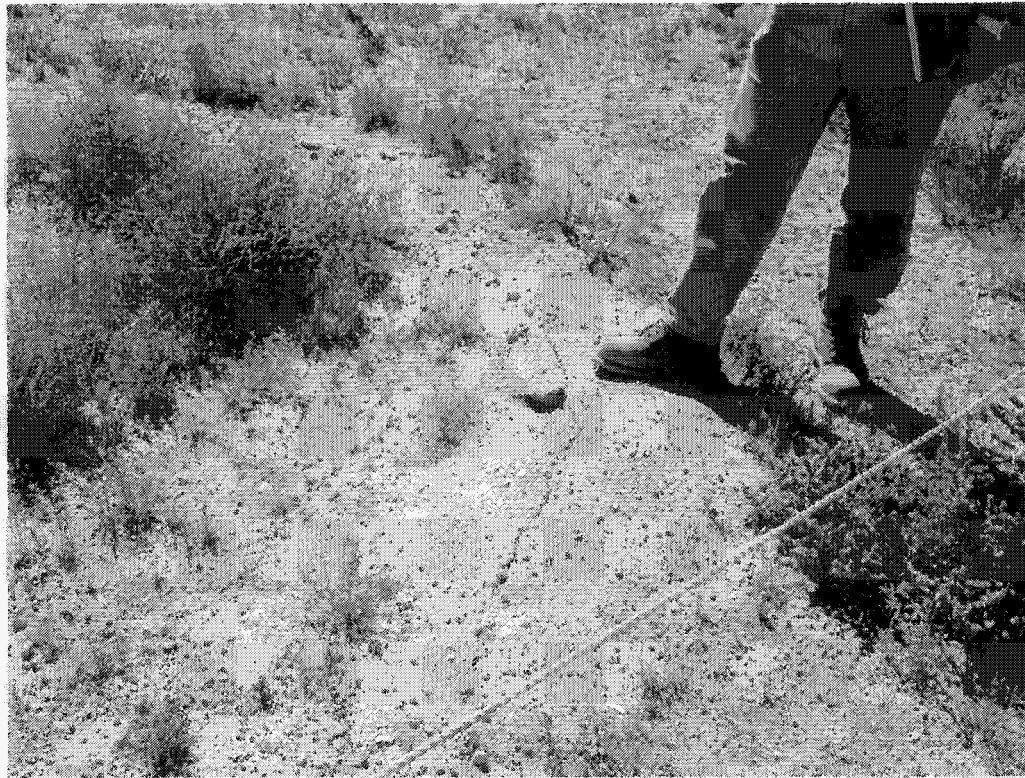
- Two areas of cracking and settling (one along the east side of the cover and one along the southeast side of the cover) were at actionable levels. The area along the east side of the cover had been repaired on three previous occasions.
- Animal burrows were noted on the cover.
- The condition of warning signs, fencing, subsidence monuments (SMs), and cover vegetation was good.

During the September 14, 2004, inspection, two areas of settling (one along the east side of the cover and one along the southeast side of the cover) exceeded the settling compliance criterion. The area along the east side of the cover had been repaired on three previous occasions. The two areas were repaired on October 25, 2004. A portable, gas-powered tamper was used to collapse the cracks and open up the void spaces to the surface. The areas were then backfilled with clean soil using wheelbarrows and shovels, and compacted using the tamper. During the repair, a third system of cracks was noticed near the area along the southeast side of the cover. This area was also repaired during this time. Field notes for this repair are included in Appendix A.

11. Subsidence area along southeast side of cover.

12. Subsidence area along southeast side of cover.

- Continue inspections as scheduled.
- Repair the two areas of cracking and settling.

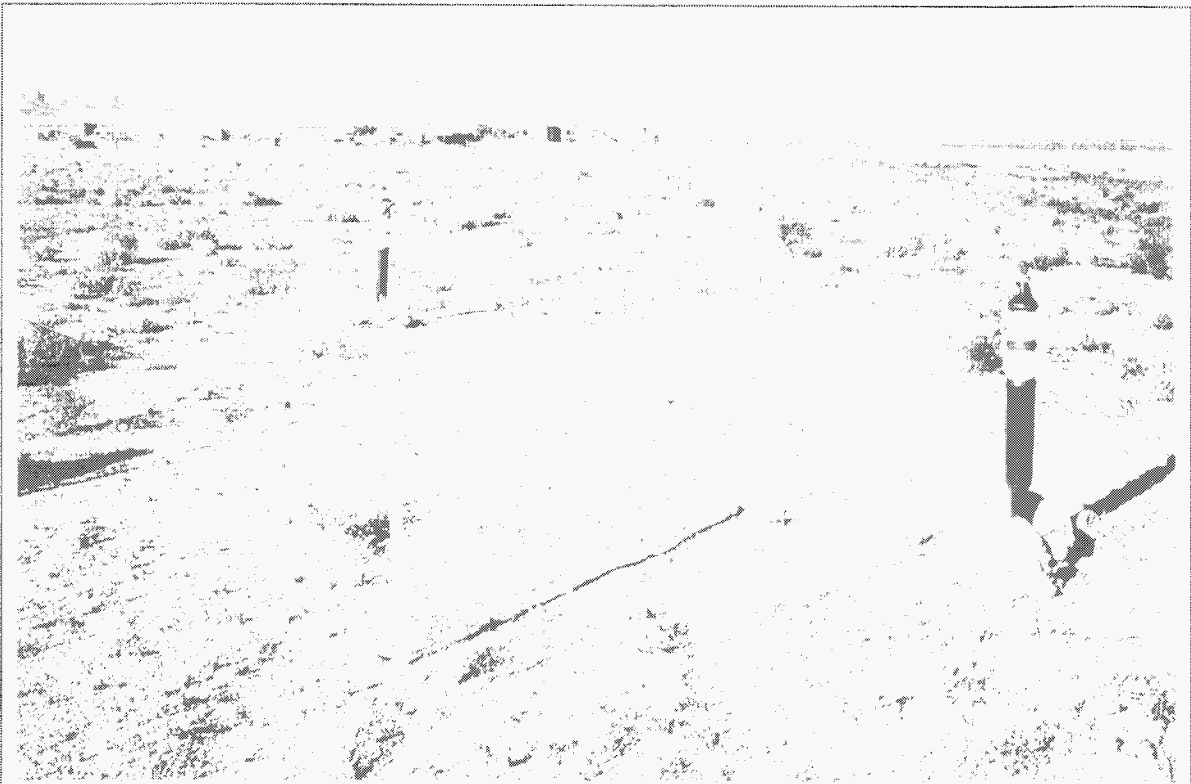
- The two areas of cracking and settling were repaired on October 25, 2004, and were in good condition during this inspection, with no indication of further cracking or settling.
- Animal burrows were noted on the cover.
- The condition of warning signs, fencing, SMs, and cover vegetation was good.

9. Repaired area along east side of cover.

- Continue inspections as scheduled.
- Monitor repaired areas for evidence of further settling.

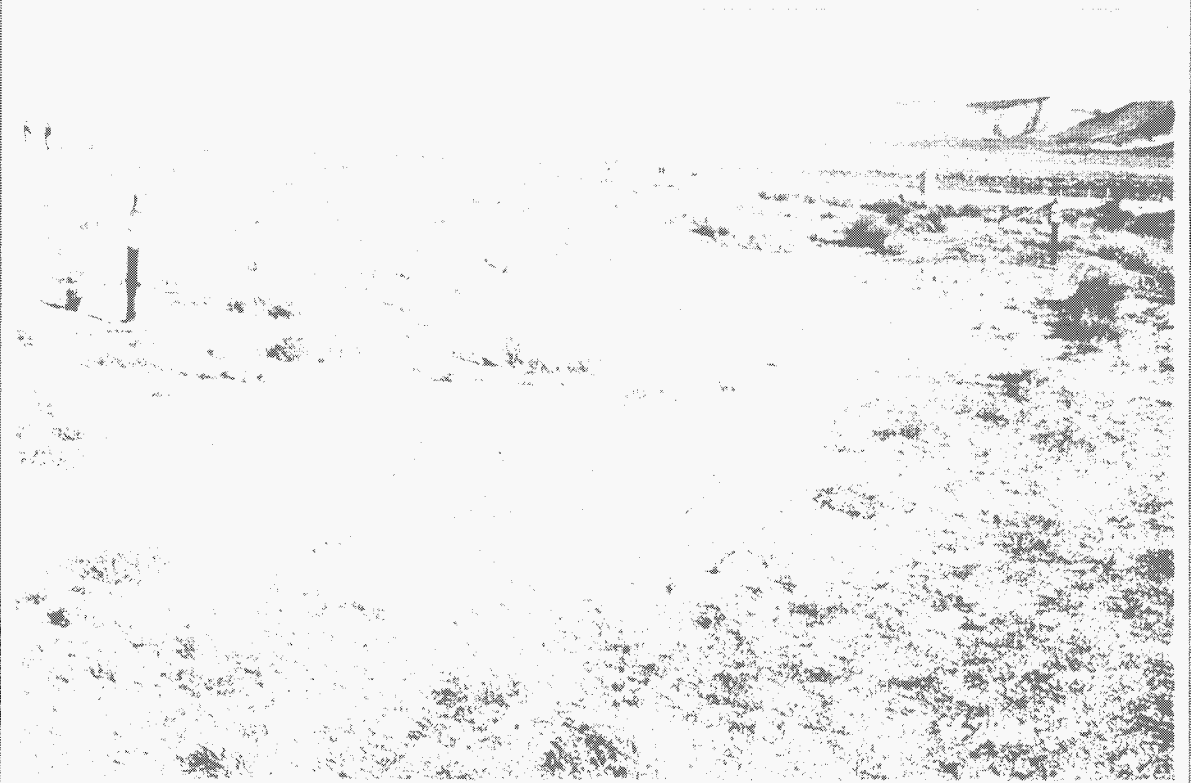
10. Two repaired areas along southeast side of cover.

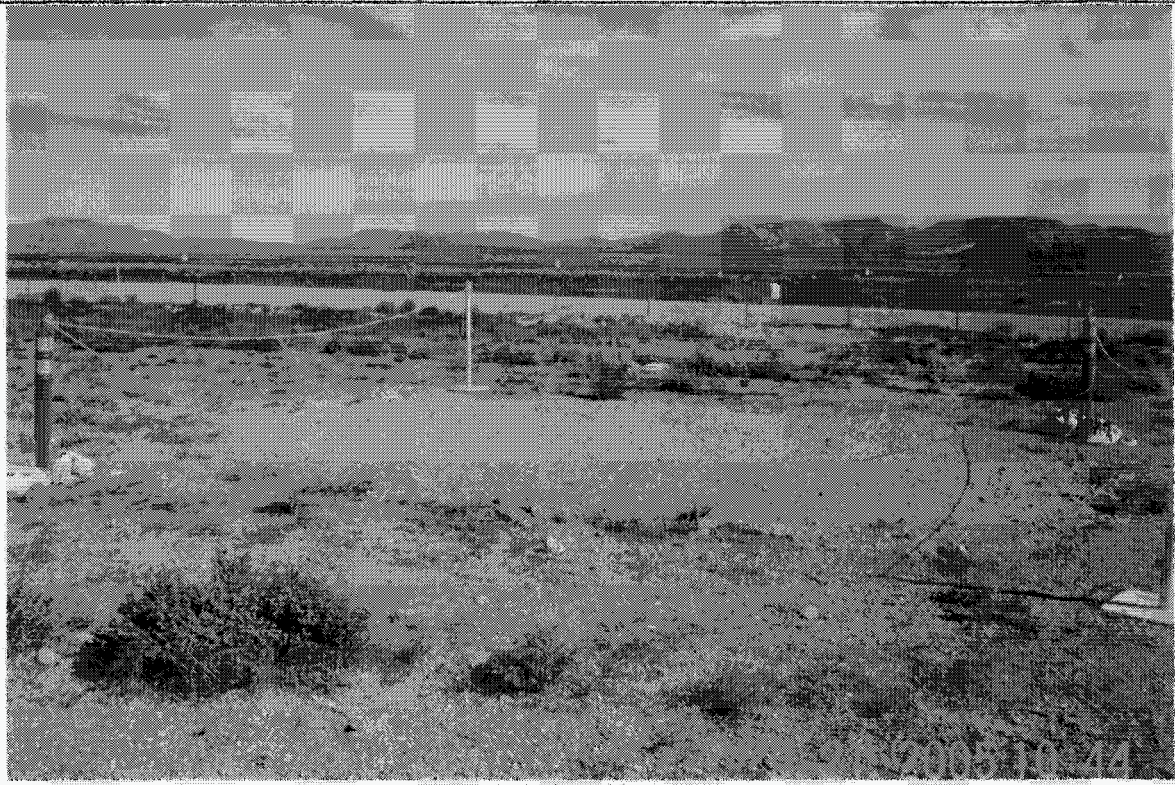
- The previously repaired areas were in good condition with no indication of cracking or settling.
- Animal burrows were noted on the cover.
- The condition of warning signs, fencing, SMs, and cover vegetation was good.

9. Repaired area along east side of cover.

- Continue inspections as scheduled.
- Trap and relocate small mammals in approximately April, June, and September of 2005.
- Monitor repaired areas for evidence of further settling.

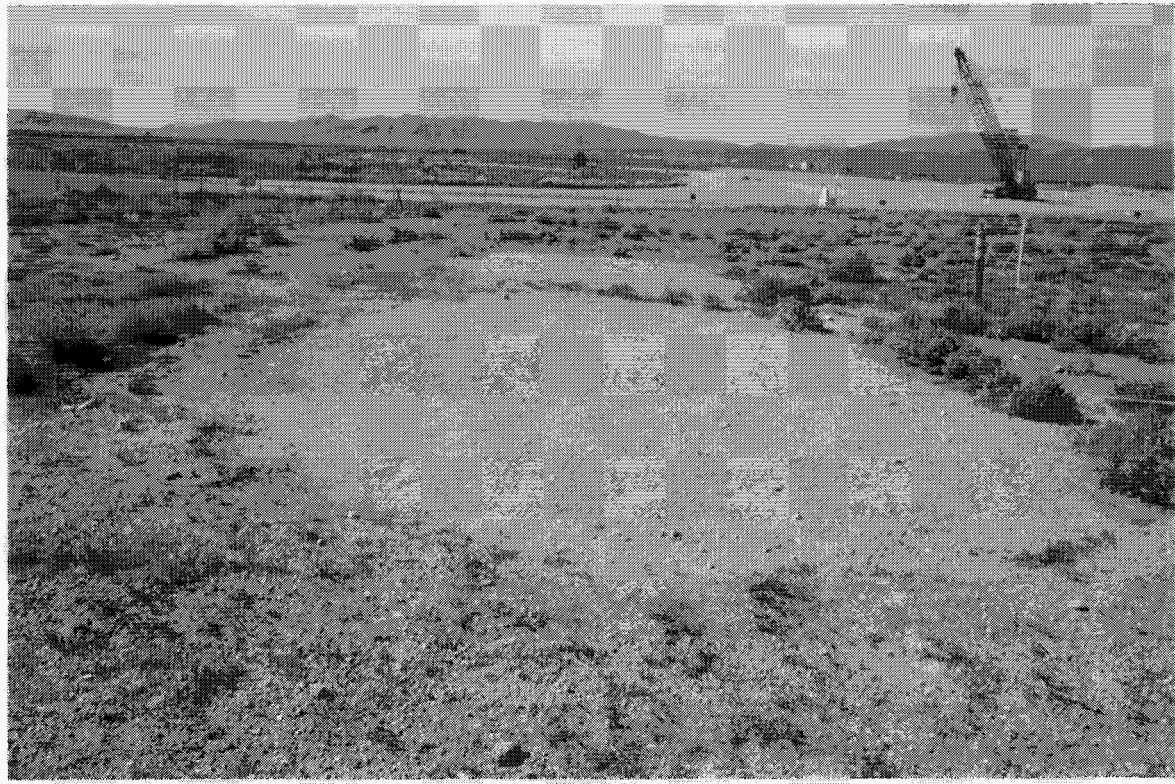
10. Two repaired areas along southeast side of cover.

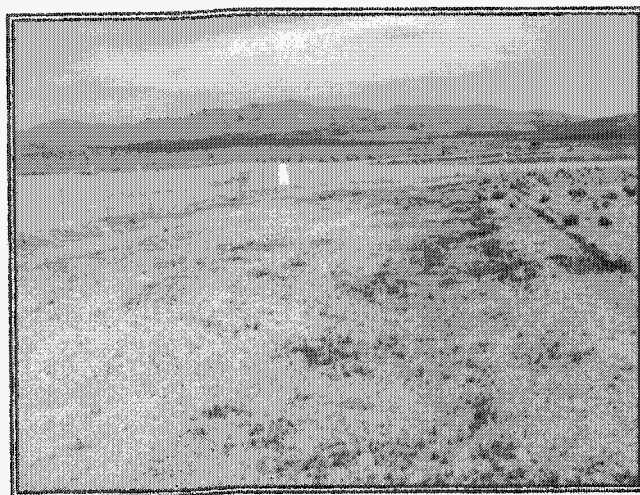
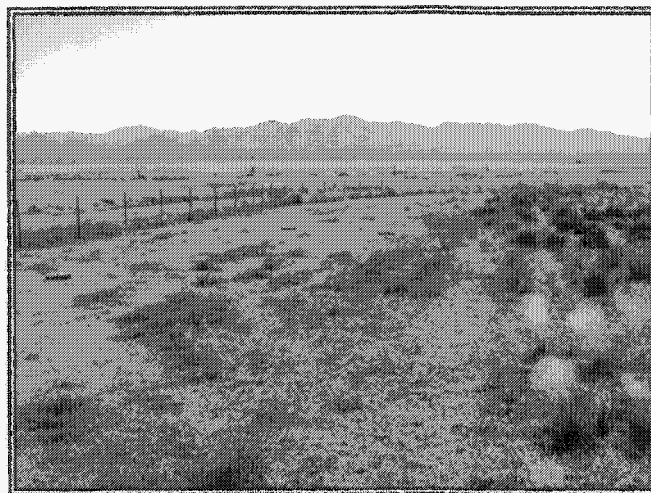
Figure 3. Invasion of weedy annual plants on the periphery of the closure cover. Photograph on left is from 2004 and shows beginning of invasion of Russian thistle and halogeton. The photograph on right was taken in 2005 and shows larger annual plants but no perennial plants.

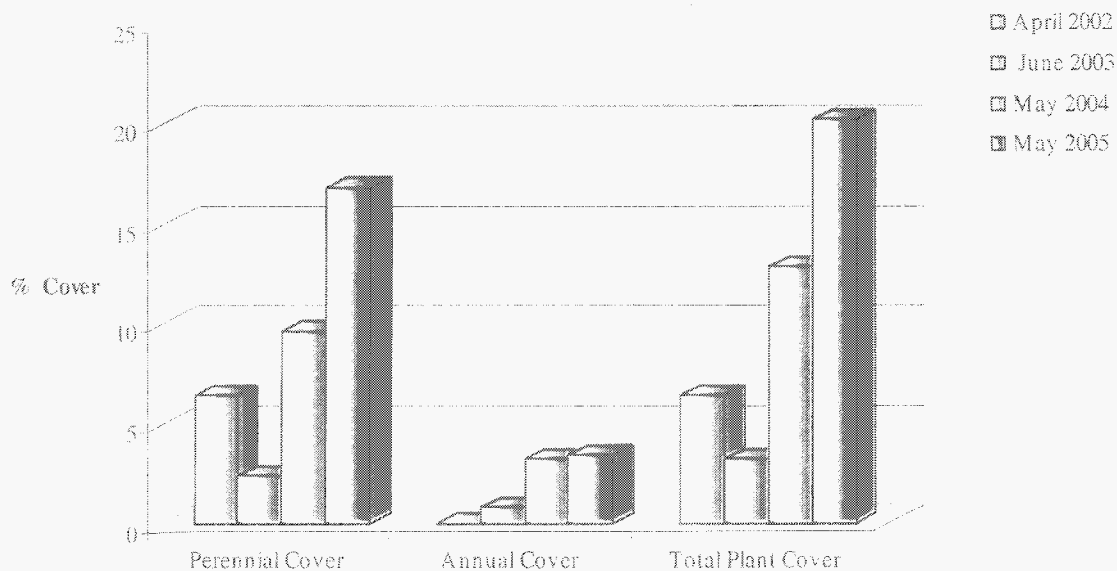
The trend in total plant cover over the last 4 years is as would be expected. After an initial flush of growth the second year after reseeding, due primarily to supplemental irrigation, plant cover declined in 2003 (Figure 5). Natural precipitation was below normal in 2003, as it had been in 2001 and 2002. Without supplemental irrigation, germination would have been less successful, and total plant cover would probably have been even lower than what was experienced the first three years after reseeding. It is due to the 17 percent plant cover this year that the native plant community on the closure cover is viable and able to endure the fluctuations in precipitation that is more typical than atypical for this region (Figures 8-12). The species of plants used in the revegetation process

Figure 5. Summary of total plant cover on the U-3ax/bl closure cover from April 2002 to May 2005.

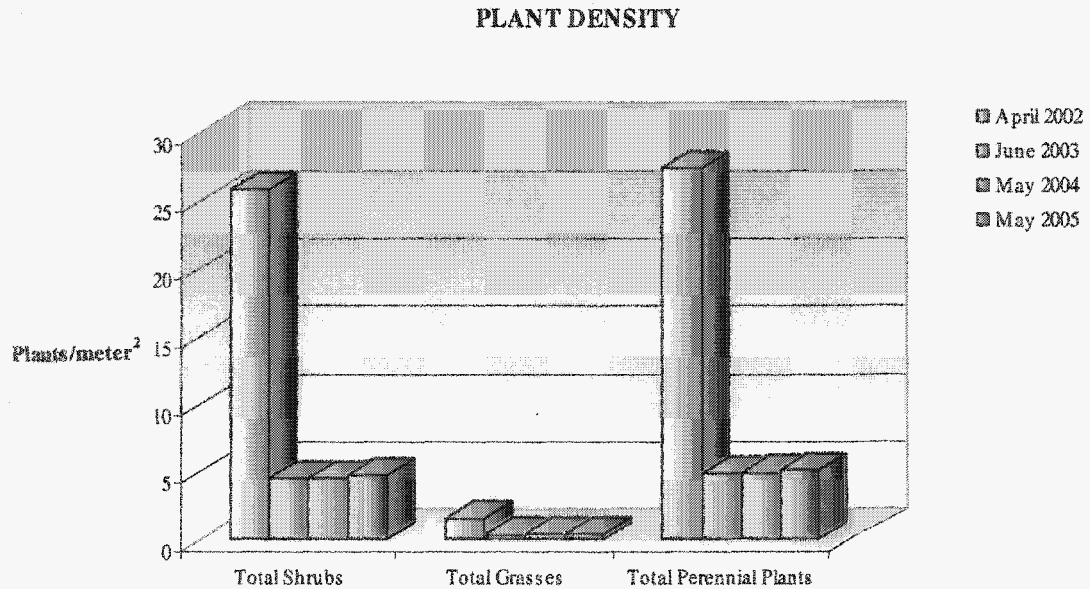
Figure 6. Summary of perennial plant density on the U-3ax/bl closure cover from April 2002 to May 2005.

The plant community on the closure cover is becoming well established. The density of perennial plant species has remained the same over the last three years. Plant cover has increased to over 20 percent, well above the goal of 12 percent. There is no indication that remedial revegetation is necessary. Vegetation monitoring in future years should focus on annual weedy species, specifically halogeton, cheatgrass, and Russian thistle. If these species increase in density and cover, and appear to have a detrimental effect on the perennial plant species, as evidenced by decreases in perennial plant cover and/or density, some remedial action may be necessary to protect the composition and stability of the vegetative cover on the U-3ax/bl closure cover.
