WANL-TME-1615

Westinghouse Astronuclear Laboratory

NOTES OF MONTHLY DEVELOPMENT TEST PROGRAM REVIEW MEETING
HELD WITH SNPO AT WANL ON MAY 4, 1967
(Title Unclassified)

NOTES OF MONTHLY DEVELOPMENT TEST PROGRAM REVIEW
MEETING HELD WITH SNPO ON MAY 4, 1967

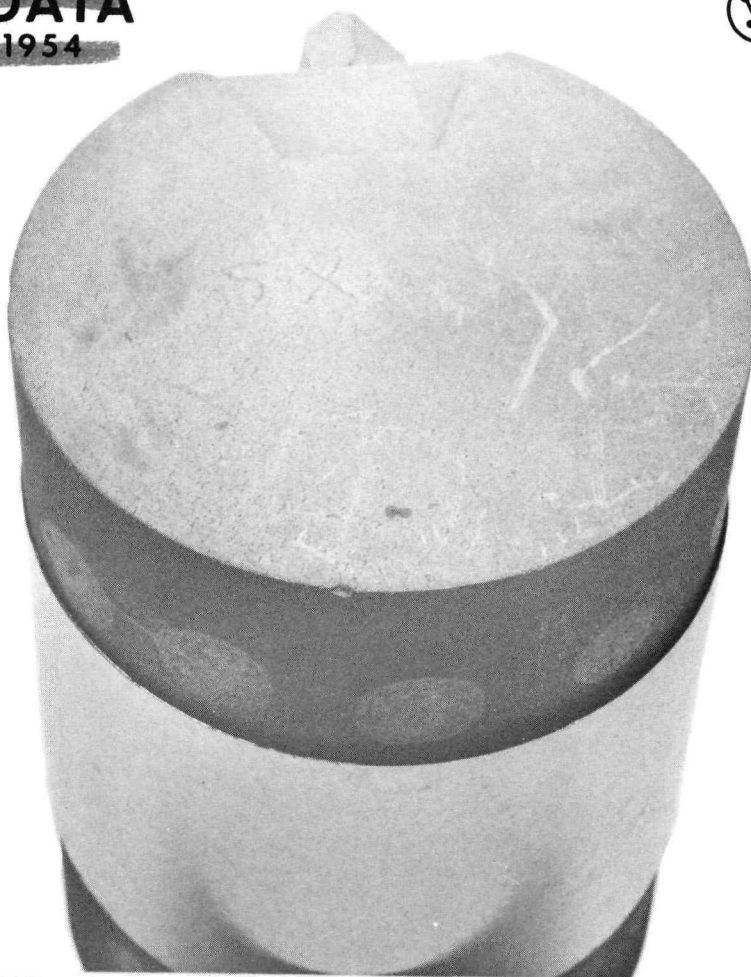
DATE 5-1-67 EML NO 93
TEST NO 1 RUN NO _____
SPECIMEN SPEC. GRADE PYROFOIL P.D.S. 30182-2
TEST 3 CYCLES 2000°R To 4500°R
AFTER TESTING

FIGURE 12
PYROFOIL WRAPPER AFTER HIGH TEMPERATURE STRAIN CYCLING

The condition of the pyrofoil wrap and permanent deformation is depicted in Figure 12 .

The NRX-A6 pyrofoil wrapper material (PDS 30182-2) successfully sustained the strain imposed by the expansion of the maximum straining log with no evidence of tears or fracture. The strain levels are beyond those anticipated in the wrapper of the NRX-A6 core.
