# **Eight Plane IPND Mechanical Testing**

**High Energy Physics Division**

February 2008

## **1 Introduction**

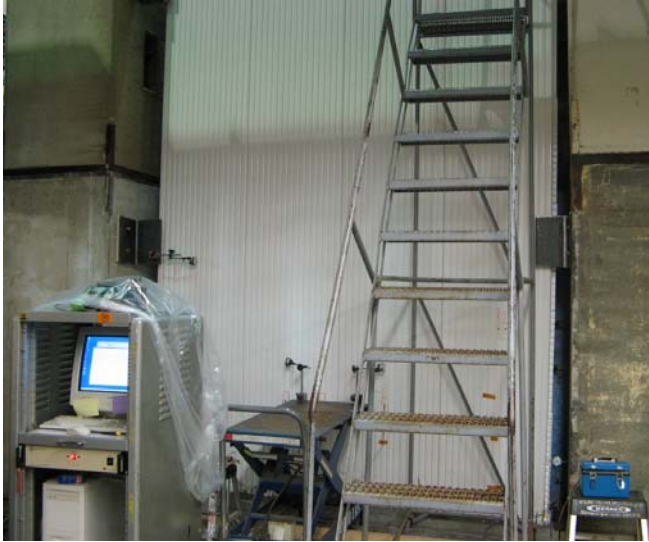
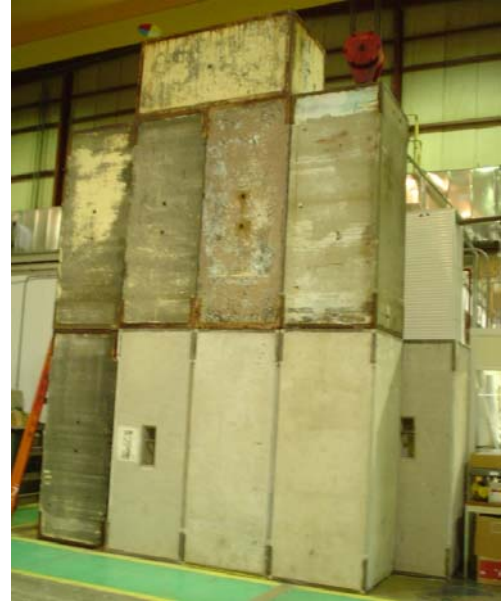
Figure 1: Photo of the front and back side of the IPND prototype and the shield blocks

A mechanical test of an 8 plane IPND mechanical prototype, which was constructed using extrusions from the testing/tryout of the 16 cell prototype extrusion die in Argonne National laboratory, was conducted. There were 4 vertical and 4 horizontal planes in this 8 plane IPND prototype. Each vertical plane had four 16 cell extrusions, while each horizontal plane had six 16 cell extrusions. Each plane was glued together using the formulation of Devcon adhesive, Devcon 60. The vertical extrusions used in the vertical planes shares the same dimensions as the horizontal extrusions in the horizontal planes with the average web thickness of 2.1 mm and the average wall thickness of 3.1 mm. This mechanical prototype was constructed with end-seals on the both ends of the vertical extrusions. The gaps were filled with epoxy between extrusions and end-seals. The overall dimension of IPND is 154.8 by 103.1 by 21.7 inches with the weigh of approximately 1200 kg, as shown in Fig. 1.

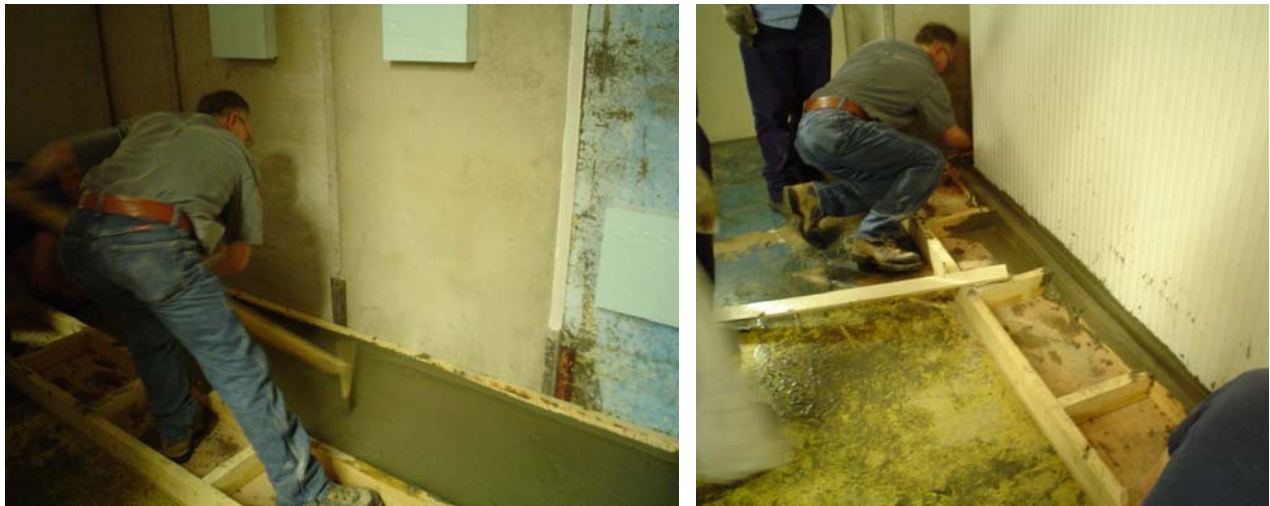
Figure 2: Grout the IPND prototype

The IPND prototype is required to stand on the floor independently without any support with the load evenly distributed across the bottom of the extrusions. This is of good similarity to the boundary condition of the final NOVA detected. In order to meet the requirement, the IPND prototype was grouted on the floor as shown in Fig. 2. First of all, a wood frame was constructed to contain the grout and protect the floor from the grout. The grout was mixed and put into a cell of the frame about 2 inches high. Then the IPND prototype was raised by a crane vertically and lowered down into the grout about 1 inch. The crane had hanged the IPND prototype for about a day to wait the grout dry. Complete dry of the grout took about 3 day.

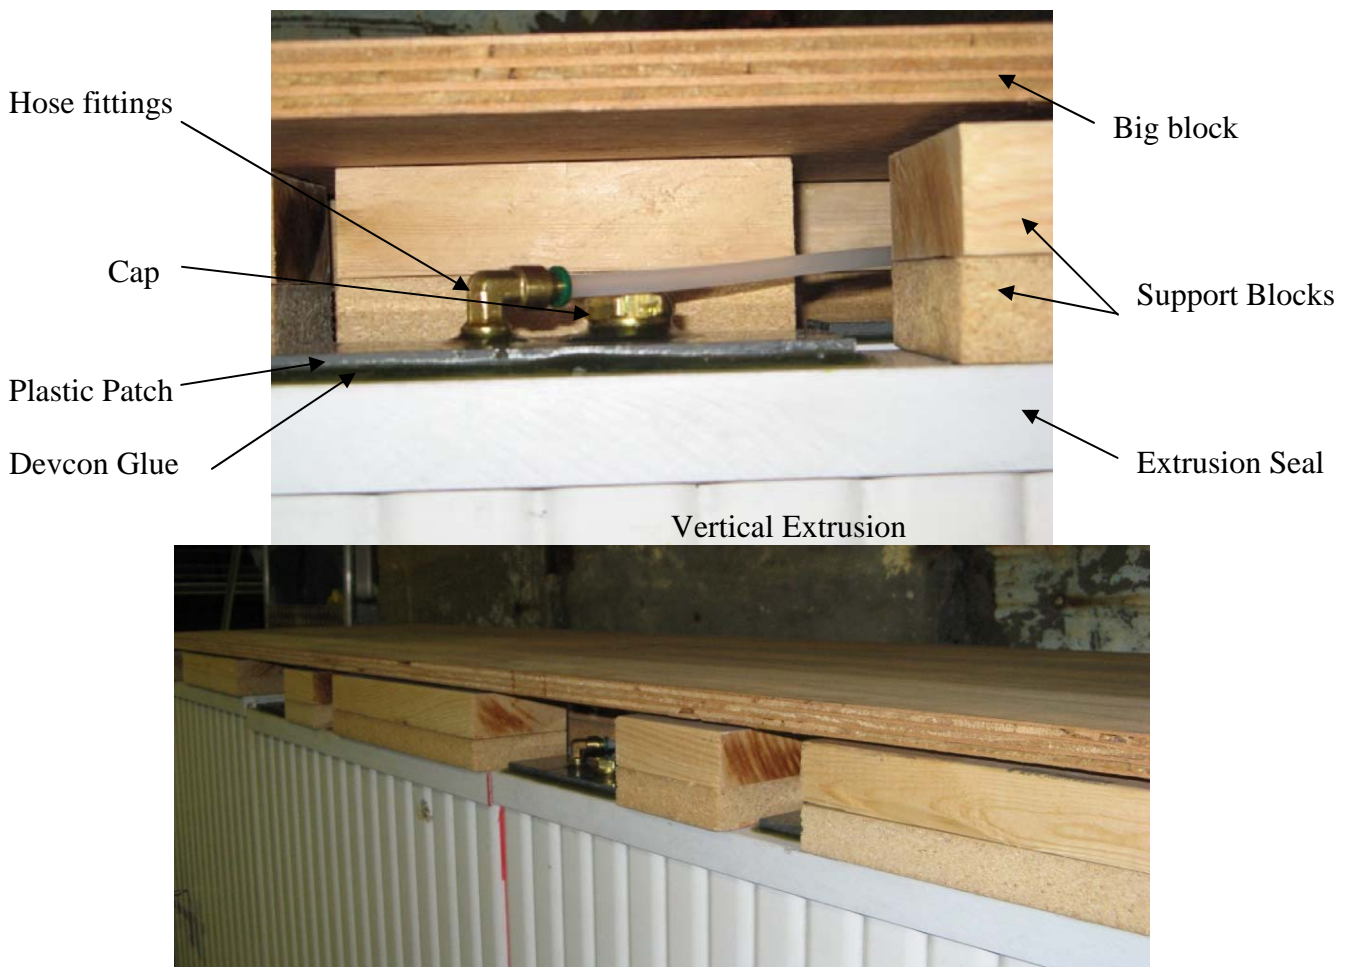
Figure 3: the top end-seal assembly of the vertical extrusion

In order to fill water into the vertical extrusions and apply internal pressure, a 0.5 inch hole and a one 1.5 inch hole were drilled and tapped on the top end-seals. Since the end-seals were too thin to be tapped, plastic patches with the thickness of half inch were attached on the top end-seals

using Devon 60 adhesive, as shown in Fig. 4. The 1.5 inch hole was used to fill water, while the 0.5 inch was used for apply air pressure. Water was filled first into the 1.5 inch hole with the other hole wide open. While filling water into the extrusion, technicians also setup the fittings of the air hoses on the 0.5 inch hole and cap of the water hole. The hoses were connected to a manifold. Each vertical extrusion was also equipped with a pressure gage to measure the air pressure. The manifold had a hose connected to a pressured vessel, which supplied pressured nitrogen to each extrusion. In this configuration, the internal pressure of each vertical extrusion can be controlled independently and facilitate the detection of air leakage.

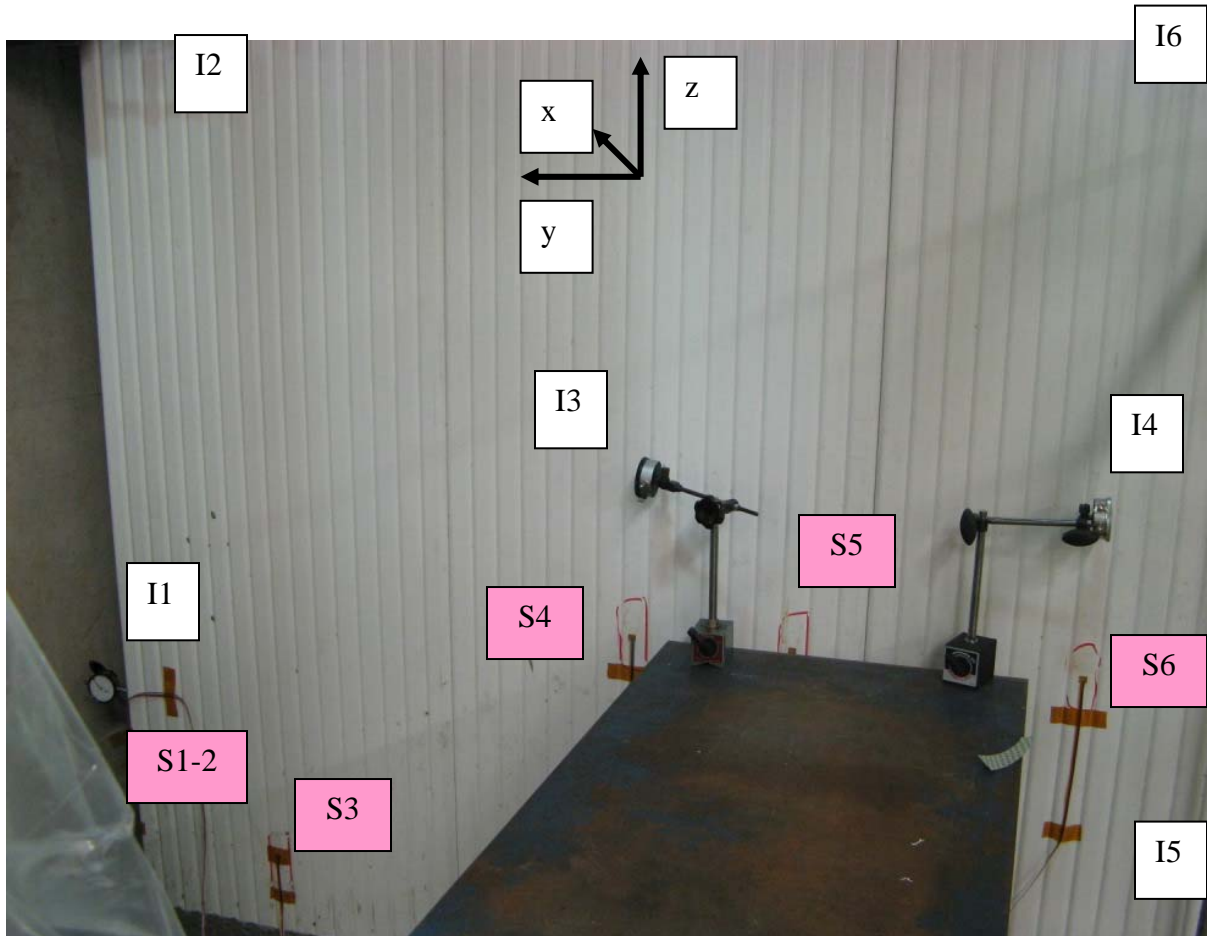
Figure 4: Layout of strain gages and dial indicators on the IPND Prototype

Strain gages and dial indicators were mounted to the edges and outside surfaces of the vertical extrusions of the IPND prototype to measure strains and displacements at the points of interest. It is convenient to describe location and orientations of the instrumentations with a defined coordinate system and a layer and extrusion numbering system. The coordinate was so defined that the positive Z direction was aligned with the upward direction of the vertical extrusions. The positive Y direction was parallel to the surface and the positive X direction was the direction of the inward depth, as shown in Fig. 5. The most outside layer of the vertical extrusion was designated as Layer #1, with second most outside layer labeled as Layer #2, so on and so forth. The most left extrusion in each layer was named as Extrusion # 1 and the most right extrusion was called as Extrusion #4. In each extrusion, the most left cell was entitled as Cell #1 with the most right cell Cell #16.

A group of three strain gages, a rosette, can measure the strains in the direction of their axis. After conversion, the strains in any direction can then be found. Since the edges of the vertical extrusions sustains most severe stresses, as predicated by FEA, two strain gages, denoting S1 and S2, were mounted at heights of 28 inches on Cell #1 of Extrusion #1 of Layer #1 and 2, respectively. There were also four strain gages mounted on the center of the outside surfaces of the vertical extrusions at two heights as well, as shown in Fig. 5. The strains from the rosettes were converted to strains in the X, Y and Z direction for comparison to the FEA model.

In addition, six indicators were placed at the outside surface to measure the displacements. The layout of dial indicators on the IPND prototype is shown in Fig. 5. There were two indicators on the edges to measure side movements and swelling of the IPND prototype at sides.

There were 4 indicators sitting on outside surfaces at different heights to measure deformation or buckling of the IPND prototype. Again, the displacements would be compared to FEM analysis.

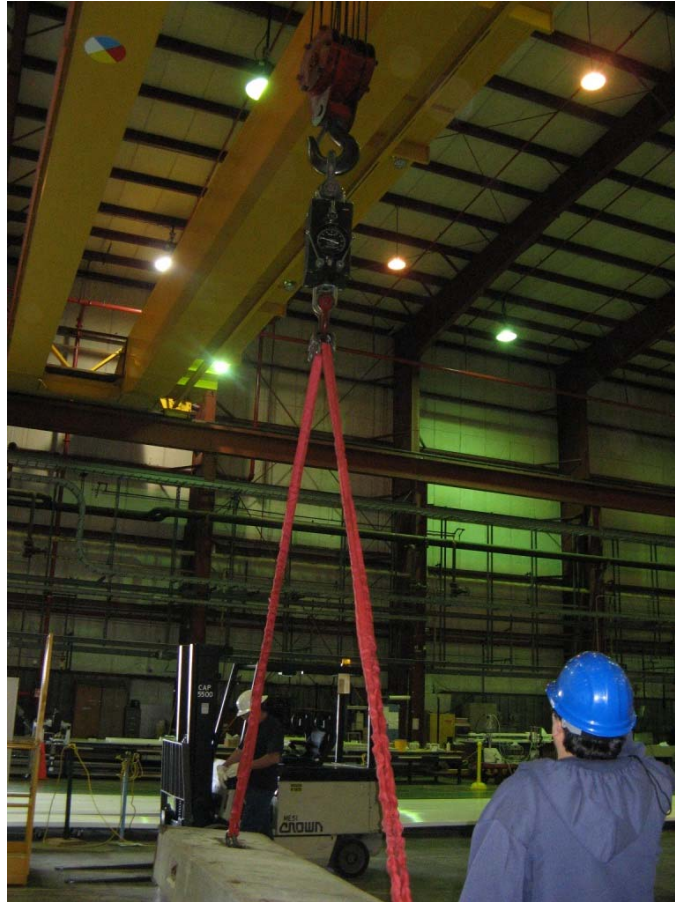
Figure 5: Weight the block using a scale

Loading weight blocks on the top of the IPND prototype was the most difficult and time consuming task. Before the loading process, each block was examined for structural integrity and weighted using a scale, as shown in Fig. 6 Each 12X12 feet block weights about 5 ton.

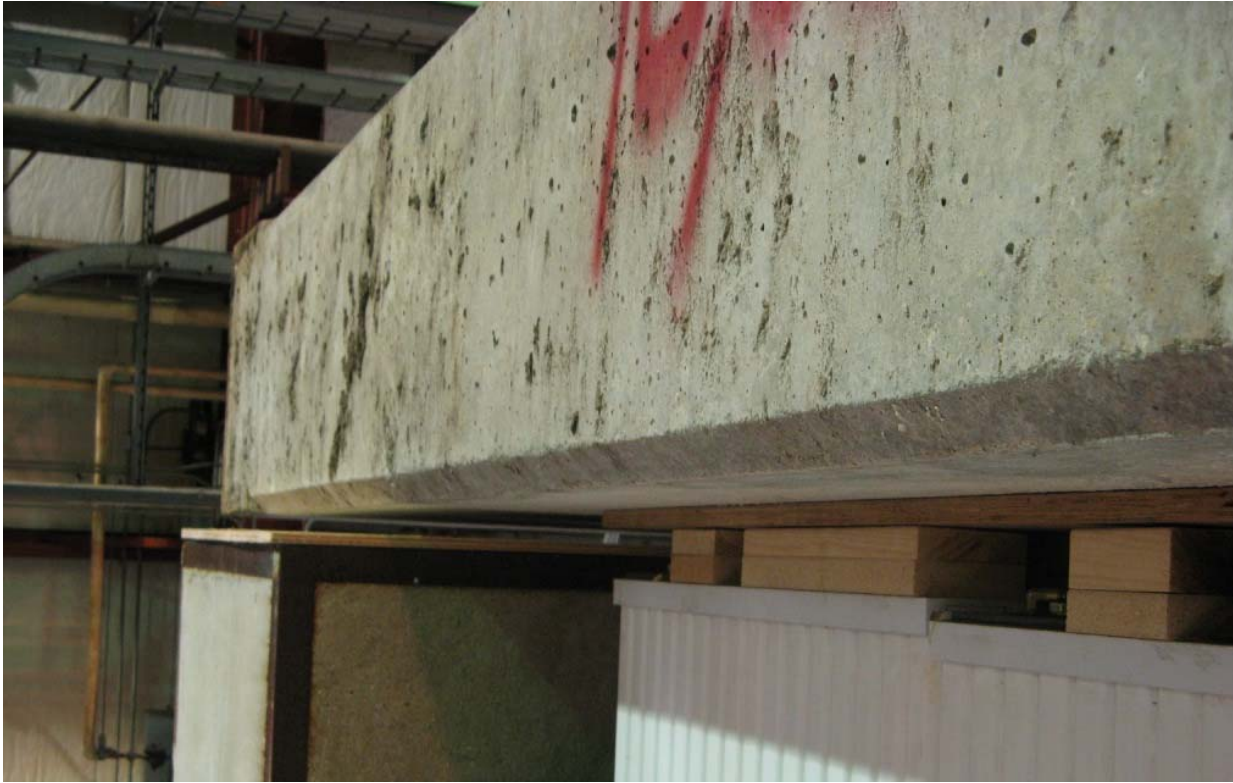
Figure 6: Put the first 5 ton weight block on top of the IPND prototype

Weight blocks had to be loaded in a controlled way to a precise location in order to provide only vertical loads with no moment applied to the IPND prototype. In addition, there should be no impact on the IPND prototype when the block touches the IPND prototype. The bottom of the block had to be oriented horizontally. On Nov. 13 morning, the first 5 ton weight block was loaded successfully on top of the IPND prototype, as shown in Fig. 7. There were some gaps between the shim and supporting blocks, indicating uneven loading on the top. The gap between the weight blocks and the top of the side blocks was controlled to be approximately half inch by putting additional wood shims on top of the side blocks, as shown in Fig. 7. On Nov. 13 afternoon, other 5 ton and 2 ton weight blocks were loaded on top of the IPND prototype successfully with total weight equal to 12 ton, as shown in Fig. 8. On Nov. 14 afternoon, two 5 ton blocks were added up on the other weight block, which brought the total 22 ton weight setting on top of the IPND prototype. **This 22 ton weight was equivalent to weight of 15 m high PVC structure plus the scintillator (both V+H).**

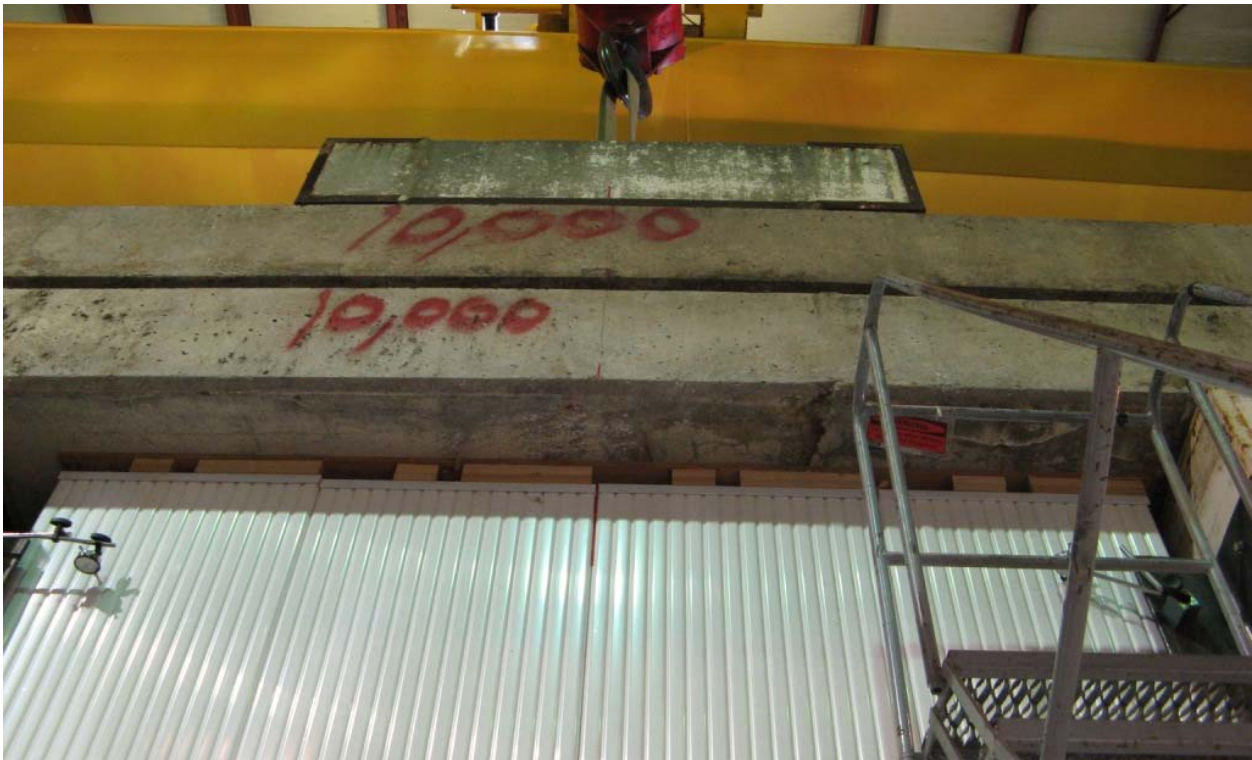
Figure 7: Put the 12 ton weight blocks on top of the IPND prototype

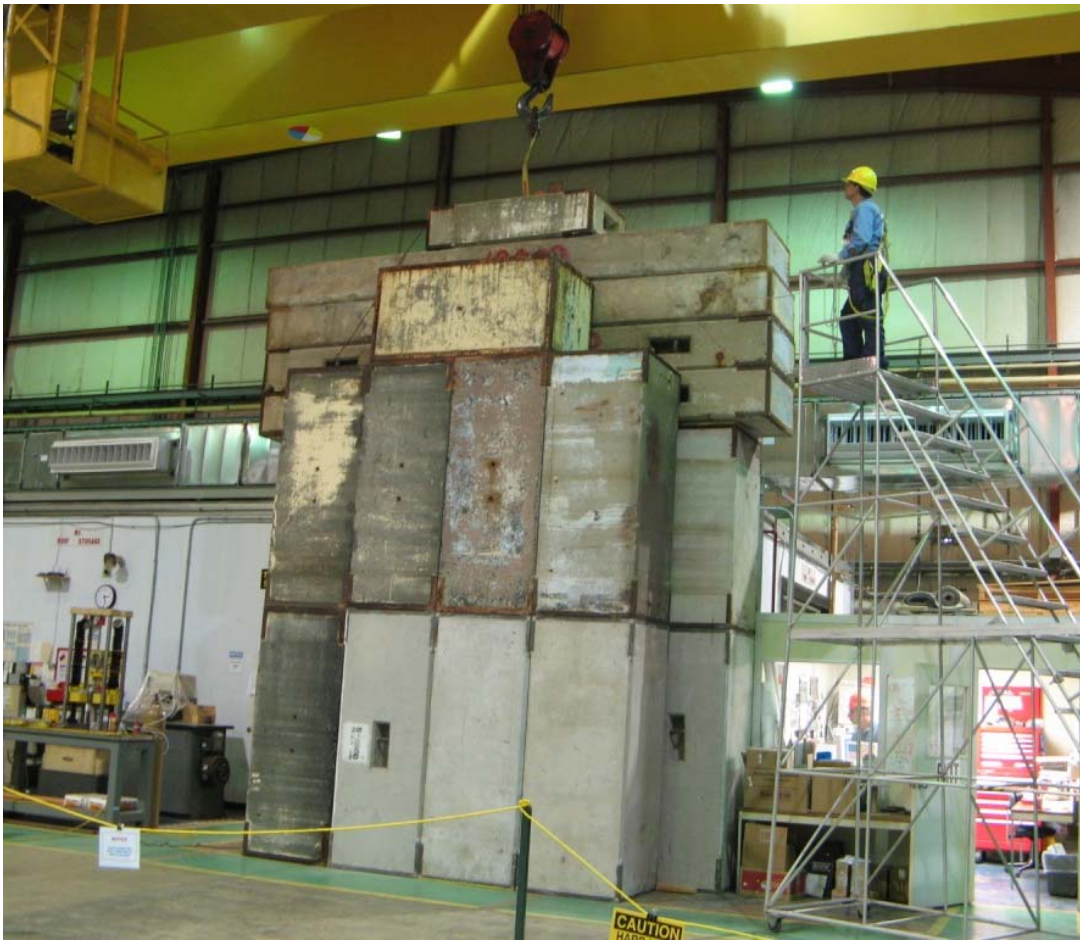
Figure 8: Put the 22 ton weight blocks on top of the IPND prototype

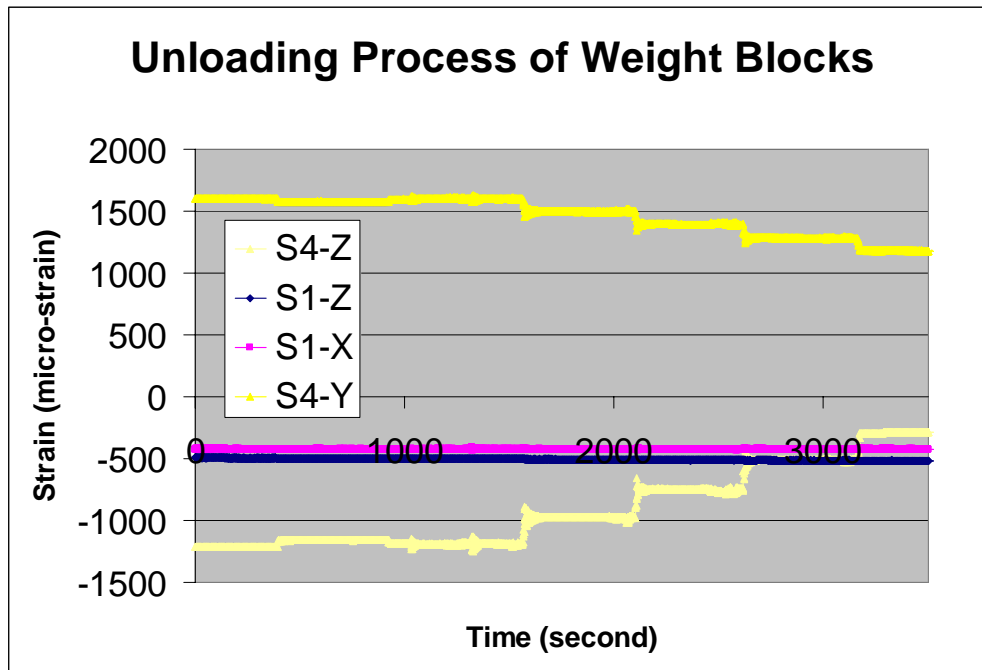
Figure 9: Dynamics during unloading process of weight blocks

After 10 ton of weight was loaded on the top of the IPND prototype, Victor Guarino pushed the IPND on the top end. On the top end, both the IPND prototype and weight swung up to about  $\frac{1}{4}$  inches back and forth. The dial indicator #2, which was located in middle left, oscillated as well. There were some apparent variations of the strain gage reading during loading and unloading of the weight blocks, as shown in Fig. 9. After the weight blocks were removed, an impulse excitation was applied to the top of IPND by quick push about half inches and release. The responses of strain gages were recorded and shown in Fig. 10. And these dynamic behaviors caused by external excitation damped out slowly with natural frequency of about 2 HZ.

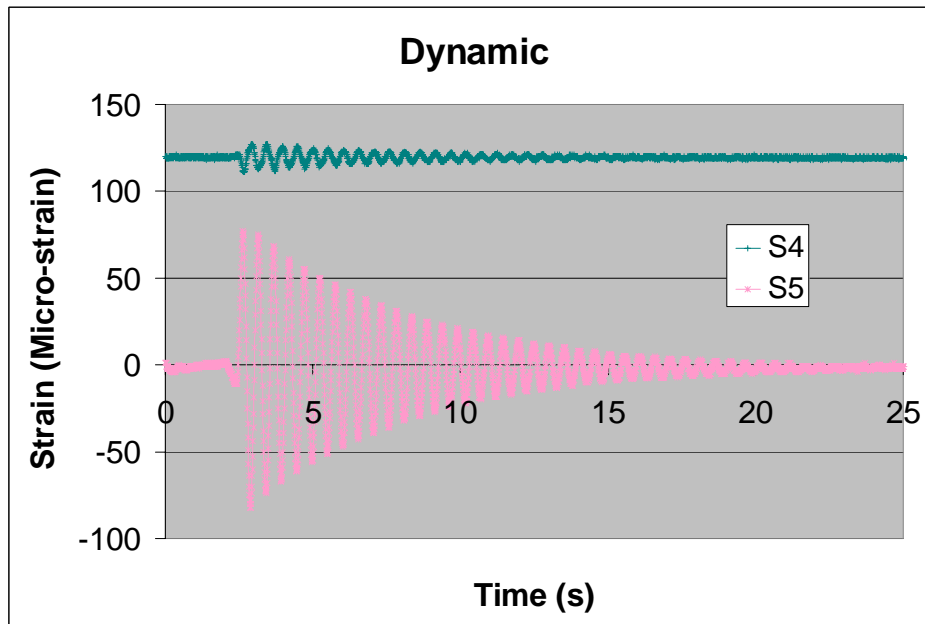
Figure 10: Free vibration without weight blocks

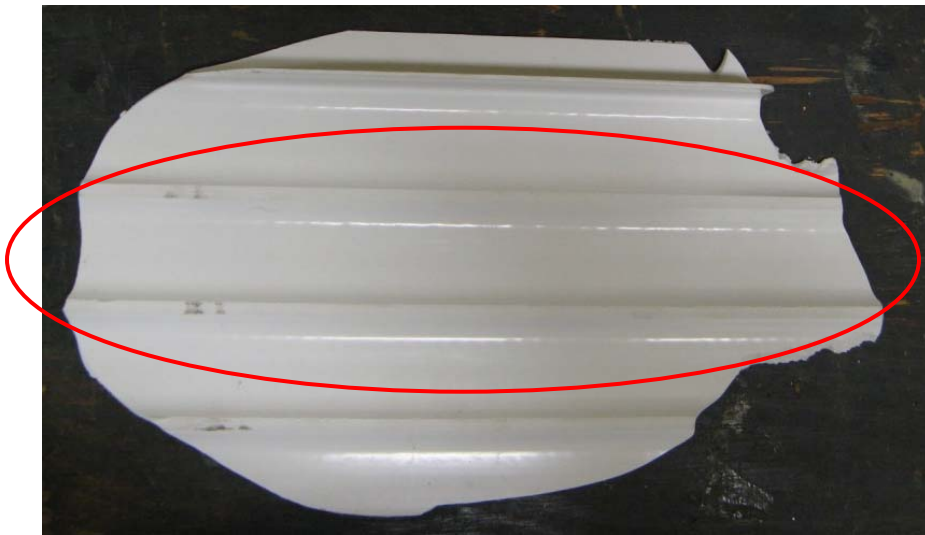
Figure 11: PVC piece from the extrusion

When the pressure was increased to about 53psi, a loud bomb sound was heard and a piece, as shown in Fig. 11, was blasted upwards from the top of cell #1 in layer #1 due to the internal pressure. The extrusion where fracture happened is shown in Fig. 12. It is clear that the PVC is elastic since the shape of the piece almost exactly matches the piece which is missing in the extrusion. The fracture piece was blow upward, indicating that the crack was initiated from the bottom. This is also confirmed by the serrated shape of the edge at the bottom. The sharp edge on the both sides is the result of fast propagation of the crack up to the top.

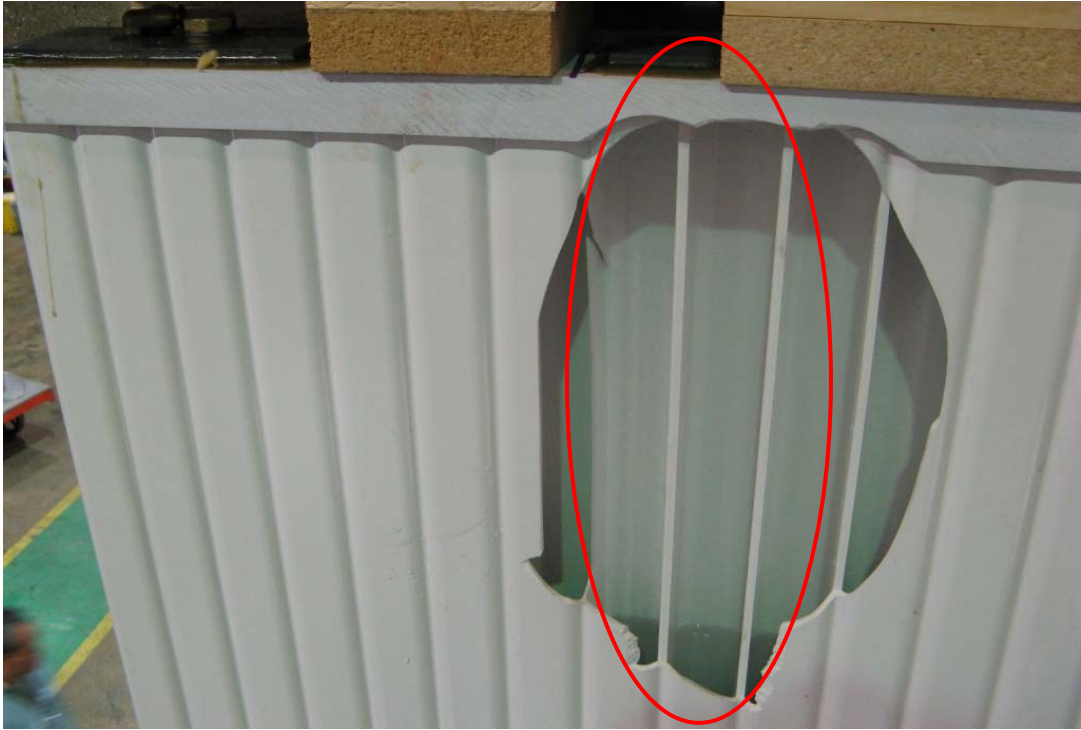
Figure 12: Fracture on the extrusion

Visual inspection was then conducted to investigate what is the root cause of this fracture. It was found that two knitting on the webs occurs at center of the fracture piece, as shown in Fig. 12. It should be noted that the crack place of the webs is smoothly. Later during the destruction of IPND, it was found that the knitting lines were all the way down to the bottom of the extrusion as shown in Fig. 13. This knitting can also be confirmed from the reading of strain gages rosette #3 shown in Fig. 13. This will be explained more detail in the following section.

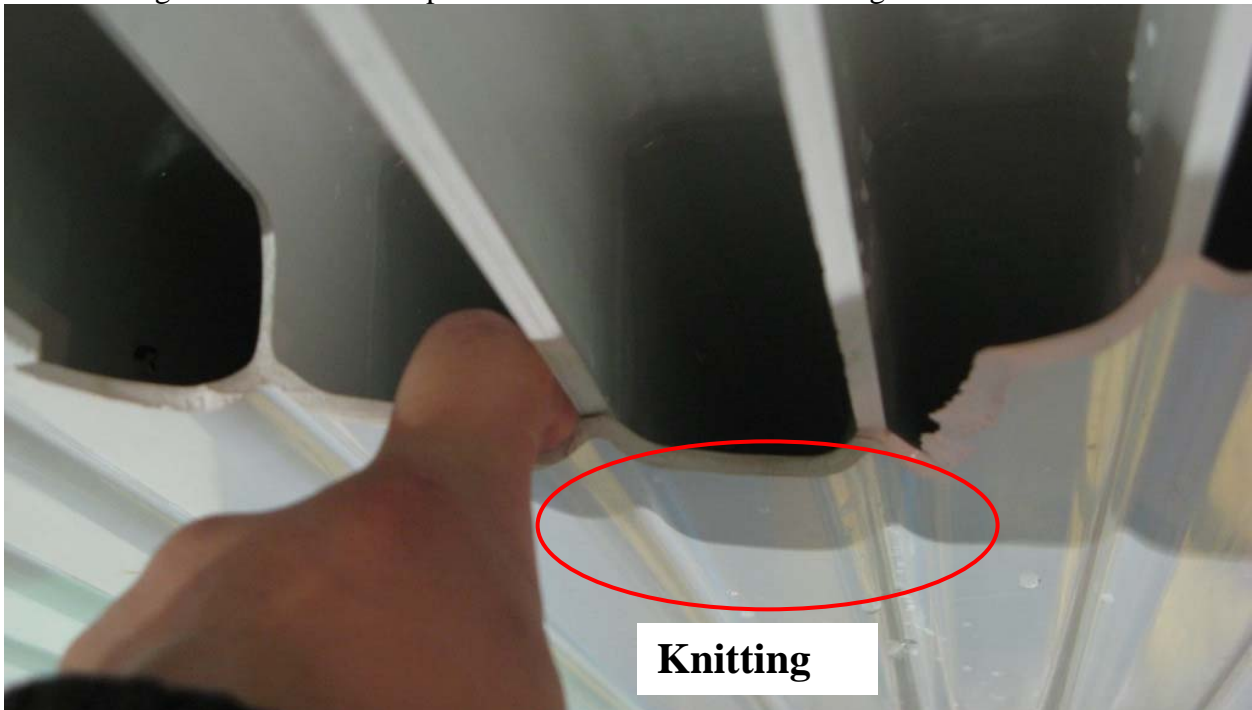
Figure 13: Knitting on webs on the top

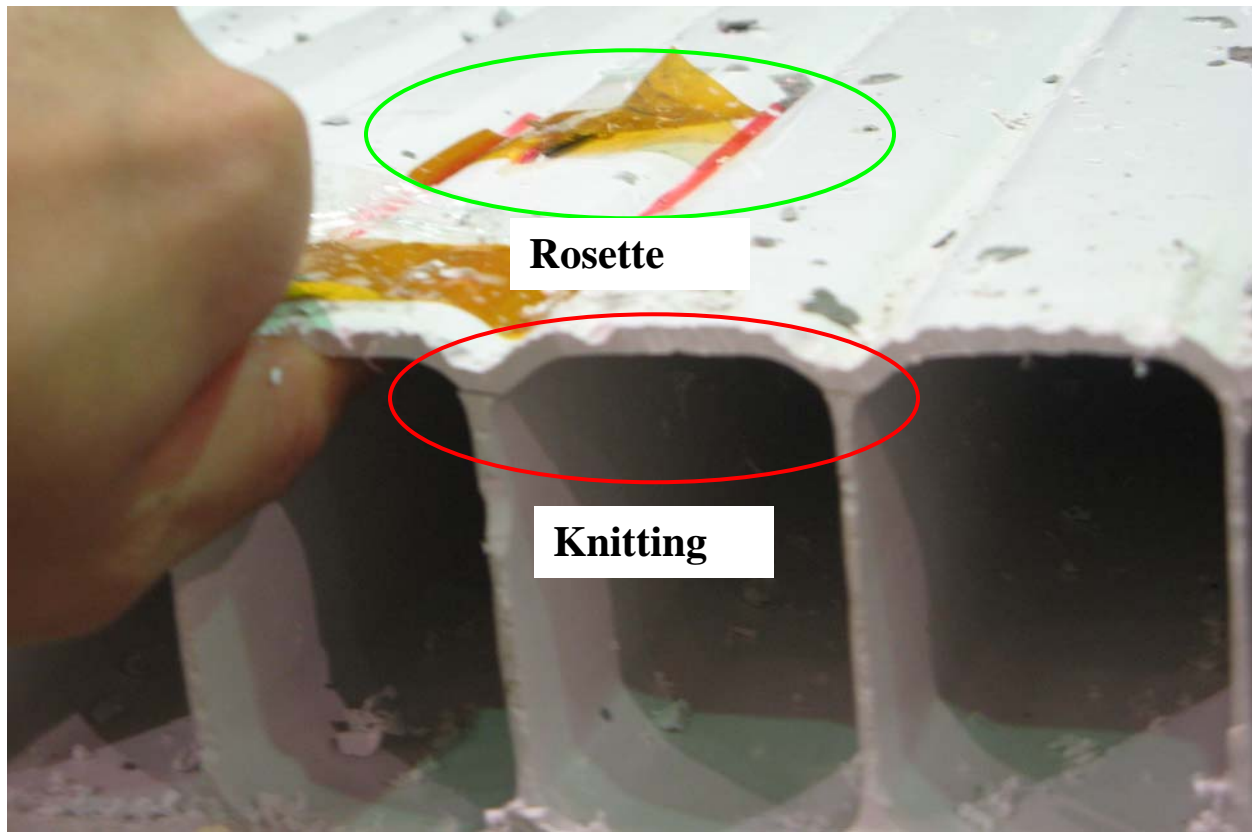
Figure 14: Knitting on webs at the bottom

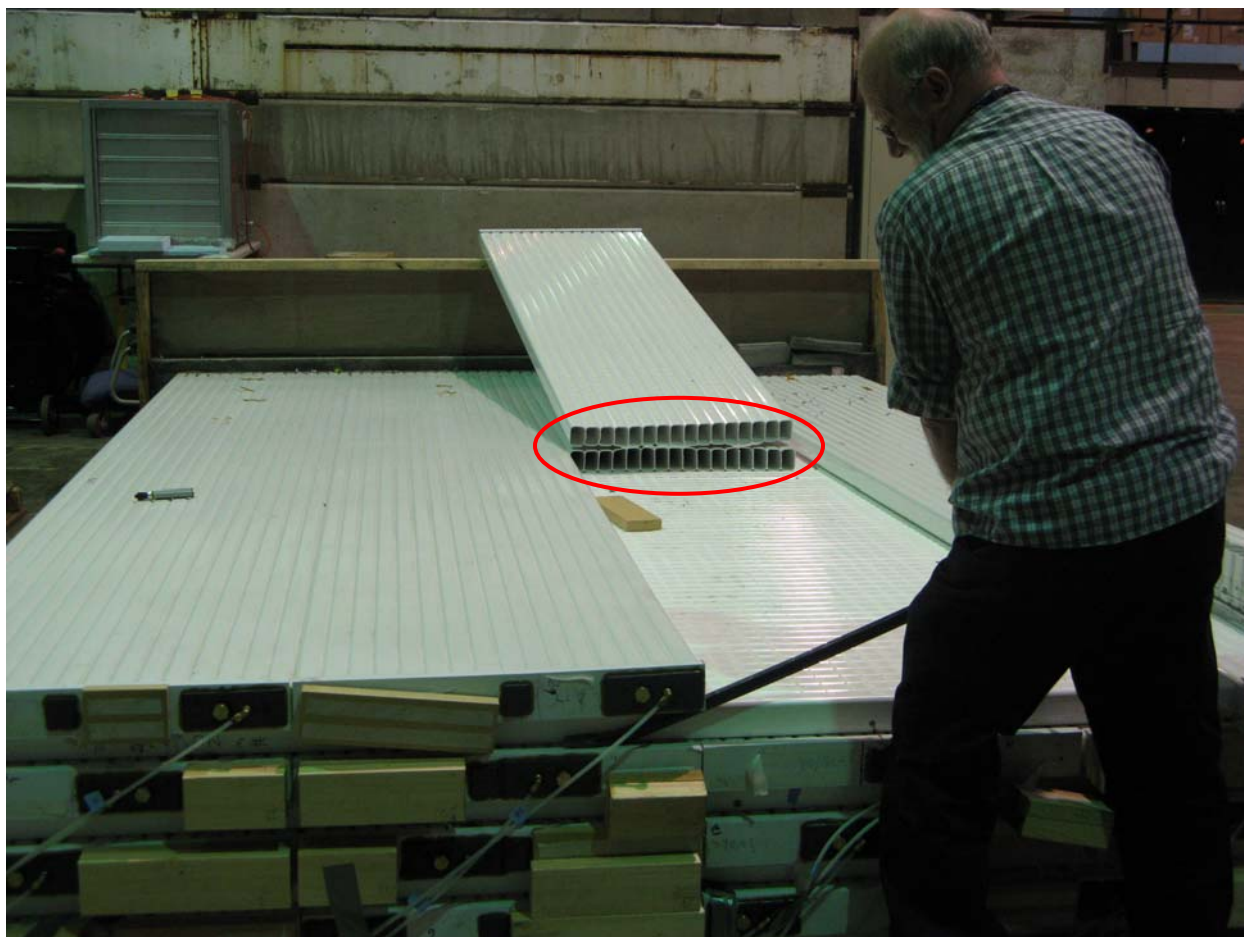
Figure 15: Destruction process of IPND

After water had been drained, the IPND prototype was laid on the floor. A crowbar was used to peel the extrusion, as shown in Fig. 15. Significant force was needed to peel off one layer of extrusion. Crack sound indicating the peel off of the adhesive pad was heard in this destruction process from time to time. It was observed that the peeling of adhesive pads did not propagate due to discontinuity of the adhesive pad as a result of the scallop between cells of the extrusion. Fig. 15 shows an extrusion which was broken in middle when a fork lift was used to peel at the top end.

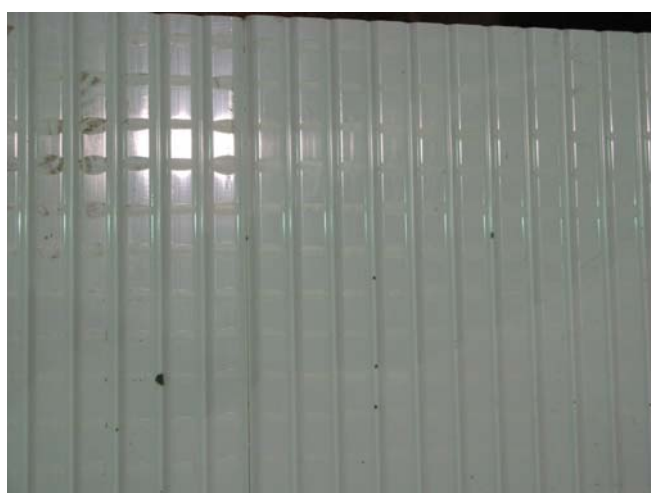
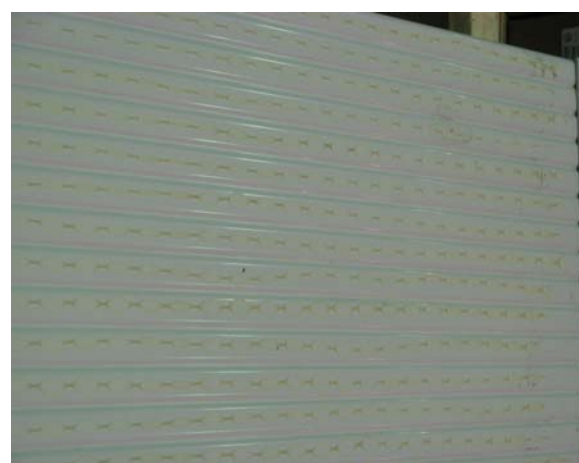
Figure 16: Adhesive bonding condition

The adhesive bonds between these two extrusions were exposed and could be examined. It was clear that most of adhesive was attached to the vertical extrusion, as shown in Fig. 16(b), with only some trace could be found on the horizontal extrusion. It should be noted that the adhesive were laid onto the verticals using a hand hold glue gun during constructing IPND. It took about 10 minutes to lay adhesive on one extrusion. Then the vertical extrusion was placed onto the horizontal extrusion and then was compressed using a 75 lb roller. A close-up view of the adhesive pads is shown in Fig. 17. The largest pad was about 60% of the total coverage, while the smallest pad covered only about 25% of area. However, the bonds seemed to not have any

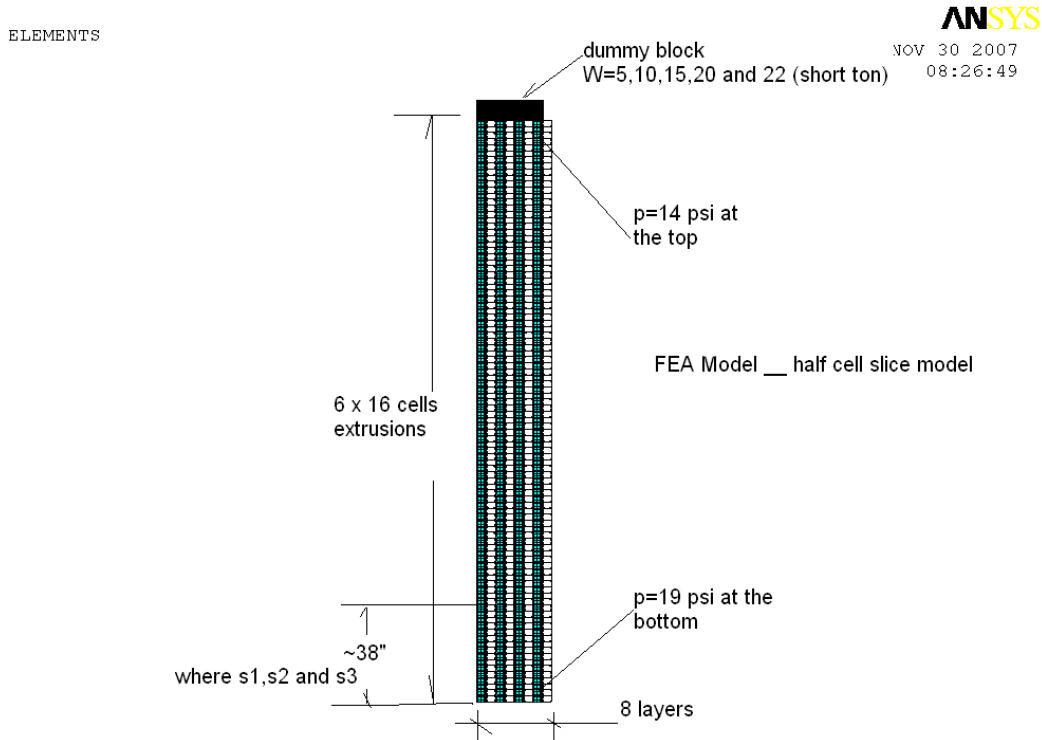
Figure 18a: The FEA slice model for the test structure

This was the first time we had chance to conduct a large scale prototype study. To validate some of earlier FEA modeling work, we've developed both a full 3D model and a half slice model which has been used extensively in the previous stress and stability study for a full height detector. The half cell \_ "slice model" is shown in Fig. 18a with its height being 6 extrusions and width being 8 layers. The model was loaded with water+ air pressure to form a 19 psi at its bottom as test did. The shielding block was simulated with a dummy block which had a vertical weight=5, 10, 15, 20 and 22 ton. The wall thickness was assumed to be 3 mm for the side wall and 2 mm for the web for both vertical and horizontal. The PVC modulus was assumed to be 0.36 mpsi for this unknown garage door type extrusion. Both the vertical (Z) and bending strains (Y) at the location of 38 " from the ground were extracted and compared with the strain gage reading from #s4, #s5 and #s6 at the same height as well as a similar interior location. Fig 18b was a full size 3D model.

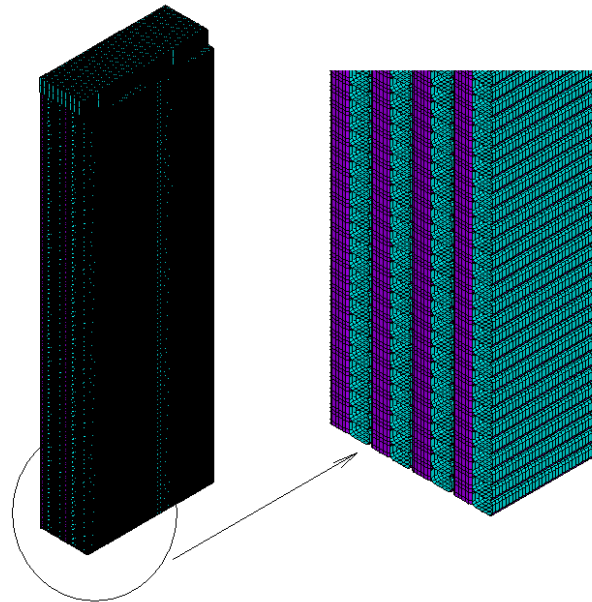
FEA full size 3D model  
For 8 layers IPND

side/web=3/2 mm, cell e=0.36E6 MPa, P (air)+5.414 (due the water)=19 psi bottom+

Figure 18b: A 3D Full size Model

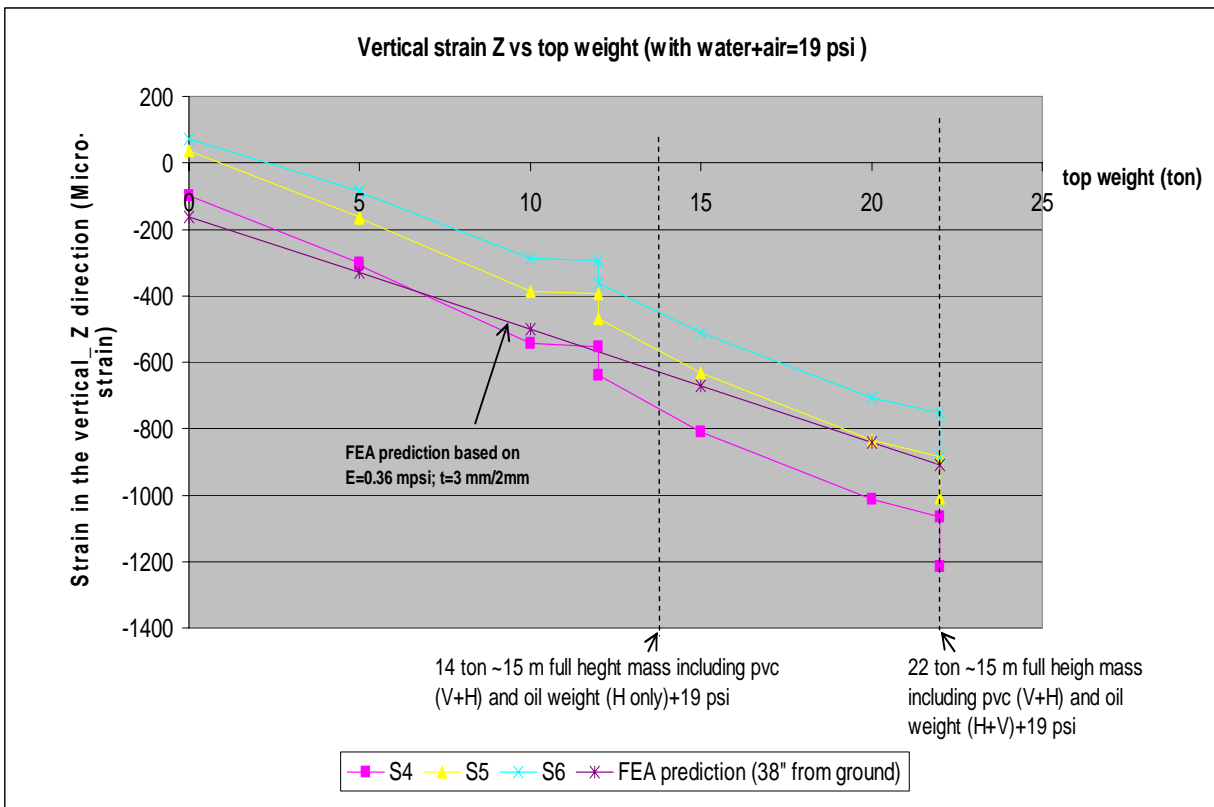
Figure 19: Comparison of FEA and strain gage measurement in the vertical direction from a "half cell" model

The results are shown in Fig 19 for the vertical strain (Z) and in Fig 20 for the bending strain (Y). The FEA result seems very compatible with the measurement. It falls right within three strain gage reading band as expected. In theory, the strain gage reading of s1, s2 and s3 should be the identical or very close due to the similar location (Y and Z). The deviation within these strain gages could be contributed to the wall thickness variation from an un-tuned die as well as the test apparatus/stain gage set-up errors. By plotting the result against three of them, an “average” sense or bandwidth can be established.

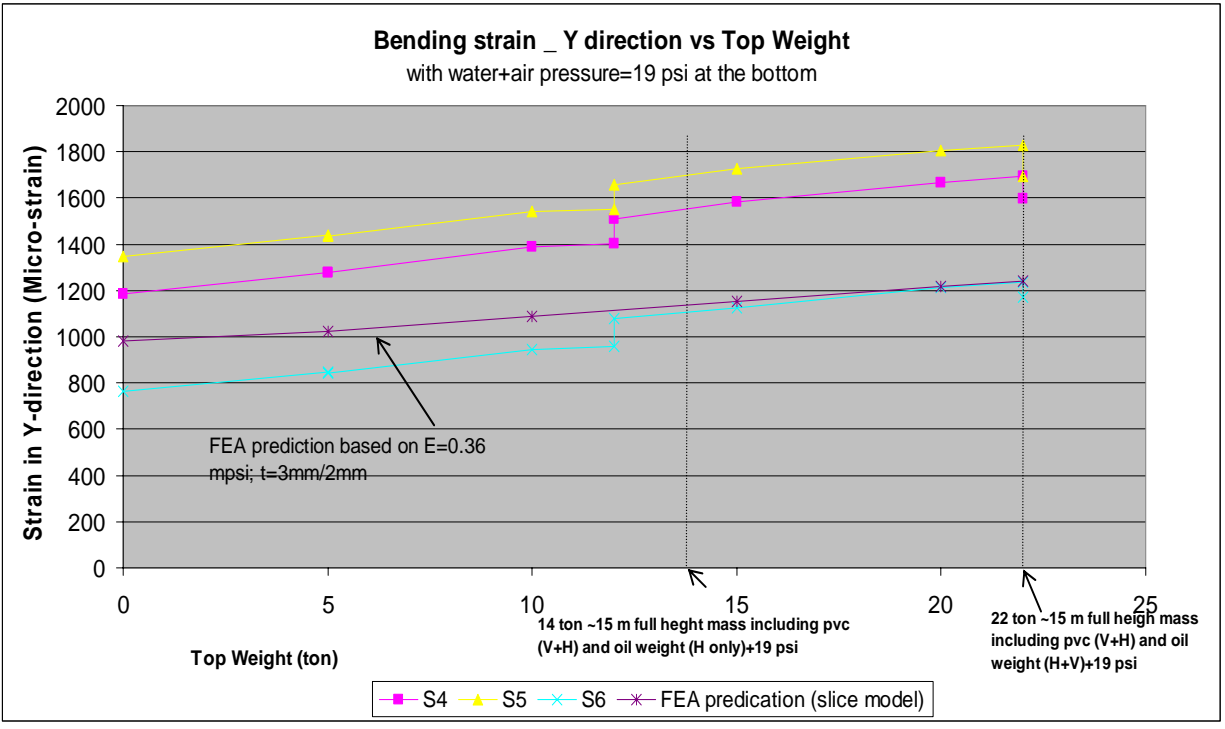
Figure 20: Comparison of FEA prediction and strain gage measurement in the bending direction from a half cell model

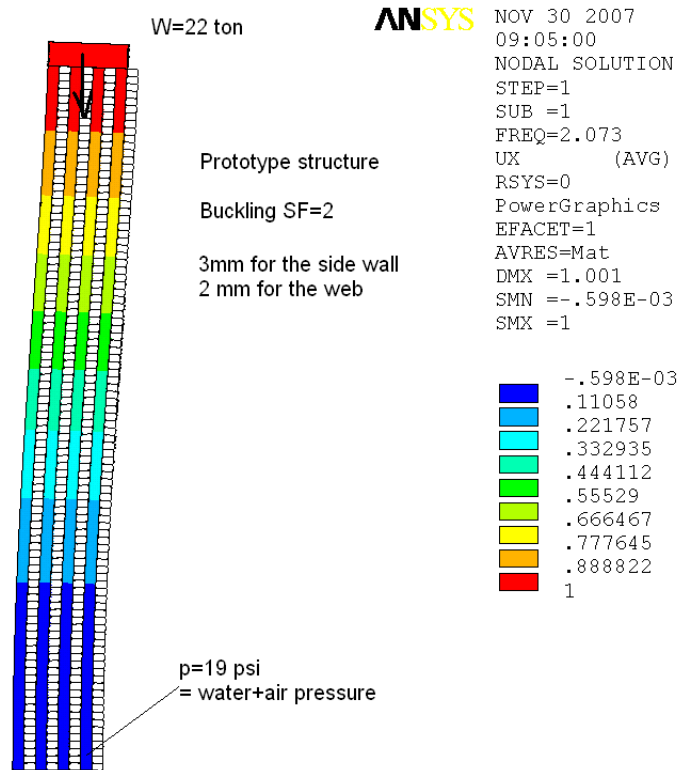
Figure 21: The Buckling SF for the test structure under 22 ton

The buckling calculation was also done to predict how much weight it could carry for this test structure with 3mm/2mm wall thickness. The FEA predicts that the structure should be able safely to withstand a top weight of 22 ton with 19 psi pressure at its bottom as shown in Fig 4.4. It has been successfully load tested up to 22 ton without any scratches and even any noticeable bowing, as expected. **Total weight of PVC (H+V) plus the scintillator in the horizontal for a full height (15.5 m) detector equals about ~14 ton and ~22 ton for the PVC and scintillator including both vertical and horizontal extrusion.**

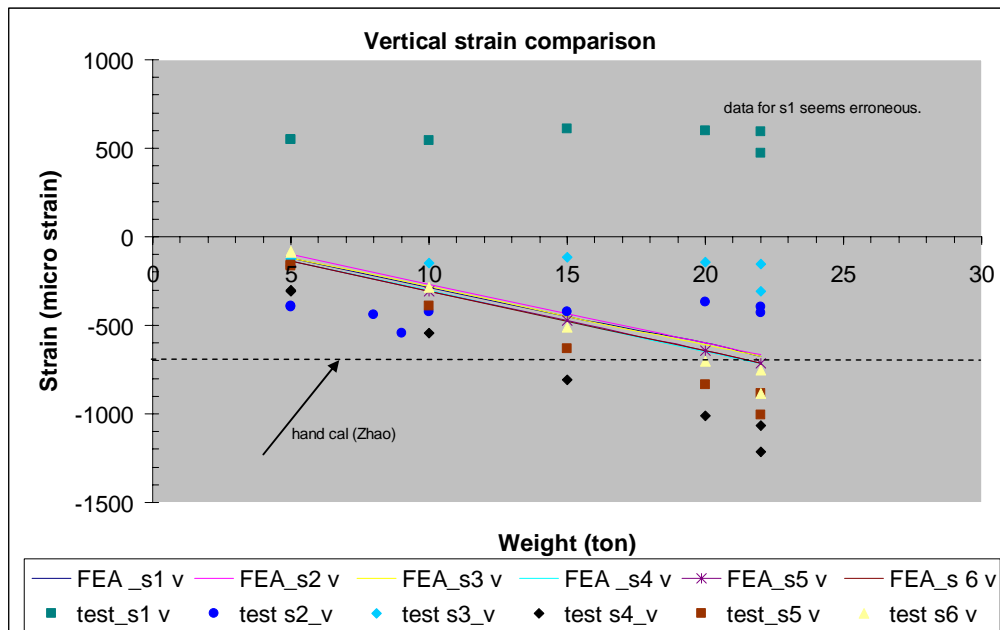
Figure 22: Comparison for the vertical stain based on the 3D model

A 3D FEA model will provide a complete strain gage comparison from s1 through s6. Fig 22 shows a vertical strain as a function of the top weight. FEA results indicate that the vertical strain is linearly proportional to the top weight. The test result indicates the similar trend for the reading of s4, s5, and s6. However, the readings from the s1, s2 and s3 show a flat pattern, regardless the top weight. One of the reasons could be the strains gage itself. Second reason is that the bottom of the concrete block is not perfect flat such that a slight curvature will result from an uneven vertical loading. It is mostly loaded on the center portion. The end cell, where the s1 and s2 located, is relatively untouched such that a flat curve for the s1, s2 and s3 and a slightly overloaded case for the rest of sensor are observed as shown in Fig 22. The hand calculation, given by Zhao, for 22 ton case matches reasonably well with the FEA result, as well as the test data from s3, s4, and s6 if above factors are considered . But, a "positive" sign of the vertical compress strain for s1 reading is still remaining a mystery to us. It could be the gage itself since the bending strain reading from s1 gives a "negative" sign as well.

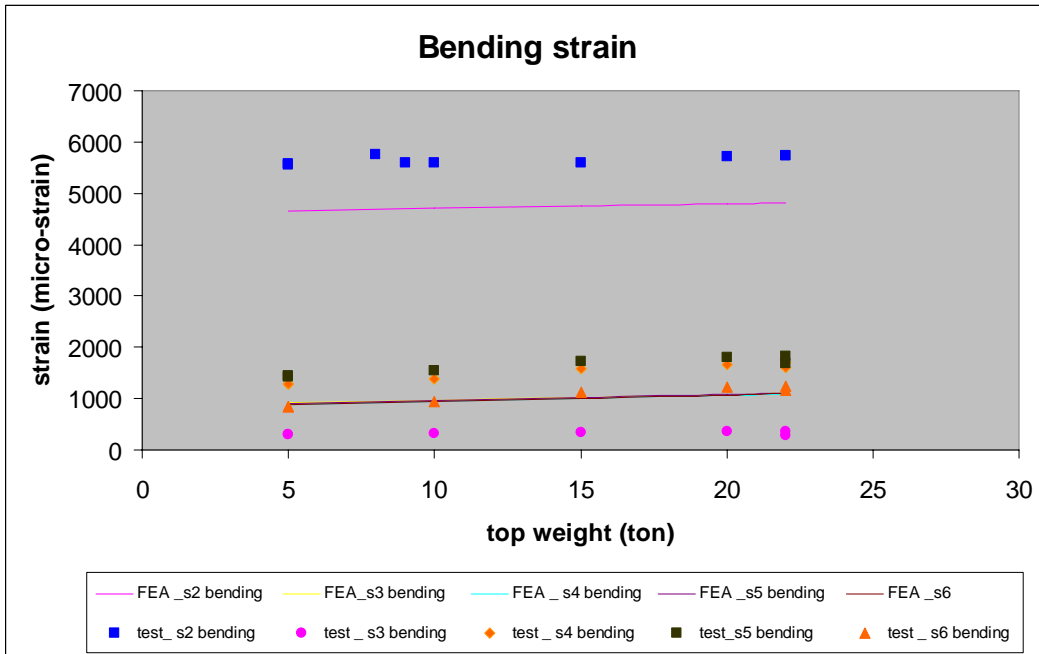
Figure 23: Comparison for the bending stain based on the 3D model

Therefore, we've compared the result for the bending strain without considering s1 data as shown in Fig 22. Both FEA and strain gage indicates a relative flat curve for the bend strain as expected. The difference for the s2 reading (top curve and data) is bonded by ~20%, which is most like due to the thickness variation of the extrusion. The wall thickness of 3/2 mm, used in the calculation, is a rough average number from the untuned die. A slight variation of the wall thickness is more than sufficient to cover the 20% deviation in the bending strain reading since the thickness is very sensitive for the bending stain. Therefore, a parametric study is carried out by varying the wall thickness up to -25% as shown in Fig 23. It seems that the FEA result matches very well for the s2 bending data by just varying -10% of the wall thickness and covers most data range with 25% variation of the wall thickness. The actual wall thickness measurement indicates the variation can go up to more than 50% in some places. By considering the "garage type" extrusion with so many un controlled factor, the FEA predication and test data fits more than reasonably well.
