# **Eight Plane IPND Mechanical Testing**

**High Energy Physics Division**

February 2008

## **1 Introduction**

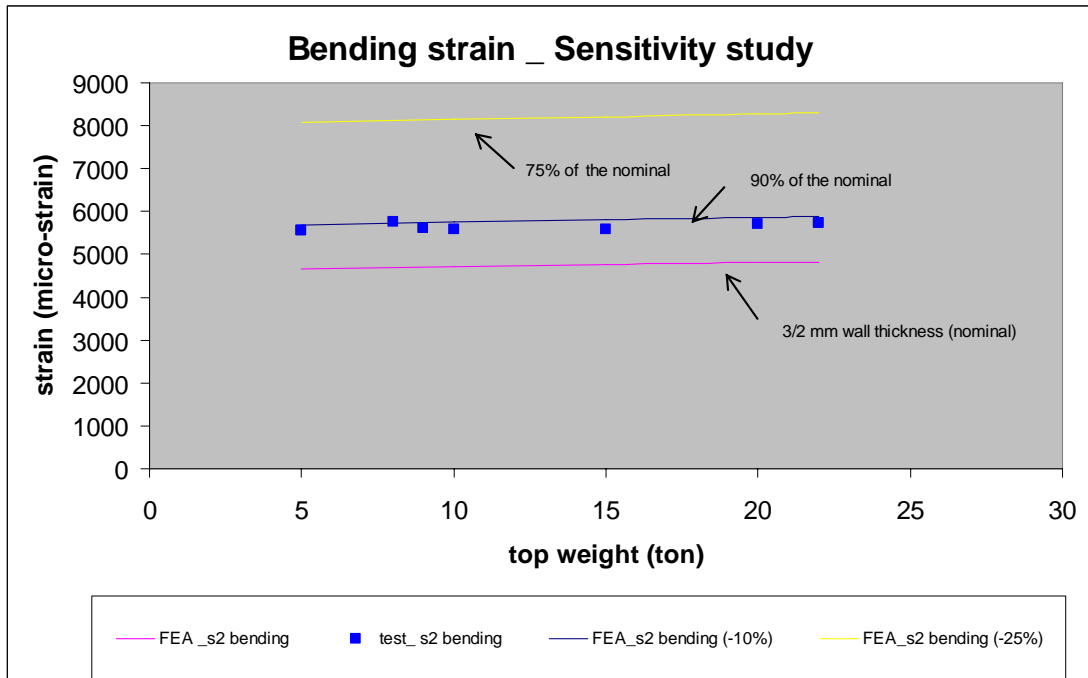
Figure 24: The wall thickness effect for S2 bending strain

Therefore, we've compared the result for the bending strain without considering s1 data as shown in Fig 22. Both FEA and strain gage indicates a relative flat curve for the bend strain as expected. The difference for the s2 reading (top curve and data) is bonded by ~20%, which is most like due to the thickness variation of the extrusion. The wall thickness of 3/2 mm, used in the calculation, is a rough average number from the untuned die. A slight variation of the wall thickness is more than sufficient to cover the 20% deviation in the bending strain reading since the thickness is very sensitive for the bending stain. Therefore, a parametric study is carried out by varying the wall thickness up to -25% as shown in Fig 23. It seems that the FEA result matches very well for the s2 bending data by just varying -10% of the wall thickness and covers most data range with 25% variation of the wall thickness. The actual wall thickness measurement indicates the variation can go up to more than 50% in some places. By considering the "garage type" extrusion with so many un controlled factor, the FEA predication and test data fits more than reasonably well.

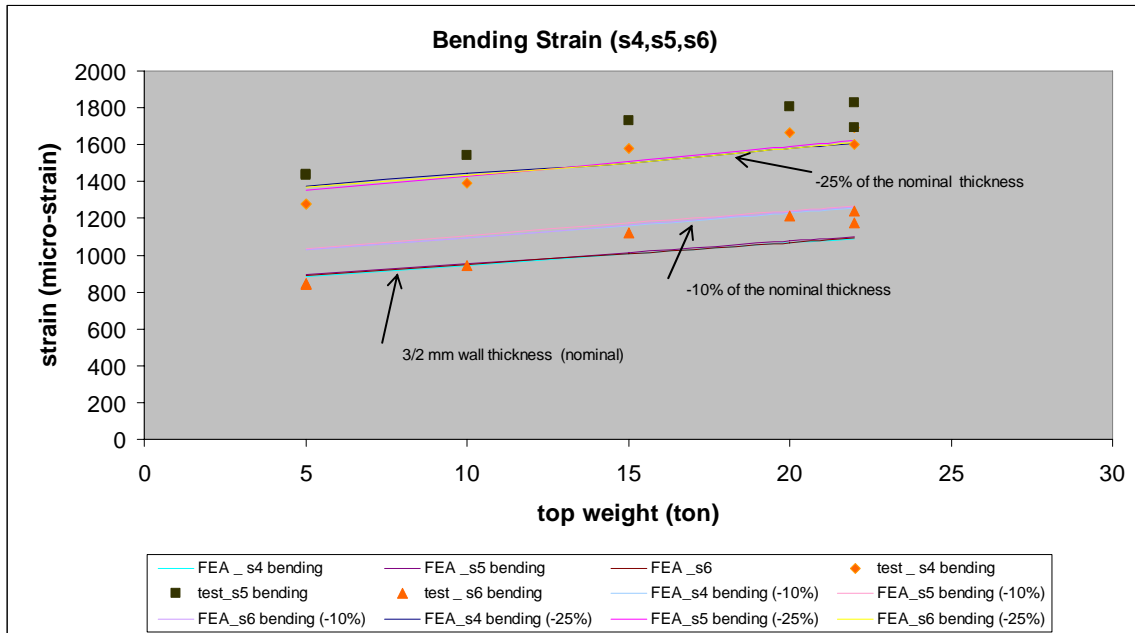
Figure 25: The Wall thickness effect for s4, s5 and s6 bending strain

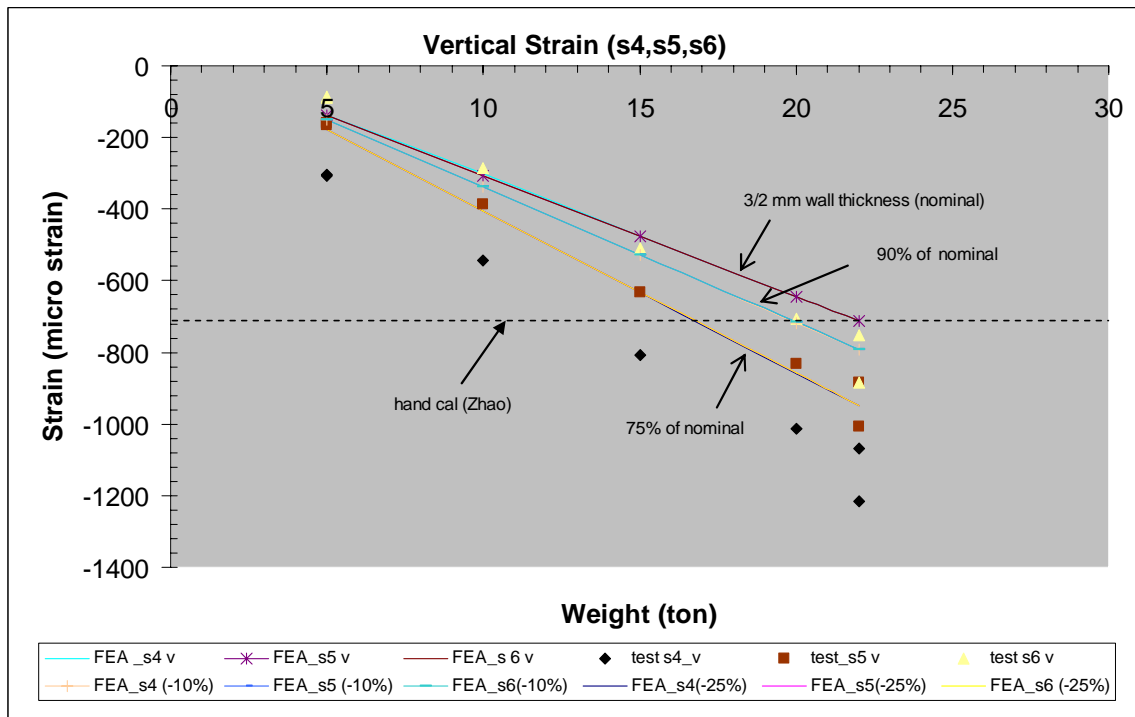
Figure 26: The Wall thickness effect for s4, s5 and s6 vertical strain

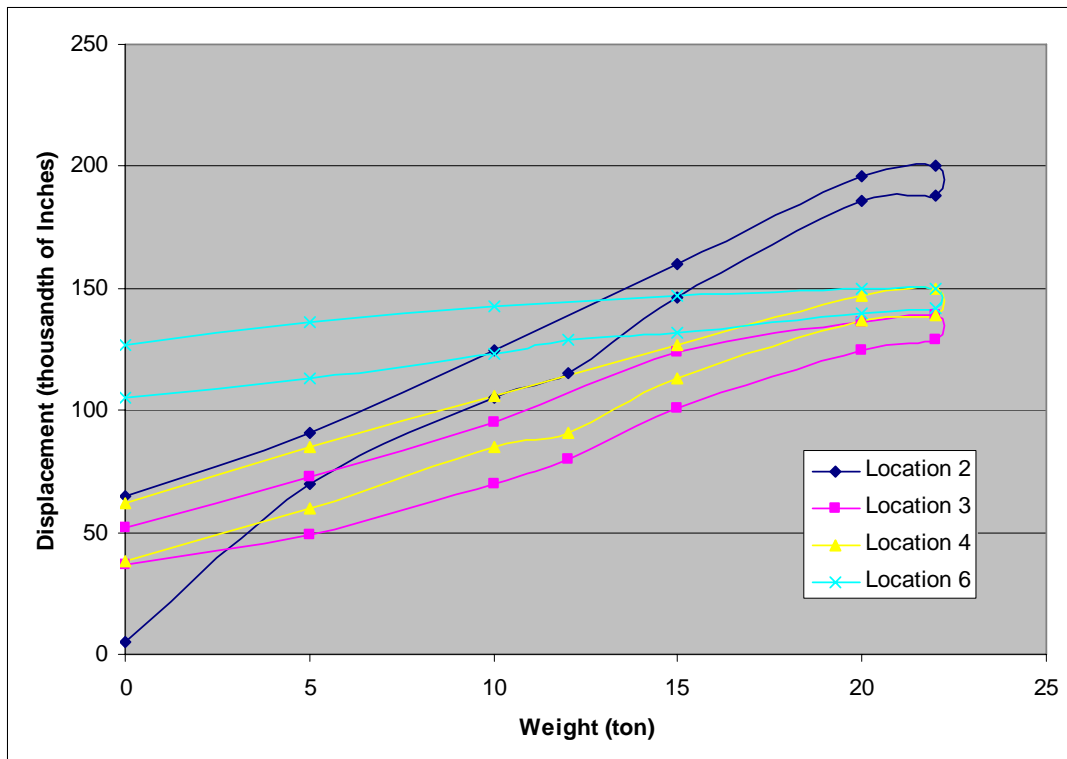
Figure 27: Displacement vs. Weight load

The displacements of dial indicators at various locations are plot against the weight on the top of IPND, as shown in Fig. 16. The displacements are linearly proportional to the weight at most

locations with different sensitivities. The drop at weight of 22 ton is a consequence of continuous loading for 16 hours. We believe creep has play critical role in this.

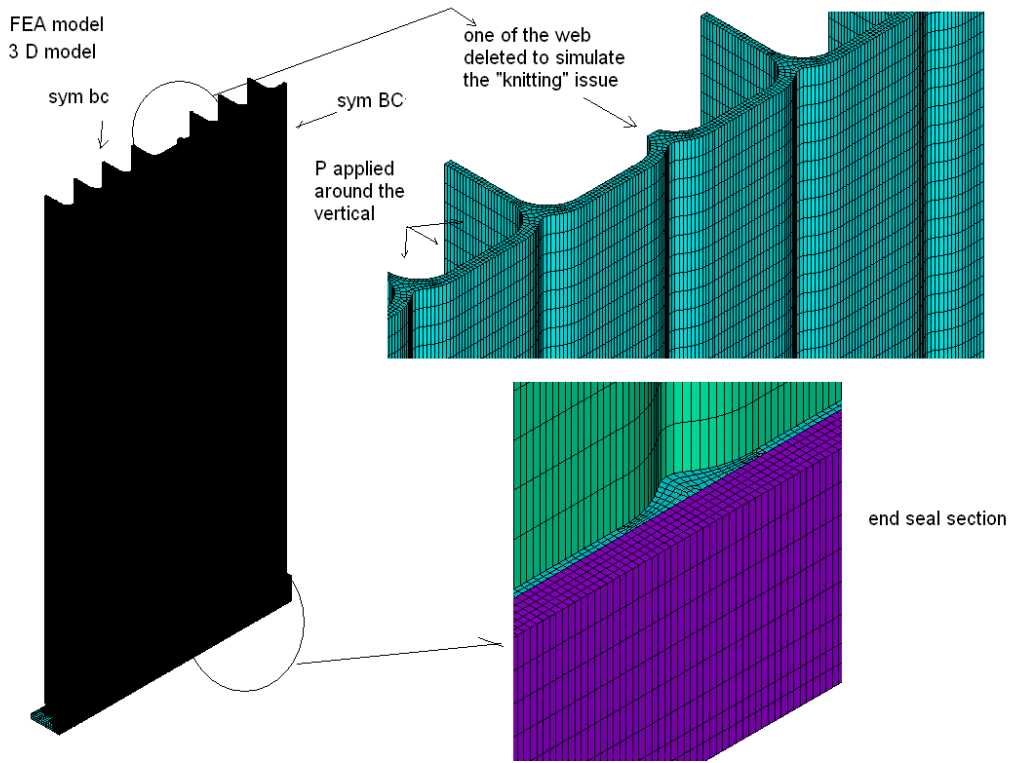
Figure 28: The 3D-FEA model

This prototype structure was subjected to a destructive internal pressure test without the top weight. The structure is able to sustain up to ~55 psi until it has been exploded as shown in Fig 12. To understand it better, we've created the several FEA models to simulate this destructive test. The first model is a 3-D model with the end seal included as shown in Fig 28. The result shows that the "end effect" is minimal as shown in Fig 29 & 30. Therefore, a 2-D model was also created due to its efficiency as shown in Fig 31 & 32. The comparison chart of Fig 33 shows that the 2D model is sufficient.

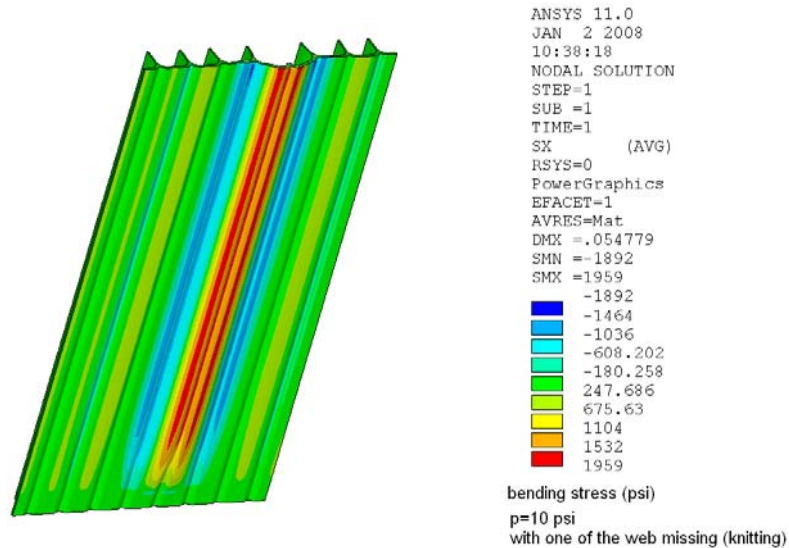
Figure 29: The bending stress for  $p=10$  psi with one of the web missing

Both 2D and 3D model indicates that the maximum bending stress is about ~5800 psi for  $P \sim 30$  psi if one of the web experiences the knitting issue. This is where we would expect the extrusion to fail if the test material is similar to PEB ( see nova PEB tensile test from Novadocdb-98-v1). However, the actual test shows the structure can sustain the pressure up to ~ 55 psi. The linear analysis (by assuming  $E=0.36$  mpsi) DOES yield a conservative result.

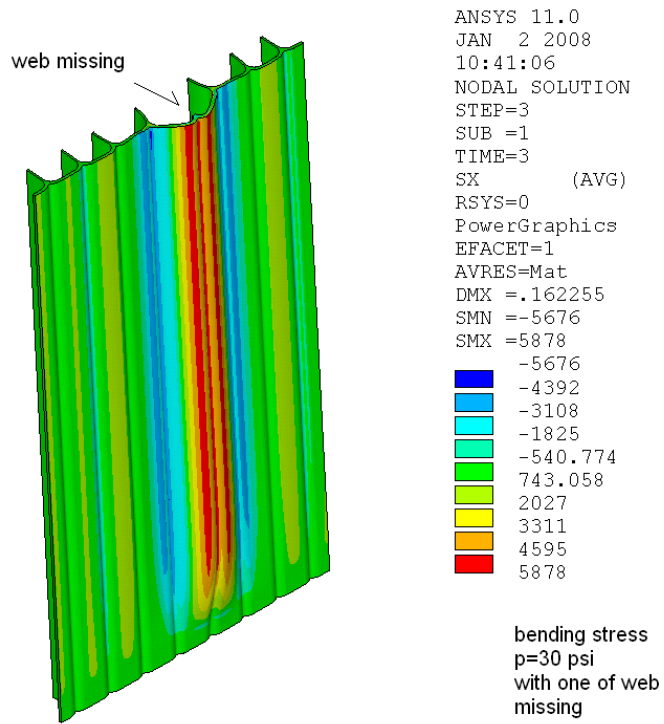
Figure 30: The bending stress for p=30 psi with one of the web missing

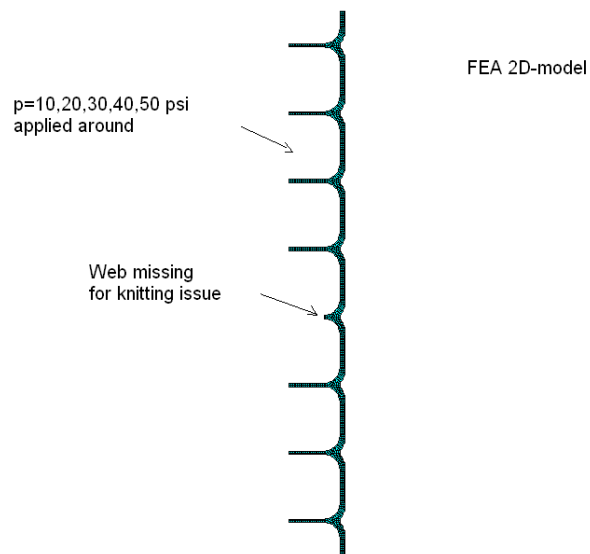
Figure 31: FEA 2-D model

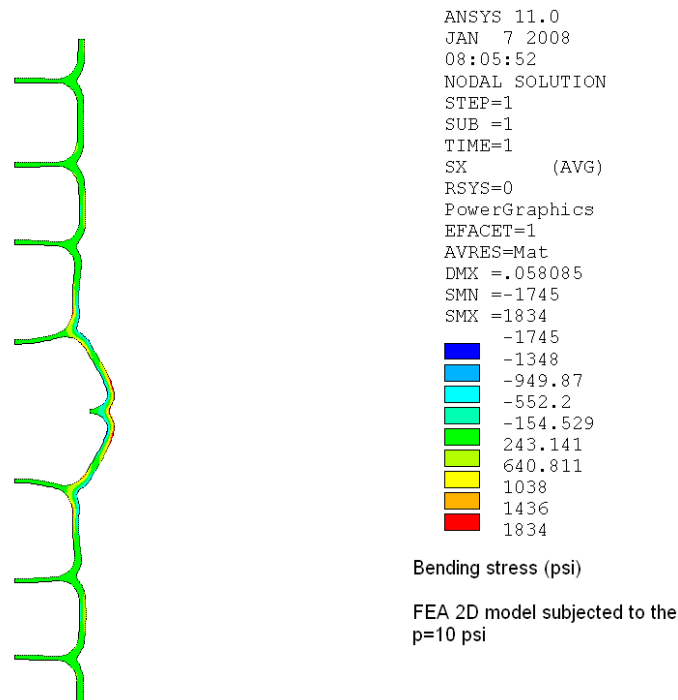
Figure 32: The bending stress for p=10 psi (2D model)

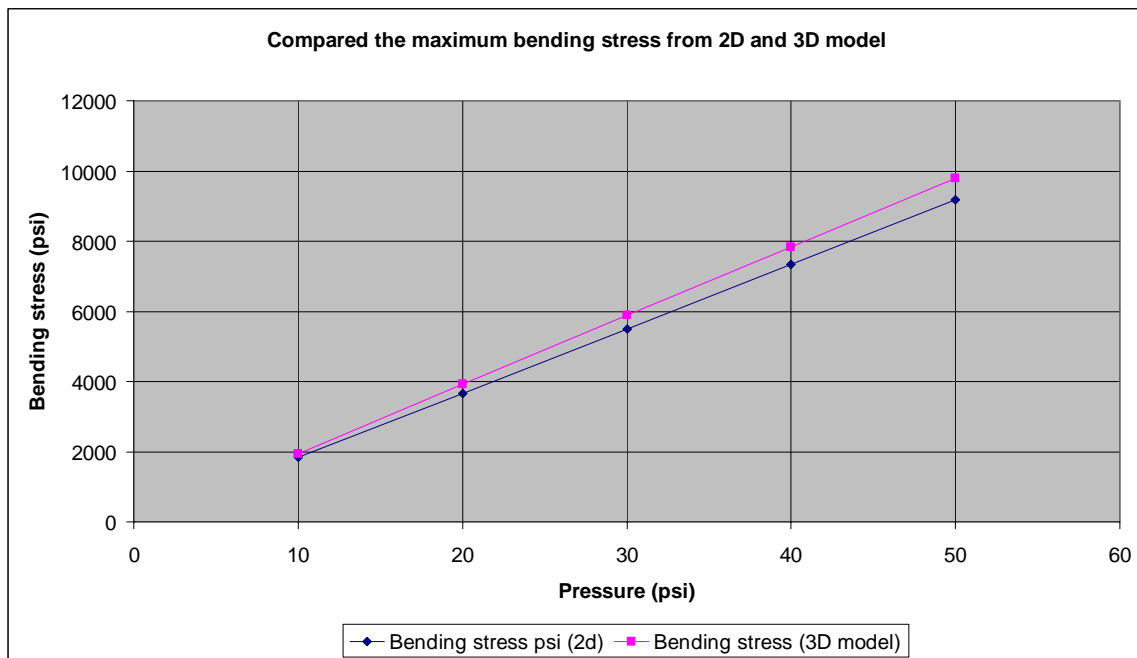
Figure 33: The bending stress from 2D and 3D model

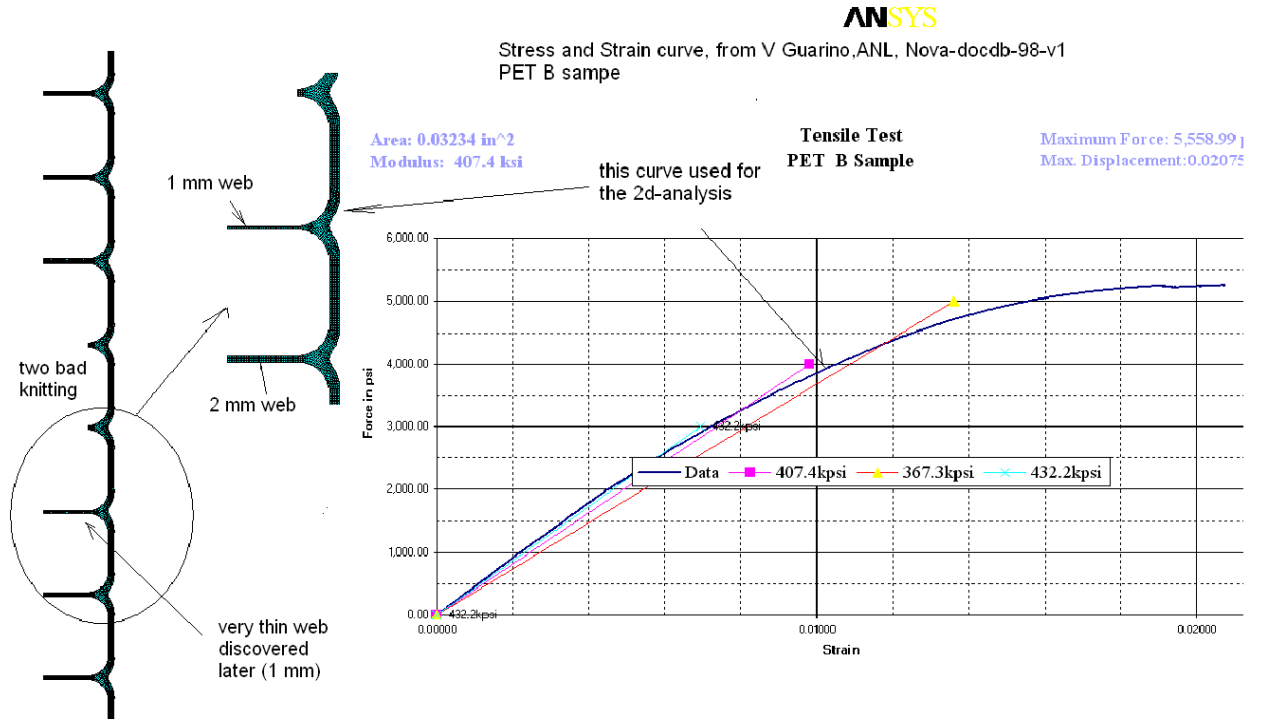
Figure 34: 2-D Non linear plasticity model

Since this is a destructive test, it will be very interesting to simulate it with a nonlinear stress - strain curve. A PET B stress-strain curve is currently available to us. We've assumed that the material in the test is a similar material. A 2-D model is used for this non-linear plasticity analysis as shown in Fig 34. It includes all the "birth defects" observed (2 web root knitting and one very thin web next to it). By pressurizing it to p=55 psi, the stress result indicates that both

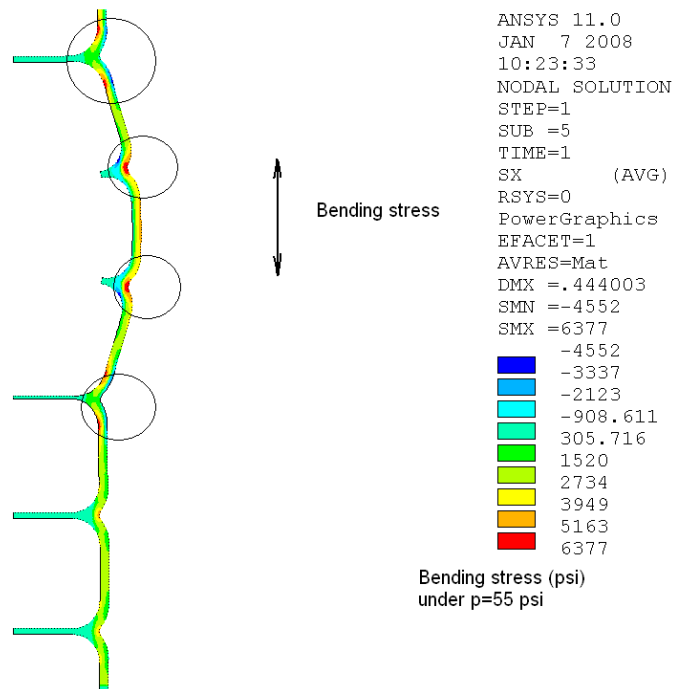
Figure 35: 2-D bending stress based on the non linear plasticity model for the side wall

bending stress in the side wall and the tensile stress in the thin web ( $t=1$  mm) reaches above 5,000 psi which is considered to be a break point as shown in Fig 35 & 36. It seems to us that the structure could be broken anywhere from either the side wall or thin web as soon as the pressure hits 55 psi. The tensile is more dangerous than the bending due to a possible "plastic hinge" effect. We think that the thin web (1 mm) was most likely broken first since its stress is in tensile nature (uniformly cross the section) and the side wall might follow after that due to an excessive span length.

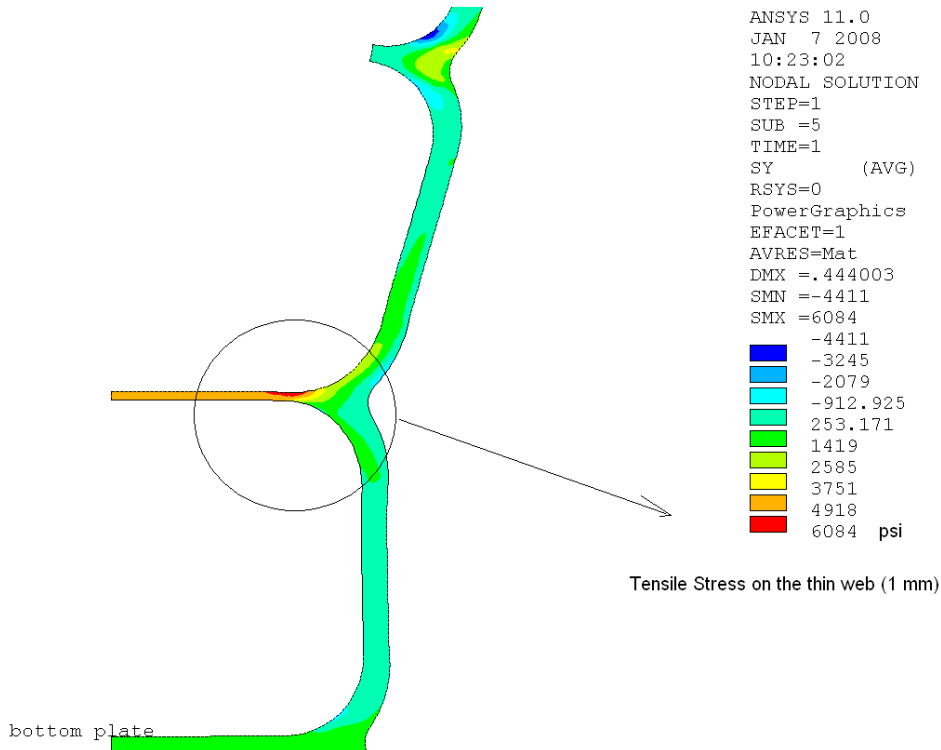
Figure 36: 2-D tensile stress based on the non linear plasticity model for the web
