SPENT FUEL MANAGEMENT AT THE SAVANNAH RIVER SITE

P. R. Vormelker and R. L. Sindelar
Savannah River National Laboratory
Washington Savannah River Company
PO Box 616
Aiken, SC 29808

ABSTRACT

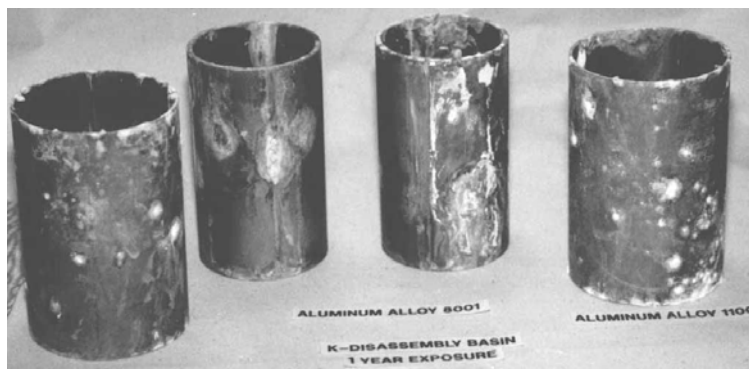
Figure 1. Aluminum clad full size target tubes after immersion in K-Basin.

Component immersion tests were conducted in SRS basins from 1992-2000. Pitting through a 30-mil clad target tube occurred in as little as 45 days when conductivity was 180 $\mu\text{S}/\text{cm}$ with a chloride level of 8 ppm (Figure 1). This was a warning sign that increased use of deionizers was necessary to eliminate aggressive water conditions.

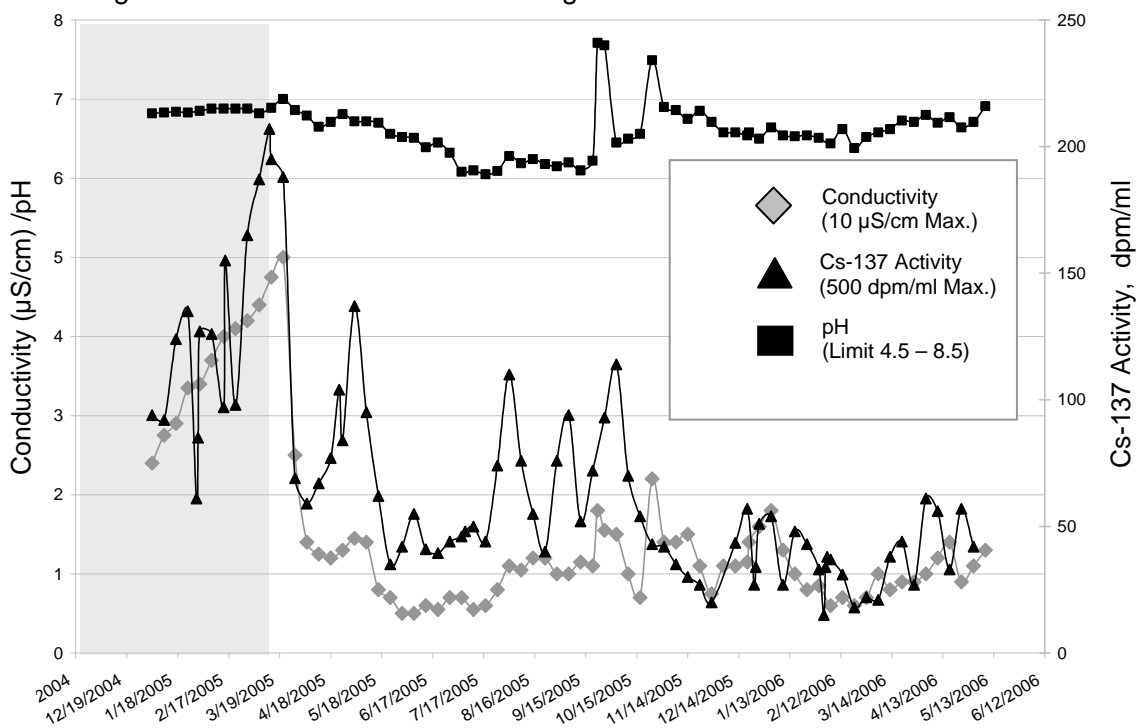
Figure 2. Cs-137 activity levels in L-Basin versus pH and conductivity during December 2004 to the middle of June 2006.

Recent trend data (2005-2006) for activity, conductivity and pH levels are shown in Figures 2 and 3. Basin activity levels have peaked during the recent storage period due to deionizer shutdown and dropped after startup. Figure 4 shows that prior increases in Cs-137 activity levels did not affect pH and conductivity levels over the time period from late 2002 to early 2004 when the fuels were received from RBOF and placed into L-Basin. This suggests that corrosion processes are not strongly affected by increases in Cs-137 activity levels. Water chemistry records show that the L-Basin water is being maintained within operating limits since 1996, except during a few periods of fuel transfer.

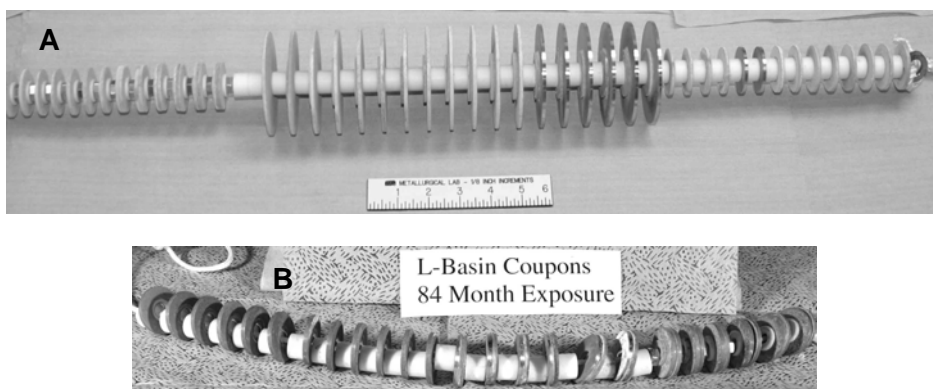
Figure 4. "Ray Gun" (A) and "Jr. Ray Gun" (B) Assemblies: As-received from L-Basin

A "Ray Gun" coupon assembly that has 70 coupons is shown in Figure 4. All "Ray Gun" coupons have been evaluated except for one assembly for evaluation upon basin closure. A "Jr.

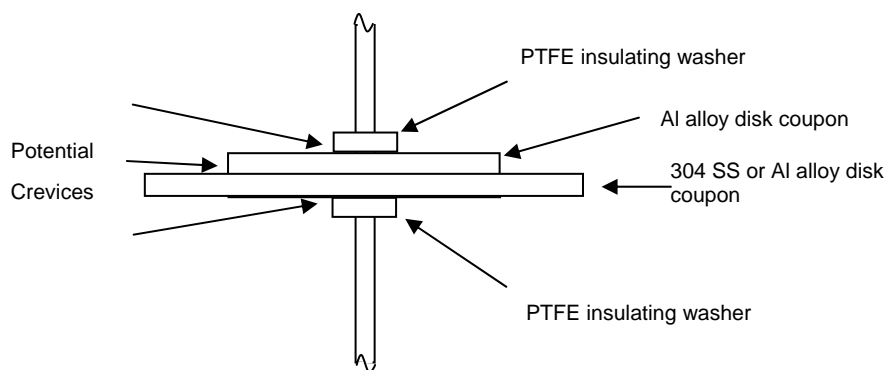
Figure 5. Sketch of Ray Gun Galvanic Coupon Arrangement. The arrangement creates a galvanic cell between the Al and a larger SS coupon (0.5:1 diameter ratio), with potential crevices between each coupon and between the coupon and each washer.

Ray Gun" coupon assembly has 36 coupons, and does not contain the 70 mm disk stainless steel coupons on the Ray Gun assembly, but does contain the 1:1 (area ratio) stainless steel to aluminum coupon galvanic couple specimens. A sketch showing the configuration of the galvanic coupons on the Ray Gun and Junior Ray Gun is shown in Figures 5 and 6. Additional specimen types in the surveillance program include "furniture rack" specimens that are flat plates and U-channel specimens of 6061-T5 and 6063-T5 (fuel storage rack) materials, respectively with R4043 weld beads which are shown hanging above the basin in Figure 7.

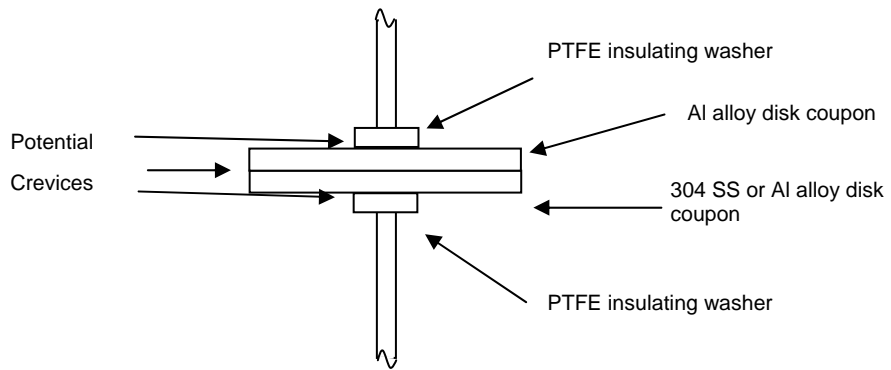
Figure 6. Sketch of Jr. Ray Gun Galvanic Coupon Arrangement. Both coupons are 32 mm in diameter, a 1:1 diameter ratio.

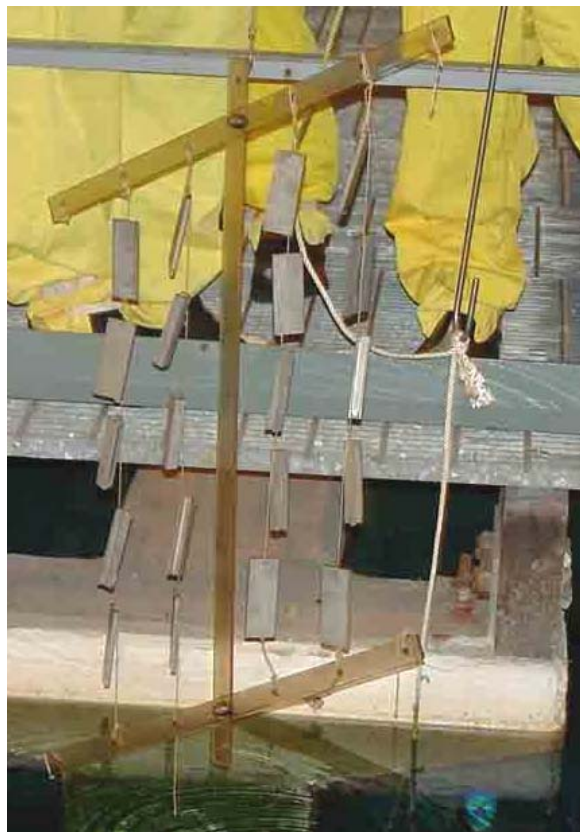
Figure 7. Hanging furniture rack coupons removed from L-Basin.

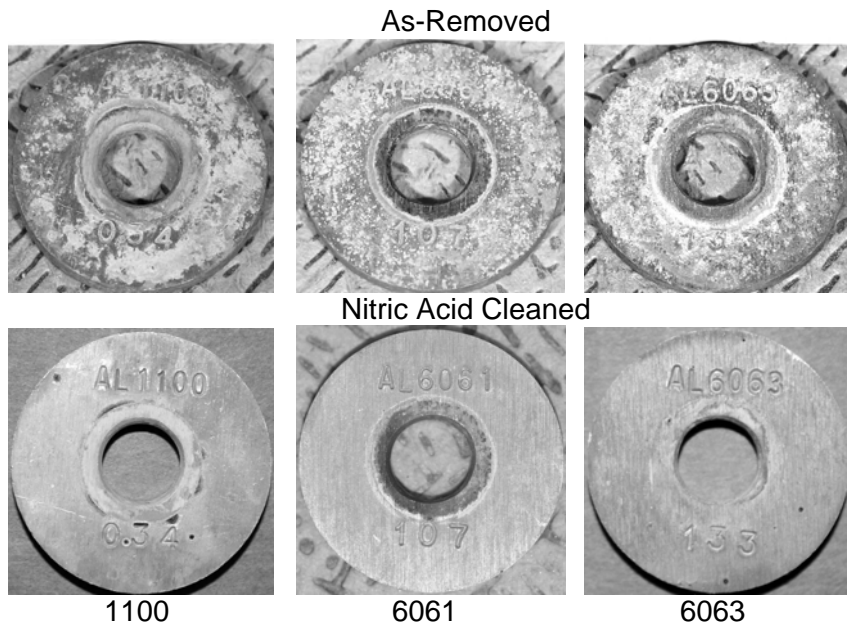
Figure 8. Selected Surveillance Coupons removed from L-Basin in 2006. The as-removed aluminum specimens exhibited a uniform oxide scale plus sand deposits and pitting attack near the crevice region created by the PTFE washer. The nitric acid cleaned coupons revealed a few large pits.

Selected images of individual surveillance coupons retrieved from the basin in 2006 after 7 years immersion are shown in Figure 8. These coupons appear slightly different when visually compared to coupons pulled in 2001, 2002, 2003, and 2004. The individual coupons from all past years of evaluation are undergoing uniform corrosion with a buildup of an oxyhydroxide layer. In 2005 and 2006, the coupons had sand deposits in addition to the oxyhydroxide buildup. In mid 2004, the sand filter was started up and a cloud of sand filter fines was released to the basin. The 2005 and 2006 coupons exhibited a yellow/tan color on exposed surfaces of the horizontally mounted coupons. Deposit studies from the literature²⁰ have indicated increased corrosion rates due to foreign particle deposition on the surface of water immersed aluminum coupons. The particles can act as cathodes (depending on particle composition) on the surface and the surrounding metal (anode) corrodes. Thus, energy dispersive spectroscopic (EDS) analysis was performed on selected 2006 corrosion coupons prior to cleaning to confirm the existence of foreign particles. EDS confirmed that sand particles containing Si, Ti, and Fe from the sand filter release were present on aluminum coupon surfaces. In a few instances, pits were observed in the as-received coupon and locations confirmed after acid cleaning (Figure 9).

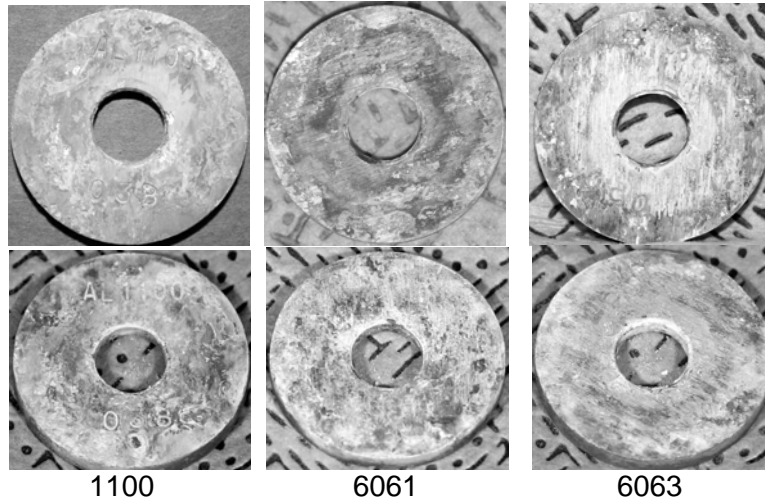
Figure 10. As-received aluminum 1100, 6061, and 6063 coupons galvanically coupled with a 304 stainless steel coupons shown with aluminum mating surfaces in view.

The most appreciable oxide buildup observed is in galvanically-coupled specimens²¹ marked by heavy oxidation between the samples of dissimilar metals (see Figure 10). Similar behavior was noted in the previous examinations in 2001, 2003, 2004 and 2005. Pitting was apparent when the oxides were removed by the cleaning of these specimens in 16M nitric acid solution.

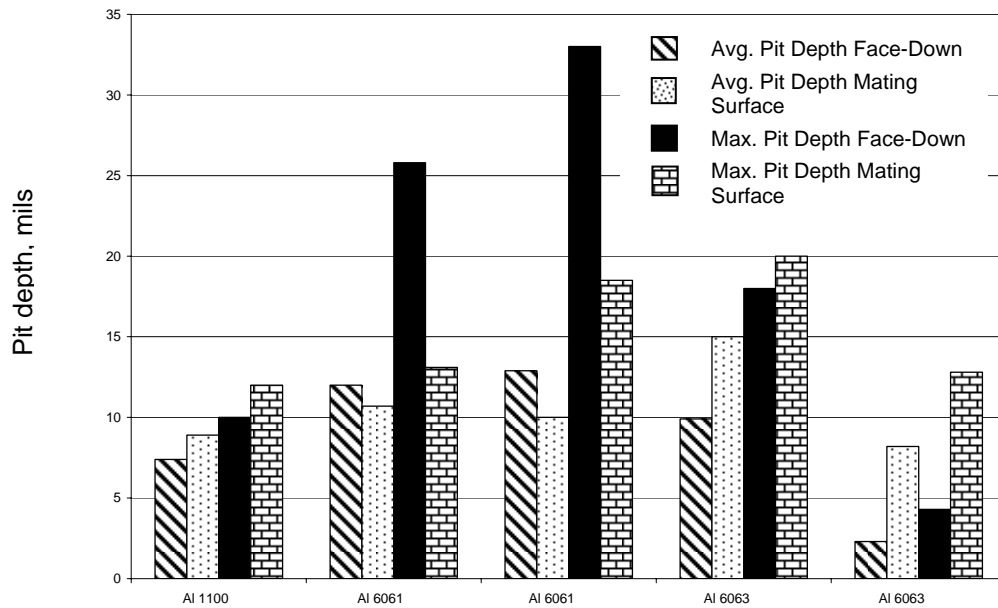
Figure 11. Average and maximum pit depths of 2006 galvanically coupled coupons. Maximum pit depths were measured near the edge of the PTFE washer area or at the coupon ID.

Pit depths were measured on all galvanically-coupled aluminum alloy coupons and summarized in Figure 11 with a display of average and maximum pit depths. Figure 11 shows a 15 mil average pit depth on a 6063 coupon and 33 mil maximum pit depth on a 6061 coupon. Both were coupled with a 304 stainless steel coupon. The pit formation is attributed to a combination of galvanic corrosion and end grain effects (6063). Similar results from the 6063 and 6061/304 coupled

coupons were observed in past coupon evaluations. Maximum pit depths on the aluminum alloy couples were located near the PTFE washer circumference and on the ID and OD of the samples.

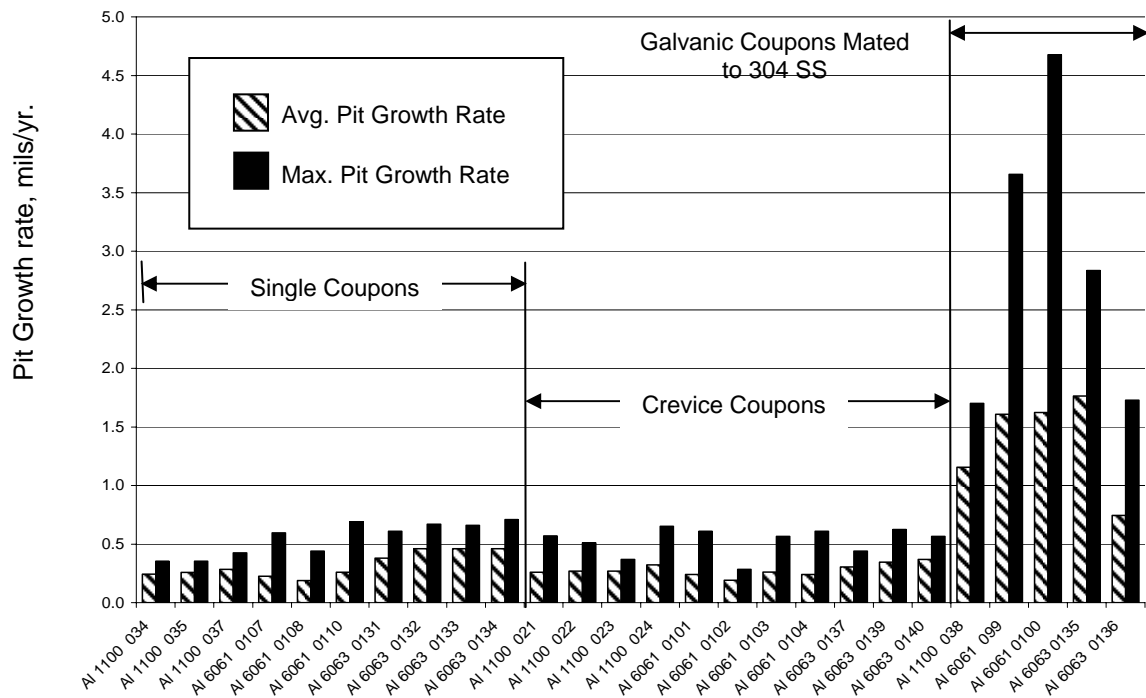
Figure 12. Average and maximum pit growth rates for single, crevice, and galvanically-coupled coupons. Coupon order and sizes are identical to those in Figure 8. The same pit depths were used with depth divided by time in basin to calculate growth rates.

Average and maximum growth rates for the galvanically-coupled coupons are shown in Figure 12. The average growth rate is less than 1.8 mils per year (mpy), based on immersion for approximately 7 years. The 6063 galvanic coupons show the highest maximum growth rate (~4.7 mpy). The galvanic coupons display substantially greater growth rates than the other coupon types due to electrochemical potential differences between 304 stainless steel and aluminum.

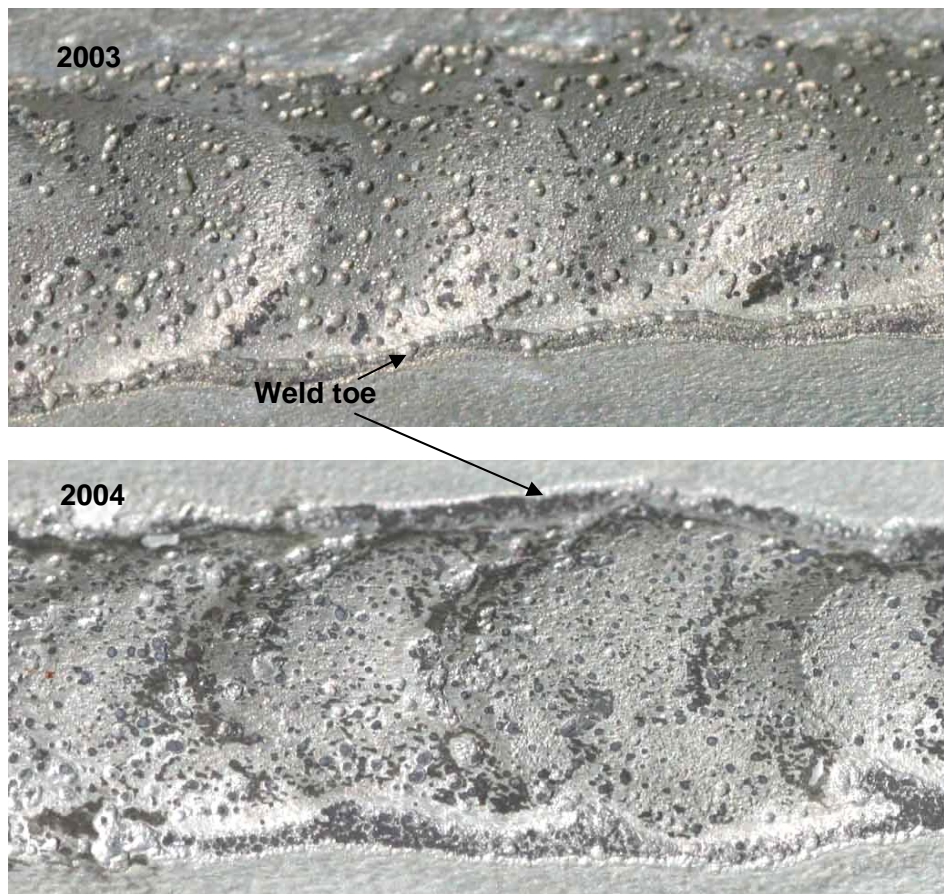
Figure 13. Cleaned R4043 weld beads on 2003 (upper) and 2004 (lower) Al 6063 T5 U-Channel samples after immersion in L-Basin for 85 and 97 months, respectively. Weld bead width is approximately 6.4 mm. Numerous pits are visible in the weld bead and weld toe on each side of bead. Few pits were found in the base metal.

Figure 13 shows the pronounced pitting on the weld-filler material on the U-Channel specimens removed in 2003 and 2004 and cleaned to remove the oxide deposits. Average pit depths in the weld bead were less than 4.5 mils while maximum pit depths (weld toe) were less than 7 mils.

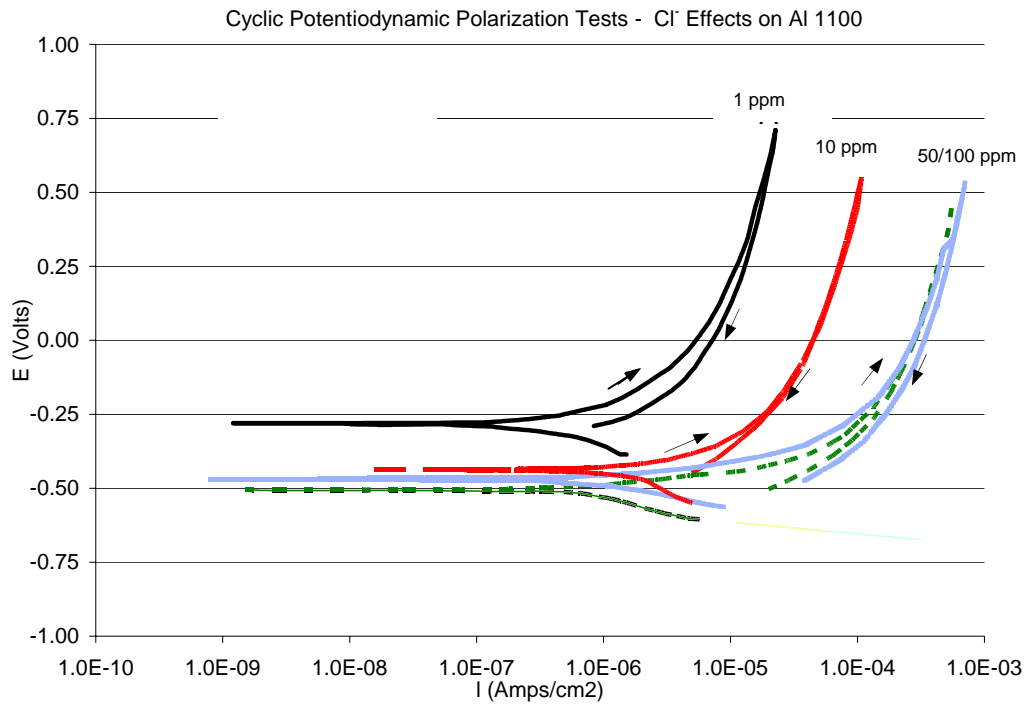
Figure 14. Cyclic Polarization Results for Al 1100 in solutions with increasing chloride levels from 1 ppm to 100 ppm. Increasing current densities is also noted as chloride levels increase.

Initial cyclic potentiodynamic polarization (CPP) testing was performed to identify the region of "aggressive" water qualities where corrosion attack would occur if the existing oxide layer were scratched, exposing the bare metal. The testing is based on CPP methods reported in References 22 and 23. Figure 14 shows that a 1 ppm chloride addition to deionized water should not cause pitting, whereas increases to 10 ppm, 50 ppm and 100 ppm chloride solutions clearly showed pitting attack, as verified by post-test metallography on Al 1100 coupons. Increasing chloride additions also increase current densities by up to 50X. The CPP curve in Figure 15 indicates that an addition of 10 ppm sulfate to 10 ppm chloride creates an aggressive pitting solution with current densities close to that of a 50 and 100 ppm chloride solution. However, adding 100 ppm nitrate to a 10 ppm chloride solution appears to act as an inhibitor in CPP results shown in Figure 16. Additional results not shown in this paper show that nitrate at low levels may serve as an inhibitor to aggressive solutions containing both chloride and sulphate. These CPP results exhibit a classic passive regime, a breakdown potential, and a repassivation potential. Future testing will support definition of a "chemistry envelope" for corrosion minimization based on these initial results.

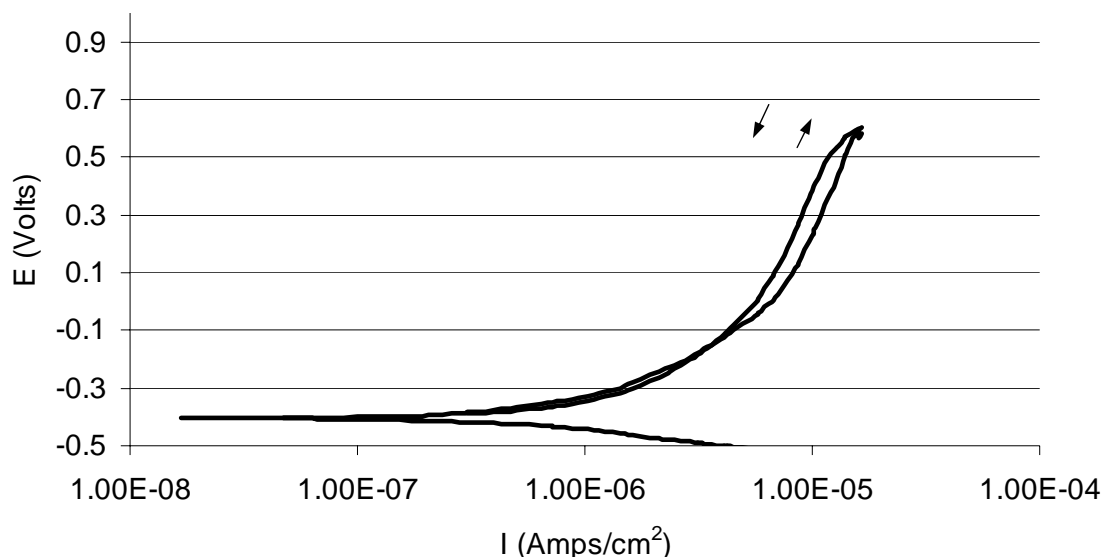
Figure 16. Cyclic Polarization Results for Al 1100 in a solution with 10 ppm Chloride plus 100 ppm Nitrate. The results show a non-aggressive solution when nitrate is added to the chloride.
