FACTORS INFLUENCING HORIZONTAL CRACKING IN CONTINUOUSLY
REINFORCED CONCRETE PAVEMENTS (CRCP)

Thesis Prepared for the Degree of
MASTER OF SCIENCE

UNIVERSITY OF NORTH TEXAS

August 2008

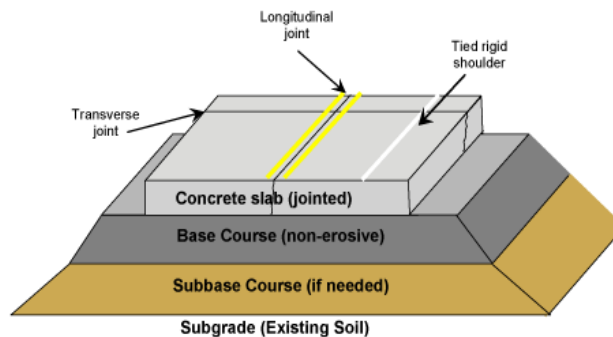
Figure 1. A typical section for a rigid pavement (Pavement Design Guide, 2006).

cement concrete (PCC) pavement, although with today's pozzolanic additives, cements may no longer be technically classified as "Portland." The surface course (concrete slab) is the stiffest and provides the majority of strength. The base or subbase layers are orders of magnitude less stiff than the PCC surface but still make important contributions to pavement drainage, frost protection and provide a working platform for construction equipment. Rigid pavements are substantially 'stiffer' than flexible pavements due to the high modulus of elasticity of the PCC material resulting in very low deflections under loading. Rigid pavements can have reinforcing steel, which is generally used to handle thermal stresses to reduce or eliminate joints and maintain tight crack widths. Figure 1 shows a typical section for a rigid pavement (Pavement Design Guide 2006).

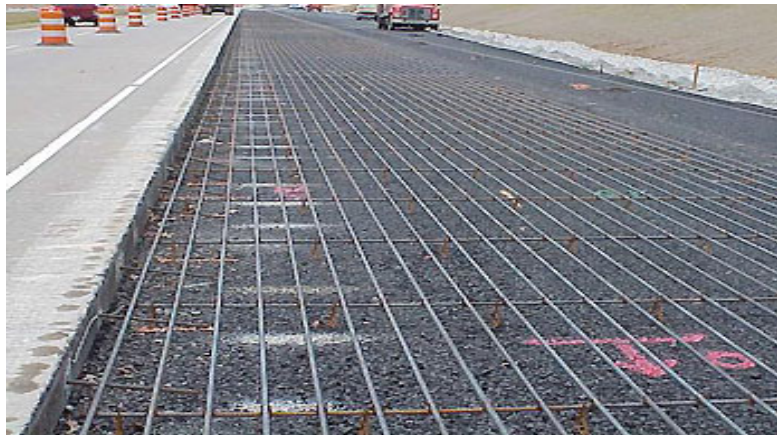
Figure 2. Continuously Reinforced Concrete Pavement (Pavement Design Guide, 2006).

The factors that influence the performance of CRCP include: (1) Portland cement concrete properties (tensile strength, elastic modulus, coefficient of thermal expansion and drying shrinkage); (2) slab and subbase resistance (vertical and horizontal stiffness); (3) steel properties (percent reinforcement, steel bar diameter and location); (4) environmental loads; (ambient air temperature, solar radiation, wind speed and relative humidity); (5) dimension and geometry of structure (pavement thickness and boundary conditions); (6) external wheel loads (static wheel load and moving dynamic load) (Jeong-Hee Nam, 2005). This study presents the factors that influence the horizontal cracking in CRCP; rebar temperature and its relationship with the concrete bond strength, influence of the water to cement ratio and the steel surface condition in terms of corroded vs. non-corroded rebar. Figure 2 shows a continuously reinforced concrete pavement under construction.

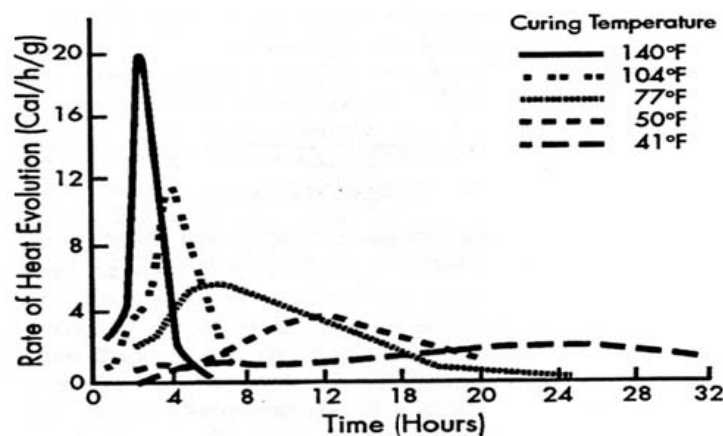
Figure 4. Effect of curing temperature on the hydration. (Suh et al., 1992).

The rate of hydration is very sensitive to temperature, especially during the primary cycle (Mindess et al., 1981). Therefore, the temperature condition during construction is an important factor affecting the rate of hydration. Figure 4 (Suh et al., 1992) shows the effect of curing temperature on the hydration of tricalcium silicate. It can be seen that the higher the curing temperature, the faster the heat release and the higher the peak.

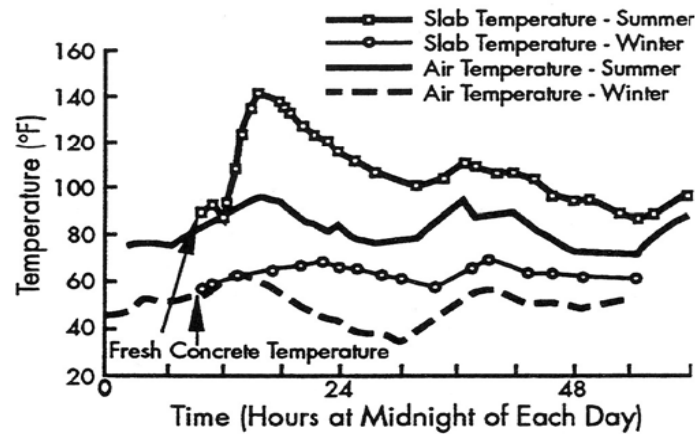
Figure 5. Ambient air temperature effects on the slab temperatures (Suh et al., 1992).

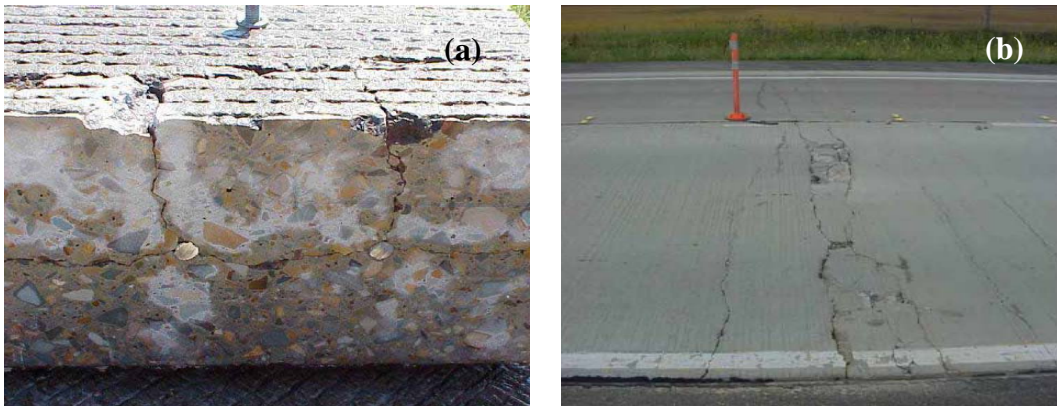
Figure 6. Horizontal cracking distresses in CRCP (Courtesy of the Center of Transportation Research, University of Texas at Austin).

Figures 6 (a) and (b) show horizontal cracking distresses in CRCP.

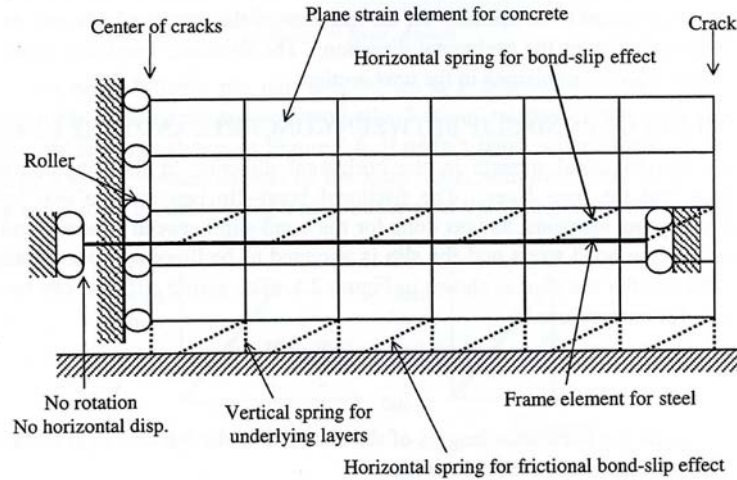
Figure 7. Finite element model of CRCP (Kim & Won, 2004).

In their theoretical analysis to estimate the effects of several design, environmental, and materials variables (number of steel layers, temperature variations, and thermal coefficient of thermal expansion and modulus of elasticity of concrete) on the potential for horizontal cracking, Kim and Won (2004) utilized a finite element modeling as shown in Figure 7. They based their analysis on horizontal cracking observed in Texas.

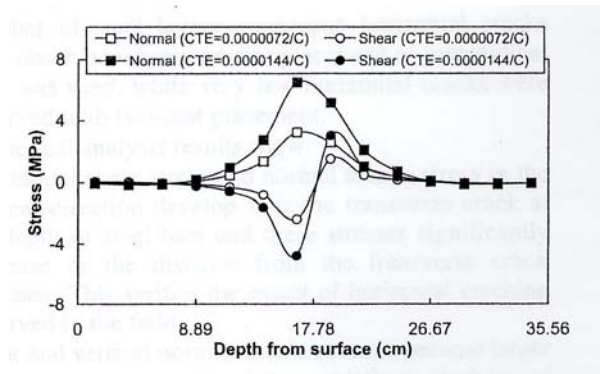
Figure 9. Effect of concrete coefficient of thermal expansion on concrete stress (Kim & Won, 2004).

CTE – concrete containing siliceous river gravel or sandstone – is more prone to horizontal cracking than concrete with low CTE – concrete containing crushed limestone.

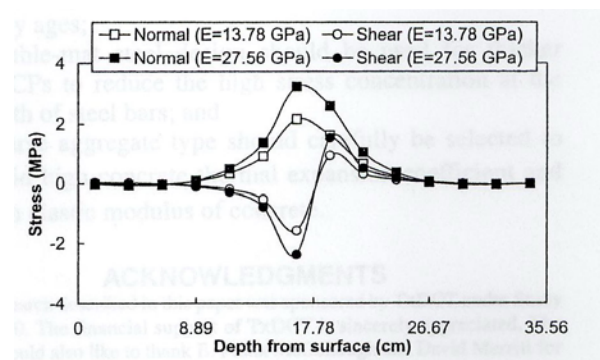
Figure 10. Effect of concrete modulus of elasticity on stress distribution along slab depth (Kim & Won, 2004).

Figure 10 shows the effect of concrete modulus of elasticity on the normal and shear stresses along the slab depth. They noted that concrete with higher modulus experiences larger normal and shear stresses. This finding also corroborated well with field observations, where concrete with higher modulus such as concrete containing hard siliceous river gravel had higher potential for horizontal cracking than concrete with lower modulus.

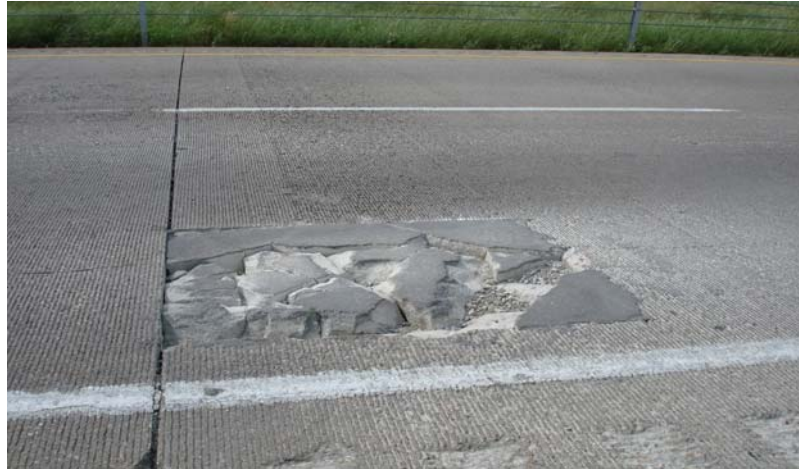
Figure 11. CRCP distress caused by horizontal cracking.
(Courtesy of the Center for Transportation Research, University of Texas at Austin)

Pavement distress due to horizontal cracks was first observed in the CRCP section of IH-30 in the Paris district in Texas. This section of pavement is 250 mm-thick CRCP, built in 1986. The typical distress types included pop outs and half-depth punchouts as shown in Figure 11.

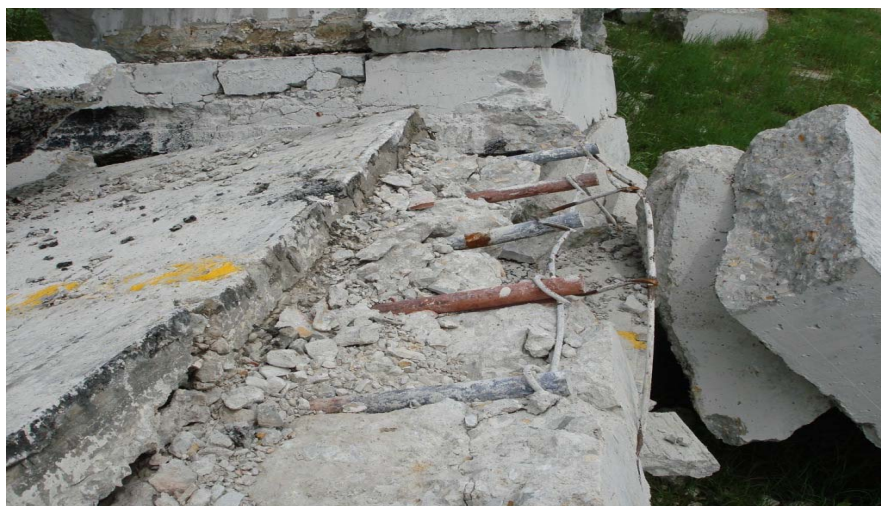
Figure 12. Mid-depth horizontal cracks.
(Courtesy of the Center for Transportation Research, University of Texas at Austin)

During the repair work, extensive horizontal cracks were observed in the removed slabs as shown in Figure 12.

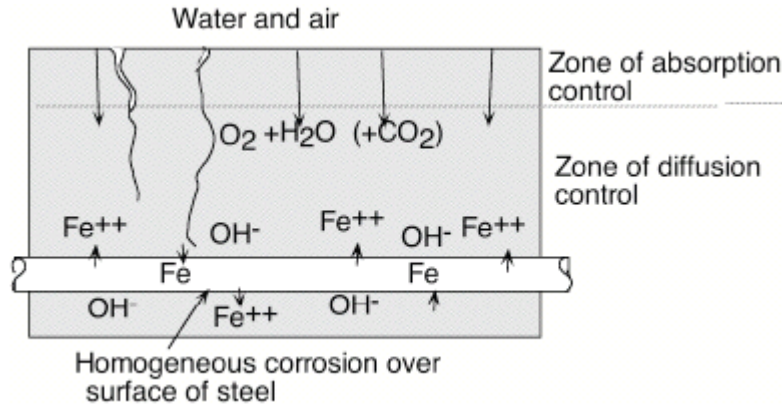
Figure 13. Schematic representation of passive corrosion (Andrade et al., 1995).

This electrochemical process is illustrated in Figure 13 (Andrade et al., 1995).

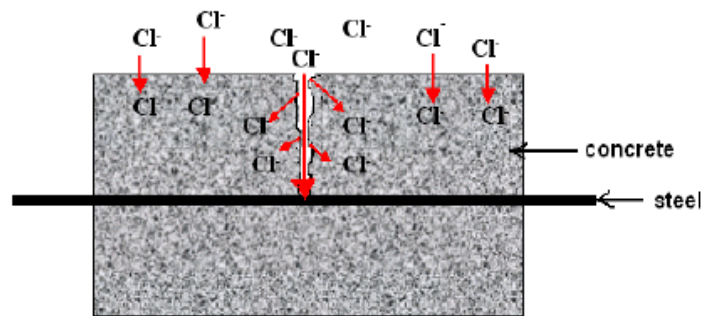
Figure 14. Schematic illustration of chloride diffusion in cracked concrete (Higgins et al., 2003).

Once the diffusion process has occurred, the Cl⁻ ions are simultaneously released and these migrate back to the anode to react further with the steel. As the hydroxyl ions are consumed during the process, the solution pH decreases enhancing further the metal dissolution. Since the Cl⁻ ions are not consumed, the attack becomes “autocatalytic” seriously compromising the reinforcement cross-section and its structural resistance. Figure 14 shows a schematic of the illustration of chloride diffusion in cracked concrete (Higgins et al., 2003).

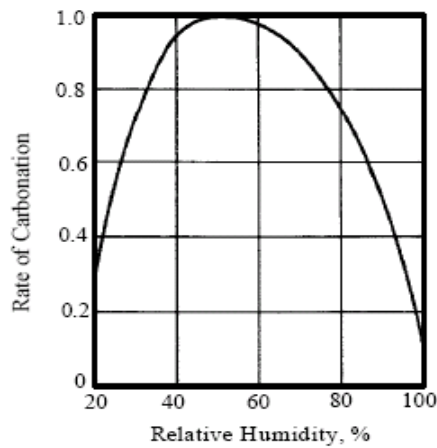
Figure 15. The Influence of relative humidity on the rate of carbonation of concrete (Tuuti, 1980).

The rate at which carbonation advances is a function of relative humidity (RH) and this increase with time. At low RH, the penetration of CO_2 into the concrete is highest. Figure 15 shows the influence of relative humidity on the rate of carbonation of concrete (Tuuti, 1980).

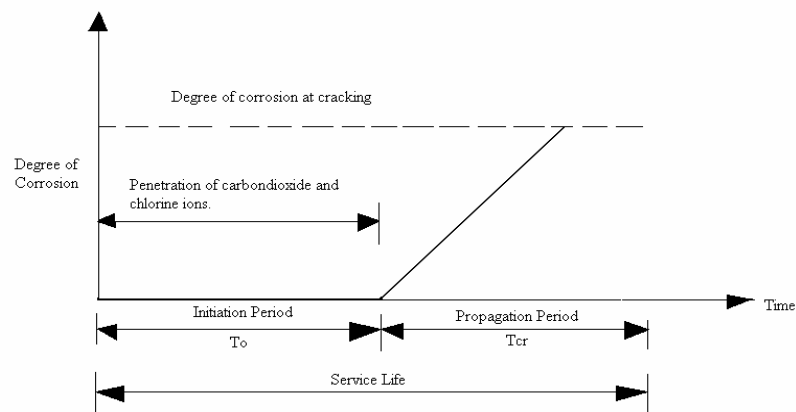
Figure 16. Service life model of corroded structures (Tuuti, 1980).

Tuuti, (1980) developed a conceptual model for the service life prediction for corroded reinforced concrete structure. This is shown in Figure 16. There are two distinct periods in deterioration caused by corrosion according to this model. The first is the initiation period, T_o , which represents the time required for CO_2 or Cl^- ions to diffuse to the steel-to-concrete interface and activate corrosion. The second is the propagation period, T_{cr} , which represents the time between corrosion initiation and corrosion cracking.

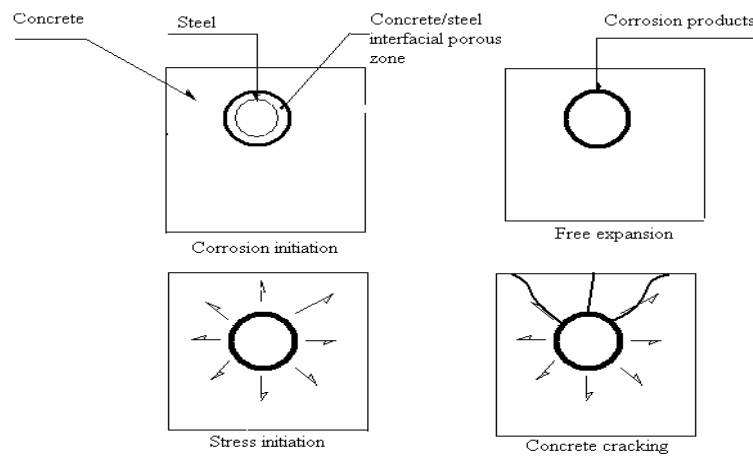
Figure 17. Corrosion and cracking process Weyers, (1998).

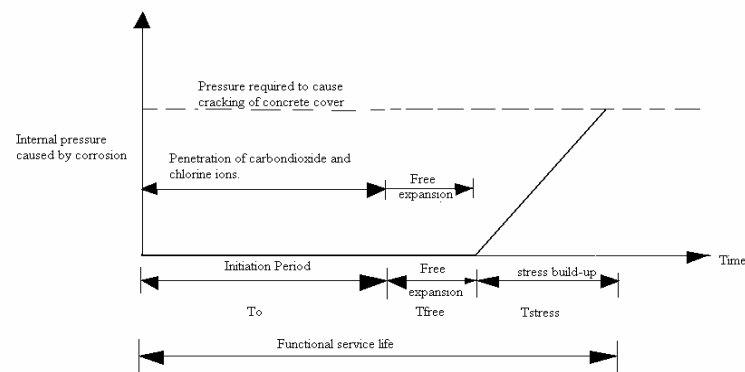
Figure 18. Modified service life model (Weyers, (1998).

and some migrate away from the steel-to-concrete interface through the concrete pores. He concluded that the conceptual model presented by Tuuti, (1980) underestimates the time to corrosion cracking compared with times obtained from field and laboratory observations. He reported that there is a porous zone around the steel reinforcing bar caused by the transition from cement paste to steel, entrapped/entrained air voids, and capillary voids in the cement paste into which corrosion products diffuse. A schematic diagram of the corrosion-cracking process as proposed by Weyers, (1998) is shown in Figure 17. A modified service life model in which the propagation period T_{cr} , divided in two different periods is shown in Figure 18.

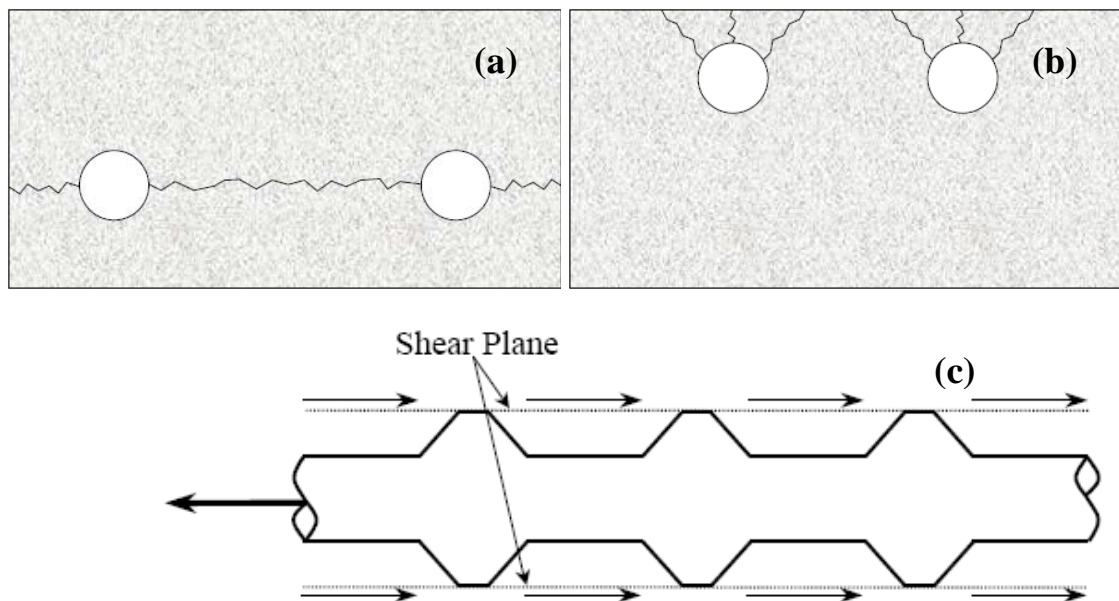
Figure 19. Side split failure (a), V-notch failure (b), Pullout failure (c). (Seddelmeyer et al., Research Report 4904-3, 2000).

This results from crushing and shearing off of the concrete keys enclosed between the bar ribs along a cylindrical plan of failure which passes by the rib tips. Pullout failure occurs if the radial confinement, caused by the presence of relatively thick concrete covers and /or excessive transverse stirrups, is greater than the transverse bond force that causes splitting of the surrounding concrete. Pullout failure is shown in Figure 19 (c).

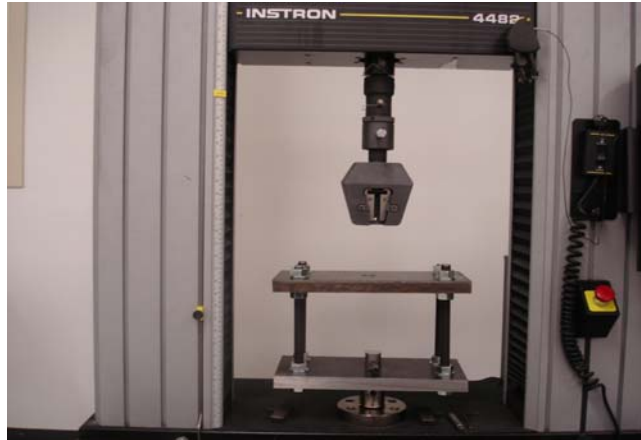
Figure 21. Instron tensile testing machine for pullout testing.

The rebar was gripped at the top by the Instron tester and secured at the bottom by the fabricated steel fixture shown in Figure 21. The pullout test setup is as shown in Figure 22. The LVDT for the measurement of slip was attached at the bottom of the specimen, and connected to

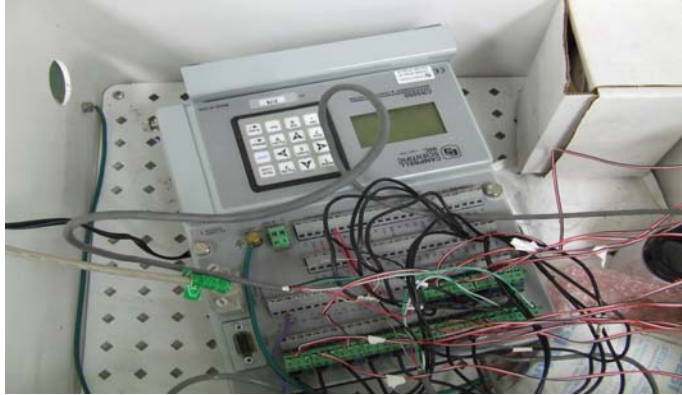
Figure 24. Data Logger.

the data logger. The data logger connection and the data logger are shown in Figures 23 and 24 respectively.

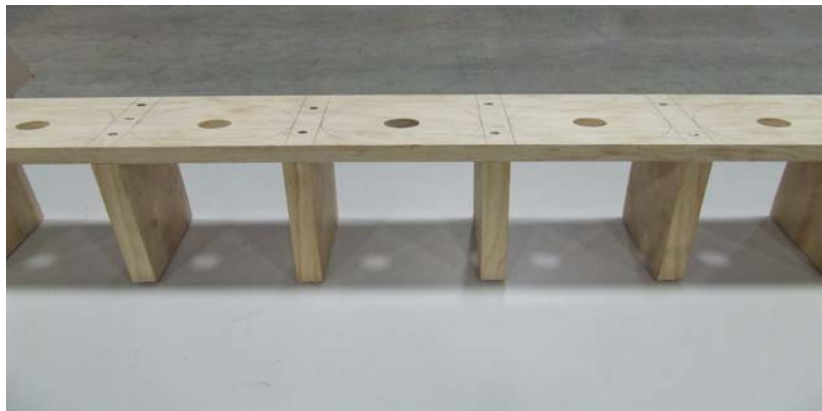
Figure 25. Centricity fixture.

In order to ensure the centricity of the test samples, a wooded fixture was created as shown in Figure 24. A 1 x 6 x 6 select radiata pine was subdivided into 13 sections. Each section was 4 inches in length representing the diameter of cylindrical molds. $\frac{3}{4}$ in diameter holes were drilled at the center for the insertion of the steel rebar. This ensured that the rebars were centered and consistent for each cast specimen.

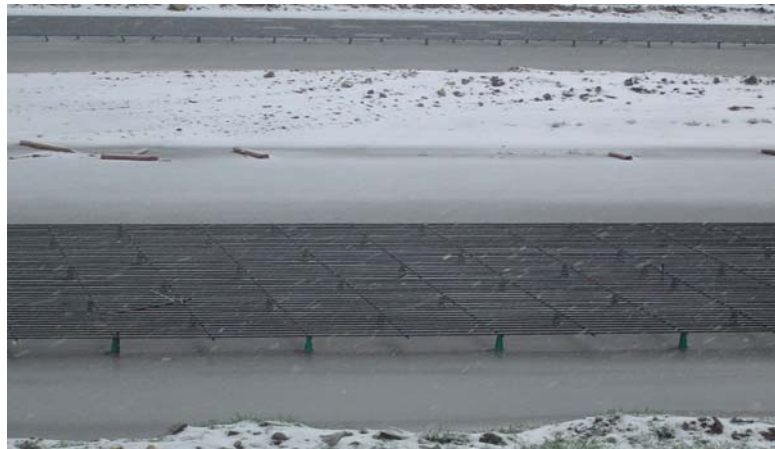
Figure 26. CRCP construction in winter conditions (Picture taken on 4/6/2008).

The normal/ ambient temperature condition, 77°F, is an approximate room temperature and did not require any adjustment on rebar temperature. Extreme summer temperature of 252°F was achieved by heating the rebar to the desired temperature in a temperature control oven. Rebars were left in the oven for four hours to ensure even heat distribution. Since pavement construction also takes place in extreme winter conditions as shown in Figure 26, a rebar temperature of 14°F was used, and this was achieved by adjusting the thermostat in the refrigerator to the 14°F-desired temperature. Rebars were left to cool for four hours to ensure even cooling on the rebar surface.

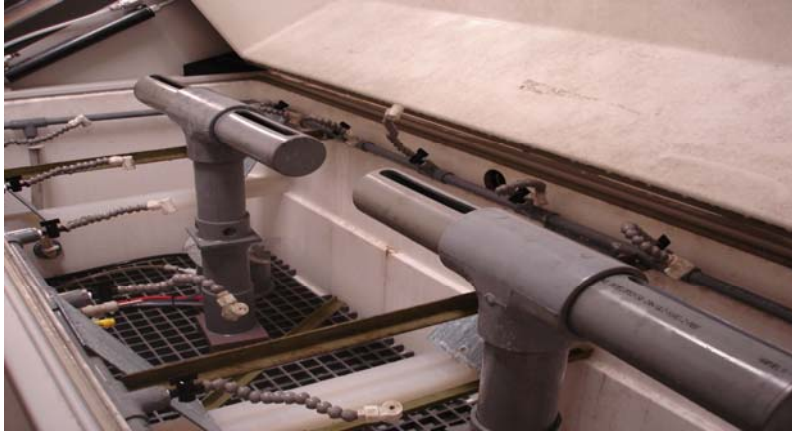
Figure 27. Interior chamber of the Atlas CCX 3000-Advanced Cyclic Exposure System.

The corrosion of the rebars used for this study was achieved by using the Atlas CCX 3000 Advanced Cyclic Exposure System and the corrosion process done in accordance to ASTM Standard G 85-02; “Standard Practice for Modified Salt Spray (Fog) Testing”. Figures 27 shows the interior cabinet of the Atlas CCX 3000 Advanced Cyclic Exposure System salt fog testing machine with the atomizing nozzles, specimen support chambers clearly visible. The rebars were left to corrode in the SFG tester for six weeks.

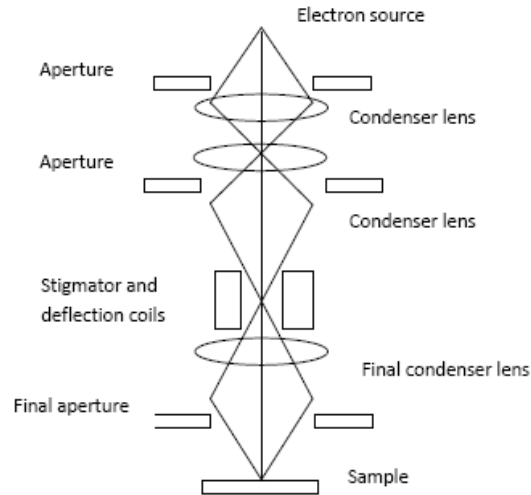
Figure 28. Schematic of scanning electron microscope.

images, secondary electron images and elemental X-rays. The electron beam raster over the surface creates for each point of the sample a point in the image (Brundle et al., 1992).

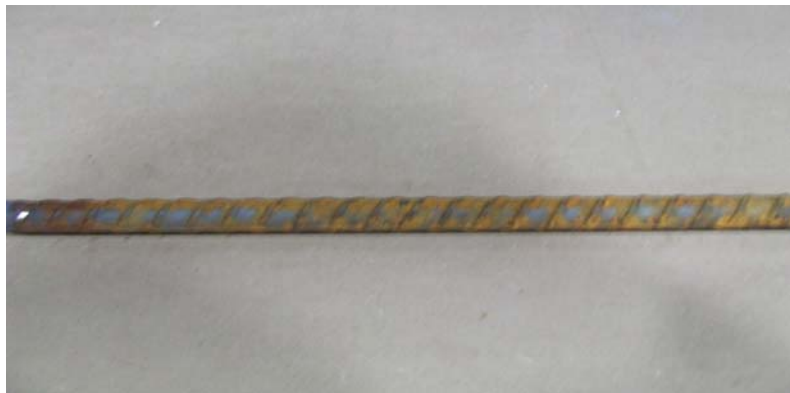
Figure 30. Partially corroded rebar used in this experiment.

The partially corroded rebar used in this experiment is shown in Figure 30.

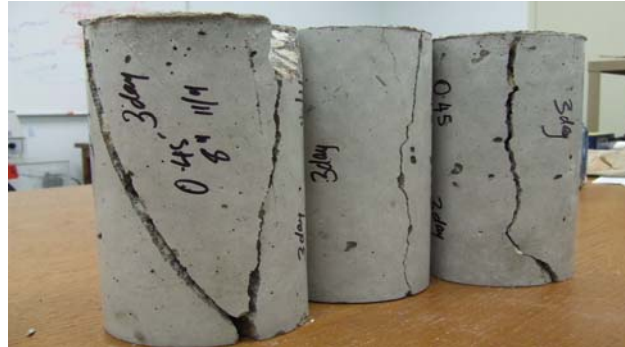
Figure 31. Pullout failure mode.

The failure mode experienced during the pullout process was pullout failure as shown in Figure 31. Failure occurred along the length of the rebar.

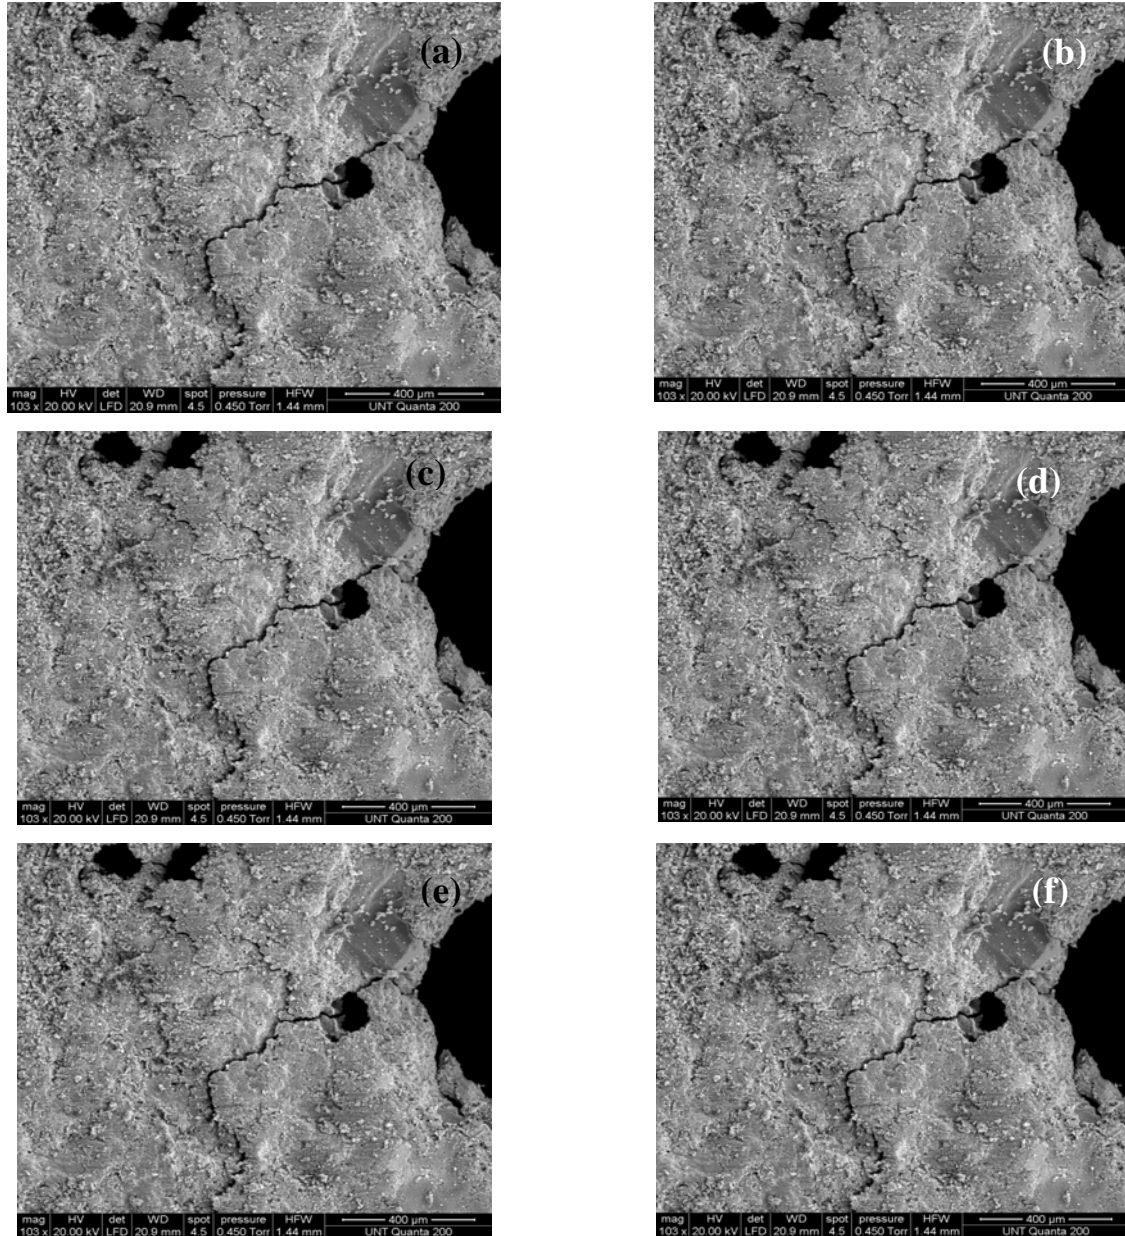
Figure 32. ESEM micrographs for the ITZ for non-corroded rebar steels at 77°F for w/c 0.40 after 3 days (a,b), 10 days (c,d), 28 days (e,f).

significantly less dense than regions farther away (Figure 32 and 33(d)). Crack bridging was also seen in samples prepared with w/c ratio of 0.45 (Figure 33 (e)). When w/c was increased to 0.50, the extent of porous ITZ region was increased to 1 mm compared to 30 μ m in a normal case. (Figure 34 (e)) Figure 34 (c) and 34 (e) shows that crack propagation takes place along the rebar length and this is in agreement with field observations.

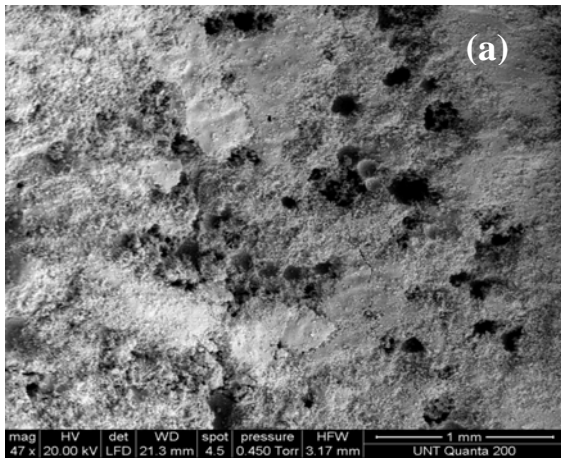
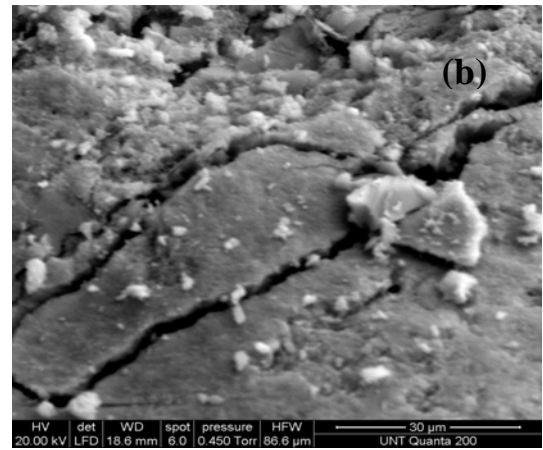
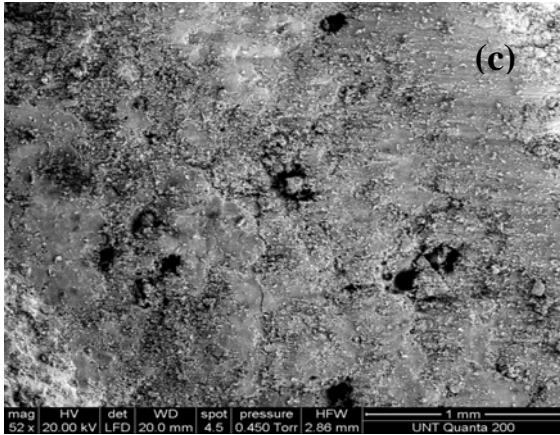
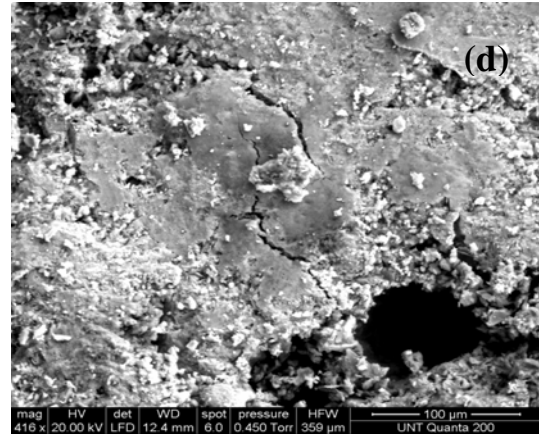
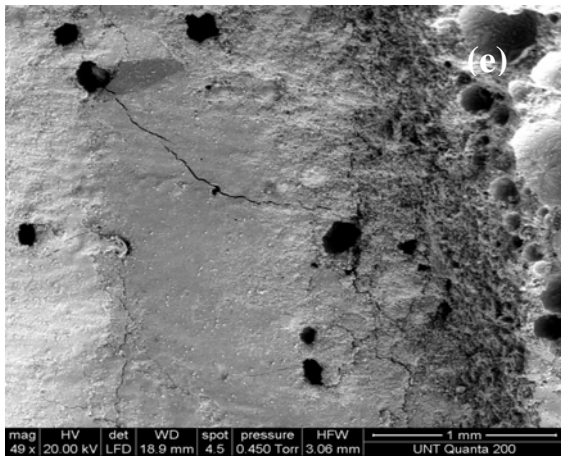
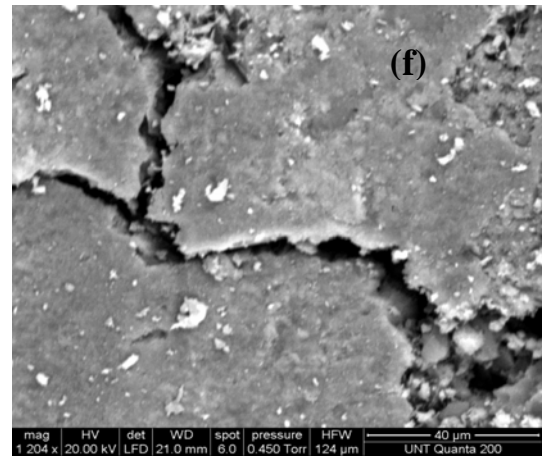
Figure 33. ESEM micrographs for the ITZ for non-corroded rebar steels at 77°F for w/c ratio 0.45 after 3 days (a,b), 10 days (c,d), 28 days (e,f).

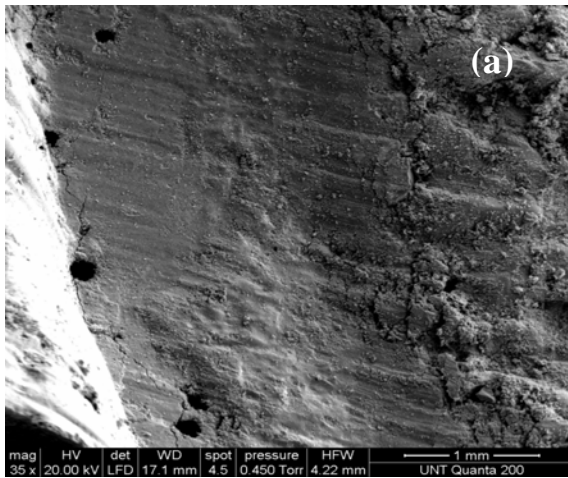
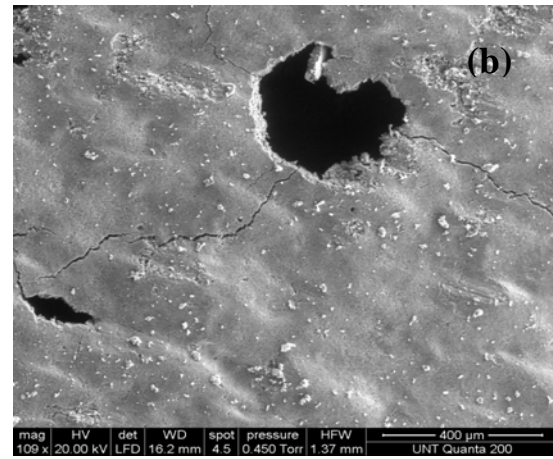
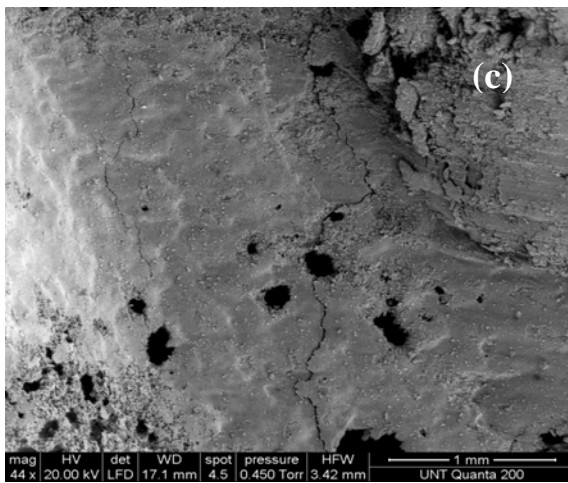
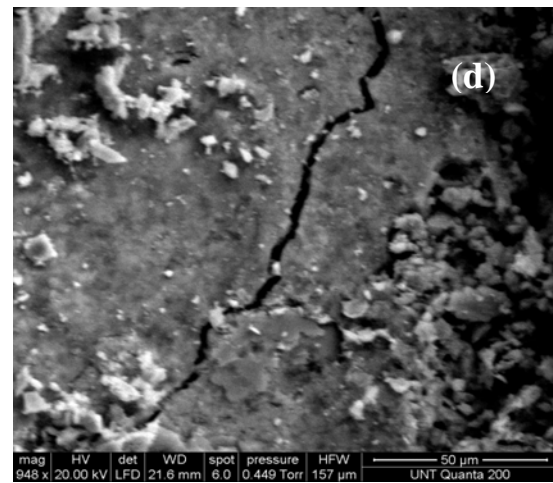
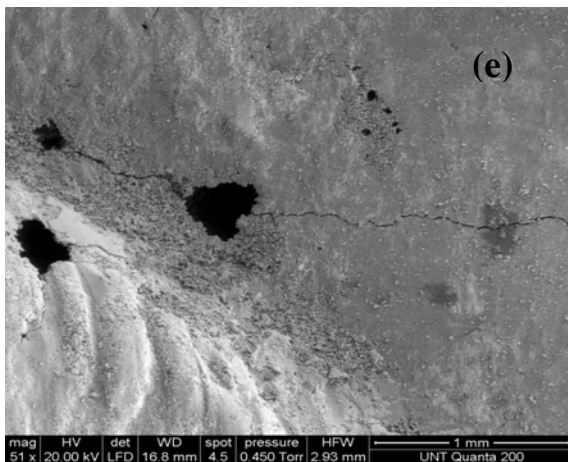
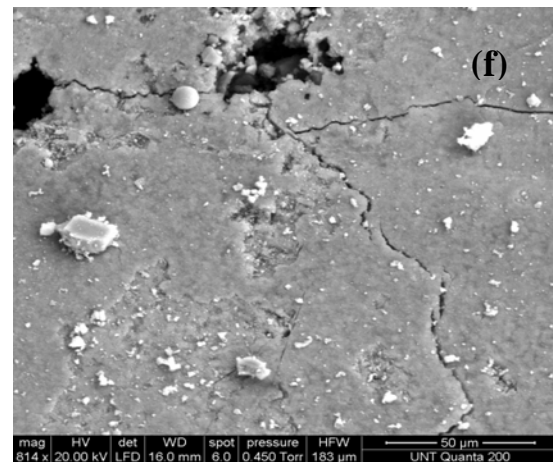
Figure 34. ESEM micrographs for the ITZ for non-corroded rebar steels at 77°F for w/c ratio 0.50 after 3 days (a,b), 10 days (c,d), 28 days (e,f).

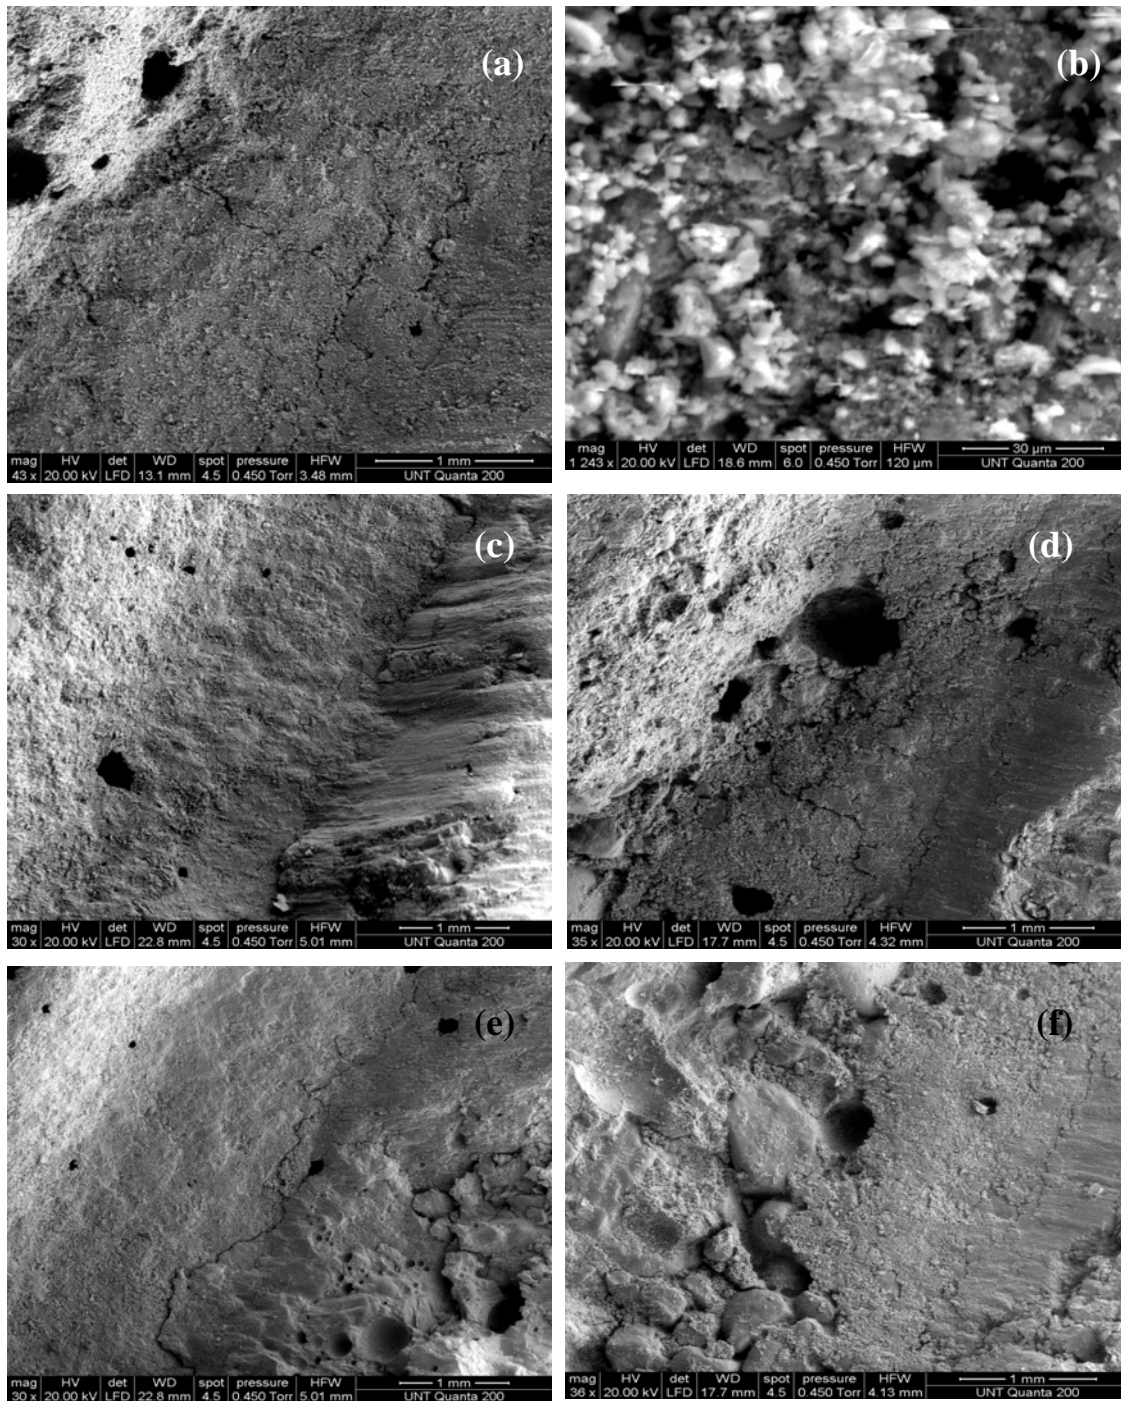
Figure 35. ESEM micrographs for the ITZ for non-corroded rebar steels at 252°F for w/c ratio 0.40 after 3 days (a,b), 10 days (c,d), 28 days (e,f).

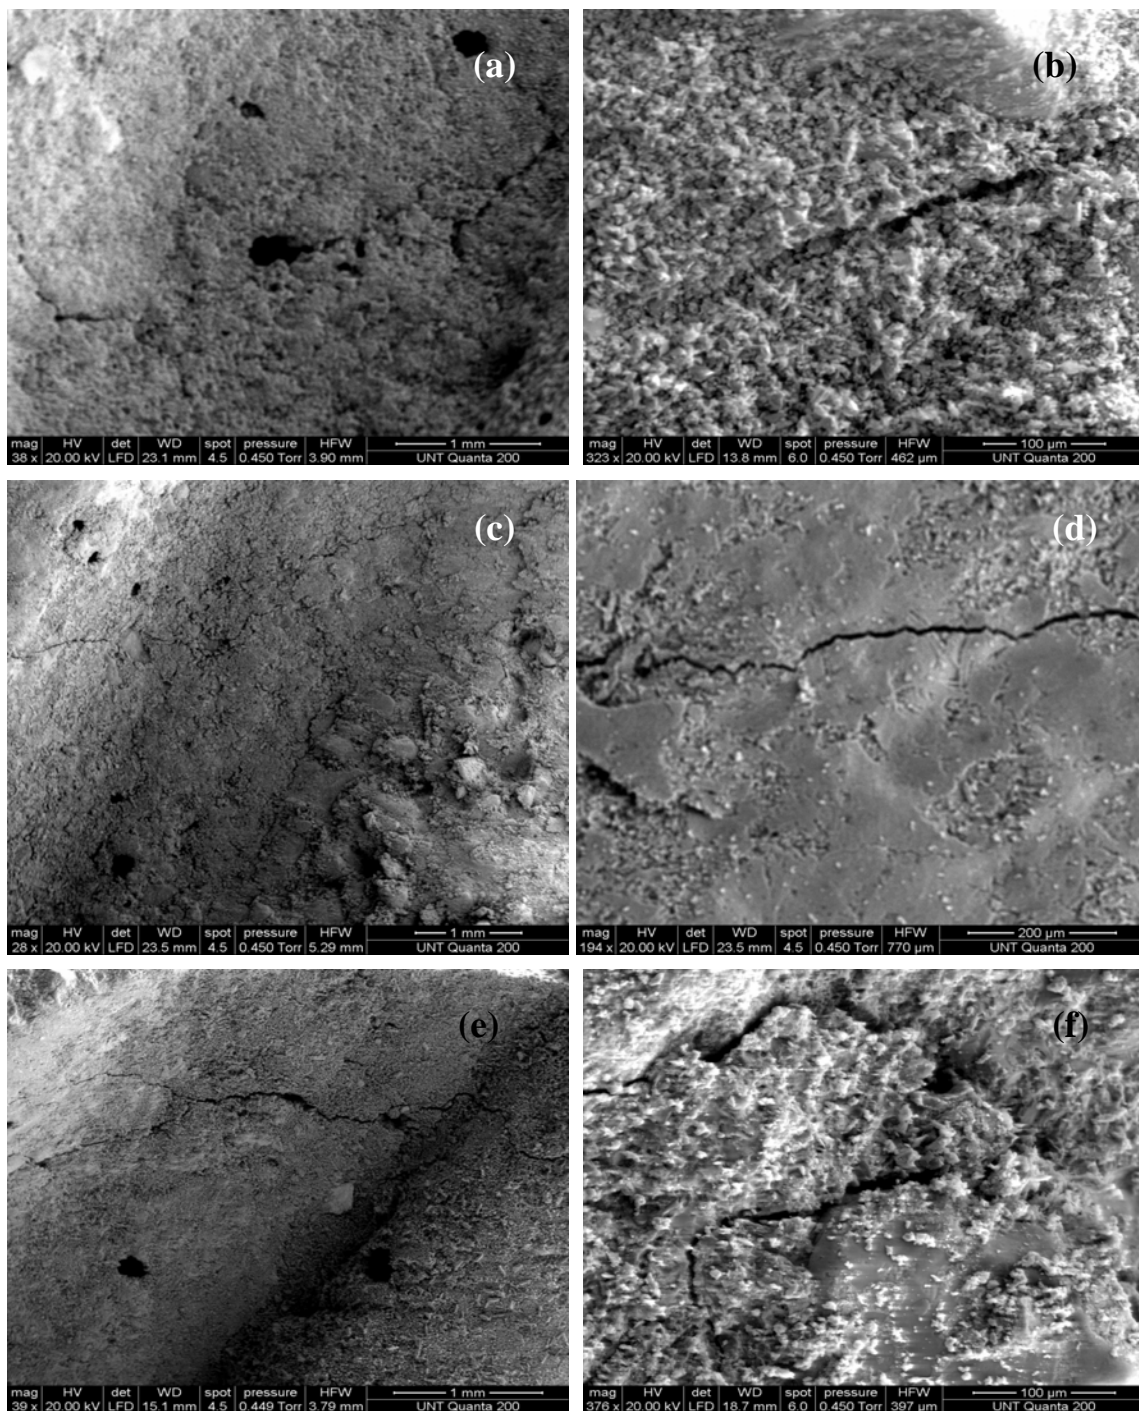
Figure 36. ESEM micrographs for the ITZ for non-corroded rebar steels at 252°F for w/c ratio 0.45 after 3 days (a,b), 10 days (c,d), 28 days (e,f).

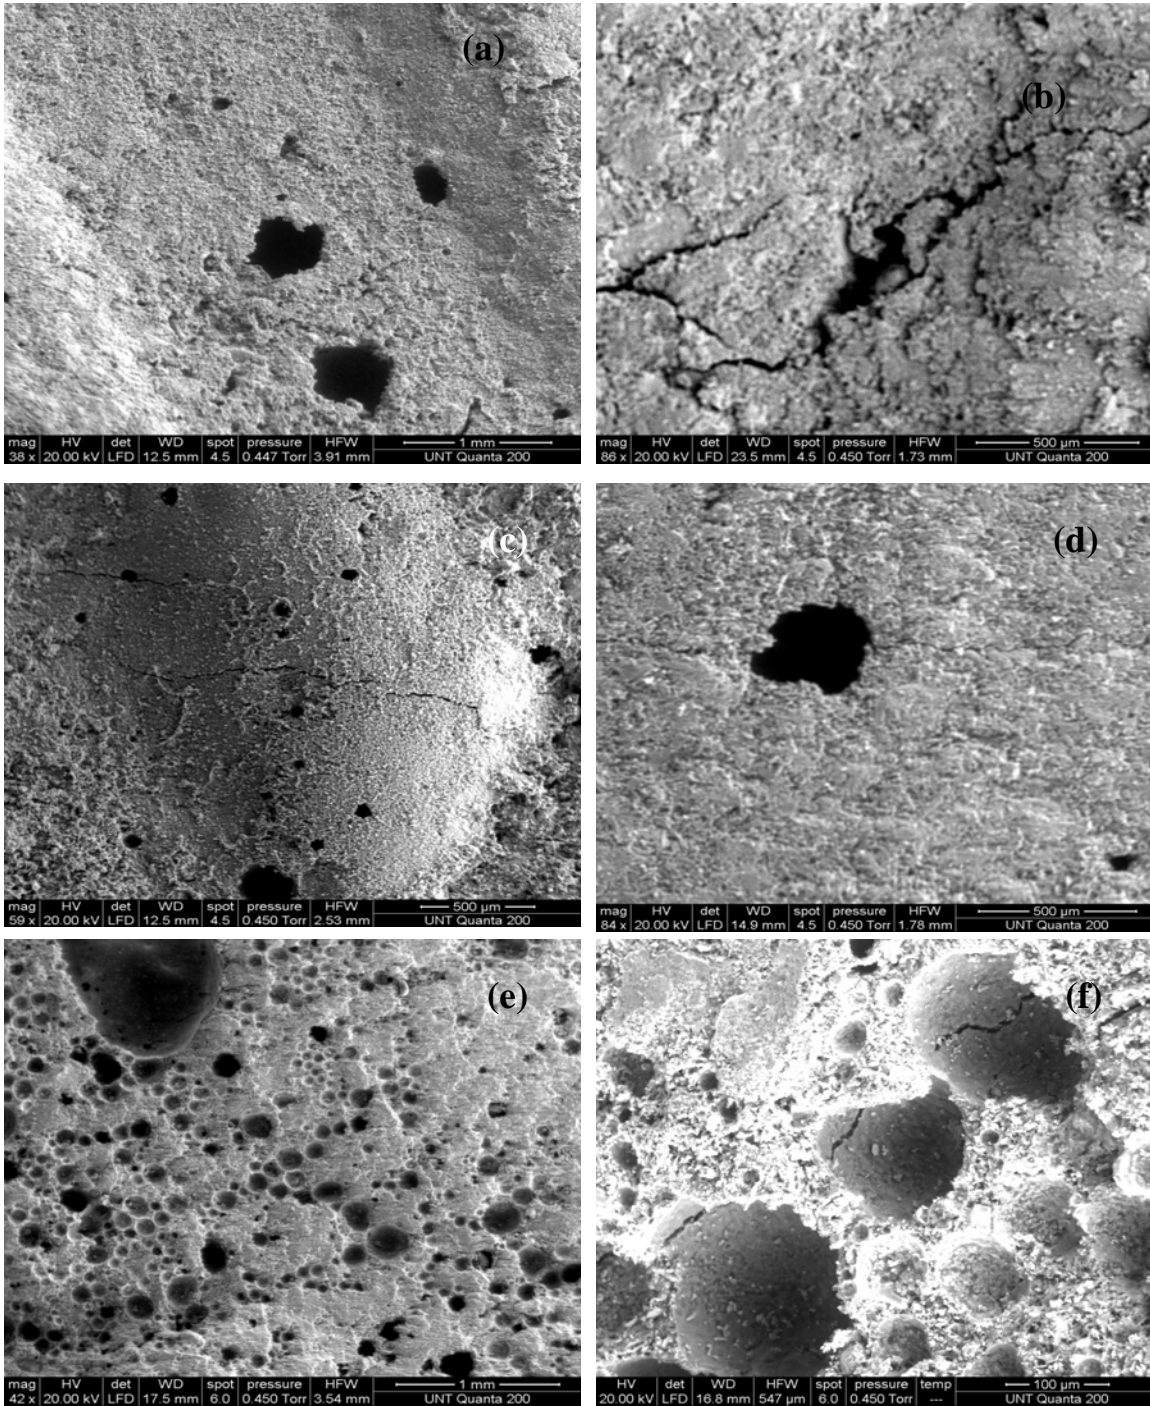
Figure 37. ESEM micrographs for the ITZ for non-corroded rebar steels at 252°F for w/c ratio 0.50 after 3 days (a,b), 10 days (c,d), 28 days (e,f).

Microcrack formation forms inside void cups as shown in Figure 37 (f). Some of the voids are μm in diameter whereas others are in mm range (Figure 37 (f)). G. Prokopksi and B. Langier (2000) also found that as the w/c ratio increased; the porosity in the ITZ is also increased, resulting in the initiation and development of microcracks in this zone. The existence of these cracks are detrimental to the concrete bond strength because when they coalesce and reach the surface, they allow for the chloride ingress into the concrete structure which will ultimately result in the formation of expansive corrosion products (rust) which occupy several times the volume of the original steel consumed.

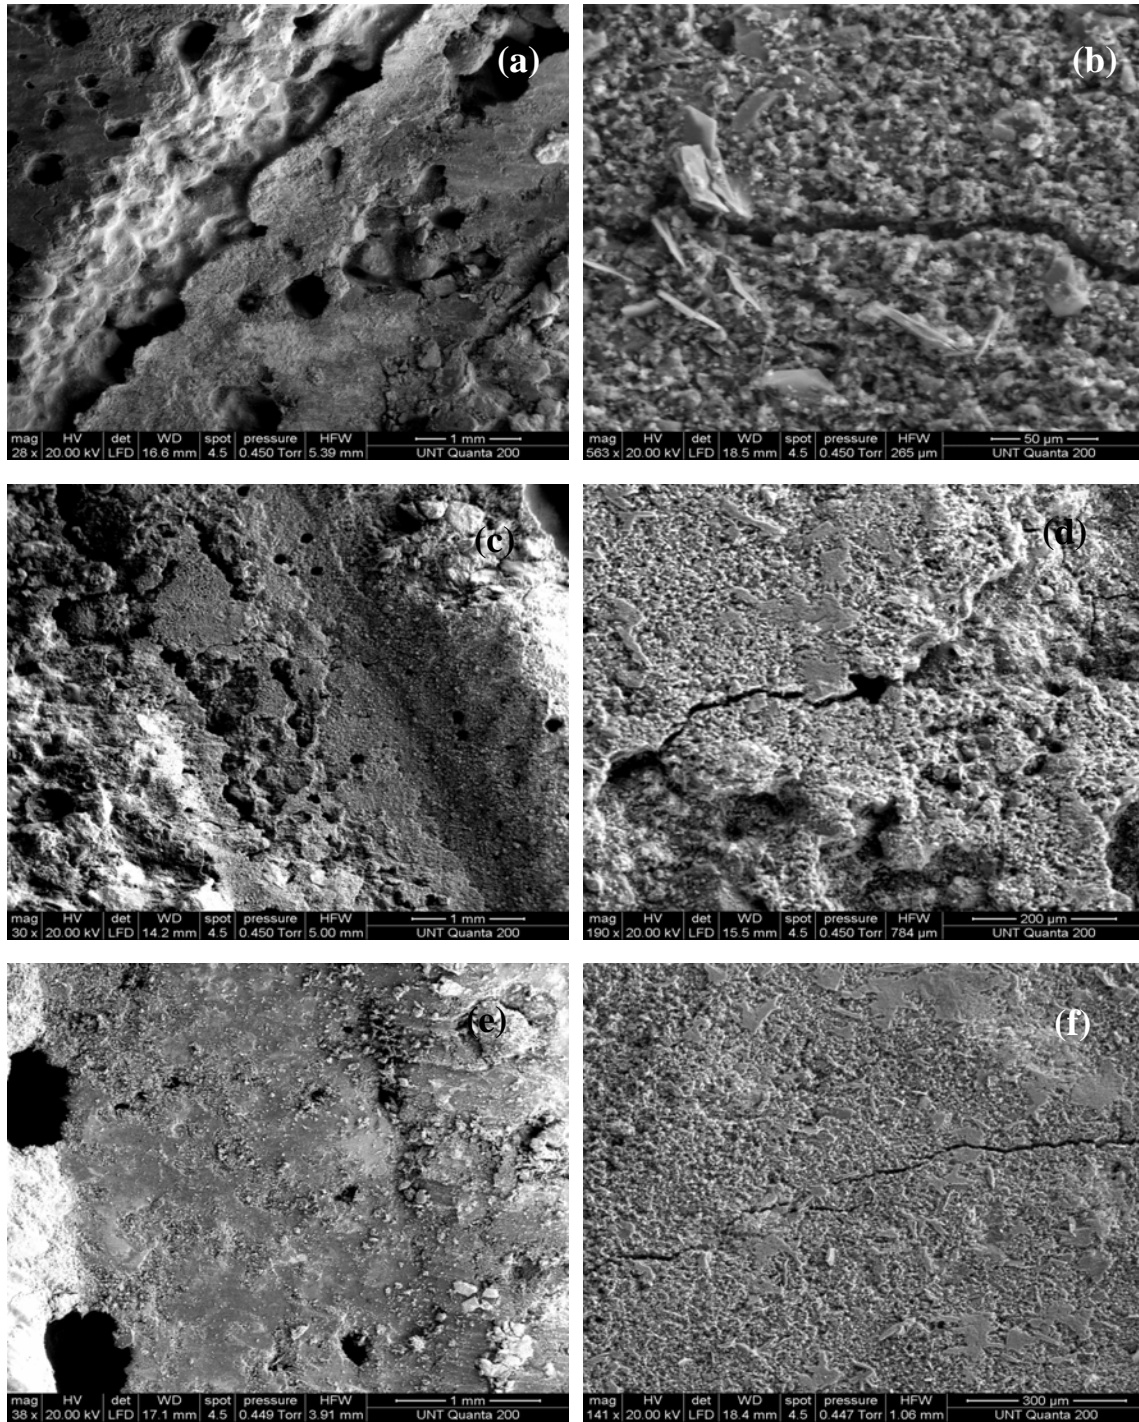
Figure 38. ESEM micrographs for the ITZ for non-corroded rebar steels at 14°F for w/c ratio 0.40 after 3 days (a,b), 10 days (c,d), 28 days (e,f).

rebar temperature as weak bonding form between rebar and concrete. Figure 38 (a-f) demonstrates incomplete inclusion of the aggregates into the matrix of concrete. Incomplete bonding is clearly shown in Figure 38 (a). Extensive cracking and porosity is shown in Figure 38 (b, c, d, and f). Increased w/c ratio to 0.45 for rebar temperature at 14°F before cement pouring showed both weak aggregate bonding and porosity (Figure 39 (b)), powdery interface (Figure 39 (d) and extensive cracking as shown in Figure 39 (b, d, and f). An interesting feature is shown in Figure 40 (d), the increase of the ITZ interface to more than 200 μ m. Generally, it is observed that at both temperature extremes (252°F and 14°F) the extent of ITZ especially for aggregate to concrete transition zone has increased in some cases by three orders of magnitude from μ m to mm range.
