FACTORS INFLUENCING HORIZONTAL CRACKING IN CONTINUOUSLY
REINFORCED CONCRETE PAVEMENTS (CRCP)

Thesis Prepared for the Degree of
MASTER OF SCIENCE

UNIVERSITY OF NORTH TEXAS

August 2008

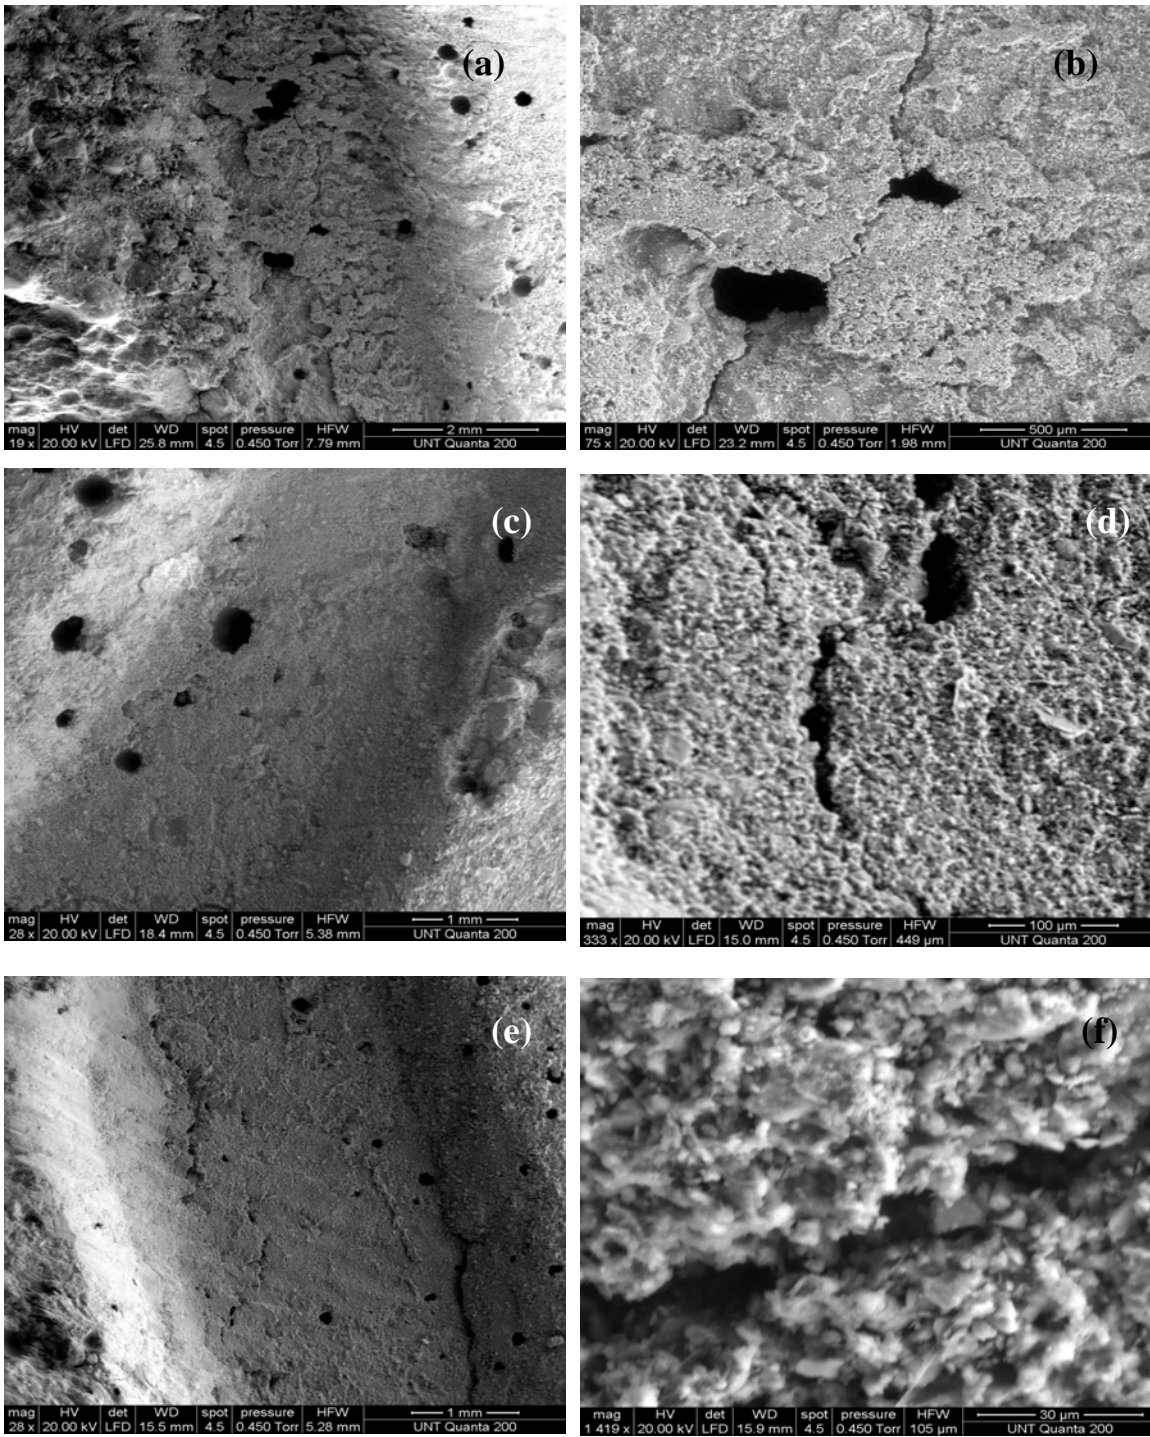
Figure 39. ESEM micrographs for the ITZ for non-corroded rebar steels at 14°F for w/c ratio 0.45 after 3 days (a,b), 10 days (c,d), 28 days (e,f).

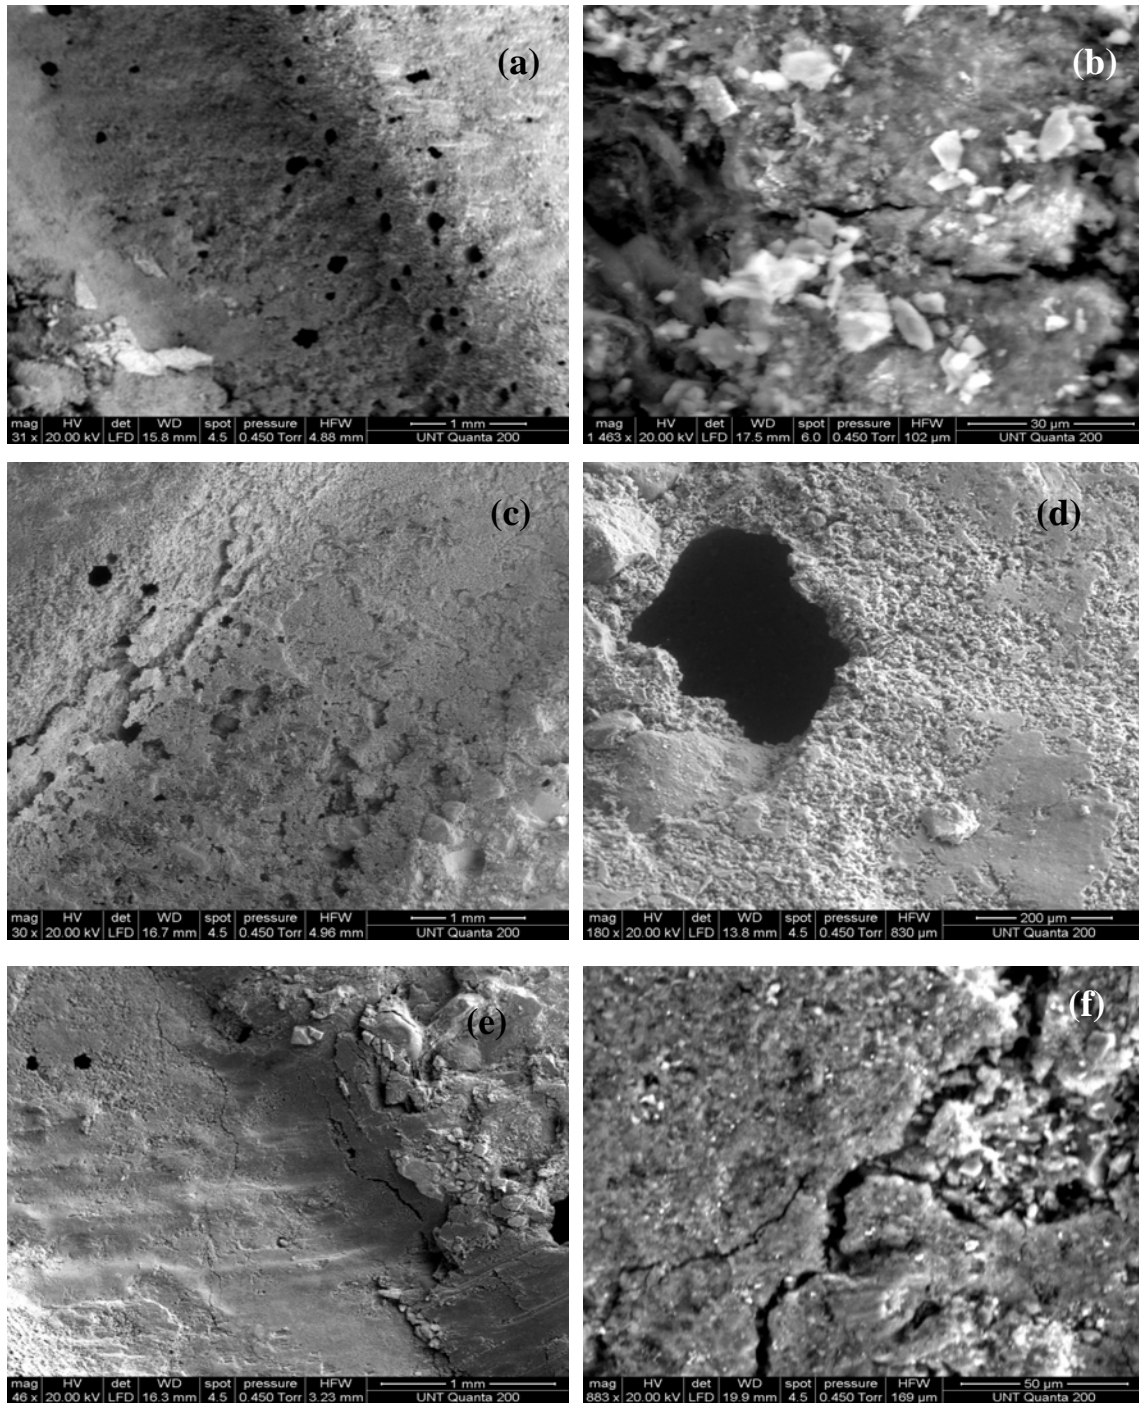
Figure 40. ESEM micrographs for the ITZ for non-corroded rebar steels at 14°F for w/c ratio 0.50 after 3 days (a,b), 10 days (c,d), 28 days (e,f).

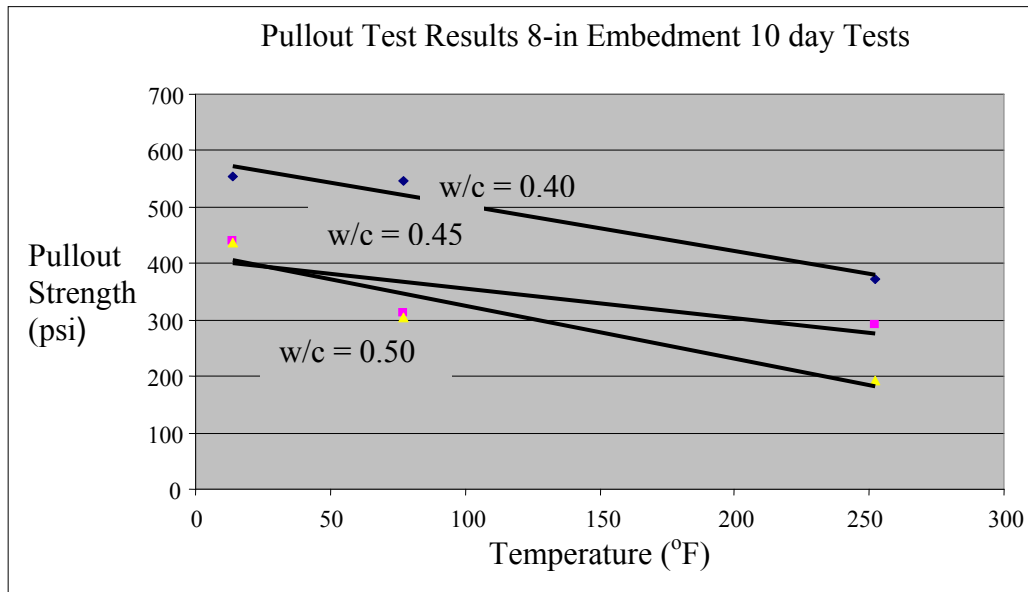
Figure 41. Bond strength vs. rebar temperature pullout test results for non-corroded rebar at 10 days.

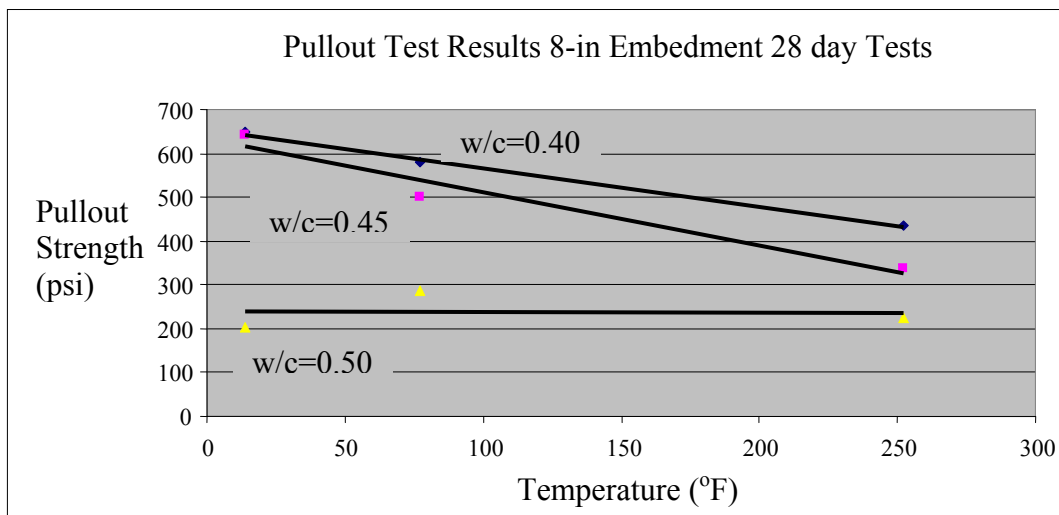
Figure 42. Bond strength vs. rebar temperature pullout test results for non-corroded rebar at 28 days.

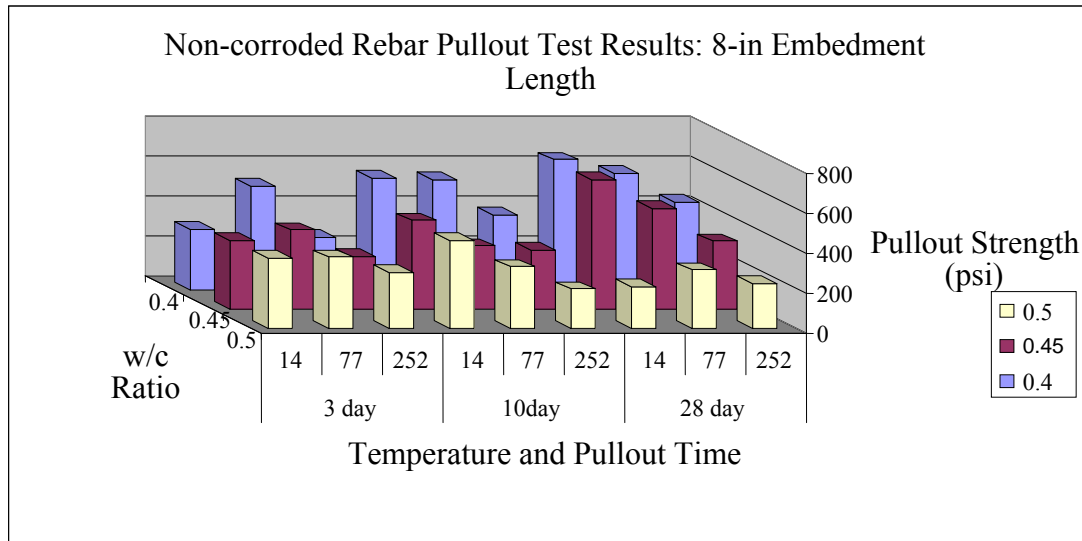
Figure 43. Non-corroded rebar pullout test results 8-in embedment length at different pullout times, temperature and w/c ratios.

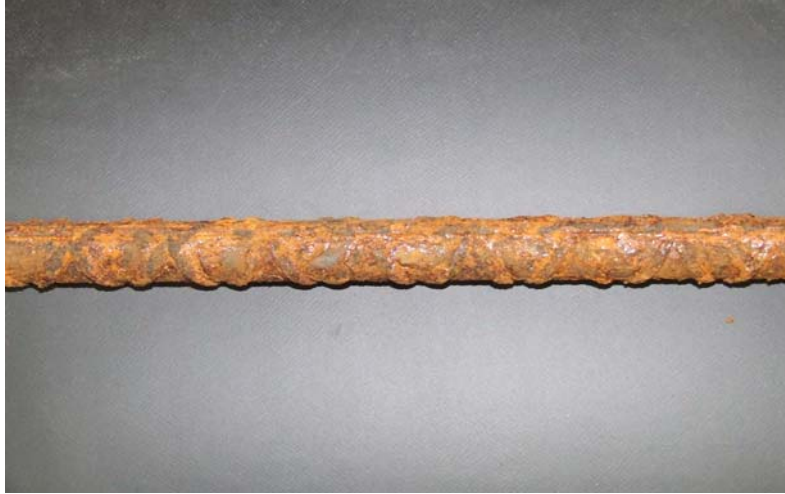
Figure 44. Corroded rebar used in this research.

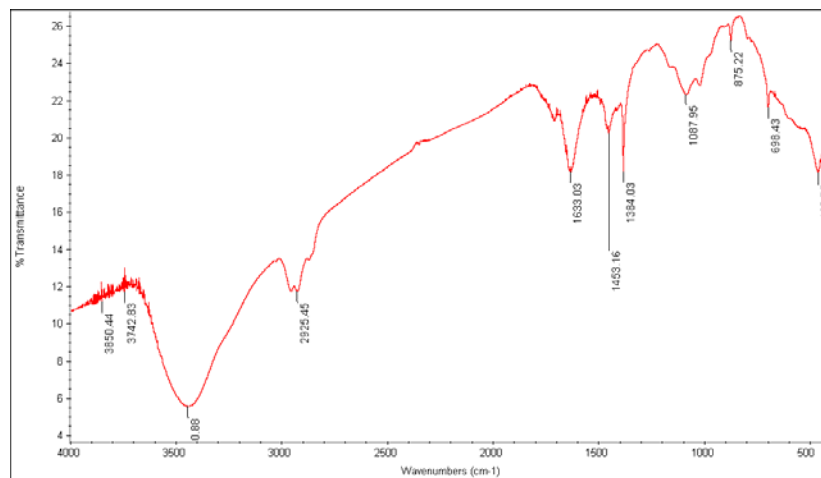
Figure 45. FTIR results of the corroded rebar used in this research.

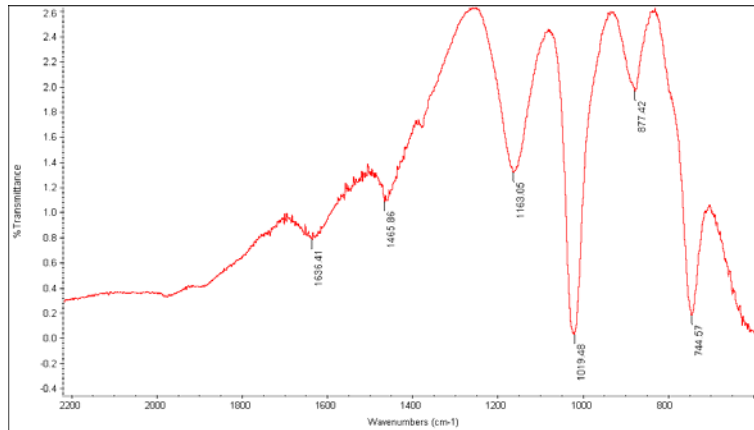
Figure 46. FTIR results of the non-corroded rebar used in this research.

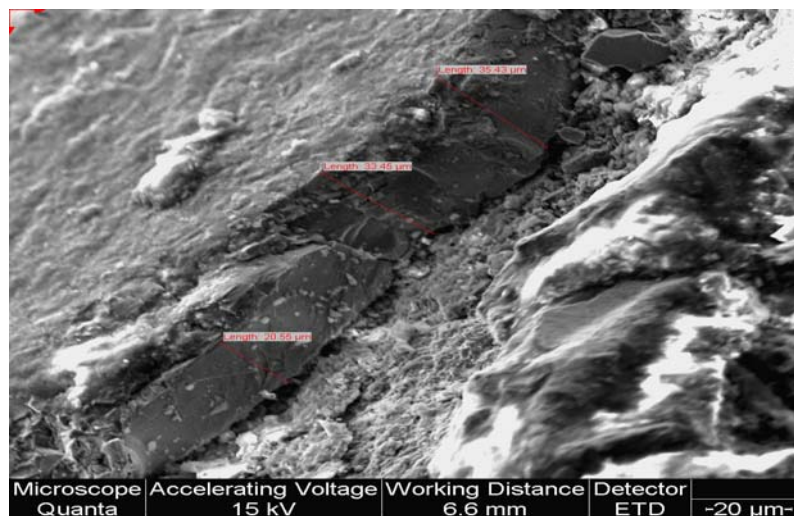
Figure 47. ESEM picture of corroded rebar.

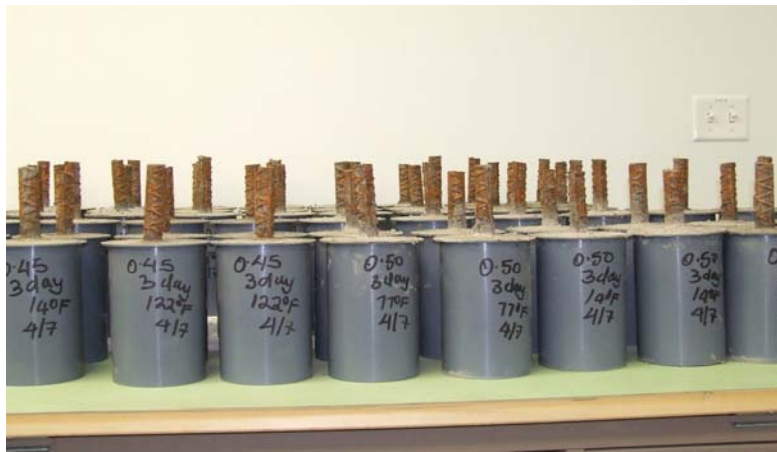
Figure 48. Specimens with 8-in embedment corroded rebars.

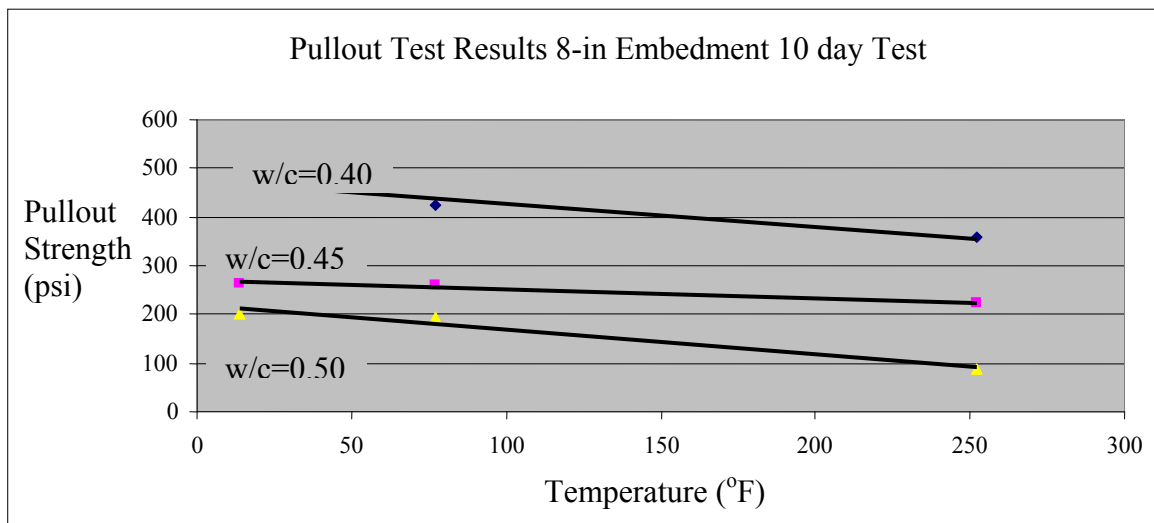
Figure 49. Bond strength vs. rebar temperature pullout test results for corroded rebar at 10 days.

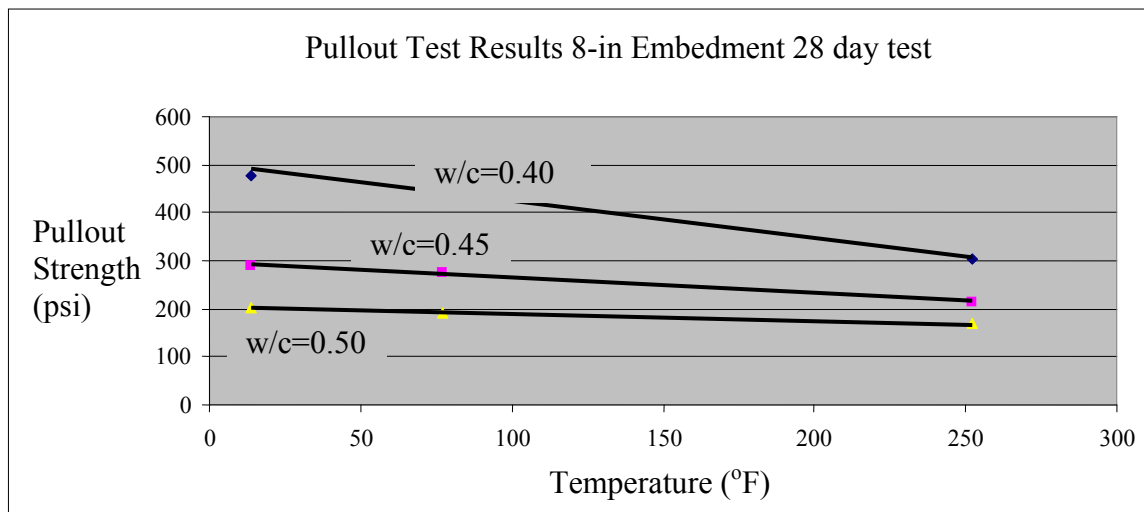
Figure 50. Bond strength vs. rebar temperature pullout test results for corroded rebar at 28 days.

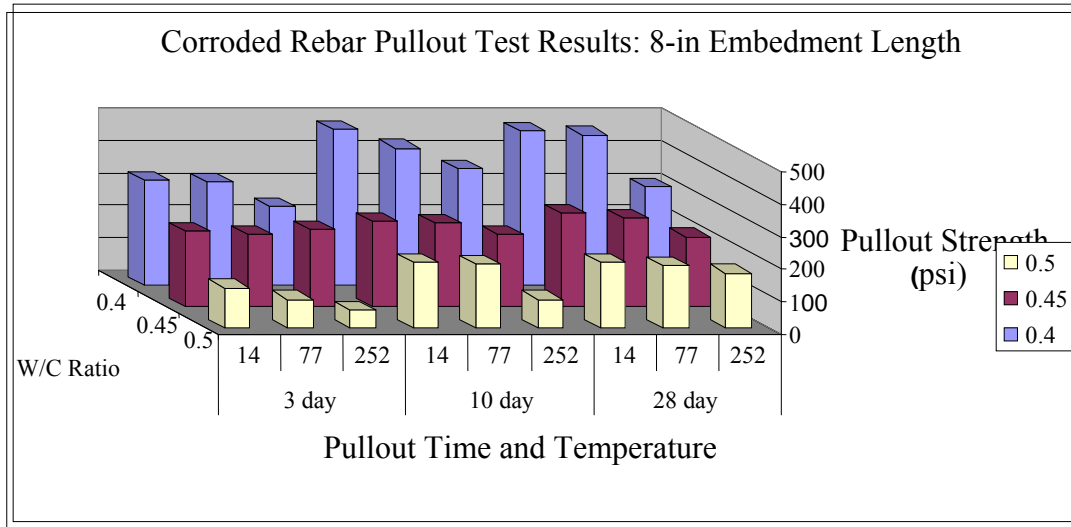
Figure 51. Corroded rebar pullout test results 8-in embedment length at different pullout times, temperature and w/c ratios.

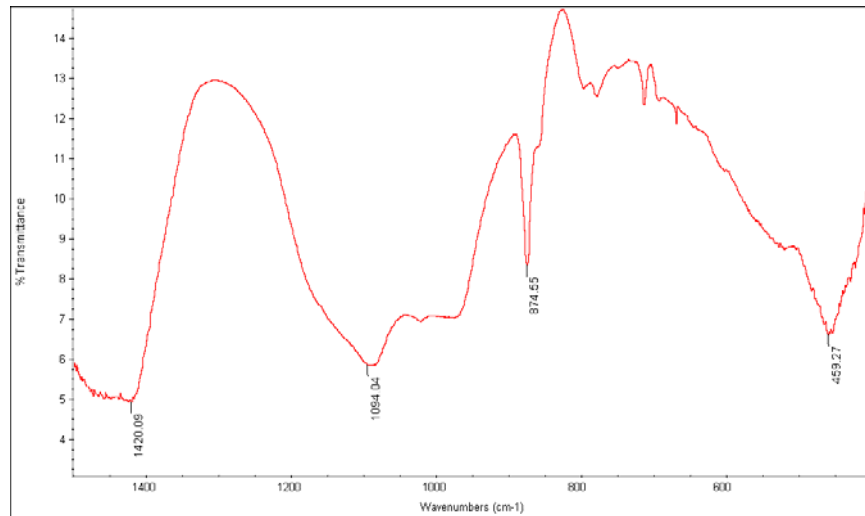
Figure 52. FTIR spectrum of corroded rebar after curing.

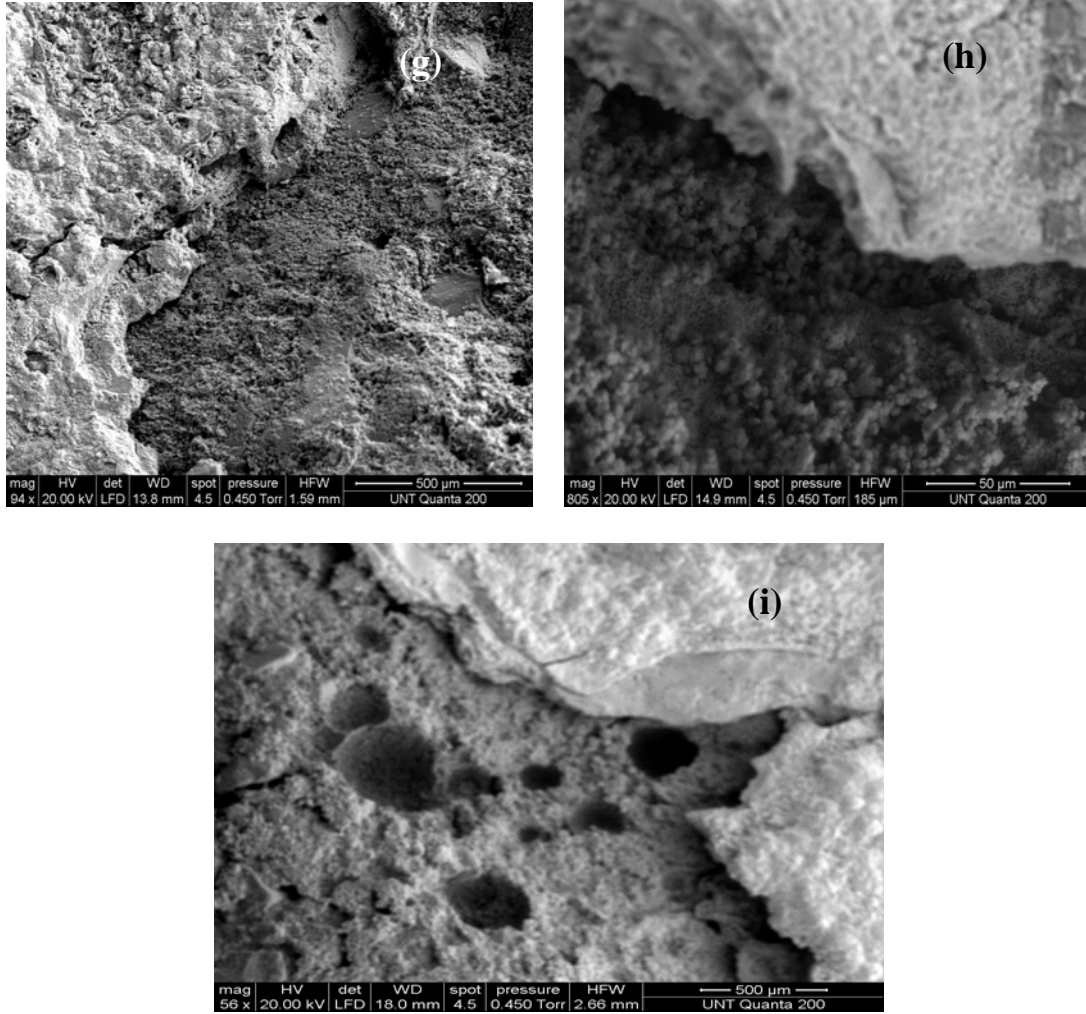
Figure 53. ESEM micrographs of the ITZ for corroded rebar steels at 14°F for w/c 0.40 after 28 days (a), 14°F for w/c 0.45 after 28 days (b), 14°F for w/c 0.50 after 28 days (c), 77°F for w/c 0.40 after 28 days (d), 77°F for w/c 0.45 after 28 days (e), 77°F for w/c 0.50 after 28 days (f), 252°F for w/c 0.40 after 28 days (g), 252°F for w/c 0.45 after 28 days (h), 252°F for w/c 0.50 after 28 days (i).

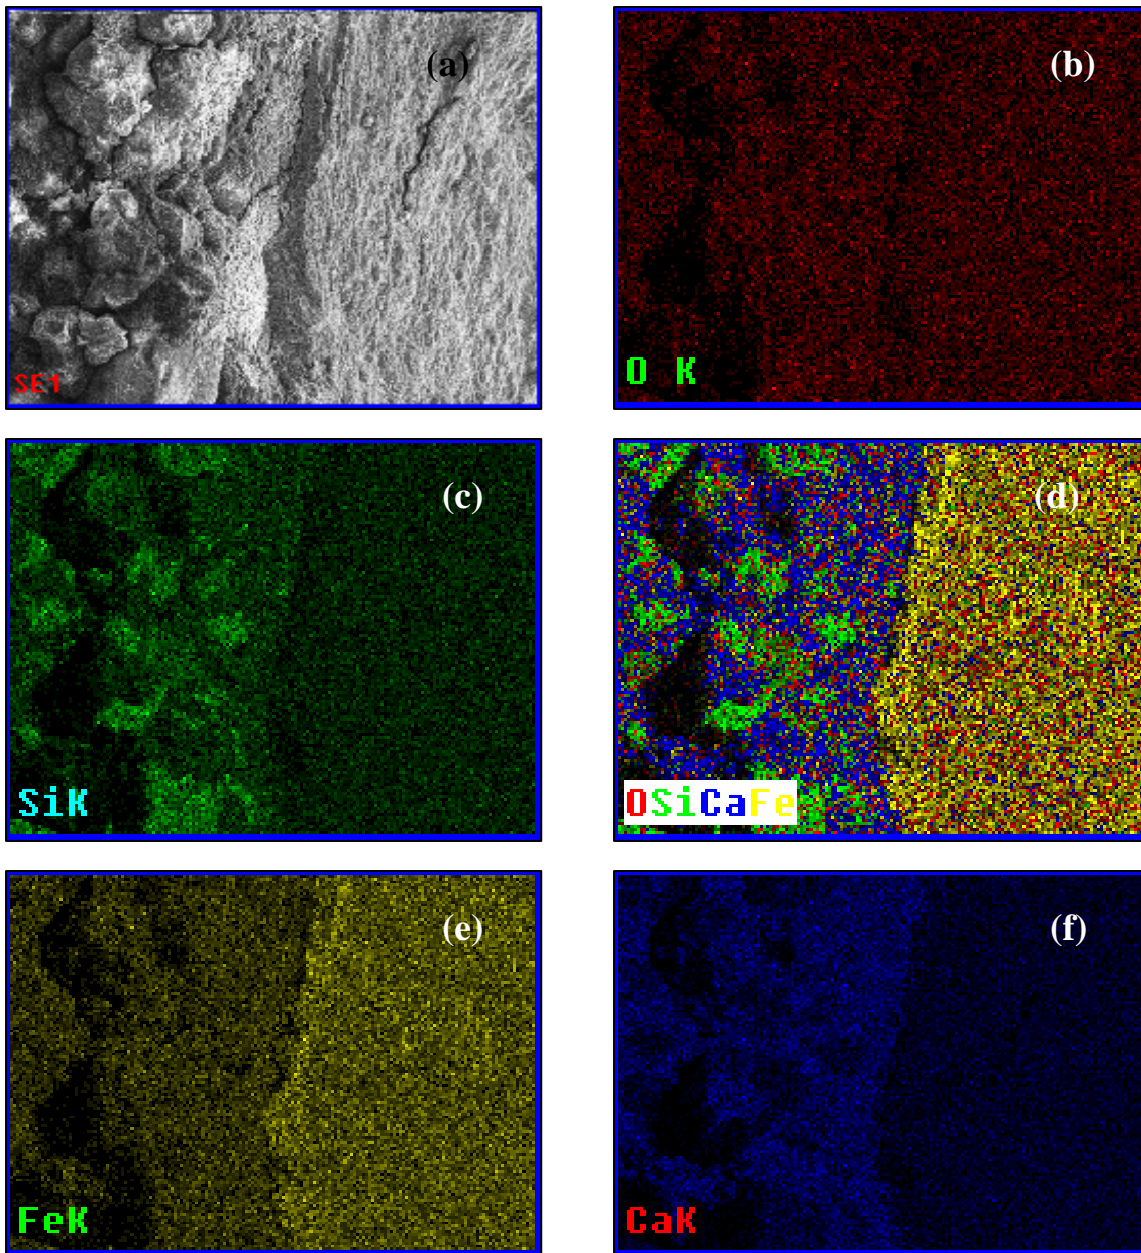
Figure 54. ESEM micrograph of the ITZ for corroded rebar steel at 14°F for w/c 0.40 after 28 days (a), oxygen mapscan (b) iron mapscan (c), calcium mapscan (d), silicon mapscan (e), EDS overlay of elements mapscan (f).

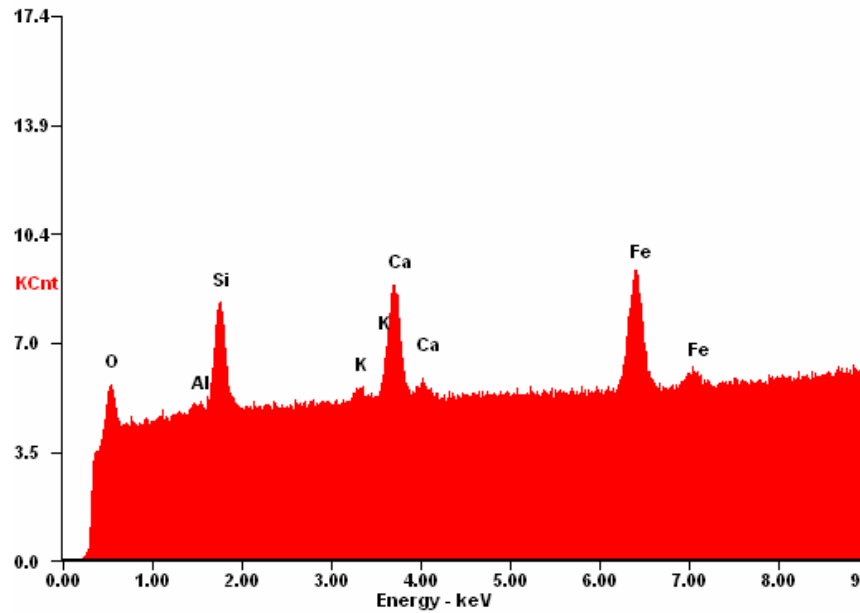
Figure 55. EDS elements spectrum for the ESEM micrograph of the ITZ for corroded rebar steel at 14°F for w/c 0.40 after 28 days.

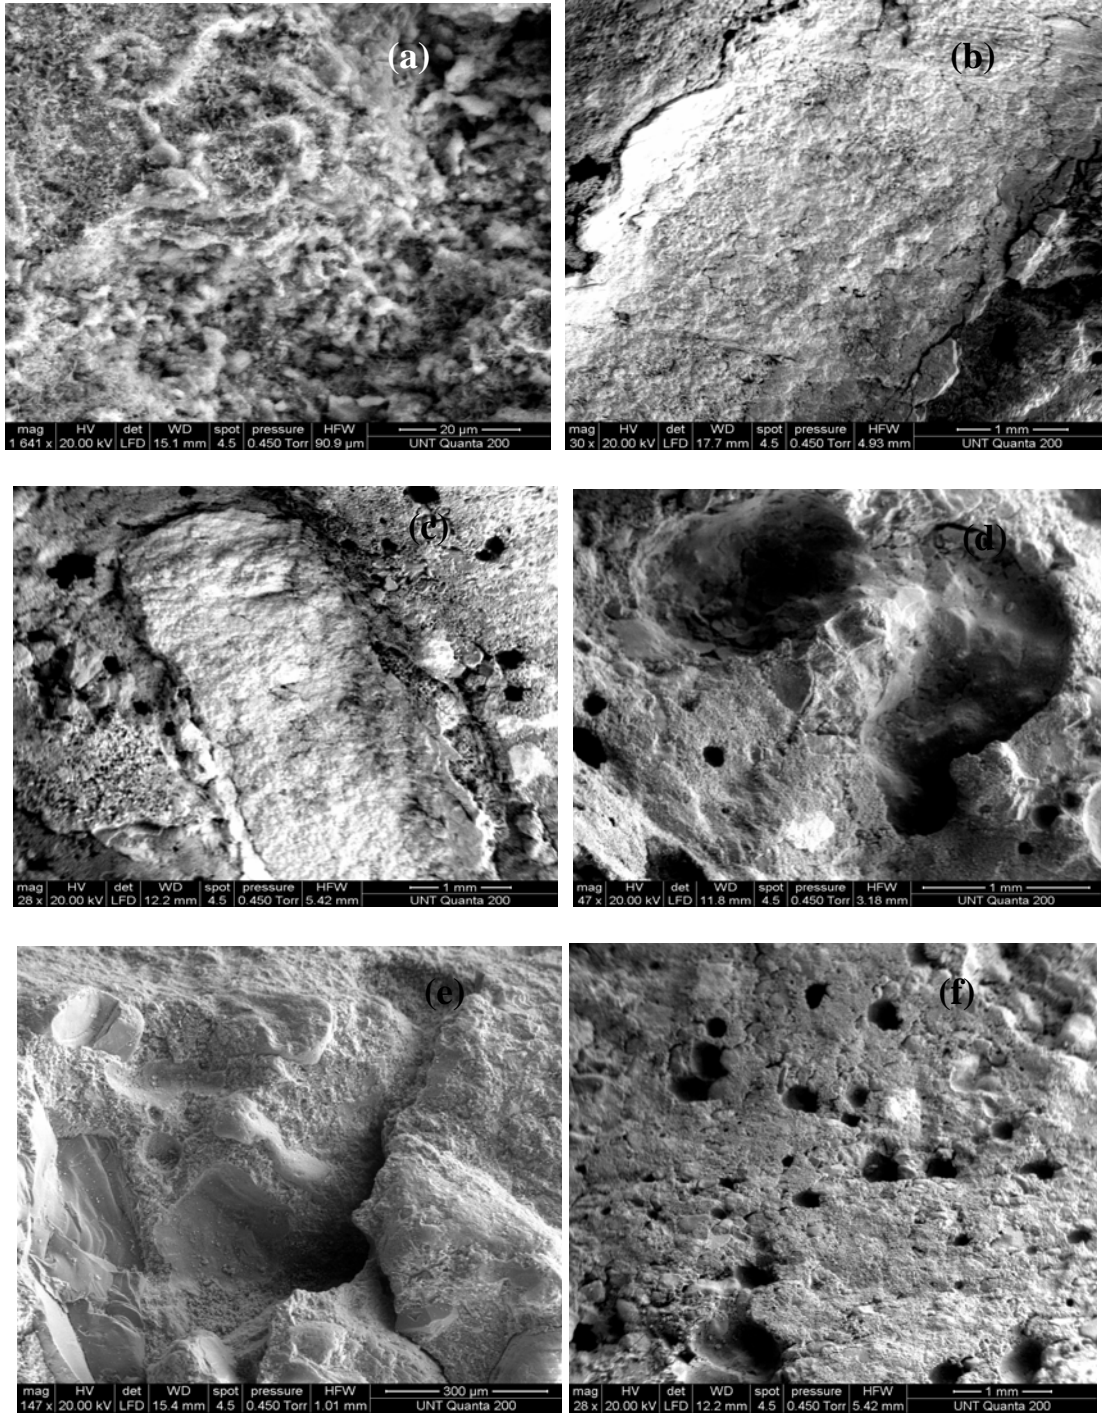
ESEM micrographs of the ITZ for corroded rebar steels at w/c 0.50 at 14°F after 3 days (a), 77°F after 3 days (b), 252°F after 3 days (c), 14°F after 10 days (d), 77°F after 10 days (e), 252°F after 10 days (f).

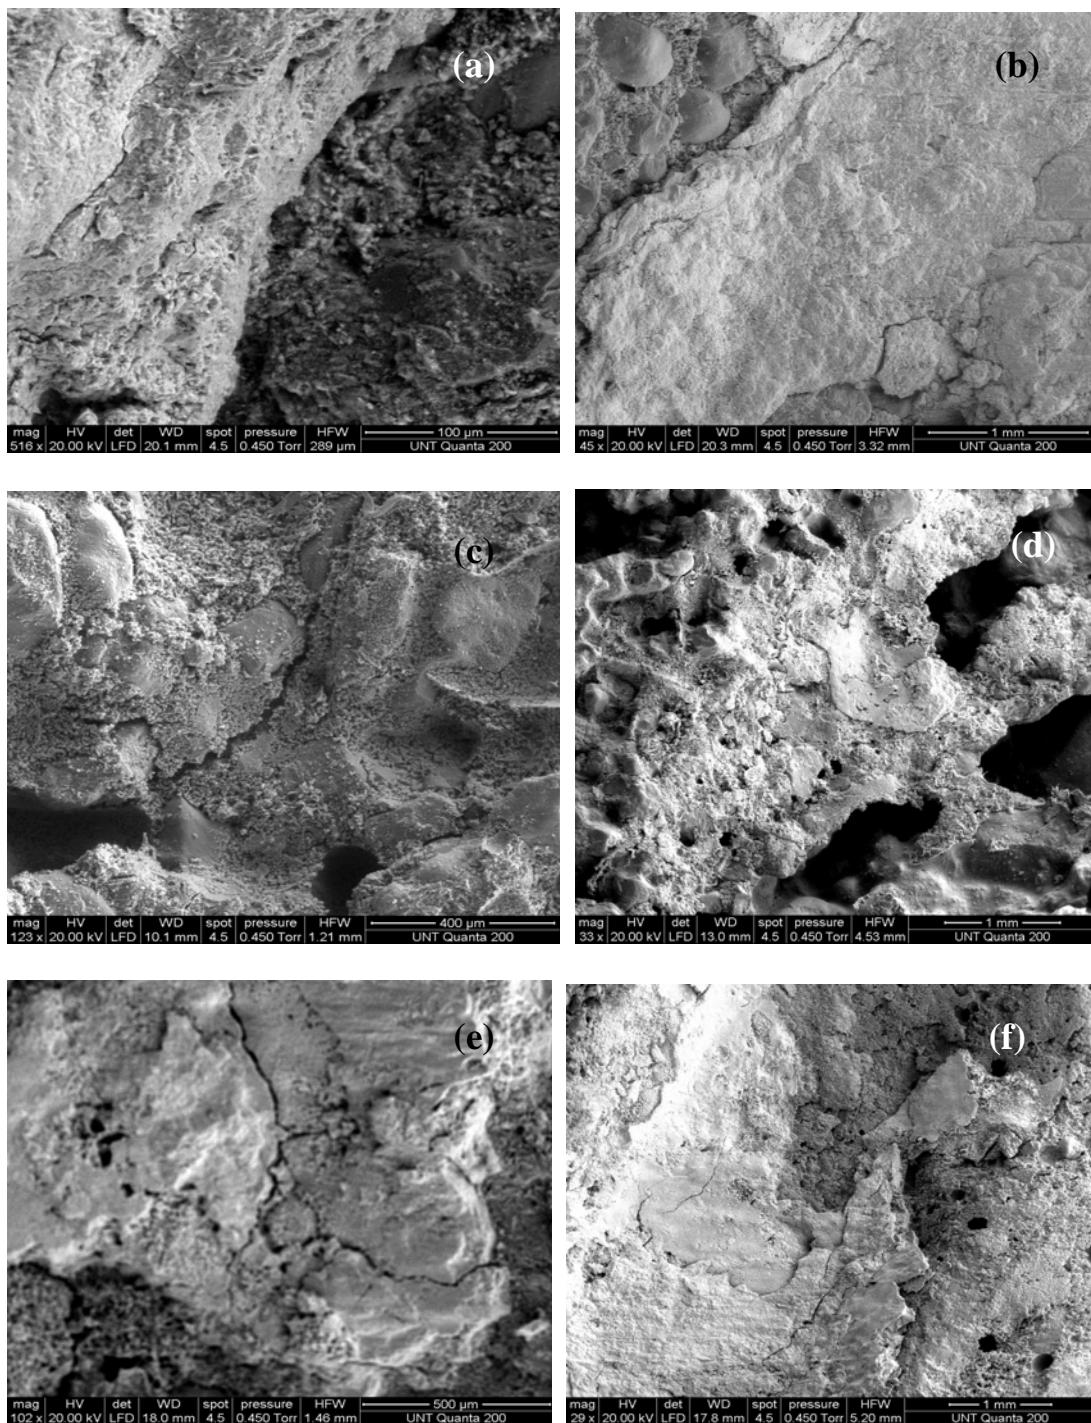
ESEM micrographs of the ITZ for corroded rebar steels at w/c 0.45 at 14°F after 3 days (a), 77°F after 3 days (b), 252°F after 3 days (c), 14°F after 10 days (d), 77°F after 10 days (e), 252°F after 10 days (f).

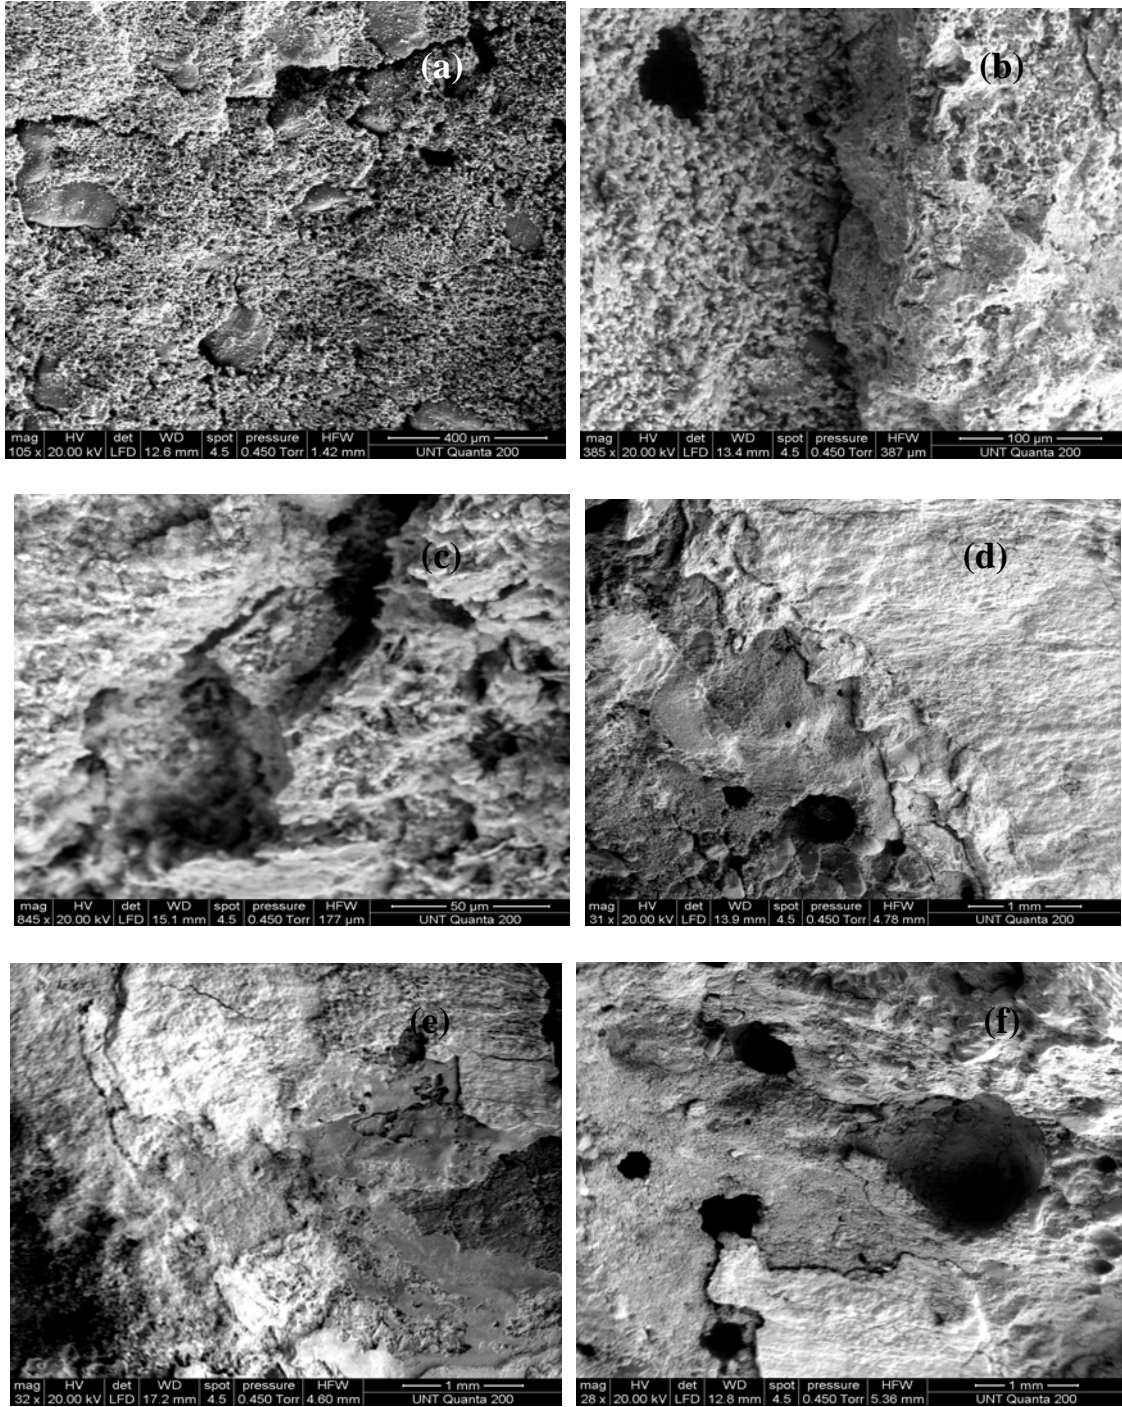
ESEM micrographs of the ITZ for corroded rebar steels at w/c 0.45 at 14°F after 3 days (a), 77°F after 3 days (b), 252°F after 3 days (c), 14°F after 10 days (d), 77°F after 10 days (e), 252°F after 10 days (f).
