River Corridor Closure Contract

300 Area D4 Project 2nd Quarter Fiscal Year 2006 Building Completion Report

June 2006

Washington Closure Hanford

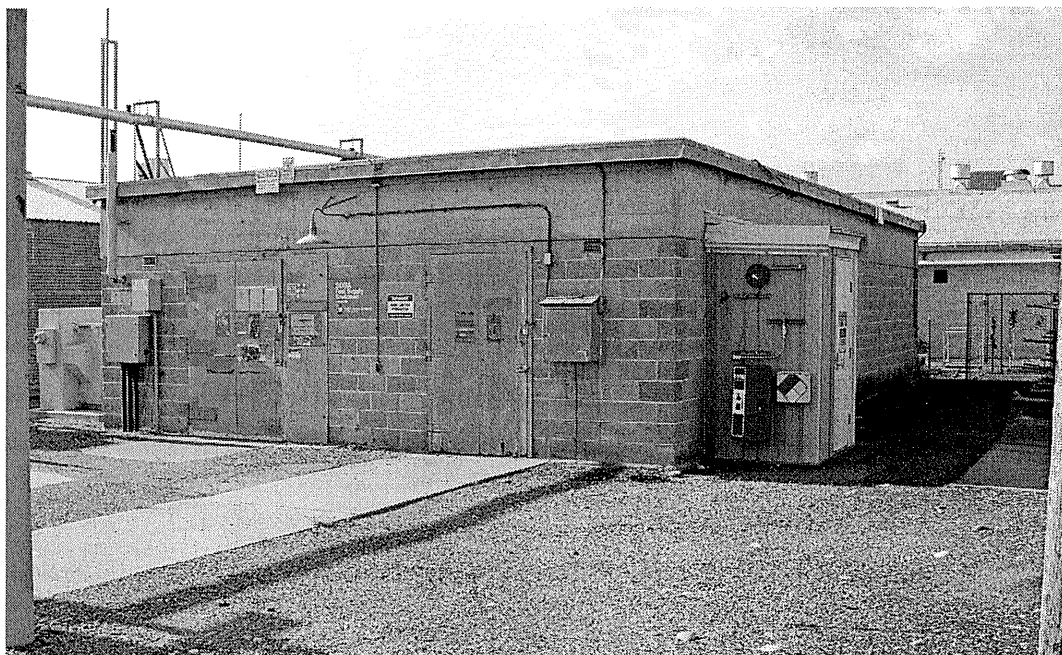
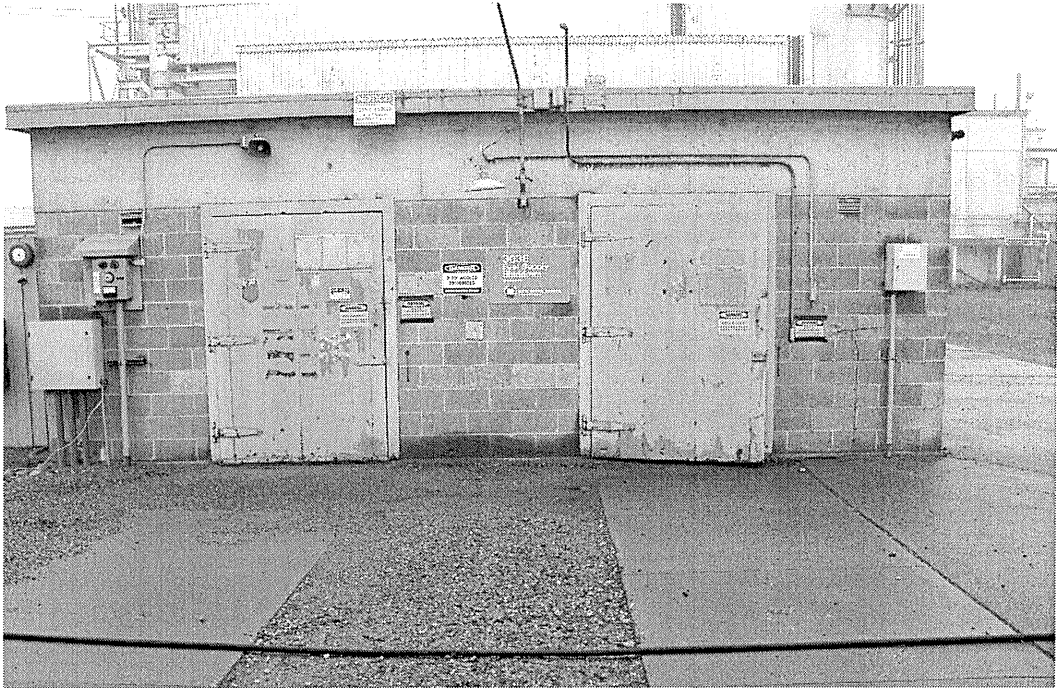
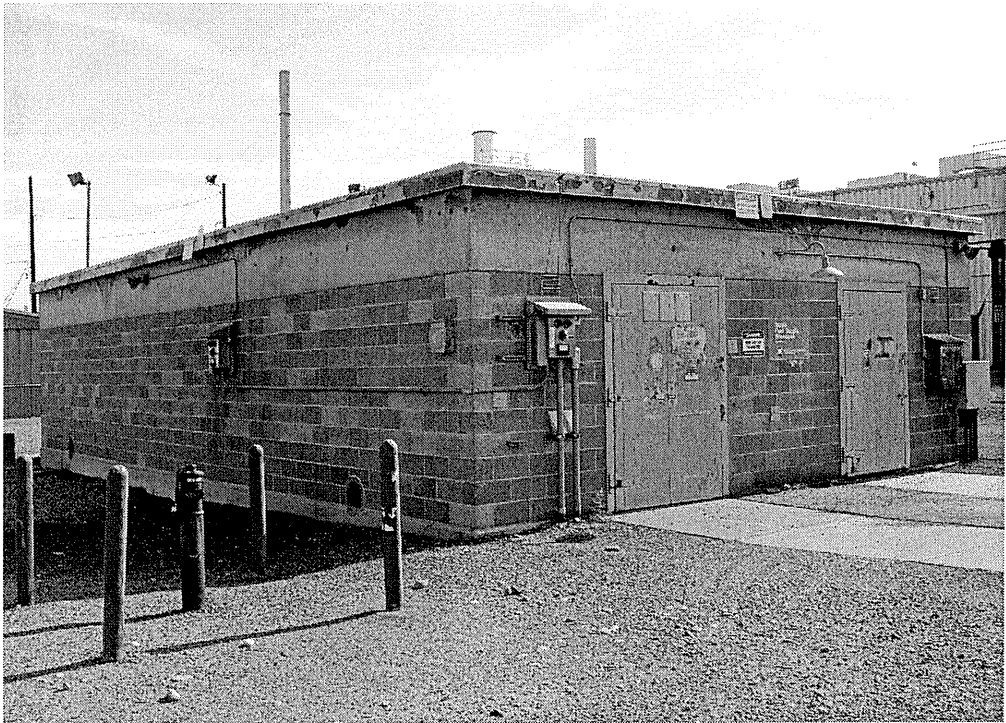
The 303A, 303E, and 303G Buildings, built during World War II, were used to store fresh metal (unirradiated uranium) and chemicals, as well as uranium scrap (Figures 1 through 3). They are all the same size (120 m²/1,296 ft²). They are all constructed with concrete block walls, concrete foundation and floor slab, and a reinforced concrete roof.

Figure 1. 303A Building.

Figure 2. 303E Building.

Figure 3. 303G Building.

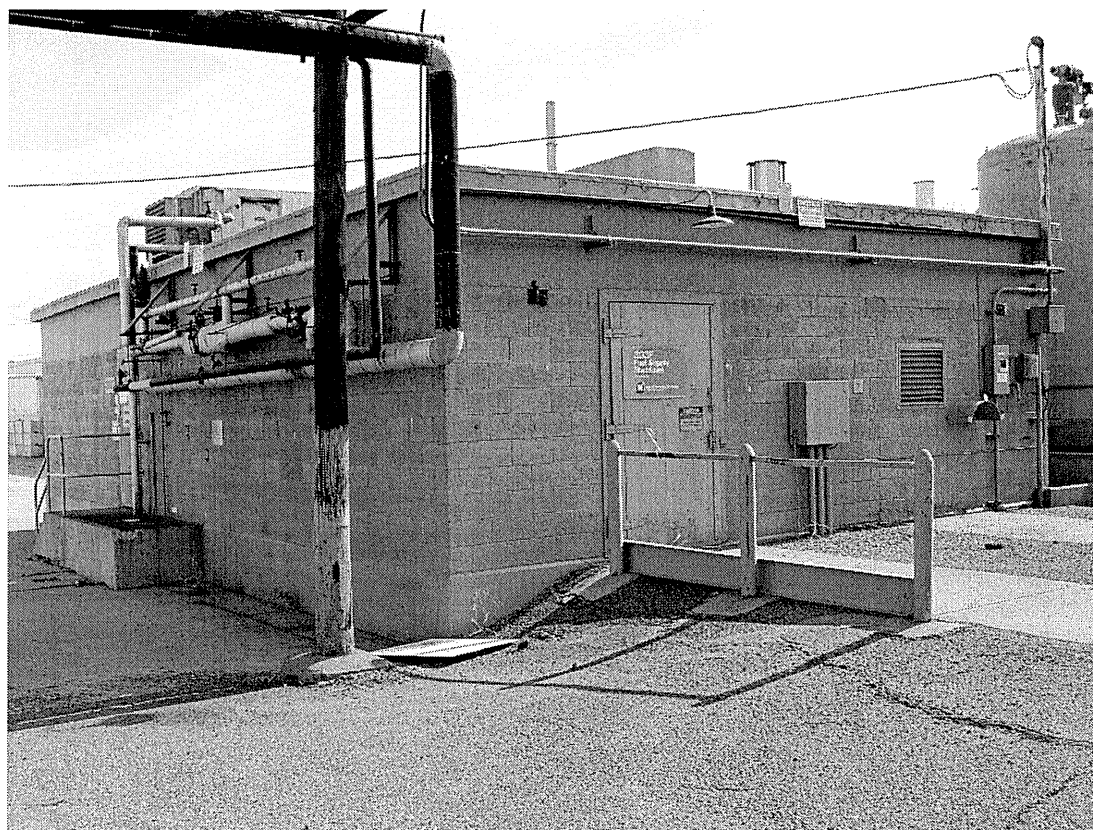
The original purpose of the 303F Building was the storage of fresh metal (uranium billets), chemicals, and uranium scrap (Figure 4). The 120.4-m² (1,296-ft²) building was built during World War II and is constructed with concrete block walls, concrete foundation and floor slab, and a reinforced concrete roof. From 1954 to 1973, the building was used as a chemical makeup facility. From 1973 to 1999, the building was used as a pumphouse as part of the 300 Area Waste Acid Treatment System (WATS) *Resource Conservation and Recovery Act of 1976* (RCRA) treatment, storage, and disposal (TSD) unit.

Figure 4. 303F Building.

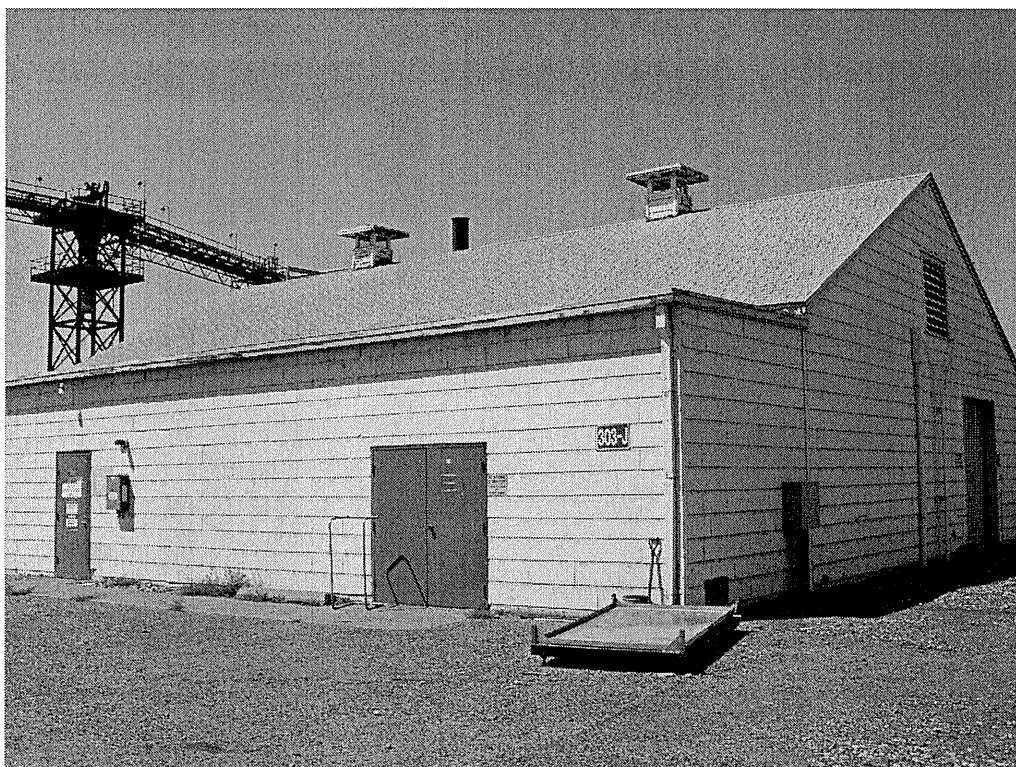
The 303J facility was a 339-m² (3,651-ft²) one-story wood frame structure built on a concrete foundation and floor slab (Figure 5). It was built in 1942 and 1943, and until 1954 was used as a pilot process test and fuel fabrication facility. Most recently it was used for storage and office space.

Figure 5. 303J Building.

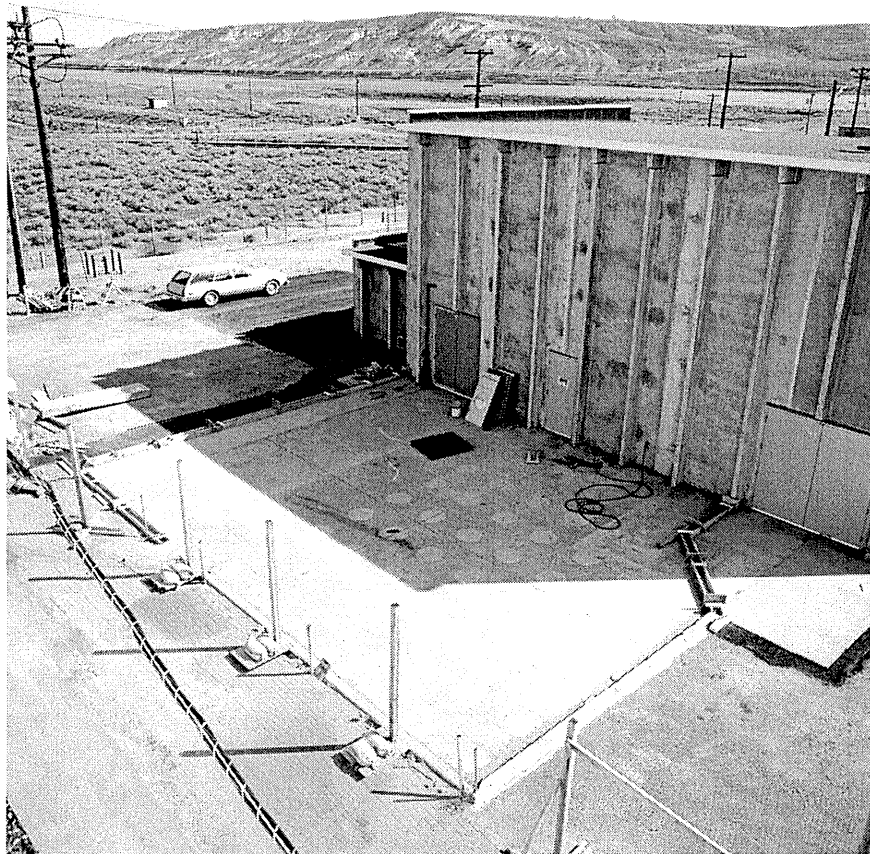
The 303M Building was built in 1983 to house a facility for converting uranium metal chips and fines from the N Reactor fuel fabrication process into uranium oxide by calcination (burning). The 195-m² (2,095-ft²) facility had a concrete floor slab, pre-cast concrete wall panels, and a precast concrete slab roof with tar-and-gravel surface (Figure 6). Operations ceased in February 1987.

Figure 6. 303M Building.

Although the demolition of the 303M Building was fairly straightforward, the 303M bag filter housings in particular required special planning and controls due to the quantity of uranium dust they contained (estimated to be approximately 220 kg). Early plans required the removal of the roof and bag filter housings using a high-capacity crane. However, as work progressed inside the building, it was determined that removal of the roof was too risky, so the project team decided to remove the south wall of the 303M Building and then remove the bag filter housings with a forklift. After the south wall was demolished, further discussions with project management, engineering, and the demolition crew (especially the excavator operator) provided an even safer approach: removal of the bag filters using the grapple attachment on the excavator. This approach was reviewed with management, craft supervision, and craft personnel, and the bag filter housings were removed intact. A small spill of uranium powder occurred as one of the bag filter housings was set on the ground, but this event was anticipated and was cleaned up without incident. The bag filter housings will be shipped to ERDF in a special Type A container in May and June 2006.

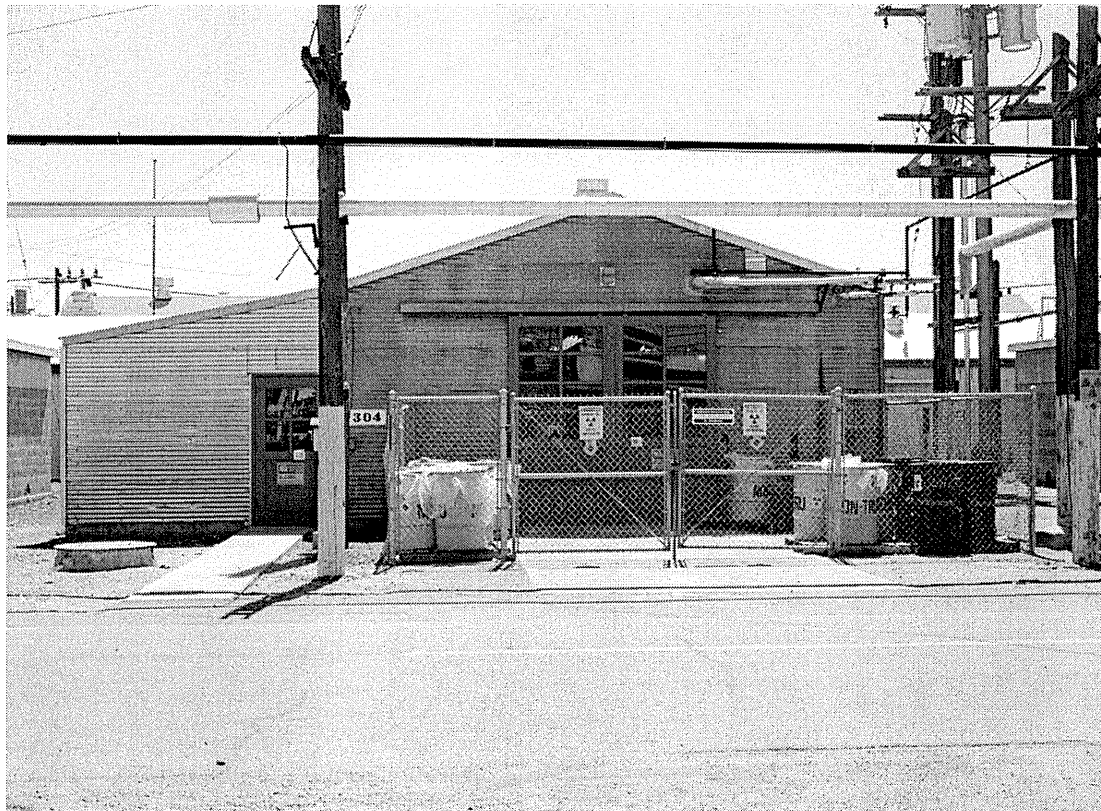
The 304 Building was built in 1952 and served as a pilot plant for testing new fuel fabrication processes known as "lead dip" and "hot die sizing" (Figure 7). This operation moved in 1962 to the 313 Building, and the 304 Building was used to store uranium scraps waiting for reclamation. The 122-m² (1,312-ft²) facility has been known as the Concretion Facility since 1971, at which time a process to solidify pyrophoric uranium scraps in a concrete matrix was initiated. Most recently, it was used for storage. It was a metal frame building with sheet metal siding. The 304A Building was a 18-m² (197-ft²) sheet metal change room added to the 304 Building on the east side.

Figure 7. 304 Building (304A is attached to the left side).

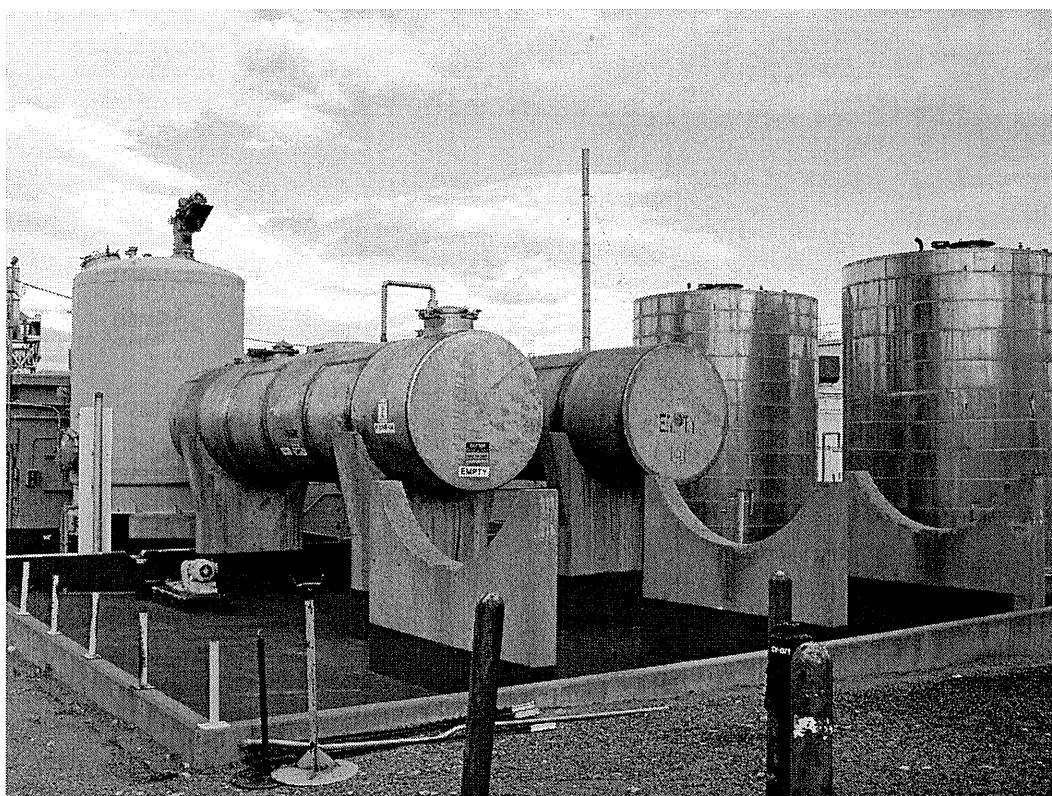
The original purpose of the 311TF Tank Farm Building was for chemical storage and to support methanol recovery operations in support of fuel fabrication (Figure 8). In 1973 it became part of the 300 WATS. The 311TF Building portion of the 300 Area WATS RCRA TSD unit was clean closed in 1999. The 84-m² (900-ft²) 311TF Tank Farm Building was built in 1954 and consisted of four aboveground chemical storage tanks, two below-ground methanol storage tanks, and the small methanol still house. The tanks were located inside a concrete containment curb or catch basin. One additional tank was built for use in the WATS program in 1985. The 311TF Building and the two below-ground methanol storage tanks were removed in 1989.

Figure 8. 311TF Tank Farm.

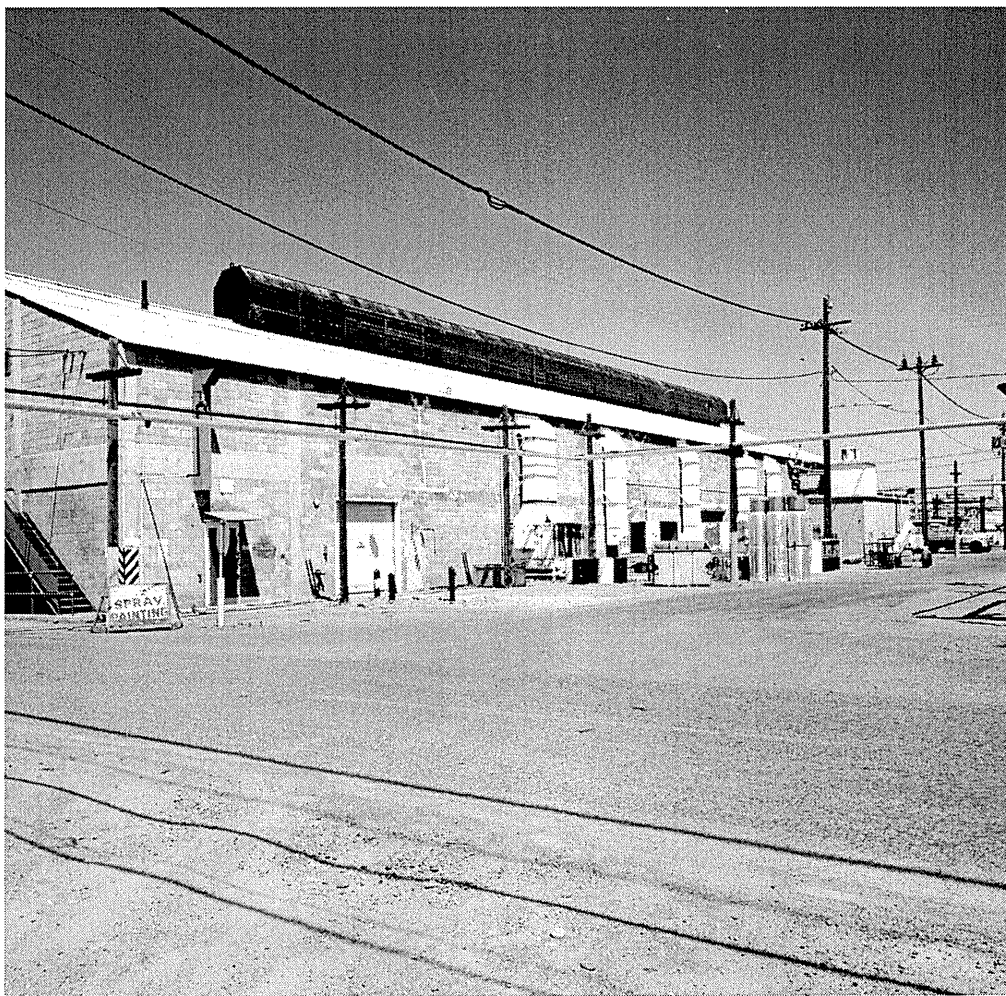
The 314 Building, referred to as the Press Building or the Metal Extrusion Building, originated as one of two primary fuel fabrication structures at the Hanford Site (Figure 9). It was a World War II-era structure that housed fuel element preparation activities from 1944 to 1971. Several additions have been constructed over the past years along the north side of the building. The 2,699-m² (29,092-ft²) 314 Building was modified in the 1970s and used by Pacific Northwest National Laboratory for a variety of research projects and crafts services.

Figure 9. 314 Building.

Like all other buildings in the 300 Area D4 project, radiological and industrial hygiene surveys were conducted in the 314 Building prior to demolition. Unlike most other buildings, however, levels of radiological, beryllium, and mold contamination were found that required special controls during the hazardous material removal and demolition processes, and all waste from the 314 Building was considered both radiologically and beryllium contaminated. Demolition took place between October and December 2005, with load out continuing into January 2006. Further details regarding the end state of the 314 Building can be found in *Post-Demolition Summary Report for the 314/314B Buildings* (WCH 2006c).

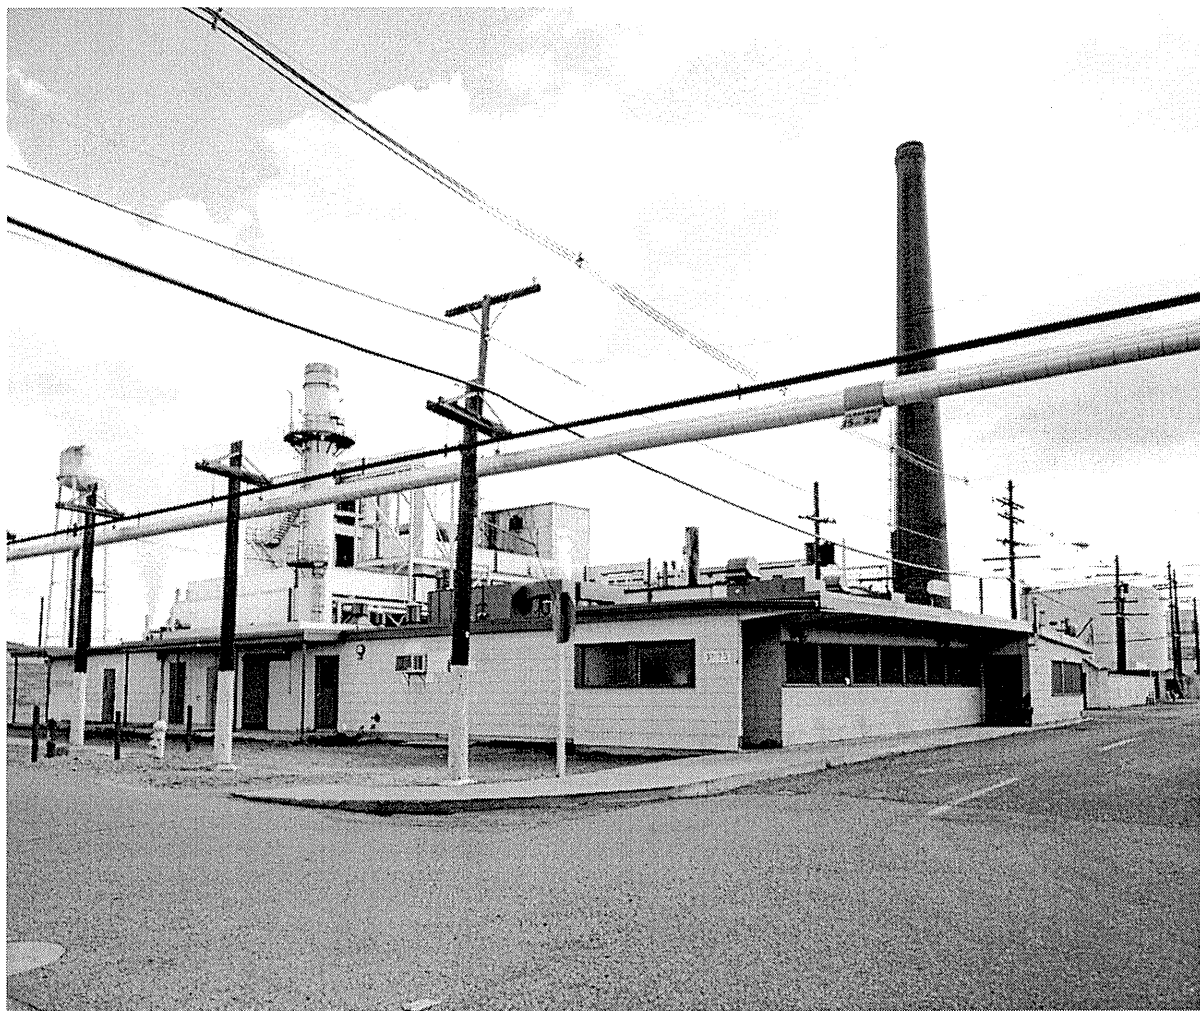
This facility was a single-story wood-framed office building (Figure 10). The 848-m² (9,127-ft²) 3707D facility has had at least three uses and configurations. The first configuration, from 1943 to about 1953, was as a 120-m² (1,296-ft²) fuel-storage facility, designated as 303-D. In 1953, the facility was expanded to about 23 m (76 ft) by 35m (115 ft), giving an enclosed space of about 790m² (8,505 ft²). The 303-D structure remained as the core of the building with additions on the east, west, and south. The new functions included a change building with lockers, showers, a lunch room, and offices. Finally, in 1971, the building was converted to a design center. The original 303-D portion of the building was referred to as the “tracing vault,” where drawings were stored. An external fire door was added to the vault. In this configuration, most of the areas were used as offices and rooms for drafting tables.

Figure 10. 3707D Information Services Building.

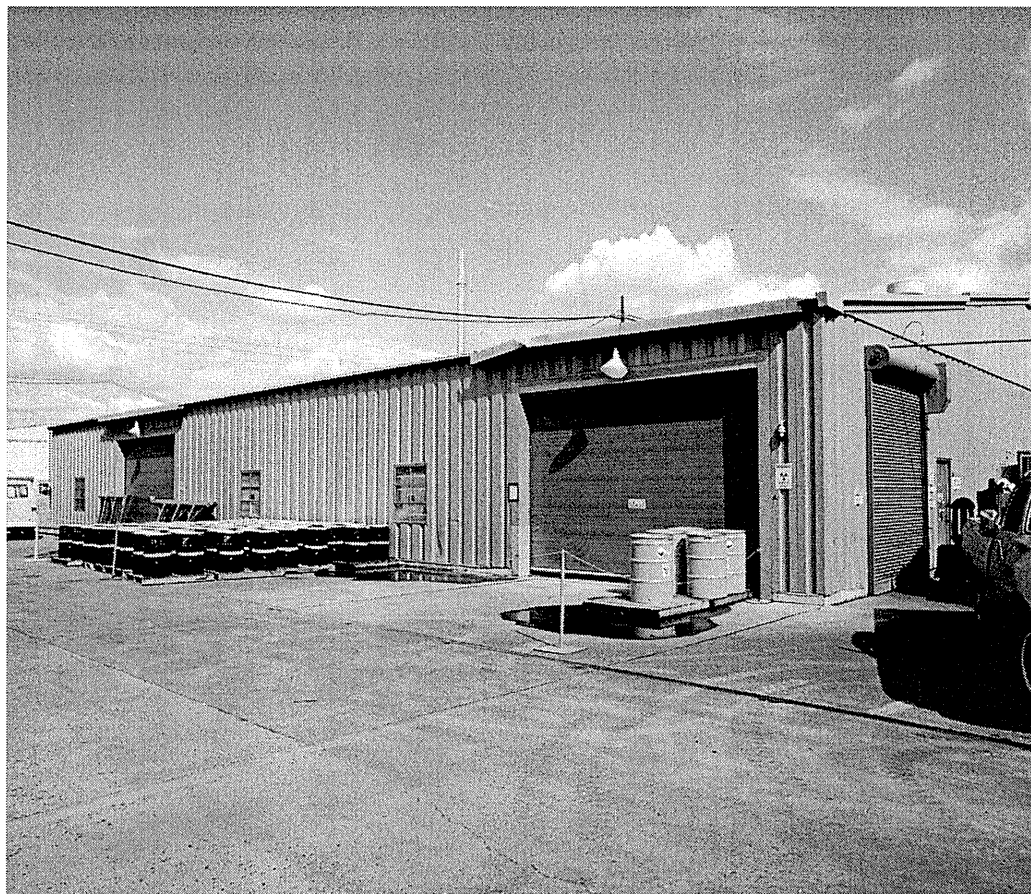
The 3712 Building is a one-story steel frame structure on a concrete floor slab with metal panel walls and roof (Figure 11). It was used to store “green” (i.e., nonirradiated) fuel for N Reactor. The building was 903 m² (9,720 ft²) in area.

Figure 11. 3712 Building.

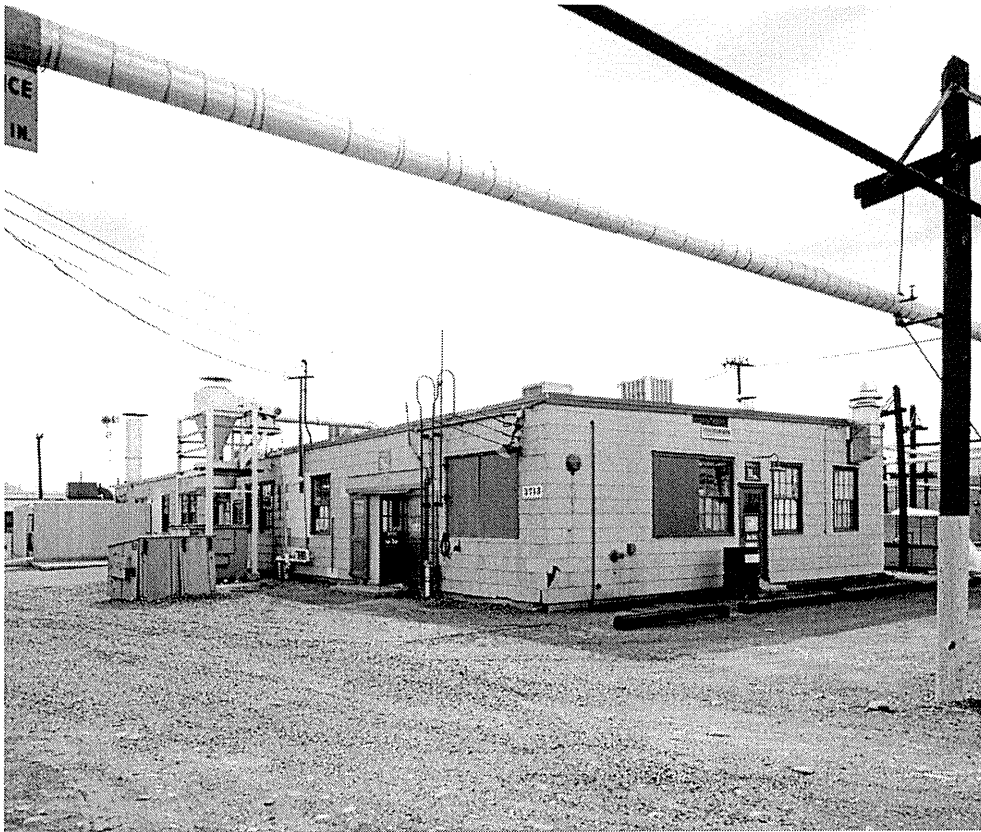
The original use for this facility was as a receiving storeroom (Figure 12). Later, it was converted into a carpenter shop. It is a 445-m² (4,800-ft²) one-story wooden frame building with concrete foundation walls with concrete spread footings, wooden beams, and interior wood posts.

Figure 12. 3713 Carpenter Shop.

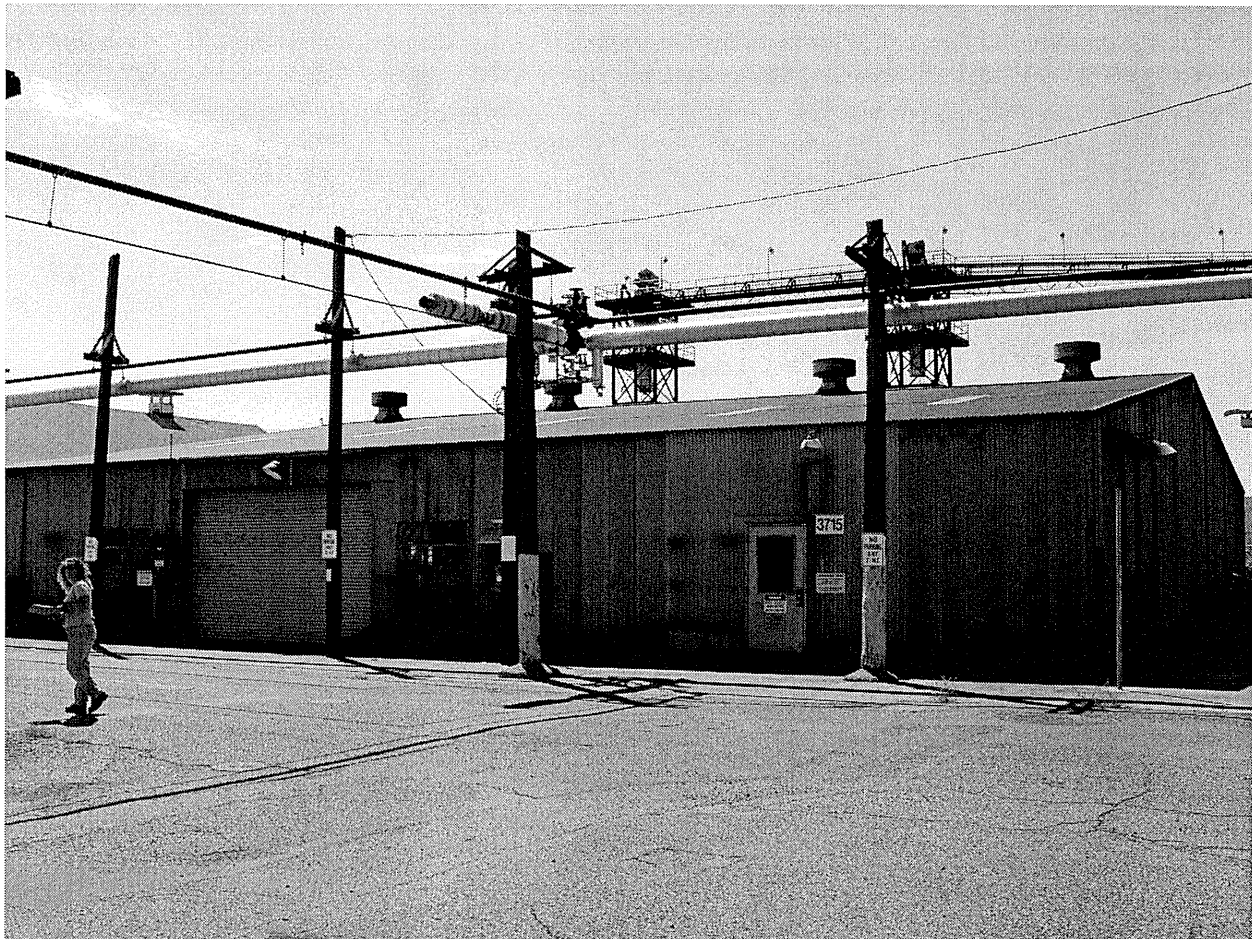
This facility was a single-story corrugated sheet-metal building on a concrete slab used for storage (Figure 13). The 595-m² (6,400-ft²) facility was built sometime between 1959 and 1961.

Figure 13. 3715 Spare House Warehouse.

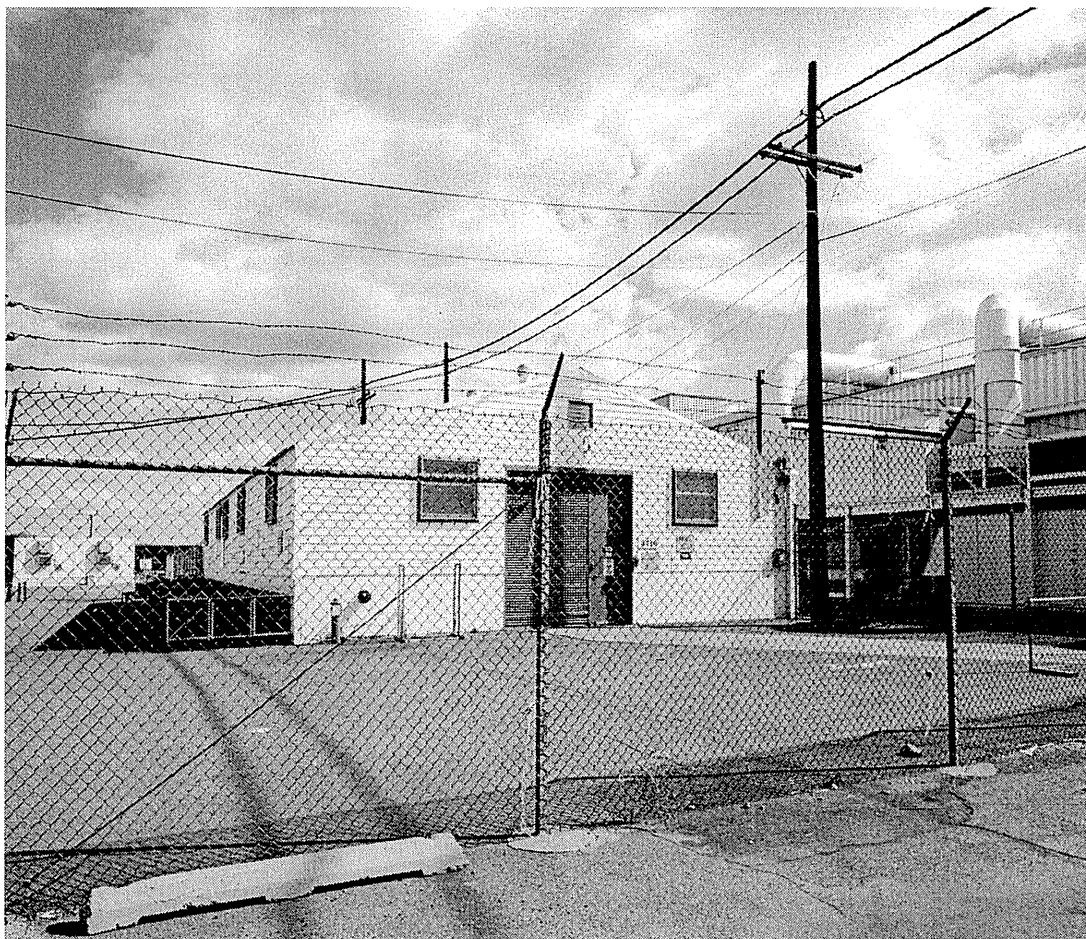
The original purpose of the 3716 Building was to support development of alternative reactor fuel fabrication processes (Figure 14). The last use of this 445-m² (4,800-ft²) facility was to store “green” (i.e., nonirradiated) N Reactor fuel. This one-story building consists of 1.2-m (4-ft)-high concrete walls mounting a metal frame structure with insulated aluminum wall and roof panels

Figure 14. 3716 Storage Building.

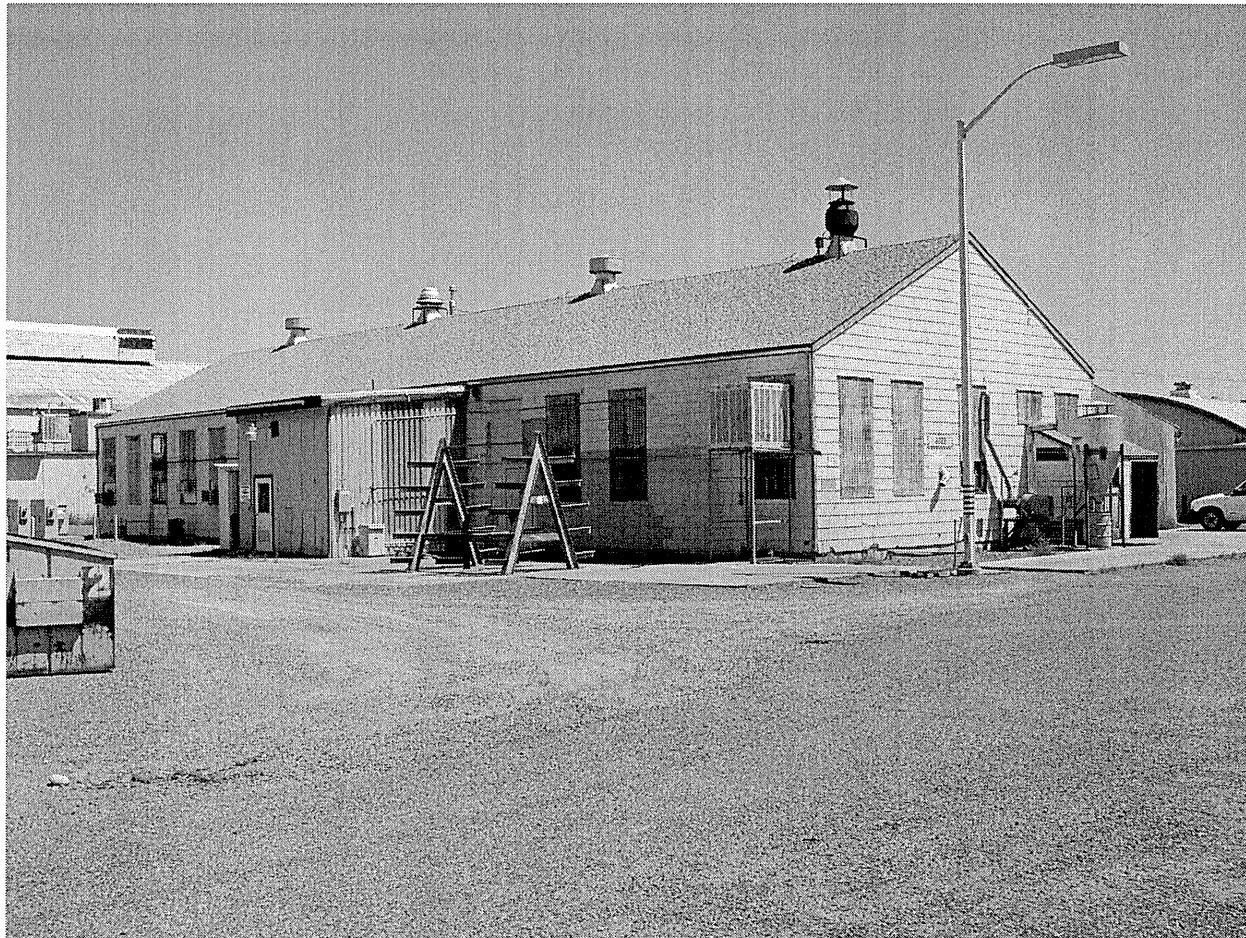
This facility was originally built as a receiving warehouse (Figure 15). It was later converted into a fabrication shop. It was a 590-m² (6,346-ft²) one-story wooden frame structure with a reinforced concrete slab floor.

Figure 15. 3722 Fabrication Shop.

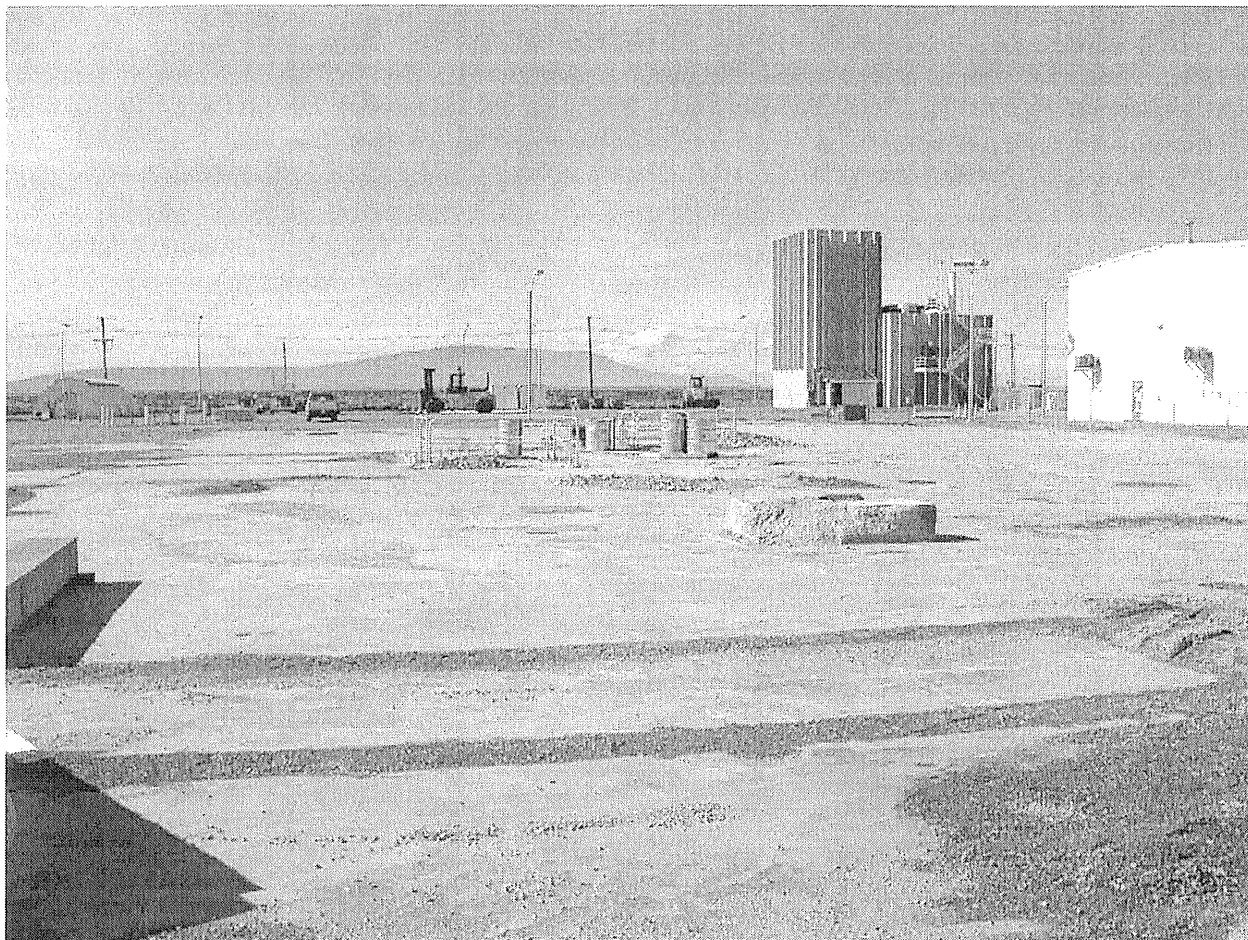
The foundation and floor slab for the 314 Building has been approved for deferral by DOE and the U.S. Environmental Protection Agency for remediation under the 300-FF-2 *Comprehensive Environmental Response, Compensation, and Liability Act of 1980* action (EPA and DOE 2006). Several below-grade areas remain in place and were backfilled with clean fill material from borrow pit 6. These areas include the basement area in the southwest corner of the building, a 10.7-m (35-ft)-deep pit in the east central area of the slab, a 3-m (10-ft)-deep pit in the north-central portion of the slab, a 1.8-m (6-ft)-deep pit in the east-central area of the slab, a concrete ventilation duct under the slab, and several small trenches. The slab is posted as Fixed Contamination Area, but is no longer posted for beryllium (Figure 16).

Figure 16. Former Site of the 314 Building.
