DRAINING HAZARDOUS FLUIDS DURING BUILDING 221-1F DEACTIVATION AT THE SAVANNAH RIVER SITE (SRS)

John C. Musall

*Savannah River Nuclear Solutions
Savannah River Site
Buildings 707-25C
Aiken, South Carolina 29802*

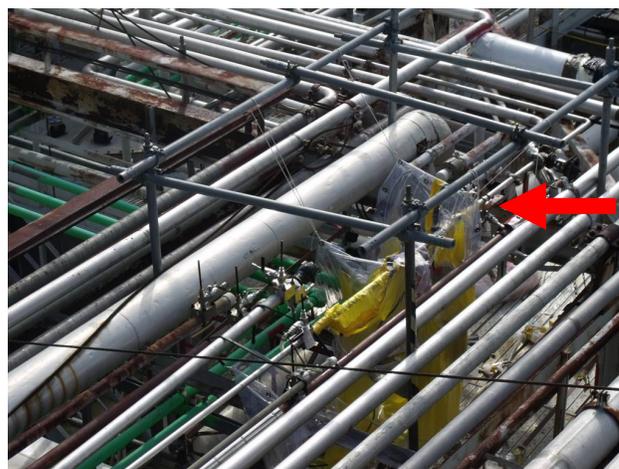
FIGURE 2 – Installed A-Line Hot Taps

Last August, SRS lost primary confinement associated with a nitric acid supply line that SRS was attempting to drain and then air gap. A hot tap was installed on the line several days prior to the release. A work bumped the drill bit, the drill bit was dislodged from the hot tap, and nitric acid spilled from the line. The spilled nitric acid contacted/ splashed several workers in the vicinity. All workers were wearing appropriate personal protective equipment (PPE); however, there are gaps at the edges of the face-shields and protective suits have seams. (For the most serious exposure, the acid penetrated the suit via the sleeve/glove interface.) End result, SRS transported three workers to a local hospital, where two were released and returned to work the same day. The third worker received skin grafts (temporary and permanent), and did not return to work for several days. Additionally, SRS transported four workers to SRS Medical as a precaution: all were released the same day. In total, the nitric acid exposures resulted in one recordable injury and four first aid cases.

Figure 2 shows the hot tap that failed. A yellow glovebag is draped over the nitric acid supply line. Just to the north and south of the glovebag are two tap: one acting as a vent and the other acting as a tap. The far tap, used as a drain, failed last August.

A final corrective action was to revise several procedures/guides in use by SRS's D&D organization and to generate a new procedure for use of the hot taps. These fixes were primarily geared to forcing and ensuring proper material and chemical evaluations during the preparation of engineering documentation and work packages, and to forcing proper usage of temporary components or tools such as the hot tap. Revised documentation includes the following:

- New hot tap procedure – SRS no longer provides the manufacturer's instructions in the work package as reference material. SRS now has a "use every time" procedure. The new procedure requires the following so as to preserve the retaining ring, and to maintain a tight grip on the drill bit:

- Instructions no to use Teflon tape on the gland nut
 - Installation of a drill stop to prevent mechanical damage during drilling
 - Torquing the gland just prior to tapping

- Torquing the gland again within 24 hours (due to creep)
 - Installing cap over the drill bit
- Guidelines for Engineering Indexes – Now more prescriptive than before. Requires sketch for all temporary rigs (e.g. leak collection rig, drain rig, vent rig, etc.) and systematic review of specified (or expected) components for material compatibility.

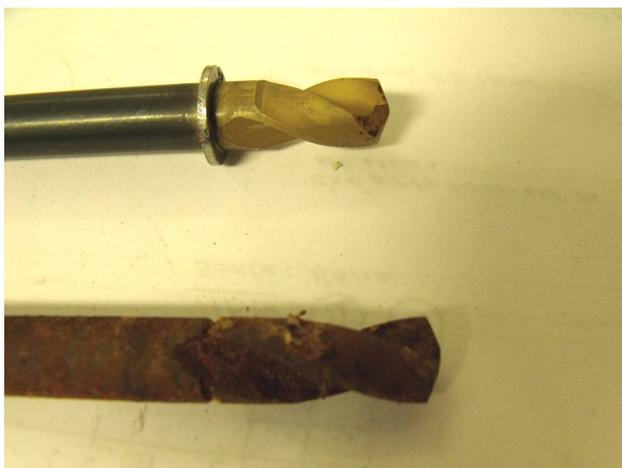
FIGURE 3 – Recovered A-Line Hot Tap

SRS investigated the nitric acid spill, and generated approximately 40 corrective actions as a result of their investigation. One corrective action was to evaluate the tap's compatibility with concentrated nitric acid. SRS found that all components are compatible with the exception of the retaining ring and drill bit, which are both carbon steel. All other materials were found to be PTFE or 304 SS, both of these materials are highly resistant to nitric acid attack.

SRS also simulated exposures at various times and nitric acid concentrations, and found that the life of the carbon steel retaining ring was relatively short. SRS also found that with proper maintenance of the gland, the tap was leak free and the drill bit was tightly held even after a week's exposure to the most aggressive concentration of nitric acid.

SRS also recovered and inspected the actual drill bit that fell out of the tap back in August. Figure 3 shows the recovered drill bit after a week of exposure to concentrated nitric acid and approximately three months to the elements. Note the sharpness of the tip and the squareness of the slot.

Based on the laboratory simulations and the inspection of the recovered drill bit, SRS concluded that the drill bit failed for two reasons: (1) the retaining ring no longer provided its function either due to mechanical damage and/or corrosion, and (2) the drill bit was not adequately gripped by the gland. It took absence of both for the drill bit to fall out of the tap. Based on the laboratory simulation, SRS confirmed that if the gland is tightened and maintained in accordance with manufacturer's instructions (main thing is to torque the gland) the drill bit is tightly gripped by the gland, with no leakage for up to

one week. Therefore, the tap can be used successfully with concentrated nitric acid.³

limitations and plan accordingly. Within the hot taps, there are some carbon steel components that will corrode and eventually fail. So you need to maintain the gland gripping the drill bit and certainly install a cap within a short period after tapping.
