UCRL-12172

NUCLEAR CRATERING EXPERIENCE AT THE PACIFIC PROVING GROUNDS

Louis J. Circeo, Jr.

November 10, 1964

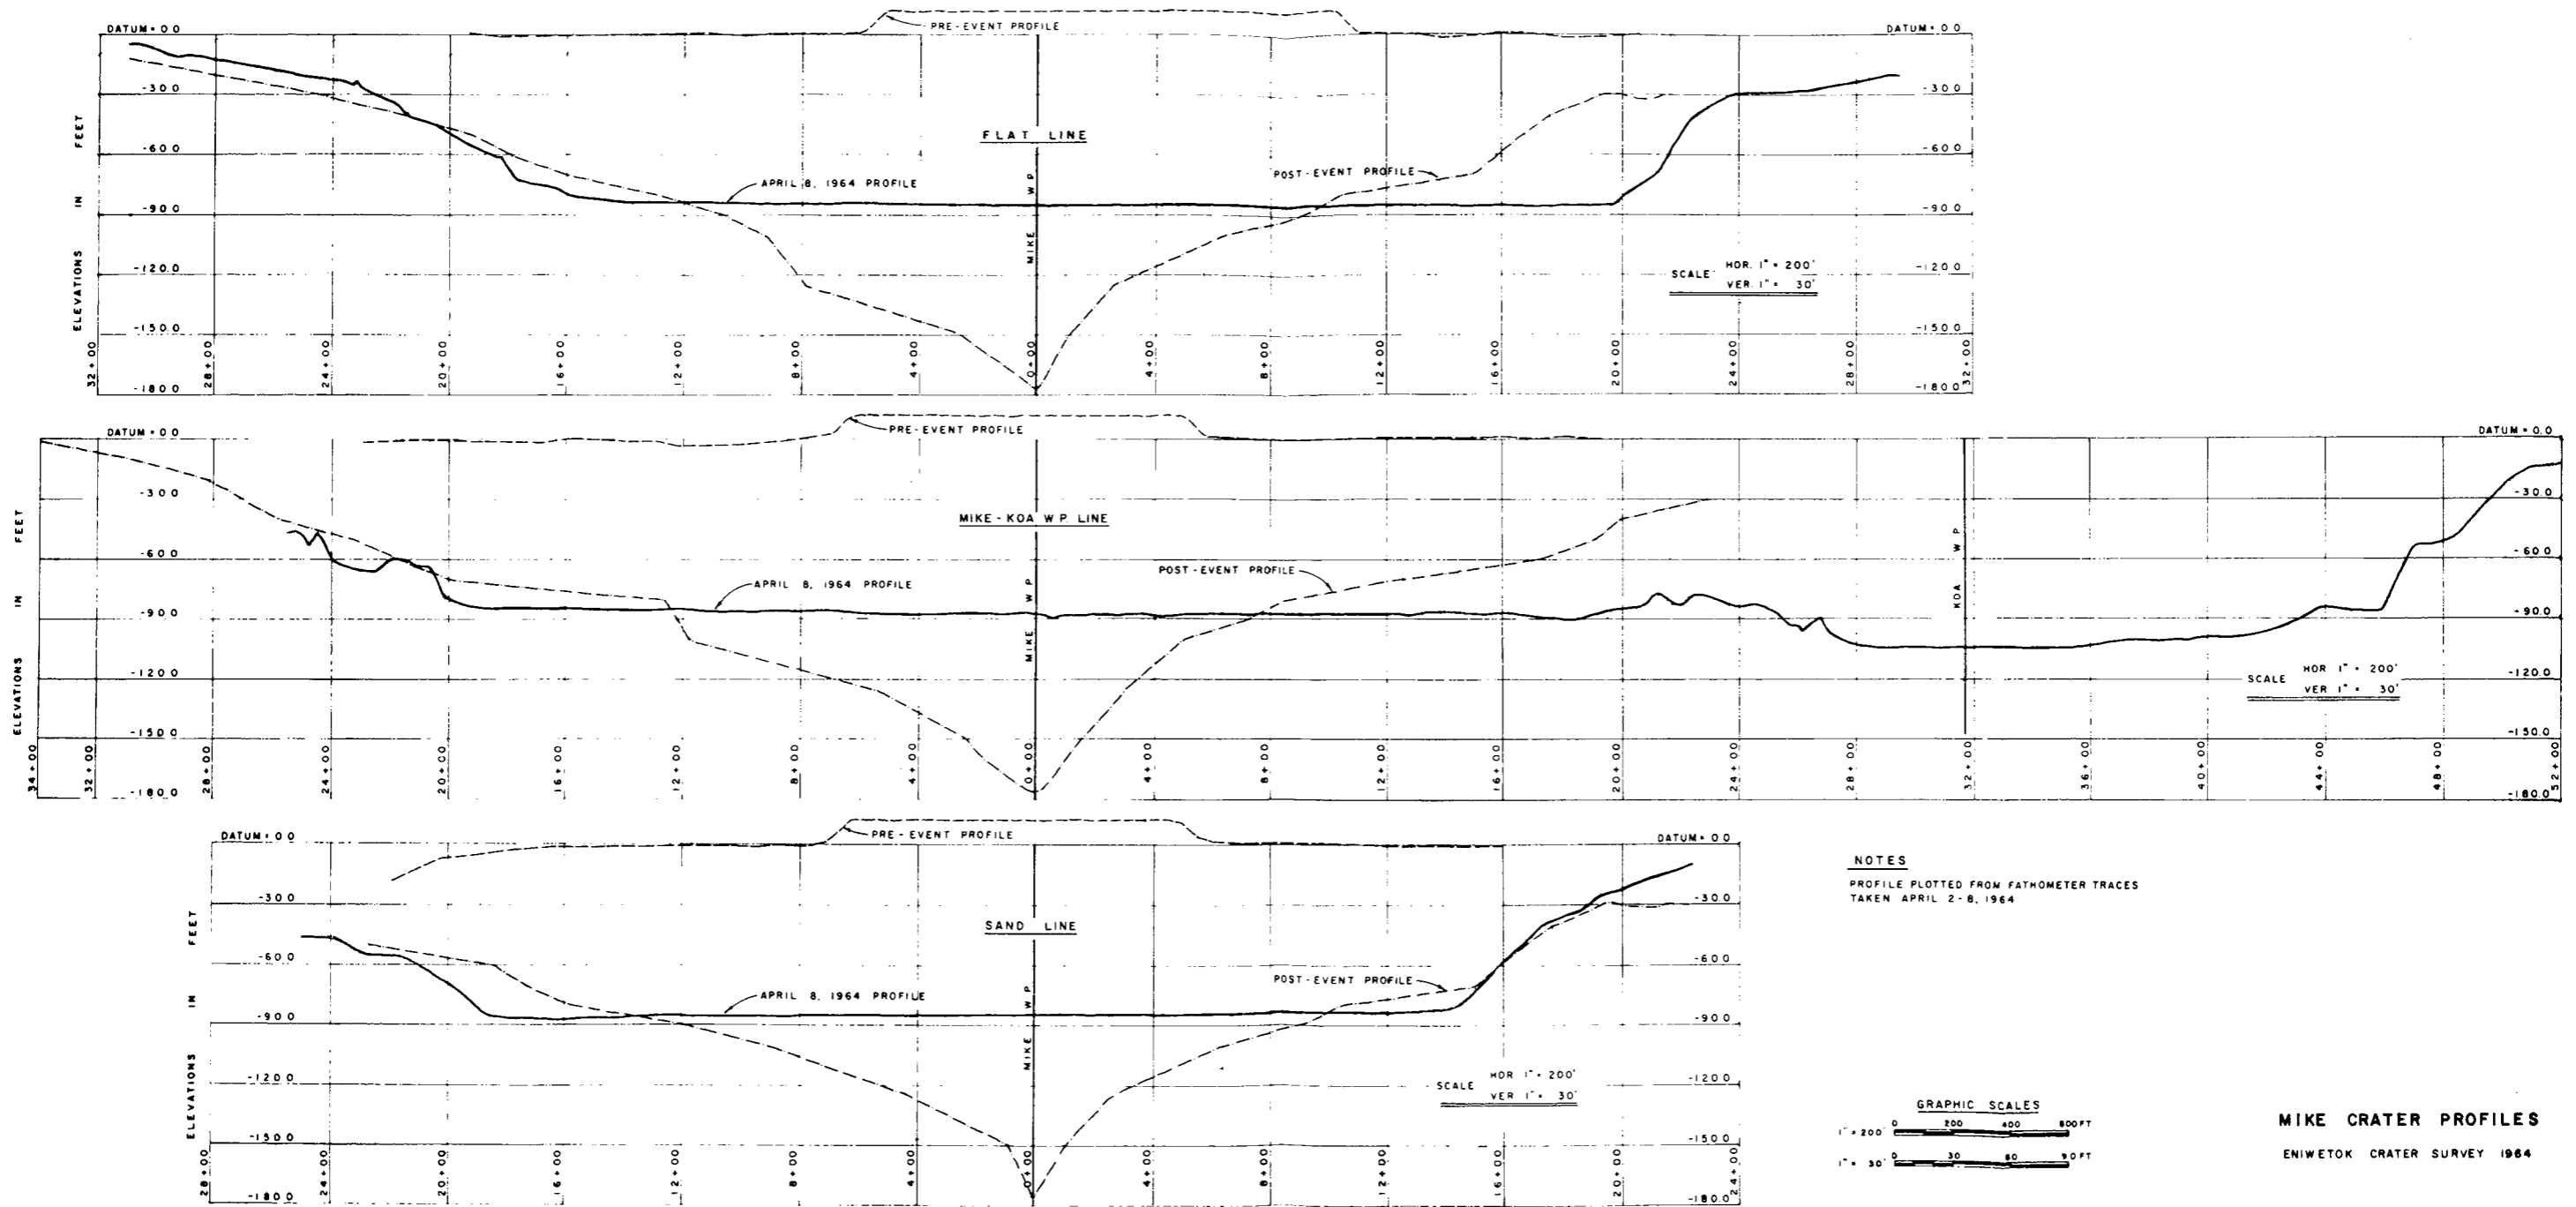
The 1964 survey was made by fathometer, with lead-line soundings to verify fathometer readings. The results of the post-event and 1964 surveys are shown in Fig. 7. One of the 1964 survey lines goes from the Mike zero point through the zero point of the adjacent Koa crater, which is discussed in a later section. The survey lines for both Mike and Koa craters are shown in Fig. 8. The greatest change in the Mike crater shape is a silting-up of the bottom. This has been caused mainly by settling of mud and silt in suspension, and throwout from the adjacent Koa shot (see frontispiece).

Fig. 7. Preshot, postshot, and 1964 survey profiles of Mike crater. Note the profile through the Mike and Koa zero points.

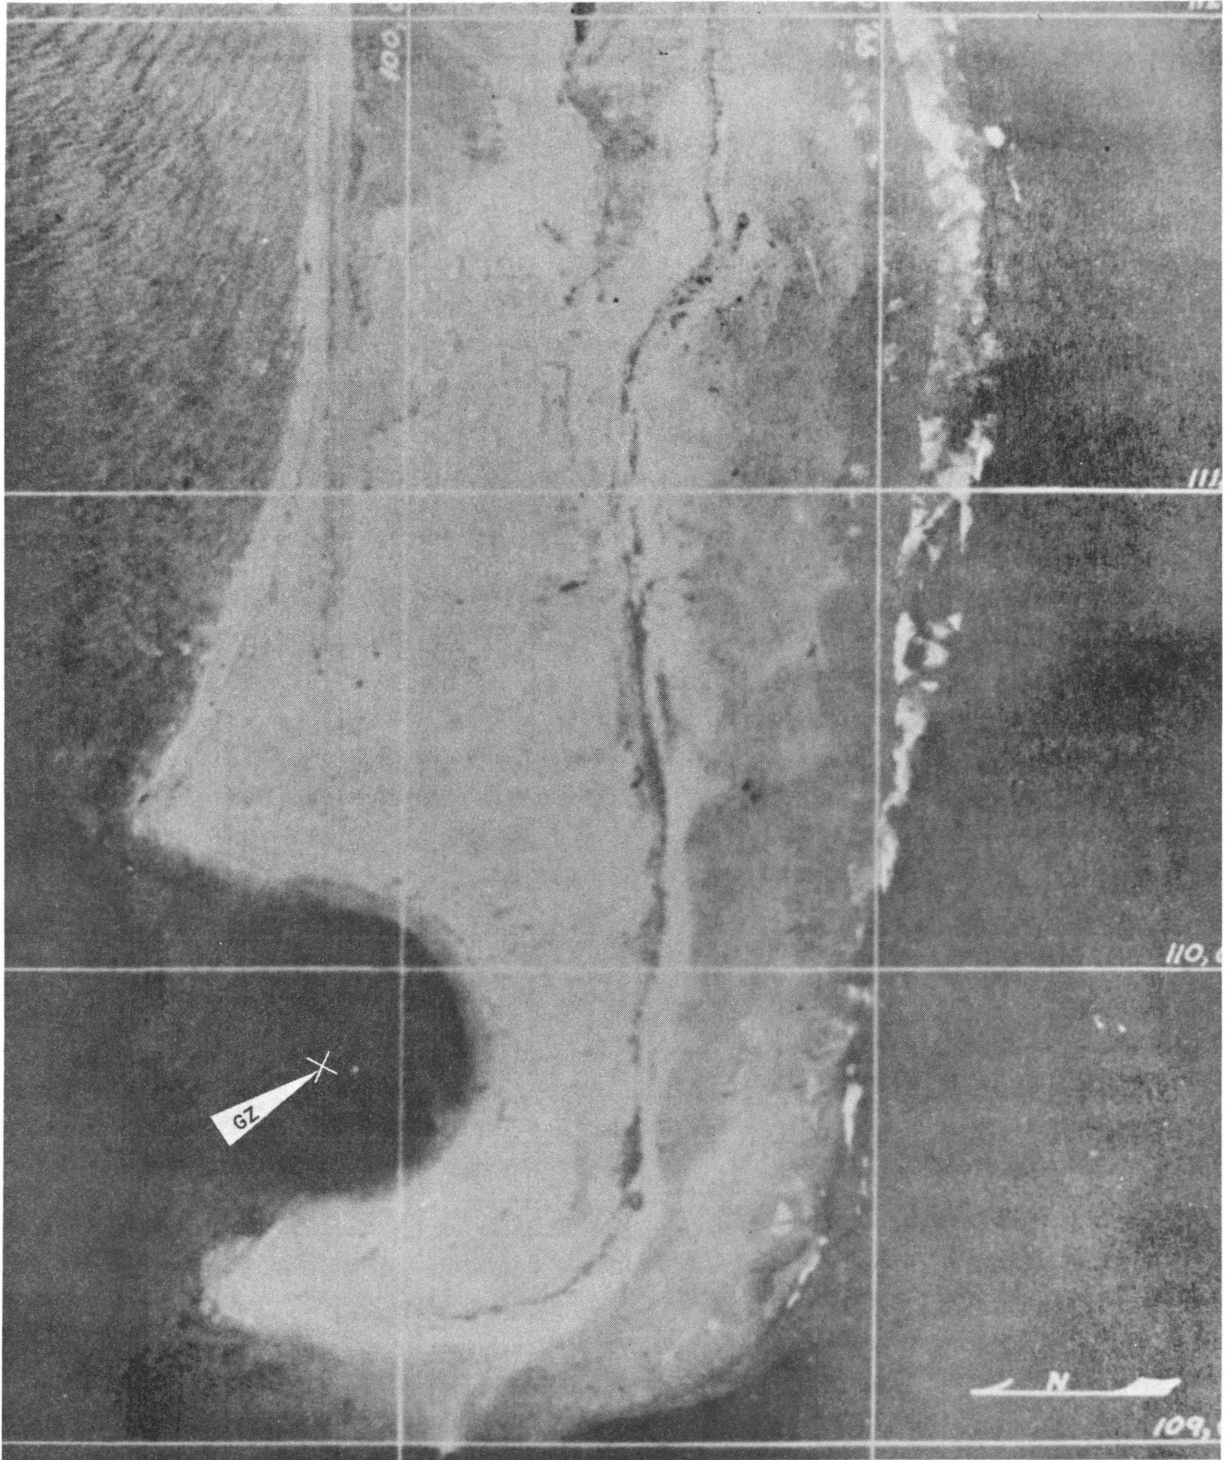
Fig. 11. Preshot Koon area.[7]

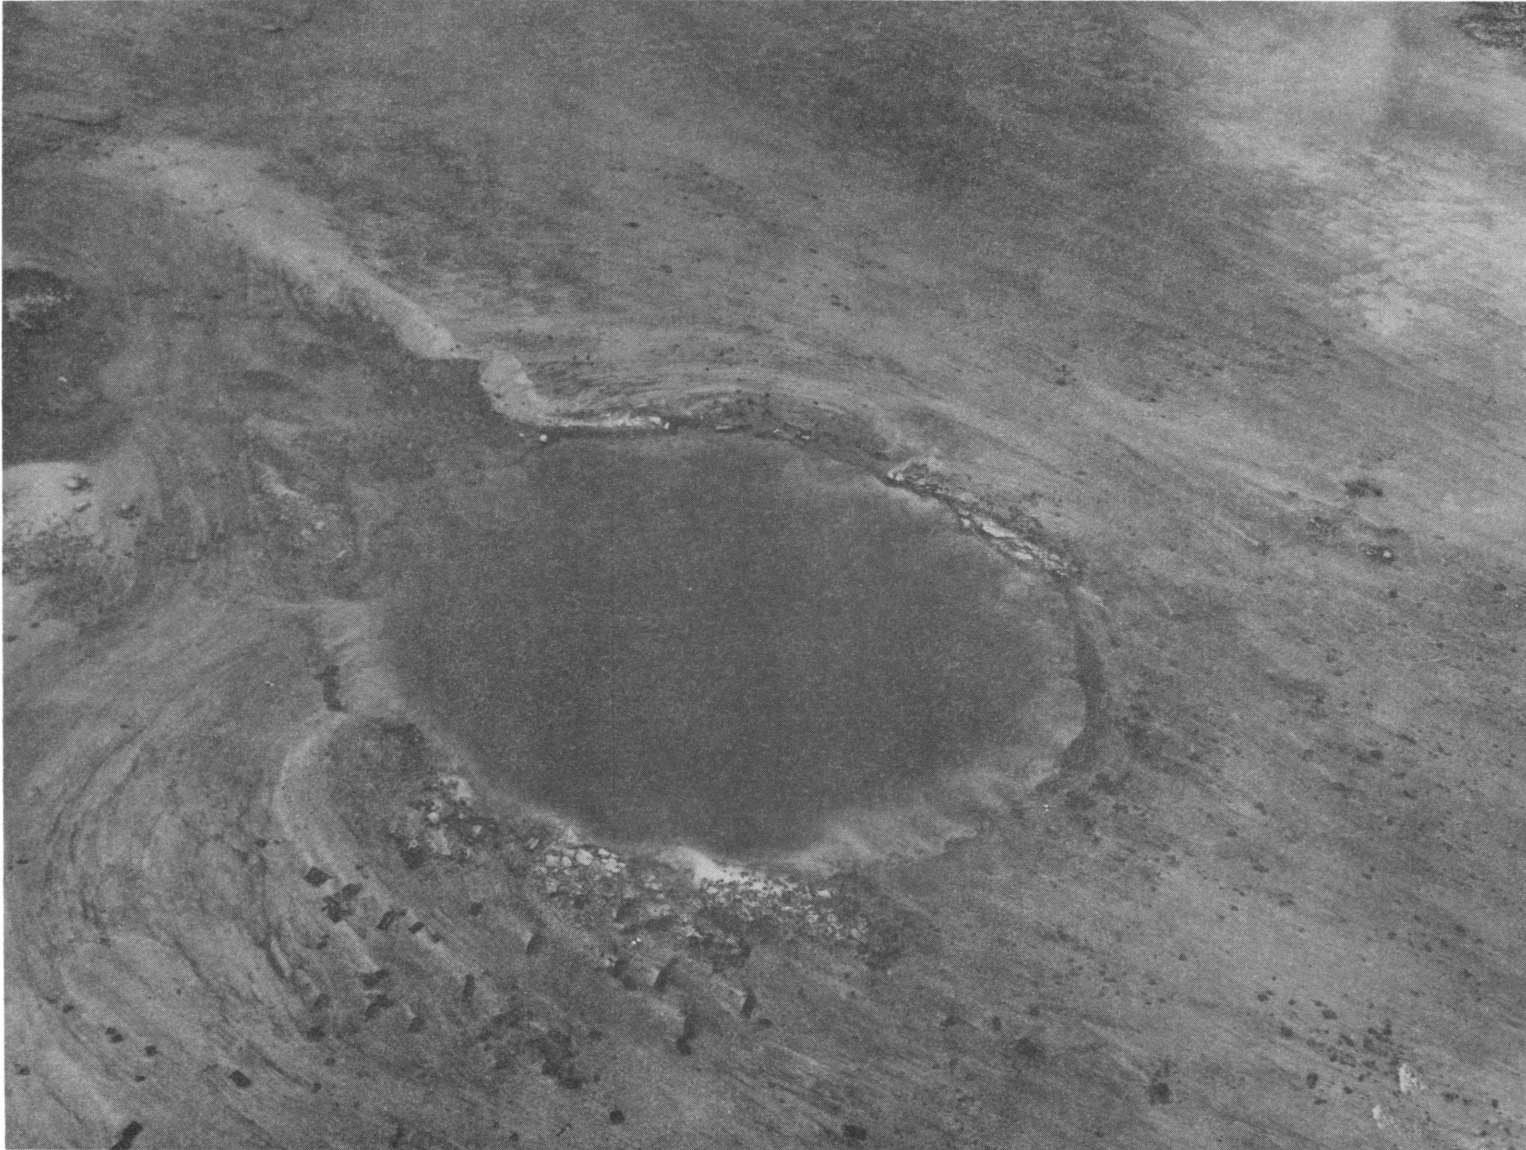
Figure 19 shows the postshot and 1964 results of lead-line soundings surveys made by a boat traversing the crater. Since the crater appeared symmetric, only range lines 1 and 4 were surveyed after the shot.[2] The 1964 survey shows that a small amount of erosion has taken place on the slopes of the crater, and has filled the bottom of the crater to a maximum depth of about 5 ft. Figure 20 is a photograph of the crater taken during the 1964 survey. Figure 21 is a contour map of the crater made from stereophotogrammetric measurements and the lead-line surveys made in 1964.

Fig. 19.   Preshot, postshot, and 1964 survey profiles of Lacrosse crater.

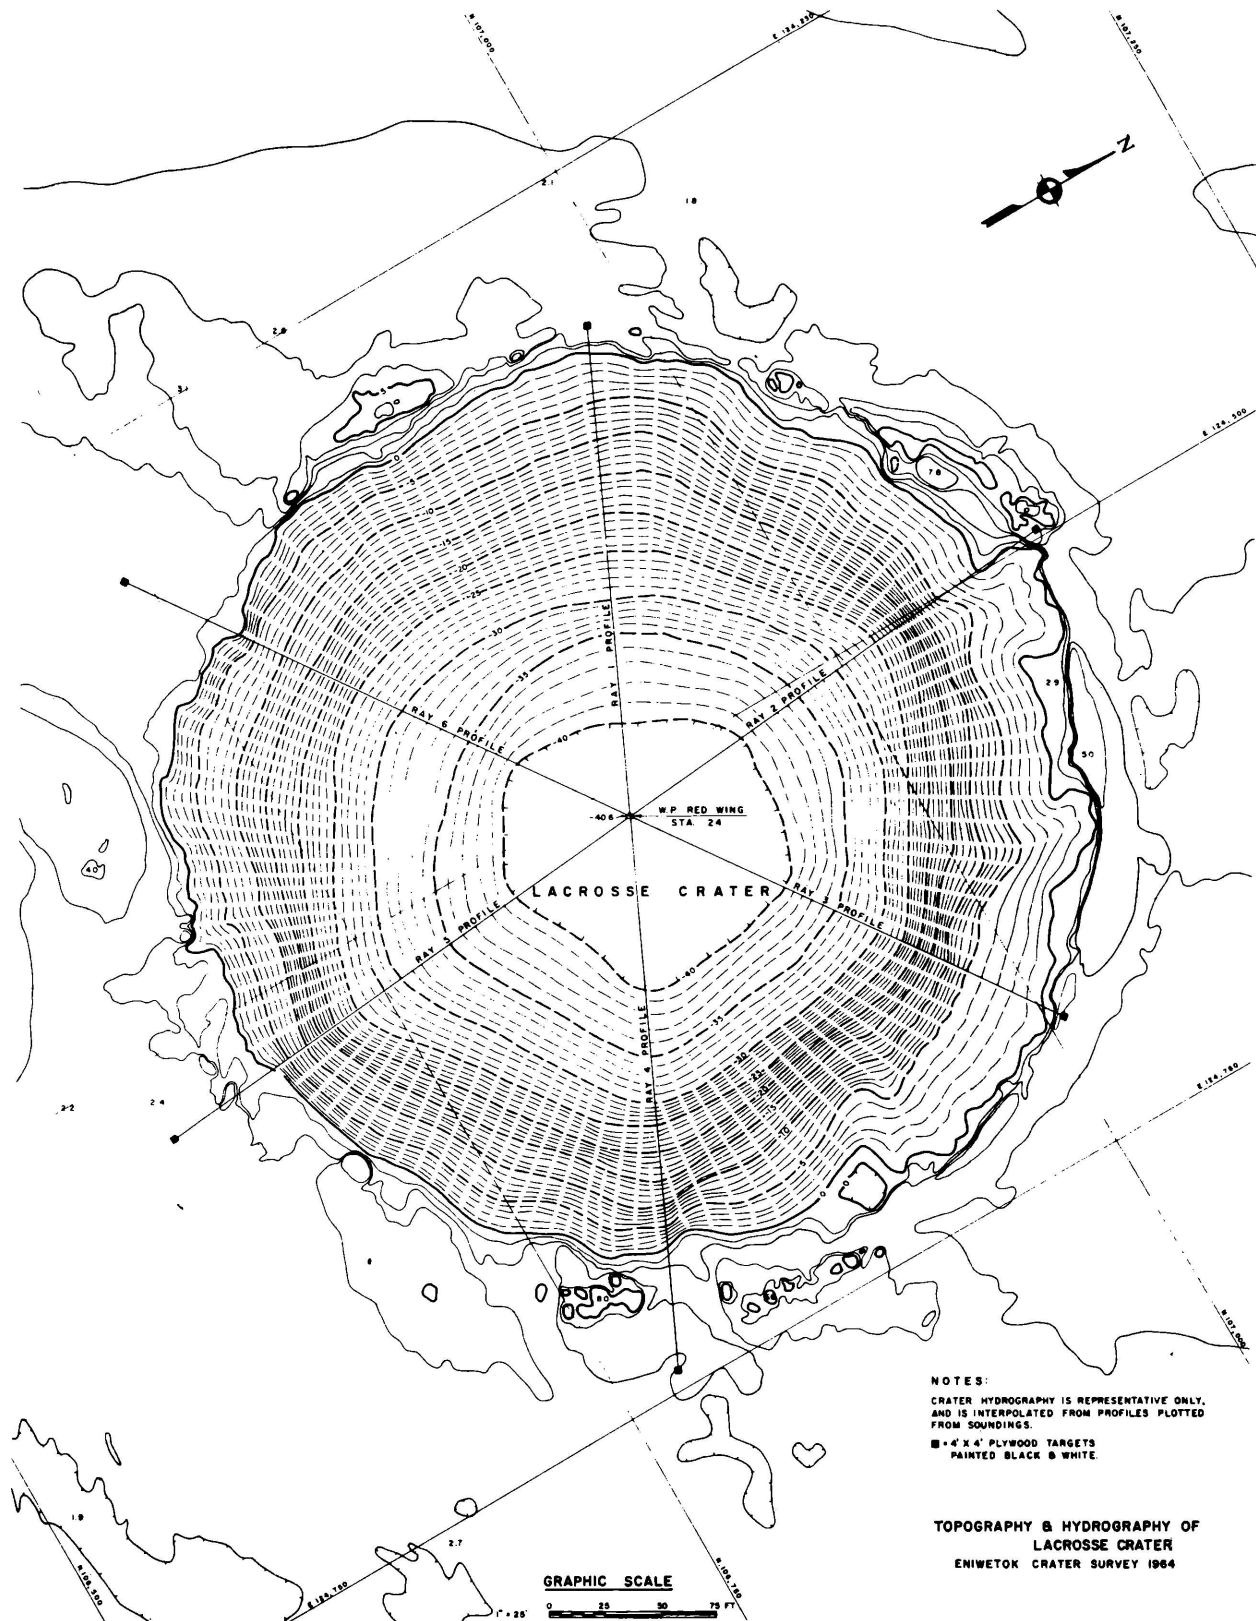
Fig. 20. 1964 photograph of Lacrosse crater.

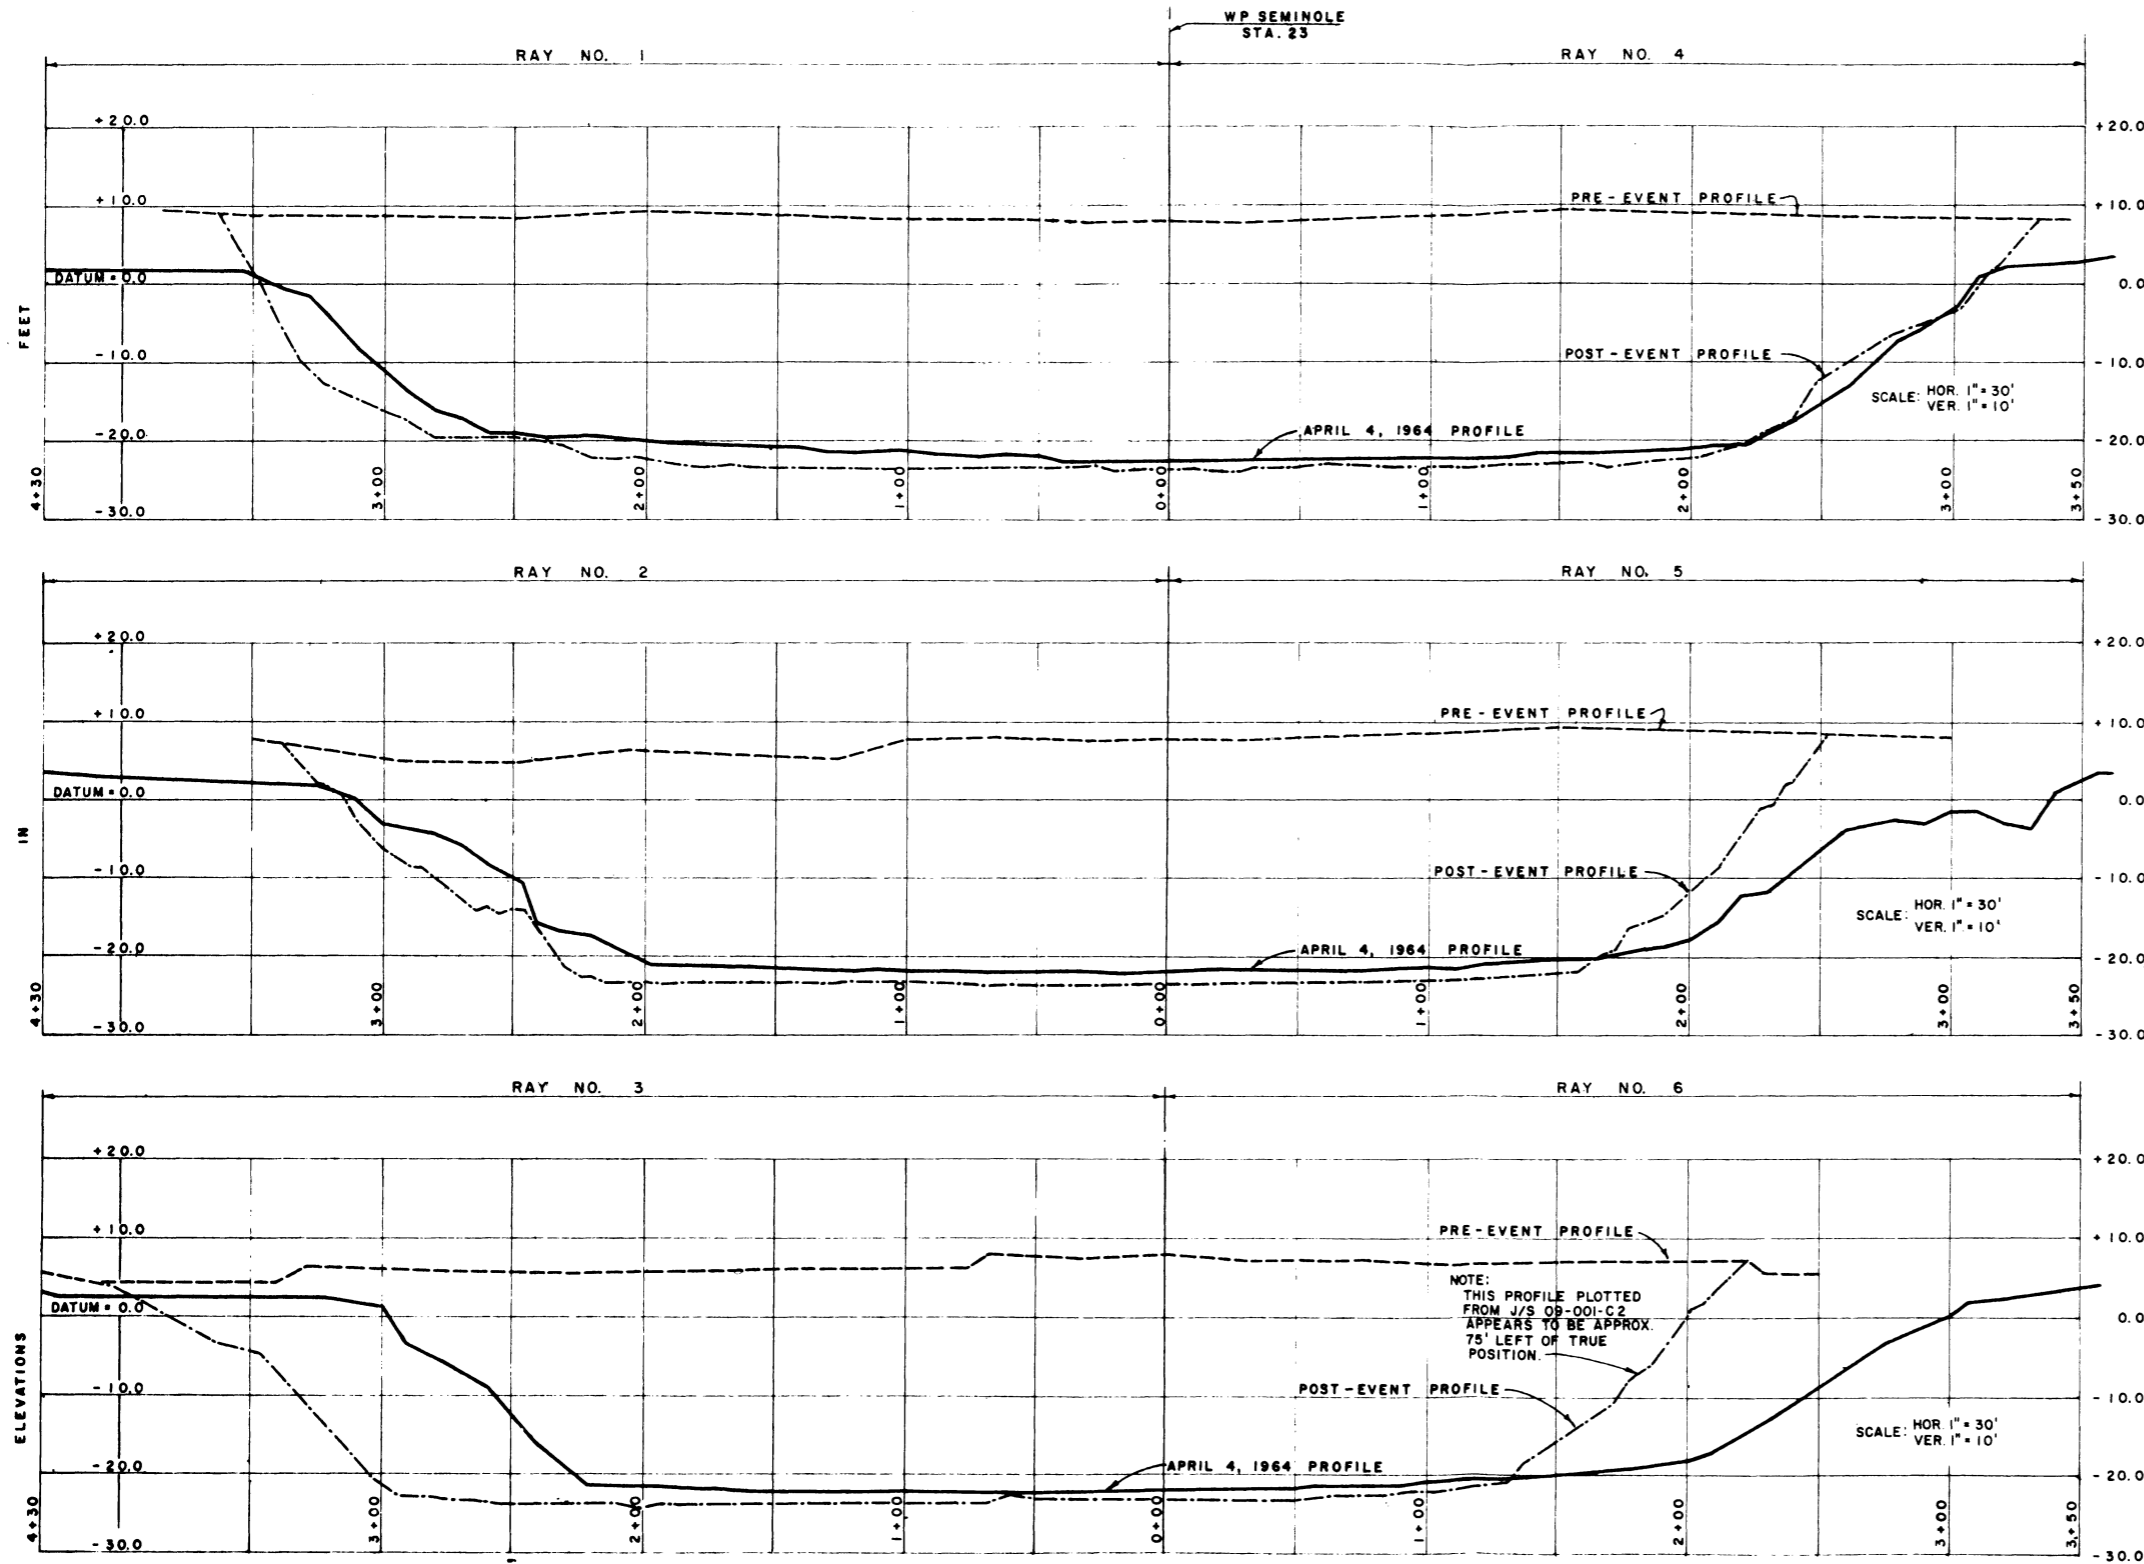
Figure 26 also illustrates the results of the 1964 survey using lead-line soundings. Note that rays 3 and 6 seem to be about 75 ft to the left of the true position indicating a probable survey error. Ray 5 shows that slope failures of the crater have occurred, although the crater bottom has only filled in a few feet. The medium appears to consist of weakly cemented sand, as shown in Table III. Several ground subsidences appeared around the crater shortly after the shot. Rays 1 and 2 indicate the slopes have filled in from an external source, probably from the erosion of its entrance channel. Figure 27 is a 1964 photograph of the crater. Figure 28 is a contour map of the crater made from surveys and photographs from the 1964 study.

Fig. 26. Preshot, postshot, and 1964 survey profiles of Seminole crater.

No major slope failures are in evidence except along ray 5 of the Seminole crater (see Fig. 26). As mentioned earlier, this was probably caused by the unstable condition of the medium. However, grading of the lip after the shot may have contributed to this. The extent that the Seminole lip was cut down and the subsequent disposition of the graded material is not known. The Mike and Koa craters (Figs. 7 and 32) have undergone minor slope failures, which were probably due, for the most part, to erosion.

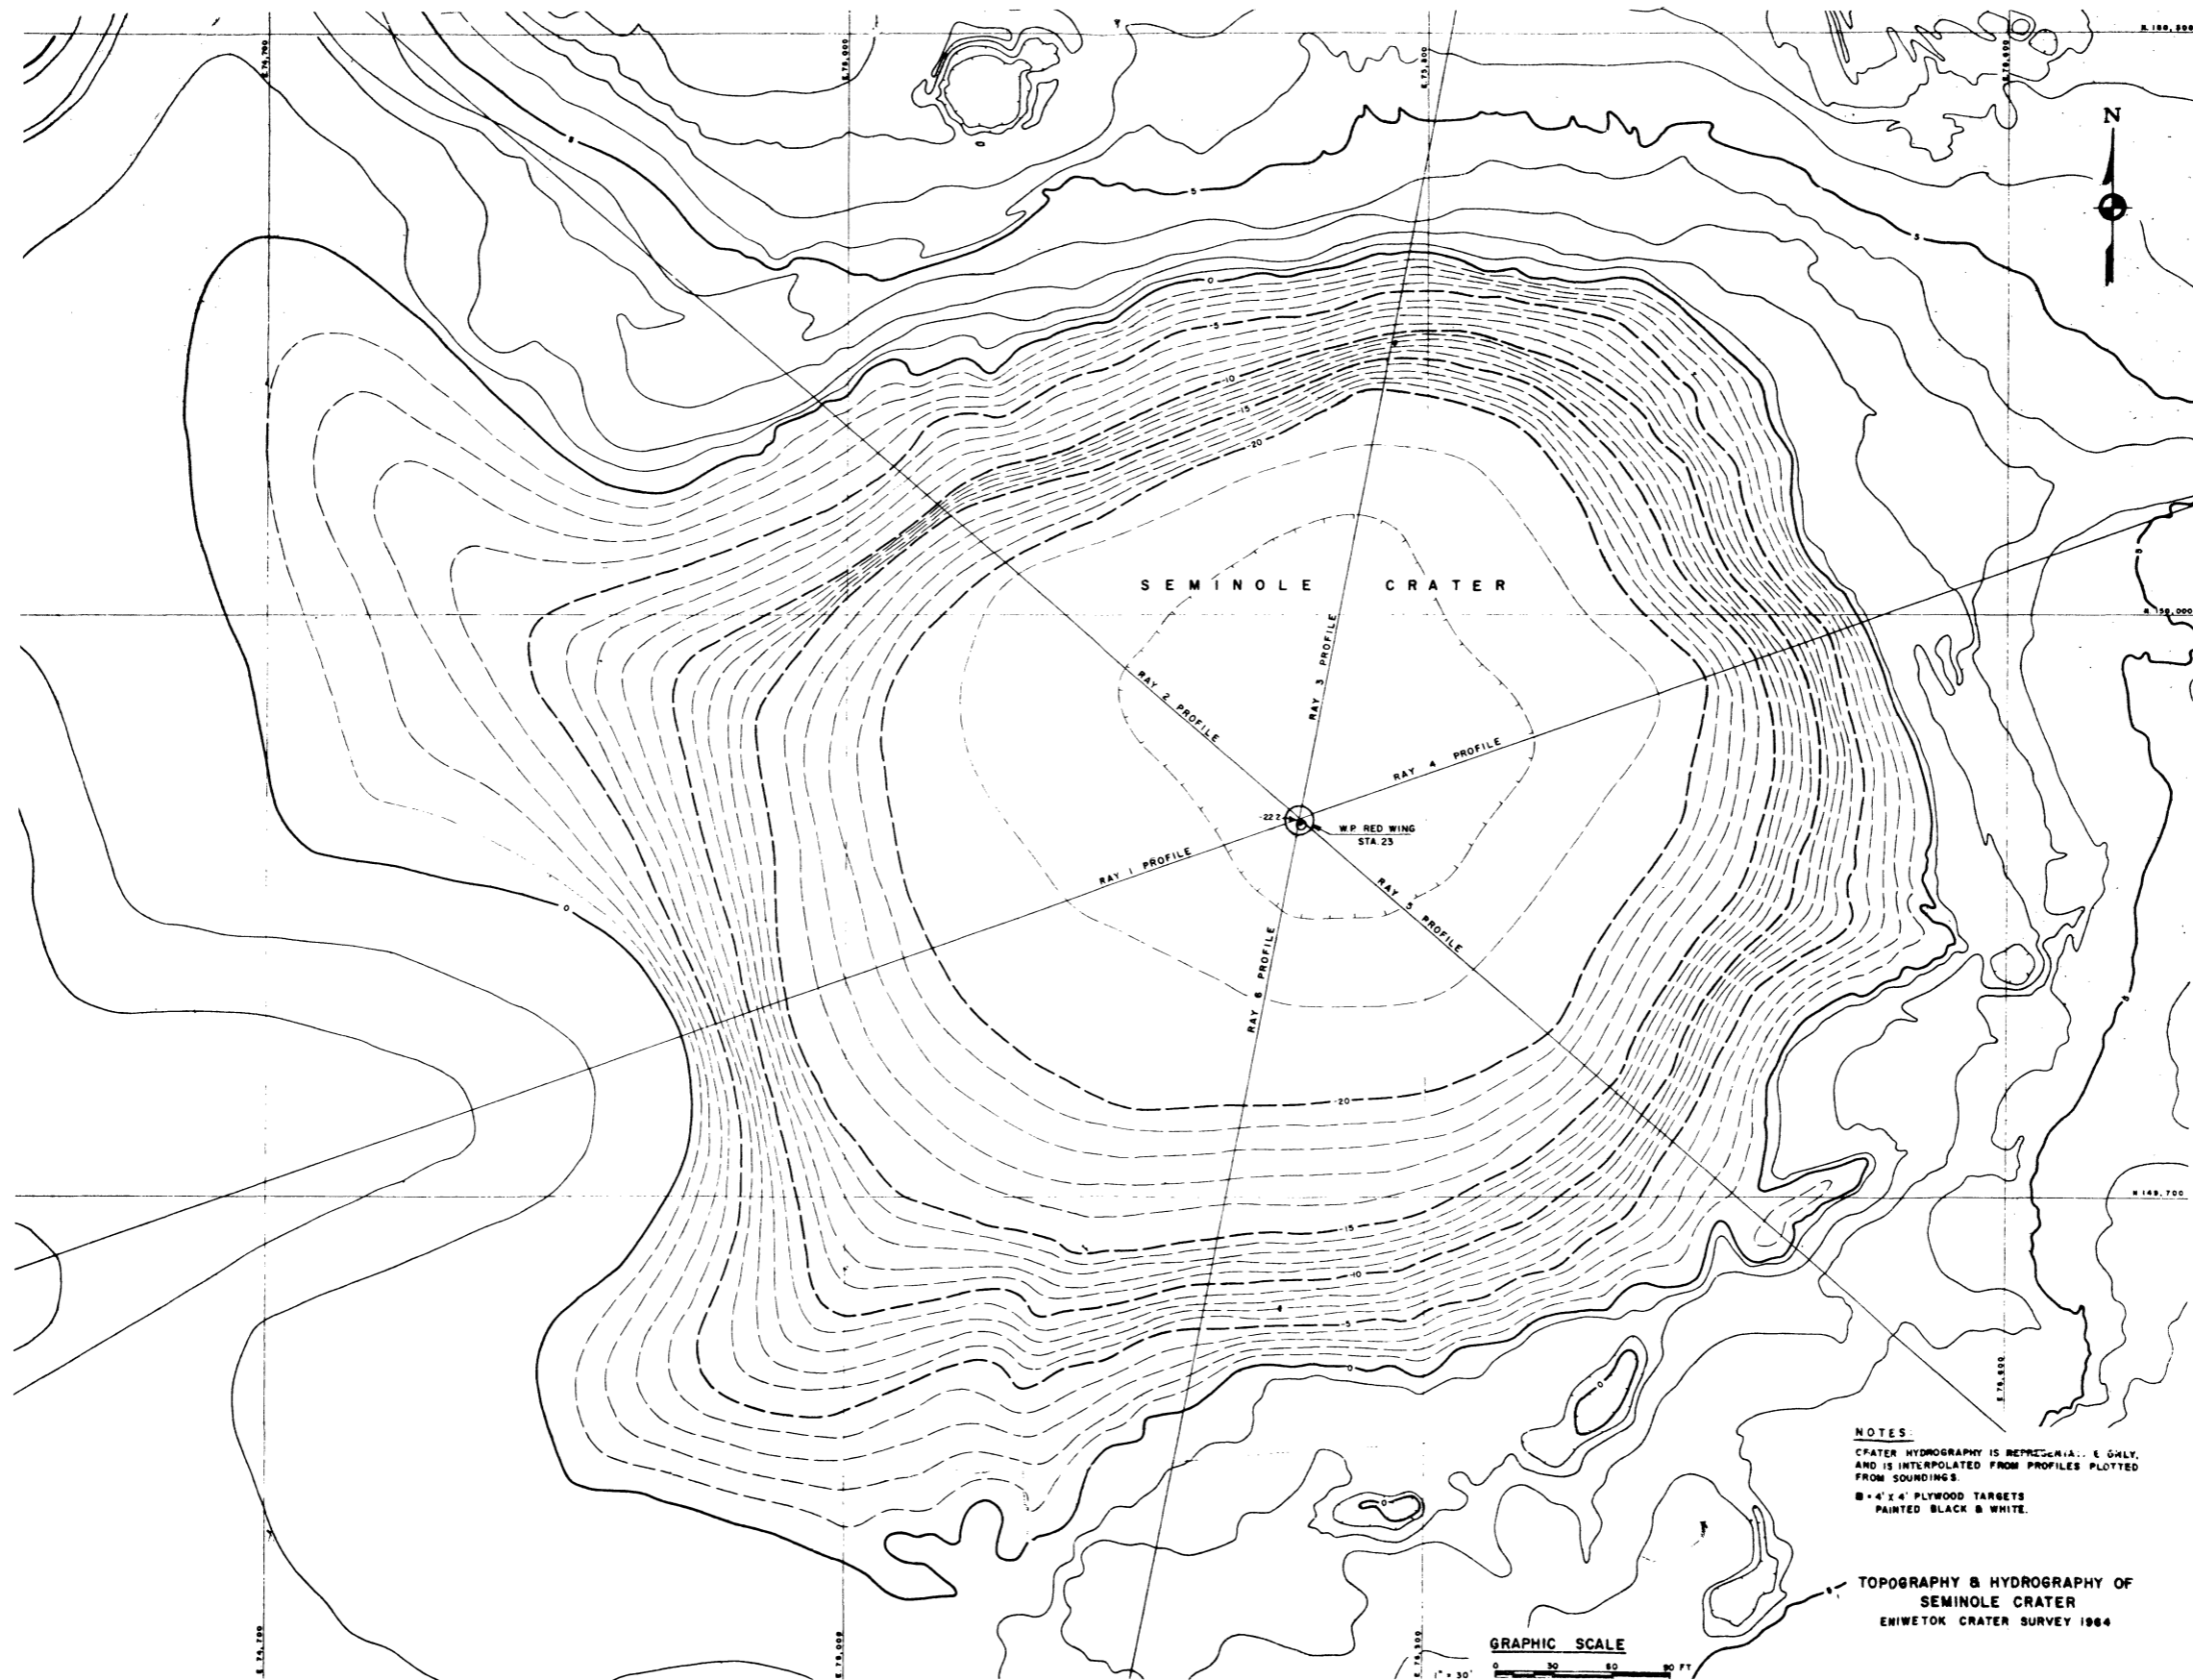
Fig. 27. 1964 aerial photomosiac of the Seminole crater.

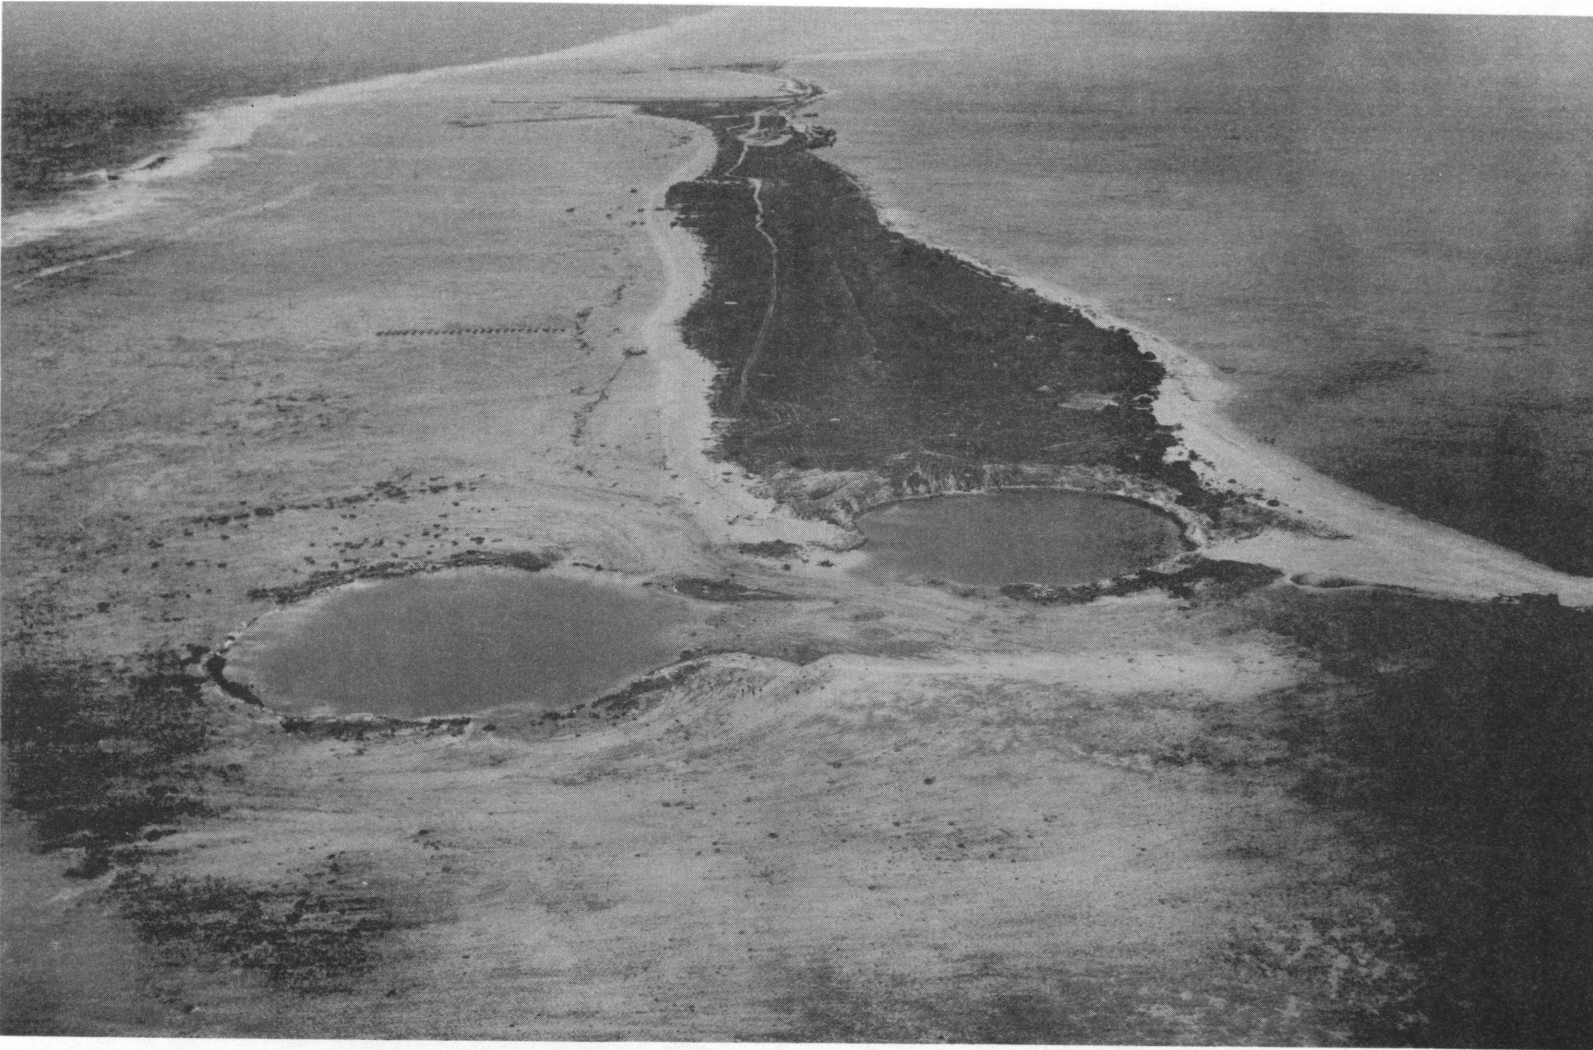
Fig. 35.   1964 photograph of the Lacrosse (left) and Cactus (right) craters.

Fig. 36. 1964 photograph of the Cactus crater and lip. Note the beach formed by lip erosion in the crater. Lacrosse crater is seen in left background.

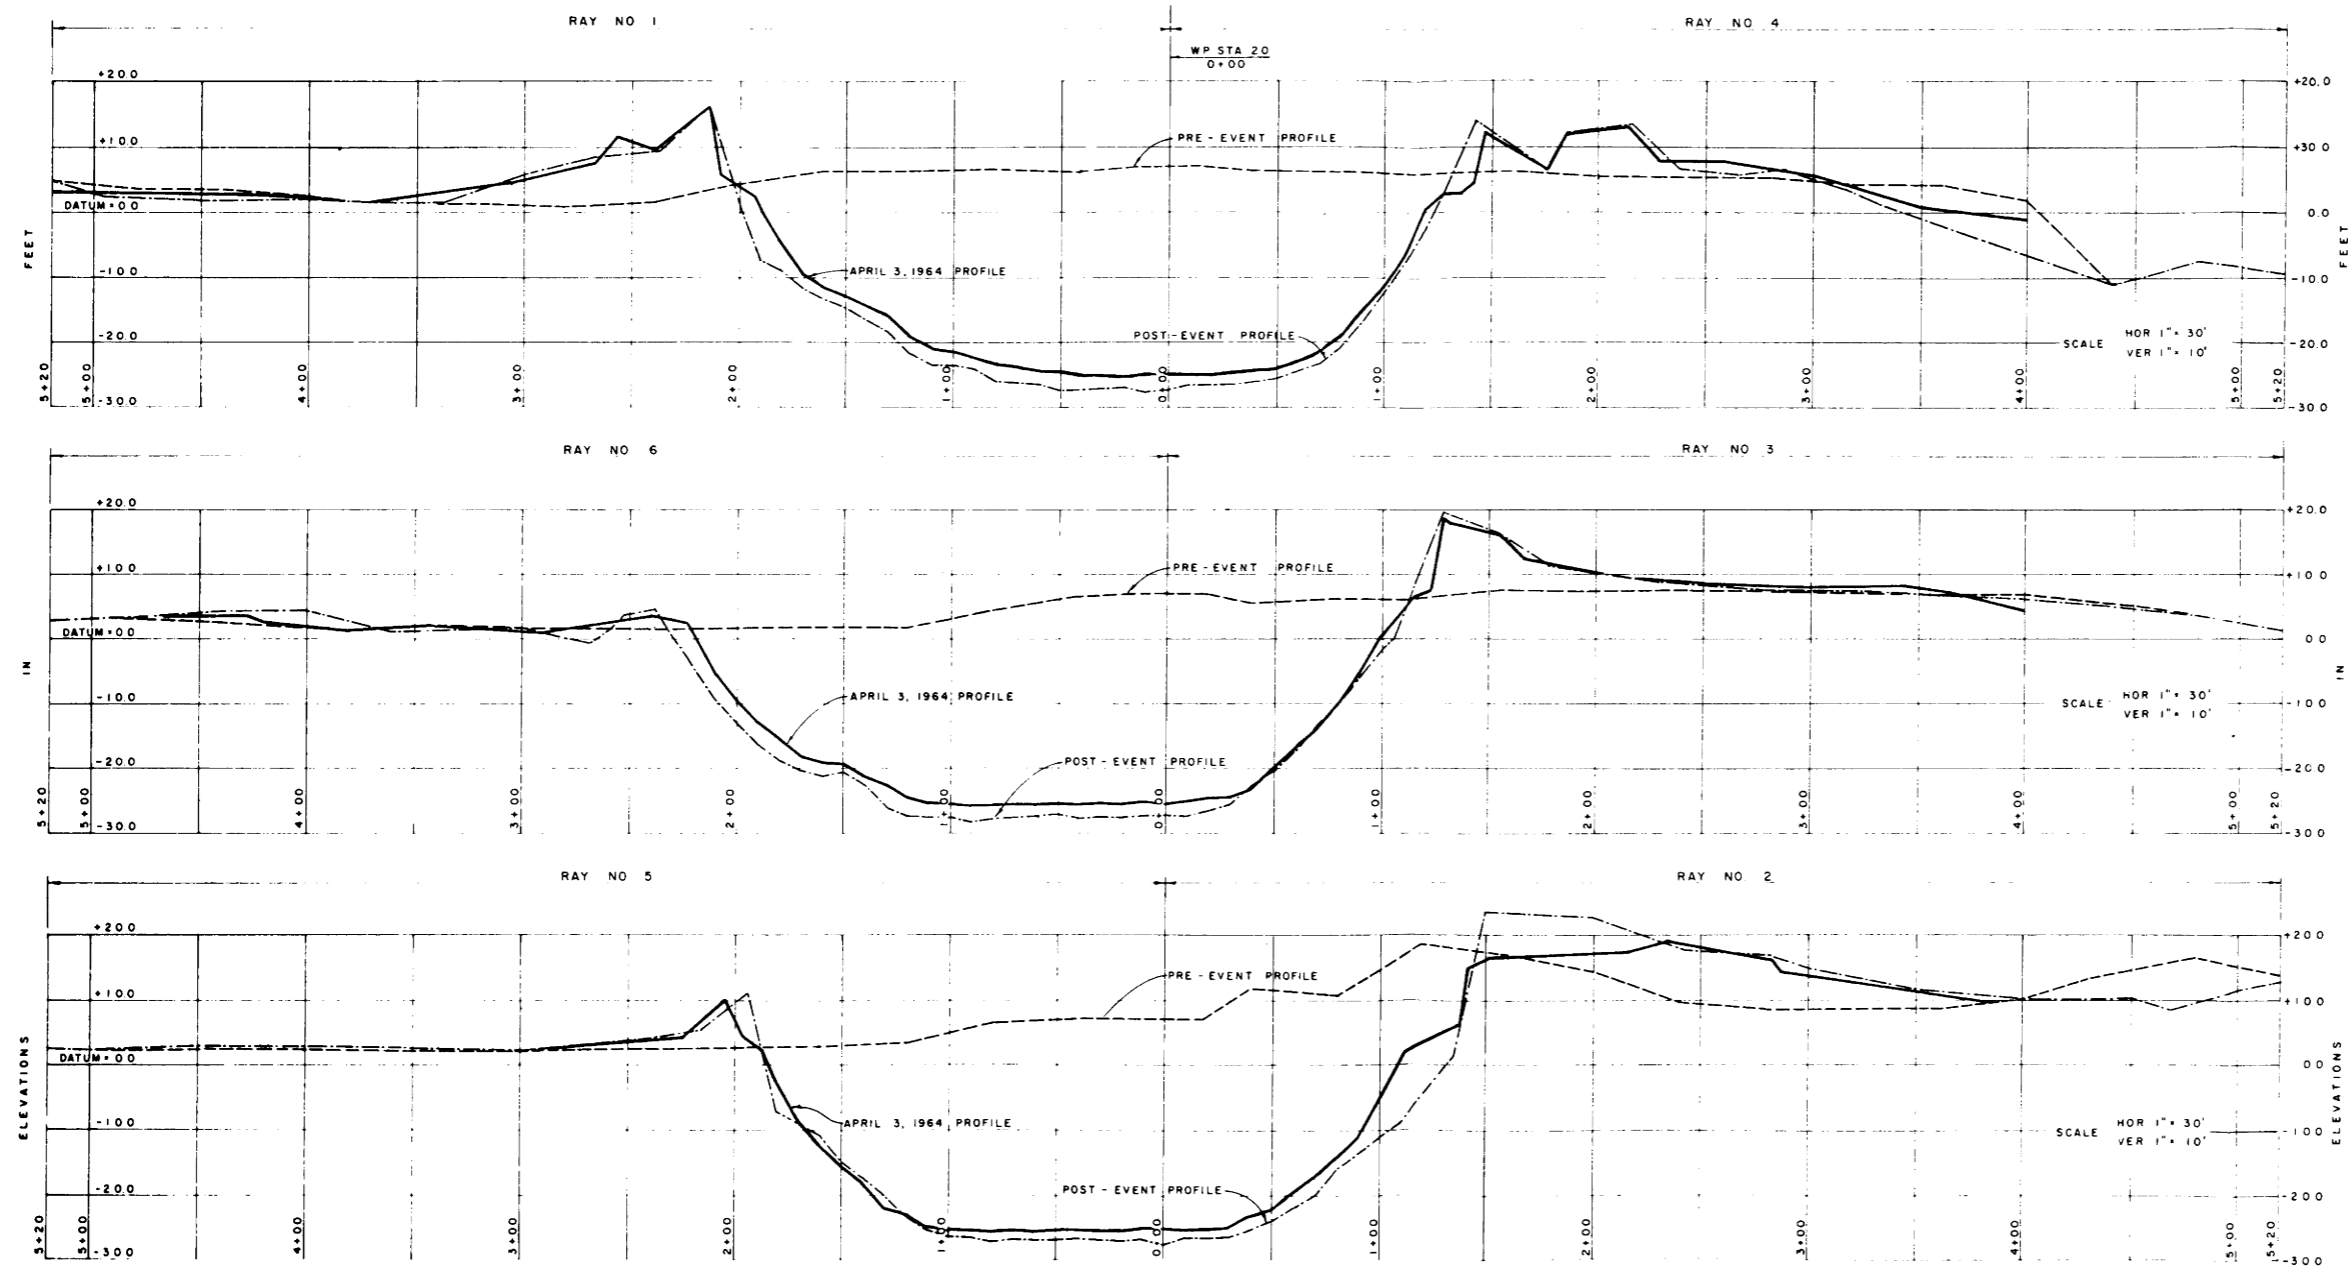
Fig. 37.   Preshot, postshot, and 1964 survey profiles of Cactus crater.

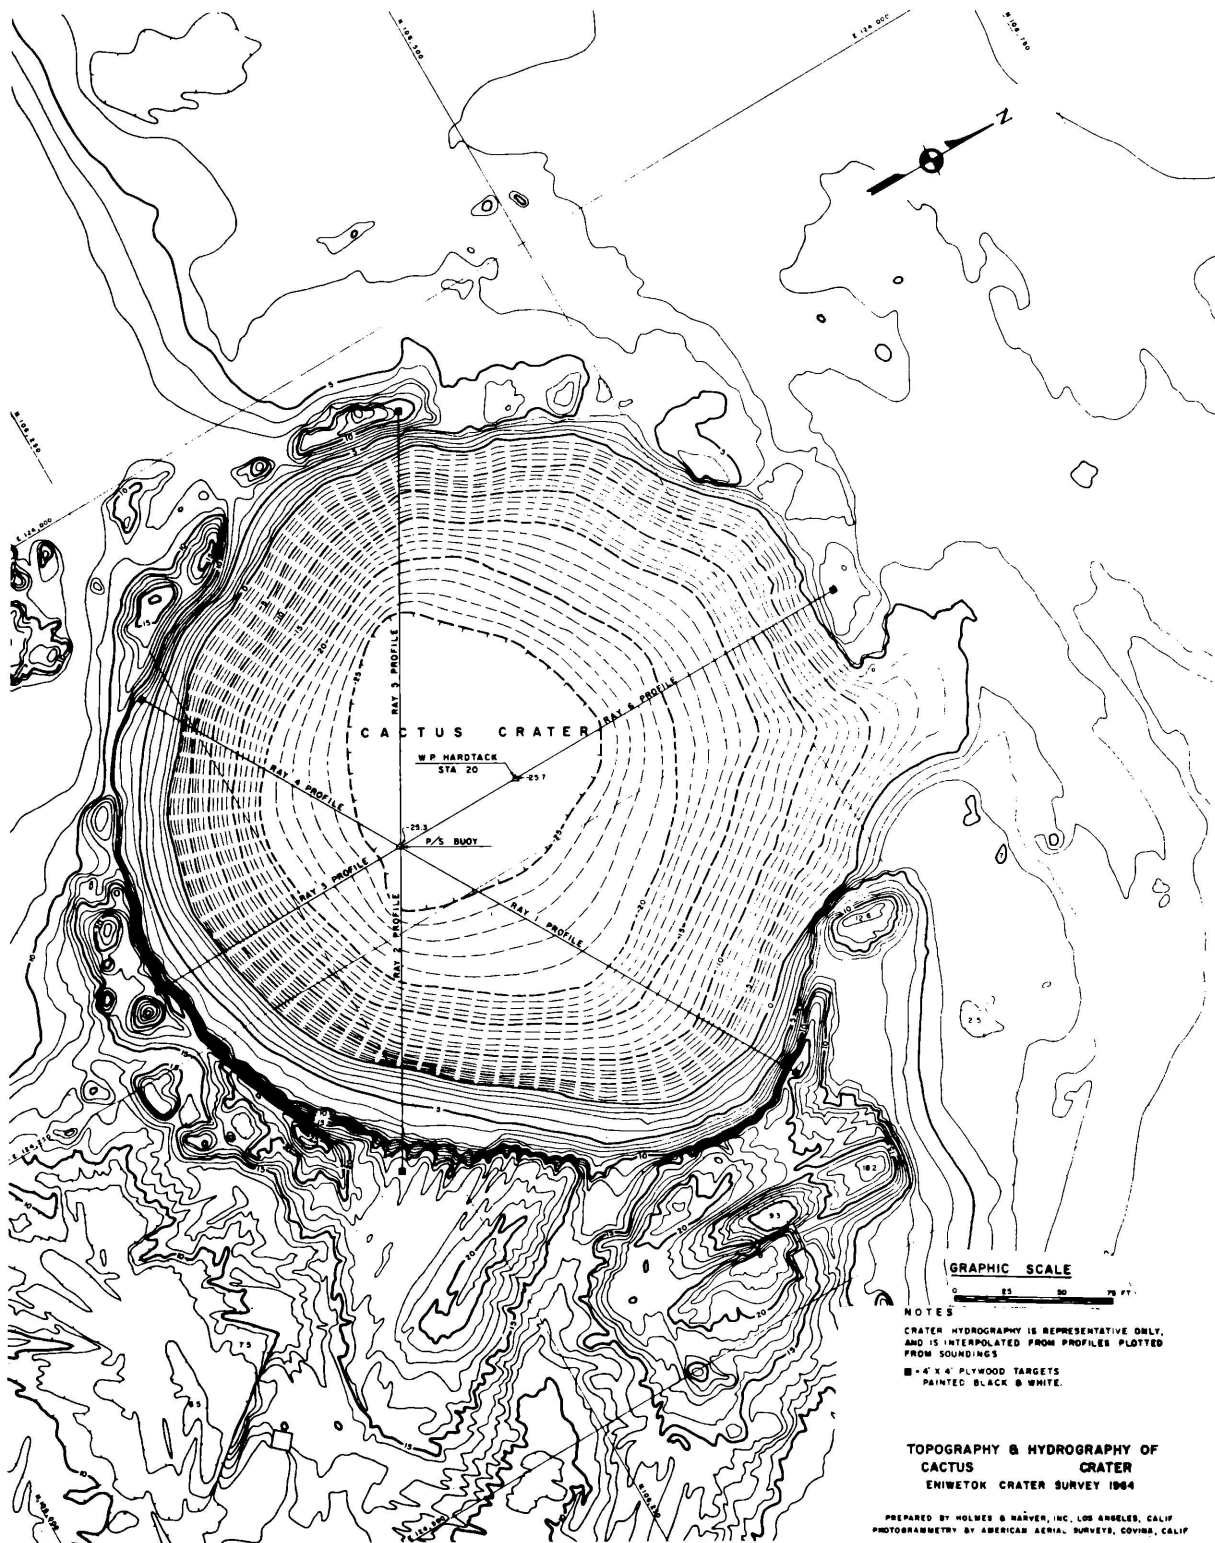
Fig. 38. 1964 contour map of Cactus crater.
