UCRL-12172

NUCLEAR CRATERING EXPERIENCE AT THE PACIFIC PROVING GROUNDS

Louis J. Circeo, Jr.

November 10, 1964

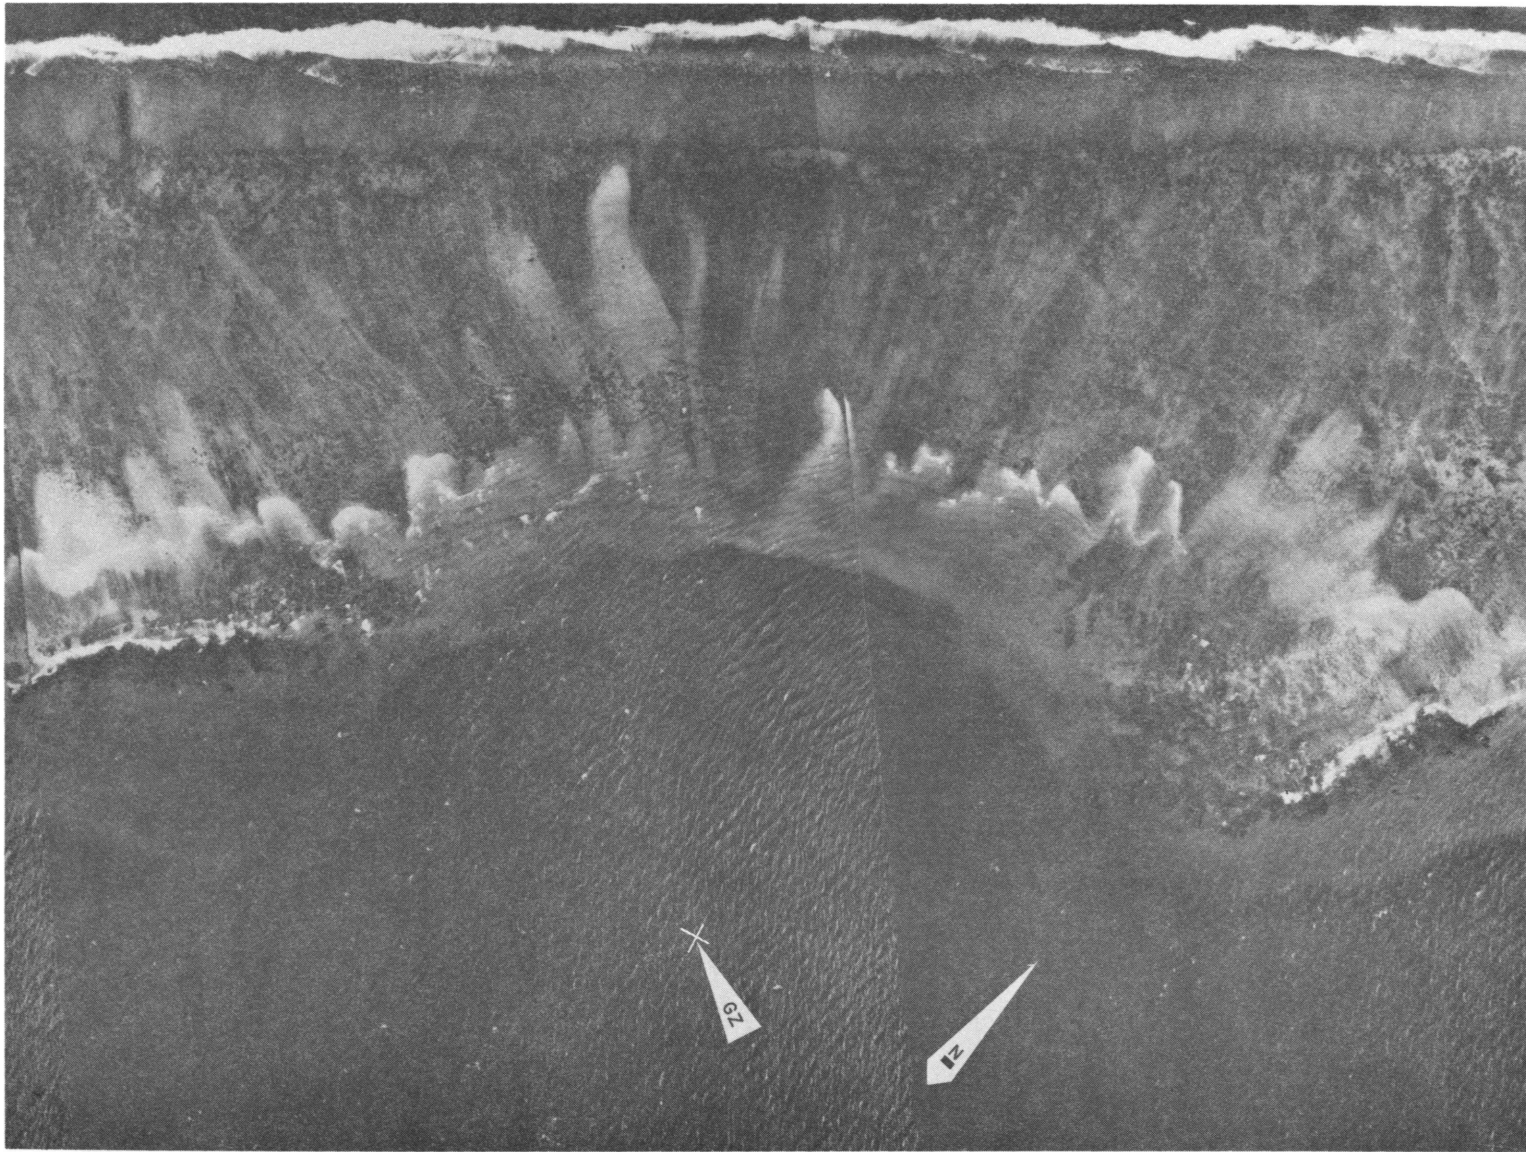
Fig. 40.   1964 photograph of the Oak crater.

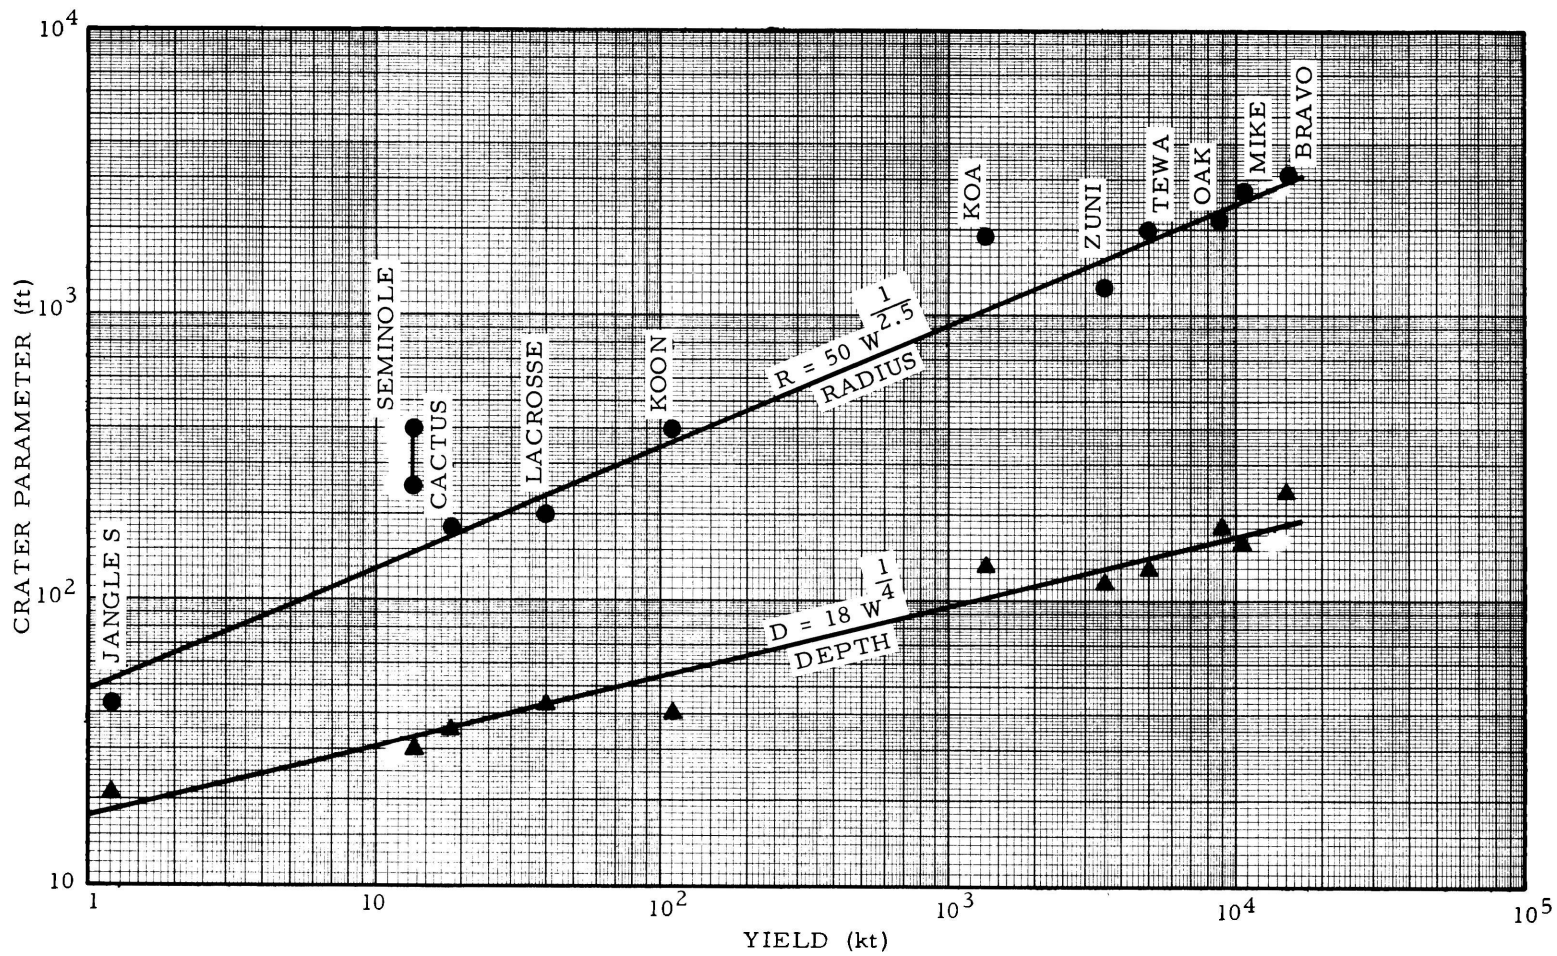
As shown in Fig. 42, a fairly good fit to the radius data can be made by the equation

Fig. 42. Crater parameters (radius and depth) vs event yields.

The relationship between crater depth and yield is also shown in Fig. 42. This indicates a scaling factor of $W^{1/4}$. This scaling factor was also observed in other studies.[10] Normally, it would be expected that this parameter would scale similarly to the radius. However, due to many physical phenomena peculiar to these shots, resulting craters are somewhat shallower.

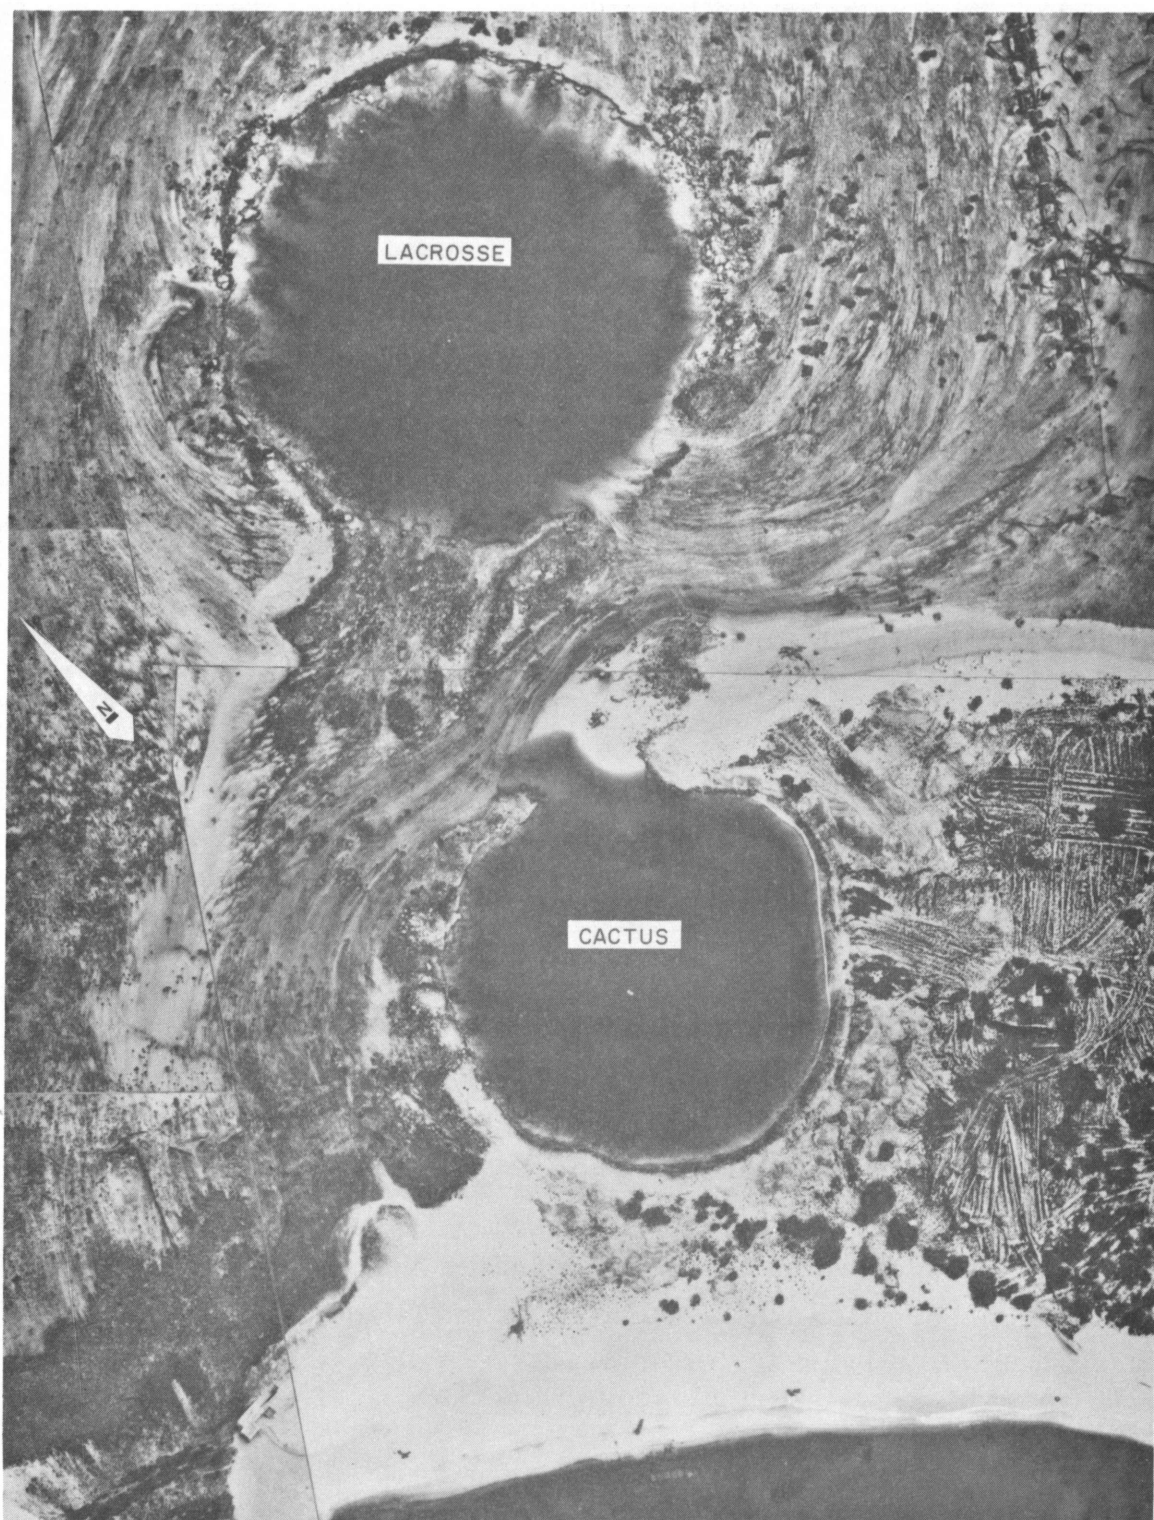
Material deposited from external sources is most evident in the Lacrosse and Cactus craters. This may be shown in Fig. 44, a 1964 aerial view of the Cactus and Lacrosse craters. The wave front is from the east (upper right), producing a source of sand from a long-shore current along Yvonne Island. The direction of littoral drift is easily seen by the pattern of sand on the reef. The lip of the Lacrosse crater dissipates wave energy and causes wave refraction, which also reduces wave energy. This reduction decreases the load-carrying capacity of the wave, resulting in sedimentation

Fig. 44.   1964 aerial photomosaic of Lacrosse and Cactus craters.

as shown by the sand patterns around the crater. In places where the water overtops or penetrates the Lacrosse lip, the wave is refracted throughout the crater, resulting in sand deposition in the crater. This can be observed at several locations around the crater. This effect is also quite noticeable in the entrance channel at the north lip of the Cactus crater. A large deposit of bed-load material is slowly filling this portion of the crater.

Extending down from the west lip of the Lacrosse crater, a sand spit is forming. This is caused by the turbulence and subsequent energy dissipation of the refracted waves combining together from each side of the crater. As these waves combine and sweep across the reef, portions of the existing sand bar are slowly being pushed into the lagoon (lower left of photograph). If the Lacrosse crater had not been present, there is a good chance that the entrance channel of Cactus crater would have been eroded, similar to the Koon crater (see Fig. 14).

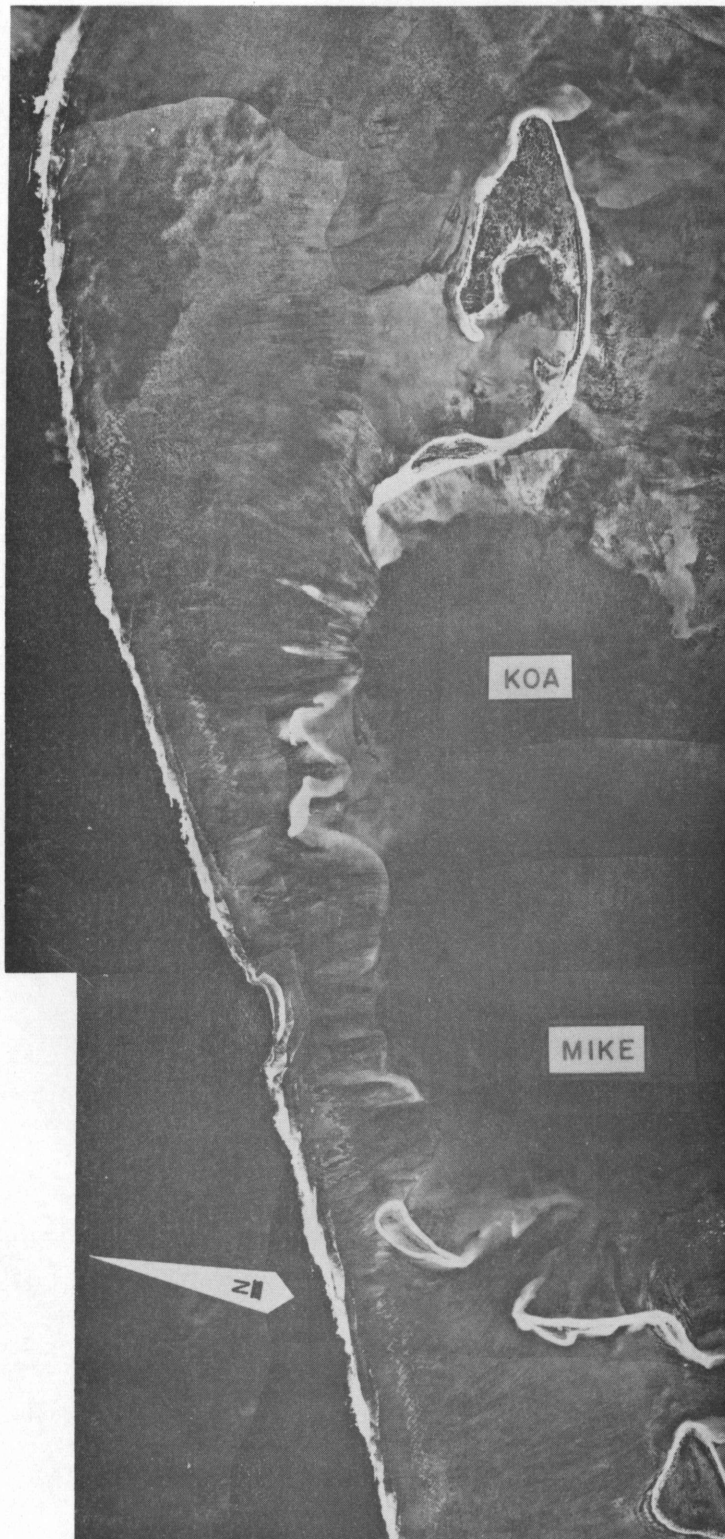
The Mike and Koa craters also seem to be receiving a certain amount of external debris. This may be observed in Fig. 45. Sand spits have built up between the sea and the craters. This material comes from debris from the sea and the reef. The transported material is most likely building up on ejecta blocks on the reef as a result of the detonations. This indicates that a significant amount of material is constantly being transported across the reef and into the craters.

Fig. 45. 1964 aerial photomosaic of Mike and Koa craters. Note the break in the reef opposite Mike crater. The Seminole crater is seen at top of photograph.

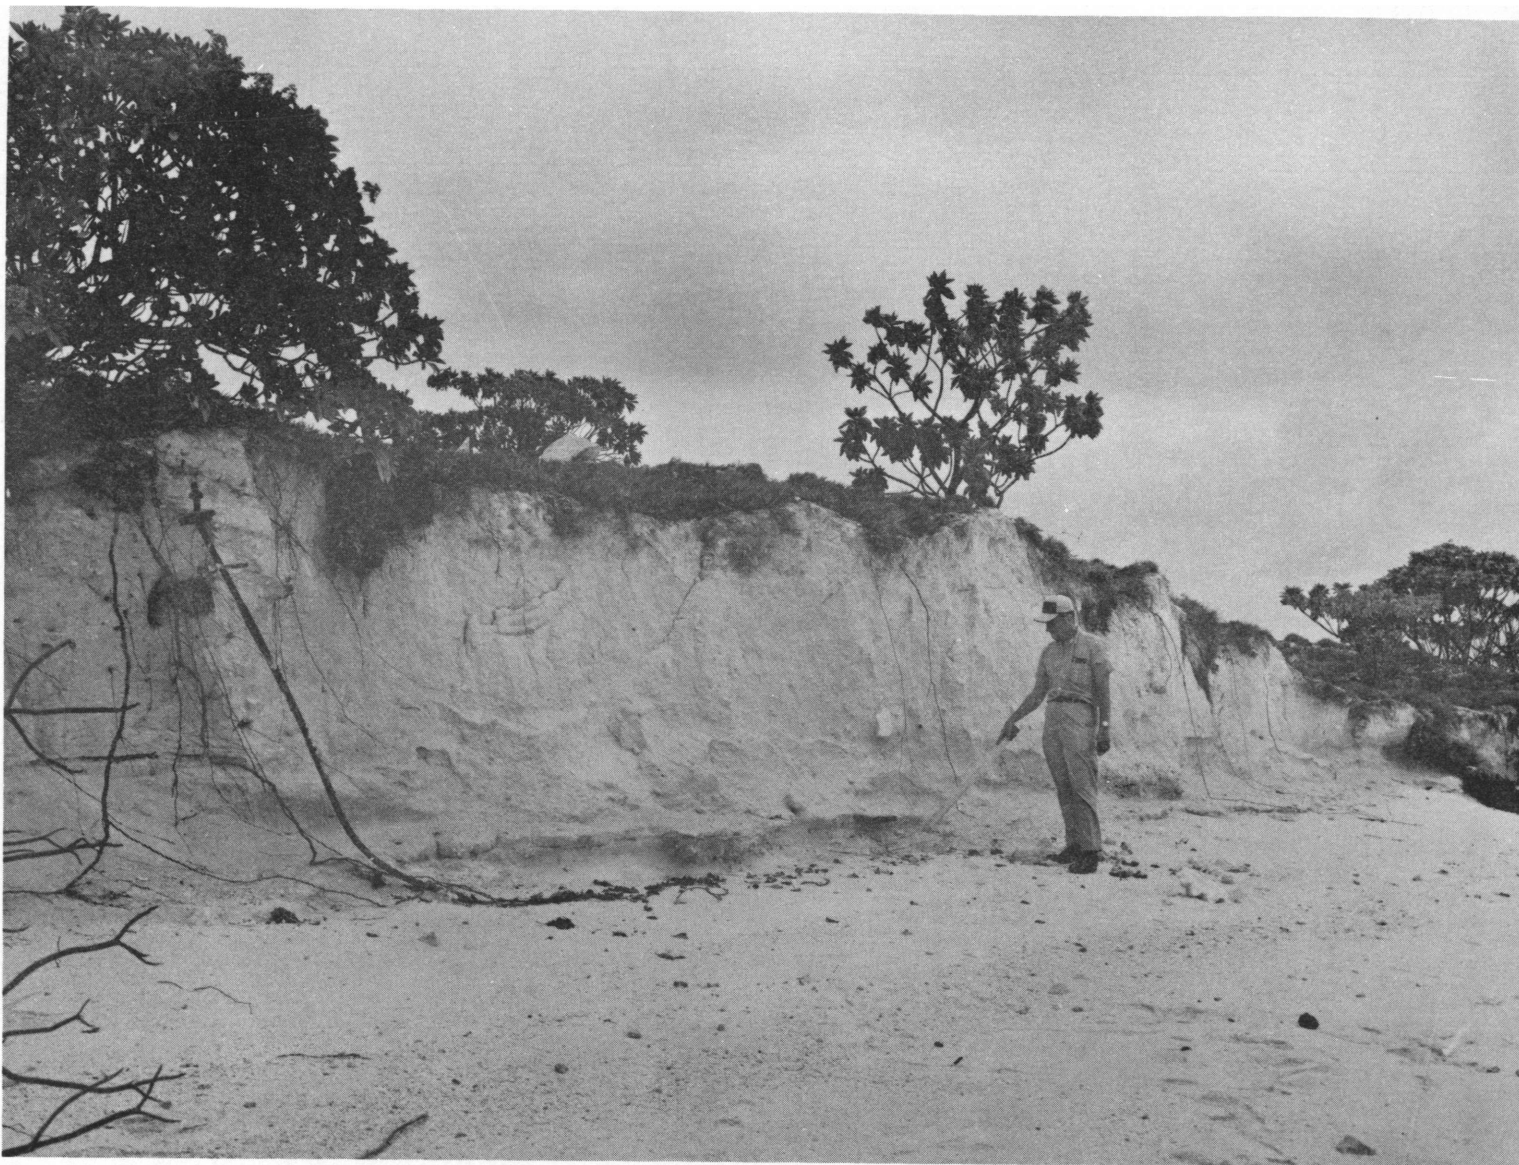
Fig. 46. 1964 photograph showing shore erosion at north end of Irene island. Note wave undercutting taking place.

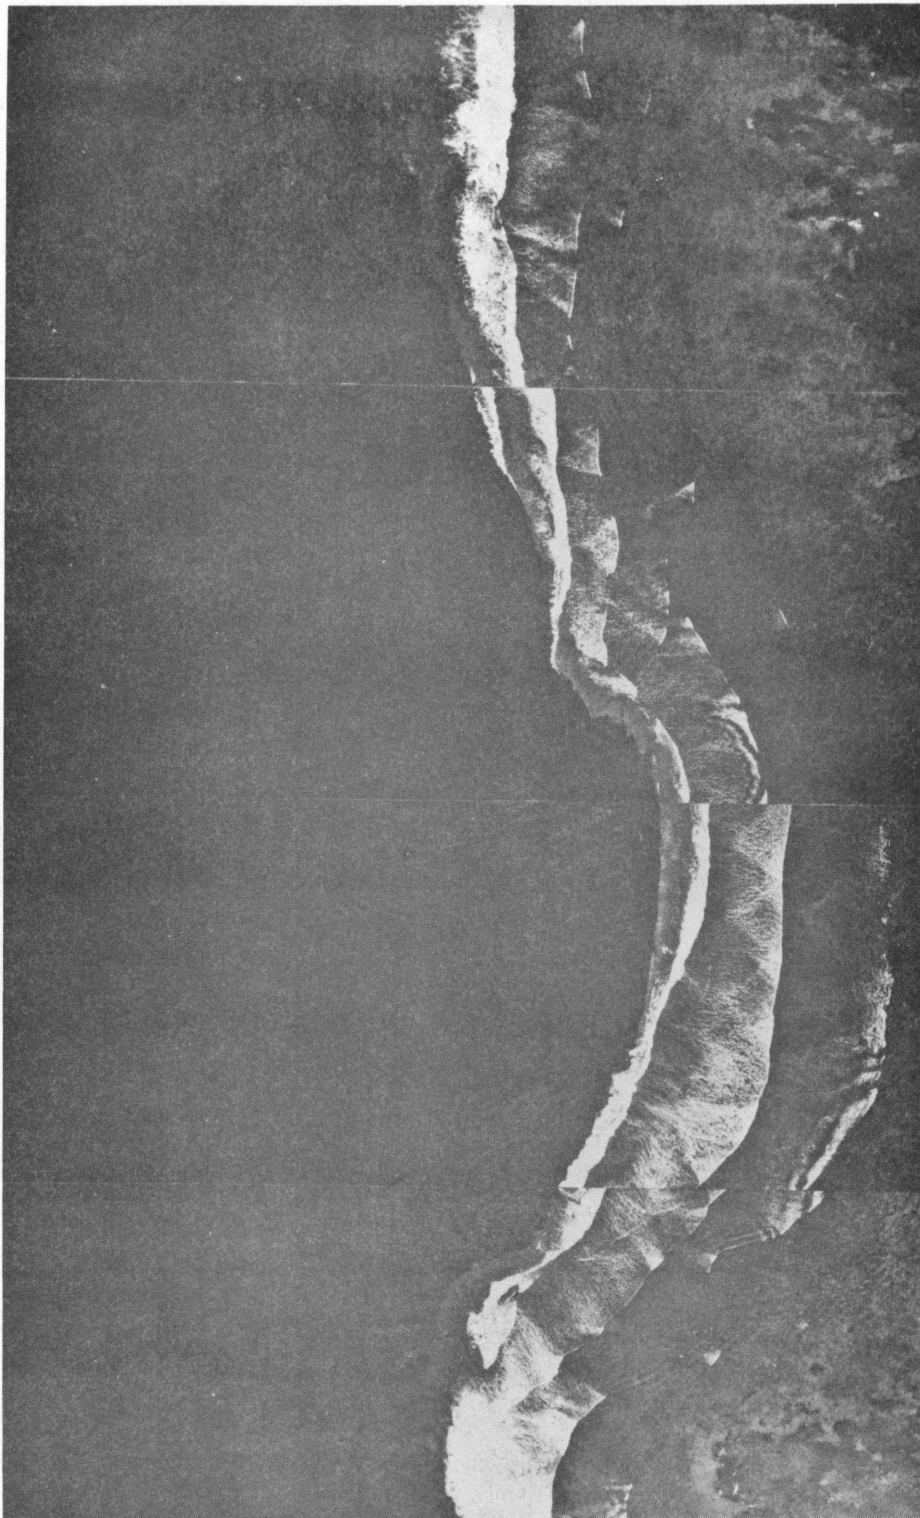
1. During the 1964 survey, it was observed that a section of the seaward reef directly opposite the Mike crater was broken off (see Fig. 45). A close view of this break is shown in Fig. 47. Initially it was thought that this section had been spalled off as a result of the Mike detonation. However, postshot Mike photography and surveys (Figs. 5 and 6) indicate that the reef was still intact after the shot. Therefore it would appear that the Koa detonation may have directly affected the break. The reef was undoubtedly weakened and cracked as a result of the Mike shot. It is suggested that the Koa detonation further broke up this section and either spalled it off the reef completely, or that subsequent wave erosion caused or completed the break. Unfortunately, no information is available about the condition of the reef between post-Mike photography and the 1964 study.

Fig. 47.   Break in reef opposite the Mike crater (see Fig. 45).
