ORNL-170

SLUG RUPTURES IN THE OAK RIDGE NATIONAL LABORATORY PILE

September 28, 1948

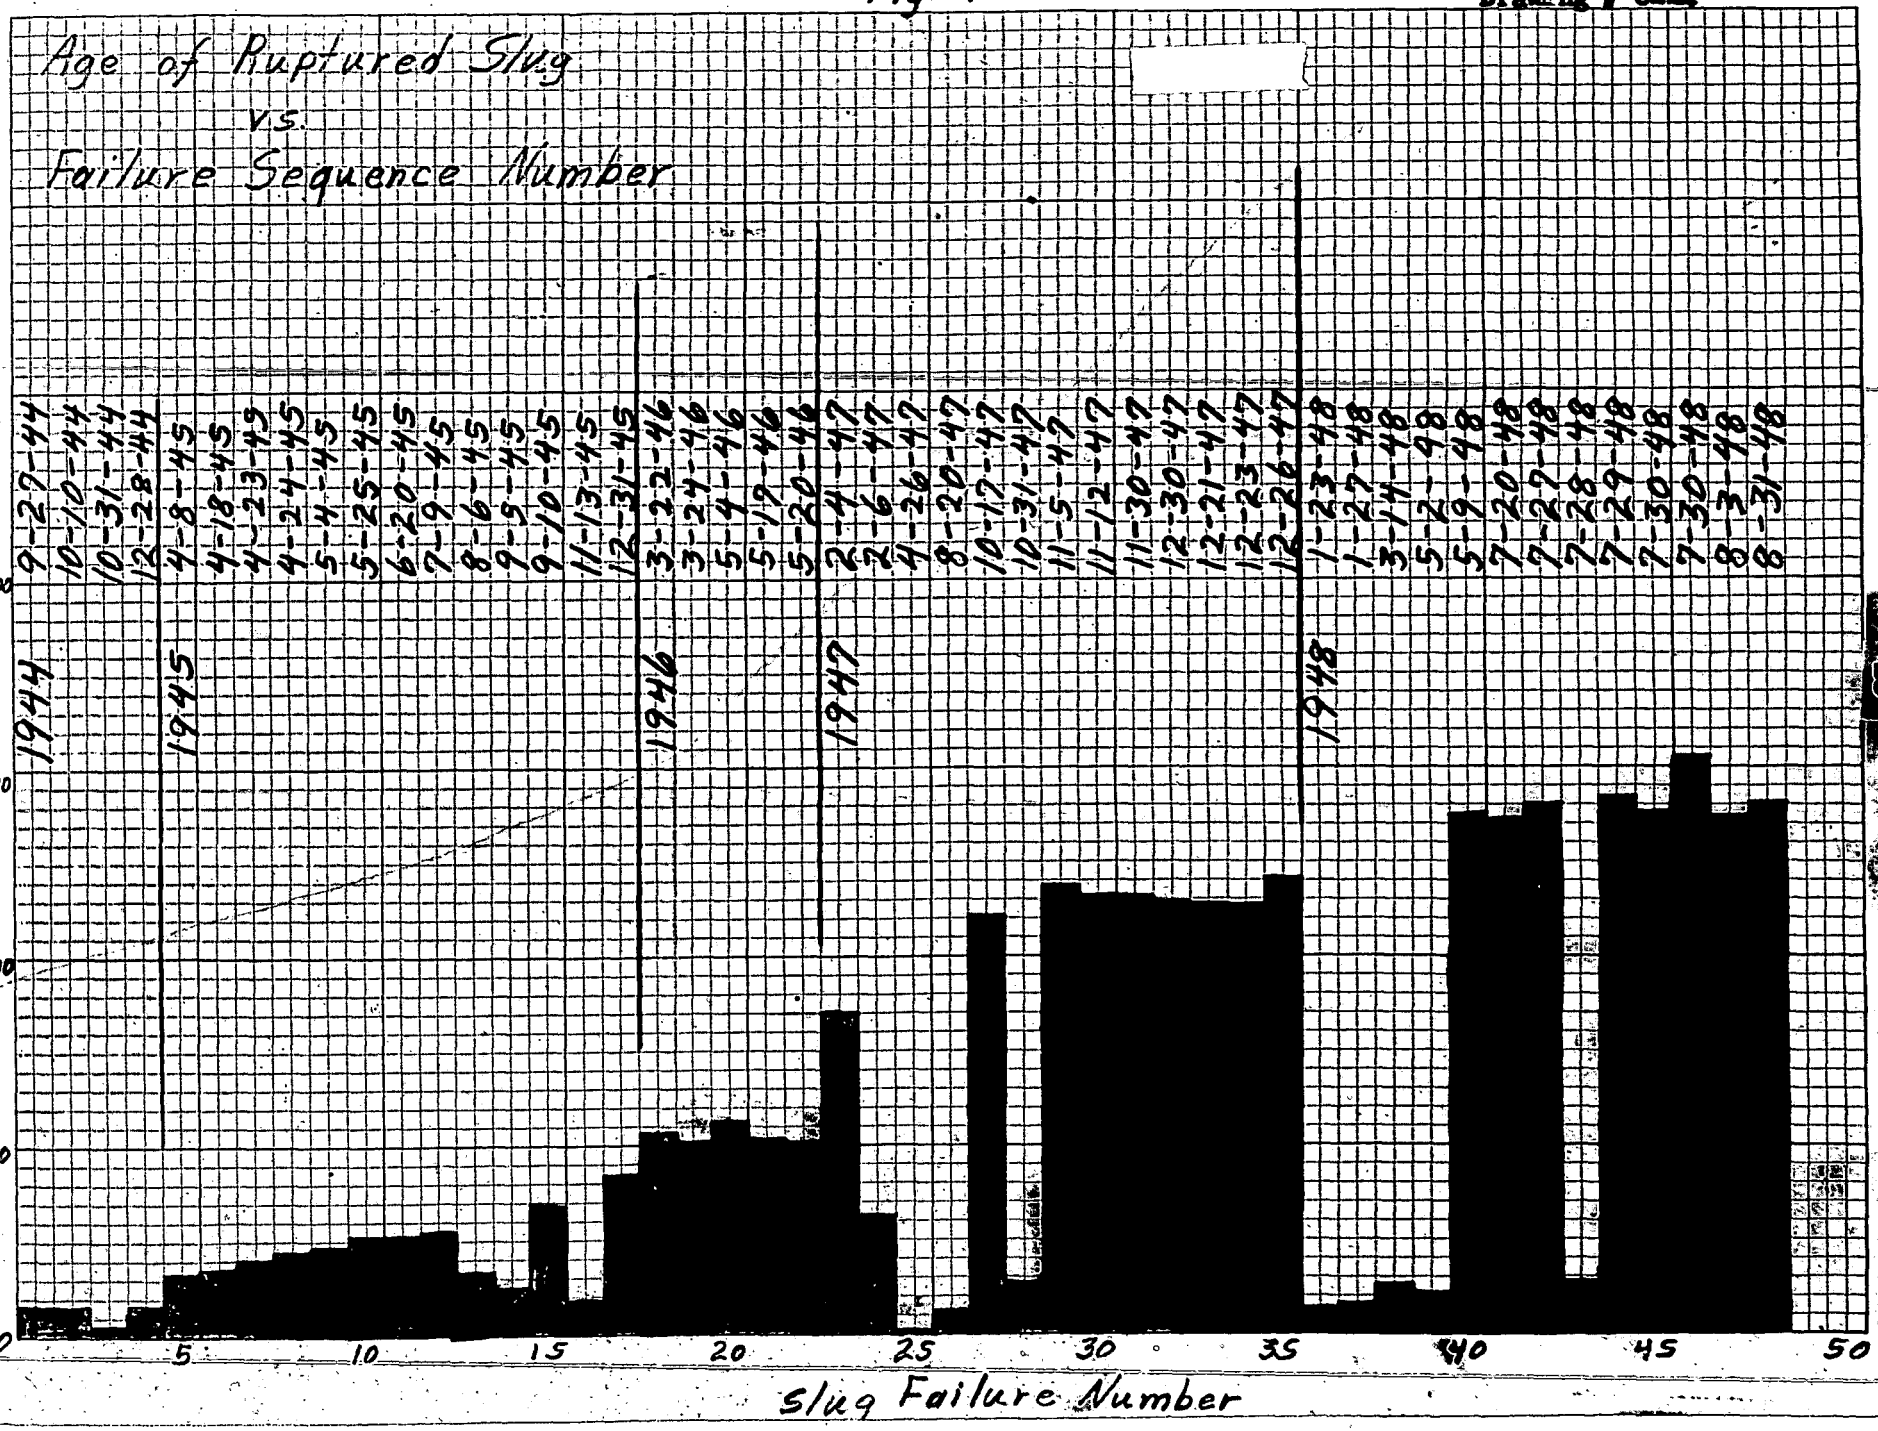
Fig. 1

concluded that temperature has the greatest influence on the slug ruptures since only the temperature distribution follows the rupture distribution in this direction. The neutron flux distribution is symmetric in the east-west direction. (See Figures 1, 2, 2a, 3, and 4.)

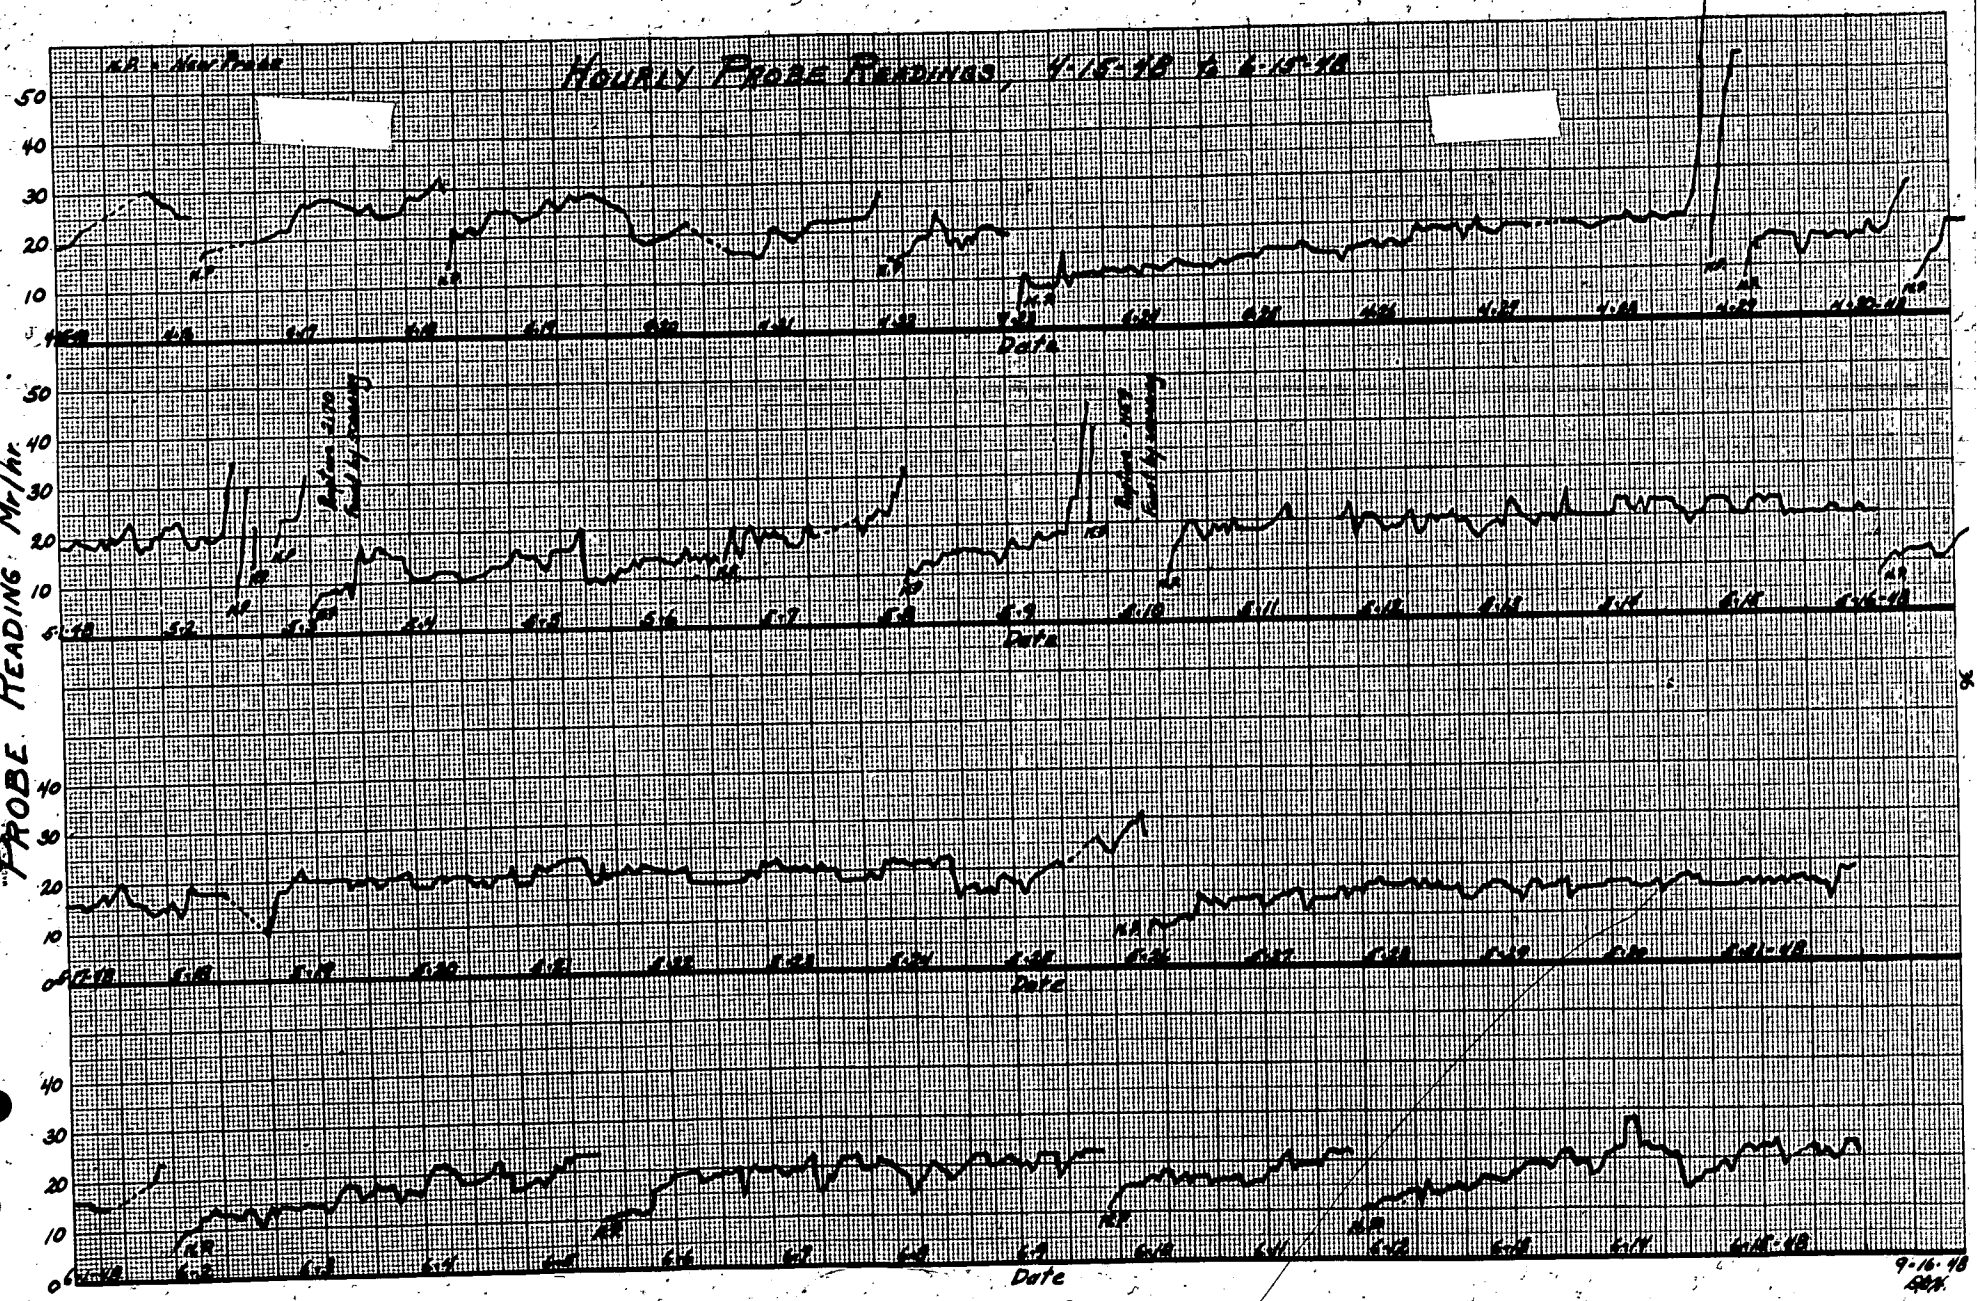
Fig. 7

In the past the best indication that a ruptured slug was in the pile was the contamination picked up by an oil-soaked rag suspended in the exit air duct between the pile and the exhaust fans. Until after 1944 the probe seldom read more than one or two mr/hour except in the event of a rupture. (When no rupture exists, the probe reading always reaches a more or less constant value due to an equilibrium being established between the number of particles impinging upon it and the number being blown off.) Up until the end of November, 1947, a probe reading of ten mr/hour obtained within one hour after inserting a clean probe was a positive and infallible indication of a ruptured slug. (See Figure 7.)

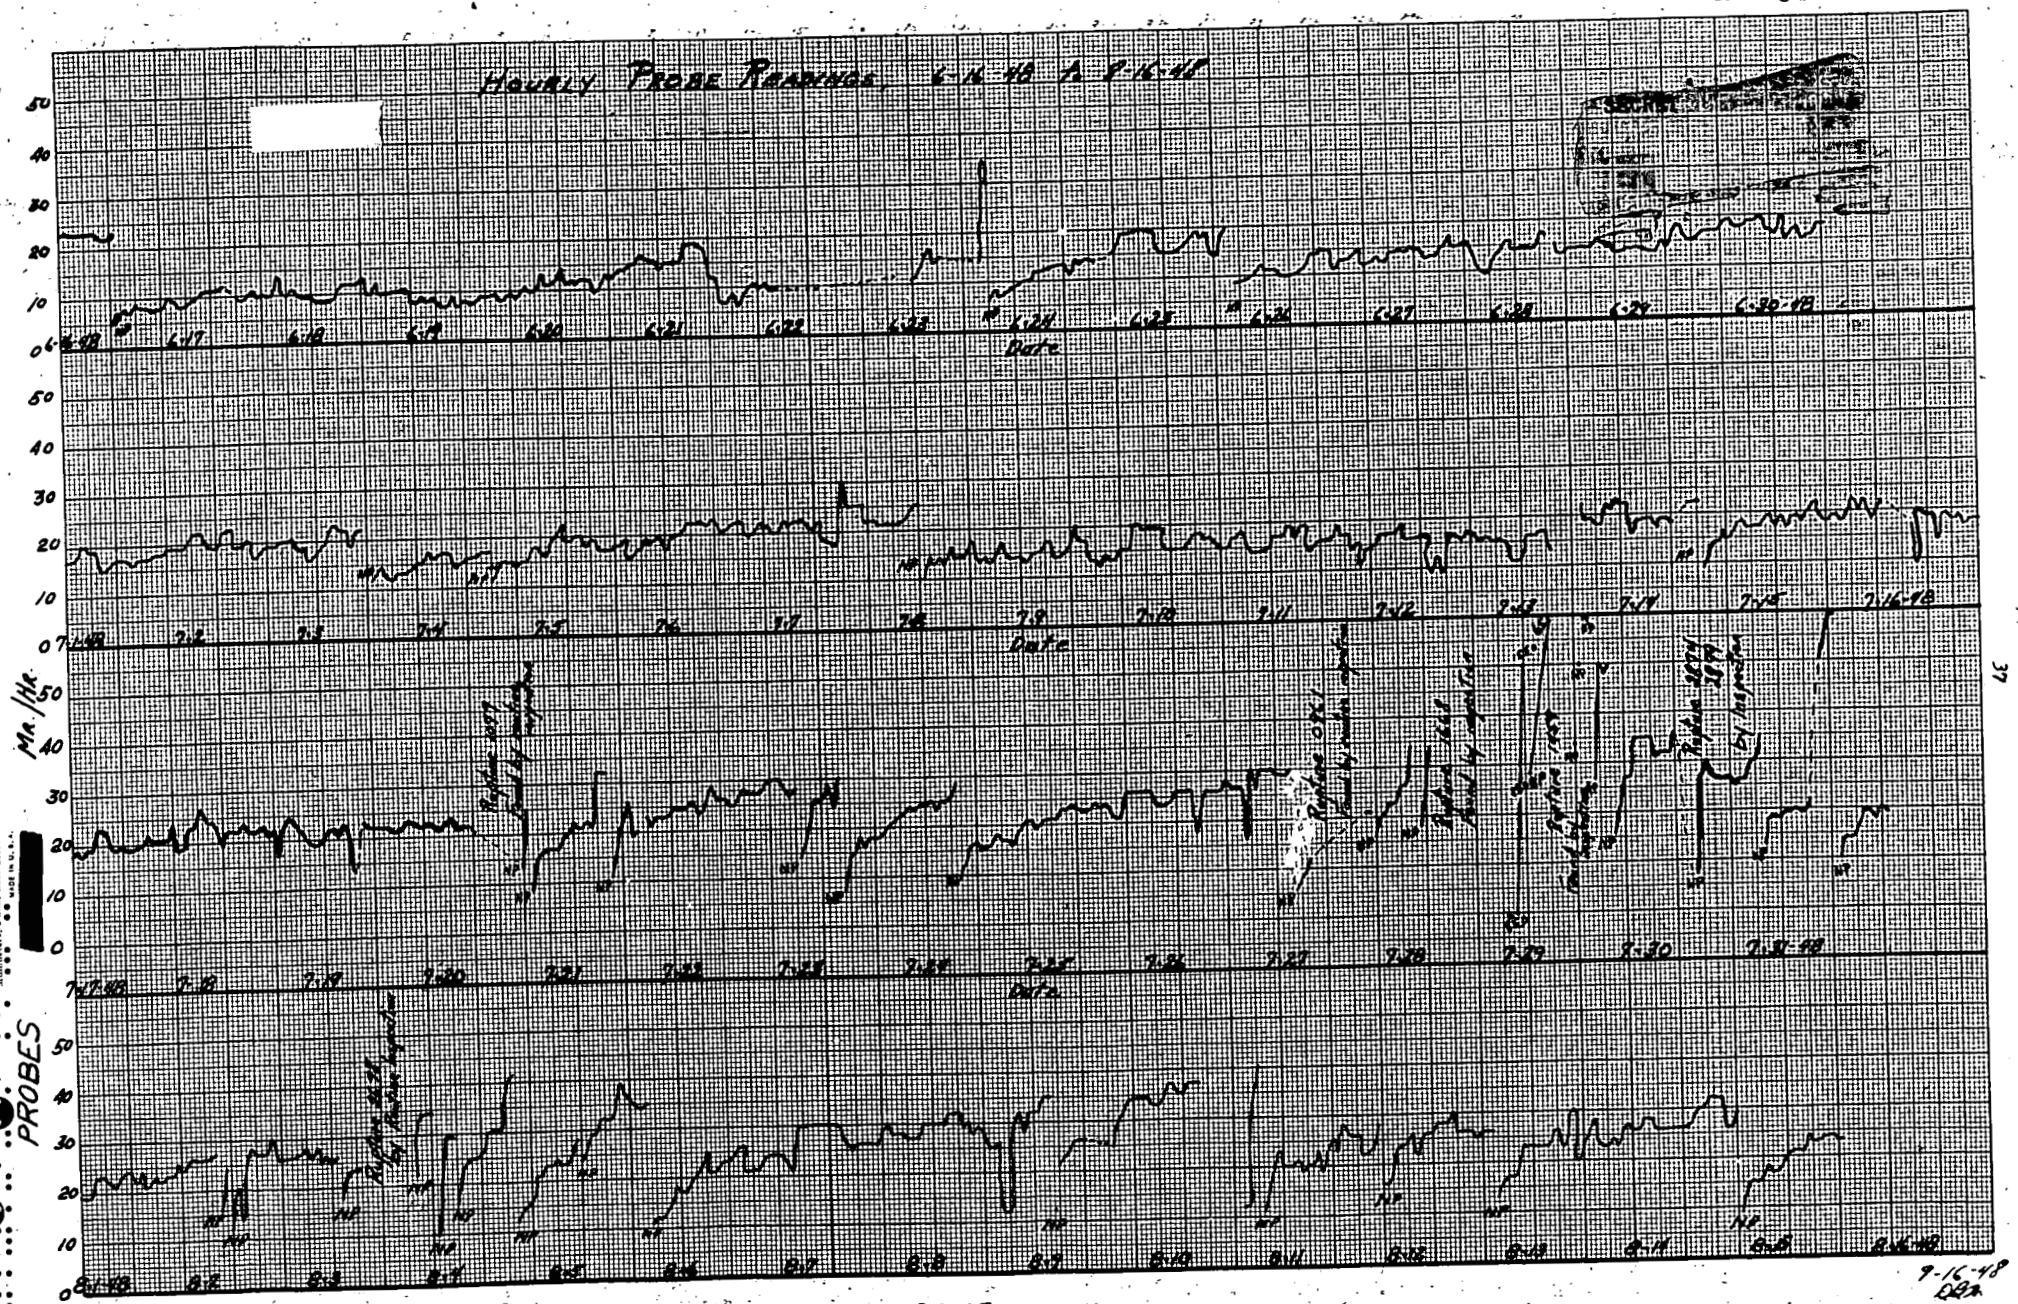
Fig. 8

After the rupture of the thirteen slugs in Channel 2079 which was detected November 30, 1947, so much radioactive uranium oxide dust had collected in surrounding slug channels and along the floors and walls of the exhaust duct that the constant reading of the probe rose to between fifteen and twenty-five mr/hour. Also many times the probe reading has risen suddenly to as much as seventy mr/hour when no rupture existed but only a release of some pocket of the uranium oxide already in the duct. Therefore, the probe is no longer a positive indicator of a rupture. (See Figures 8, 9, and 10.)
