ORNL/TM-11828

# Corrosion of SiC and Oxide-Composite Ceramics by a Simulated Steam-Reformer Atmosphere

J. I. Federer, H. E. Kim, and A. J. Moorhead

Date Published: September 1991

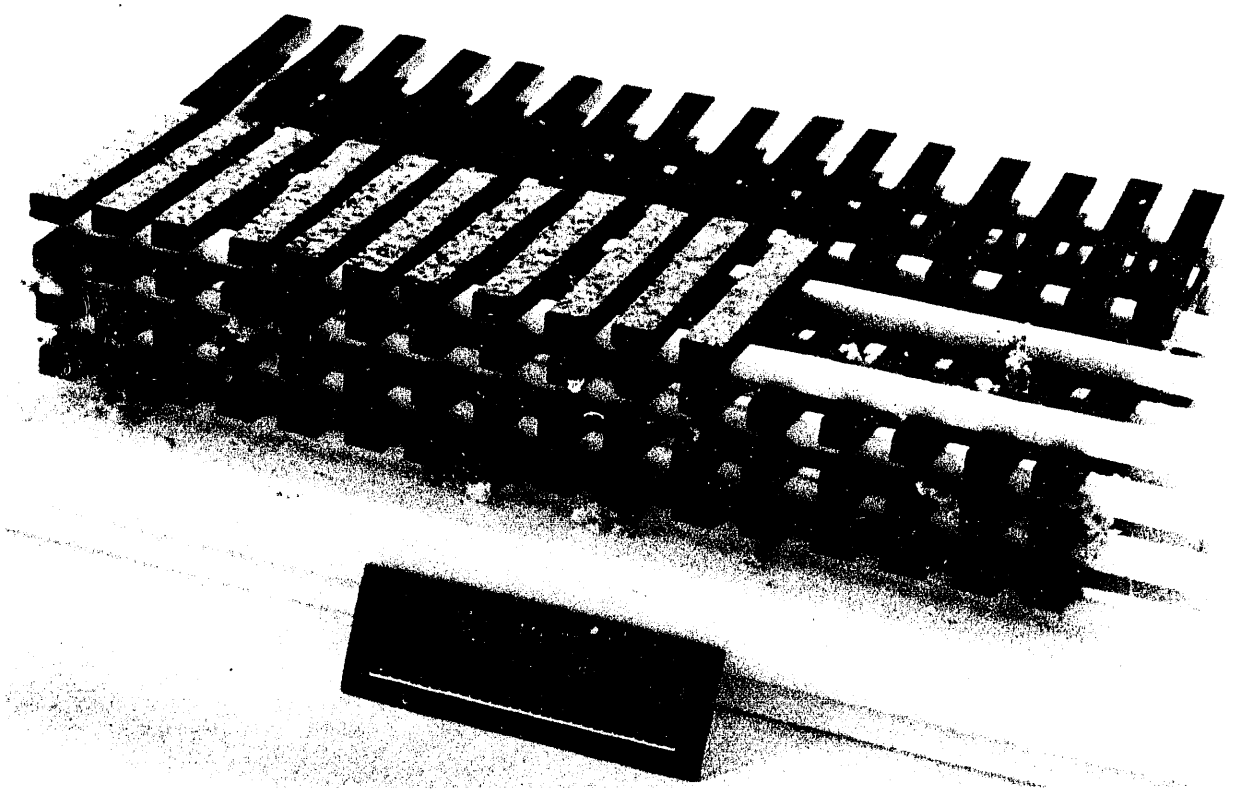
Figure 2 shows specimens of the original eight materials still resting on the $Al_2O_3$ rails after an exposure of 100 h. A glassy, transparent, or white film had formed on the Si-based specimens, while the original polished surfaces of the two alumina-based composite materials had become dull. A white material, identified as $Al_2O_3$ by X-ray diffraction, had formed on surfaces of the LAS specimens and some particles had migrated to other specimens (Fig. 2). Evidently, residual Al had exuded to the surface and oxidized. Most of this material was easily removed with a wire brush before weighing. The appearance of the four materials exposed for 2000 h was similar to that after exposure for 100 h.

Fig. 2. Flexure bars after an exposure of 100 h to a simulated steam-reformer atmosphere at 1260°C.

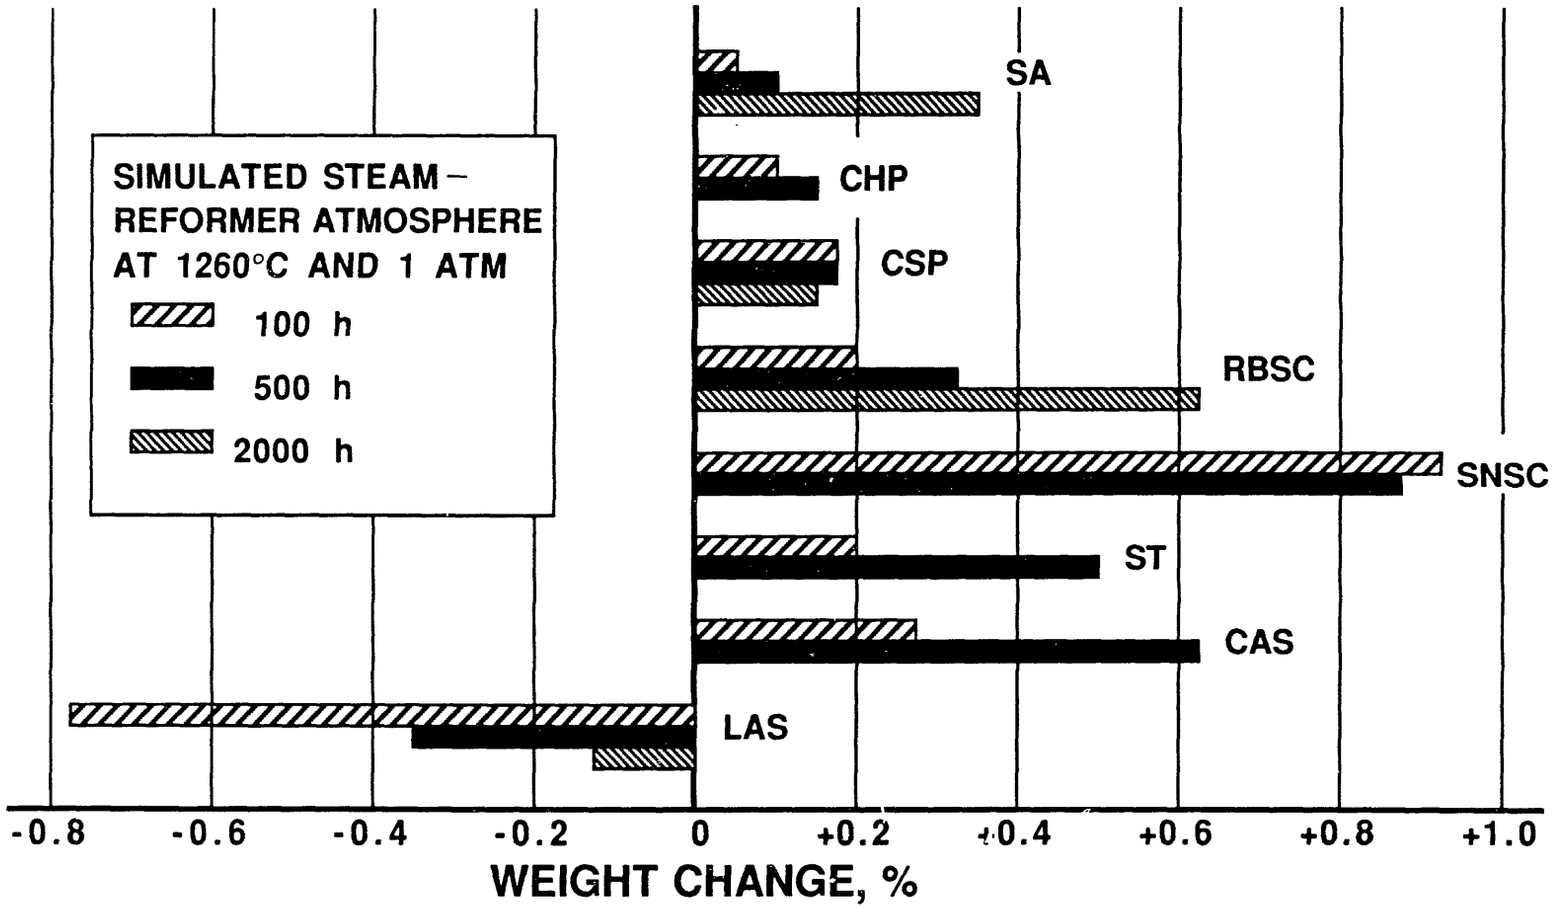
All materials had net weight gains during exposure except the LAS (Fig. 3). The bars for each material exposed for 100 h represent an average weight of 16 specimens (except only 11 for SNSC); those exposed for 500 h, an average weight of 8 specimens (except only 5 for SNSC); and those exposed for 2000 h, an average weight of 20 specimens. Two of the SiC ceramics (SA and RBSC) gained weight between 500 and 2000 h, while the other (CSP) did not change significantly between 100 and 2000 h. In the case of the SiC ceramics, each incremental weight gain of 0.1% is approximately equivalent to a calculated uniform surface recession (by oxidation) of only about 1 μm. Each material had an oxide layer on the surface. In contrast, the LAS material lost weight, but the magnitude of the net loss decreased during

Fig. 3. Weight changes of materials exposed to the simulated steam-reformer atmosphere.

successive exposure periods. The initial high weight loss associated with loss of Al was followed by oxidation, which eventually would have probably caused a net weight gain. During the 500-h exposure, CAS gained more weight than most of the SiC ceramics. This behavior was attributed to the oxidation of the SiC whiskers in the $Al_2O_3$ matrix and the formation of new phases (discussed in Subsection 4.2).

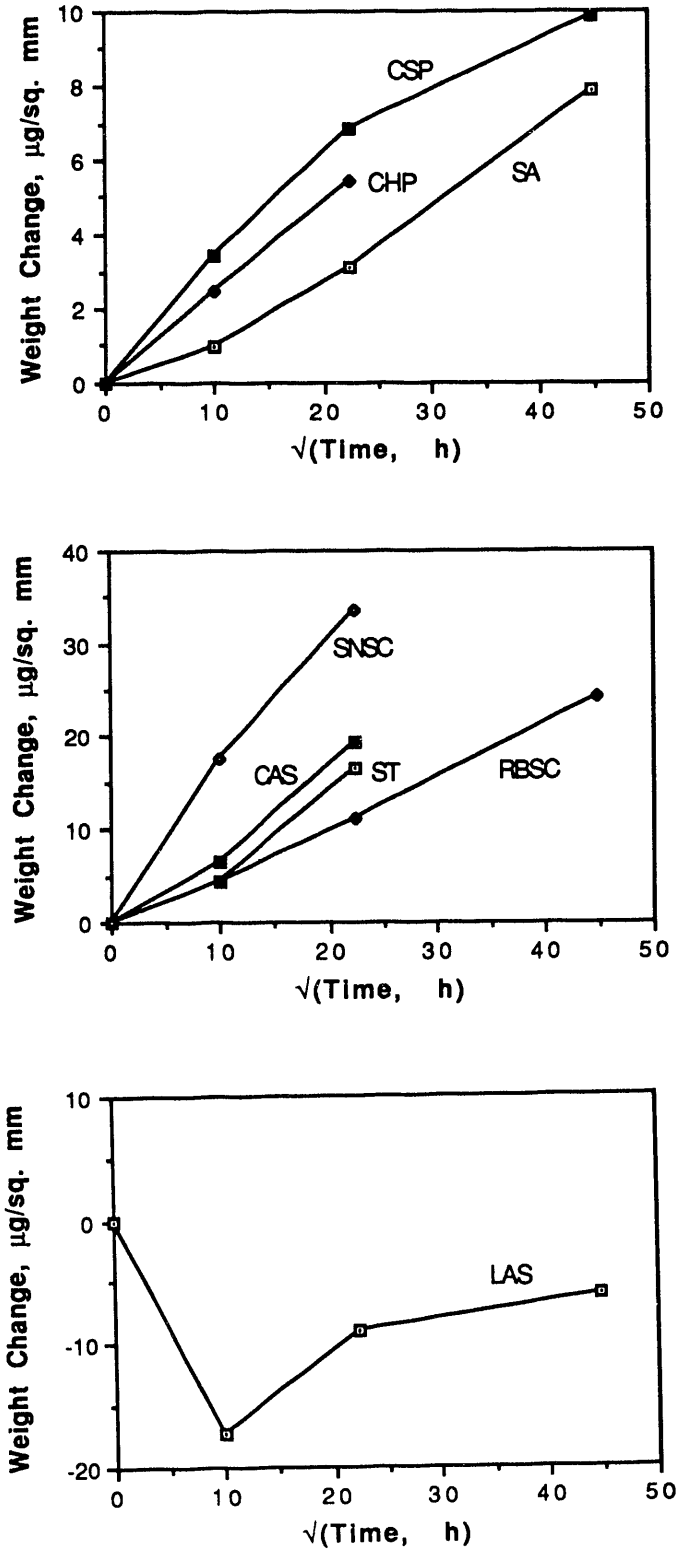
Cumulative weight changes per unit area are plotted versus the square root of exposure time in Fig. 4 to determine if the data conform to the parabolic expression $x^2 = kt$, where x is the weight of oxidation product, k is a constant, and t is oxidation time.[6] The plot for CHP is linear, and the plots for SNSC and RBSC are approximately linear; this indicates that oxidation of these materials was controlled by diffusion of (probably) $H_2O$ through the oxide layer to the SiC. The corrosion of the CSP was linear during the first 500 h, but oxidation occurred more slowly in the interval of 500 to 2000 h. SA, ST, and CAS each exhibited "slow" kinetics during the first 100 h, but the plot for SA is approximately linear for the period of 100 to 2000 h. The LAS plot exhibits the results of weight loss caused by loss of Al and simultaneous oxidation. A linear weight change might eventually occur during a longer exposure than 2000 h.

Fig. 4. Cumulative weight changes versus √time.

Fracture surfaces of the LAS in Fig. 10 show gradual growth of the surface layer with increasing time of exposure. Porosity is evident both wit' .in the layer and the adjacent parent material. Thickening of the layer would minimize release of residual Al. The weight change data for LAS in Figs. 3 and 4 show that weight loss, presumably caused by loss of Al, occurred during the first 100 h of exposure; thereafter, the material gained weight because of thickening of the surface layer.

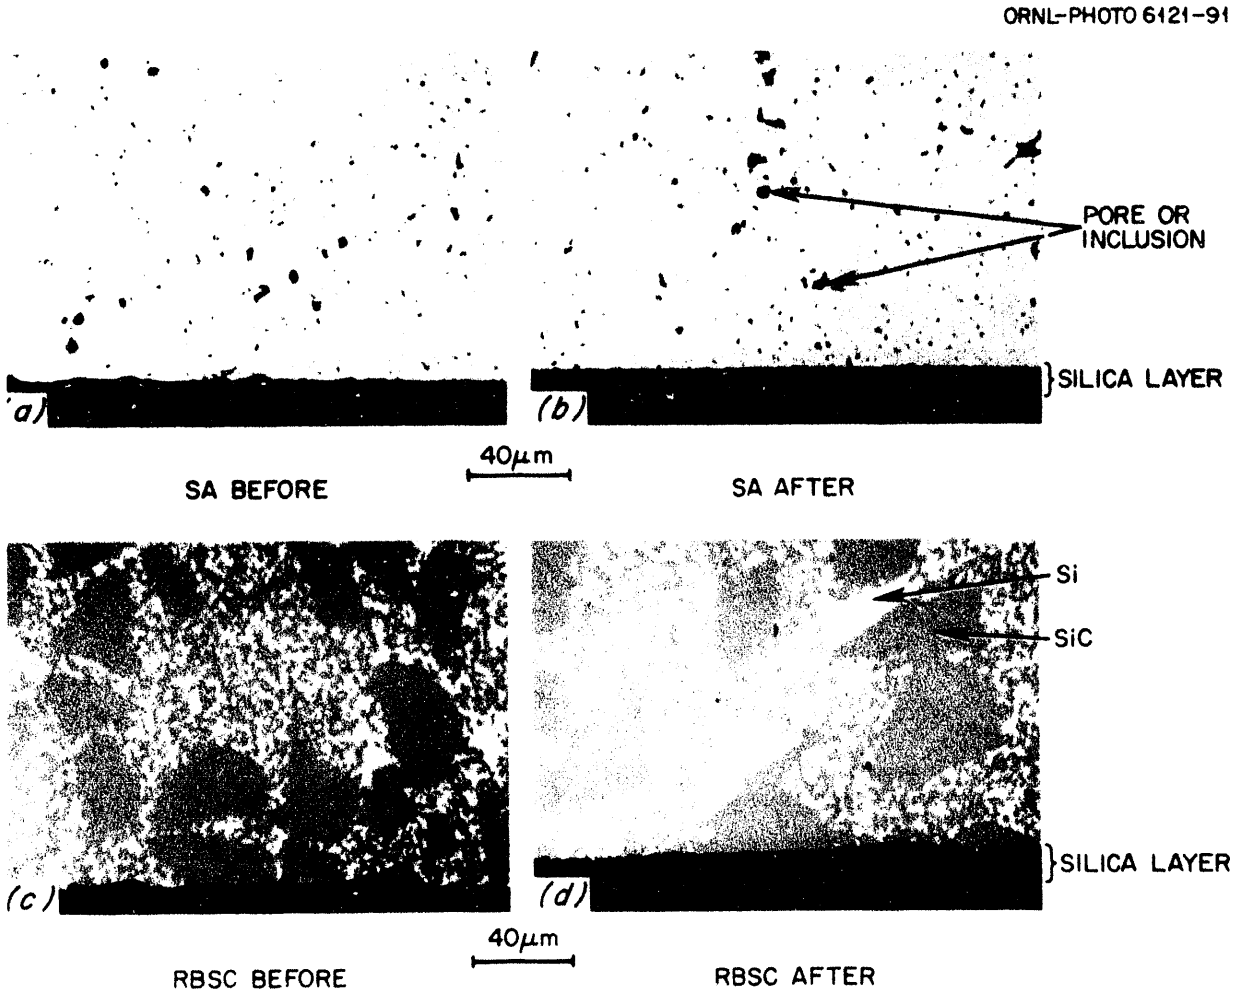
Optical photomicrographs of polished cross sections of specimens before and after the 500-h exposure to the simulated steam-reformer atmosphere at 1260°C are shown in Figs. 5 through 8. Each material exhibits a reaction layer on the surface that varied in thickness from about 10 μm for the SiC ceramics to about 50 μm for SNSC, CAS, and LAS. The reaction layer on the SiC ceramics (Figs. 5 and 6) appears to be a simple oxide. The Si phase in these materials was not attacked significantly faster than the SiC phase. Figure 7 indicates that the $TiB_2$ particles in ST were attacked preferentially to the SiC matrix and that the $Si_3N_4$ matrix was attacked preferentially to the SiC particles in SNSC. The reaction layers on both ST and SNSC appear to contain new phases that might have precipitated during cooling. The two oxide composites (i.e., CAS and LAS) in Fig. 8 exhibit relatively thick reaction layers containing apparent voids and new phases. The CAS material, as previously mentioned, consists of SiC whiskers in an $Al_2O_3$ matrix, while LAS consists of SiC particles and residual Al in an $Al_2O_3$ matrix. Aluminum, the phase having the lightest shading in the LAS material, is still present after 2000 h. Pores in the Al indicate shrinkage on cooling from the molten state or loss of material by evaporation.

Fig. 5. SA and RBSC before and after 500-h exposure to simulated steam-reformer atmosphere at 1260°C.

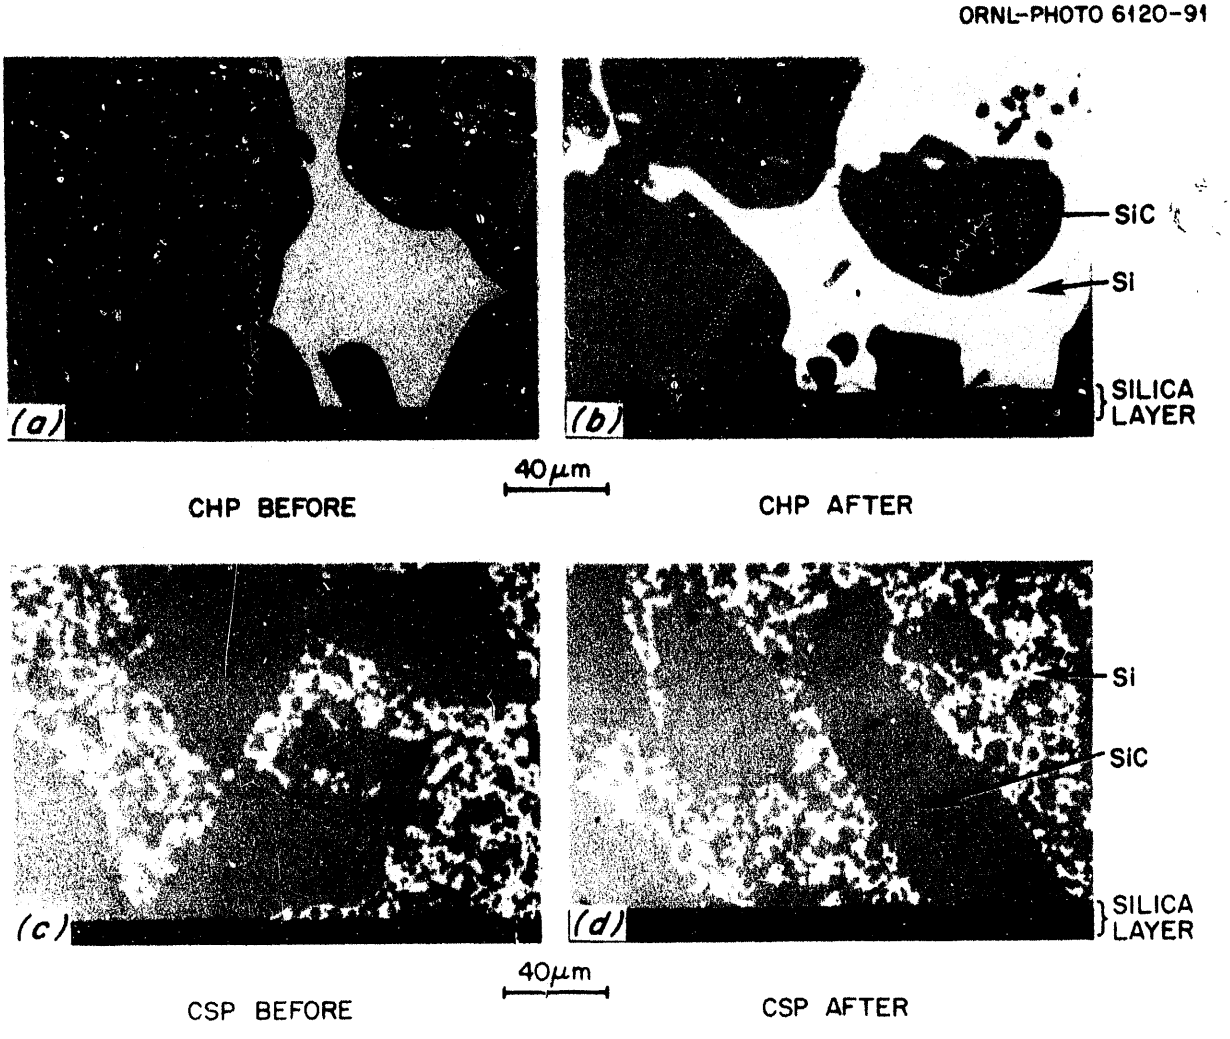
Fig. 6. CHP and CSP before and after 500-h exposure to simulated steam-reformer atmosphere at 1260°C.

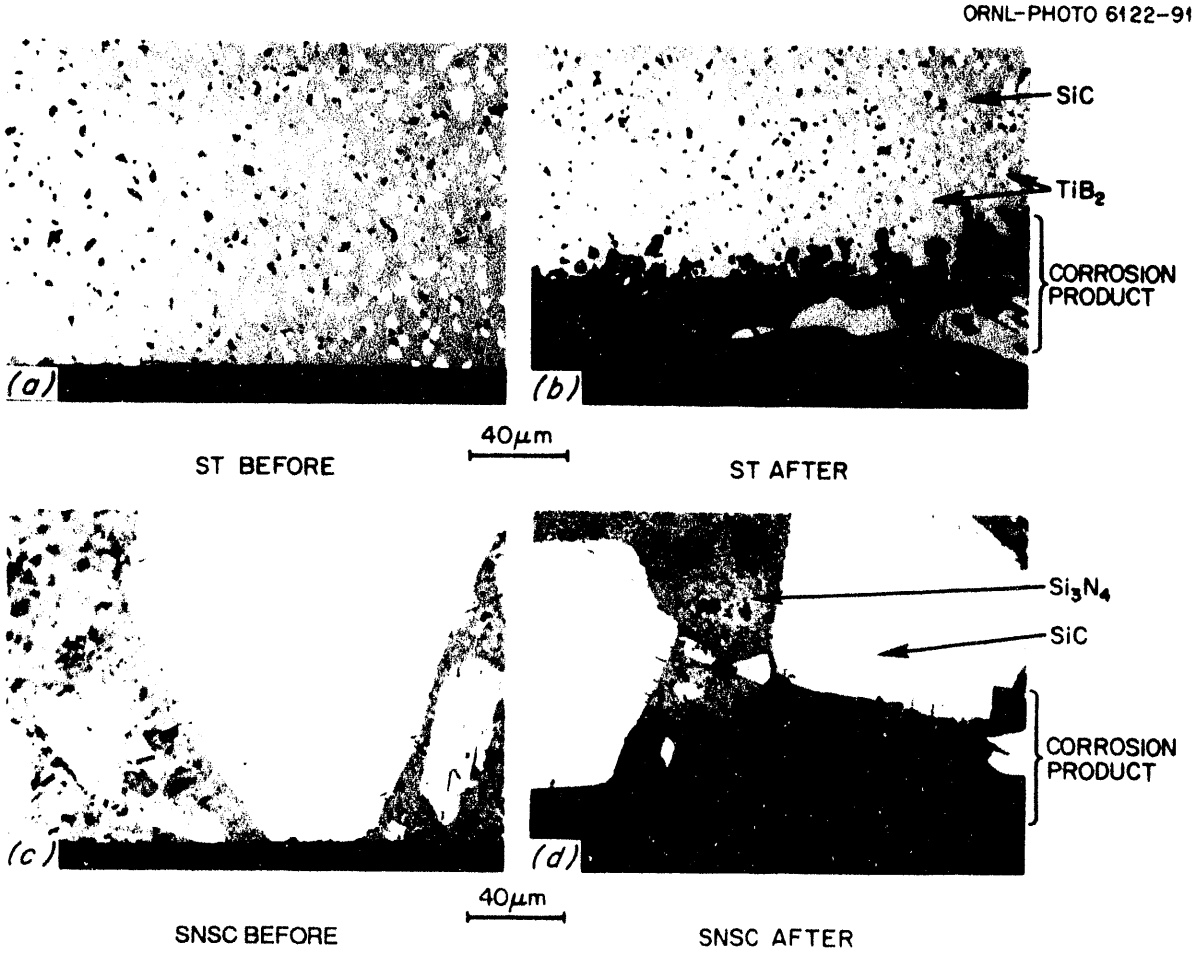
Fig. 7. ST and SNSC before and after 500-h exposure to simulated steam-reformer atmosphere at 1260°C.

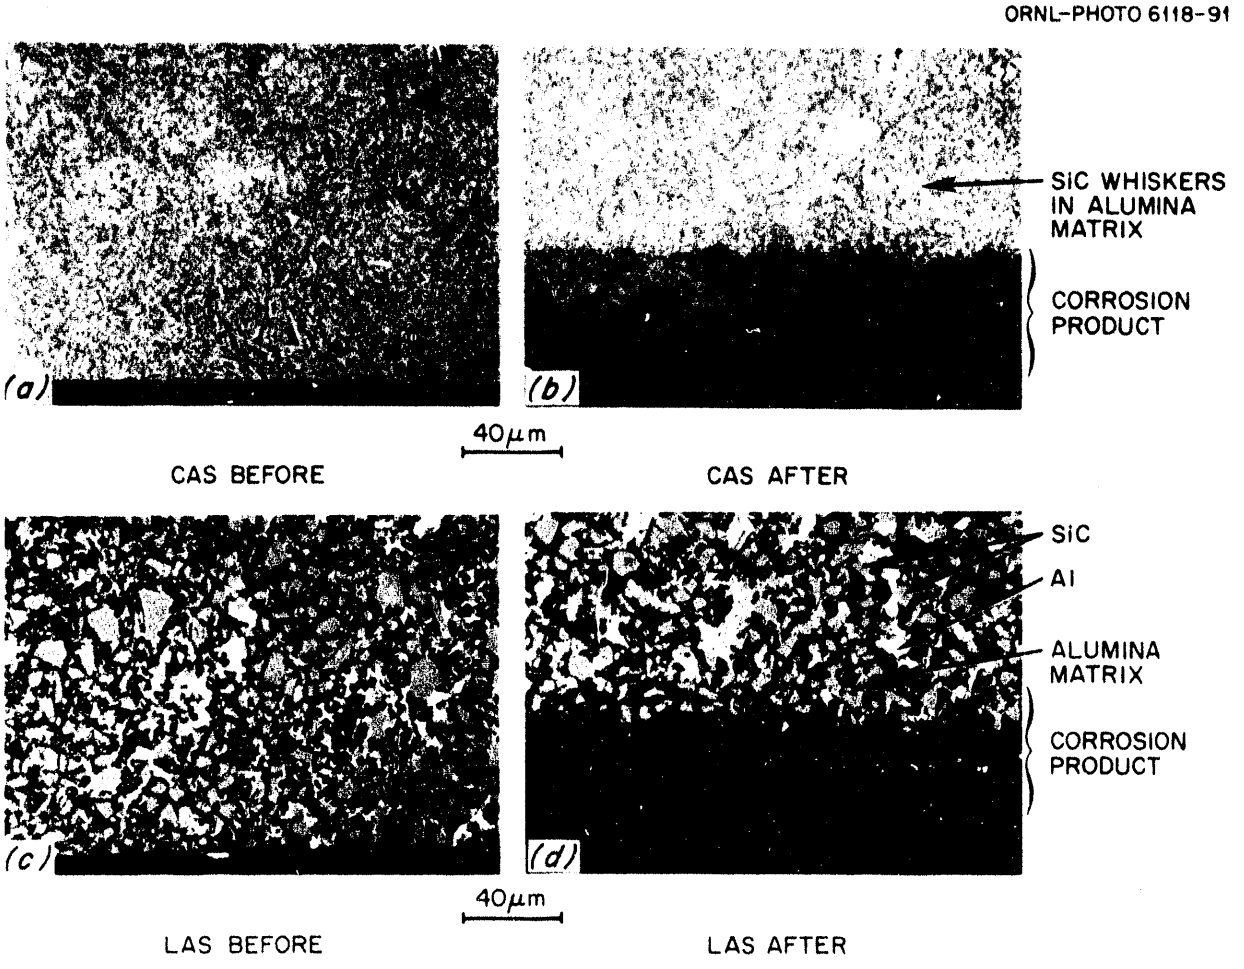
Fig. 8. CAS and LAS before and after 500-h exposure to simulated steam-reformer atmosphere at 1260°C.

increased. Although the composition of the layer on the CAS was not investigated, Fig. 8 clearly shows that the layer was similar to that on the LAS (i.e., crystalline and rough on the outer surface).

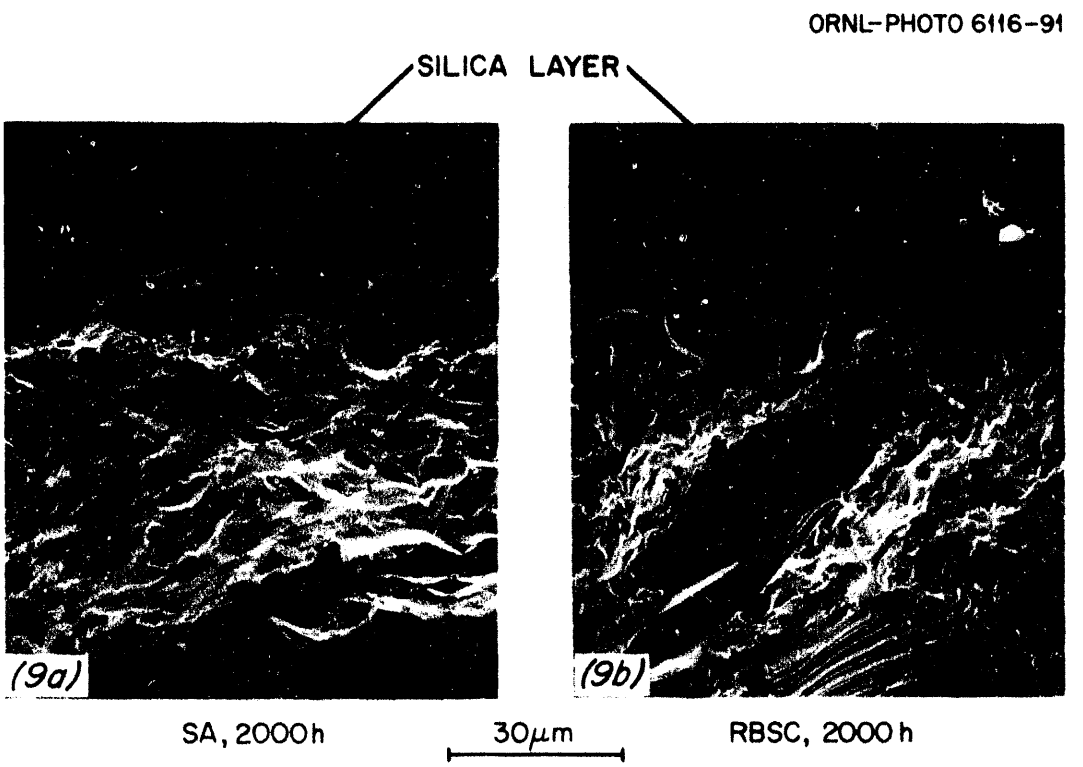
After 2000-h exposure, the three SiC ceramics (i.e., SA, CSP, and RBSC) had corrosion-produced layers with thicknesses in the range of 20 to 25 μm, while the layer on the LAS was about 80-μm thick. Using layer thicknesses after 500 h to aid in projection, the estimated layer thickness on SA, CSP, and RBSC would be 2.3 mm (0.09 in.) after 10,000 h. Similarly, the estimated layer thickness on LAS would be 8.4 mm (0.33 in.). The layer thickness is substantially larger than the thickness of original material consumed. For example, the calculated thickness of SiC consumed and thickness of the $SiO_2$ layer on SA are about 1.8 and 3.6 μm, respectively, based on a weight change of 2.5 mg and the theoretical densities of SiC and $SiO_2$, but the actual layer thickness was about 25 μm. Evolution of CO during reaction and formation of bubbles of this gas in the layer might be the reason for this discrepancy. Additional insight into the nature of the surface layers can be obtained from the scanning electron microscope photographs in Figs. 9 through 11. Fracture surfaces of SA and RBSC after an exposure of 2000 h in Fig. 9 reveal an irregular interface between the layer and the parent material. Porosity is evident at the interface and isolated porosity occurs within the layers. Otherwise, the layers appear to be quite dense. The appearance of CSP was similar to that of SA and RBSC. X-ray diffraction revealed only one new compound, tridymite, in the layers on SA, CSP, and RBSC. Tridymite is a high-temperature, crystalline form of silica ($SiO_2$). The presence of SiC in the diffraction patterns for the three materials was attributed to penetration of the X-ray beam through the surface layer to the underlying parent material.

Fig. 9. Scanning electron microscope photographs of fracture surfaces of materials corroded for 2000 h: (*a*) SA and (*b*) RBSC210.

The specific volumes of tridymite and SiC are about 0.44 and 0.31 $cm^3/g$, respectively; thus, some disruption of the silica layer during growth could be expected. Figure 9 shows that the interface between the silica layer and the SiC ceramics is irregular and contains considerable porosity, an indication of the misfit that occurred when silica formed from the parent SiC. The temperature of 1260°C, however, apparently was high enough for surface diffusion to produce a relatively smooth outer surface, also evident in Fig. 9.

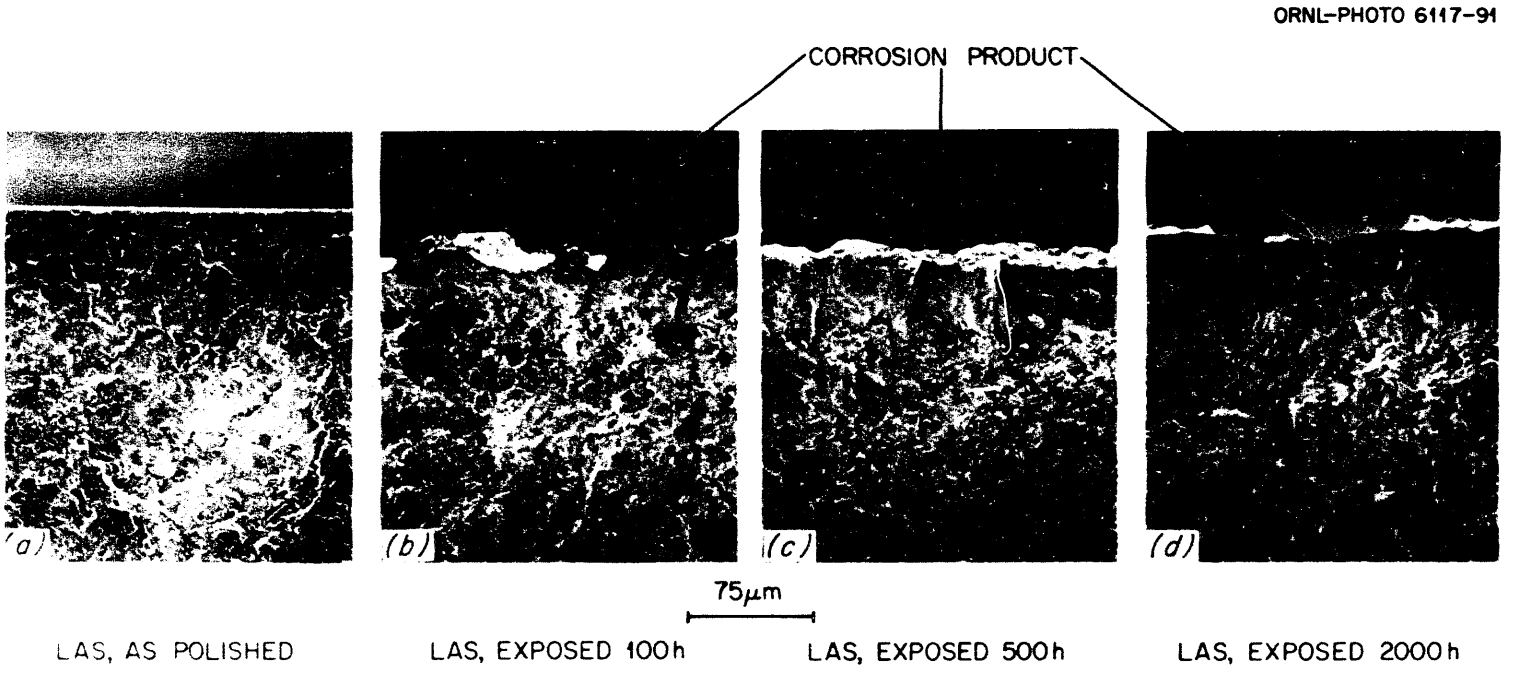
Fig. 10. Scanning electron microscope photographs of fracture surfaces of LAS: (*a*) as polished, (*b*) exposed 100 h, (*c*) exposed 500 h, and (*d*) exposed 2000 h.

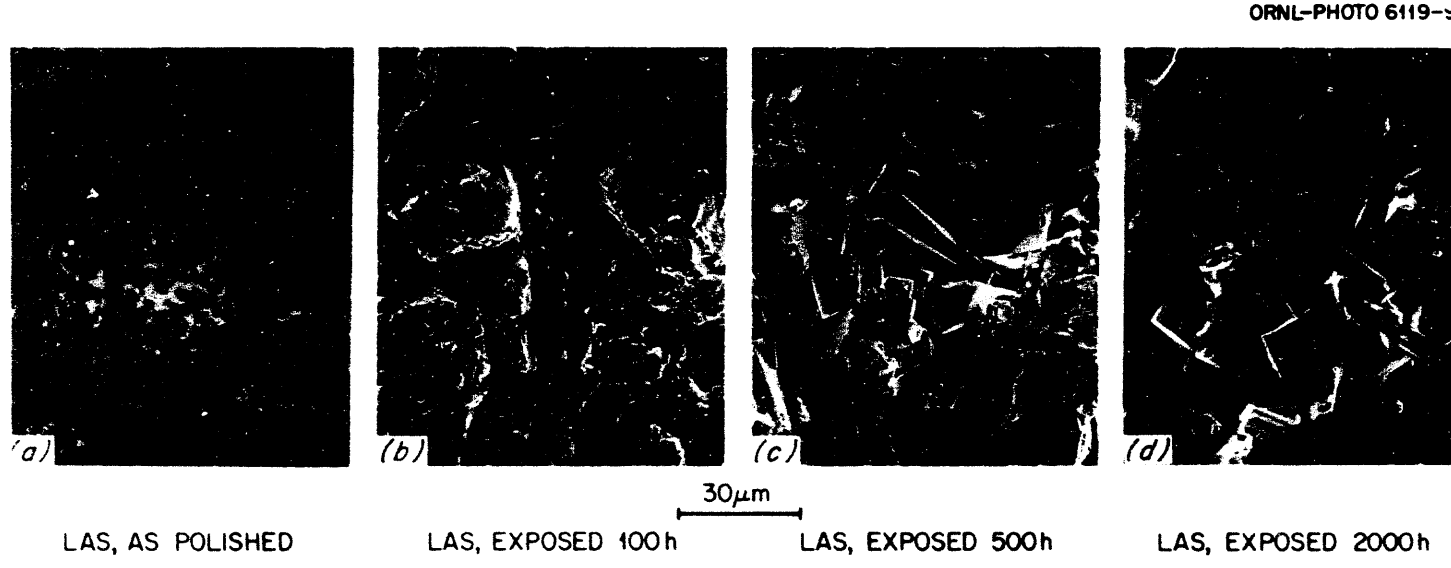
The morphology of the surface layer on the LAS is shown in Fig. 11. The original surface, which consisted of a mixture of phases, appears to consist of a rough glass containing needle-like crystals after an exposure of 100 h. Substantial crystal growth, which is evident after 500 and 2000 h, produced very irregular surfaces. The layer contained $Al_2O_3$, mullite ($3Al_2O_3 \cdot 2SiO_2$), and cordierite ($2MgO \cdot 2Al_2O_3 \cdot 5SiO_2$). Formation of cordierite was possible because the LAS contained a small amount of MgO as an impurity or fabrication aid. Comparison of the composition of the layer after 2000 h with that of the layer after 500 h indicated that the amount of mullite had decreased and that the amount of cordierite had

Fig. 11. Scanning electron microscope photographs of the corroded surfaces of LAS: (*a*) as polished, (*b*) exposed 100 h, (*c*) exposed 500 h, and (*d*) exposed 2000 h.

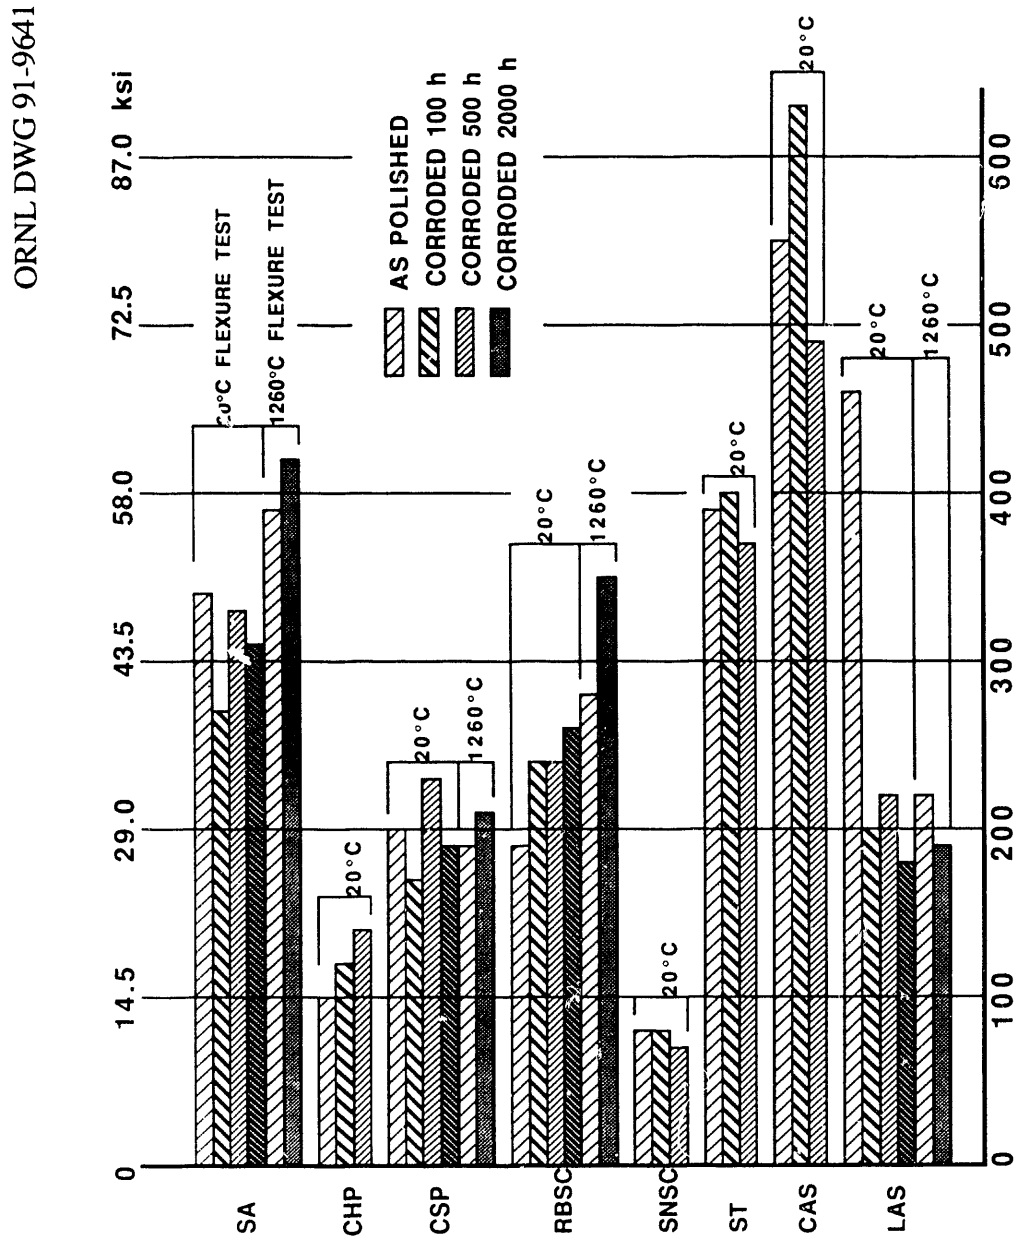
The results of flexure testing are summarized in Table 4 and in Fig. 12. Corrosion testing of CHP, SNSC, ST, and CAS was stopped after only 500 h because the manufacturers indicated that these materials probably would not be available in the form of tubes of the required size within the time frame of this project. In addition, CHP and SNSC had relatively low flexure strengths (Fig. 12). The other four materials (i.e., SA, CSP, RBSC, and LAS)

Fig. 12. Flexure strengths of materials exposed to a simulated steam-reformer atmosphere.

Figure 12 shows that the strength of the LAS in the as-polished condition was lower at 1260°C than at 20°C. Although the flexure test at 1260°C involved only about 1 h at temperature, we assume that migration of Al to the surface, followed by oxidation and reaction with silica, formed strength-limiting defects, but this phenomenon has not been thoroughly investigated.

Figure 12 also shows that the strength of the CAS increased after exposure for 100 h but decreased after 500 h. This behavior was probably caused by the initial growth of a beneficial silica layer (which increased strength) followed by the formation of crystals within the thickening layer (which decreased strength).
