# U.S. Department of Energy
Idaho Operations Office • Idaho National Engineering Laboratory

Reactivity Initiated Accident Test Series
Test RIA 1-2 Fuel Behavior Report

January 1981

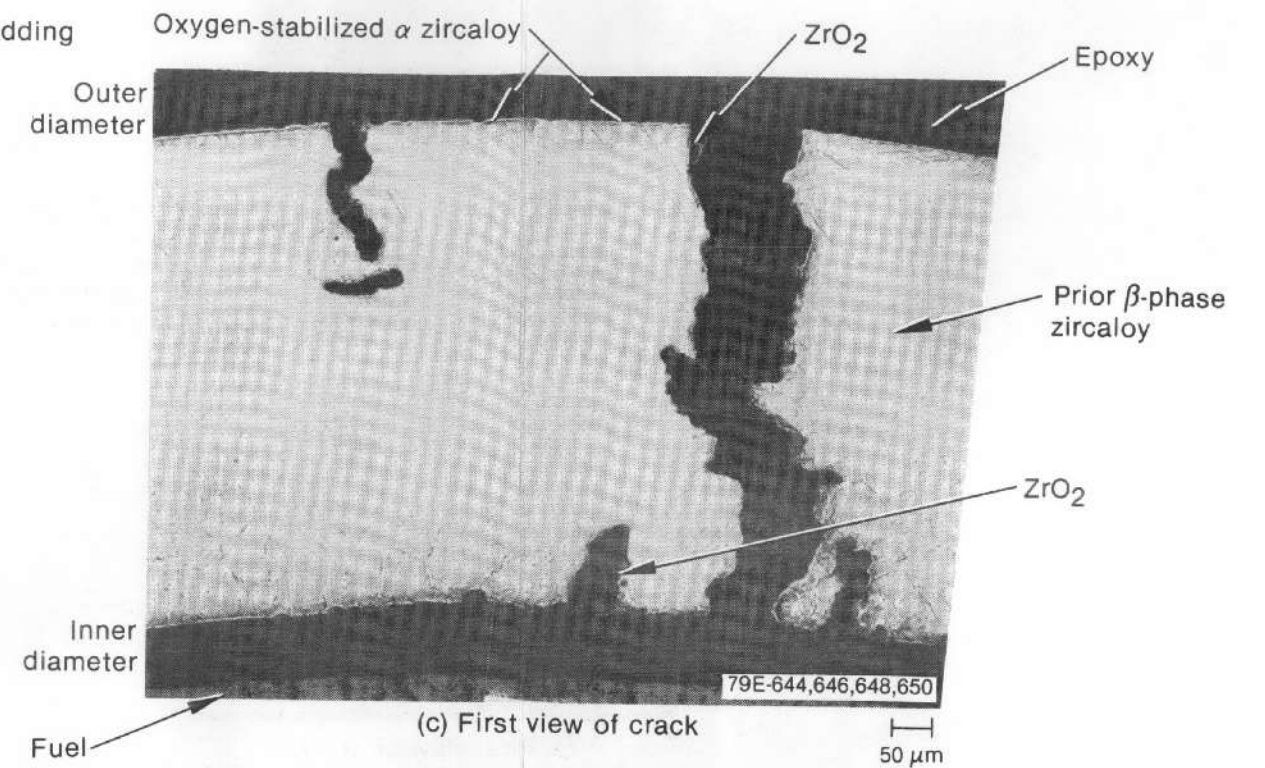
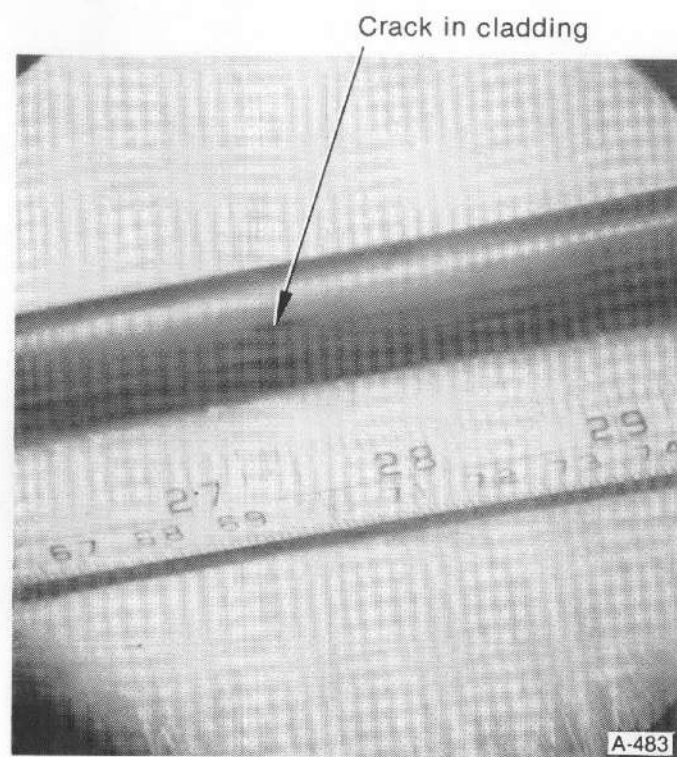
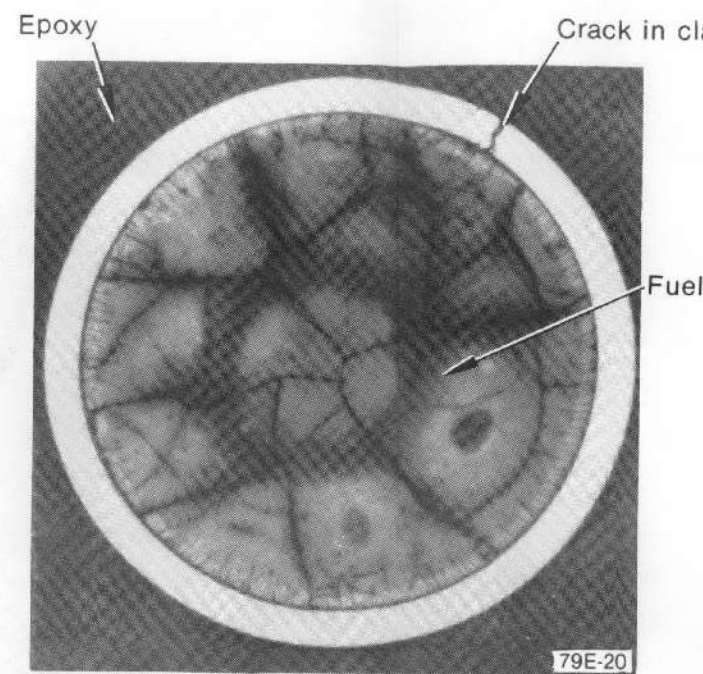
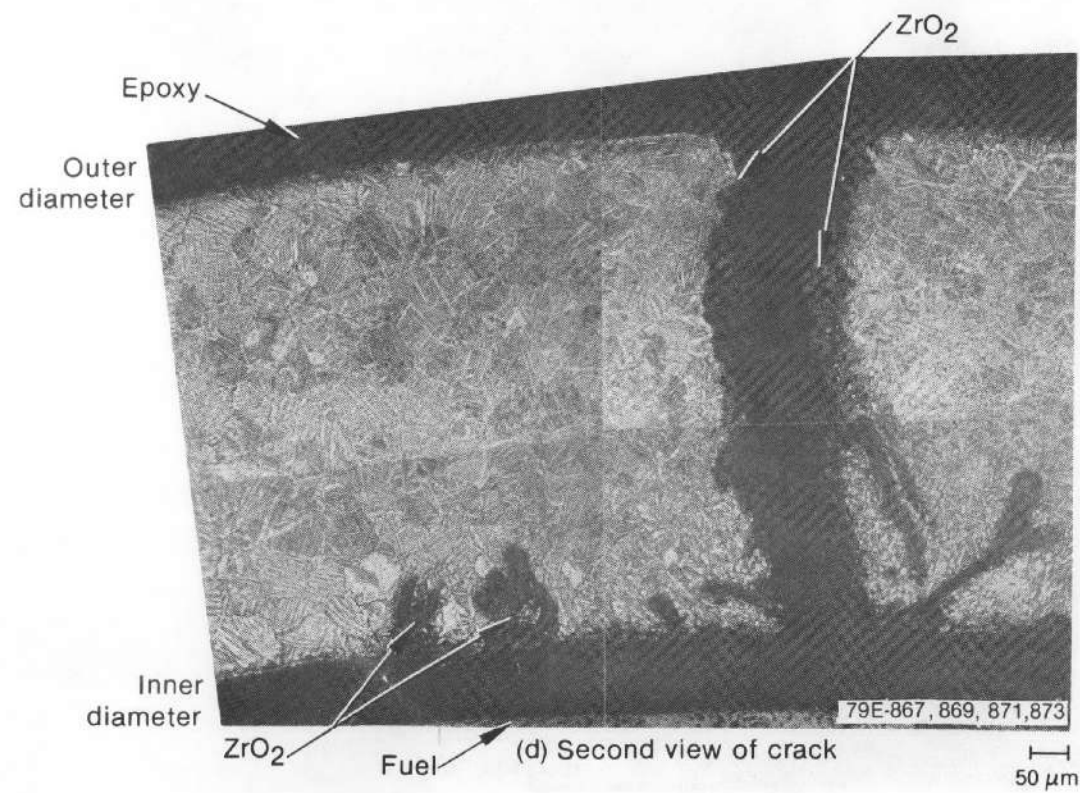
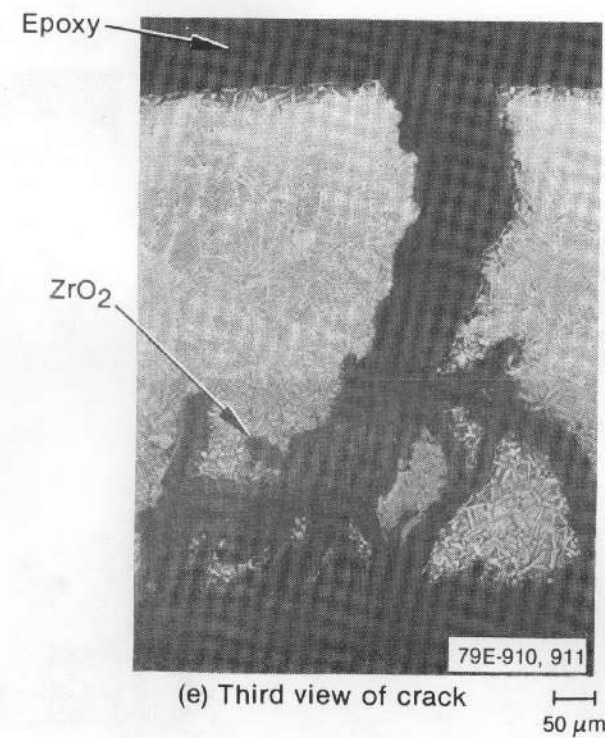
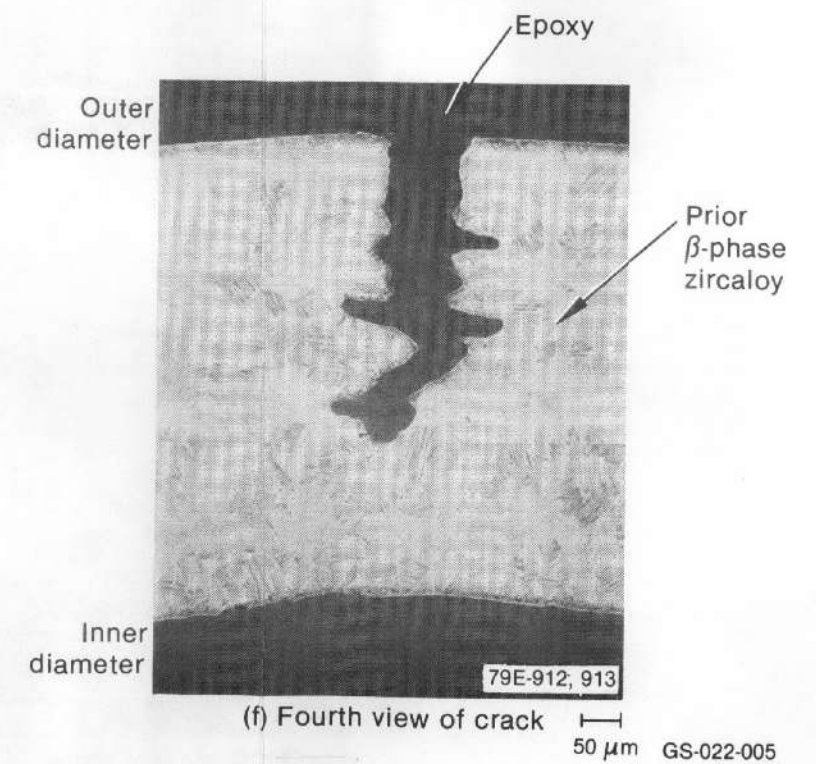
Figure 21. Crack in cladding at the 67.2-cm elevation of Rod 802-3.

mode. Cracks at the 67.2-, 49.4-, 48-, and 37-cm elevations are shown in various stages as the cracks were polished through in Figures 21 through 26. The crack at the 67.2-cm elevation (Figure 21) was wide, without the deposition on the outside surface around the crack seen at other crack locations. A transverse sample was cut at this location, mounted, and polished to show the crack in cross section. The figure shows the crack as it was ground through. In the first view, the crack is fairly straight through the wall. In Figure 21(c), there are two incipient cracks on the cladding inside surface and one on the outside surface. The oxygen-stabilized alpha zircaloy and ZrO_2 are equally as thick on the inside of the crack as they are on the outside surface of the cladding, indicating that the cladding failed at low temperature, before the rod went into film boiling. This is characteristic of all of the cracks examined. Although it appears that the cracking follows the prior beta grain boundaries, the cracks probably occurred before the beta structure was formed, and the beta grains then formed along the cracks. Zirconium dioxide has filled the incipient cracks on the inside surface of the cladding shown in Figure 21(d). The through-wall crack in this view is straighter, with rounded corners at the cladding inside and outside surface. This is probably due to the oxidation of the crack surface. The crack is branched at the inside surface in Figure 21(e), and it no longer extends through the cladding in the view shown in Figure 21(f).

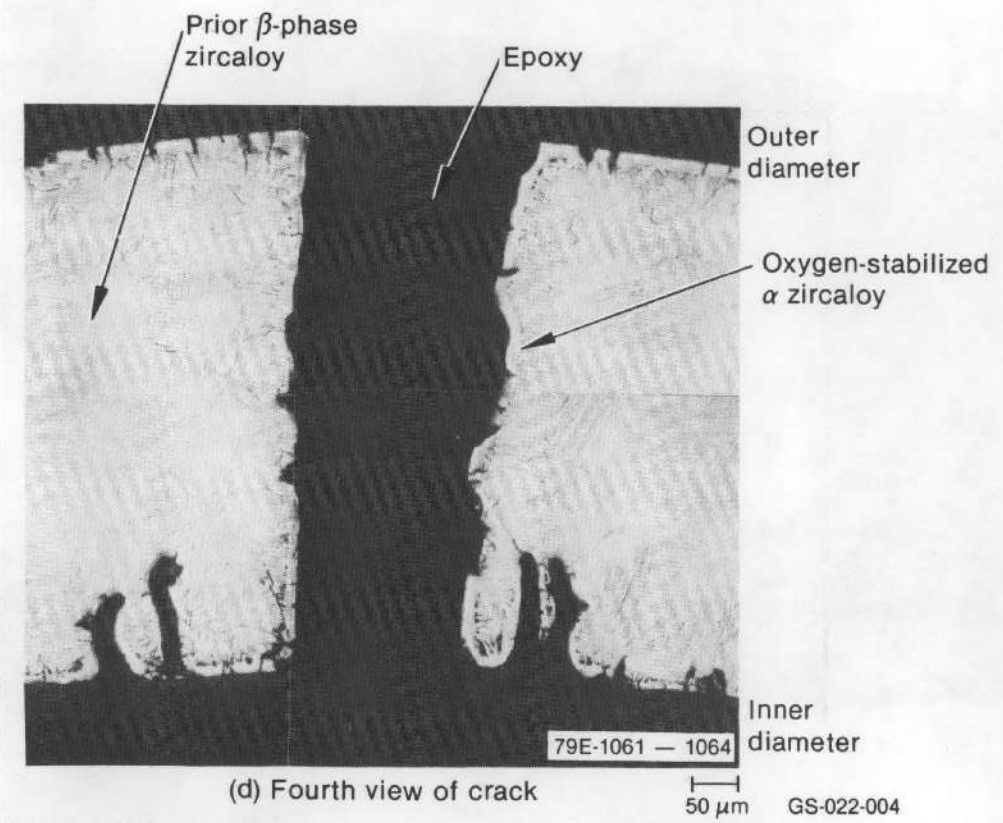
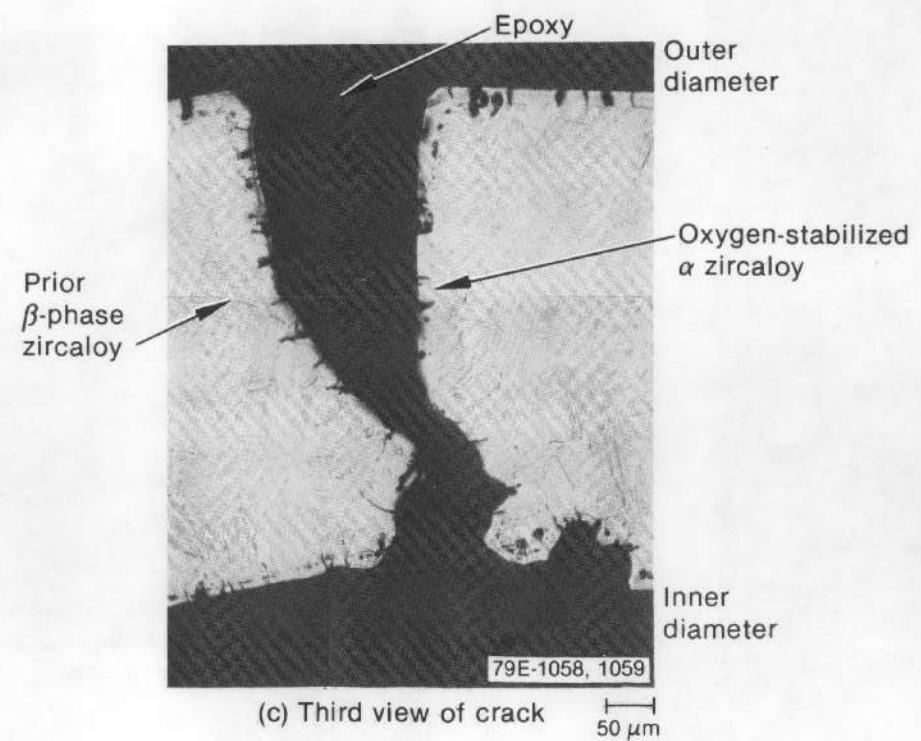
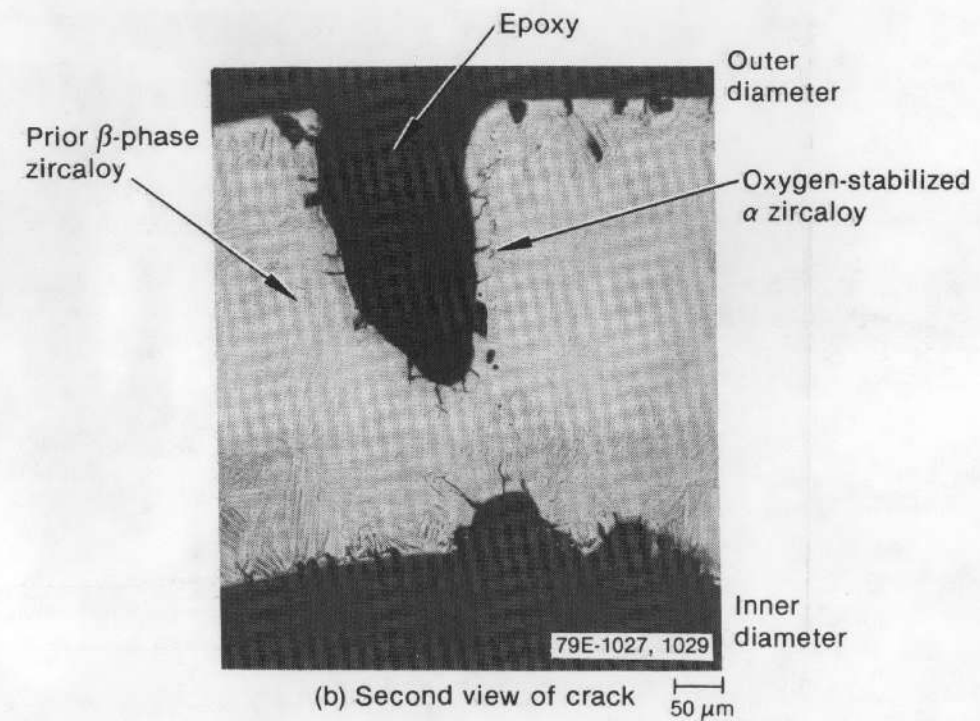
Figure 22.   Crack in cladding at the 49.4-cm elevation of Rod 802-3.

The crack at 49.4 cm, shown in Figure 22, appears to join a crack from the outside surface and an irregularity on the inside surface of the cladding. Although the cracks appear to have initiated on the outside surface of the cladding, it may be that they initiated on the inside surface and propagated in the axial as well as the radial direction. The higher temperature at this location compared with the location shown in Figure 21 resulted in significantly more oxygen-stabilized alpha on the outside surface of the cladding and on the surfaces of the crack. The oxygen-stabilized alpha layer was brittle, and severe cracking of this layer is apparent in the photographs. As the sample polishing progressed, it became evident that the cladding crack was a straight, through-wall crack. In Figure 22(d), four incipient cracks are evident on the inside of the cladding.

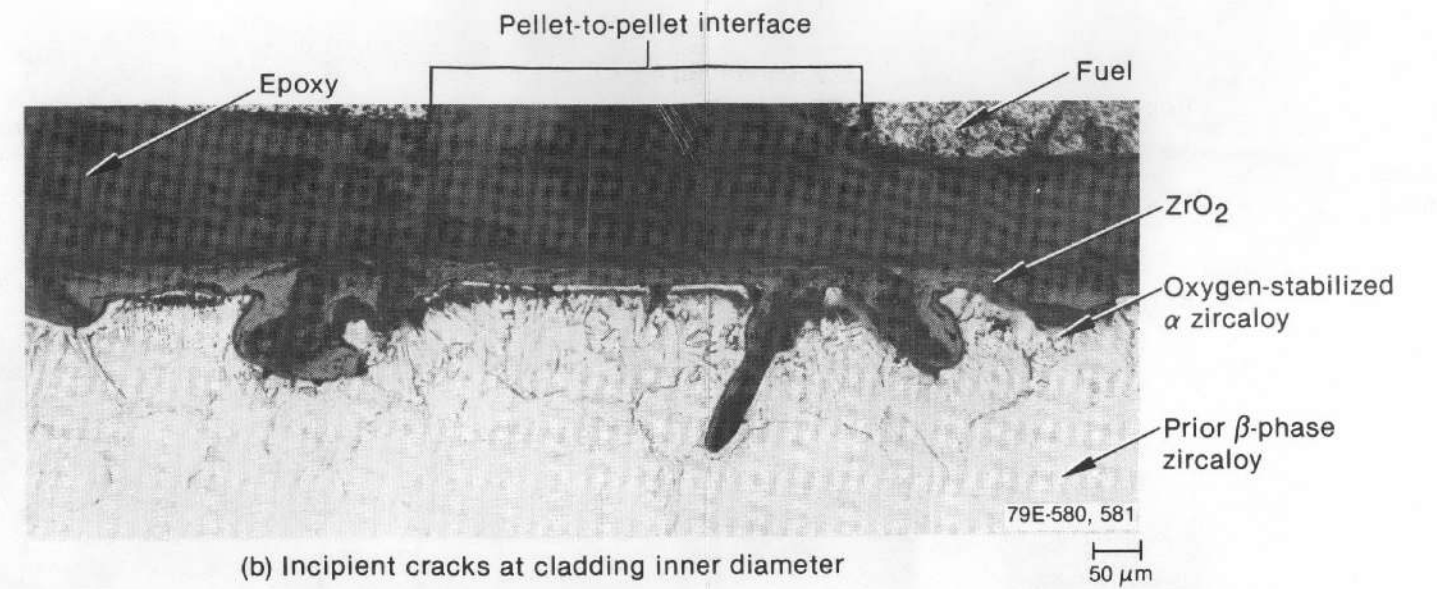
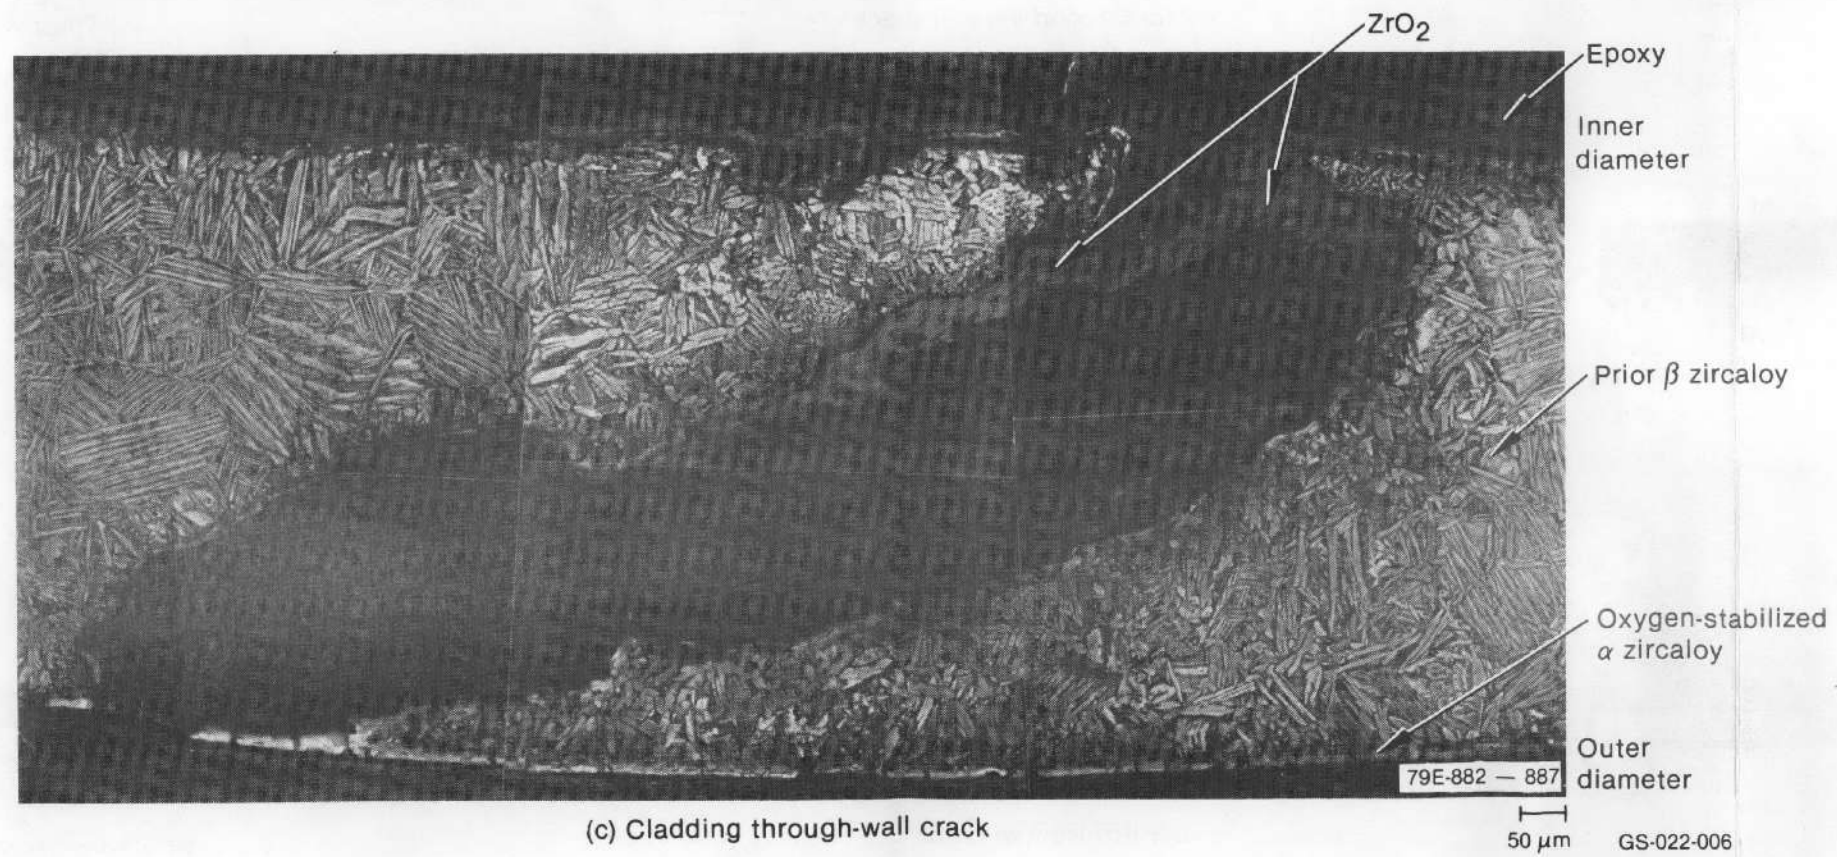
Figure 23.   Crack in cladding at the 48-cm elevation of Rod 802-3.

The crack shown in Figure 23 (at 48 cm) occurred at the location of a pellet-to-pellet interface, a high stress point in the cladding. The section of

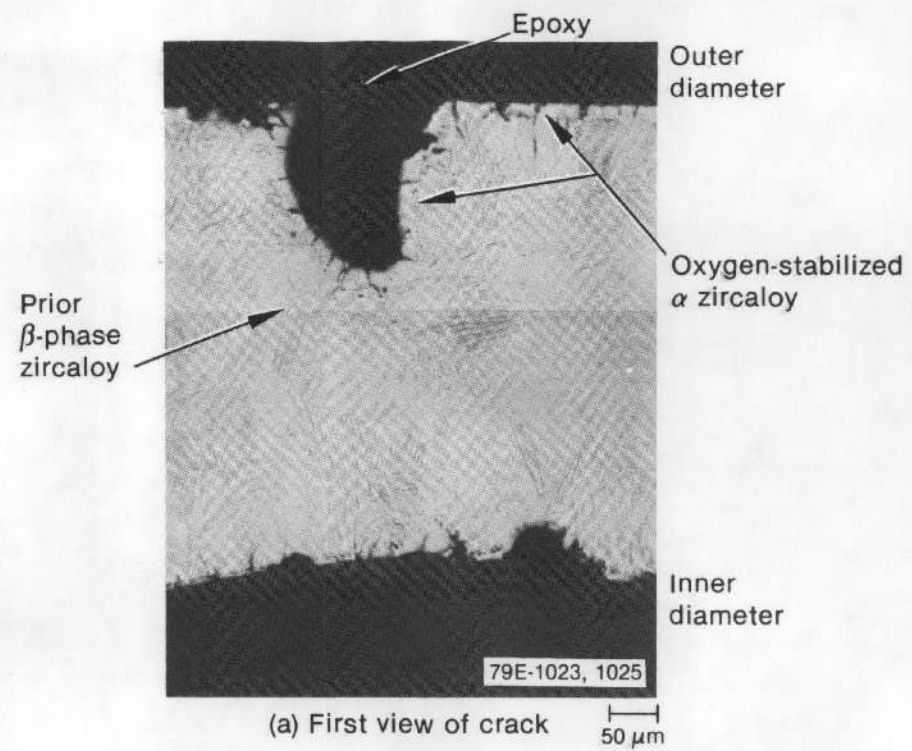
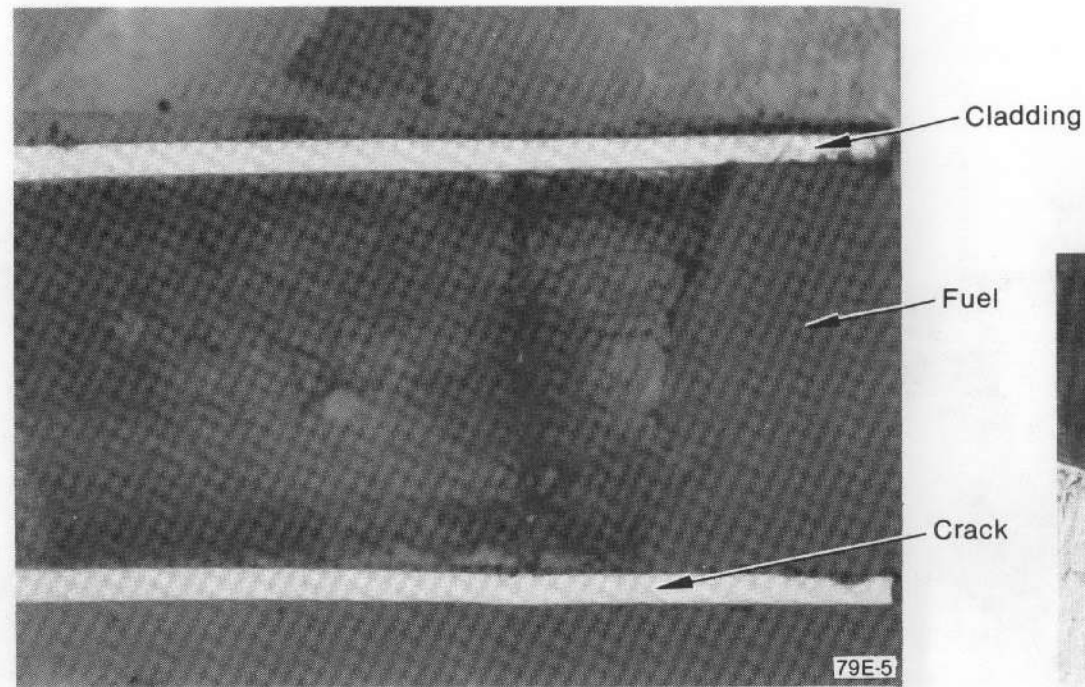
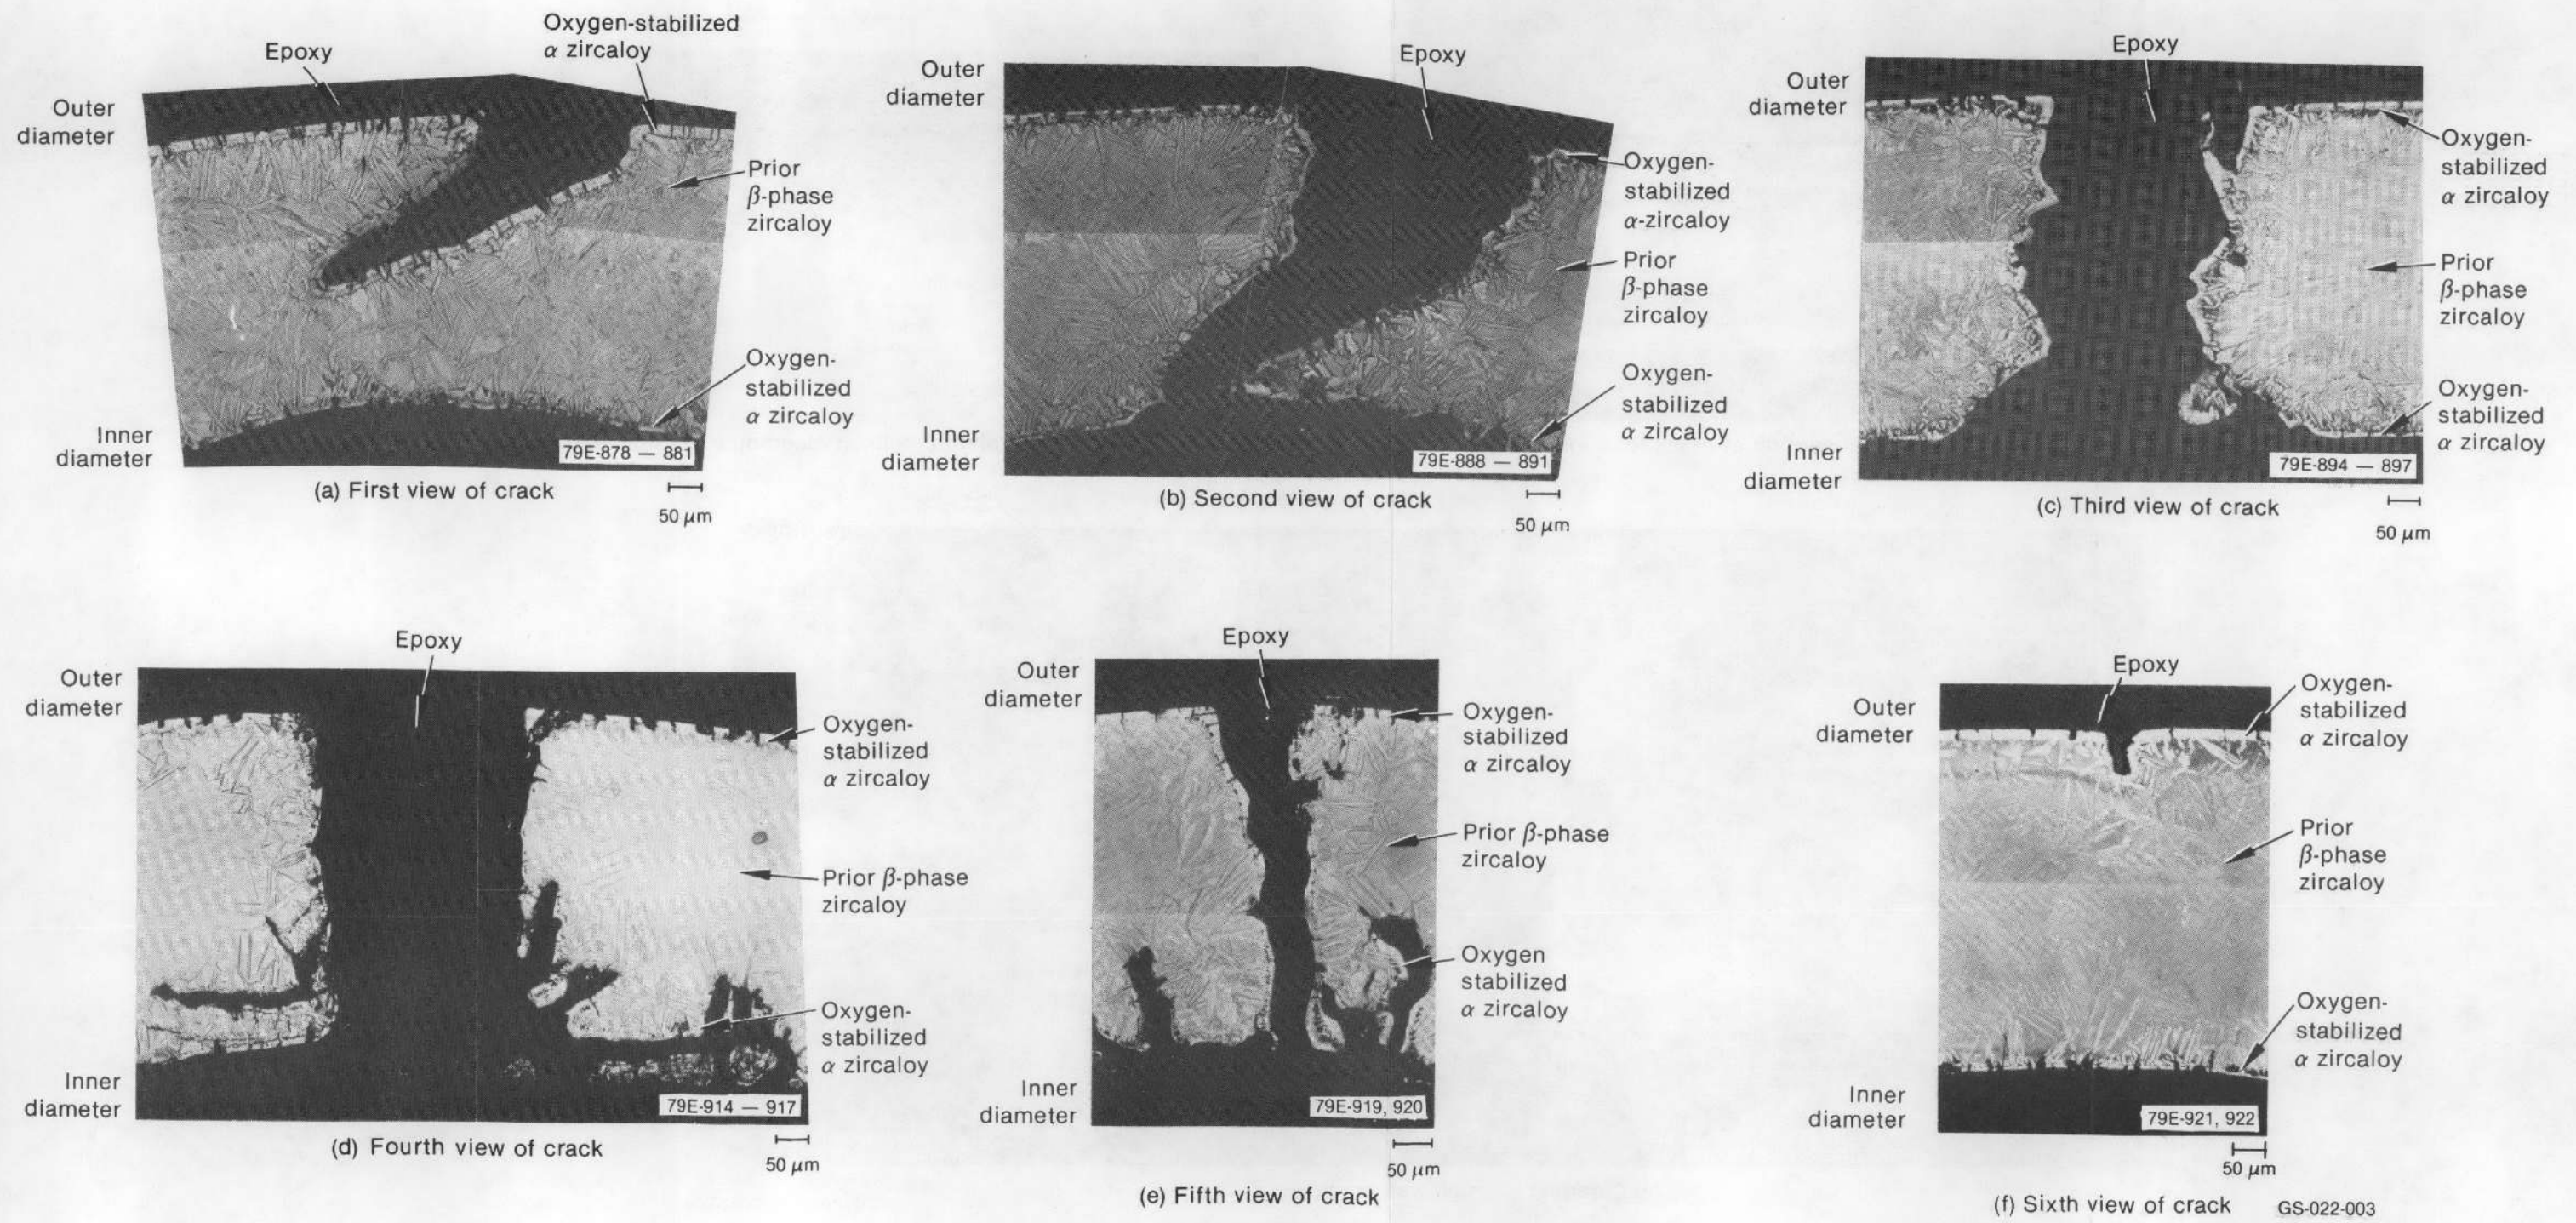
Figure 24. Crack in cladding at the 37-cm elevation of Rod 802-3.

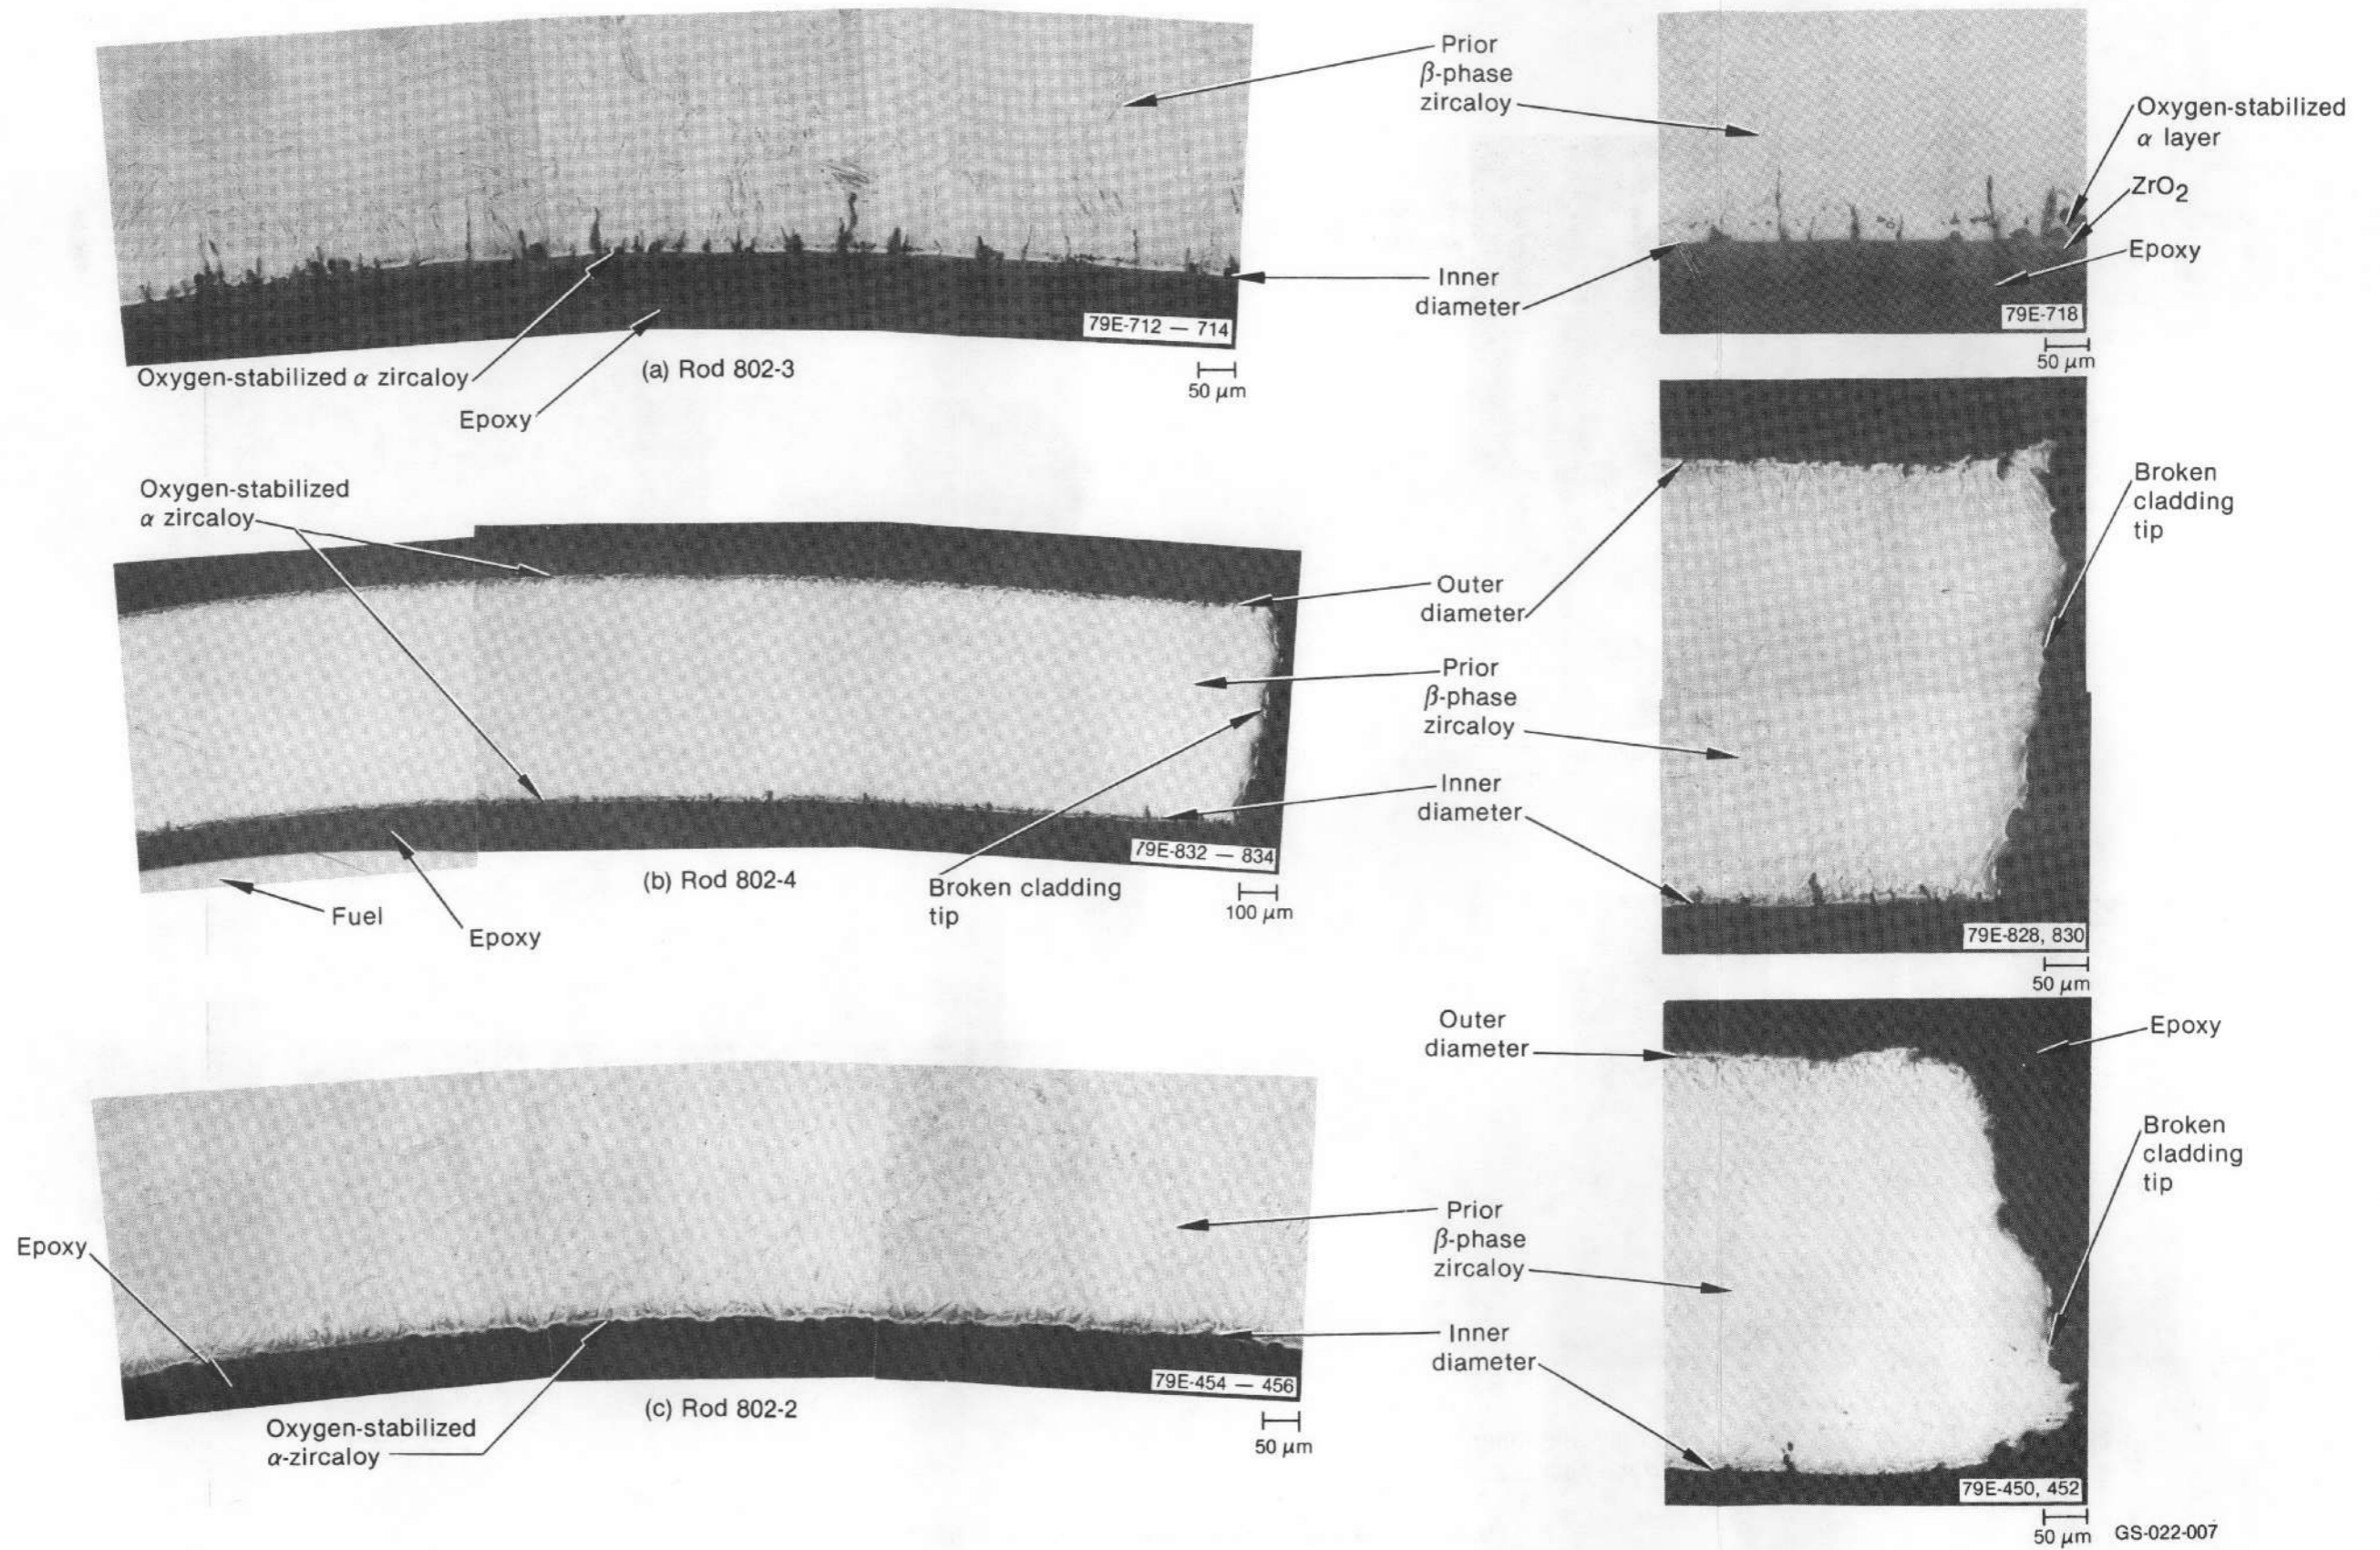
Figure 25. Cracking on the inner surface of the cladding of Rods 802-3, 802-4, and 802-2 when stressed at low temperatures.

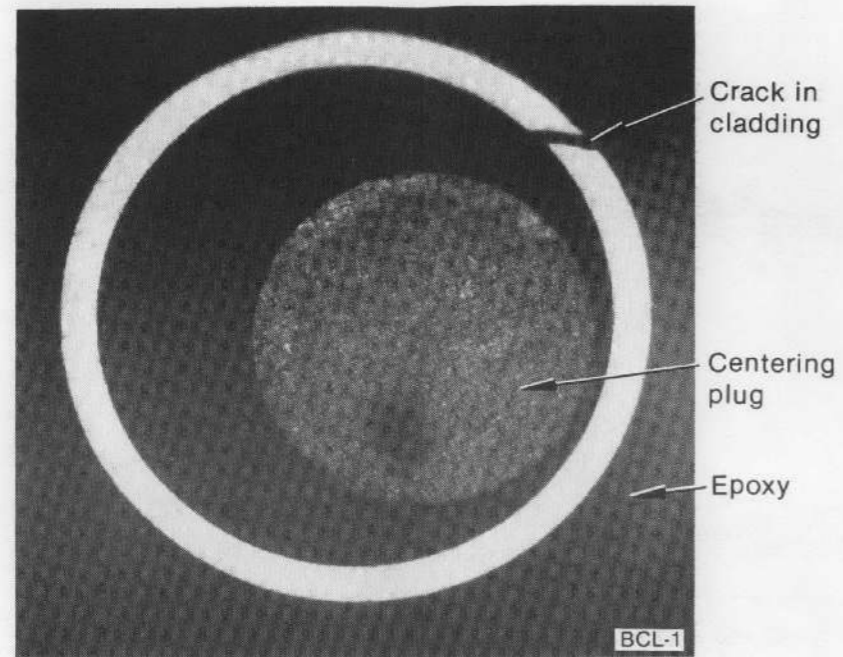
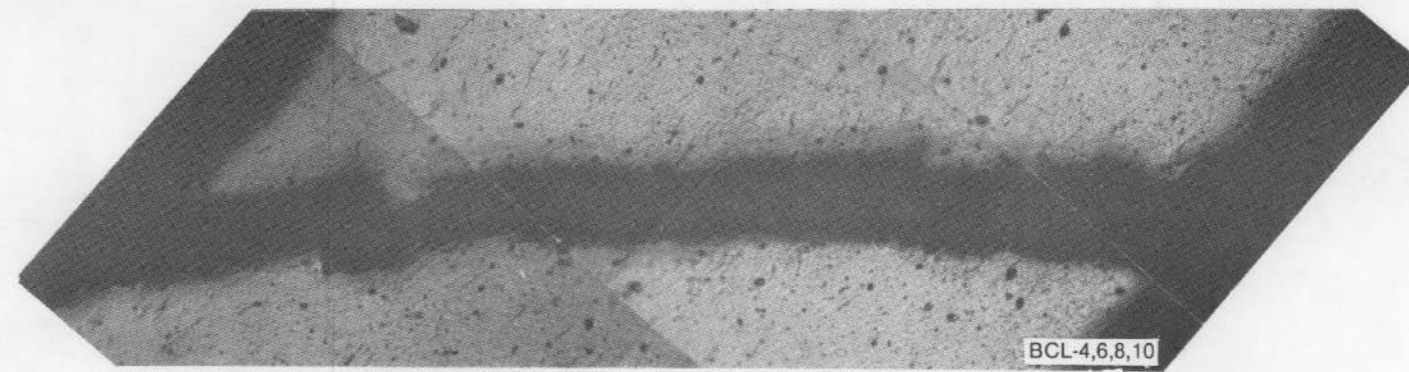
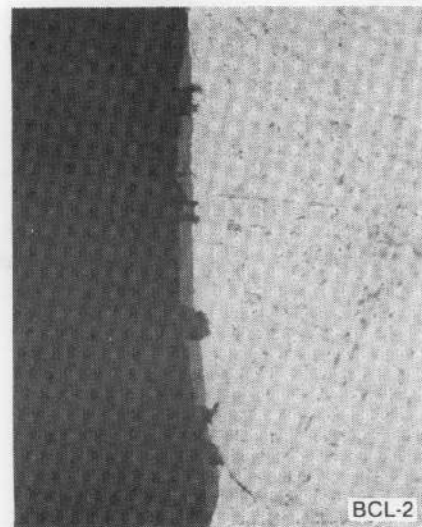
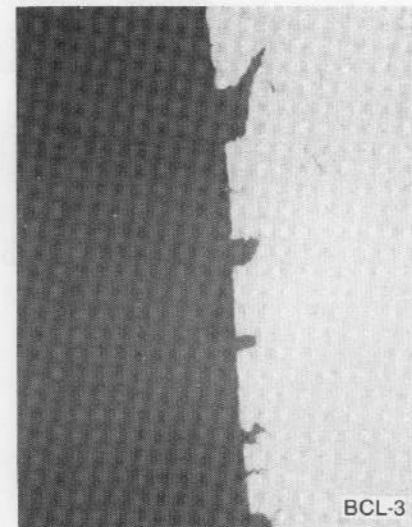
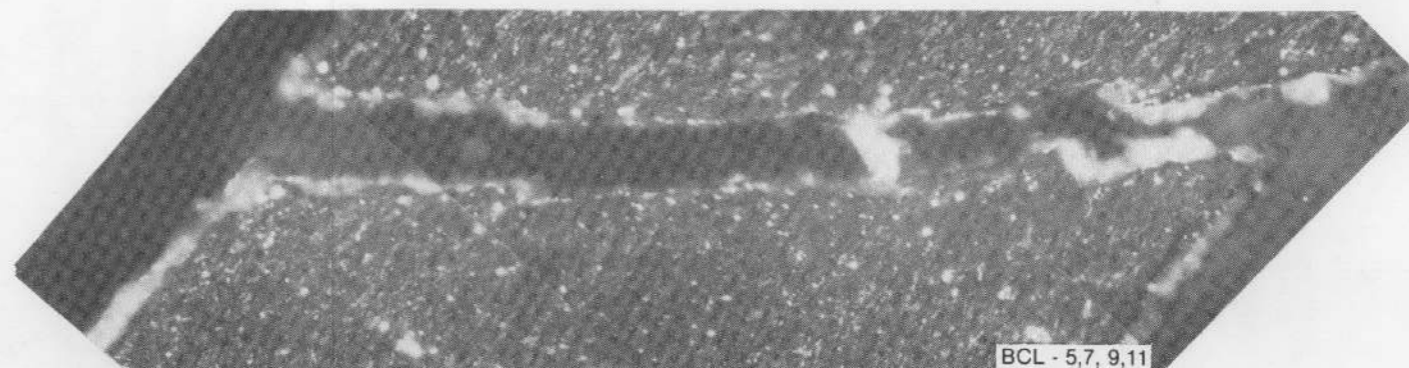
(a) Transverse sample at crack elevation

Crack in cladding

(b) Cladding through-wall crack, bright field

(d) Cladding outer surface away from crack

(e) Cladding inner surface near crack

(c) Cladding through-wall crack, polarized light

No through-wall cracks were found in any of the other three fuel rods. However, during one portion of the posttest examination, some incipient cracks were initiated on the inside surface of the cladding from Rods 802-2 and 802-4. A small half-ring was cut from each of the rods and flattened. All of the samples fractured axially down the middle of the sample. The broken sections were mounted and examined. Figure 25 shows numerous incipient cracks on the inside surface of the cladding from Rod 802-3, which is typical of many of the locations examined on the rod before posttest mechanical deformation. Similar cracking occurred on the inside of the Rod 802-4 cladding and, to a very limited extent, on Rod 802-2 near the fresh fracture surface. The inner surface cracking was not observed at any other locations on Rods 802-2 and 802-4 besides those that were mechanically deformed posttest.

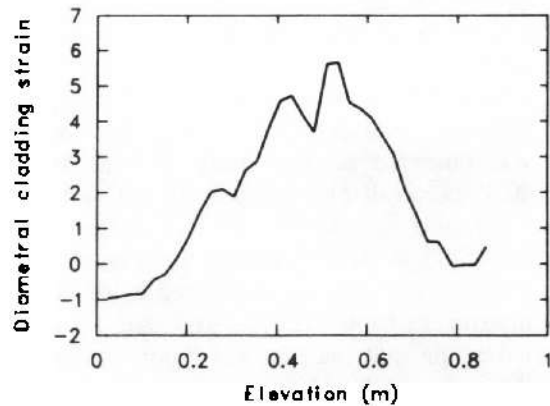
Figure 27. Diametral cladding strain of Rod 802-1.

The cladding deformation of the four fuel rods was characterized by diameter measurements and visual examination, and correlated with cladding peak temperatures. The cladding strain over the length of the rods is plotted in Figures 27 through 30. The maximum diametral strain for the high pressure rods was twice that of the low pressure rods. The two rods with cladding thermocouples (Rods 802-1 and 802-2) showed more strain than the rods without cladding thermocouples, with corresponding pressures. All four fuel rods collapsed near the ends of the rods.

The temperature differences between the four rods were presented in an earlier section. The high pressure rods operated at lower cladding peak temperatures than the low pressure rods. The failed rod with steam present inside operated at the highest cladding temperature. It was found that the higher the maximum diametral strain, the lower the cladding temperature.

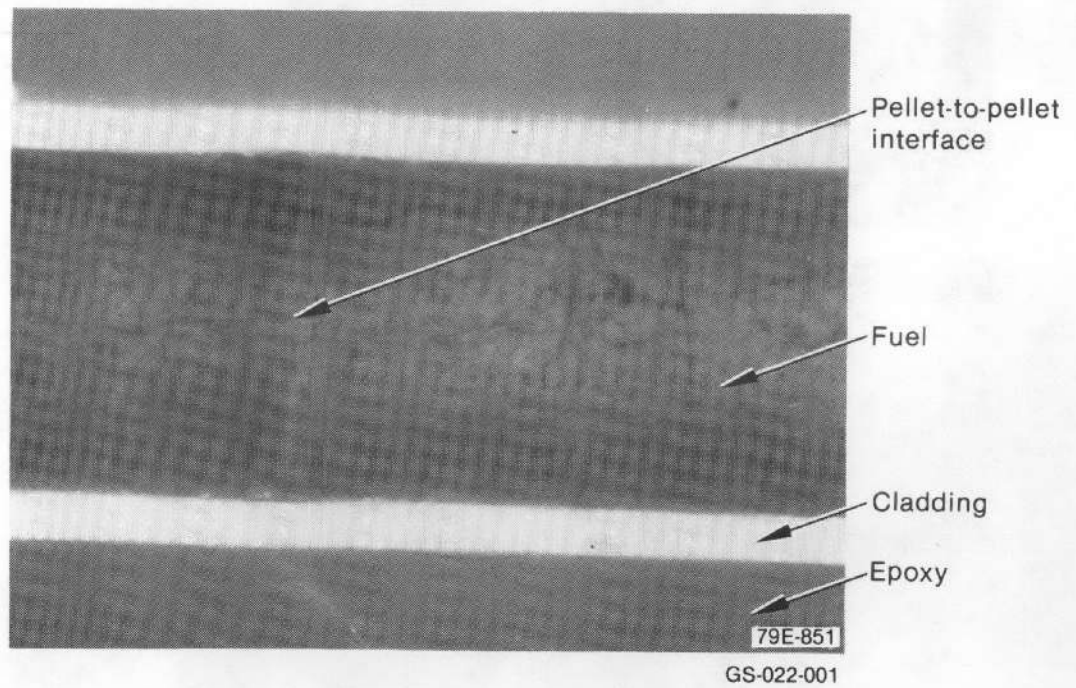
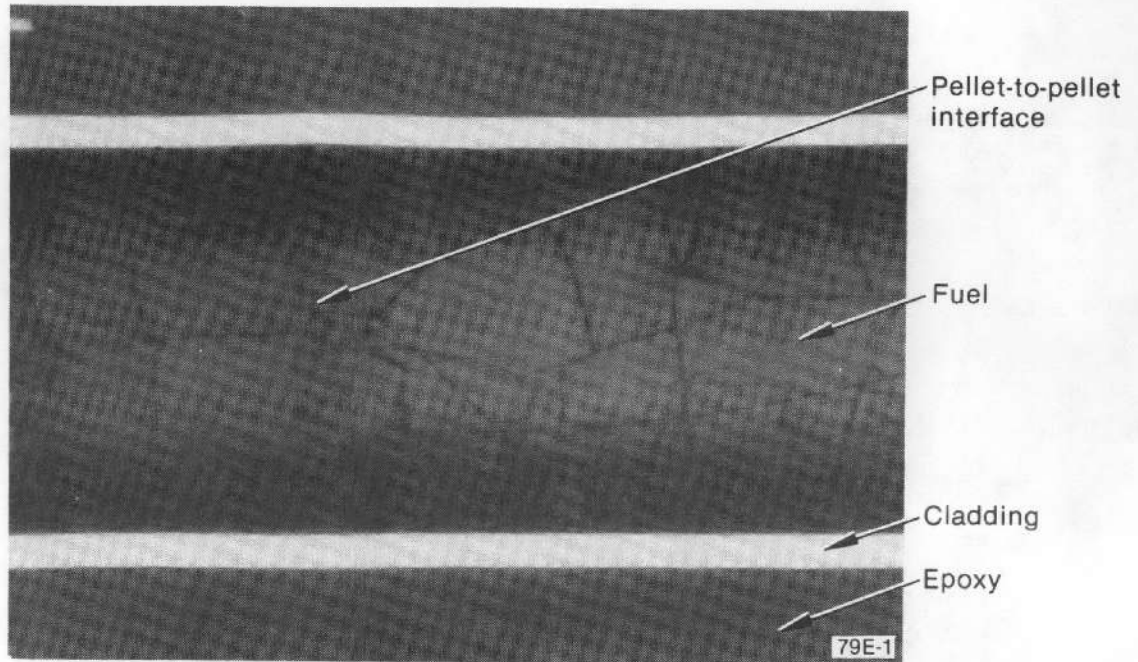
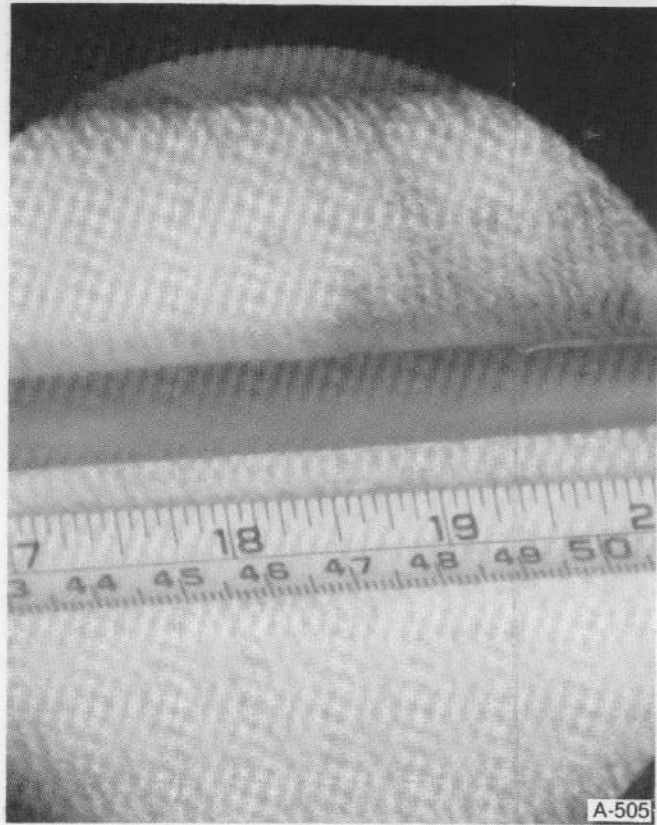
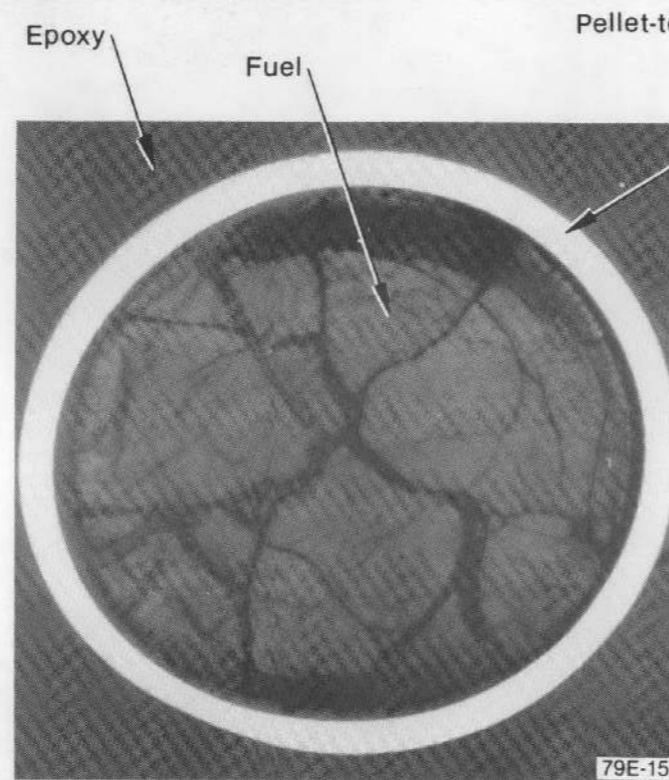
Ridging of the cladding was observed at axial distances equal to the length of the pellets in all

Figure 31.   Ridging at pellet interfaces of Rod 802-1.
