# U.S. Department of Energy
Idaho Operations Office • Idaho National Engineering Laboratory

Reactivity Initiated Accident Test Series
Test RIA 1-2 Fuel Behavior Report

January 1981

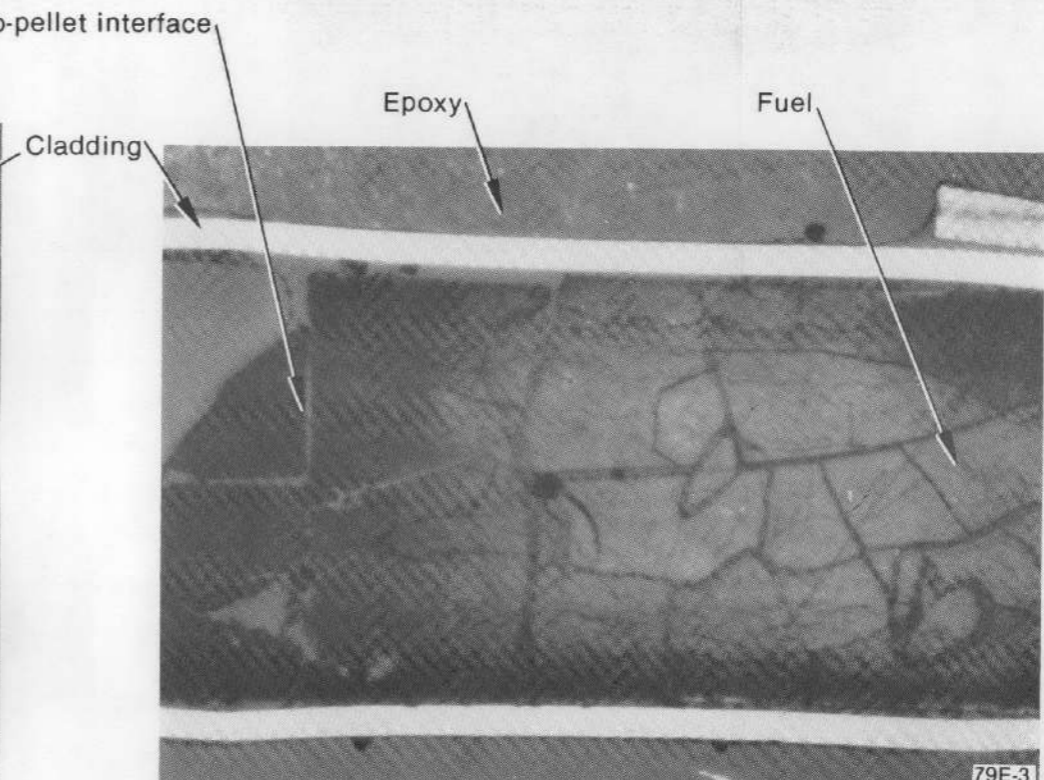
Figure 31.   Ridging at pellet interfaces of Rod 802-1.

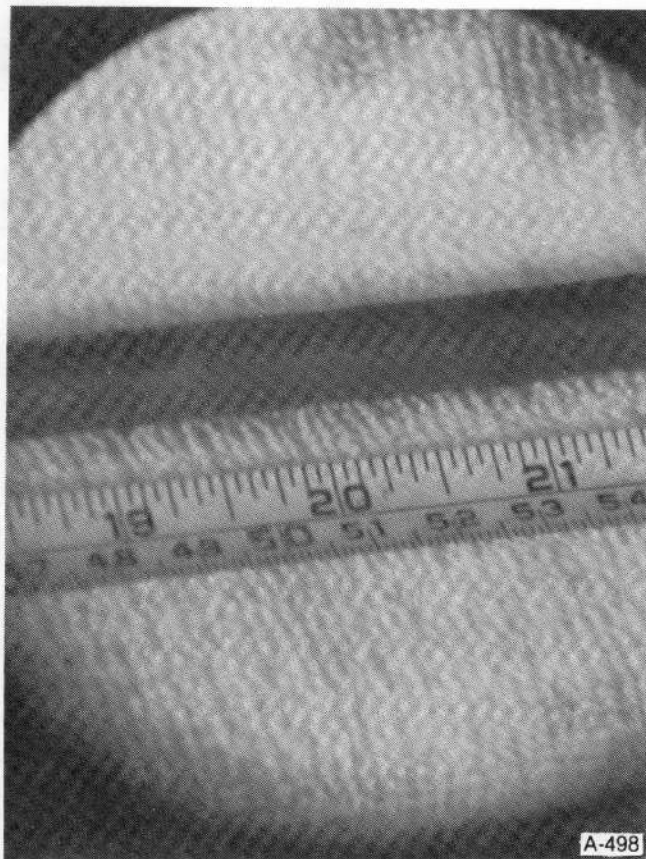
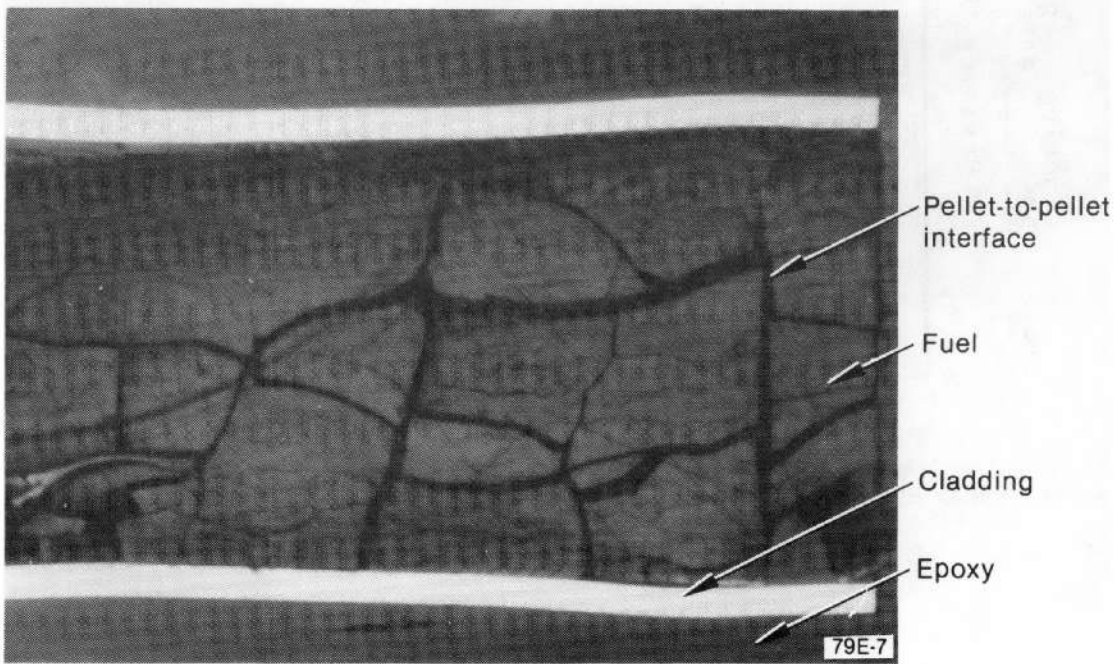
The observed deformation included ridging of the cladding on the high pressure rods at intervals equal to the length of a fuel pellet, in addition to a maximum of 6% increase in rod diameter. The ridging occurred from 23.5 to 55.4 cm and from 27.1 to 65 cm on high pressure Rods 802-2 and 802-4, respectively. A limited amount of ridging was observed on low pressure Rods 802-1 and 802-3. Overall photographs of rod sections and macrophotographs of rod cross sections showing the ridging are presented in Figures 31, 32, and 33. The ridging correlated with the pellet interfaces of low pressure Rods 802-1 and 802-3, indicating that the fuel was tightly locked within the cladding. No shifting of the fuel stack occurred upon thermal contraction. A crack initiated on the inside surface of the cladding of Rod 802-3 (shown in Figure 22) at the location of maximum deformation. As this crack was polished through, it was found to eventually penetrate the cladding wall. The area of maximum deformation in the high pressure rods did not correlate with fuel pellet interfaces, indicating that the fuel stack was not locked with the cladding upon cooldown. The deformation of Rod 802-2 is shown in Figure 32, and of Rod 802-4 in Figure 33.

The cross section in Figure 32(b) shows that the deformation also included some wall thinning. The wall thickness as a function of orientation for one axial location on Rod 802-2 and the thicknesses for several axial locations on Rod 802-1 are plotted in Figures 34 and 35, respectively. Although the cladding wall thickness of Rod 802-1 averages about 7.5% higher than the nominal thickness of 0.572 mm, the actual wall thickness does not deviate from the average measured thickness at any location by more than 6.3%. Therefore, the initial wall thickness of the cladding of Rod 802-1 was probably 7.5% greater than the nominal pretest thickness. The wall thickness of the cladding of Rod 802-2 at the peak power location (Figure 34) decreased by as much as 27% from the nominal thickness.

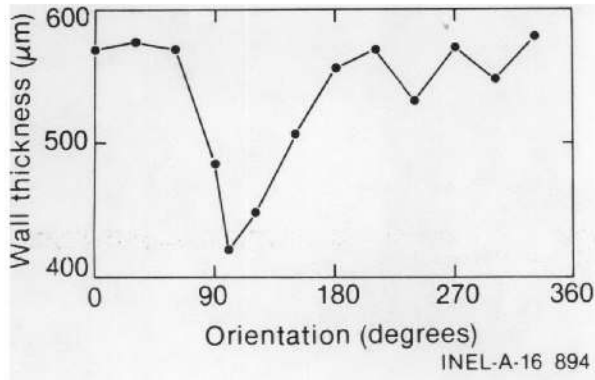
Figure 33. Deformation of Rod 802-4 cladding.
