NATIONAL ADVISORY COMMITTEE FOR AERONAUTICS

TECHNICAL NOTE

APPLICATION OF STATISTICAL METHODS TO STUDY

OF GAS-TURBINE BLADE FAILURES

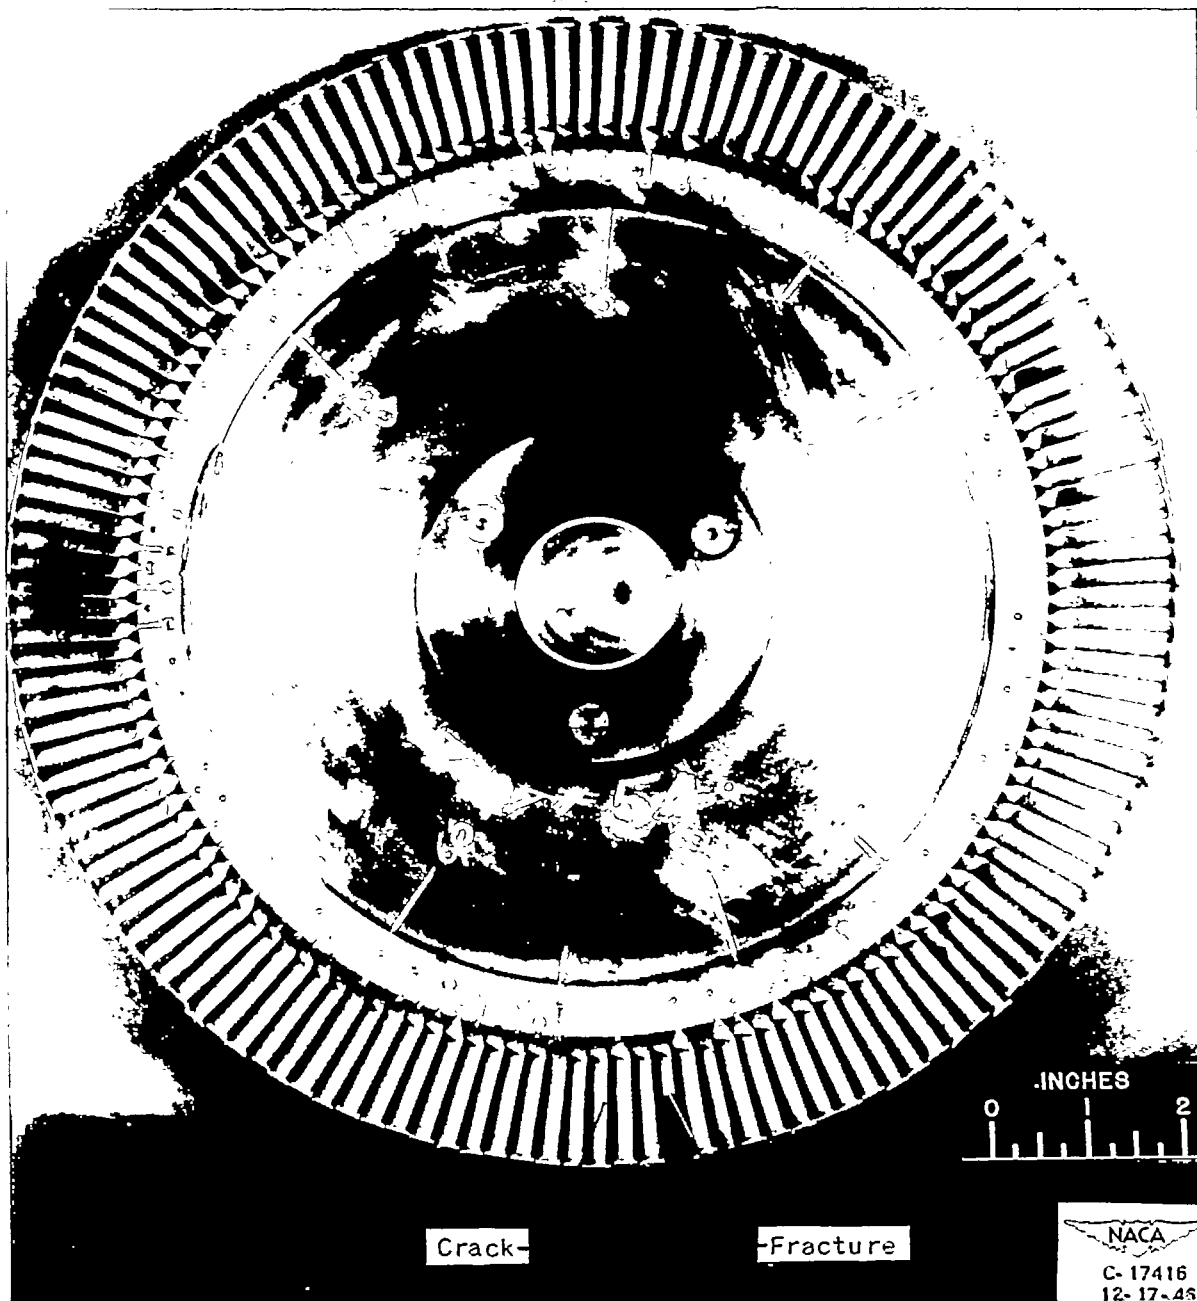
(a)   Turbine wheel showing cracked and fractured blades.

The appearance of wheel 1 after a total of $28\frac{1}{2}$ hours of power and condition time is shown in figure 3(a). The blade-root portion and fragments from wheel 1 after a total of $28\frac{1}{2}$ hours of power and condition time are shown in figure 3(b). These photographs are

representative of the failures experienced with the exception of
one blade that exhibited local necking. The damaged condition of
the fragments thrown from the wheel is the result of the impact of
the fragments upon the water-cooled drum.

of the wheel during initial runs revealed that a few blades were
badly cracked (figure 3(a)). The assumption was therefore made
that these cracked blades would fail very soon and removal of
blades which had cracks longer than half the blade width would speed
the program by lengthening the interval between wheel removals. The
criterion of failure of the material was therefore considered to be
fracture or severe cracking. The number of failures recorded during
a given time period was the total of all replaced. Operation in this
manner was found to allow periods of operation as long as 5.4 hours
without shutdown for overhaul. At shutdown as many as nine
fractured blades and as many as 13 cracked blades were replaced.
The use of these data in the plotting of distribution curves was
found to be difficult. The time interval chosen for plotting the
frequency-distribution curve was necessarily large because the

Figure 3. — Damage to blades of wheel 1 after $28\frac{1}{2}$ hours of power and
condition time.

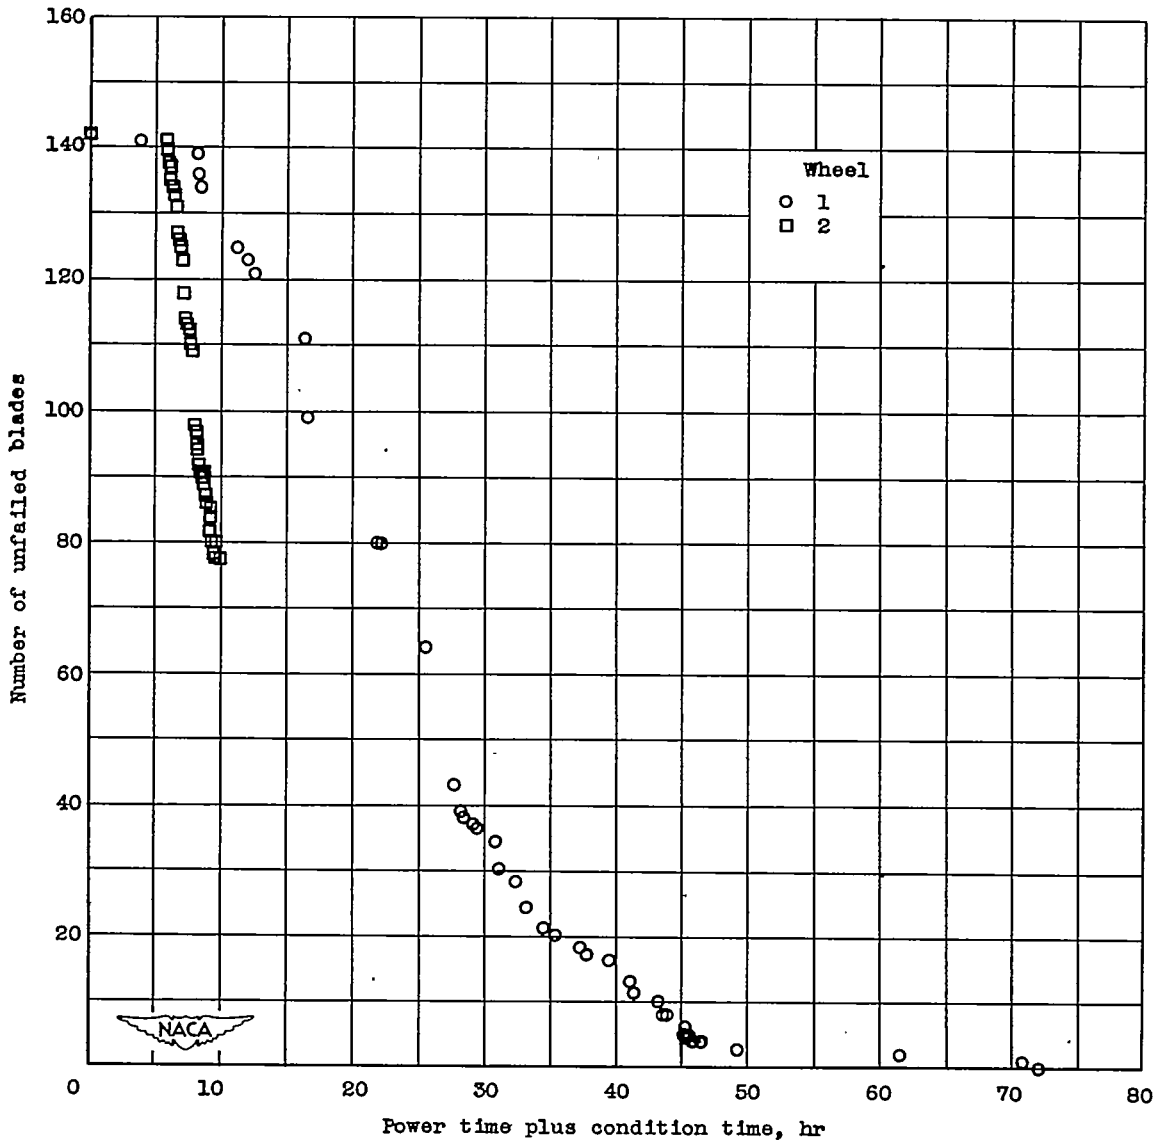
Wheel 1. - The failures for wheels 1 and 2 are summarized in
tables I and II, respectively. The blade failures experienced
appeared to be of the stress-rupture type, in combination with other
effects. The distribution of blade failures for wheel 1 are shown
in figure 5. The abscissa is the total of power and condition times

Figure 5. - Distribution of time to blade failure for wheel 1.
