PREDICTION OF FAILURE PRESSURE AND LEAK RATE OF STRESS CORROSION CRACKS*

S. Majumdar, K. Kasza, J. Y. Park, and S. Bakhtiari
Energy Technology Division
Argonne National Laboratory
Argonne, IL 60439 USA

January 2002

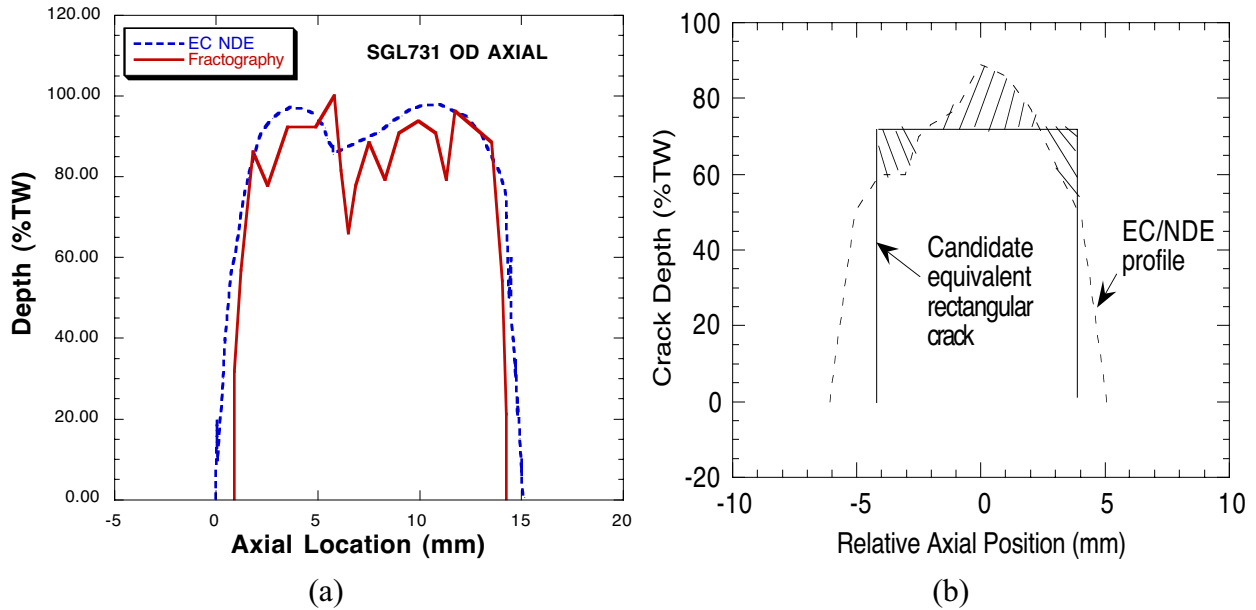
A typical crack depth profile of an SCC is shown in Fig. 1a. No widely accepted models are available for predicting the ligament failure pressure of such SCCs. From a limit analysis viewpoint, it can be argued that the collapse behavior of a crack tip ligament with an irregular point-by-point variation of crack depth should be similar to that of a crack with a smoothed-out, "average" crack-depth profile. Local variations in crack depth and geometry are smoothed out in the EC measurements because the EC signals are averaged over a finite volume, and hence, the EC data tend to show a relatively smooth variation of crack depth along the crack length (for example, Fig. 1a). For the present, we assume that the average profile measured by the dvanced EC/NDE method is the one that is relevant for limit analysis. From the viewpoint of this assumption and plastic collapse of the ligament, the tube profile has a smoothly varying average ligament thickness (or crack depth), although the real crack may have short throughwall segments at a number of locations (deep SCCs sometimes leak when pressurized with 0.3 MPa air, but do not have measurable water leak rates until much higher pressures).

The equivalent rectangular crack is determined from the measured crack depth profile by considering all possible candidate crack lengths ($\leq$ full crack length, an example is shown in Fig. 1b), determining the equivalent depths by equating areas (e.g., the hatched areas in Fig. 1b) so

Fig. 1.   (a) Crack depth profile in specimen SGL-731 as measured by EC/NDE and fractography and (b) a typical candidate equivalent rectangular crack.

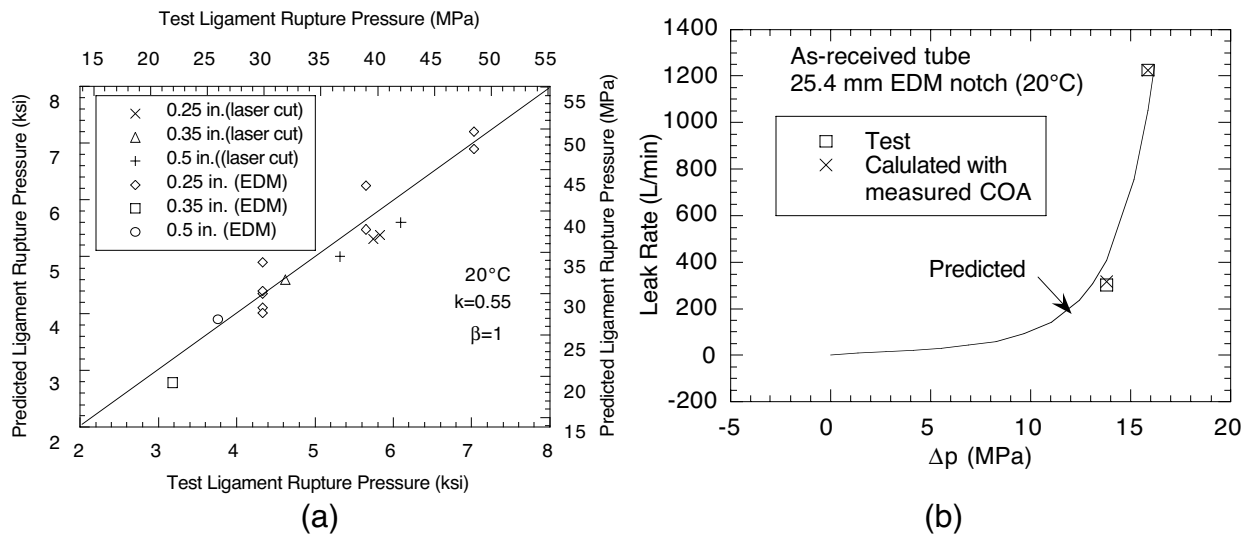
Both the ligament rupture pressure and leak rate equations have been validated with tests on rectangular machined notches at ANL.[5] Examples are shown in Figs. 2a and 2b.

Fig. 2.   (a) Predicted vs. observed ligament rupture pressures for rectangular electrodischarge machined (EDM) and laser cut flaws and (b) calculated (solid line) vs. experimentally measured (symbols) leak rates for 22-mm (7/8 in.)-diameter tube with 25.4-mm (1 in.) throughwall axial EDM notches. Cross symbols (x) in Fig. 2b denote calculated leak rates using posttest measured crack opening areas (COAs).

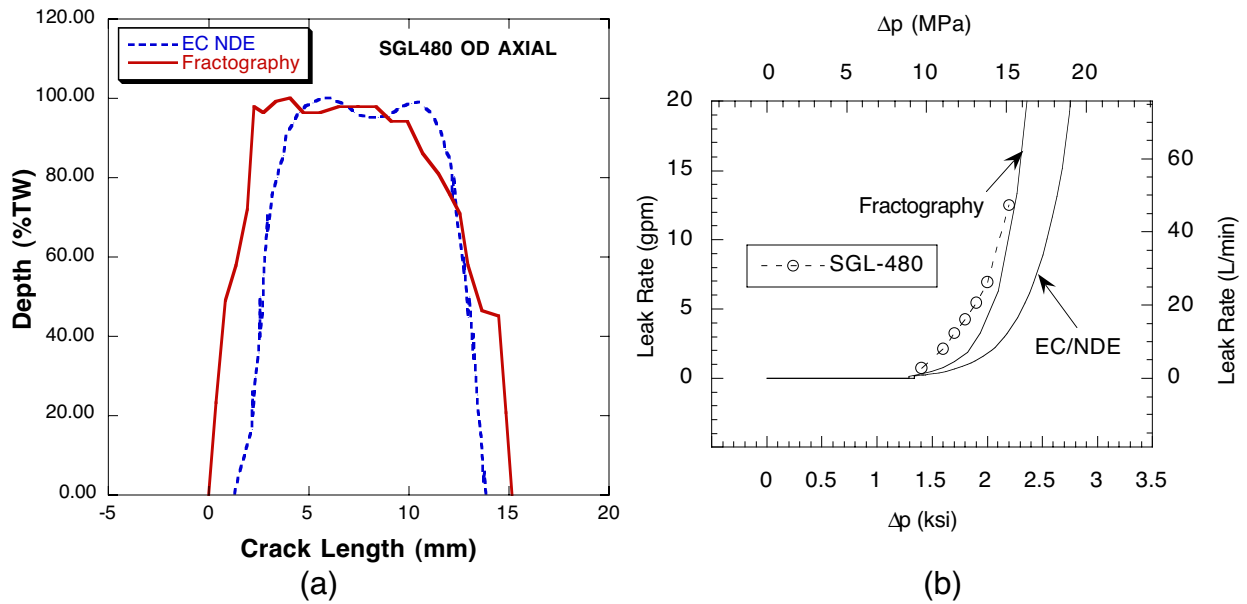
Figure 3a shows the crack depth profiles of specimen SGL 480 measured by pre-test NDE and post-test fractography. The predicted ligament rupture pressures corresponding to the NDE and fractography profiles are 9.2 and 8.9 Mpa,. respectively, compared to the experimentally measured pressure of 6.2 MPa at onset of first leakage. At the final test pressure of 15.1 MPa, the throughwall crack length is predicted to be 10.7 and 12.7 mm by the NDE and fractography profile, respectively. The measured leak rates (Fig. 3b) follow the predicted curve reasonably closely. The post-test OD view of the crack (Fig. 4) shows the open portion to be ≈ 12.7 mm. Both the final crack length and the final leak rate are closer to the predictions based on fractography than NDE.

Fig. 3.   (a) Crack depth profiles in specimen SGL 480 measured by pre-test EC and post-test fractography and (b) measured (symbols) and predicted (based on NDE and fractography depth data) pressure vs. leak rate plots for Test SGL-480. Room temperature.

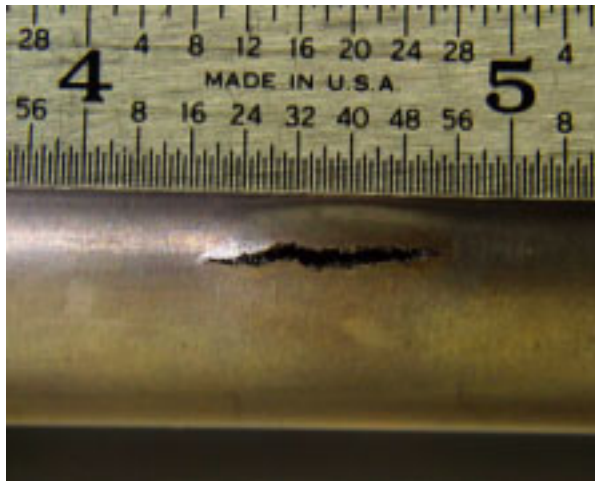
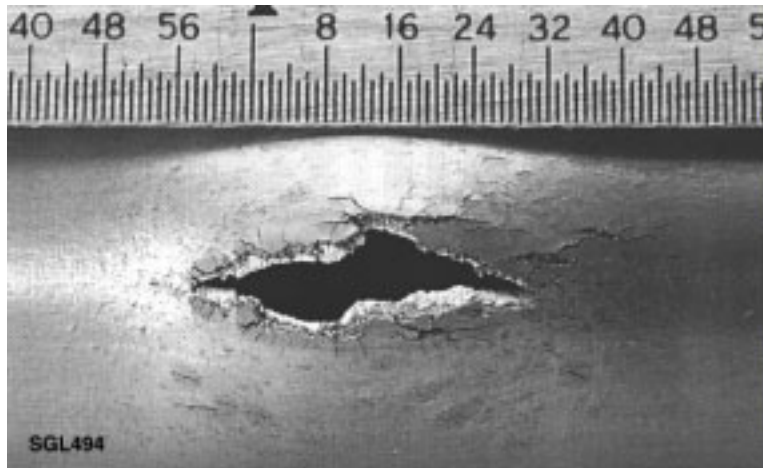
*Fig. 4.   Post-test view of the OD surface of specimen SGL 480*

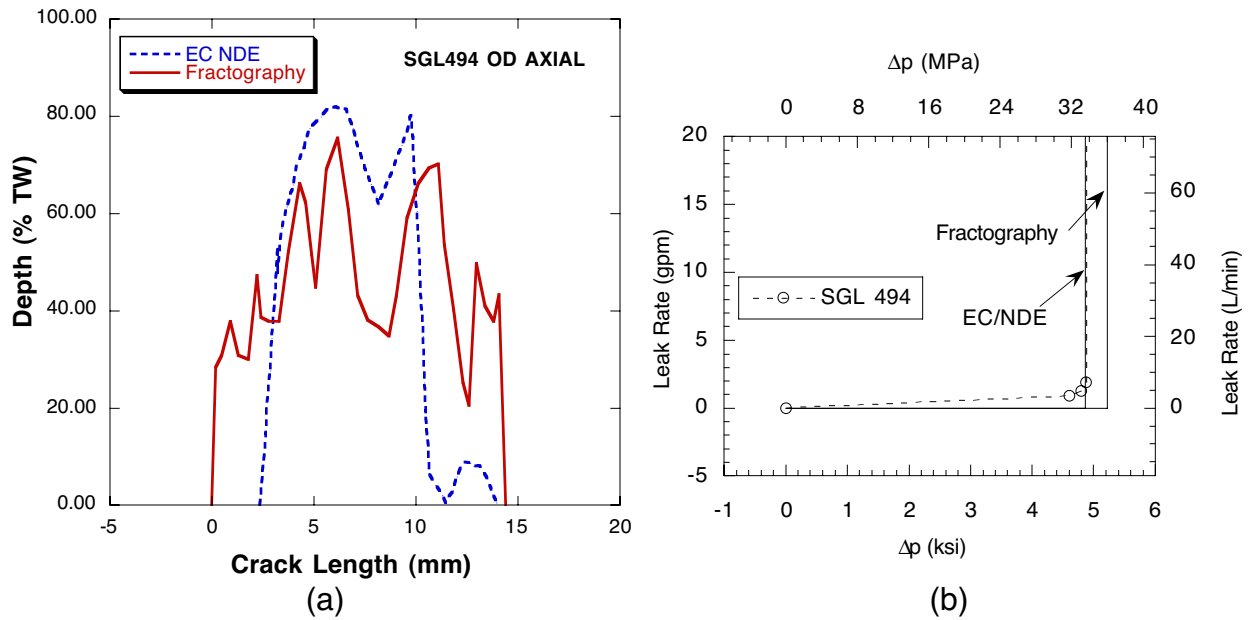
The crack depth profiles of specimen SGL 494 measured by pre-test NDE and post-test fractography are shown in Fig. 5a. The ligament rupture pressures corresponding to the NDE profile and fractography profile are 33.1 and 35.9 MPa, respectively. Both profiles predict the crack to become unstable after some crack growth. The leak rates are also predicted to increase rapidly immediately after ligament rupture (Fig. 5b). The test showed the leak rate to increase from zero to almost 47.3 L/min abruptly at a pressure of 32-33 MPa. The post-test OD view of the crack (Fig. 6) shows that itsopen portion is much larger compared to that of SGL 480 (Fig. 4), and the evidence of tearing at the crack tip suggests that this specimen was close to burst, as predicted.

Fig. 5.   (a) Crack depth profiles in specimen SGL 494 measured by pre-test EC and post-test fractography and (b) measured (symbols) and predicted (based on NDE and fractography depth data) pressure vs. leak rate plots for Test SGL-494. Room temperature.

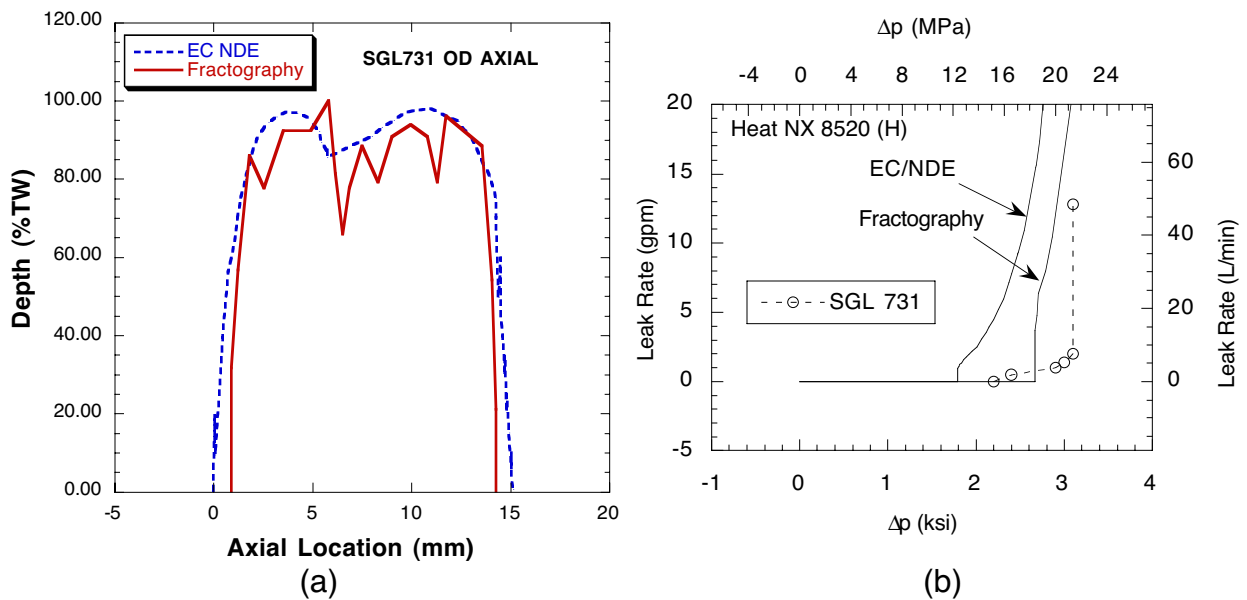
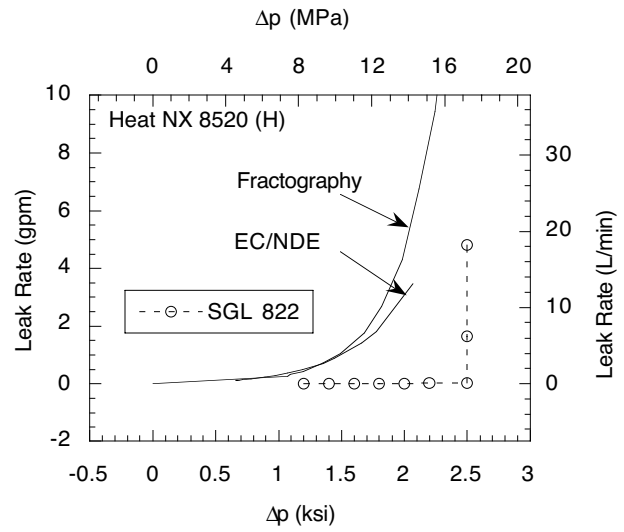
Figure 8a shows the depth profiles as measured by EC/NDE and fractography for an as-received specimen (later used in test SGL-731). Figure 8b compares the predicted and experimental pressure vs. leak rates for test SGL-731, which was conducted at room temperature. Similar comparisons for a high-temperature test, SGL-822, are shown in Figs. 9a and 9b. Both fractography and EC/NDE results indicated significant throughwall penetration of the crack for SGL-731. As a result, the leak rates are predicted to start at very low pressures. In contrast, test SGL-822 showed no measurable leakage before 14 MPa (2 ksi) pressure. During a 30-min hold at 17 MPa (2.5 ksi), the leak rate in this specimen increased from 6 to 18 L/min (1.6 to 4.8 gpm). Currently, we do not have the ability to predict such time-dependent increase of leak rate at constant pressure.

Fig. 8.   (a) Crack depth profiles by EC/NDE and fractography and (b) predicted and measured pressure vs. leak rate plots of test SGL-731. Room temperature.

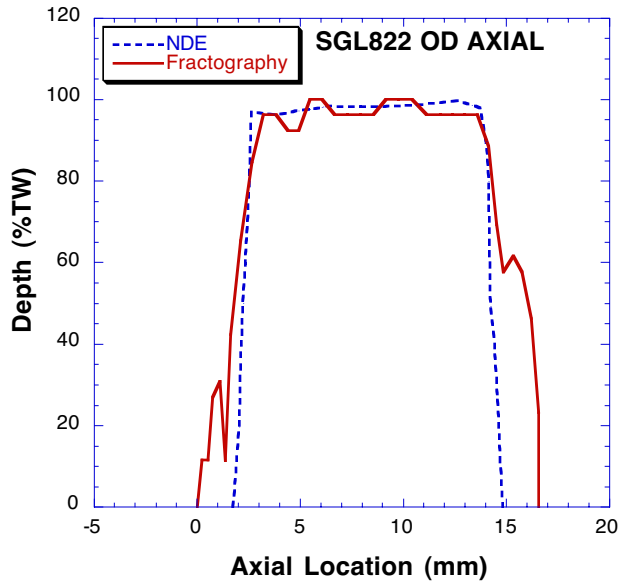
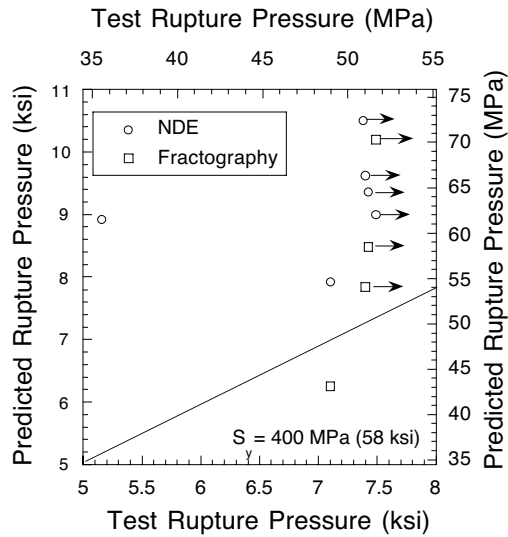
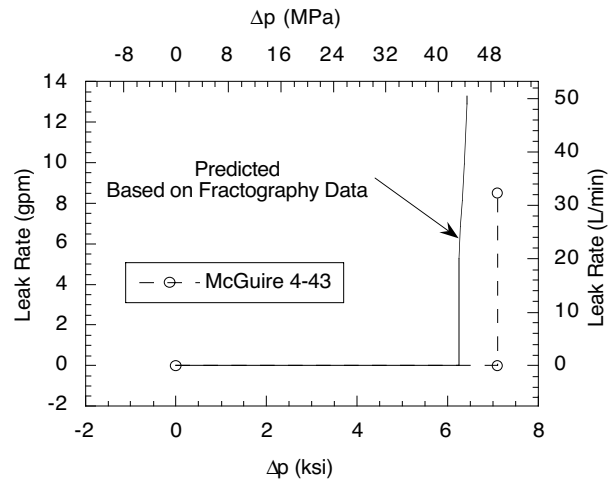
Fig. 9.   (a) Crack depth profiles by EC/NDE and fractography and (b) predicted and measured pressure vs. leak rate plots of test SGL-822. Test temperature = 282°C.

Fig. 10.   (a) Observed vs. predicted rupture pressures for McGuire tubes (right arrows indicate no rupture) and (b) observed and predicted pressure vs. leak rats for McGuire test 4-43-2.
