Fukushima Daiichi Accident Study (Status as of April 2012)

Sandia National Laboratories

Abstract

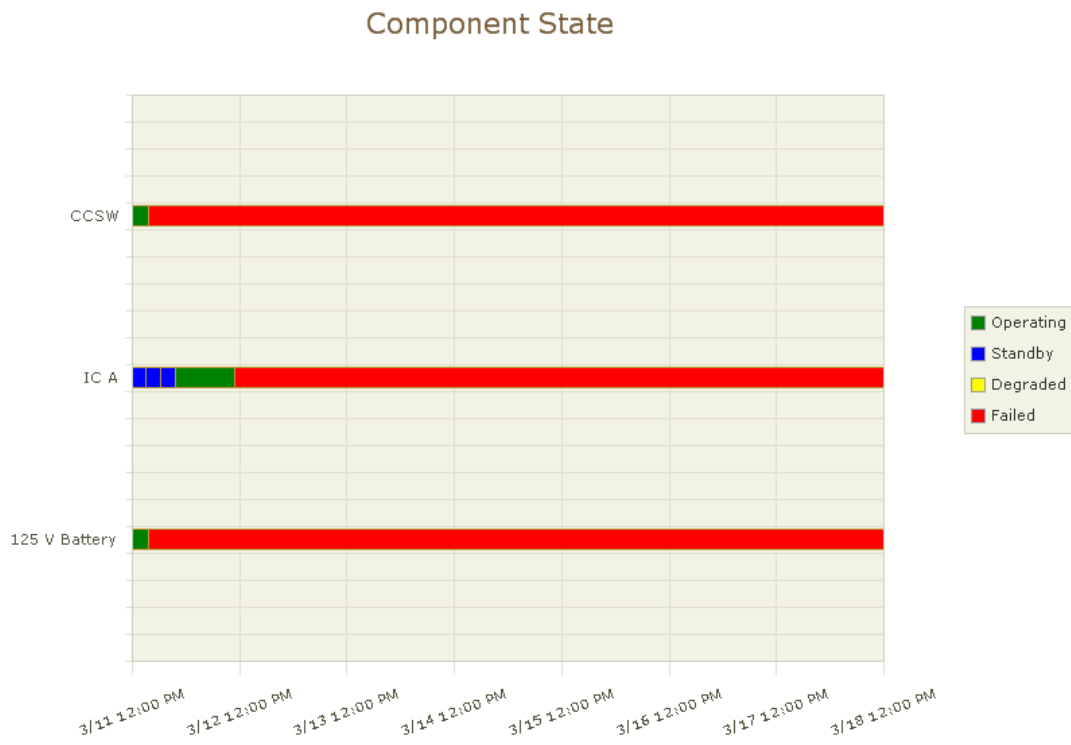
In Figure 5, we see that the DC Power system and Service Water System worked for a short period of time following the earthquake (the green region on the status chart) but then was failed (on March 11, 2011) effectively at the time of the tsunami. The Isolation Condenser A (IC A) was initially in standby, then worked, but eventually failed later on March 11, 2011. This detail can be seen simply by changing the starting/ending date/time options. .

Figure 5. Output from the Component State Chart View.

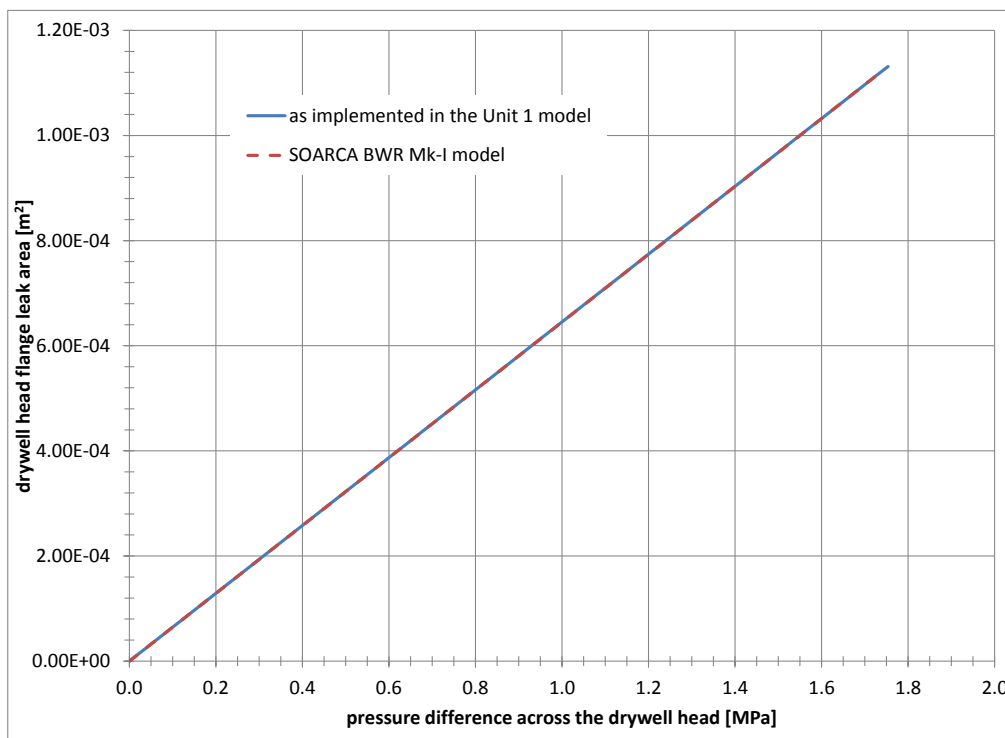
During the initial Unit 1 model development it was noted that the MELCOR containment pressure results after RPV depressurization were consistently lower than the TEPCO containment pressure data. This was due to the drywell head beginning to lift (in the MELCOR analysis), and hence venting the containment into the reactor building, at a pressure of 82 psig (0.565 MPa) (the value from the SOARCA BWR/4 Mk-I model). In order to better match the TEPCO containment pressure data during the period of sustained and nearly constant high pressure, based on the presumption that the leveling off of the observed pressure was likely due to leaking at the drywell head flange, the MELCOR curve for DW pressure versus leak area was adjusted upwards by 4 psig (0.026 MPa) (see Figure 22). Without this adjustment, the MELCOR model would predict the sustained maximum containment pressure at a lower value (82 psig [0.565 MPa]).

Figure 22. Drywell Head Flange Leakage versus Containment Pressure.

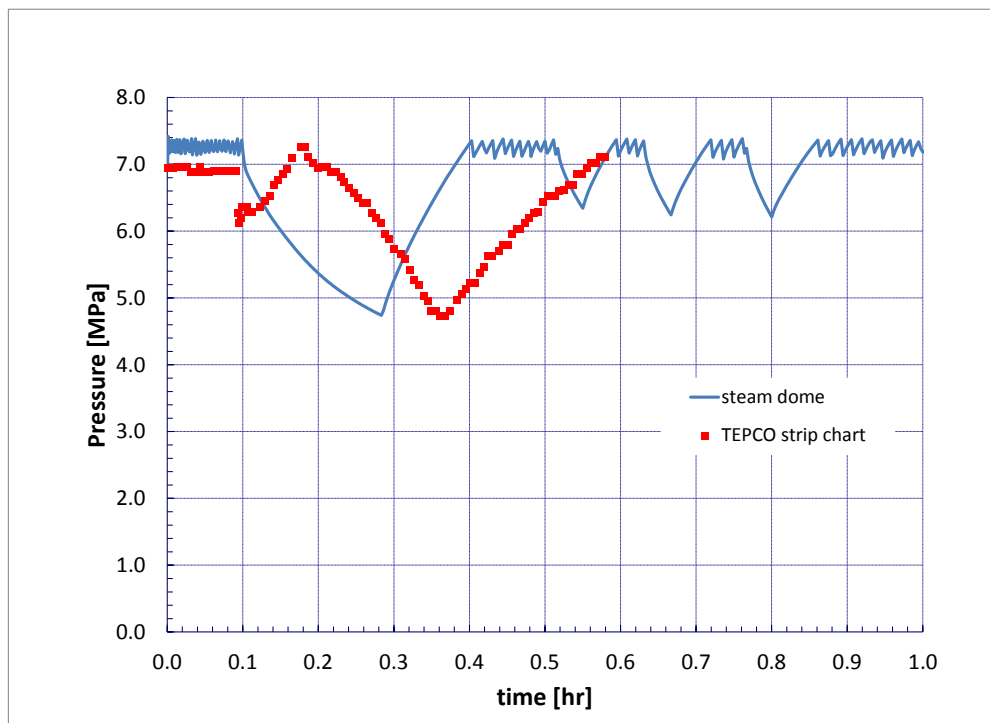
Figure 24. MELCOR Predicted RPV Pressure Response during Operation of the Isolation Condensers, Compared with TEPCO Strip Chart Data (Unit 1).

With loss of heat rejection, the RPV pressure thereafter remained at the SRV setpoint as shown in Figure 24, with steam from the vessel venting through the SRV to the suppression pool as water was lost from the primary system. The loss of water through the cycling SRVs led to core uncovering in a short period of time as shown in Figure 25.

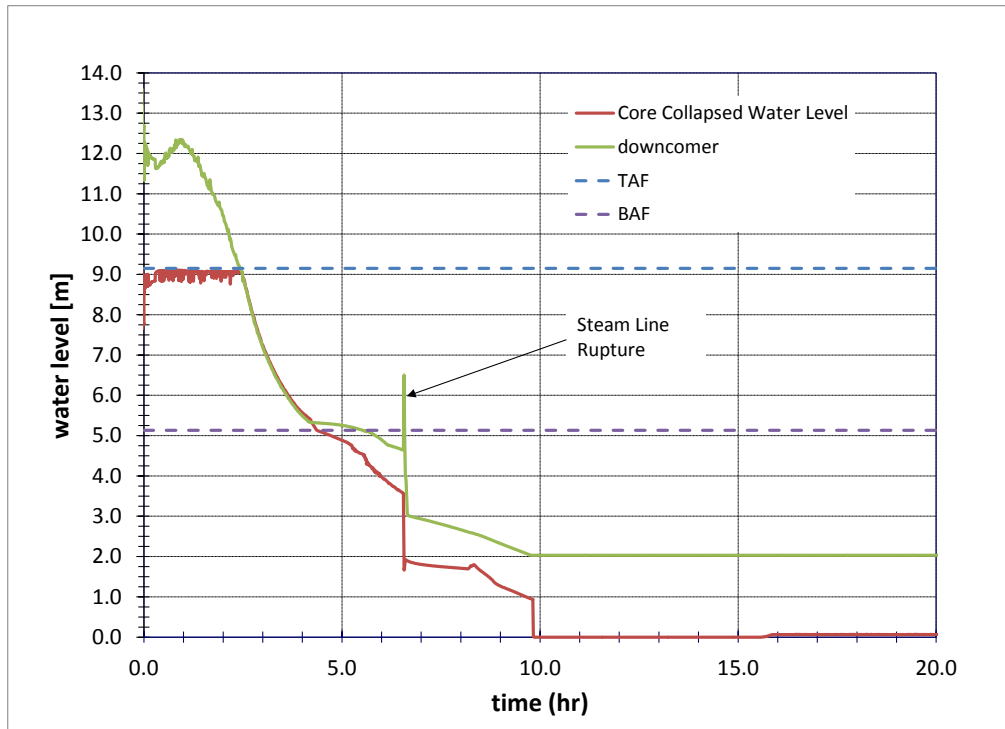
Figure 25. MELCOR Predicted Water Level in the Reactor Core and Downcomer Regions (Unit 1).

As the core water level decreased, initially the steam generation cooled the exposed fuel rods; but as the water level dropped to near the bottom of the active fuel, the steaming rate had diminished to a sufficiently low level that the rods were no longer convectively cooled and heatup commenced. After fuel cladding temperatures exceed 1300 to 1400 K, steam-oxidation of the Zircaloy cladding becomes significant, producing an increased fuel heat-up rate from the exothermic oxidation reaction, as well as producing hydrogen from the reaction with steam. Fuel heatup is shown in Figure 26.[15] Note that by four hours, core damage and hydrogen generation had initiated (see Figure 26, Figure 27 and Figure 28). The generation of hydrogen gas at 4 hr would later render the isolation condensers ineffective when they were subsequently activated

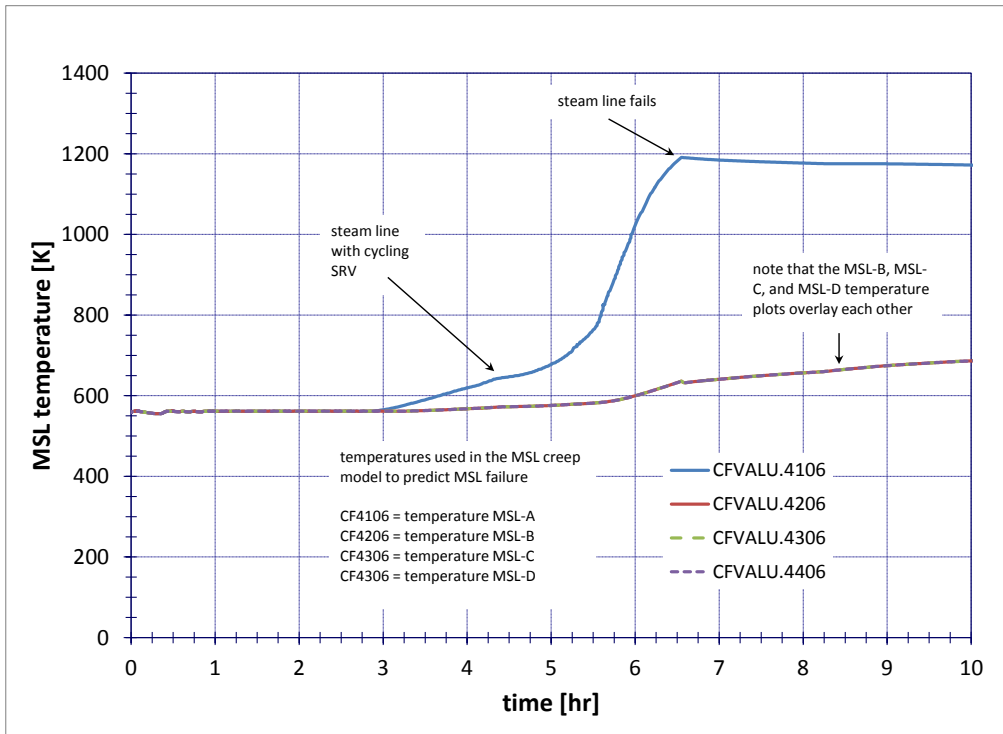
After 5 hr the model shows that core exit gas temperatures began to significantly increase, with superheated steam and hydrogen gas flowing into the main steam line associated with the cycling SRV. Steam line temperatures are shown in Figure 29. This hot gas heated the steam line significantly, and because the reactor pressure was high (at the lowest SRV set point), thermal creep in the hottest steam line eventually led to failure of the main steam line[16] and a depressurization of the RPV at about 6.6 hours as seen in Figure 30. This integrity of the pressure boundary for over five hours and the loss of pressure boundary sometime thereafter predicted in the model is consistent with the available data (see Figure 30) which shows the RPV held pressure for more than 5 hours but underwent a significant decrease by 12 hours.

Figure 29. MELCOR Predicted Steam Line Temperatures (Unit 1).

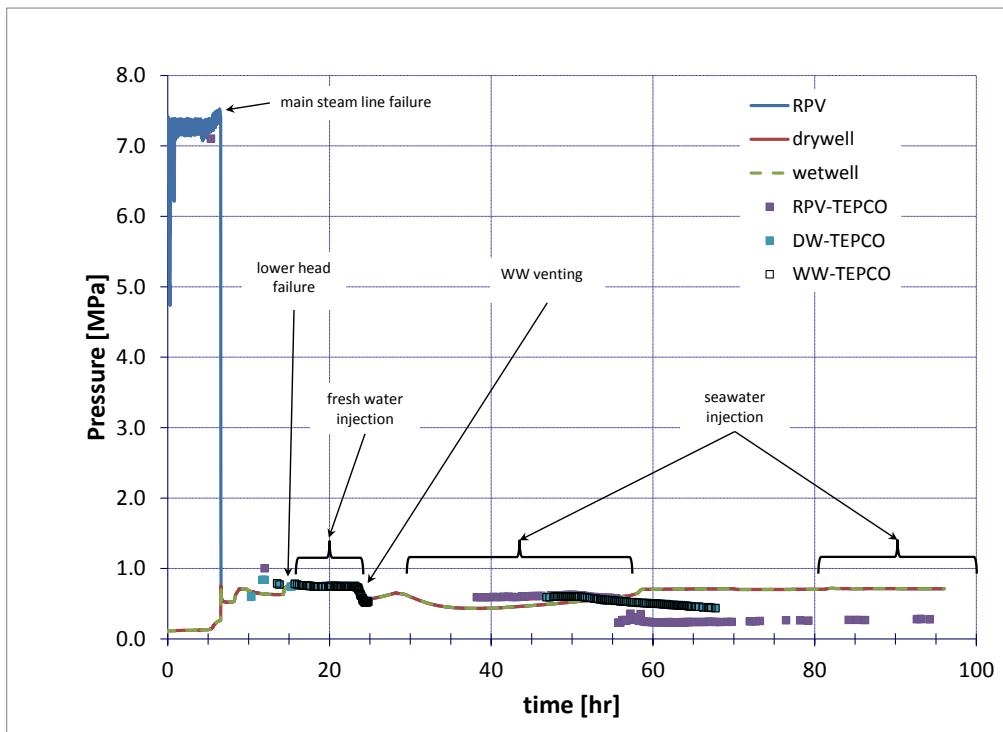
In the Unit 1 timeline drywell venting is reported to have been attempted at 18.32 hr after reactor scram. However, examination of the TEPCO pressure data shows no drop in drywell pressure at this time (see Figure 30 in Section 4.1), and subsequently TEPCO has stated that venting did not occur. It appears that that while actions were taken to vent the drywell, they were unsuccessful. Therefore, this event is not implemented in the MELCOR model.

Figure 30. MELCOR RPV and Containment Pressure Prediction Compared to TEPCO Data (Unit 1).

Note that the limited TEPCO pressure data for the RPV, drywell, and wetwell compare reasonably well with the MELCOR prediction. While main steam line failure was predicted by MELCOR, an alternative scenario is also deemed possible where the cycling SRV seizes open due to excessive cycling and high temperature gases degrading the valve. While not documented in this report, predicted drywell pressure for the alternative "stuck-open" SRV case does not compare as favorably with the measured values, producing a lower post-blowdown DW pressure. This is due to more RPV thermal energy being deposited in the still subcooled suppression pool.

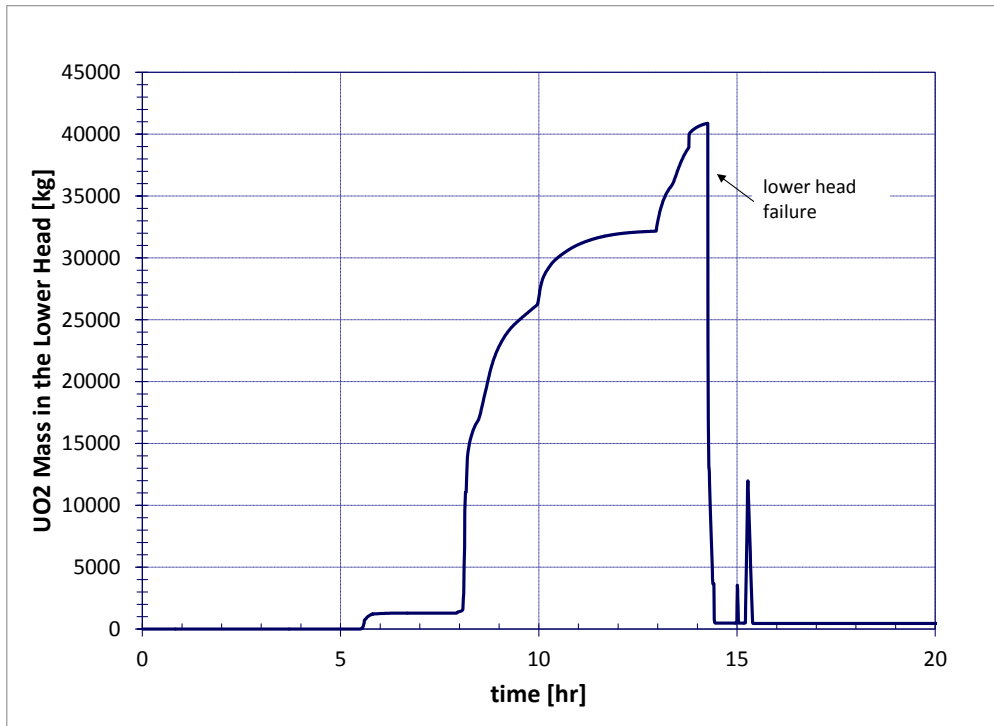
After 5.5 hr, core materials begin to accumulate in the lower vessel head region (see Figure 31), drying out the lower plenum water and heating the vessel head, and by 14 hours, lower head failure is predicted to occur by melting of the head wall, as seen in Figure 32. Some 139,000 kg of core materials (UO_2, Zr, Stainless Steel, and oxides) and lower vessel head steel is predicted to have accumulated on the lower reactor cavity concrete following head failure (see Figure 33). The relocated material is mostly solid (i.e., particulate debris). Due to its low temperature (see Figure 37) the relocated core debris does not move from the pedestal cavity region (CAV 0) to the cavity regions adjacent to the drywell liner (CAV 1 and 2) (see Figure 20).

Figure 31. MELCOR Predicted Accumulation of Fuel Materials in the Lower Plenum Region of the Reactor (Unit 1).

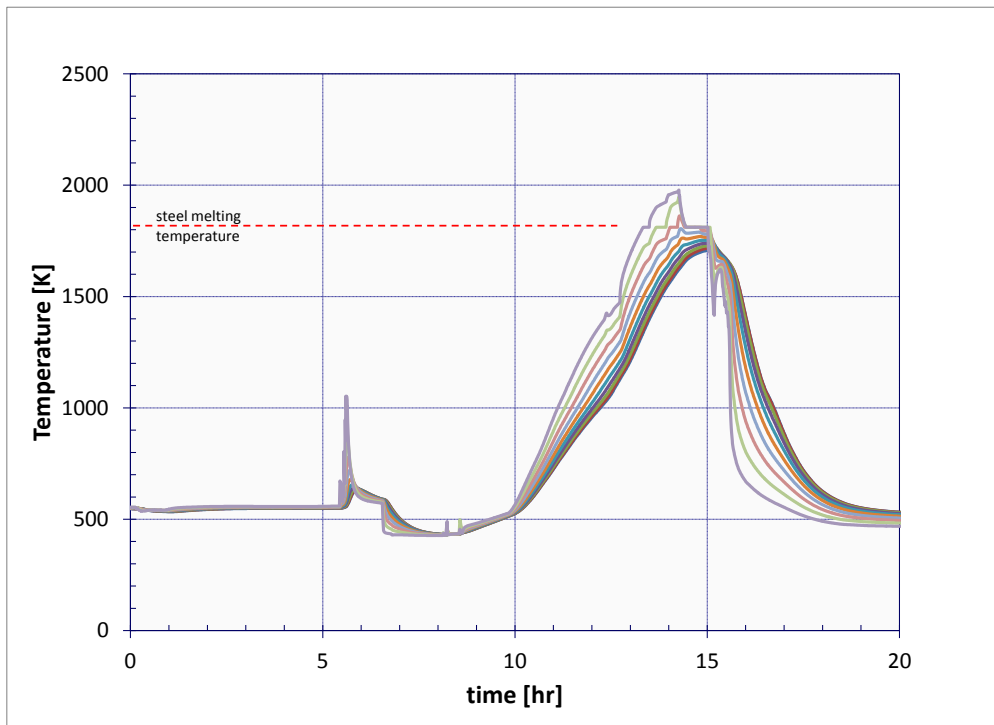
Figure 32. MELCOR Predicted Lower Head Wall Node Temperatures (Unit 1).

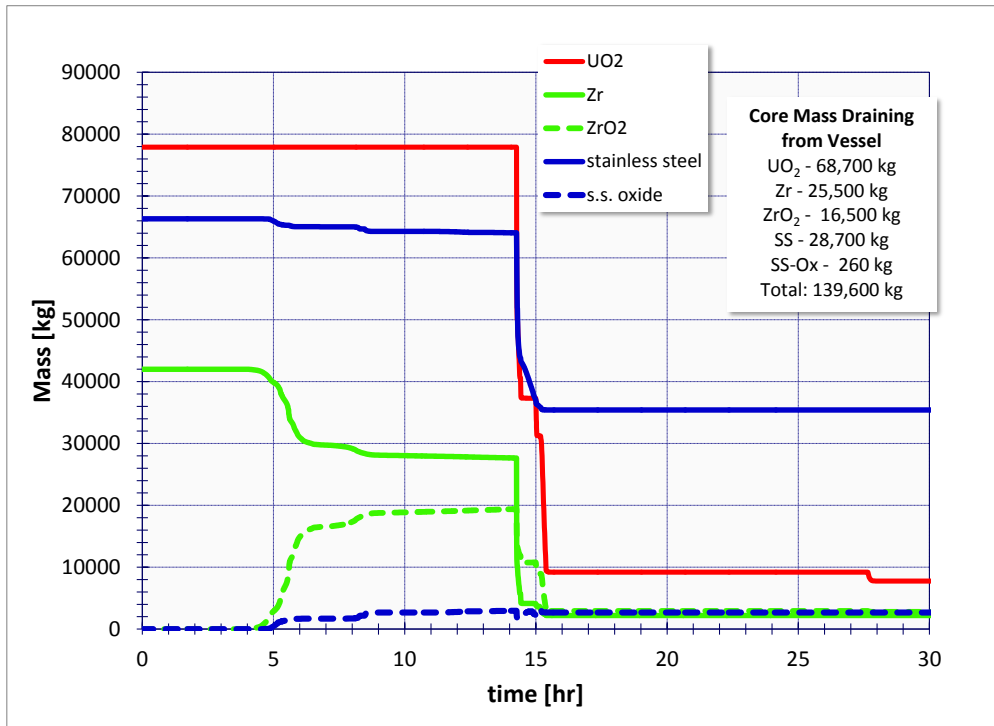
Figure 33. MELCOR Predicted Mass Remaining in the Vessel on Failure of Lower Head (Unit 1).

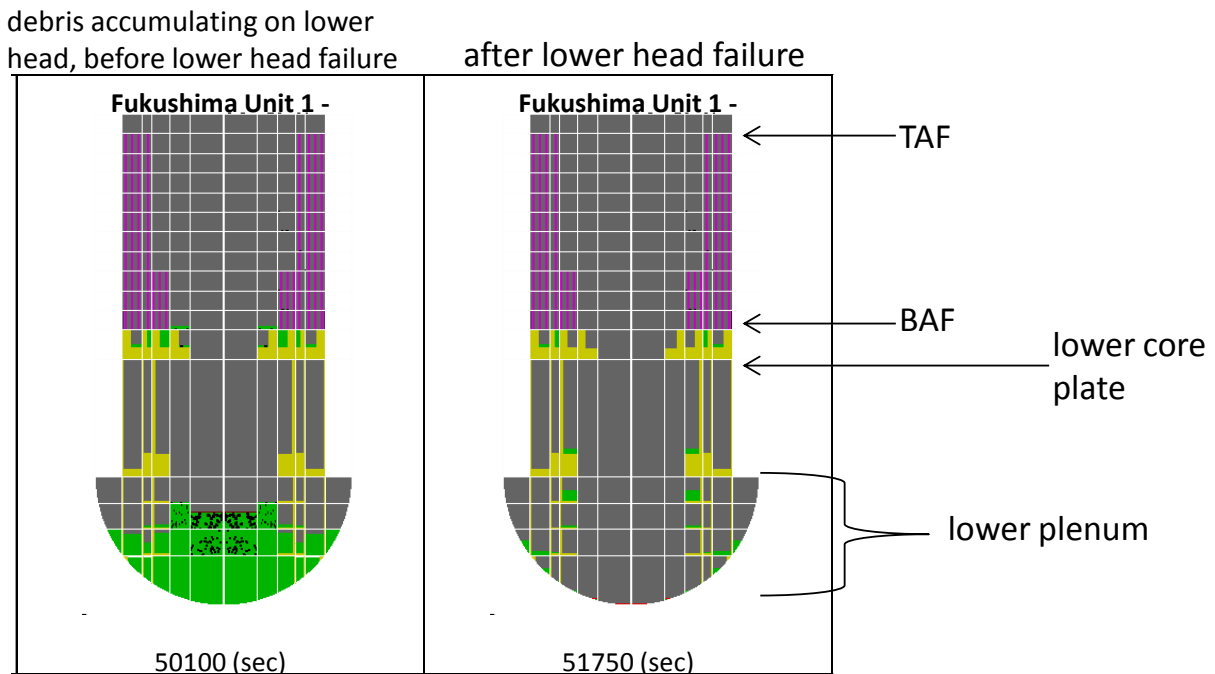
Figure 34. MELCOR Predicted Core Damage State near Time of Lower Head Failure (Unit 1). NOTE: Some intact fuel assemblies remain in the core region.

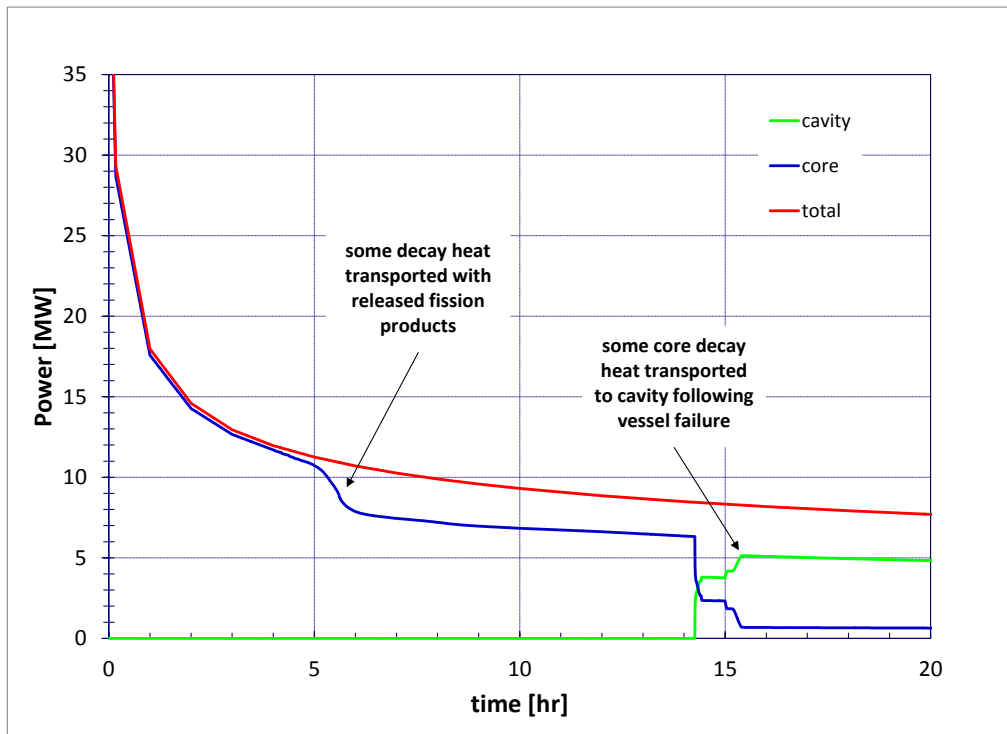
Figure 35 shows the predicted redistribution of decay heat, accounting for fission product release and transport in the RPV and relocation of decay heat bearing materials to the lower cavity region.

Figure 35. MELCOR Predicted Distribution of Decay Heat During Core Damage: Fuel Releases Diminish In-Core Decay Heating and Vessel Failure Transfers Decay Heat from Vessel to Cavity (Unit 1).

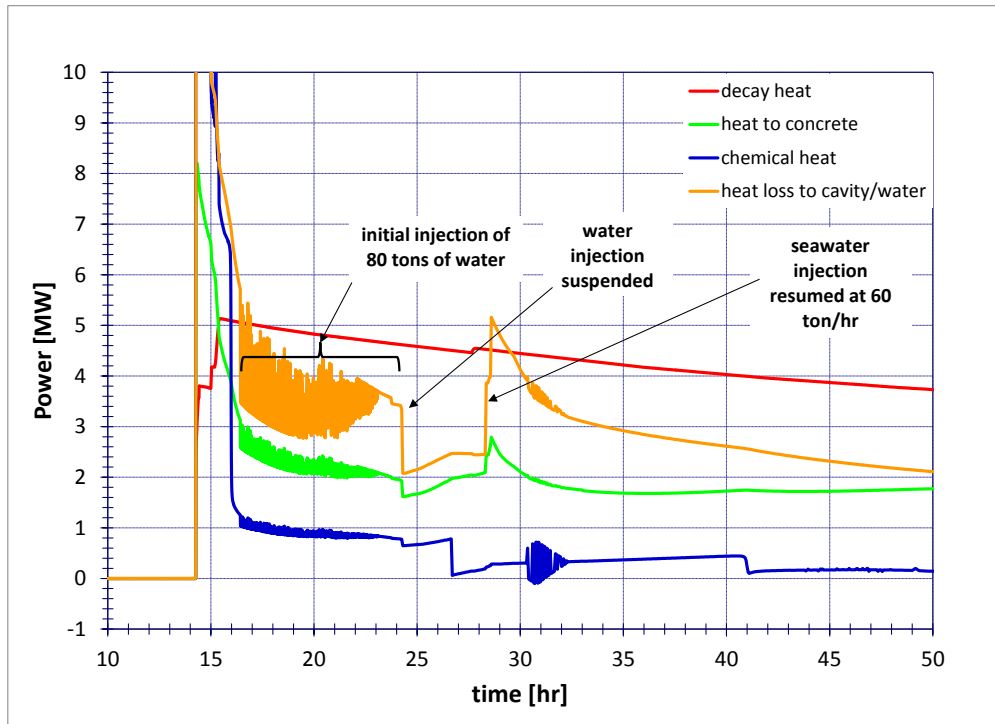
The heat generated from the exothermic chemical heating and the fuel decay heat in the reactor cavity region is shown in Figure 36, along with the heat transfer to the seawater that was being dumped onto the cavity floor through the vessel breach.

Figure 36. MELCOR Predicted Decay Heat and MCCI Chemical Heat in the Reactor Cavity (Unit 1)

NOTE: The enhanced cooling of the MCCI at ~15 hours is due to seawater entering the cavity through the vessel rupture.

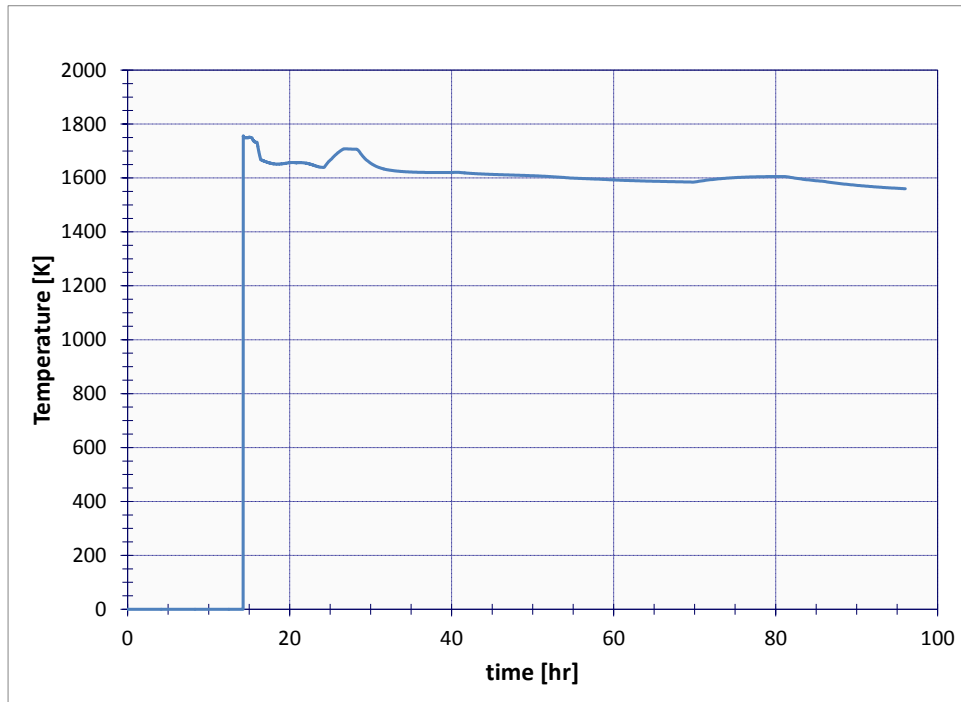
The temperature of the core-concrete interaction hovers just above the ablation temperature, indicating a relatively low intensity molten core-concrete interaction (MCCI), as shown in Figure 37. The MCCI both melts and erodes the concrete, and produces non-condensable gases from concrete decomposition (CO, CO_2) and H_2 from the oxidation of metals in the core melt, principally Zr and stainless steel, and steam. The MELCOR-predicted erosion depth from the cavity MCCI is about 1.5 meters by 30 hours.[17]

Figure 37. MELCOR Predicted Temperature of Core-Concrete Interaction Materials (Unit 1).

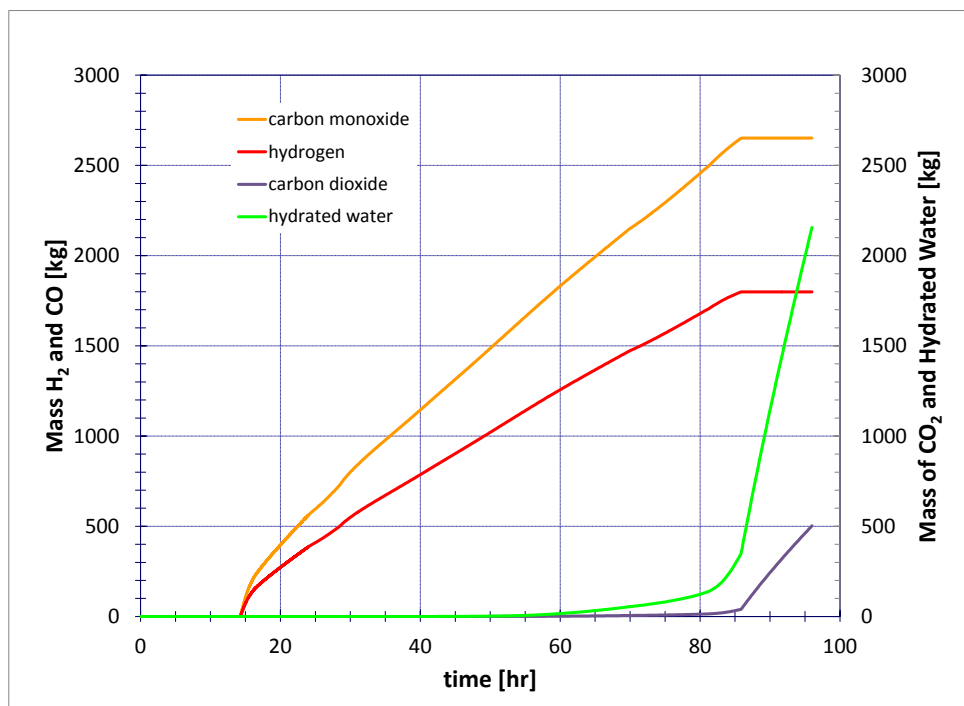
The MCCI reaction products are shown in Figure 38. Nearly 600 kg of CO and 400 kg of H_2 are produced by 24 hours, roughly the time at which manual containment venting was achieved. These non-condensable gases, which are released to the reactor drywell containment volume, occupy considerable volume when compared to the free volume of the reactor drywell. These gases cause the pressure in the drywell to rise to the point that the drywell head bolts are elastically strained, opening a vent path to the refueling bay at the upper drywell head flange region. The vent path opens just enough to relieve the gas generation and hovers at a value of about 0.7 MPa (110 psi) as seen in Figure 39 where calculated and measured drywell pressures are shown. Notice that when the manual containment venting operation is accomplished just before 24 hours, the drywell pressure is decreased to below the value required to maintain the head bolt strain for leakage and the head flange leak is predicted to stop thereafter. The strain in

Figure 38. MELCOR Predicted Reaction Products from Core-Concrete Interaction (Unit 1).

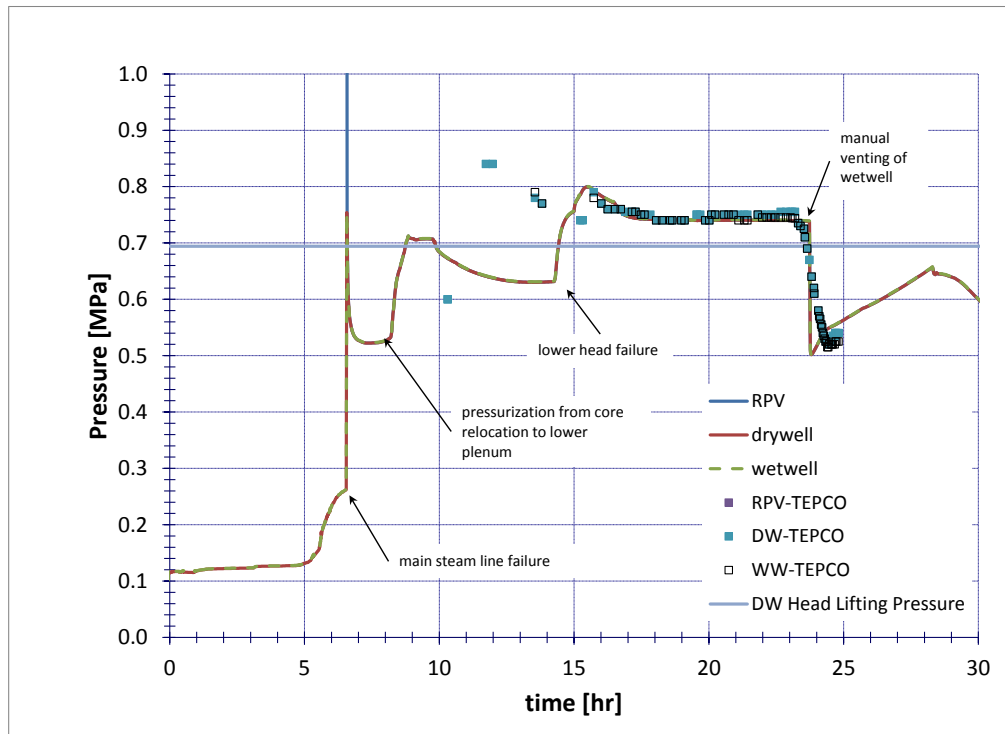
Figure 39. MELCOR Predicted Containment Pressure During the MCCI Gas Generation Phase Up To the Point of Manual Containment Venting (Unit 1).

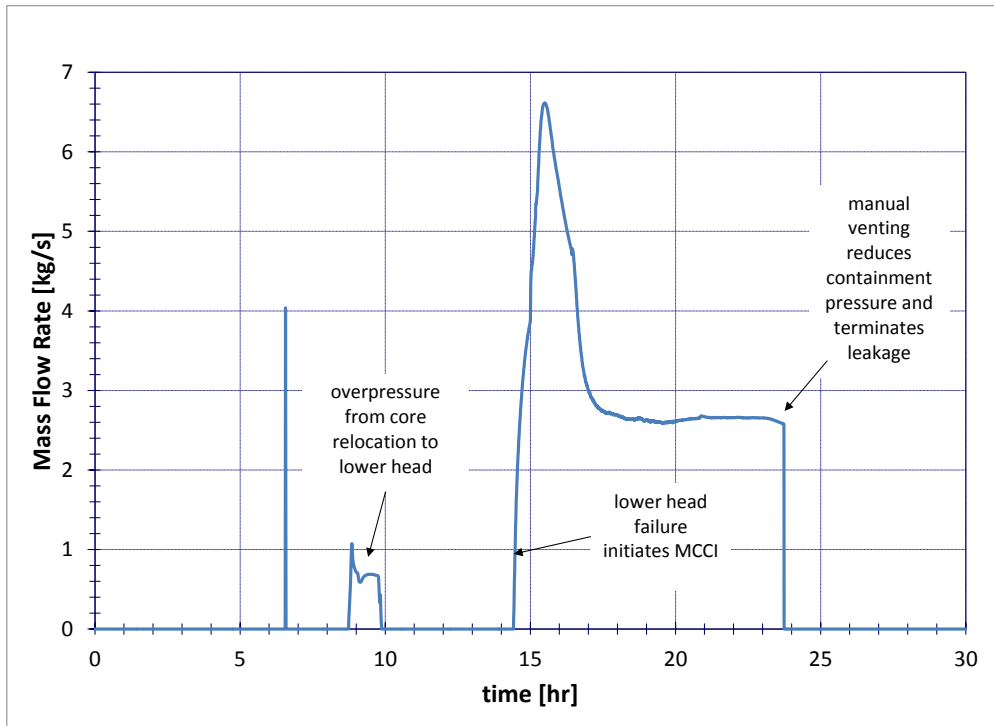
The leakage through the head flange region is shown in Figure 40. Notice that there is a momentary leak caused by the transient pressurization when the steam line failed; however, the principal leak initiated at ~14 hours when the core materials exited the failed vessel head and began to interact with the concrete. Note also that a large constituent of the leaking gases is actually steam, initially from the boildown of water residing in the cavity from the earlier steam line rupture, and later from the addition of water to the RPV (which goes to the cavity) at ~15 hours.

Figure 40. MELCOR Predicted Mass Flow of Gases and Steam through Drywell Head Flange Leak (Unit 1).

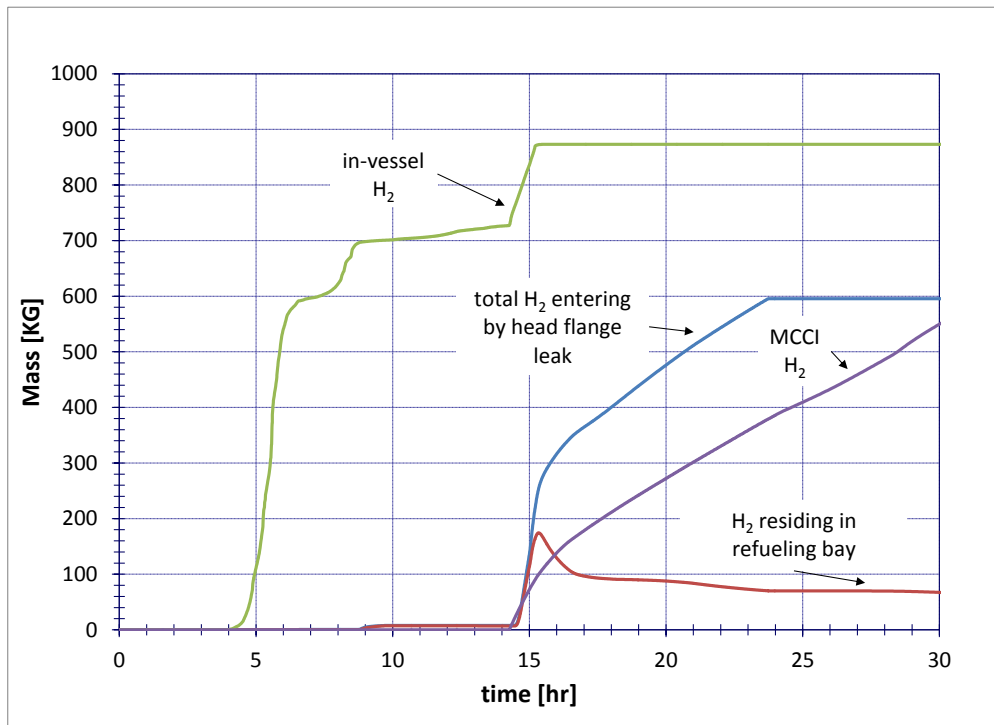
Figure 41 shows the total hydrogen produced in-vessel and through MCCI, as well as the total mass of hydrogen leaked into the refueling building, and the instantaneous mass of hydrogen resident in the refueling bay.

Figure 41. MELCOR Predicted Hydrogen Generation, Total Transport through Head Flange Leak, and Amount Resident in Refueling Bay (Unit 1).

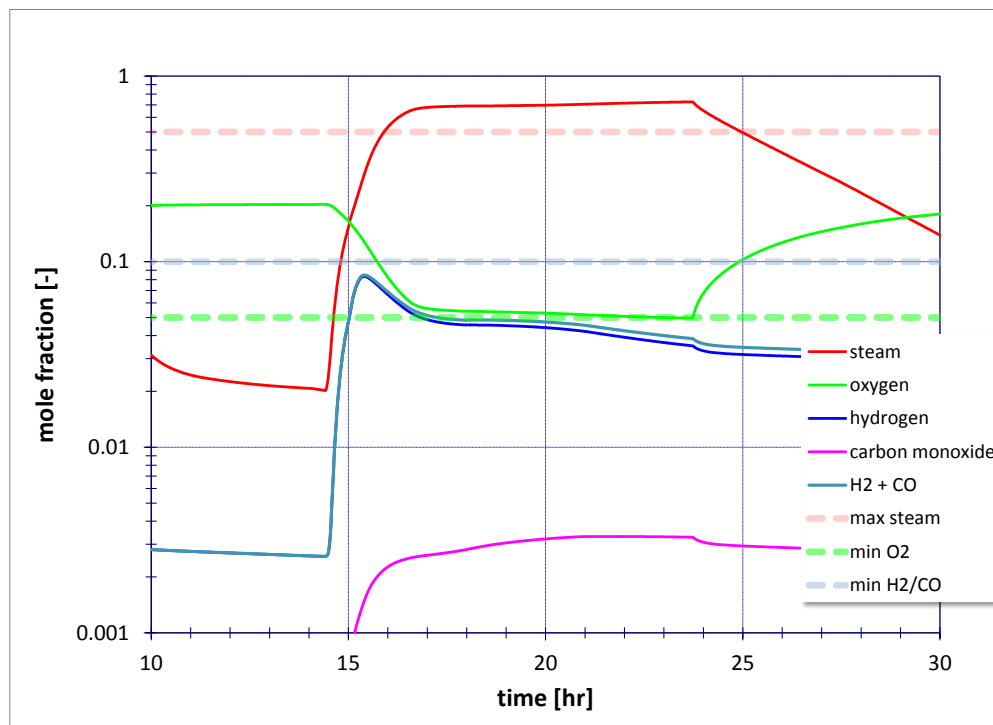
As can be seen in Figure 42, for the most part, up until the venting operation, the steam molar concentration in the refueling bay is greater than 50%, effectively inerting the environment in spite of accumulation of ~100 kg of hydrogen and ~100 kg of CO.

Additionally, the mole fraction of the combustible CO and H_2 are generally below 10%, also discouraging spontaneous ignition. The manual venting operation just prior to 24 hours, however, led to profound changes in the refueling bay atmosphere, resulting in conditions supporting deflagration of the CO and H_2 gas,[18] as will be described as follows.

Figure 42. MELCOR Predicted Molar Composition of Atmosphere in the Refueling Bay during the Predicted Head Flange Leak Period. Shown Are Gas Mole Fractions and Min/Max Conditions for Hydrogen Deflagration (Unit 1).

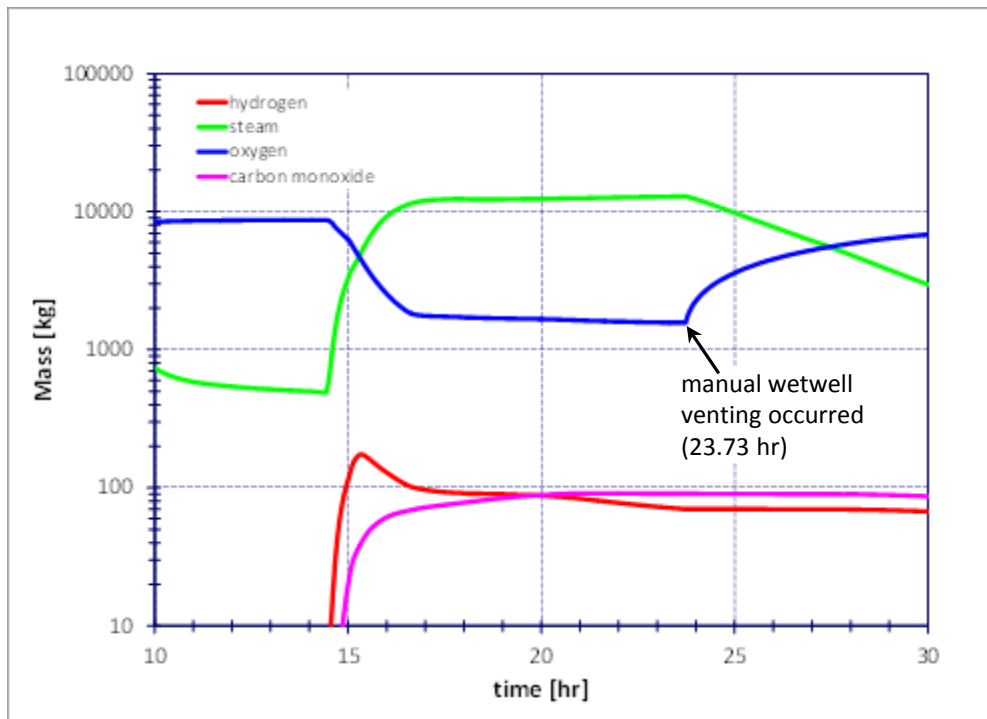
Figure 43. MELCOR Predicted Mass Composition of Atmosphere in the Refueling Bay during the Predicted Head Flange Leak Period (Unit 1).

The manual venting operation just prior to 24 hours reduced the containment pressure as intended; however, this reduction in internal drywell pressure also allowed the drywell head flange bolts to contract and close off the leak path to the refueling bay, thereby terminating the leakage of steam in the building. Up to this point, the continuous steam leakage produced largely from the boiloff of the water injected to the RPV had kept conditions in the refueling bay inert both from high steam mole fraction and by purging oxygen from the building. After the venting operation terminated the leak of steam to the refueling bay, the steam residing within the refueling bay atmosphere began to condense as the building temperatures dropped due to heat losses from the building. The condensation of steam produced a relative vacuum in the refueling bay, which in turn began to draw in air from the outside of the building through the natural leakage paths in the building. This effect both decreased the steam mole fraction and increased the oxygen content, as seen in Figure 43.

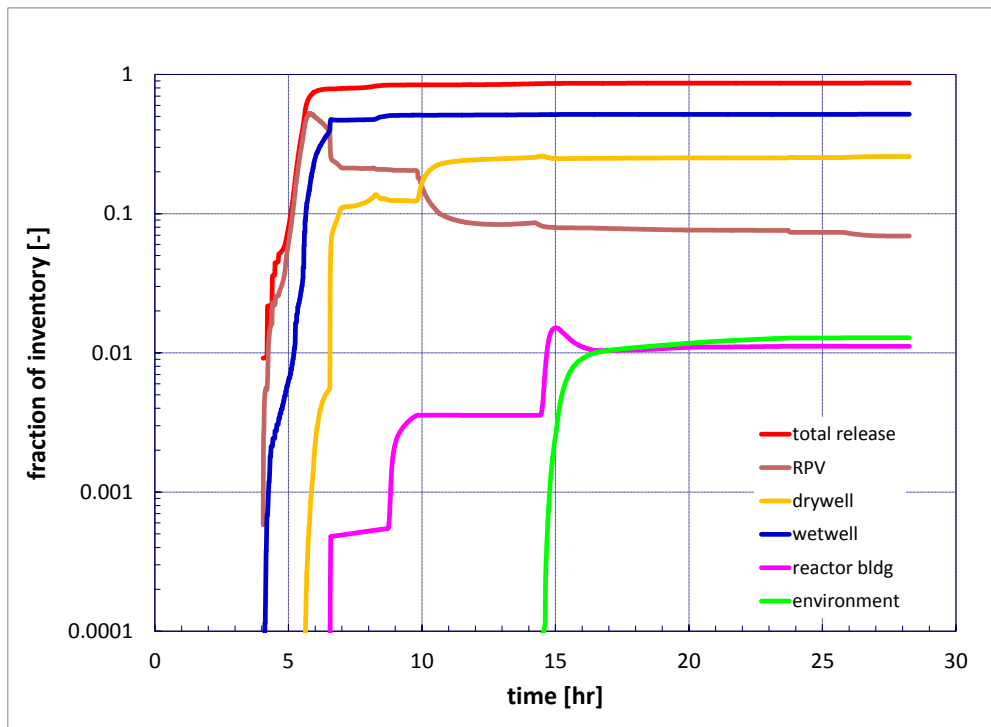
Predicted fission product releases are shown in Figure 44 for cesium iodine (CsI). Environmental releases are predicted to be on the order of 1 to 2 percent of the core inventory.

Figure 44. MELCOR Predicted CsI Distribution (Unit 1).
Note that release to environment from the reactor building explosion is not reflected in this distribution.

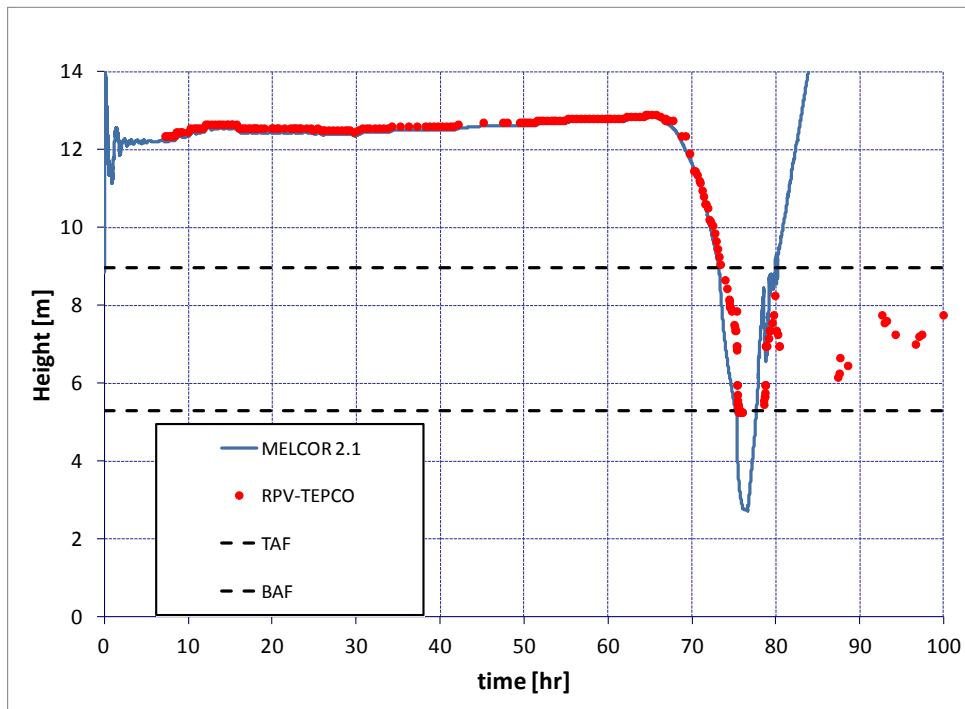
Similar to the events at Unit 1, the tsunami that inundated the site disrupted the remaining power supplies; diesel generators and battery power were lost. RCIC was operating at the time of the station blackout and continued to do so for nearly 70 hours. A determination of the RCIC failure state due to a loss of DC power was not available; therefore, RCIC water injection was modeled to track the available water level data, assuming the data are acceptable, until RCIC was observed to deteriorate and/or fail. In this respect, RCIC injection is treated as a boundary condition to minimize the uncertainty associated with its operational state. The maintenance of RPV water level based on the available level data is presented in Figure 45.

Figure 45. MELCOR Predicted RPV Water Level Compared with TEPCO Data (Unit 2).

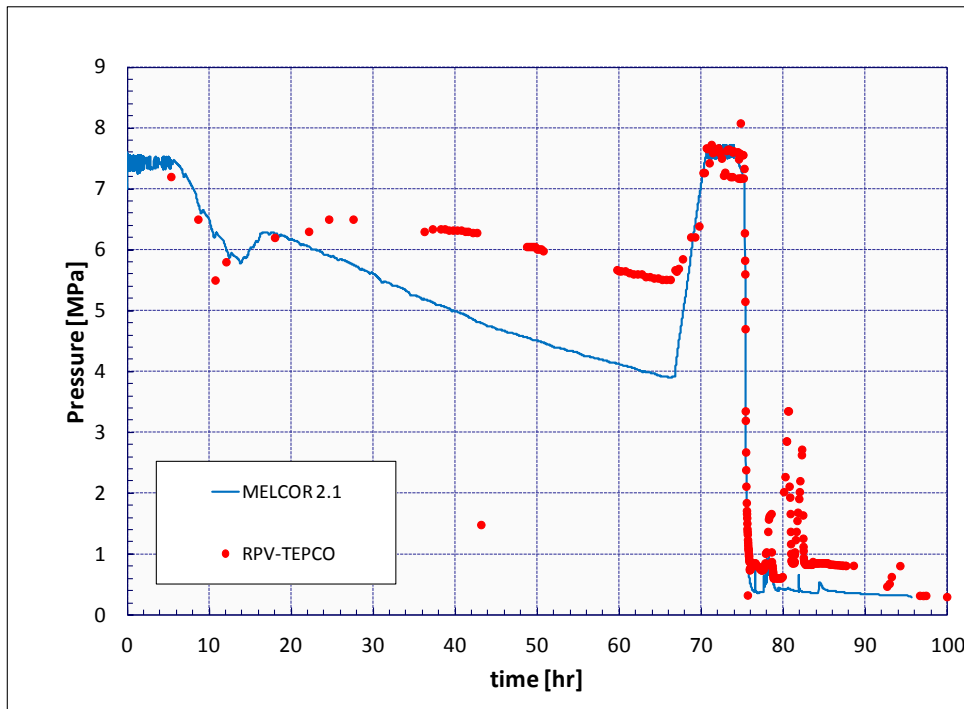
Steam released from the RPV, given expectations of the nominal accident progression, is either due to the SRV cycling or steam utilized for RCIC turbine operation. The RPV pressure trend, Figure 46, depicts a deviation from the SRV cycling set-point when the RPV begins to depressurize and remains below the SRV cycling set-point until RCIC fails. Prior analyses [19, 47] of the RCIC operating at capacity do not predict a depressurization of the RPV throughout the period when RCIC was operational; therefore, a leak from the RPV has been assumed. In addition, it was assumed the cycling SRV failed to completely reseat when the RPV began to depressurize, around 5.33 hrs.

Figure 46. MELCOR Predicted RPV Pressure Compared with TEPCO Data (Unit 2).

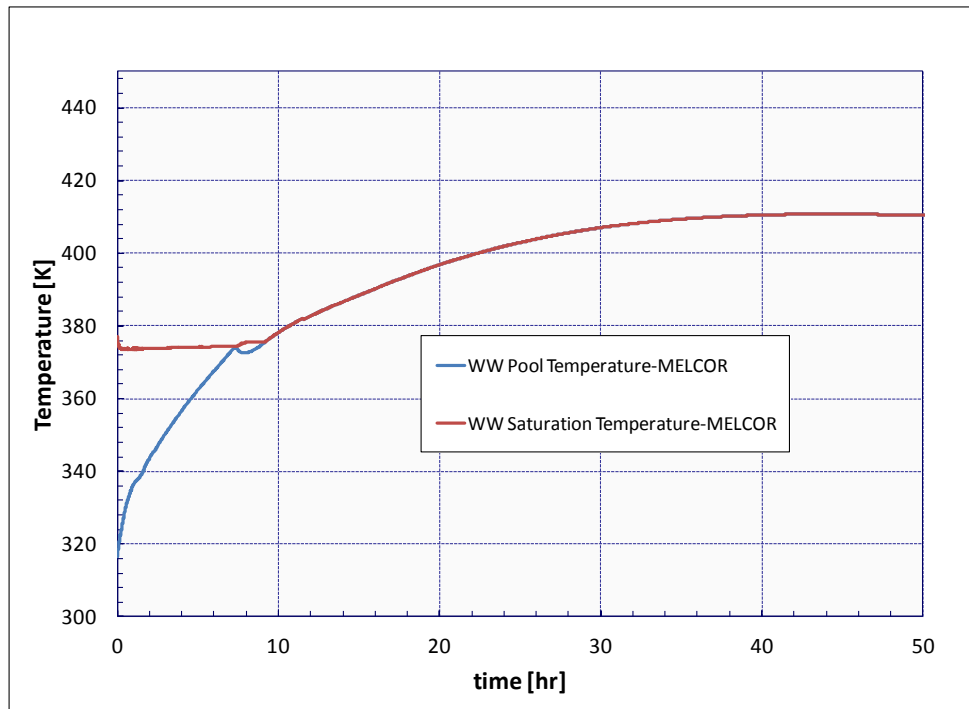
temperature increases, the pool subcooling is diminished and the suppression pool begins to approach saturation condition, as seen in Figure 47. Once saturated, the suppression pool heat capacity is essentially depleted, and thereafter, steam released in the suppression pool fails to condense within the pool and instead passes to the suppression chamber vapor space. Pressurization of the suppression chamber vapor space forces the vacuum breakers connecting the suppression chamber and drywell to open. This releases steam into the drywell pressurizing the drywell as well. The MELCOR analysis predicts saturation of the suppression pool at 9 hours. Once saturated, the pressurization of containment is expedited.

Figure 47. MELCOR Predicted Suppression Pool Water Temperature and Saturation Temperature (Unit 2).

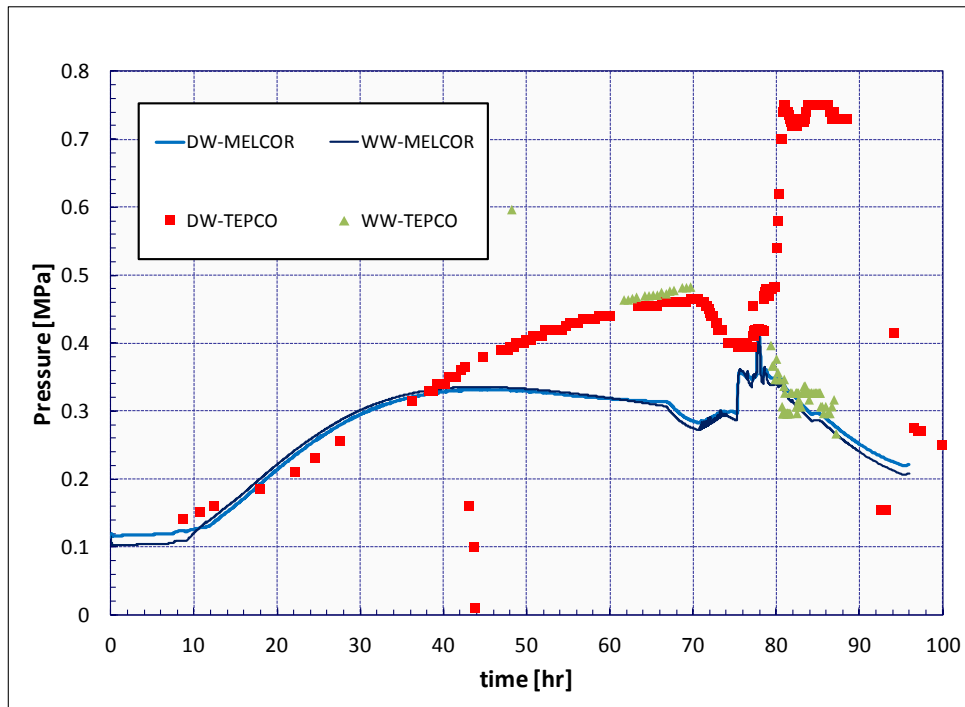
Prior analyses [19, 47] have demonstrated containment pressurization far exceeding the observed Unit 2 containment pressure data. A possible explanation for the observed deviation from the data trend is that a leak has formed somewhere in the containment boundary, reducing the observed pressurization rate. Analyses performed for Unit 2 have assumed an unspecified leak forming in the containment boundary equivalent to a 2-in. diameter hole (see Section 3.6.1.5). Sensitivity to the timing with which the containment breached formed is negligible prior to the suppression pool becoming saturated. Figure 48 depicts the containment pressurization calculated by the analysis.

Figure 48. MELCOR Predicted Containment Pressure Compared to TEPCO Data (Unit 2).
