Fukushima Daiichi Accident Study (Status as of April 2012)

Sandia National Laboratories

Abstract

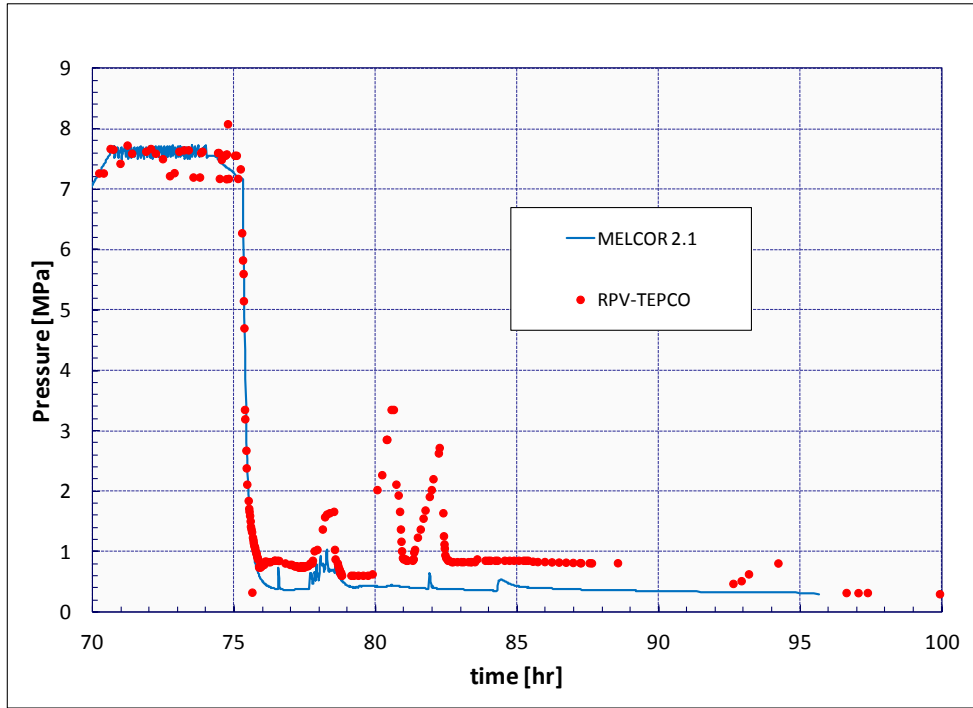
The MELCOR analysis of the RPV response after the system re-pressurized in response to the RCIC failing is presented in Figure 49. During the SRV cycling, the MELCOR trend separates from the SRV actuation set-point earlier than the data. This suggests that in the model water level is no longer in sufficient contact with the active fuel to maintain the steam production rate, resulting in a slow depressurization prior to the operators actuating relief mode operation of an SRV to depressurize the RPV. Given this lower water level, in comparison to the RPV water level data, the amount of core degradation may be overestimated at this point in the analysis.

Following depressurization, sea water injection began. In the analysis, the injection of cold water quickly produces a pressurization response similar to the pressure increase seen at 78 hr. After the second SRV was opened to relieve the pressure, the second pressure excursion, resulting from closing the second SRV, is not apparent in the MELCOR analysis. This would result if the seawater water injection was overestimated. Application of the constant seawater injection rate quickly floods the vessel (see Figure 50). Given the magnitude and rate of the re-pressurization, the available heat capacity of the RPV water inventory is most likely inconsistent. The final pressure excursion seen in Figure 49 is also not present in the MELCOR analysis.

At this time, it is believed that the actual seawater injection is less than assumed in the MELCOR analysis, most likely due to RPV pressure exceeding the effective shutoff head of the injection pumps or some other yet unrecognized leak. The observed RPV pressure spikes after 80 hours suggest quenching of hot fuel by water is taking place, possibly as core materials degrade and fall into the lower plenum of the vessel. This would imply significantly greater core damage than currently captured in this MELCOR analysis. Future analyses should focus on refining the effective seawater injection, giving consideration to the observed RPV pressure.

Figure 49. MELCOR Predicted Late-Time RPV Depressurization Compared to TEPCO Data (Unit 2).

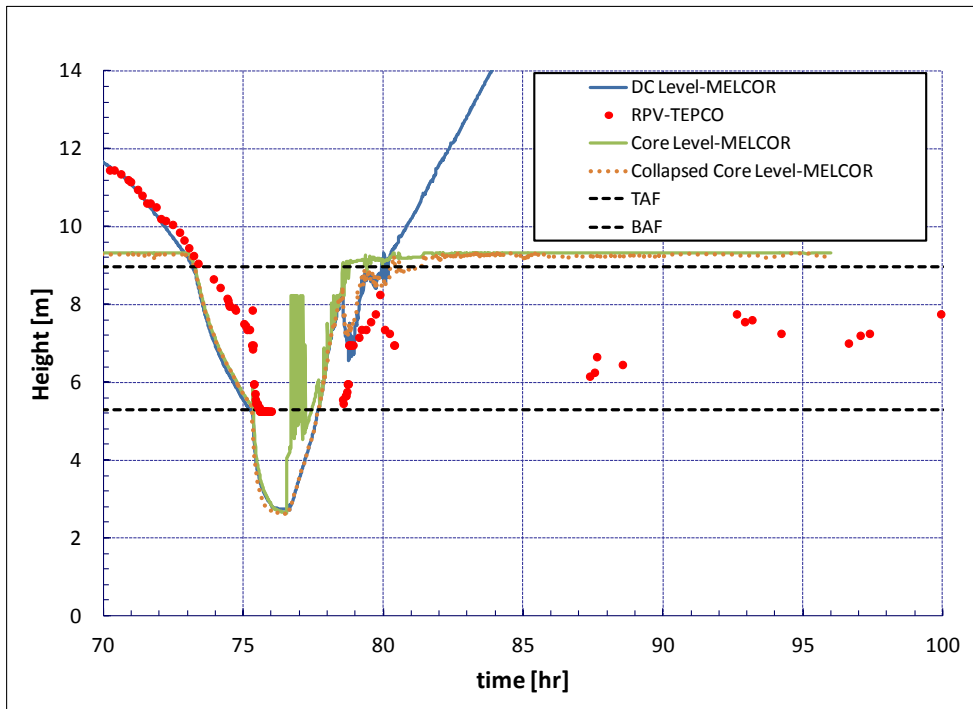
Figure 50. MELCOR Predicted Late-Time RPV Level Compared to TEPCO Data (Unit 2).

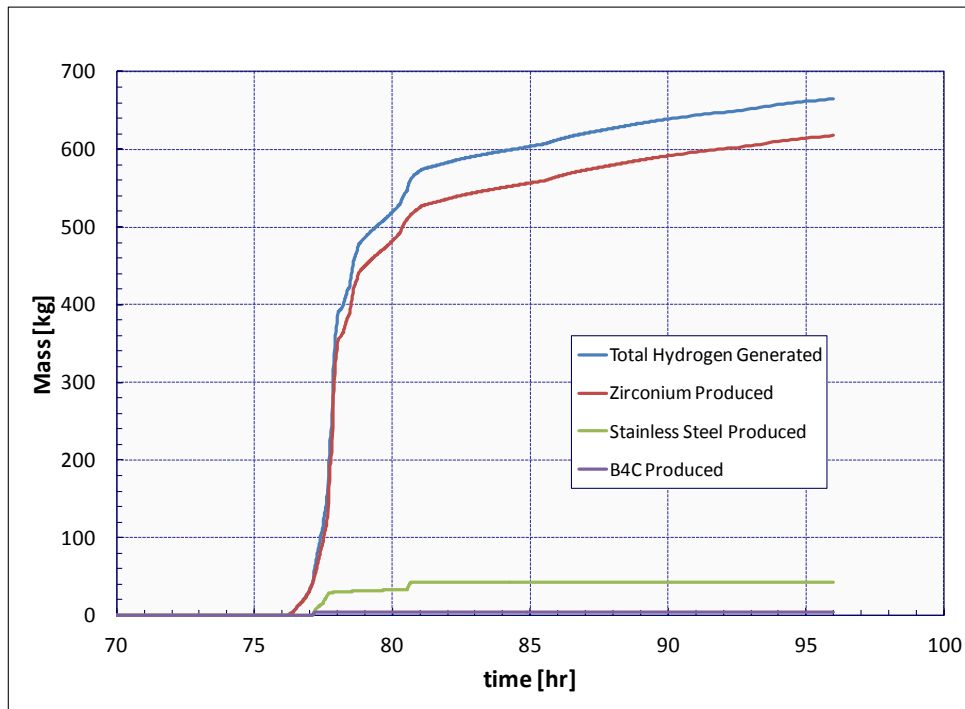
The onset of hydrogen production due to zirconium oxidation, signifying core damage, can be observed from the cumulative hydrogen produced in Figure 51, which occur shortly after the RPV water level falls below active fuel (see Figure 52). Figure 52 depicts the reactor core and vessel at two different points in time (in 2-D cylindrical geometry). The pink material is intact fuel and cladding, blue material is liquid water, yellow material is steel, and green material is particulate debris. The figure demonstrates that MELCOR predicts very little fuel and cladding damage for Unit 2. At 96 hours, only the majority of the top axial node (the top guide level that contains no active fuel) has relocated to the lower core plate as particulate debris. The initiation of the seawater injection near 77 hours rapidly restores water level above the top of active fuel (TAF).

Figure 51. MELCOR Predicted Hydrogen Generation (Unit 2).

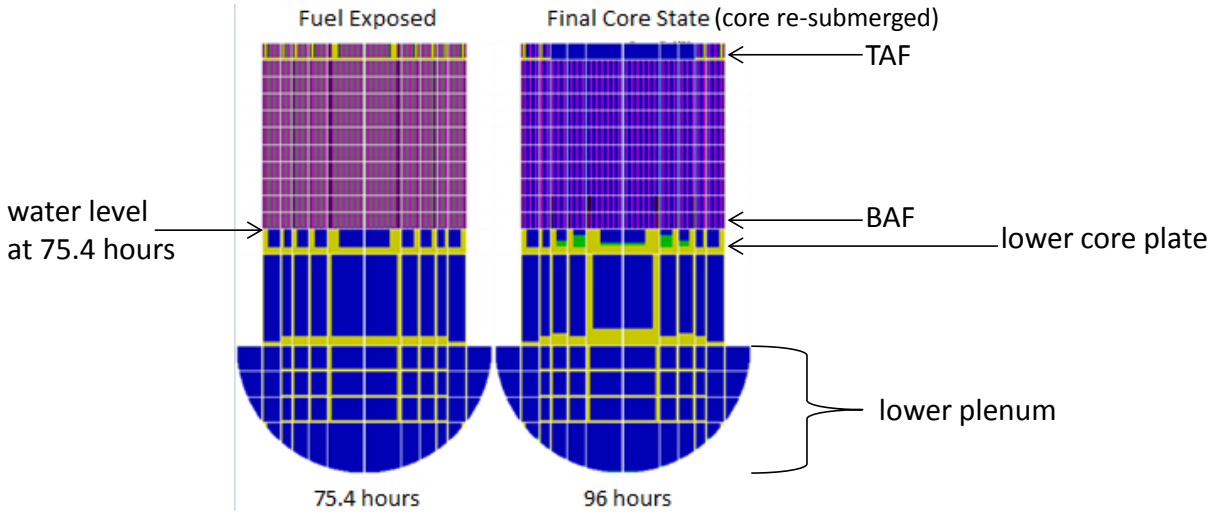
Figure 52. MELCOR Predicted Core Damage States (Unit 2).

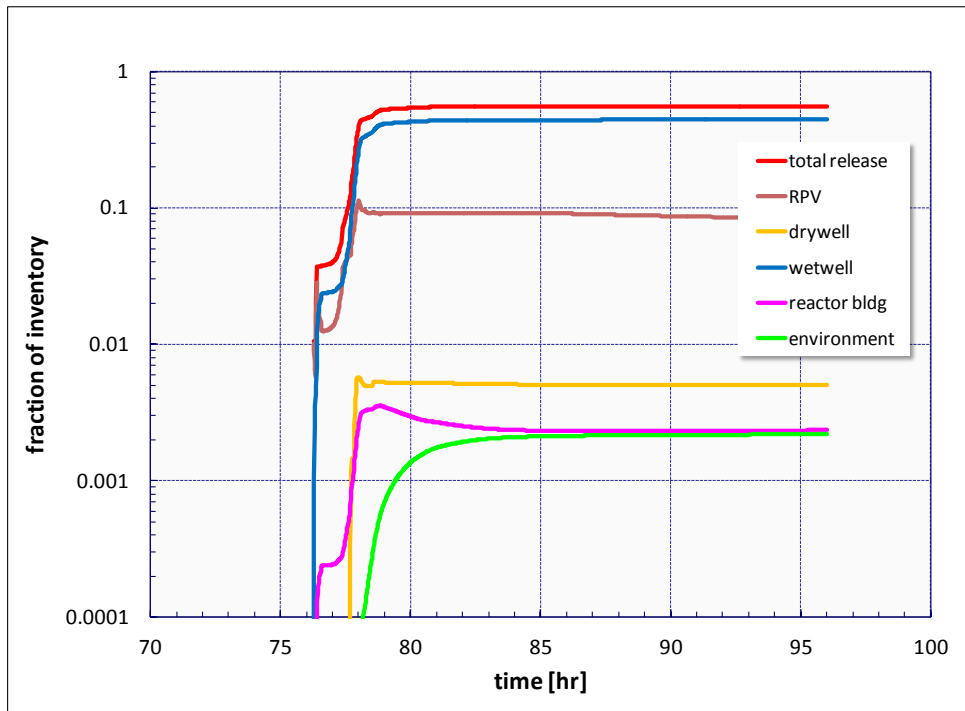
The loss of core coverage resulted in core damage and radionuclides were released from the fuel. The steam released from the RPV transported fission products outside of the RCS barrier to the wetwell pool through the open SRVs. From the wetwell, the fission products not retained in the suppression pool were available for transportation outside of containment to the reactor building and ultimately the environment due to the nominal containment leakage as well as the assumed containment failure. Figure 53 presents the corrected[20] release fraction distribution of CsI within the RPV, containment, reactor building, and environment.

[20] Scrubbing of aerosolized fission products released from the SRVs to the wetwell was found to be in error due to inaccurate bubble diameter specification. The SOARCA Peach Bottom long-term station blackout decontamination factor (~100) was imposed through post processing to adjust the CsI capture in the wetwell. The original Unit 2 analysis decontamination factor for the reactor building was assumed to be unchanged.

Figure 53. MELCOR Corrected CsI Distribution (Unit 2).

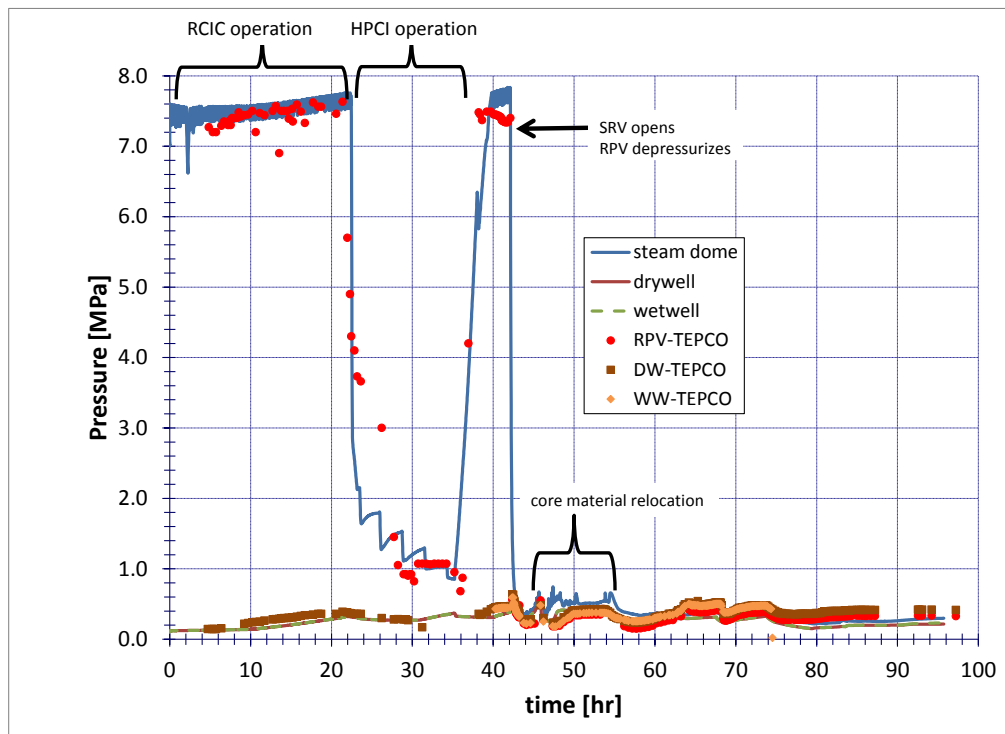
From approximately the time of reactor shutdown to 36 hours, the RCIC and HPCI systems inject water into the RPV, remove decay heat, and maintain the RPV water level near nominal levels. Figure 54 shows the predicted and measured RPV pressure response for unit 3. Figure 55 shows the core and RPV water levels. From 0 to 20.8 hours, the RCIC is modeled as operating essentially continuously in order to maintain a target RPV water level; simultaneously, SRV1 cycles during this time period in the analysis. The SRV operation and the RCIC turbine exhaust both eject steam to the saturated wetwell, which pressurizes the containment (see Figure 56). The operation of the HPCI, having 9.9 times the capacity of the RCIC system in the SNL model (965 t/hr vs. 97 t/hr), results in a rapid depressurization of the RPV at 21.8 hours as a result of the large steam draw from the RPV. The HPCI turbine also discharges exhaust steam to the wetwell pool. At 42.13 hours, the RPV depressurizes via manual SRV opening. Small spikes in the RPV pressure are calculated to occur from 45 to 50 hours due to hot core materials falling from dry upper regions of the core into the water that is still present in the lower regions of the core. The measured data also show some transient spikes in this time period.

Figure 54. MELCOR Predicted RPV and Containment Pressures Compared to TEPCO Data (Unit 3).

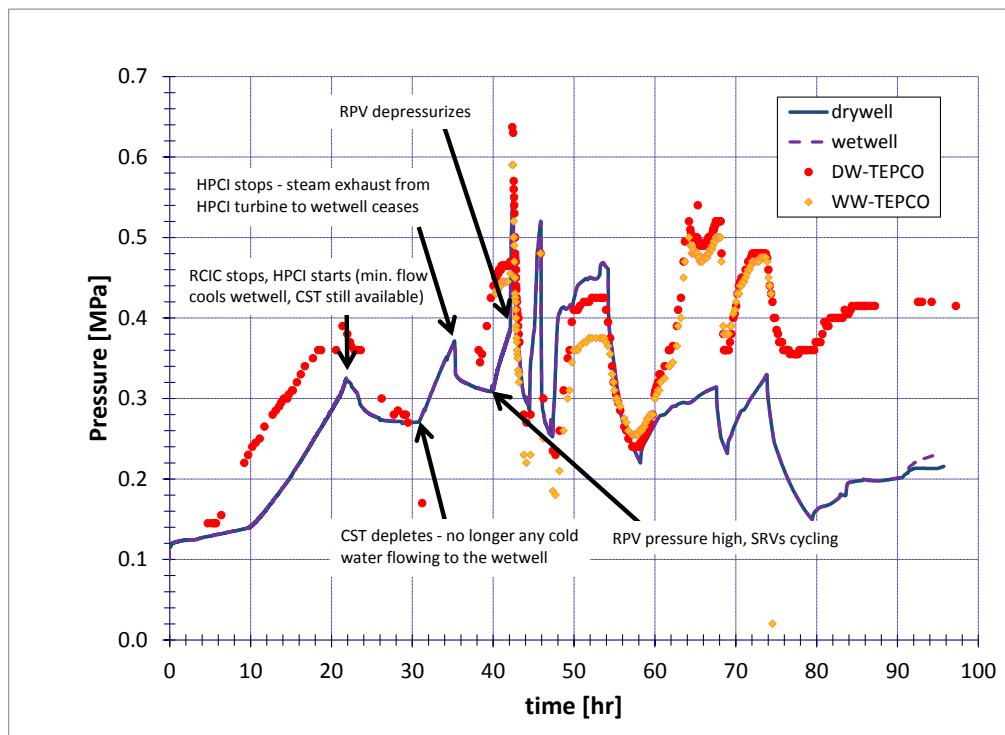
Figure 56 shows the drywell and wetwell pressure response. The wetwell and drywell pressures are nearly identical; thus, they are indistinguishable in Figure 56. The RCIC steam exhaust and the steam discharged from the cycling SRV #1 cause the containment pressure to increase until the HPCI starts at 21.8 hours. (Note: the wetwell pool saturates near 10 hours.) Since RPV water level is maintained by RCIC operation, the HPCI initially transports some cold water from the CST to the wetwell (via the minimum flow line), causing a temporary depressurization of the containment. At this point the wetwell is sub-cooled again. Near 30 hours, the CST inventory is calculated to become depleted and cold water stops flowing to the wetwell. HPCI steam exhaust quickly re-saturates the wetwell and containment pressure is calculated to increase. At 36 hours the HPCI stops, at which point the HPCI turbine ceases operation and steam exhaust no longer flows to the wetwell. Near 40 hours, the RPV pressure reaches the SRV set-points, and steam from the RPV pressurizes the containment. At 42.13 hours, the RPV is fully depressurized via SRV opening, producing the largest peak in the containment pressure (caused by the sudden and large flow of hot steam from the RPV to the wetwell, via the open SRV). The maximum containment pressure calculated by MELCOR is 80.1 psia (0.55 MPa). The TEPCO data lists a maximum drywell pressure of 92.4 psia (0.64 MPa) and a maximum wetwell pressure of 85.6 psia (0.59 MPa).

Figure 56. MELCOR Predicted Drywell and Wetwell Pressures Compared to TEPCO Data (Unit 3).

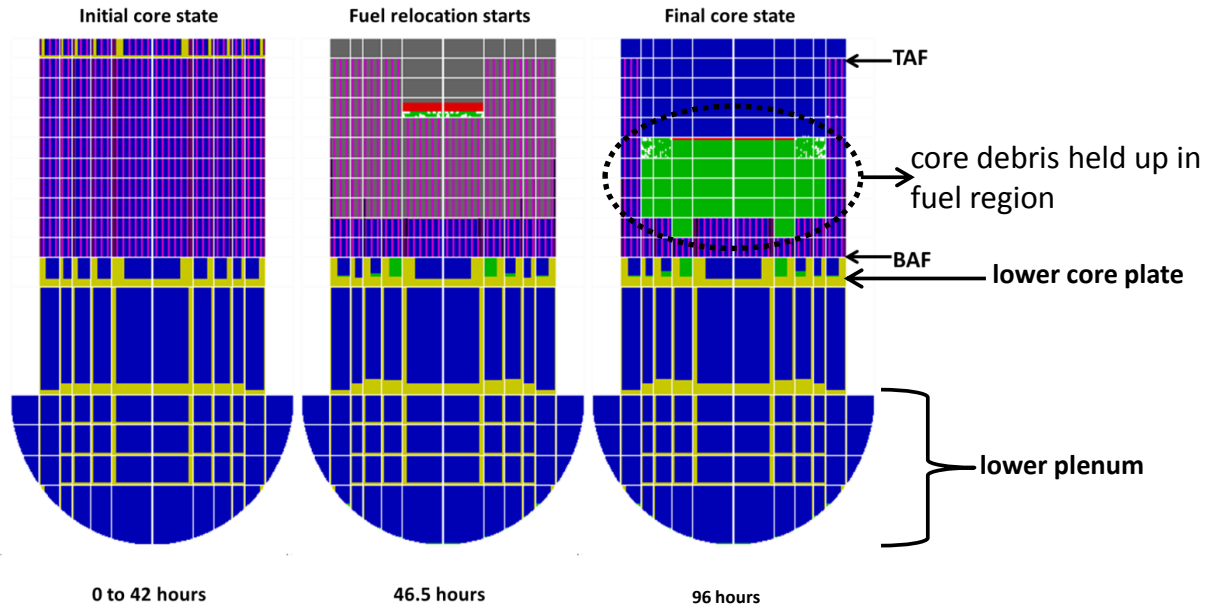
By 96 hours, approximately 52% of the initial UO_2 inventory has been converted to debris, and approximately 54% of the initial B_4C inventory has been converted to debris. The "final core state" depicted in Figure 60 does not take into account further core damage that may result from loss of emergency injection after 96 hours.

Figure 60. MELCOR Predicted Core Damage Progression (Unit 3).

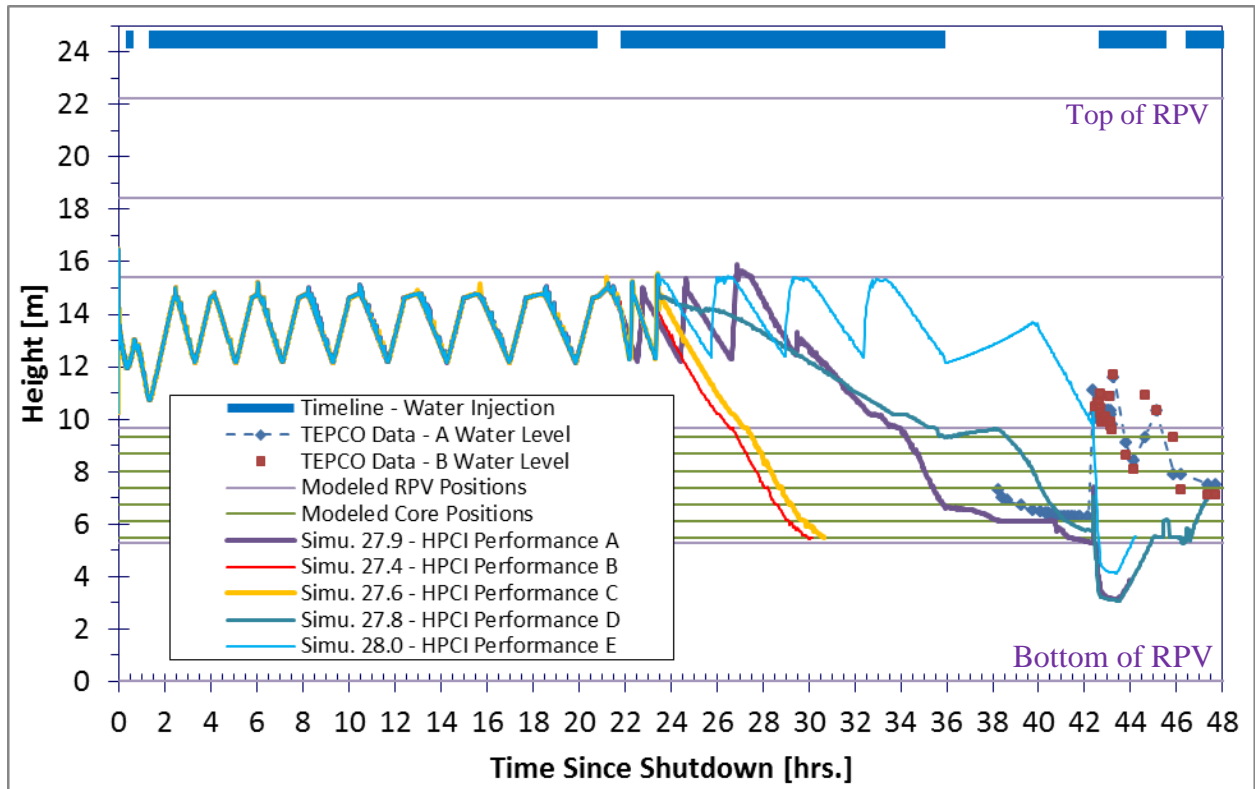
Methods B, C, E used the HPCI pump and turbine curves shown in Figure 82 through Figure 84, and method D used the curves shown in Figure 67. The low steam pressure trip at 100 psig was removed. As shown Figure 85 and Figure 86, the HPCI performance has a large impact on the water level and reactor pressure. Table 15 summarizes the time until first fuel gap release and cladding failure.

Figure 85. HPCI Performance on Water Level.

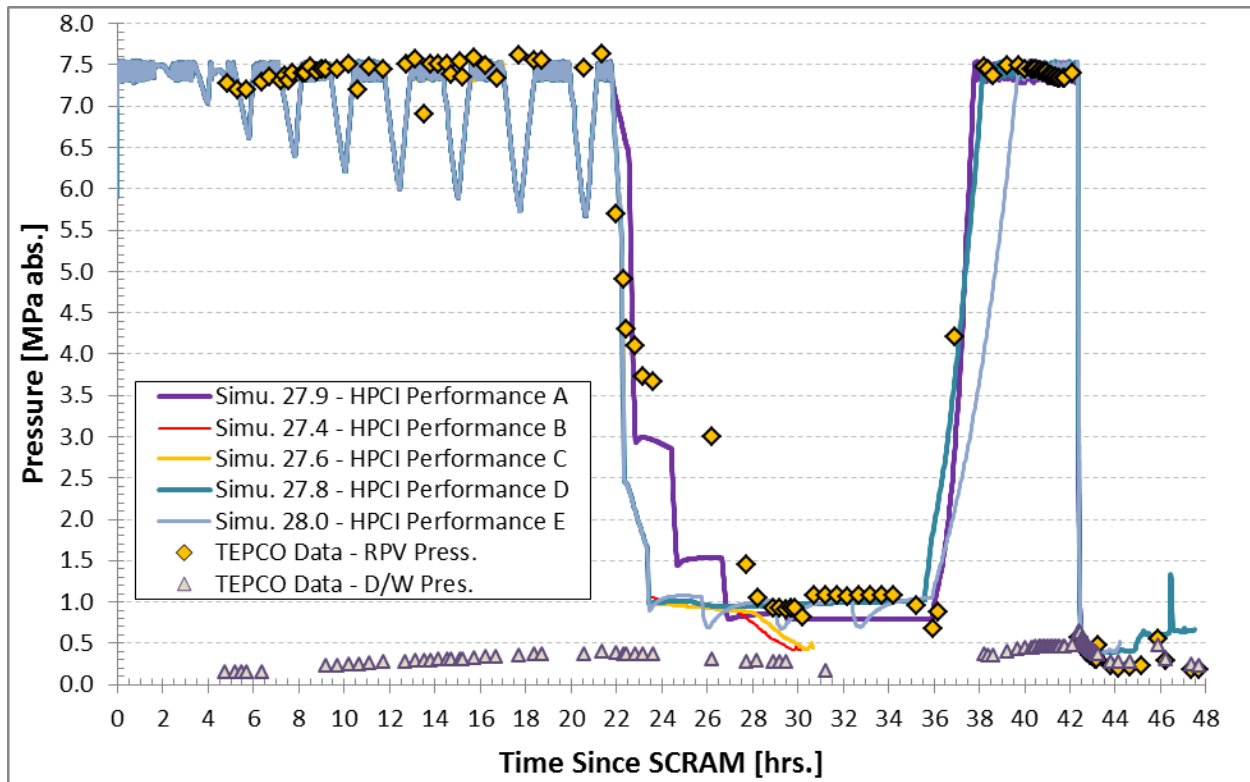
Figure 86. HPCI Performance on RPV Pressure.

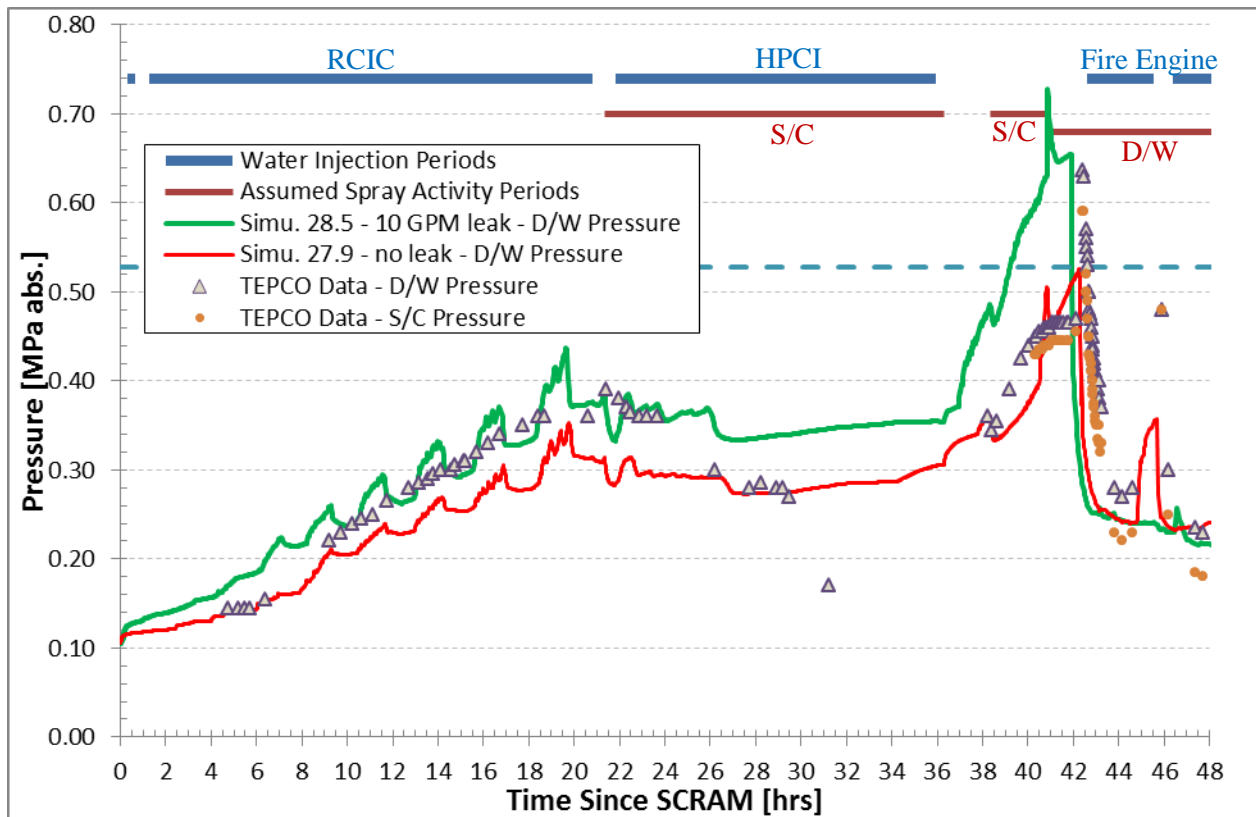
The leak increased early pressurization by 16% during the first 20 hours (RCIC operation period). Seal leakage combined with core failure produced very high PCV pressures between {36:00} and {42:00}. Pump seal leakage should be considered for further investigation.

Figure 87. Recirculation Seal Leak impact on D/W Pressure

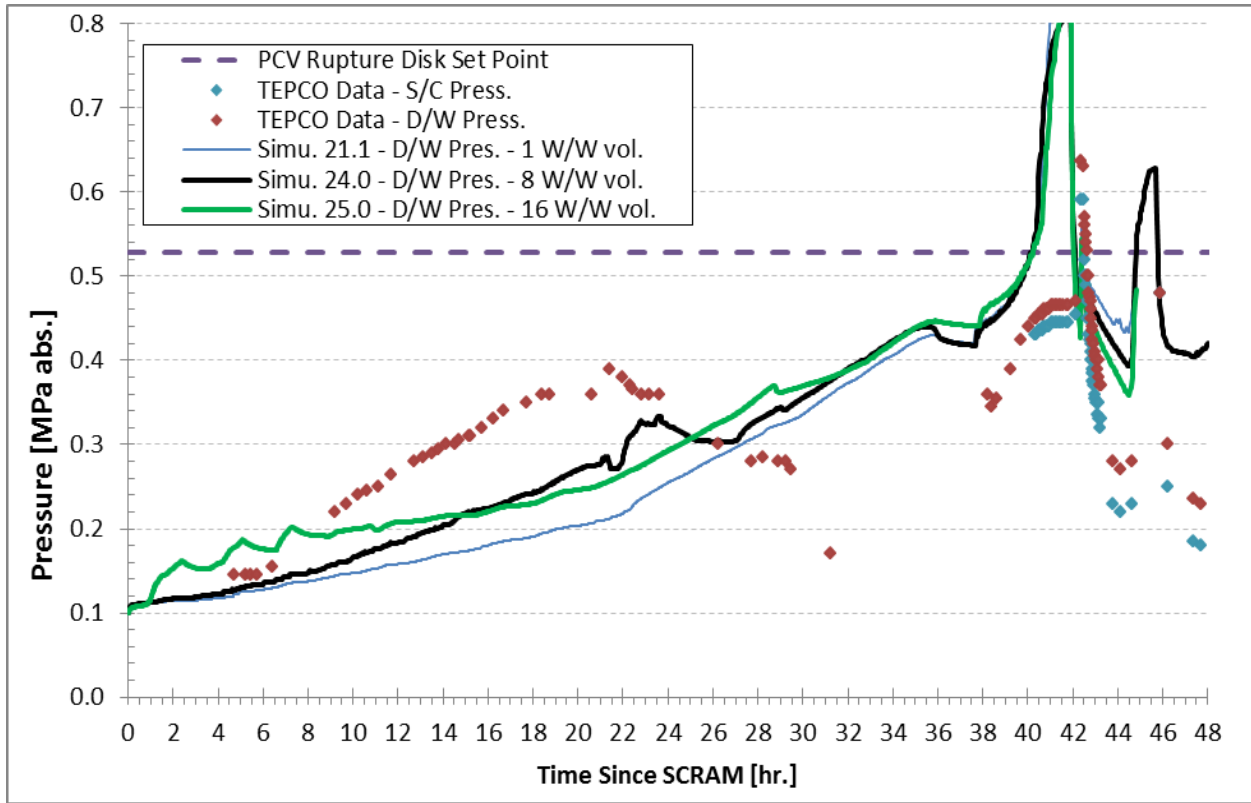
The Peach Bottom MELCOR model, used as the basis for this modeling study, used one control volume to represent the torus with one vent line connecting the D/W to the S/C. Modeling the S/C in this manner cannot capture localized saturation of the S/C. Three different cases of S/C modeling are presented in Figure 88, Figure 89, and Figure 90. Utilizing only one S/C control volume results in the pool remaining subcooled until the containment is vented (around {42:00}).

These results demonstrate the impact the S/C nodalization has on D/W pressurization. More specifically, the results demonstrate the impact of the S/C phenomena of circumferential variations of pool temperature (eight control volume case) and the impact of convection cells (16 control volume case). It is possible the D/W pressurization discrepancy may be resolved through refinement of the S/C nodalization.

Figure 88. S/C Nodalization Impact on D/W Pressure.

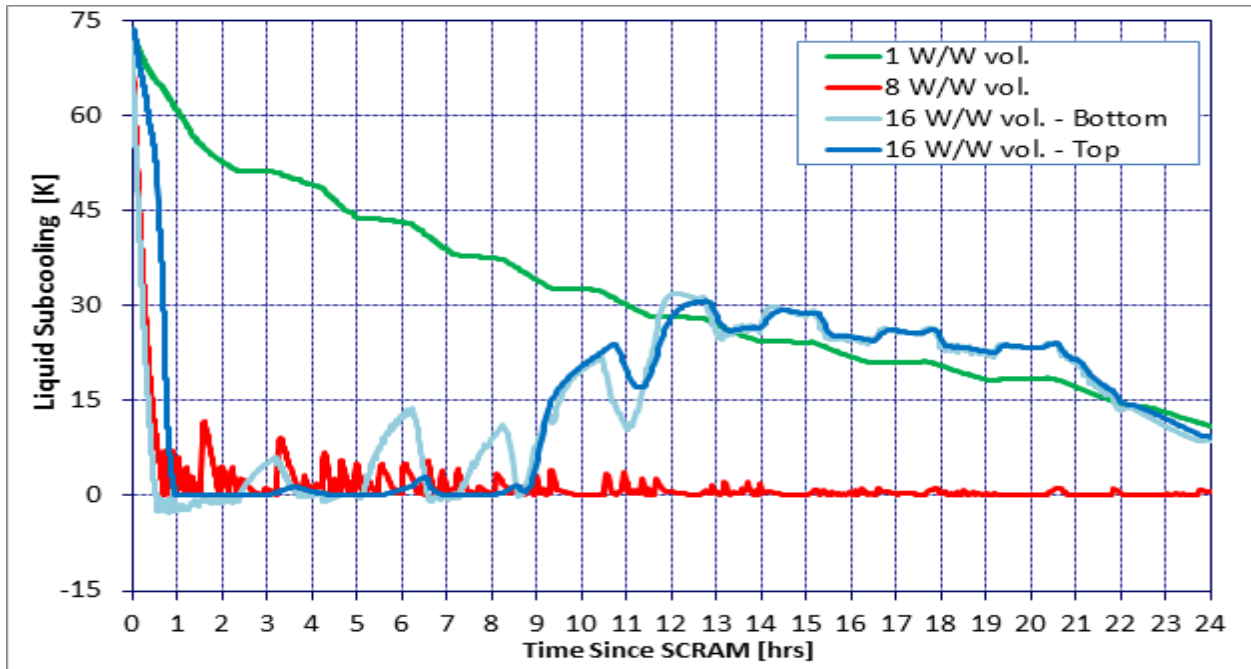
Further dividing the pool into 16 divisions, eight in the circumferential direction and two in the vertical direction, allows for circulation cells to form in the pool. Using 16 divisions resulted in stratification of the pool and rapid saturation (around {00:31} for bottom and {00:57} for top cell) near the main venting location. The S/C and D/W then begin to pressurize rapidly as the steam vented into the S/C is not efficiently condensed in the pool. However, from around {08:30} to {11:30}, a convection cell forms bringing subcooled water in from neighboring torus control volumes. This results in sub-cooling of the previously saturated control volumes in the S/C and increases the efficiency of the S/C at condensing the vented steam. Note the trend in D/W pressurization is then similar to the one S/C control volume case.

Figure 89. S/C Nodalization Impact on S/C Water Subcooling.

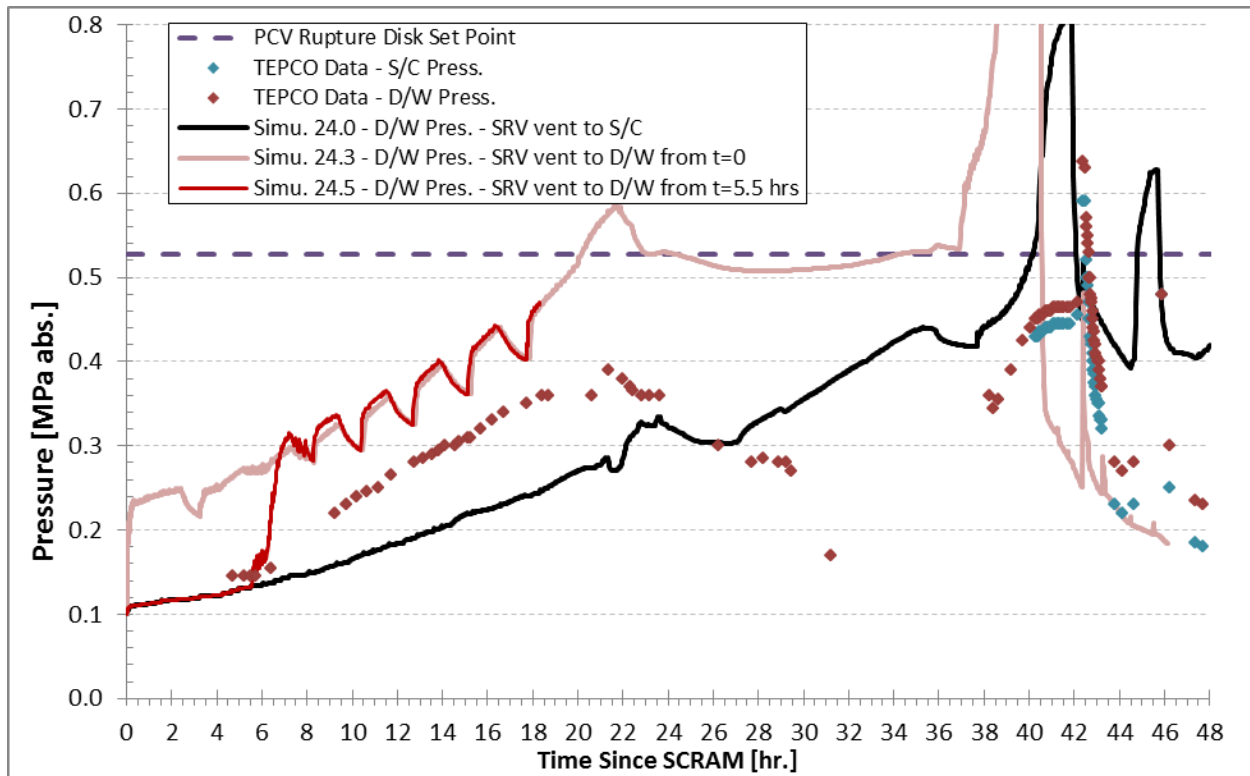
Figure 90. SRV Vent to D/W, Impact on D/W Pressure.

Another possibility for the pressurization discrepancy between the D/W data and the MELCOR simulations during the first 20 hours is if steam was directly vented into the PCV, bypassing the S/C pool. This may occur if part of the SRV or SRV vent piping failed.

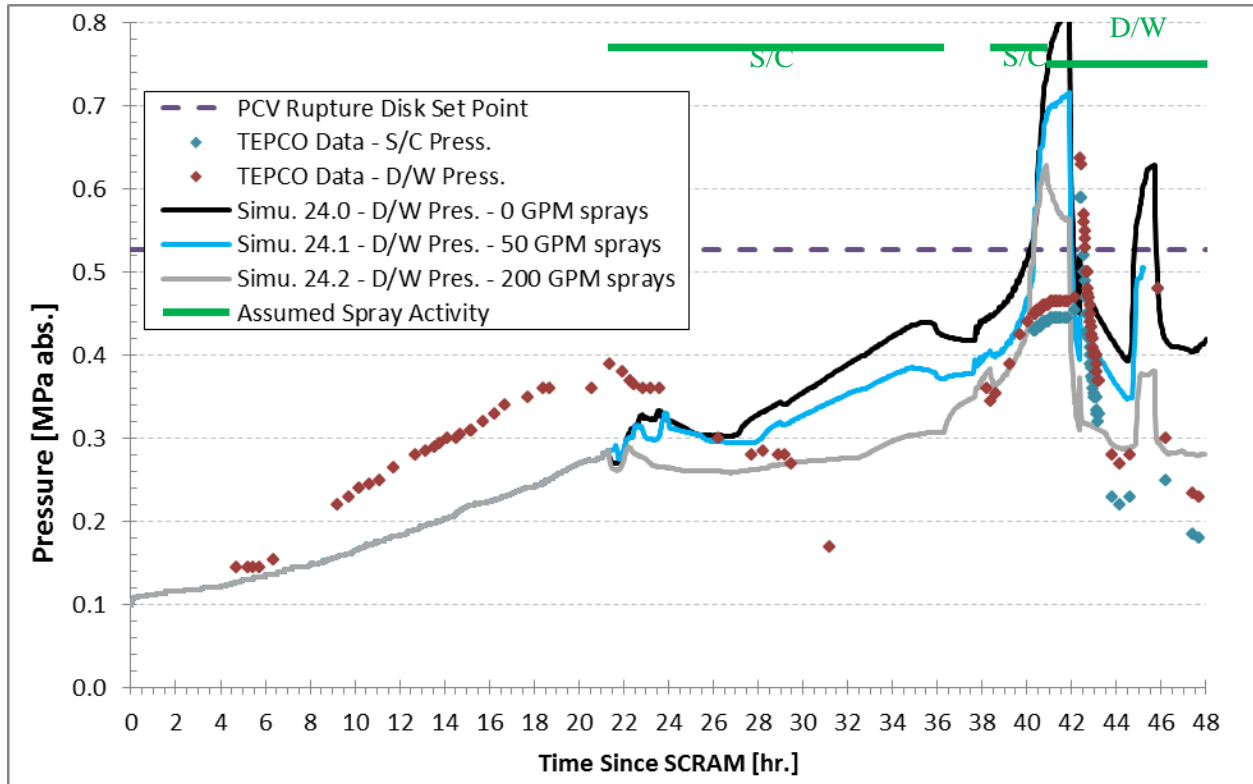
Two simulations were performed to investigate the impact of the containment sprays. One case injected 50 GPM and the other case injected 200 GPM of water through the S/C or D/W sprays during assumed periods (see Figure 91). Activating the sprays did result in a decrease in PCV pressure. The flow rate and precise timing of the spray activity are currently unknown.

Figure 91. PCV Sprays Impact on D/W Pressure.

The TEPCO representative at the January 25, 2012, technical exchange meeting noted the TEPCO report released on Dec. 22, 2011, which is still in Japanese at this time, contains information indicating the containment sprays were used during the period of HPCI operation and later. The flow rate and precise timing of the spray activity are currently unknown.

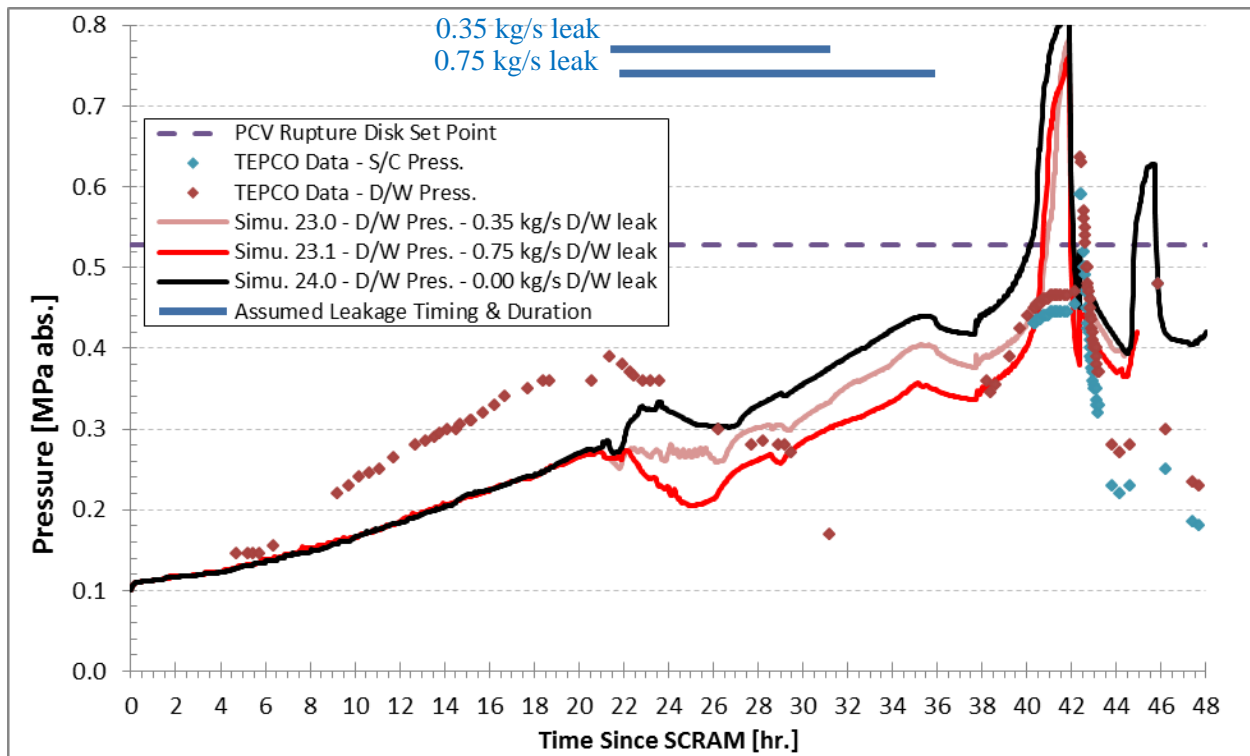
Currently, utilization of the containment sprays is thought to be the cause for the decrease in PCV pressure around the period {21:48} to {35:55}. However, a possible alternate scenario, leakage from the PCV, could also cause the decrease in PCV pressure. Flashing of the water in containment works to limit the depressurization.

Figure 92. PCV Leakage Impact on D/W Pressure.

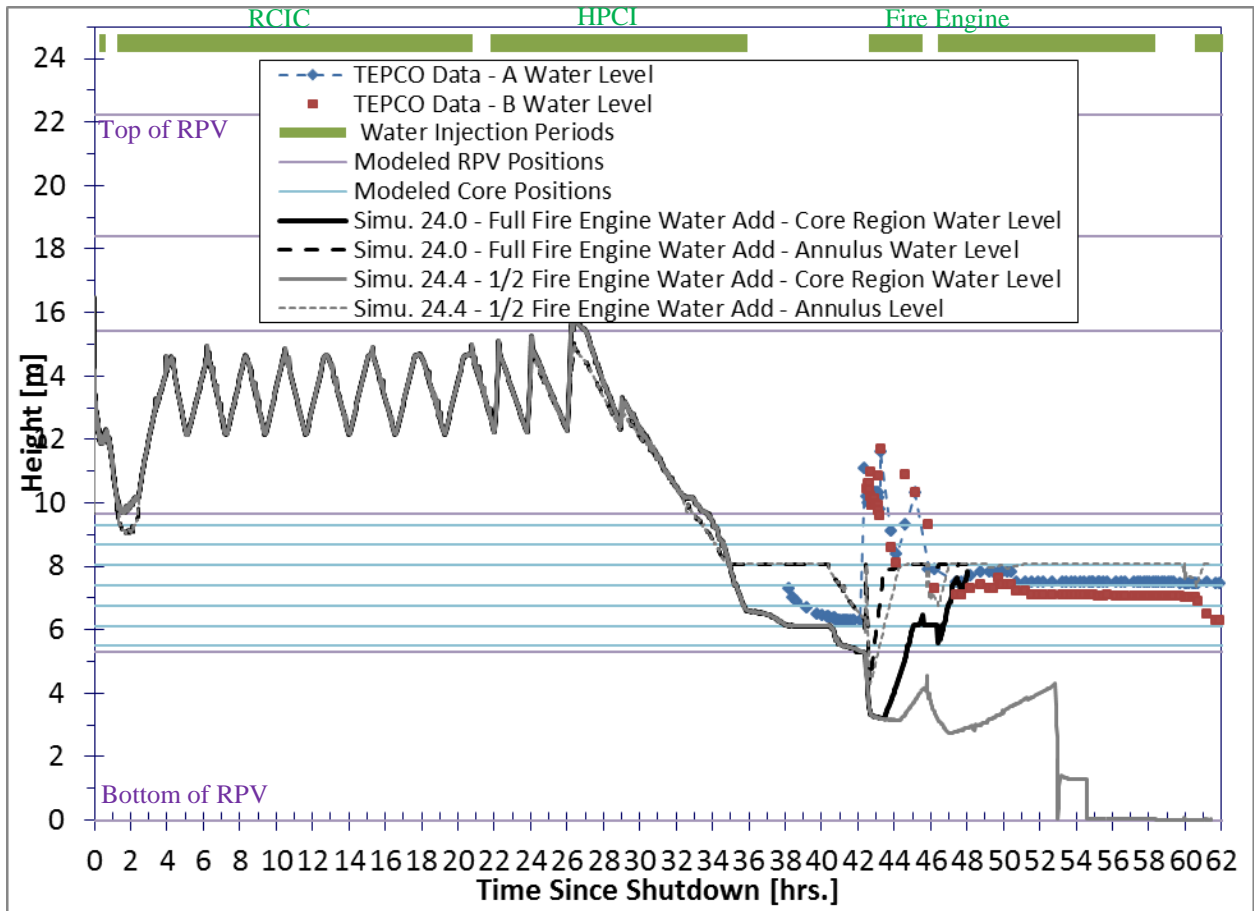
The water level in the core region, as well as in the annulus is plotted in Figure 93. Note that both of the simulations are the same until the water injection via the fire engines start. As expected, for the case where only half of the fire engine water is added, the bottom head dries out and fails, causing melt to be relocated into the PCV. Note that for the ½ fire engine water addition case, less zirconium is oxidized and less hydrogen gas is generated (Figure 94). This is due to the water level dropping below the bottom core plate, reducing the steam generation, which drives the hydrogen generation process.

Figure 93. Fire Engine Water Addition Rate Impact on Water Level.

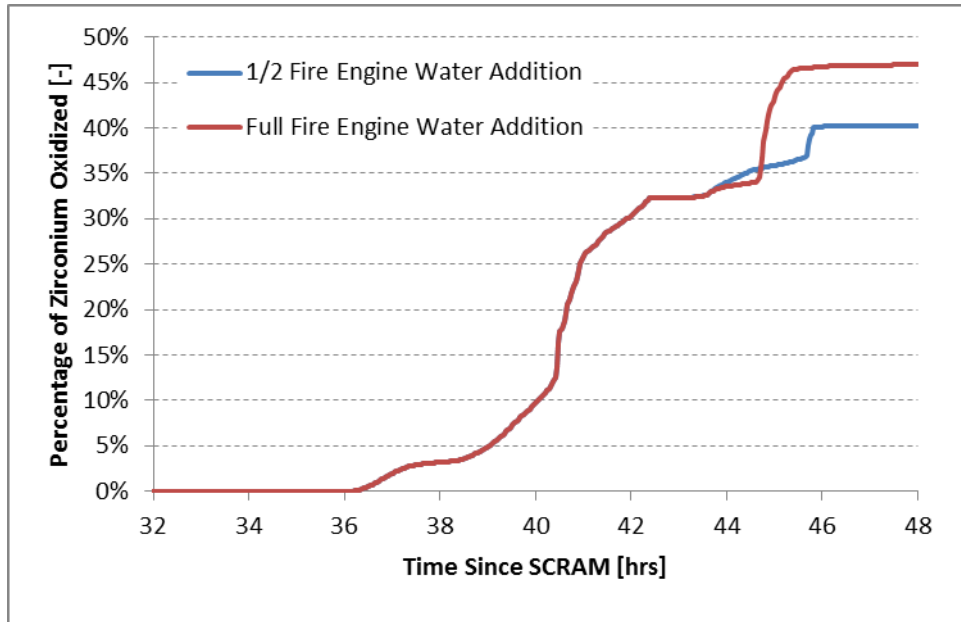
Figure 94. Fire Engine Water Addition Rate Impact on Zirconium Oxidation.

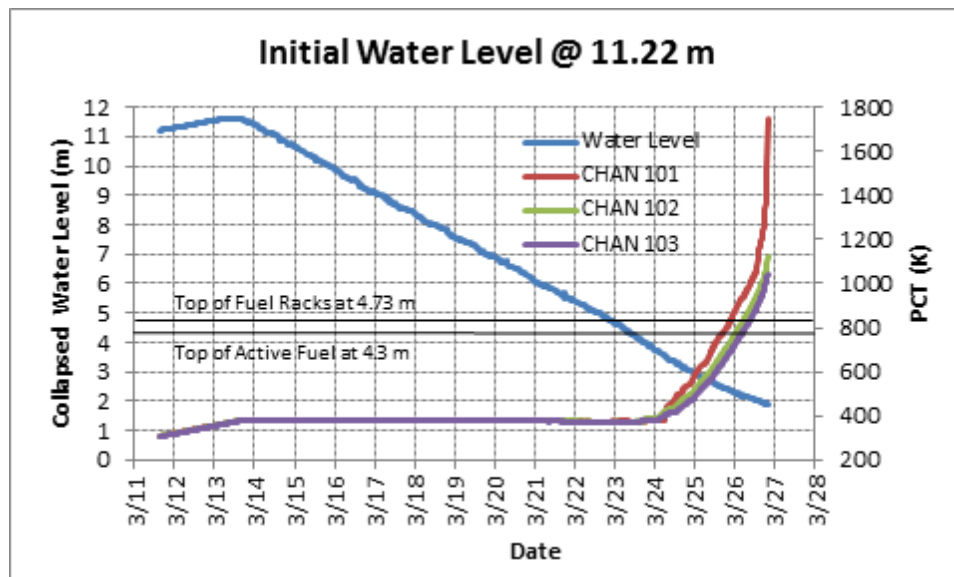
Figure 103 shows the predicted collapsed water level and the peak cladding temperature (PCT) for the first case with the initial pool level 11.22 m. Figure 104 shows the integrated water boil-off mass. The TRACE simulation shows that the pool level increased in the first two days as the water temperature was rising. When the pool water temperature reached to the saturation point, the pool started to boil off water at a rate of about 0.99 kg/s and consequently the pool level started to decrease. It would take about 11 days for the water level to drop down to the top of fuel racks (7.43 m) from the initial level. Therefore, if the pool was at this initial level at the time of the accident, the fuel would not have been uncovered by the time of the explosion in the Unit 4 building. If the pool level had fallen below the top of fuel racks, natural circulation flow would have stopped. Shortly after the fuel became uncovered the fuel cladding temperature would have started to increase as shown in Figure 103. If the cladding temperature had reached above 1000 °C, the chemical reaction between the zircaloy clad and vapor would have taken place, resulting in hydrogen generation. The reaction would have generated significant heat and therefore accelerated fuel heat-up. Eventually the cladding temperature would have reached its melting point. However, fuel heat-up would have been a slow process and would have taken about two and a half days.

Figure 103. Calculated Pool Level and PCT for Initial Pool Level 11.22 m.

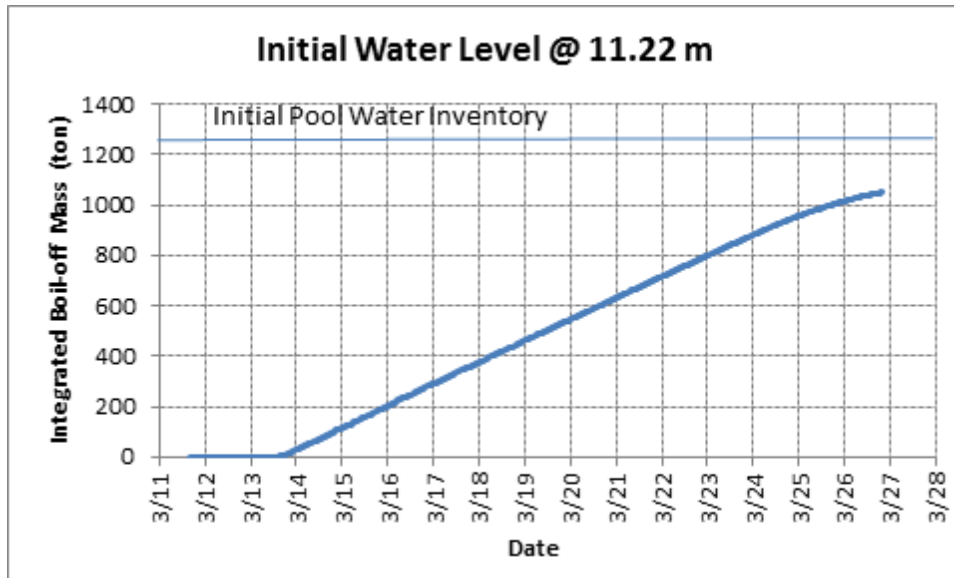
Figure 104. Integrated Boil-off Mass.

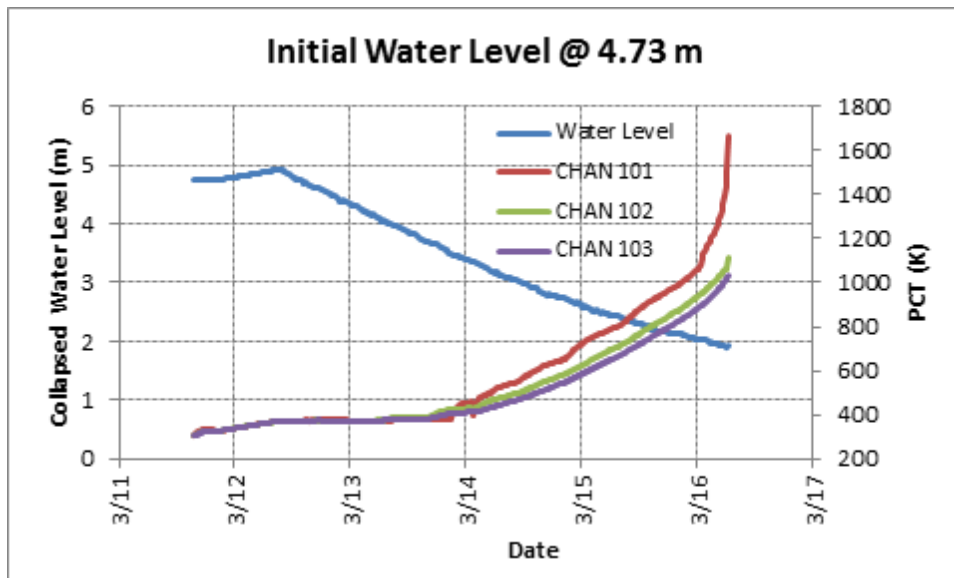
Figure 105 shows TRACE results for the second case with the initial water level 4.73 m. Fuel heat-up took place sooner than the first case because it started at a very low pool level. However, even if the water level somehow dropped to right above the racks, the time for the fuel to heat up to above 1000°C so that hydrogen generation could begin still does not align with an explosion on the morning of March 15.

Figure 105. Calculated Pool Level and PCT for Initial Pool Level 4.73 m.

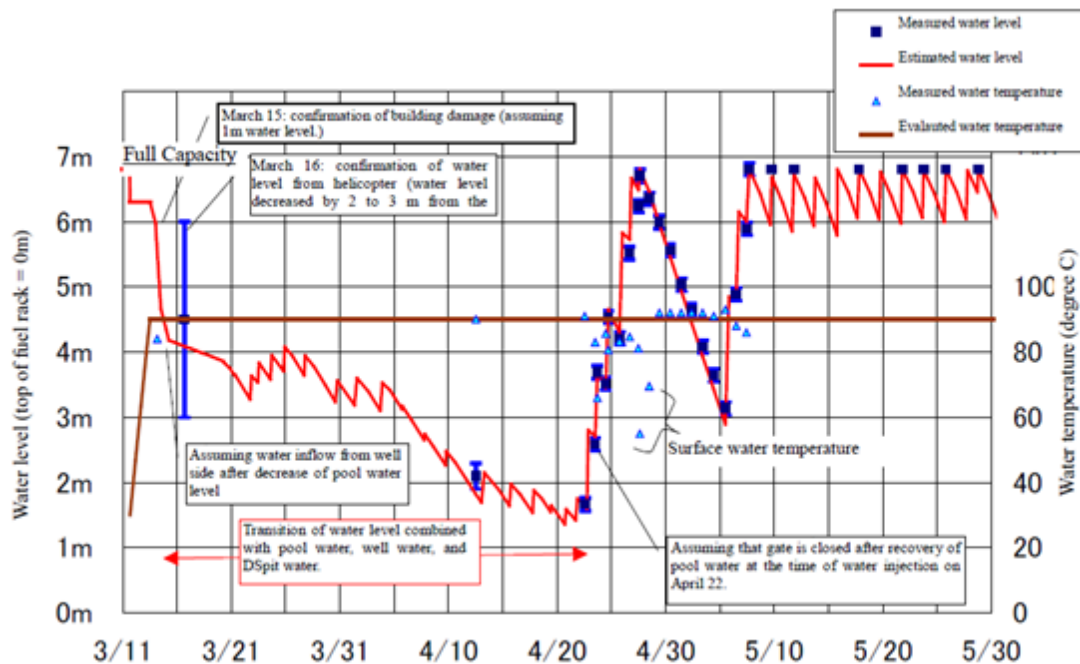
Recently, the government of Japan released the second IAEA report on the Fukushima accident [21]. The report presents results of evaluation of Fukushima NPS pools conducted by TEPCO. The results of SFP4 are shown in Figure 106. The major assumptions in TEPCO analysis are as follows:

- The water level is presumed to have been reduced by 1.5 m (~181 tons of water) as a result of sloshing by the earthquake and the explosion.
- Inflow from the reactor well occurred before April 22 (see discussions that follows). The water level was calculated by considering the water in the pool and the water in the reactor well and DS pit collectively. After April 22, the pool gate gap was closed, and no inflow from the reactor well was considered.

Figure 106. TEPCO Evaluation Results of SFP4.

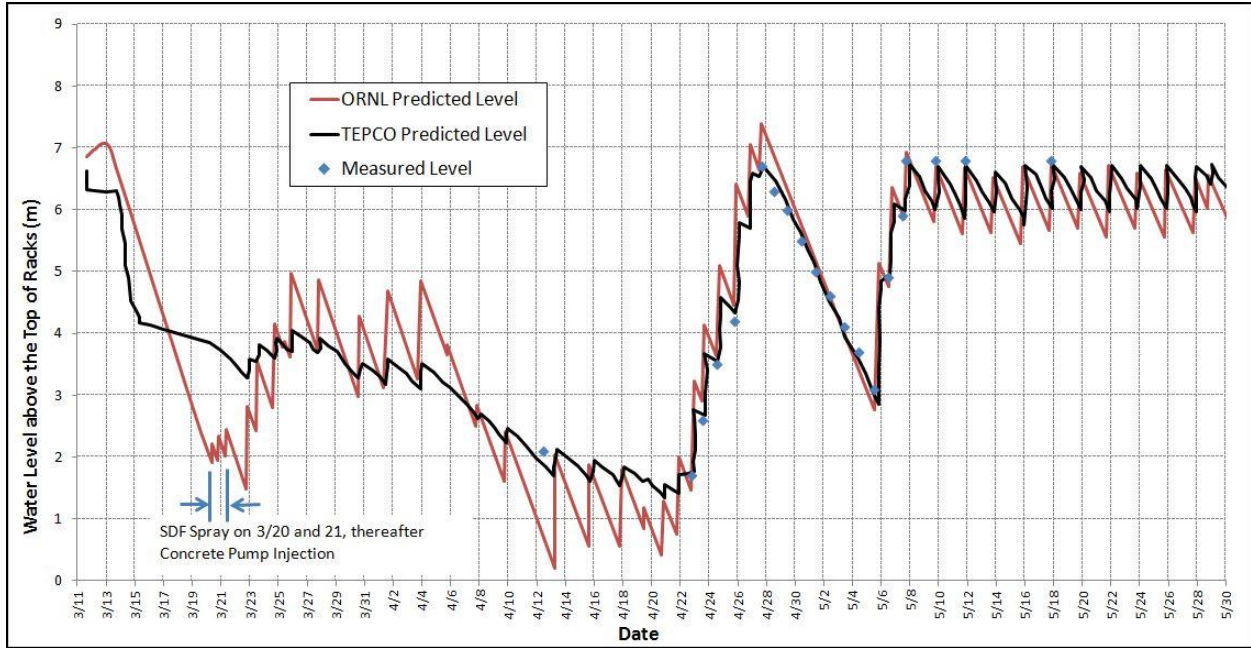
The results of our analysis are presented in Figure 107. For comparison TEPCO results are included. Our analysis matches the measured data very well (except for April 12). The key differences between the TEPCO assumptions and ours are the initial water level and the inflow from the reactor well.

As discussed in the Japan September report, the reactor well and dryer and separator pit (DS pit) were full of water before the earthquake since the reactor was under regular maintenance. The water-tightness of the pool gate was lost because the gate received water pressure from the reactor well side when the pool level became low. Then the water flowed into the pool through a small pool-gate gap.

Figure 107. ORNL Level Results for SFP4.
