Fukushima Daiichi Accident Study (Status as of April 2012)

Sandia National Laboratories

Abstract

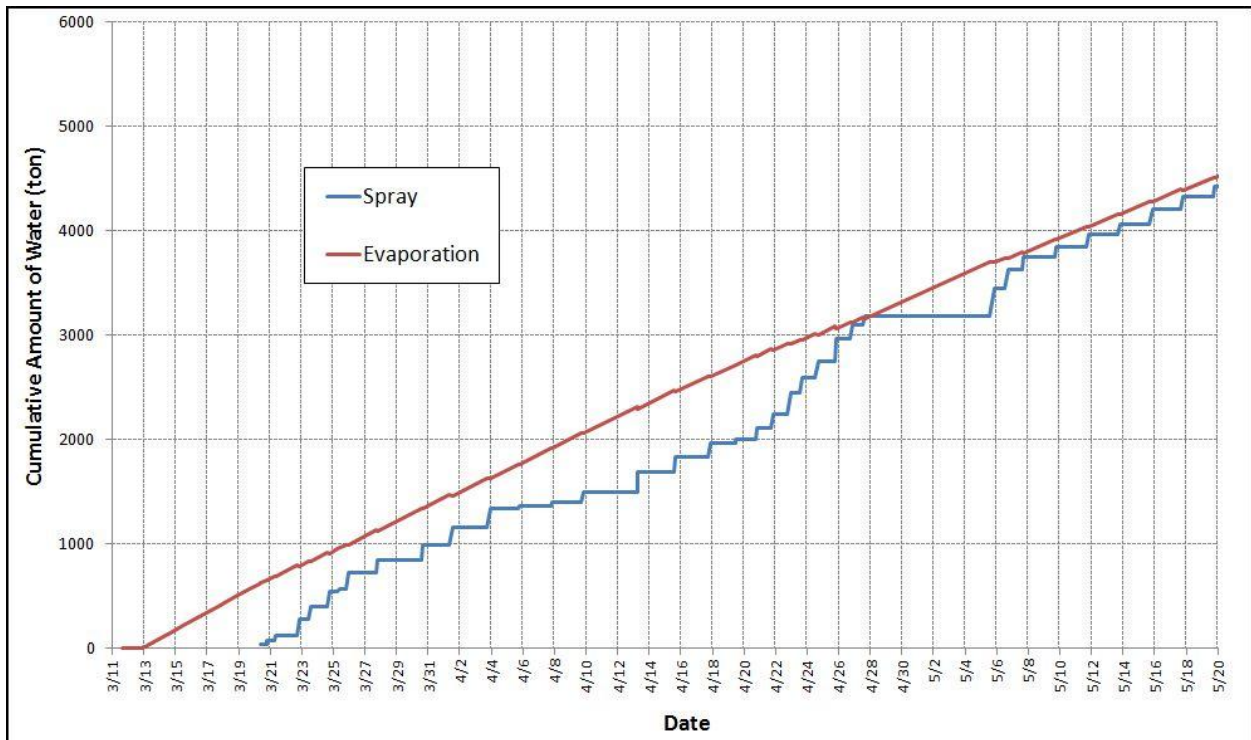
Figure 108 shows accumulated water amounts of spray and evaporation since March 11, respectively. This figure plays a key role in understanding the pool level change. It is interesting to see that the total amount of evaporated water and the total amount of sprayed water approached a balance on April 27. It implies that the total inflow from the reactor well side should be about the same as the total sloshed water caused by the earthquake and explosion. So we can estimate the diminished water level at the beginning of the accident based on the total amount of inflow. On April 27, the measurement of water level on the reactor well side was conducted and the level was TAF + 1.8 m. If we assume the initial water level in the reactor well and DS pit is TAF + 7.2 m, there would be 150 - 300 ton of water which had entered the pool from the reactor well side. In other words, the diminished water level by the earthquake and explosion would be 1.2 – 2.4 m.

Figure 108. ORNL Spray and Evaporation Results for SFP4.
