CORROSION OF THE VOLATILITY PILOT PLANT
INOR-8 HYDROFLUORINATOR AND NICKEL 201
FLUORINATOR DURING FORTY FUEL-PROCESSING
RUNS WITH ZIRCONIUM-URANIUM ALLOY

ORNL-3623

Chemical Technology Division

MARCH 1965

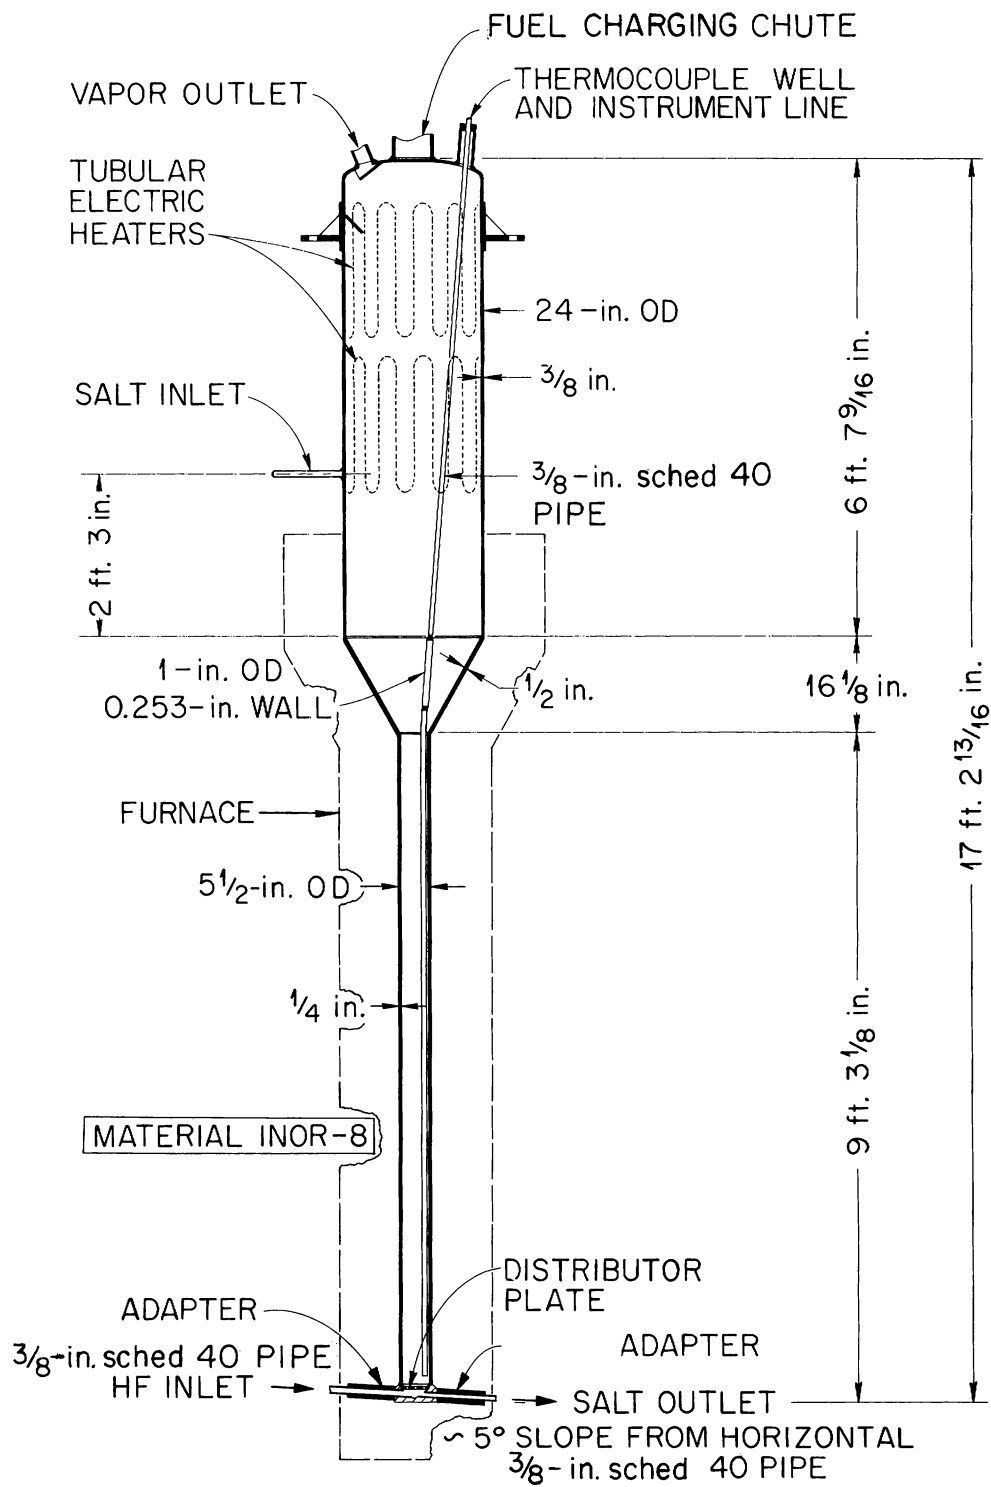
The hydrofluorinator was about 17-ft high and was constructed of rolled and welded INOR-8 plate (Fig. 1). The lower 9 ft, which held the fuel elements during dissolution, was 5-1/2 in. in outer diameter and was made from four 2-ft sections and one 1-ft section of rolled 1/4-in. plate welded together. Above this section was a 16-in.-high cone made from 1/2-in. plate. The salt interface was normally in the conical section. Above the cone was a 24-in.-OD vapor de-entrainment section made of 3/8-in. plate. The vessel was located in cell 1 of Building 3019 and had a 6-in.-diam pipe extending upward into the penthouse for fuel-element charging.

Fig. 1. Volatility Pilot Plant Hydrofluorinator.

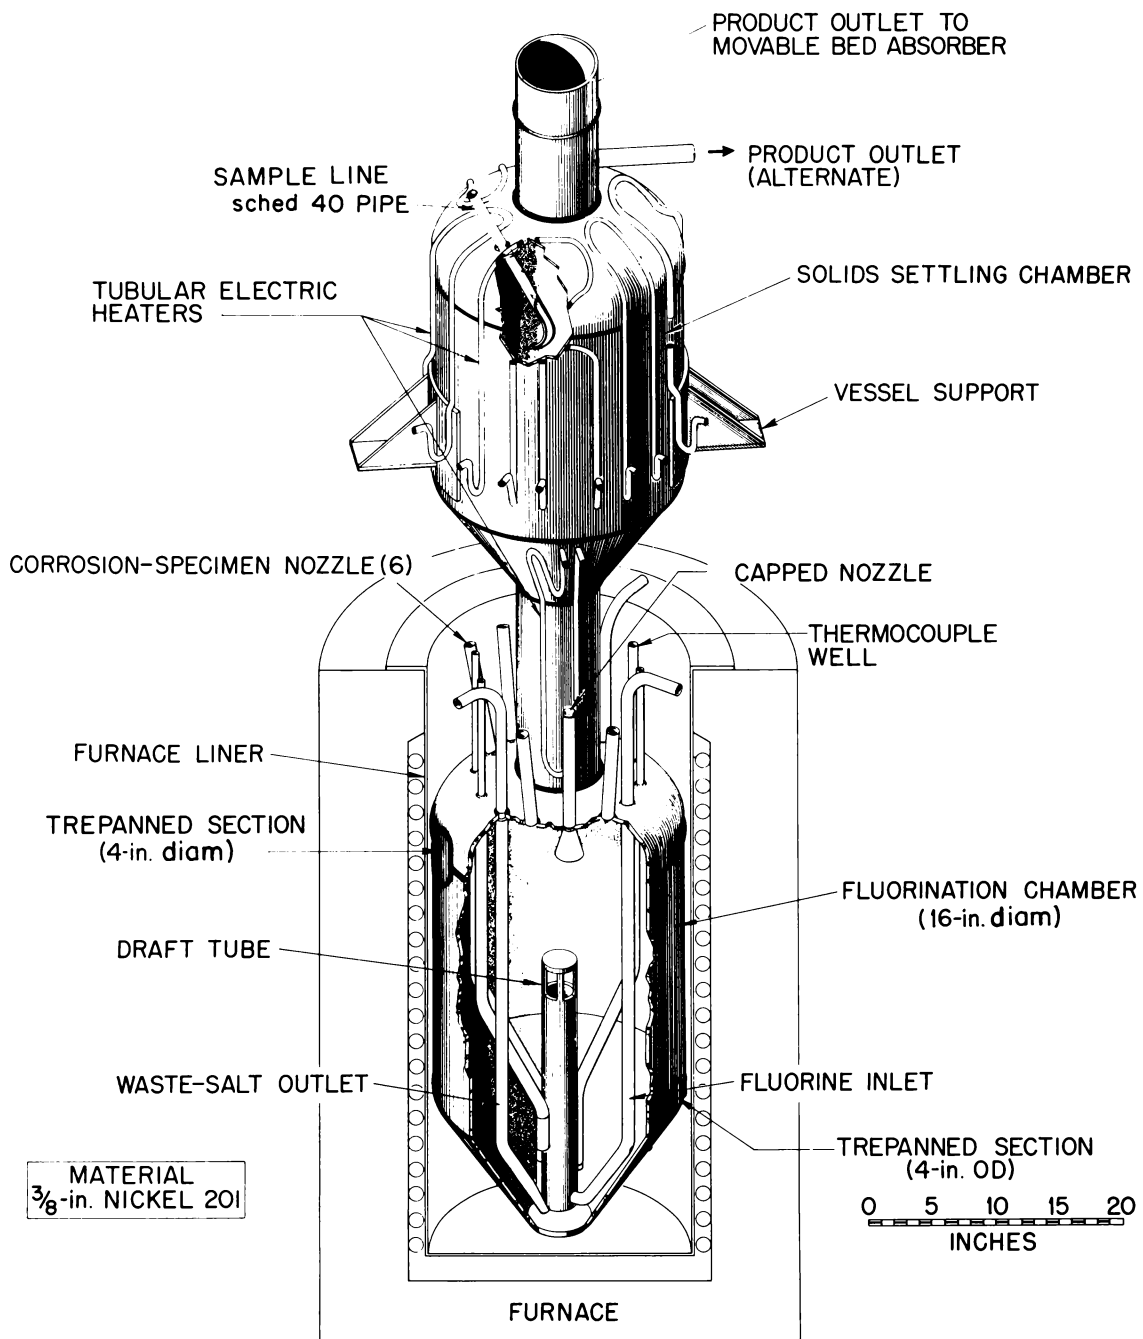
The Volatility Pilot Plant fluorinator^b was about 7 ft high and was made from 3/8-in.-thick Nickel 201 plate. Welds were made with filler metal 61^c. The upper and lower sections of the vessel were 16 in. in outer diameter. They were joined by a 5-3/4-in.-OD center section, as shown in Fig. 10. Only the lower section contained salt. The center and

Fig. 10. Volatility Pilot Plant Fluorinator, Mark III.

Two 4-in.-diam disks were trepanned from the lower section of the fluorinator after T-11 (29 runs) for metallurgical analysis. They were removed from the intersection of girth and seam welds (Fig. 10) after radiography revealed that the weld had been selectively attacked. New plugs were welded into the holes from which the disks were removed.

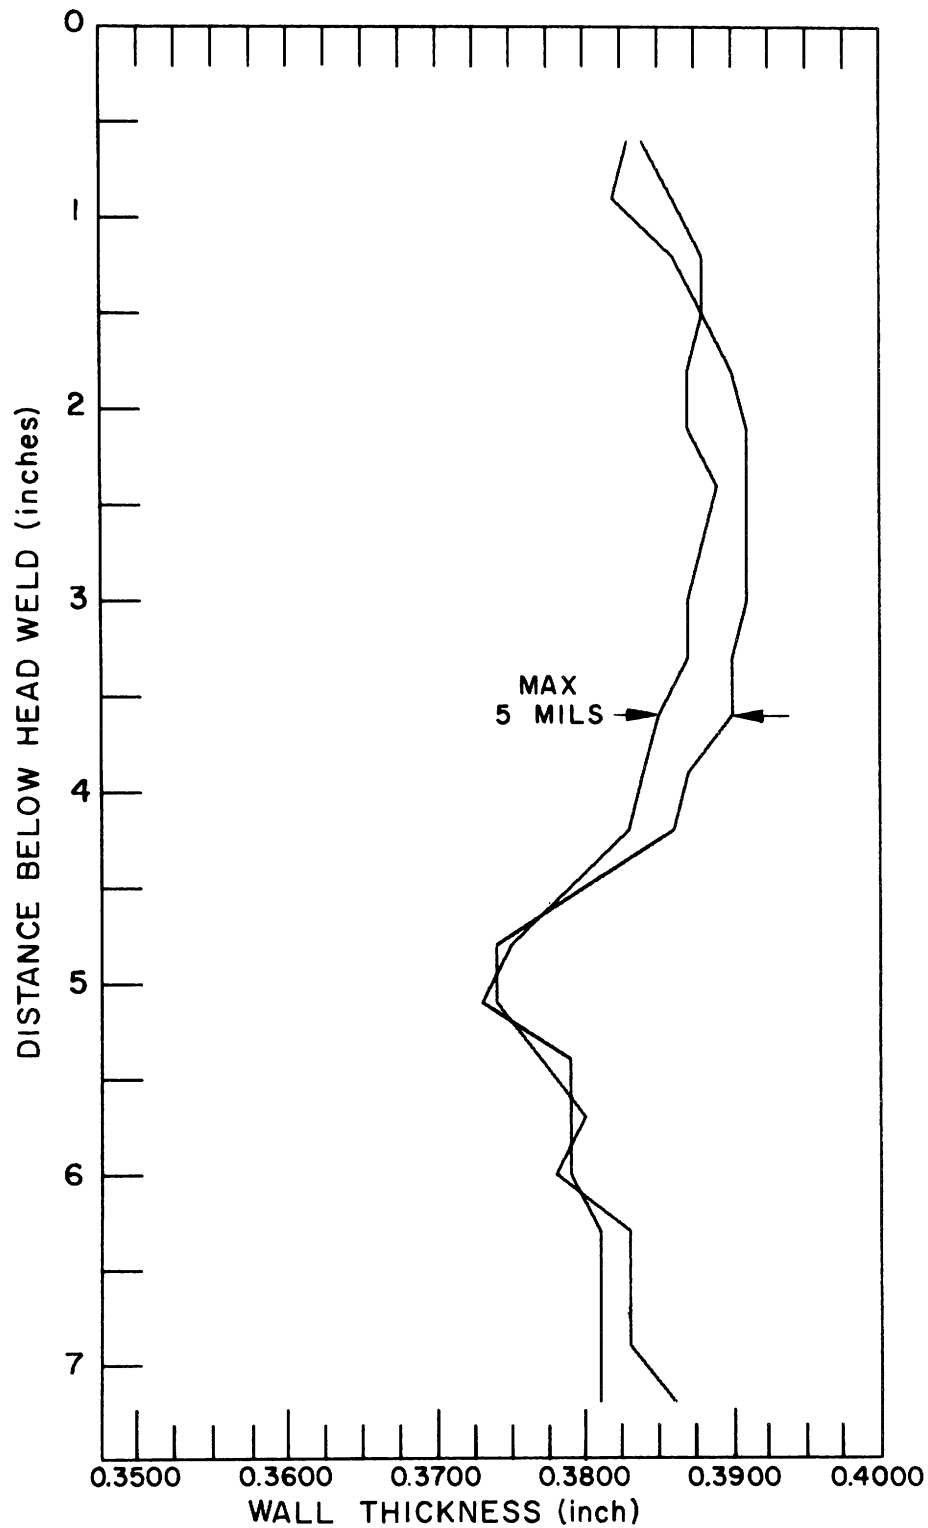
After 40 runs, the hydrofluorinator was only partially decontaminated, and wall-thickness measurements were made with the ultrasonic pulse-echo procedure originally developed for the Homogeneous Reactor Test.¹ With this method, a crystal transducer was placed inside the hydrofluorinator, which was filled with water to couple the transducer to the wall. The transducer emitted ultrasonic pulses that produced reverberation in the vessel wall at a point opposite the transducer. The time between pulses from these reverberations was measured by an electronic gating circuit and counter and was converted directly into wall thickness. This method also indicated predominant wall thickness. An estimate of the error of the pulse-echo system, based on time constants in the electronic circuitry, is $\pm 3.3\%$ for 1/4-in. material and $\pm 2.5\%$ for 1/2-in. material; however, the error could be as high as $\pm 10\%$.⁵ The variation of duplicate measurements taken in the 3/8-in. large-cylinder section of the hydrofluorinator is shown in Fig. 1A in the Appendix. These measurements have a maximum variation of 5 mils or 1.3% of the wall thickness.

Fig. 1A. Duplicate Measurements Made in the Hydrofluorinator to Indicate the Precision of the Pulse-Echo Technique.
