EVALUATION OF FAILED HOT GAS ISOSTATIC PRESSED FUEL RODS

C. J. Baroch

March 20, 1963

Vallecitos Atomic Laboratory
General Electric Company
San Jose, California

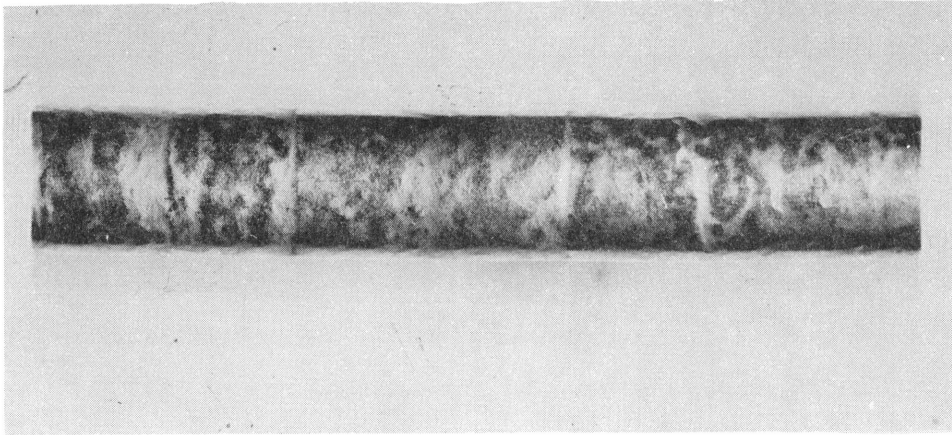
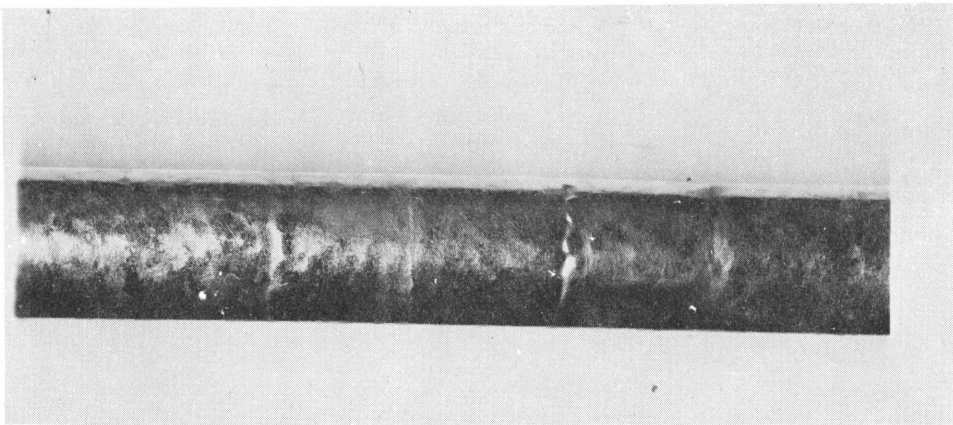
1136-2

Four isostatic pressed fuel rods were received at APED on September 9, 1961, and underwent further nondestructive examination. This examination indicated that the surface of the rods was quite rough with frequent indentations, particularly at pellet interfaces as shown in Figure 2. Diameter measurements which were made along the lengths of the rods showed that the deepest depression was about 0.033 inch. All four rods had at least a 0.040 inch bow over a length of 40-3/4 inches; the maximum bow was 0.060 inch.

FIGURE 2 TYPICAL SURFACE OF ISOSTATIC PRESSED FUEL RODS

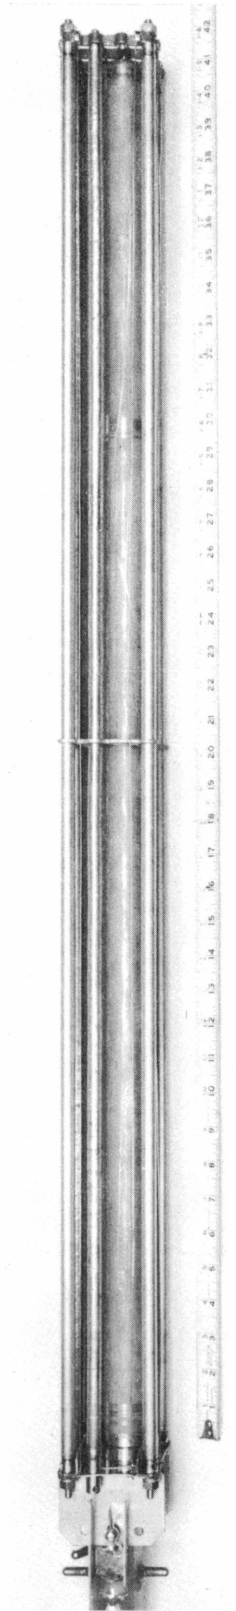
522-13

FIGURE 3 SIDE VIEW OF ASSEMBLY 4-L

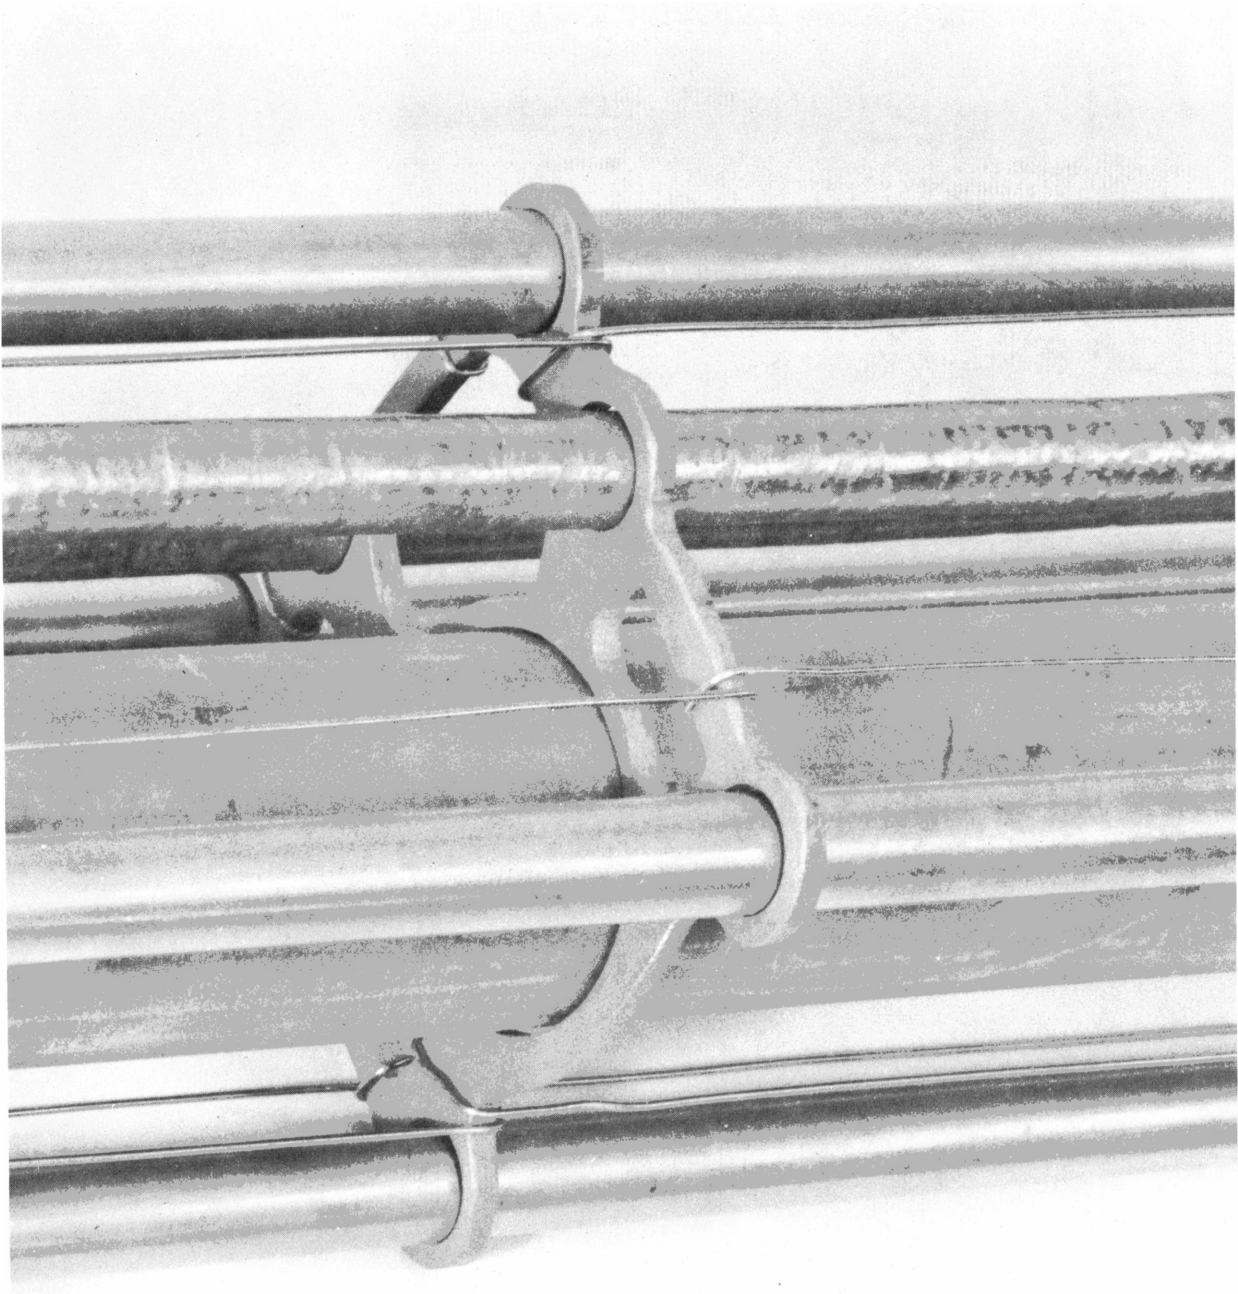
522-14

**FIGURE 4 ISOTATIC PRESSED AND CENTER MELT CALIBRATION
ROD ARRANGEMENT IN ASSEMBLY 4-L**

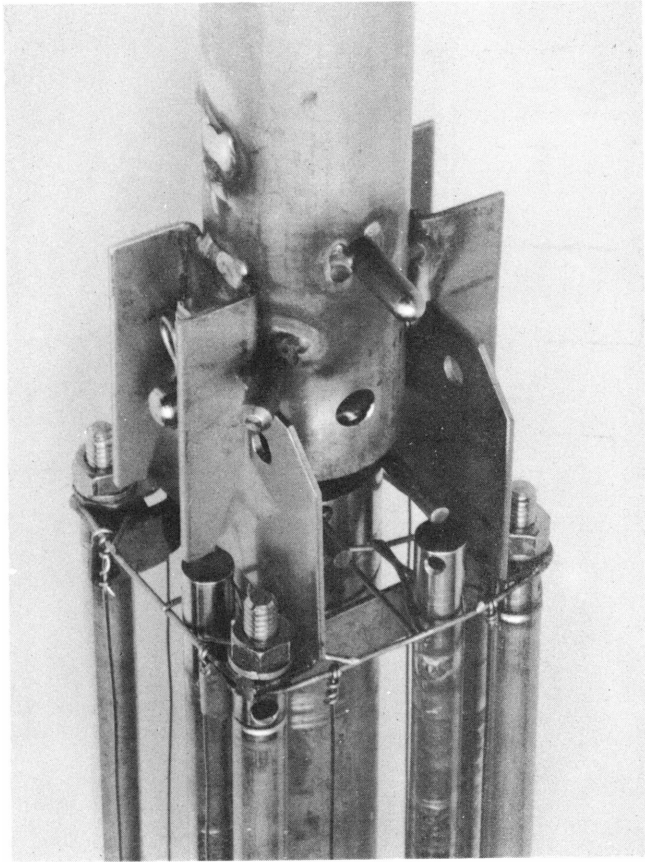
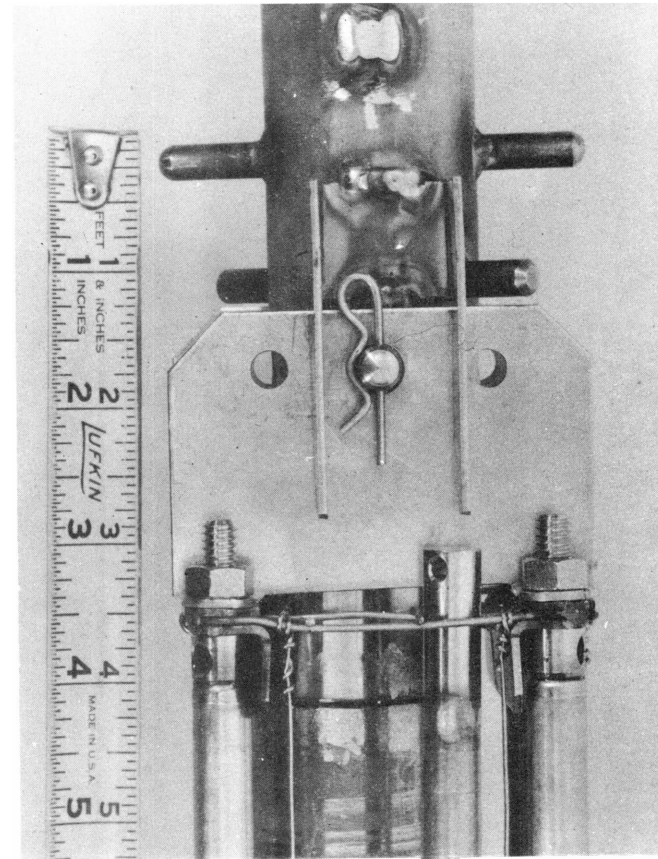
522-15

FIGURE 5 QUICK DISCONNECT FOR ASSEMBLY 4-L,
SHOWING RETAINER CLIP (RIGHT PHOTO) AND
ROD HOLD-DOWN ARRANGEMENT (LEFT PHOTO)

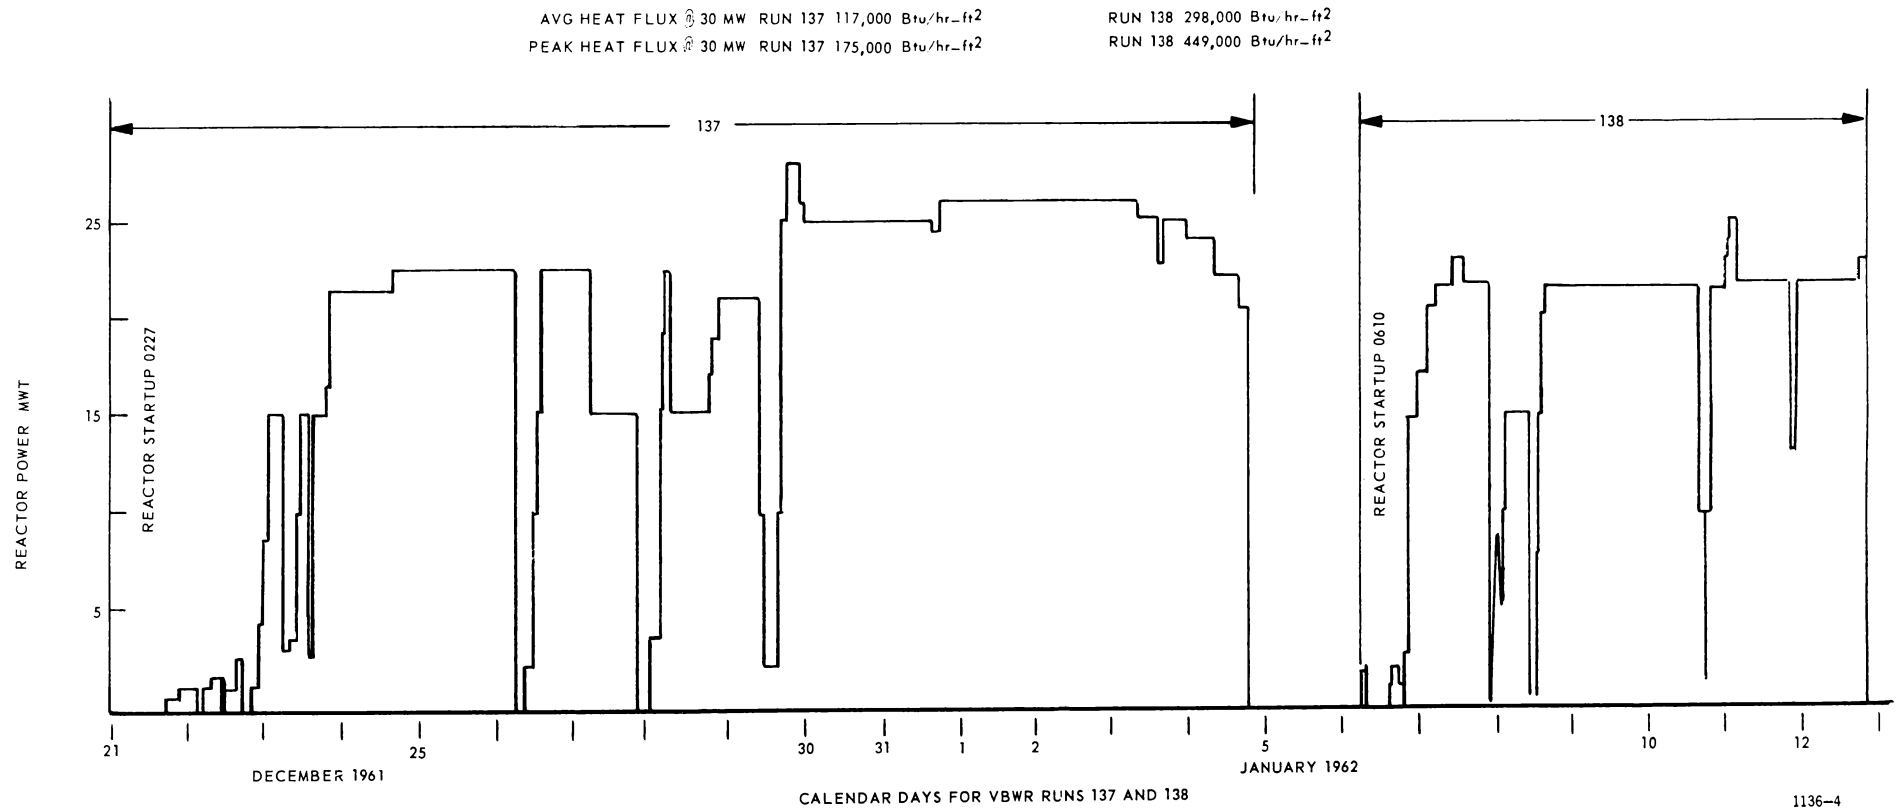
During runs 137 and 138 there were 15 reactor scrams. The duration of the shutdowns as indicated in Table I ranged from 14 to 813 minutes. The scram of 813 minutes duration was for reactor shutdown at the completion of run 137 and before startup of run 138. A plot of reactor power versus time is shown in Figure 7. The heat flux at any given time experienced by the rods can be obtained by multiplying the heat flux at 30 MW by the ratio of the reactor power at any given

FIGURE 7 PLOT OF REACTOR POWER VERSIJS TIME FOR RUNS 137 AND 138

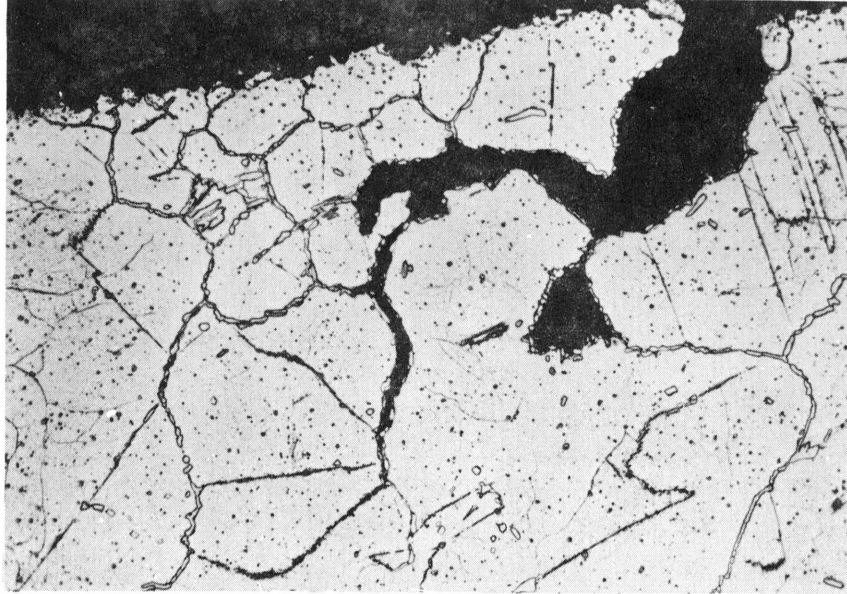
1136-16

Metallographic examination was conducted on cladding samples including the brittle areas from rod IR-21-8. A complete rod (IR-12-6) was ground along its full length, polished and then examined for cladding structure uniformity. All areas of this sample were similar to that noted in the tubing exposed to a pressing cycle as discussed previously. As can be seen from a representative structure shown in Figure 21, large grains with no grain boundary precipitation were evident. In contrast extremely heavy grain boundary precipitation was shown in the microstructure of the brittle clad areas of rod IR-12-8. Such a structure which had an average DPH of 320 (31Rc) is shown in Figure 22. The most likely cause for this extent of grain boundary phase would appear to be excessive carbon resulting in heavy carbide precipitation during cooling in the bonding cycle. A sample of this material was exposed for 72 hours in 550 F water resulting in no apparent corrosion attack. A microstructure of this sample shown in Figure 23 shows separation at the grain boundaries and the apparent removal of several grains from the structure. These events occurred during the removal of the UO₂ core rather than during the corrosion test. The cracking propagated from the inside surface of the clad which was placed in tension by the flattening operation. Areas of the structure near the surface showed no corrosion penetration.

FIGURE 22 MICROSTRUCTURE OF THE BRITTLE CLAD AREA IN THE HOT GAS ISOSTATIC PRESSED ROD IR-12-8
