December 19, 1966

TECHNICAL LETTER: DRIBBLE-46, Supplement 1

FINAL INVESTIGATIONS OF WATER-WELL COMPLAINTS RELATED TO
SALMON EVENT IN TATUM SALT DOME AREA,
LAMAR COUNTY, MISSISSIPPI

R. E. Taylor

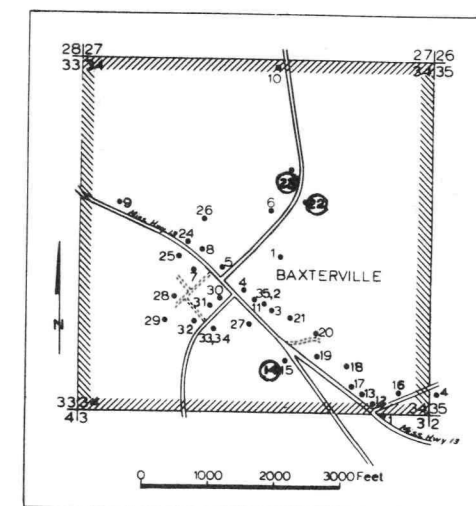
FIGURE 2.— WATER WELL LOCATIONS WITHIN 5-MILE RADIUS OF TATUM DOME, LAMAR AND MARION COUNTIES, MISSISSIPPI.

Figure 2 shows that some complaints on wells are clustered in groups of 2 or 3. This clustering may be partially due to the fact that when one owner or tenant has his well examined or pulled a neighbor may also decide to have his well examined.

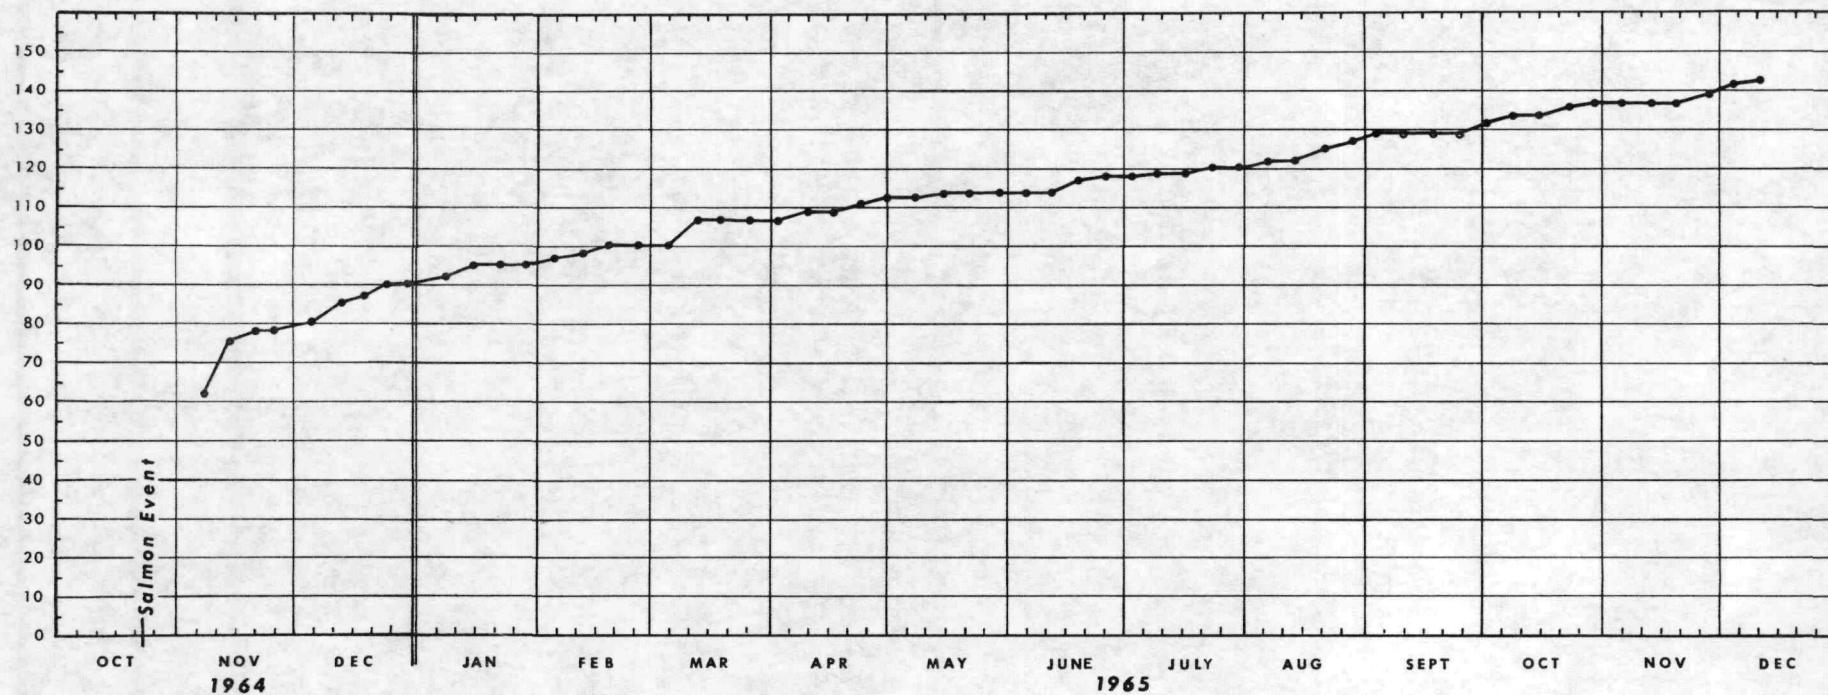
Figure 3 shows the cumulative increase of complaint and inquiry reports during the investigative period after the Salmon Event. The plot does not represent the actual dates that reports were received but is the number accumulated by the time of weekly administrative reports (usually dated on a Friday). Investigations began the same day as the detonation and the number of incoming reports rose quickly. Seventy-six complaints (53 percent of the total) had been reported by November 13, 1964, 22 days after the detonation. Fewer reports were received weekly after November 13, and in 26 of the next 56 weeks no reports were received.

Figure 3.--Cumulative number of wells (142) and springs (1) reported with 139 inquiries and complaints on water-supply systems.
