EXPERIENCE WITH STRESS CORROSION CRACKING AND MATERIALS

COMPATIBILITY AT THE HIGH FLUX BEAM REACTOR

R. W. Powell
J. G. Y. Chow
W. J. Brynda
M. H. Brooks
J. R. Weeks

Brookhaven National Laboratory
Upton, L. I., New York

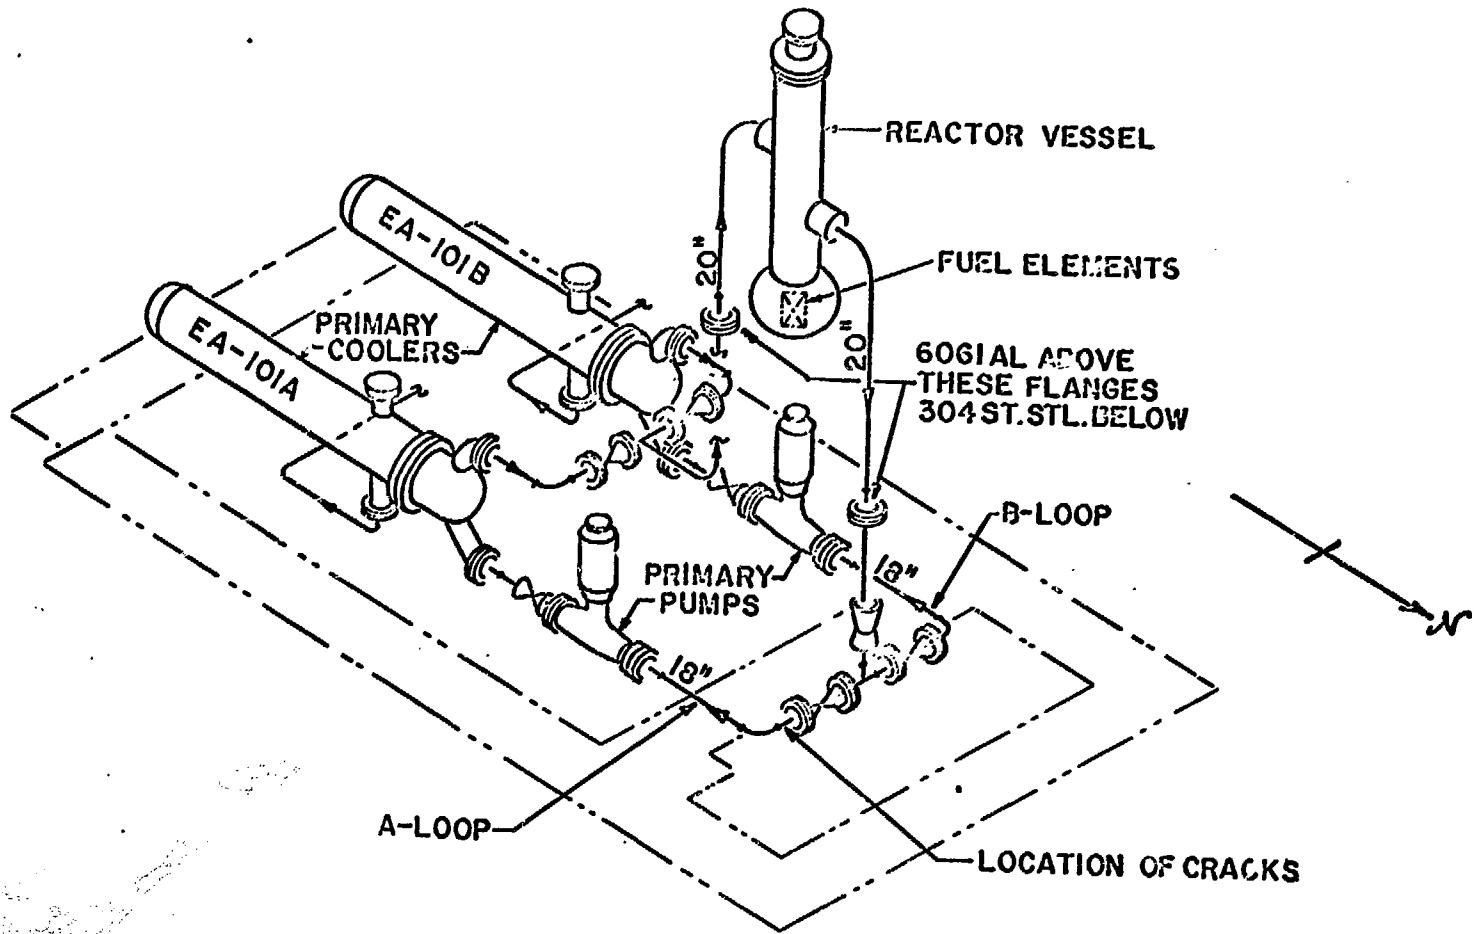
FIG. 1

The cracked flange was part of the "A" loop primary system piping. This flange was bolted to the outlet side of reactor outlet valve "A" and butt welded to 18" stainless steel piping, which directs primary flow to the suction side of primary pump "A", Fig. 1.

HFBR PRIMARY COOLING CIRCUIT
