DESTRUCTIVE ANALYSIS OF NEUTRON SOURCES M-71 AND 1053S

April 6, 1972

K. L. Breakall

MOUND LABORATORY

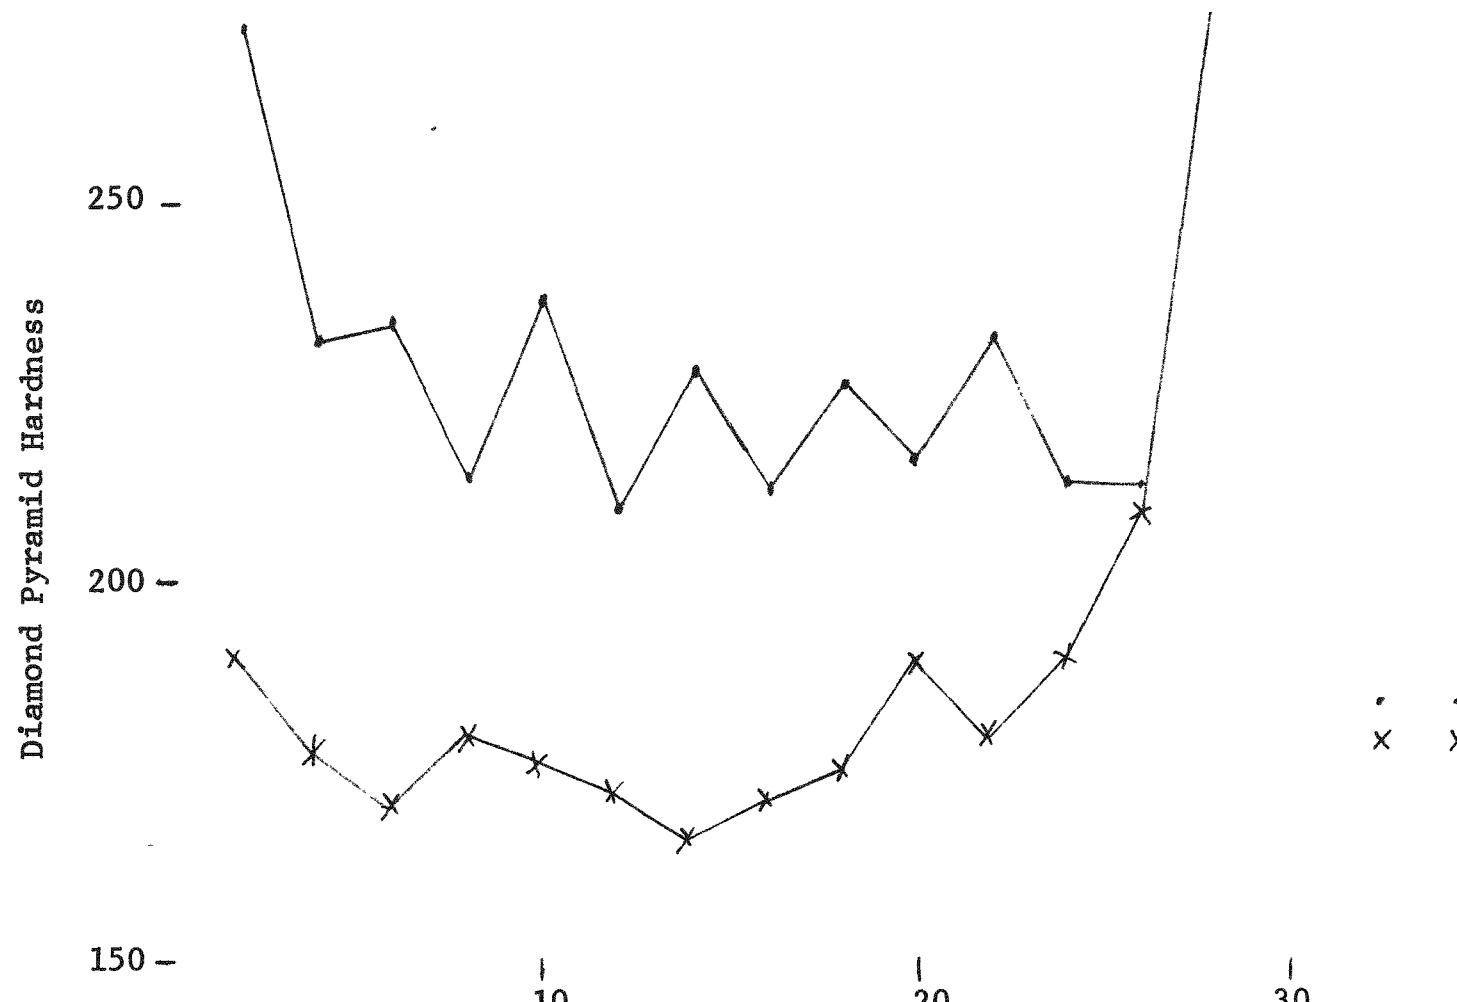
FIGURE 23. Distance from Outside Edge (mils)

Microhardness data, as shown in Figure 20, was typical of the values obtained for the top edge and side walls of the outer stainless steel container. Figures 21 and 22 show photomicrographs of the areas tested. The differences in the hardness that exist may be attributed to the cold working and the small grain size of the outer stainless lid in Figure 21, as compared with the annealed side wall in Figure 22. Figure 23 represents the hardness of the stainless outer top and side wall of M-71. These larger differences are unaccountable at this time, but are probably related to the reasons already stated. This source was subjected to a severe overpressure which may have contributed to the greater hardness differences.
