ORNL-NSIC-64

ABNORMAL REACTOR OPERATING EXPERIENCES 1966—1968

U. S. Atomic Energy Commission
Division of Reactor Licensing

NUCLEAR SAFETY INFORMATION CENTER

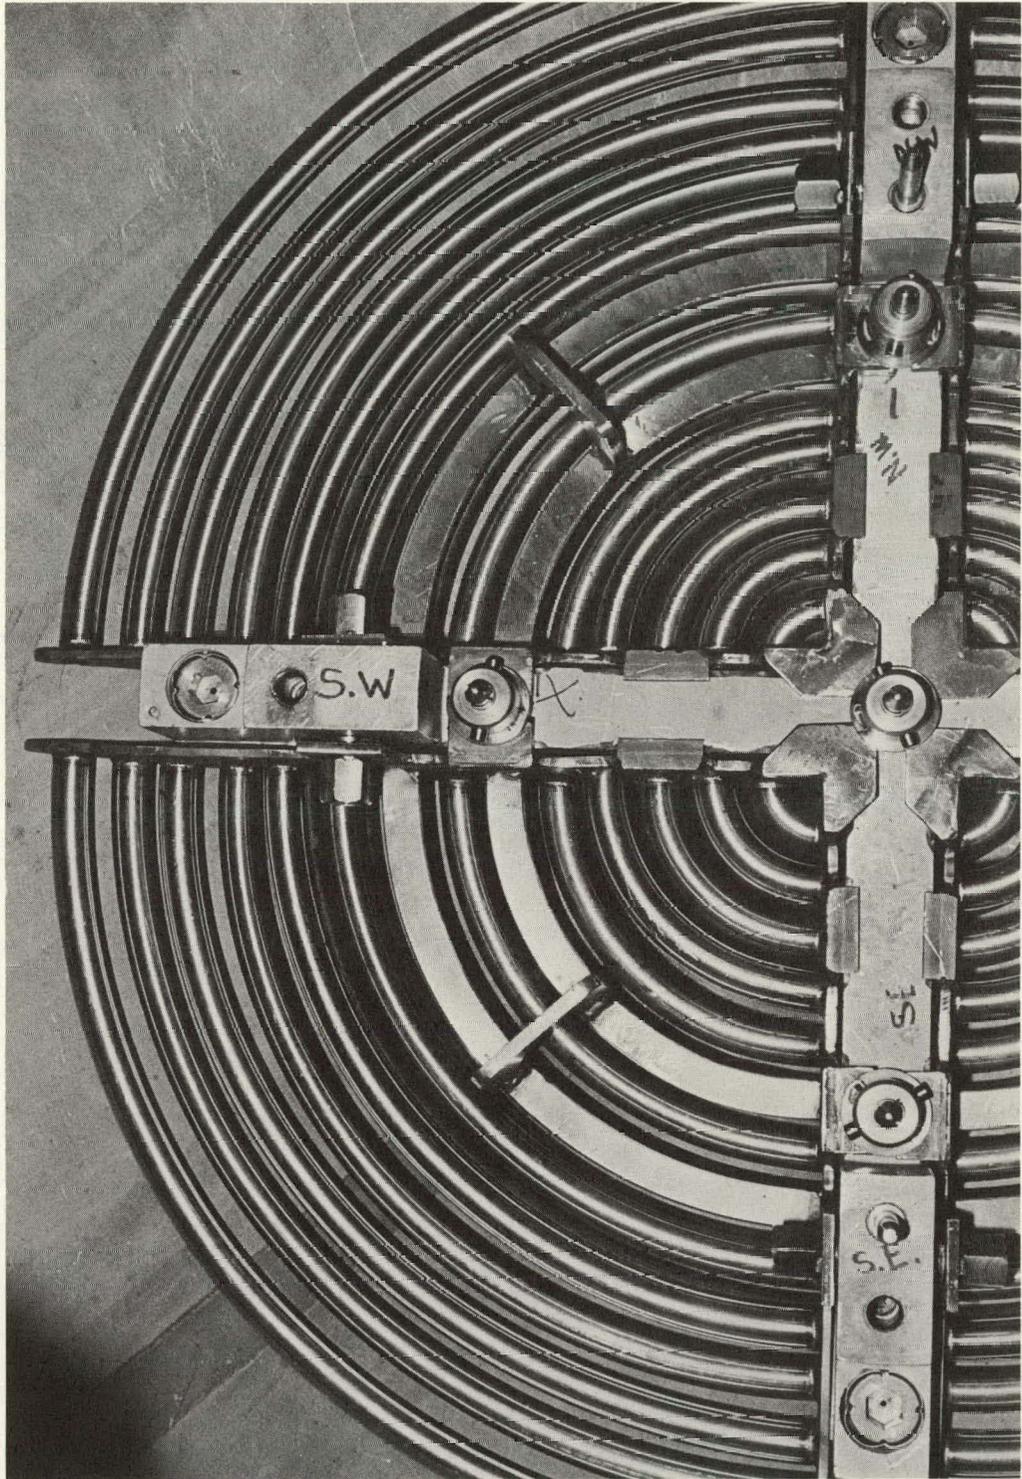
Fig. 67-7-1. Anticritical Grid.

The HFBR anti-critical grid is a set of stainless steel bars mounted in the bottom of the vessel to prevent criticality of a fuel mixture resulting from a core meltdown accident. The grid is divided into four segments which are bolted to the support saddle in the base of the vessel (Fig. 67-7-1).
