**Shippingport Atomic Power Station  
Steam Generator Tube Damage  
and Water Chemistry Control  
(1965 - 1975)**

W. J. Singley

January 1978

BETTIS ATOMIC POWER LABORATORY

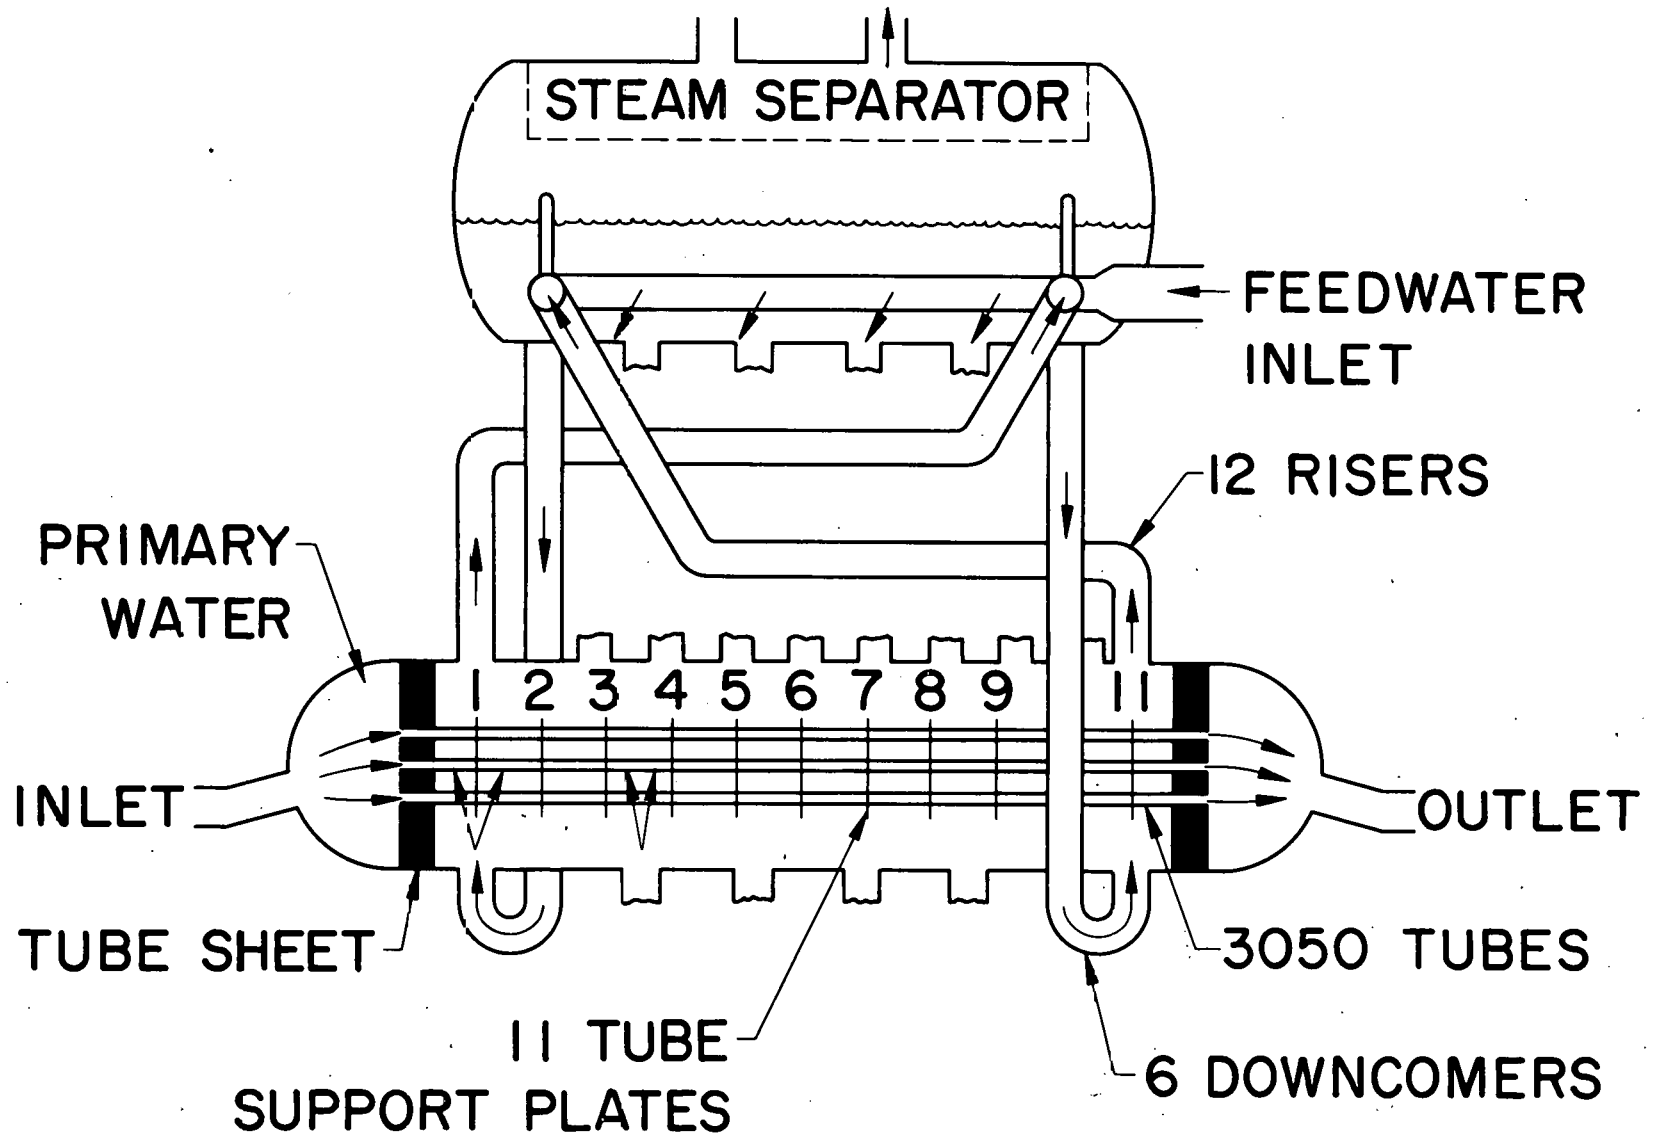
The arrangement of the 1A and 1D straight tube units is shown schematically in Figure 1. The arrangement for the 1B and 1C steam generators is similar, except that the tubes are U-shaped. All steam generators are of the natural recirculation type and have separate steam drums with external risers and downcomers. Design parameters for the steam generators are given in Table I. An important difference in the design of the two types of steam generators is the geometry of the annular crevice formed between the support plate hole and the tube. The support plate crevice region designs for the two types of units are shown in Figure 2. Cavities and flow blocked regions are formed between the tubes of the U-bend steam generators (1B and 1C) and the loop end support straps, Figure 3.

Fig. 1 Schematic of Shippingport Horizontal Straight Tube Steam Generator

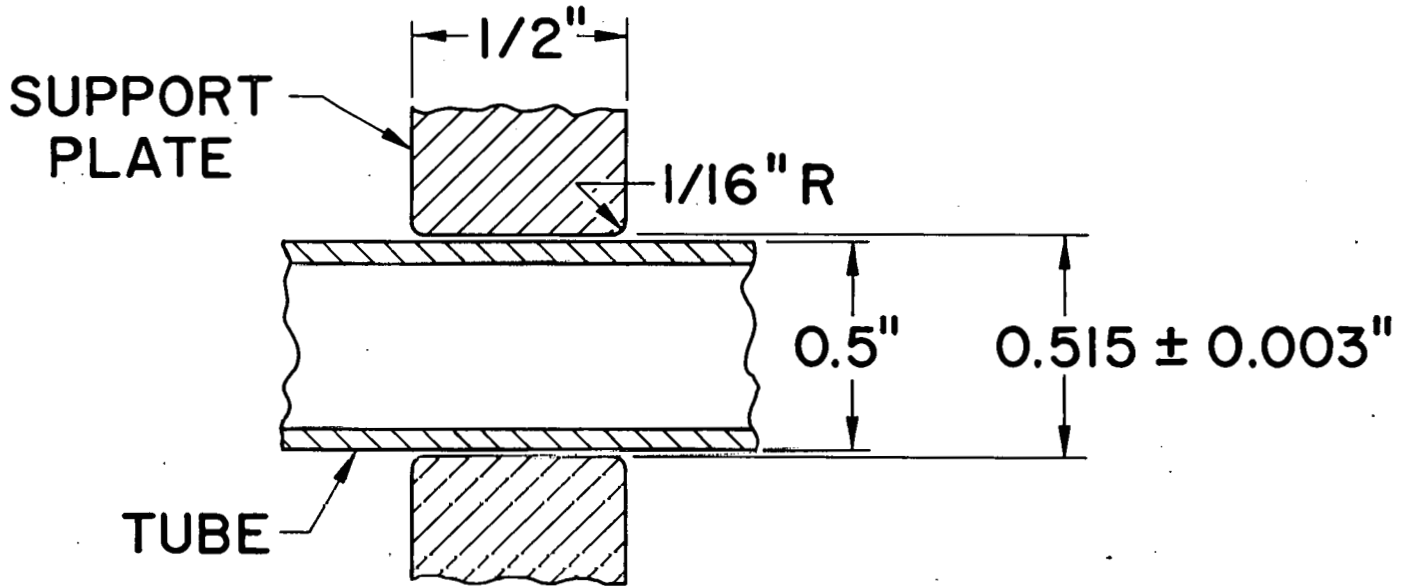
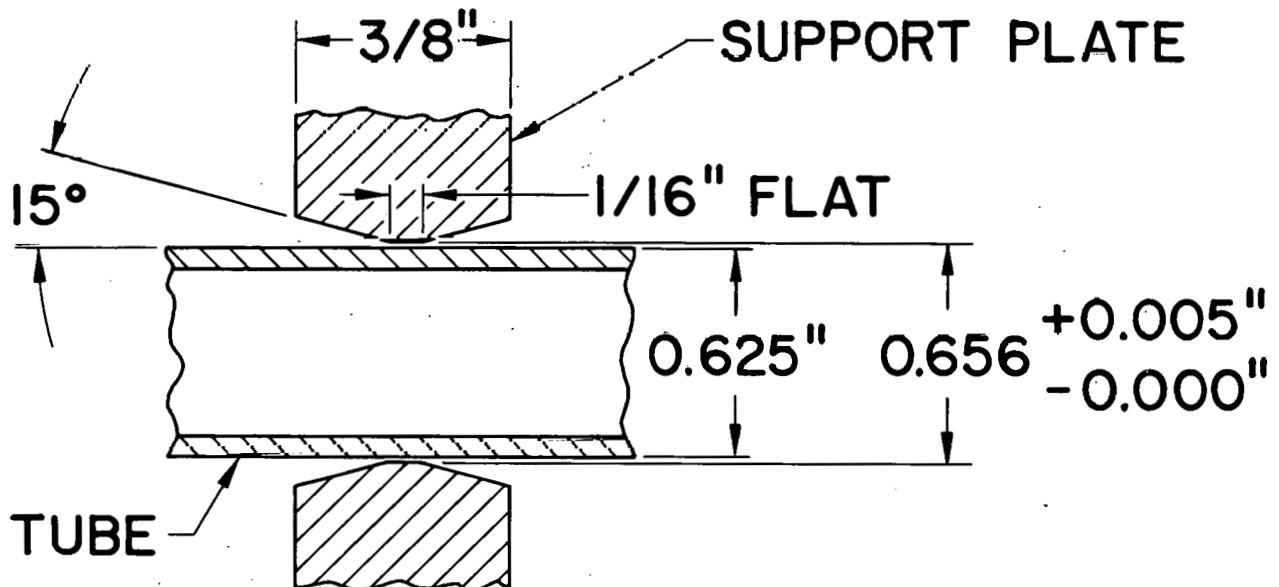
<u>Steam Generator Designation</u>	<u>Tube Bundle Orientation</u>	<u>Tube Bundle Type</u>	<u>Support Plate Hole Geometry</u>
1A, 1D	Horizontal	Straight-Tube	Cylindrical
1B, 1C	Horizontal	U-Bend	Hourglass (Double Chamfer - see Fig. 2)

SECTION THROUGH CYLINDRICAL HOLE  
SUPPORT PLATE, IA AND ID UNITS

SECTION THROUGH HOURGLASS HOLE  
SUPPORT PLATE, IB AND IC UNITS

Fig. 2 Support Plate Hole Geometry For Straight Lengths of Tubing  
(Top of Steam Generator is toward top of illustration.)

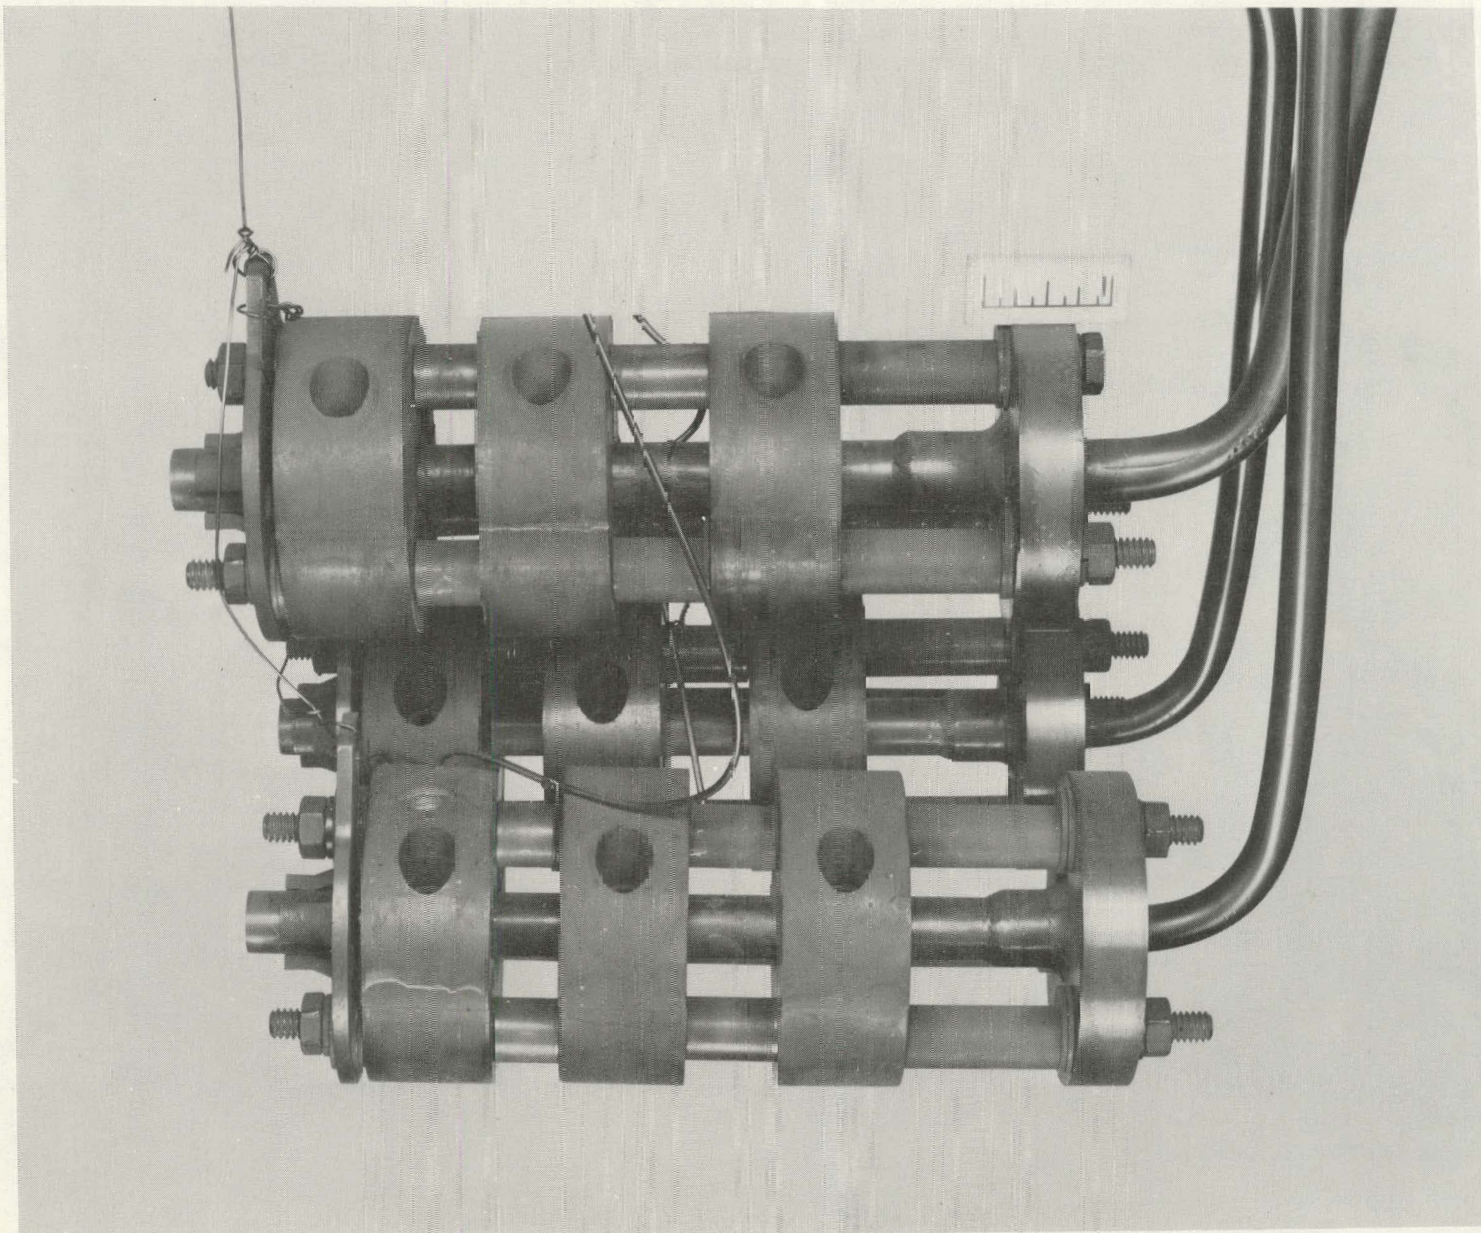
flux corresponding to that at the first support plate in the Shippingport steam generators. Temperature and pressure were controlled to simulate conditions existing in Shippingport. Defects which visually appeared similar (including the shallow grain boundary attack and intragrain pitting) to those on the Shippingport tubes were produced with a maximum depth up to about 4 mils in 3400 hours of heat transfer operation. The defects in the test did not sustain this initial rate of corrosion penetration, unlike the defects in the operating steam generators. The test assembly as-removed from the autoclave is shown in Figure 11, and the appearance of the tubes after removal of the mockup support plates is shown in Figure 12. Note the similarity in appearance of defects with those shown in Figure 5 for a tube removed from the 1D steam generator. The surface of defects found on the test tubes showed grain boundary attack and intragrain pitting (Figure 13) similar to that observed on removed Shippingport steam generator tubes. Metallographic sections through a typical defect from the heated tube test are shown in Figure 14.

Fig. 11 Heated Tube Assembly as removed from test after 4000 hours
