DOE/ET/15457-1523  
(DE84008900)

LONG TERM MATERIALS TEST PROGRAM

Quarterly Report, April—June 1983

By  
General Electric Company  
Advanced Energy Programs Department  
Schenectady, New York

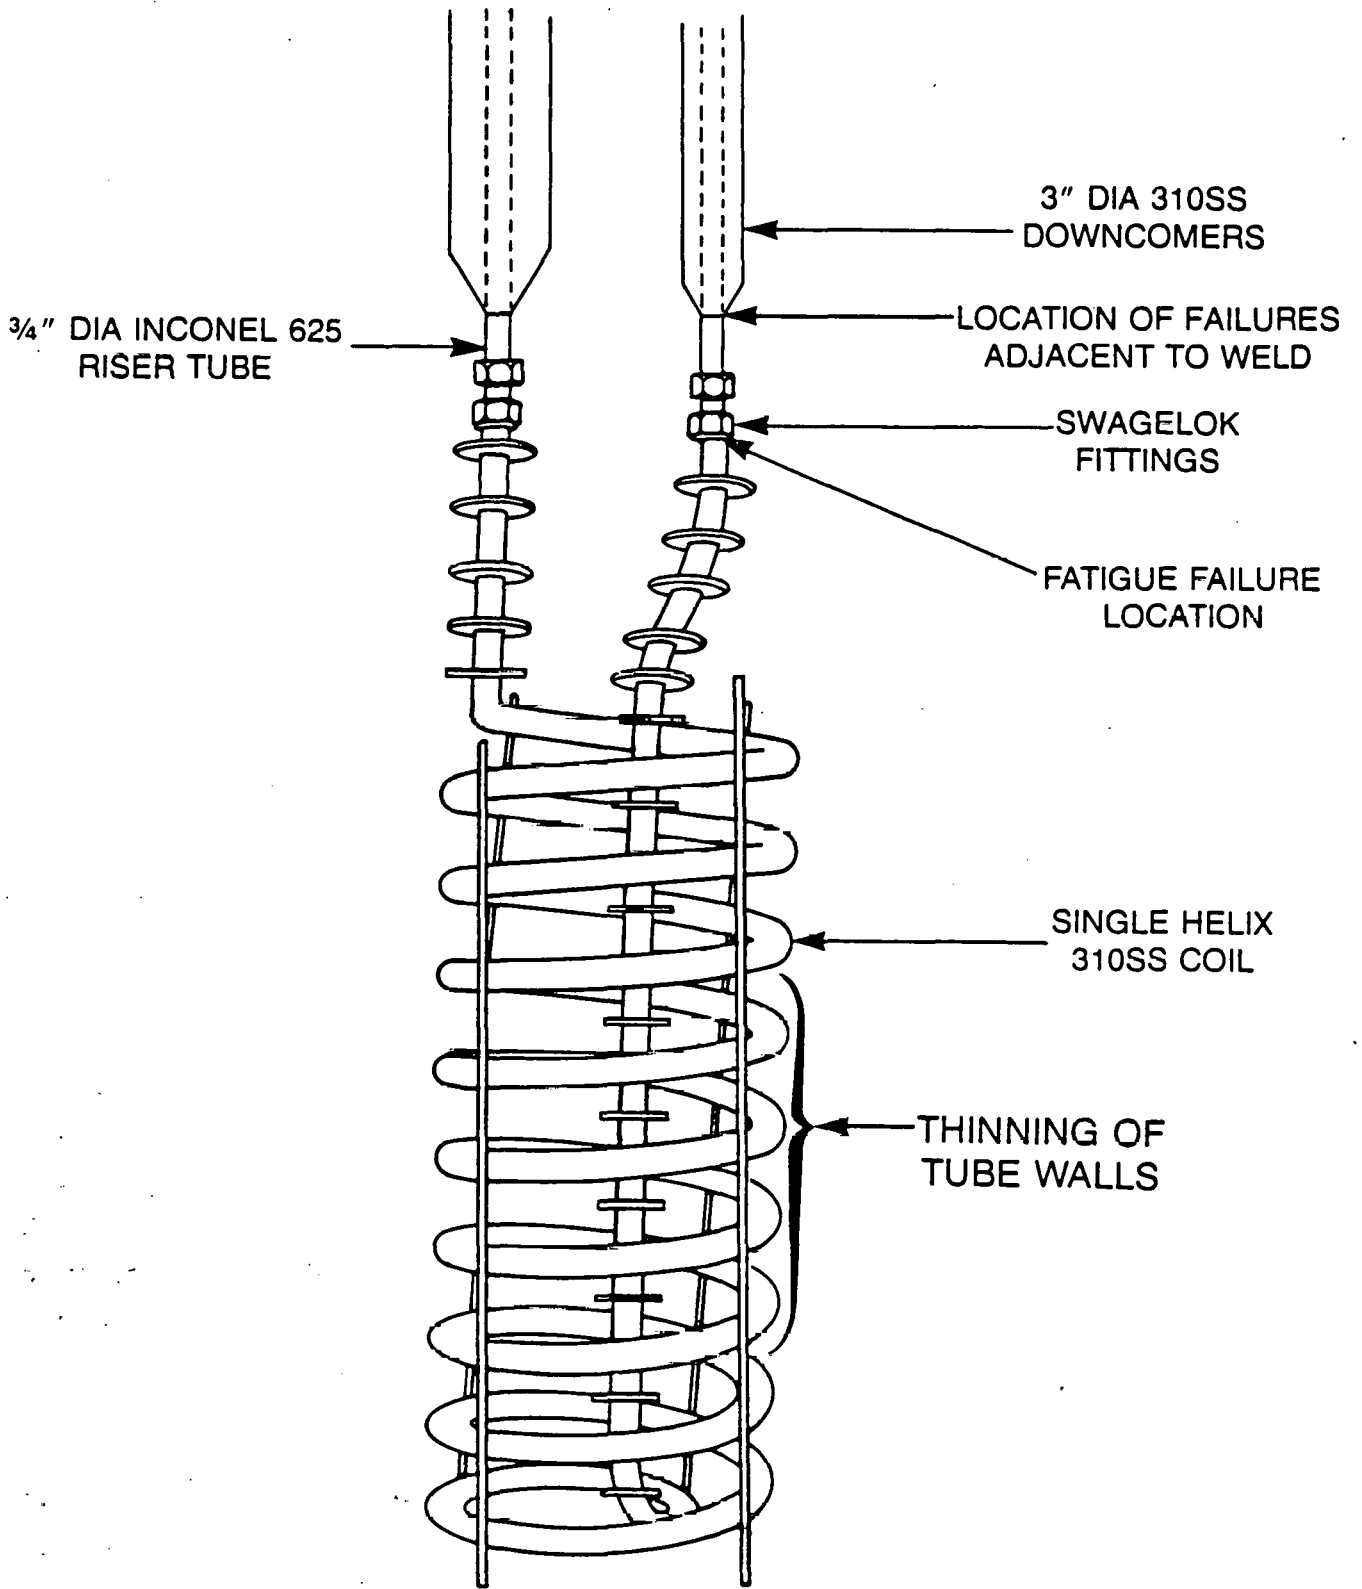
Figure 2-1. IN-BED Heat Exchanger Coil Assembly

After approximately 620 hours of service, failure of this coil occurred by complete fracture of the inlet tube just below the Swagelok fitting that connects the 310 SS coil to the Inconel 625 riser tube, Figure 2-1. Figures 2-2 (a & b) are scanning electron micrographs of the fractured tube wall. Approximately one-half of the wall thickness toward the OD, Figure 2-2a, is covered with a thick corrosion or oxide layer with the remaining area extending to the ID covered with fatigue striations, Figure 2-2b. The fatigue striations indicate propagation from the OD to the ID of the tube wall. It is unclear, however, whether the failure initiated on the outer surface by pitting or

crevice type corrosion, followed by fatigue crack propagation, or a fatigue crack initiated whose surface was subsequently corroded/oxidized. Pitting attack has previously been observed at various locations on the in-bed heat exchanger assembly. (Fractures similar to that described above have previously occurred on the heat exchanger heat exchanger assembly, but these earlier fractures occurred in the downcomer assembly at the weld connecting the 3/4-inch diameter riser tube to the 3-inch downcomer, see Figure 2-1.) The inlet tube was replaced and the coil successfully returned to service at a later date.

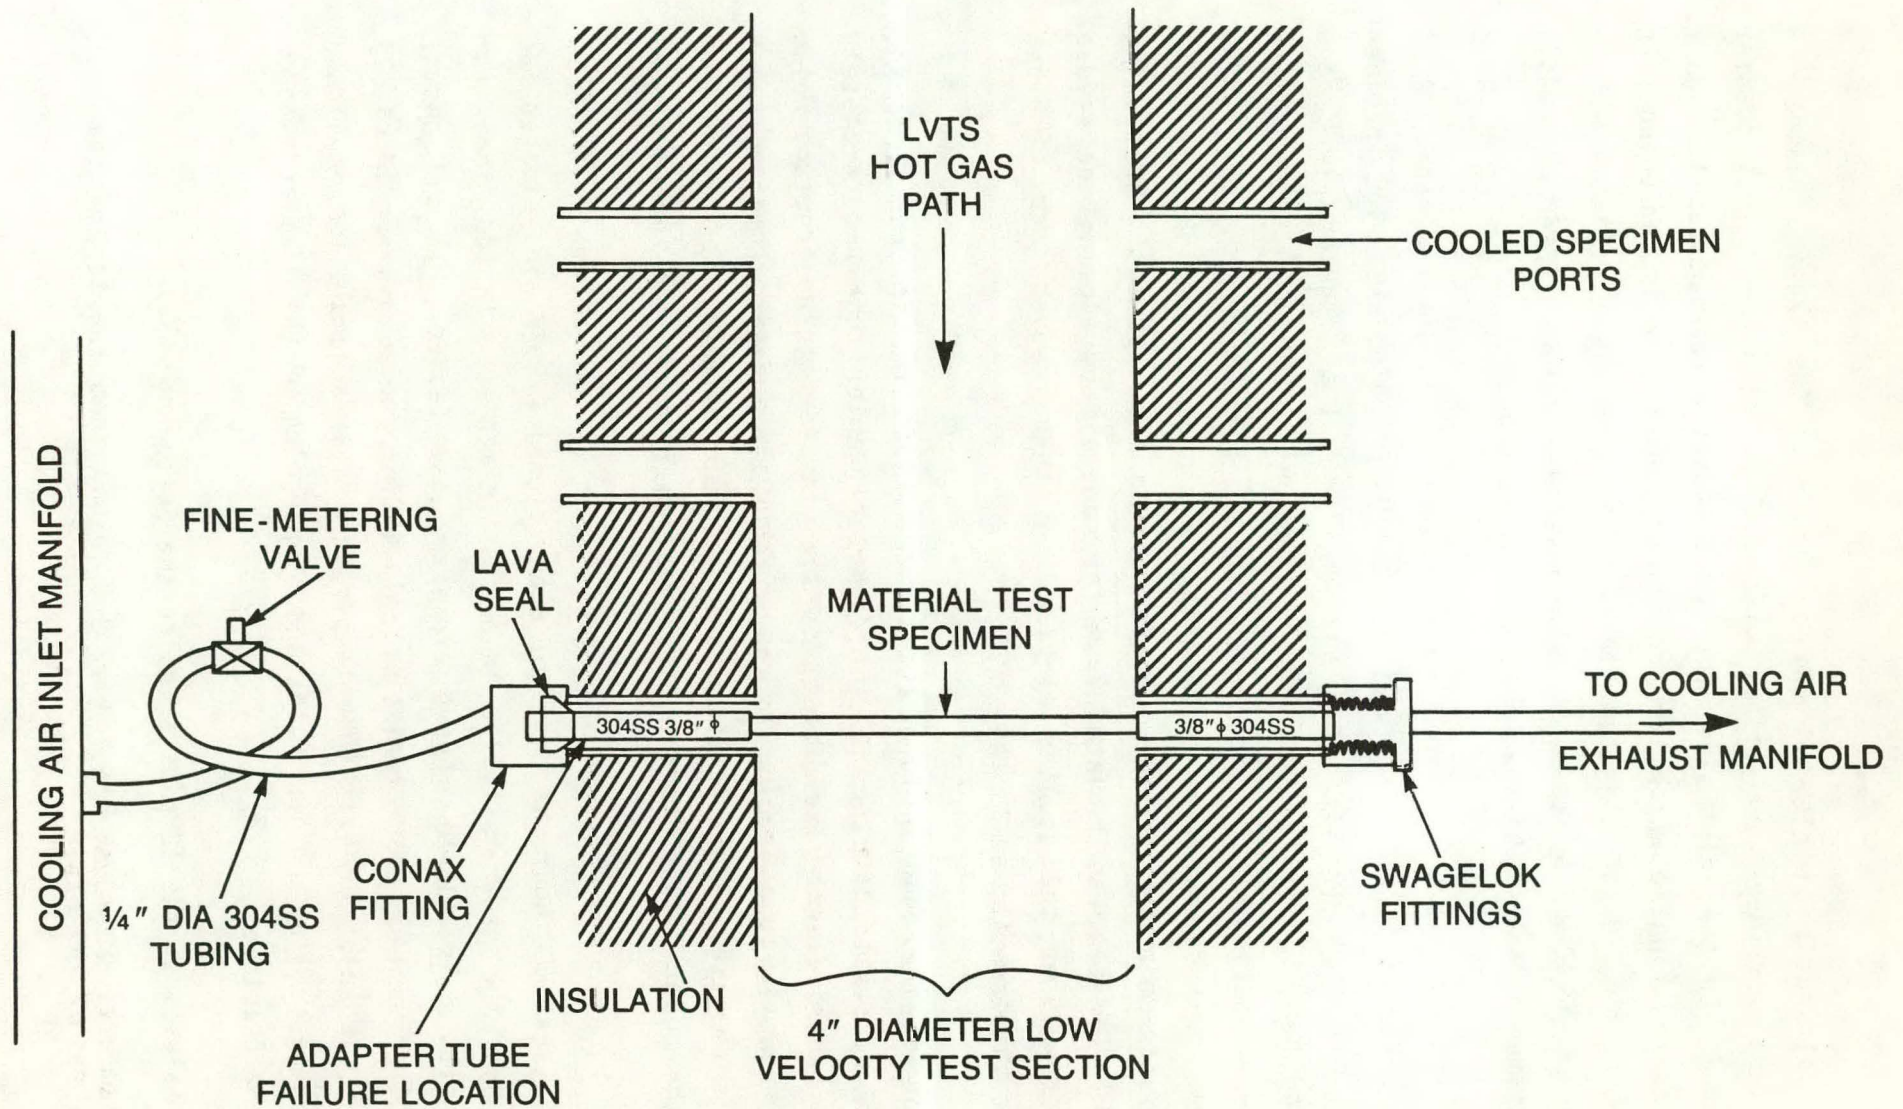
Figure 2-3. Schematic of LVTS Cooled Pin Specimen Configuration

fold which distributes air to all 60 cooled pins. The 1/4-in. diameter x 6-in. long test specimens are fitted with 3/8-in. diameter 304 SS adapter tubes as shown. On the inlet side, the 304 SS adapter tube passes through a Conax-Lava seal fitting to which the cooling air inlet tube is connected. On the exit side, the 3/8-in. diameter stainless adapter tube is fitted with a Swagelok fitting welded to its end. The Swagelok fitting threads directly into the specimen ports in the low-velocity test section.

At the 1500-hour mark of the long-term test, a failure of the 304 SS adapter tube occurred on the inlet side of an 1100°F cooled pin. The specimen which failed had been in test since the outset of the long-term test, and therefore, had seen the full 1500 hours of exposure. Failure of the specimen was noted by a sharp rise in the temperature of the stainless steel tubing (normally near room temperature) connecting the pin to the cooling air manifold, and an accumulation of liquid condensate in the bottom of the cooling air manifold. The pin was isolated from the manifold by closing the needle valve which regulates the cooling airflow, and then removed from the test section after shutdown at week's end.

Inspection of the adapter tube after removal of the specimens from the test section, revealed that the 3/8-in. diameter adapter tube was completely plugged with a hard cement-like deposit on the pin side of the fracture while the piece of adapter tube leading to the cooling air manifold remained relatively free of deposit. The fracture was located approximately 3 1/4-in. from the end of the adapter tube, putting its location 1-in. inside the Lava seal connection.

During the next 600 hours of testing, 8 additional 1100°F pins exposed for periods of 1800 to 2100 hours failed in a similar manner. In addition, four 1100°F pins with only 600-1000 hours exposure also failed. In all cases, failure exhibited similar characteristics: 1) 1100°F cooled pin specimens, 2) sharp rise in the inlet or exit tube temperature, 3) accumulation of liquid condensate in the cooling air manifold, and 4) plugging of the adapter tube on one side of the fracture.
