Outages of Electric Power Supply Resulting from Cable Failures Boston Edison Company System

July 1980

Prepared by:
Commonwealth Associates Inc.
Jackson, Michigan 49201
Under Contract No. AC01-78RG06674

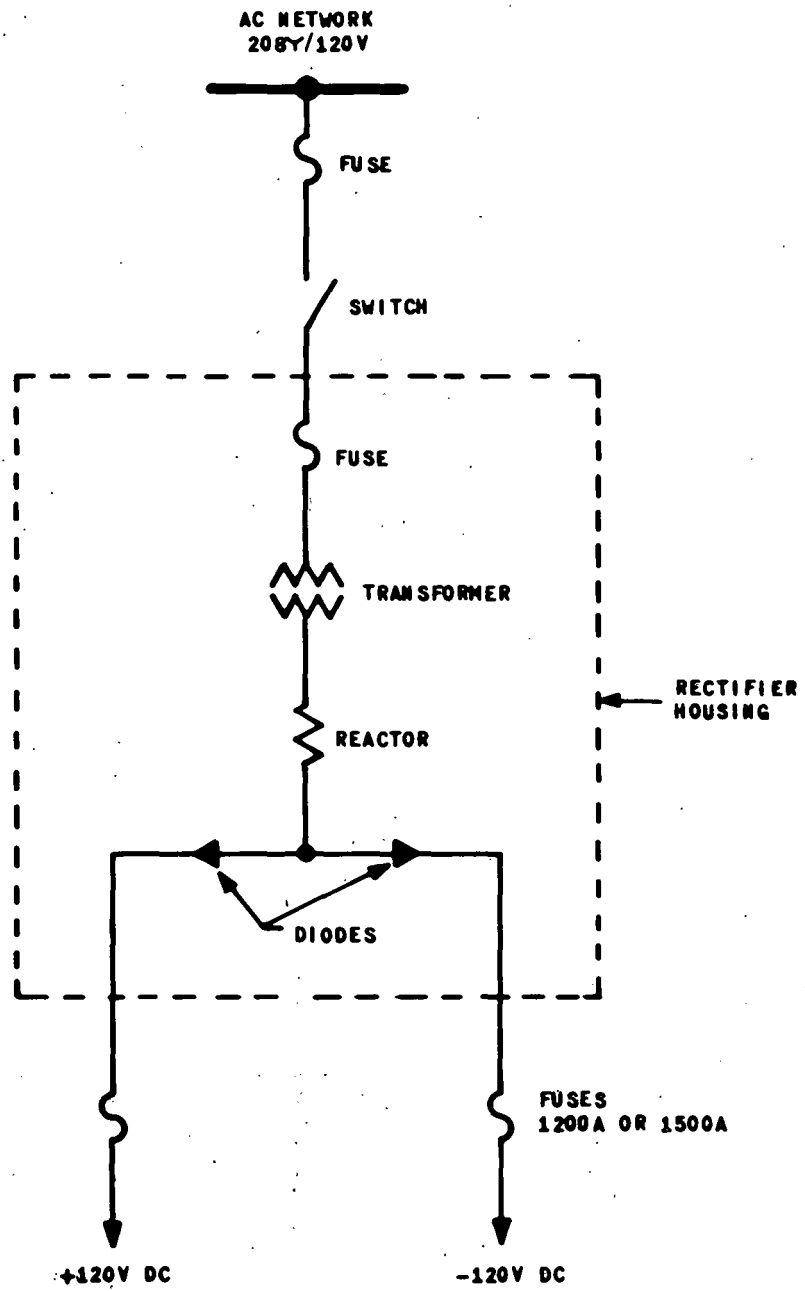
TYPICAL ELECTRICAL CONNECTION
250 KW POWER RECTIFIER

The 1,200 ampere fuses on the dc side of the rectifier must permit load current to flow without interruption, yet operate quickly for short circuits. For a maximum fault, this fuse would blow almost instantaneously so that heat generated would be negligible and that there would be no damage to adjacent cables. However, the speed of interruption decreases rapidly with reduction in fault current, which can be caused by arc resistance and/or distance between the fuse and the short circuit. For example, this fuse would require 10 seconds to blow for a 2,500 ampere short circuit.

One of the most difficult problems with the dc secondary grid is clearing faults. Arcing faults may not draw enough current to blow fuses as in the case of the Back Bay incident. This problem is compounded by the decreasing size of the dc system. As links in the dc grid are no longer needed and are retired and moved, the impedance of the grid increases. This causes a decrease in fault currents and correspondingly increases the probability that faults will not be cleared by the fuses.

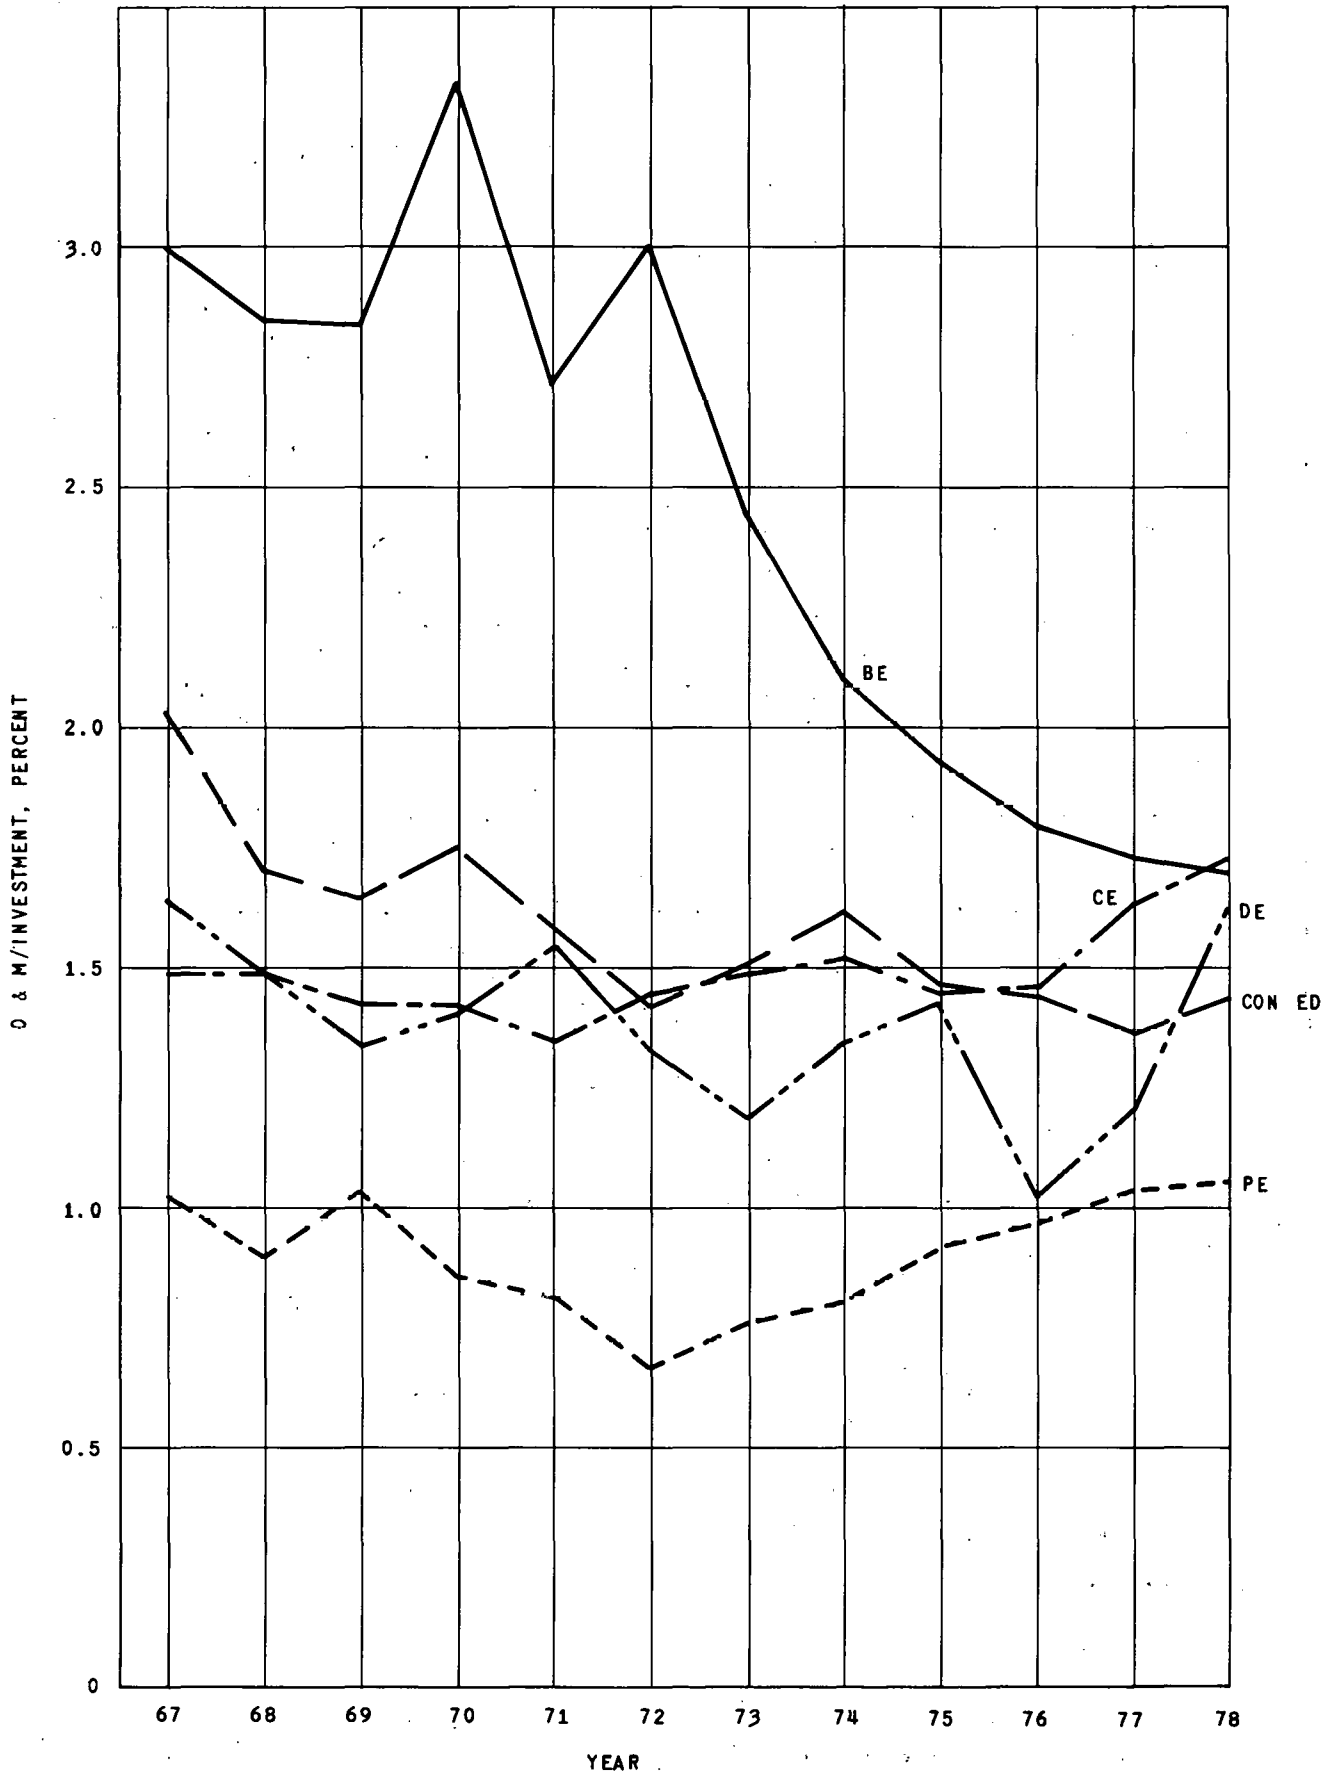
DISTRIBUTION OPERATING AND MAINTENANCE EXPENSE
 PERCENT OF UNDERGROUND DISTRIBUTION INVESTMENT
 (VALUES ADJUSTED TO 1967 INDEX)

It is not feasible to draw specific conclusions for a particular incident from statistical data as grouped for this appendix. However, it is evident that there has been a reduction in underground distribution system maintenance by Boston Edison Company in recent years. This can lead to failure to detect incipient failures on cables or other equipment. This is particularly true with lead-sheathed, paper-insulated cable, which is extremely vulnerable to failure upon entry of moisture. A good inspection and testing program can locate such problems as cracked or worn sheaths or changes in characteristics which are indications of possible failure in the near term.

The Wellesley, Roslindale, and East Boston/Chelsea outages were all caused by multiple failures of old cable. It is possible that at least some of these could have been forestalled by an aggressive cable inspection and testing program.

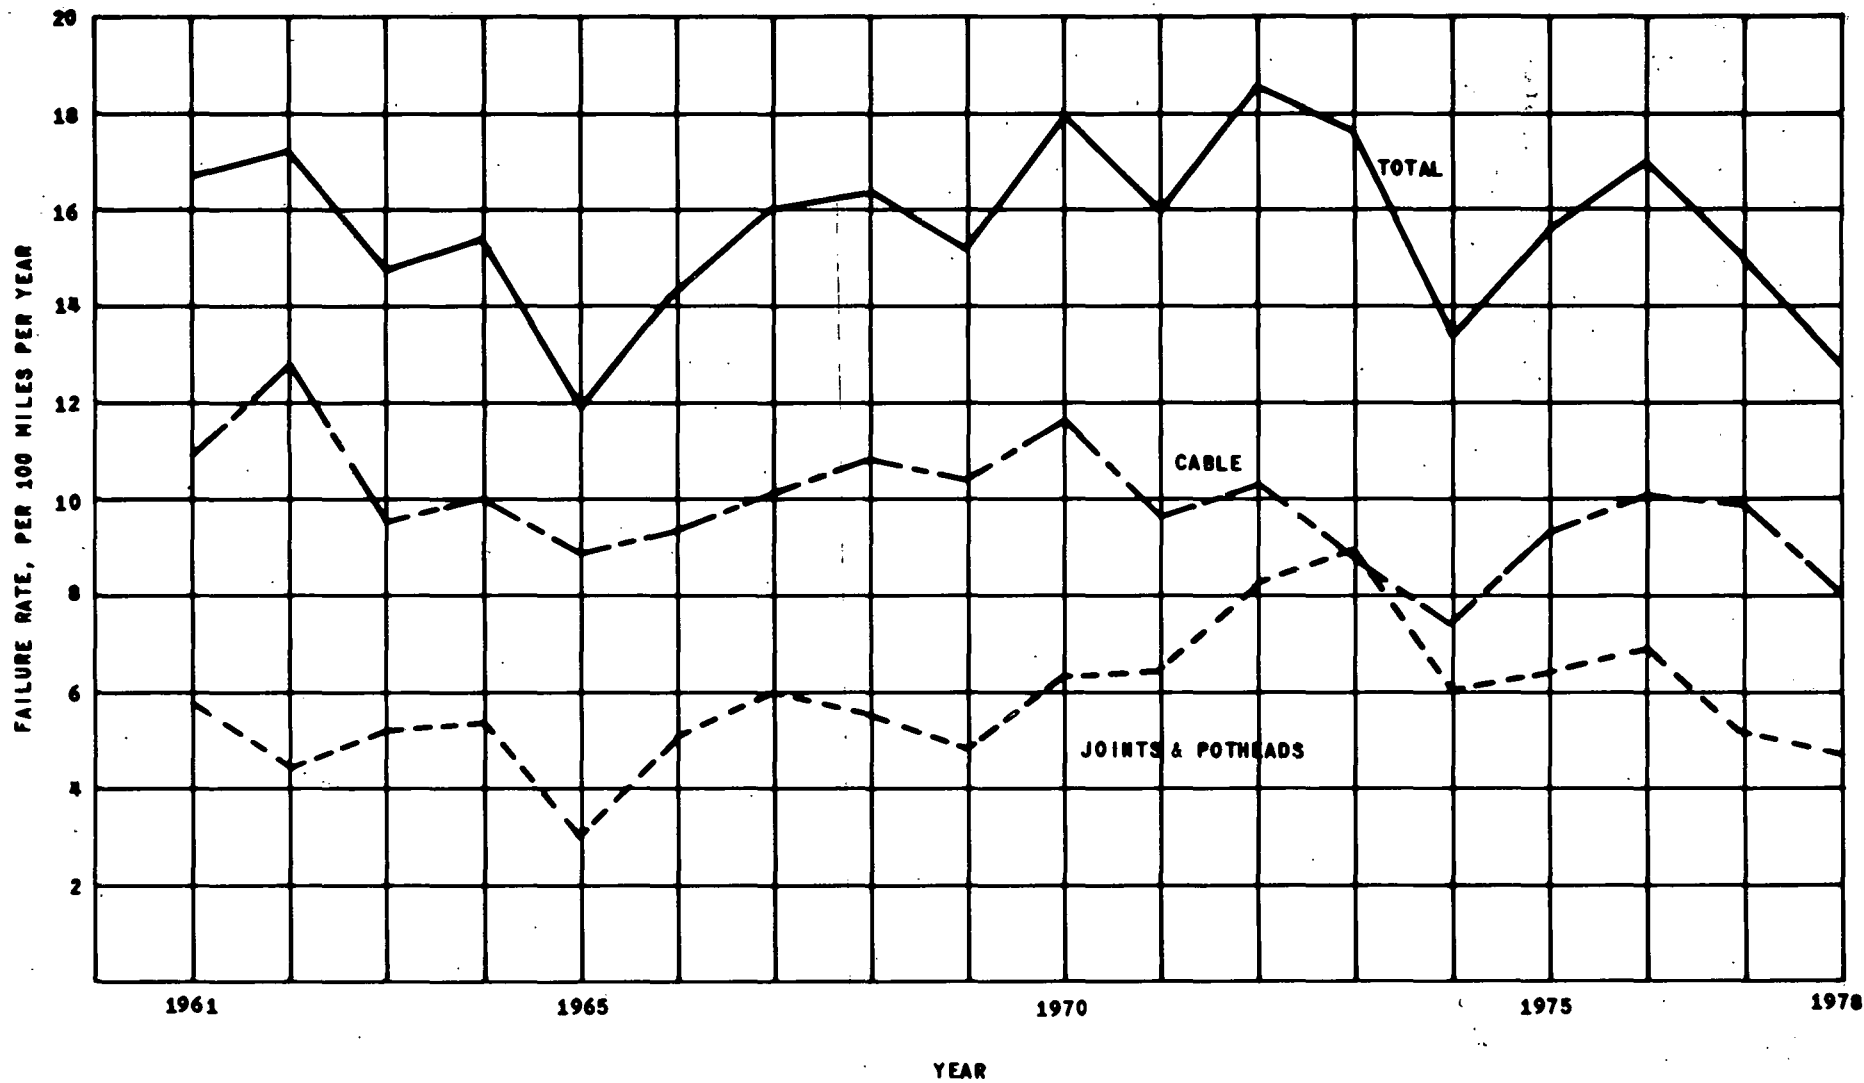
BOSTON EDISON COMPANY
CABLE SYSTEM FAILURE RATES
6.9 KV AND ABOVE

jacket over the lead sheath. A protective jacket would improve protection against corrosion, mechanical damage, and those moisture-induced failures which can be coupled to sheath wear. A carefully-designed cathodic protection system can also reduce the number of failures caused by corrosion. Such systems are in place, but it is possible that improvements could be made.
