NUREG/CR-3562  
PNL-4629

# Steam Generator Tube Integrity Program Leak Rate Tests

## Progress Report

**Pacific Northwest Laboratory**  
Operated by  
Battelle Memorial Institute

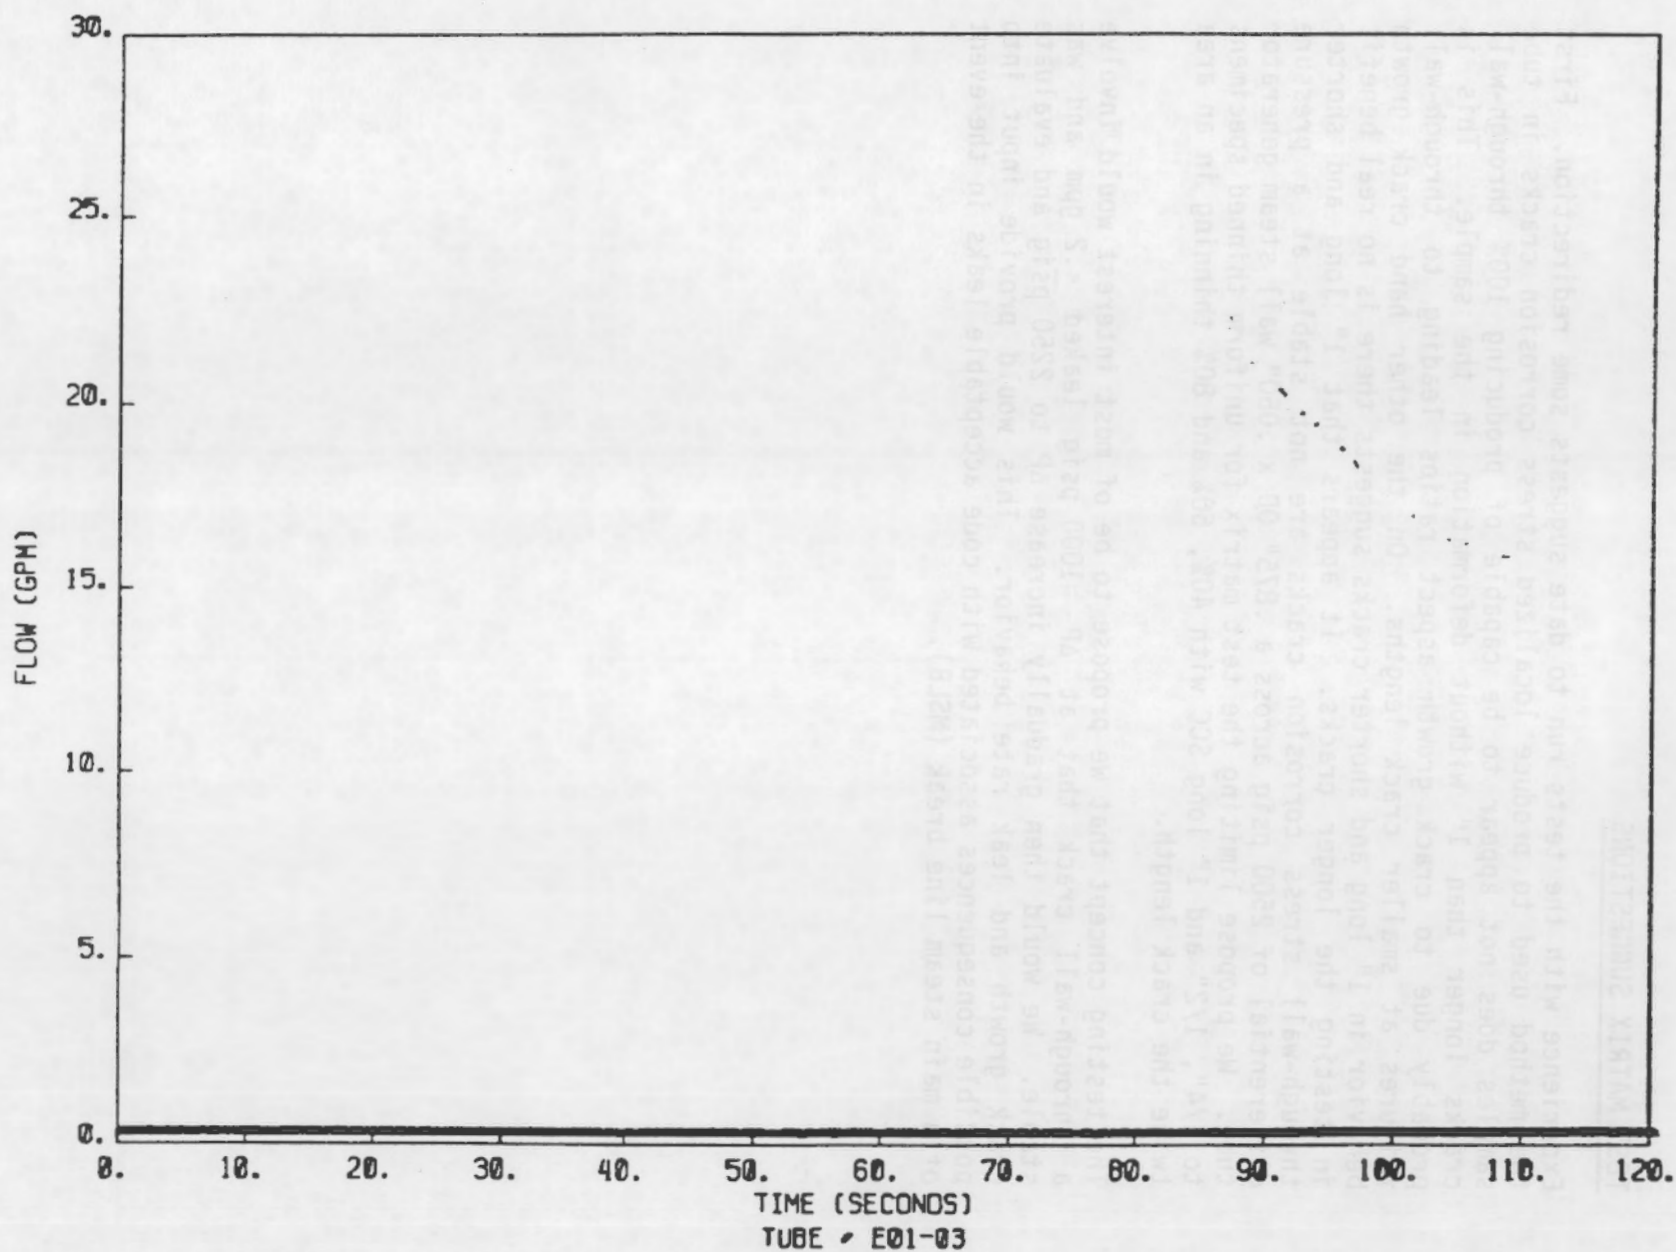
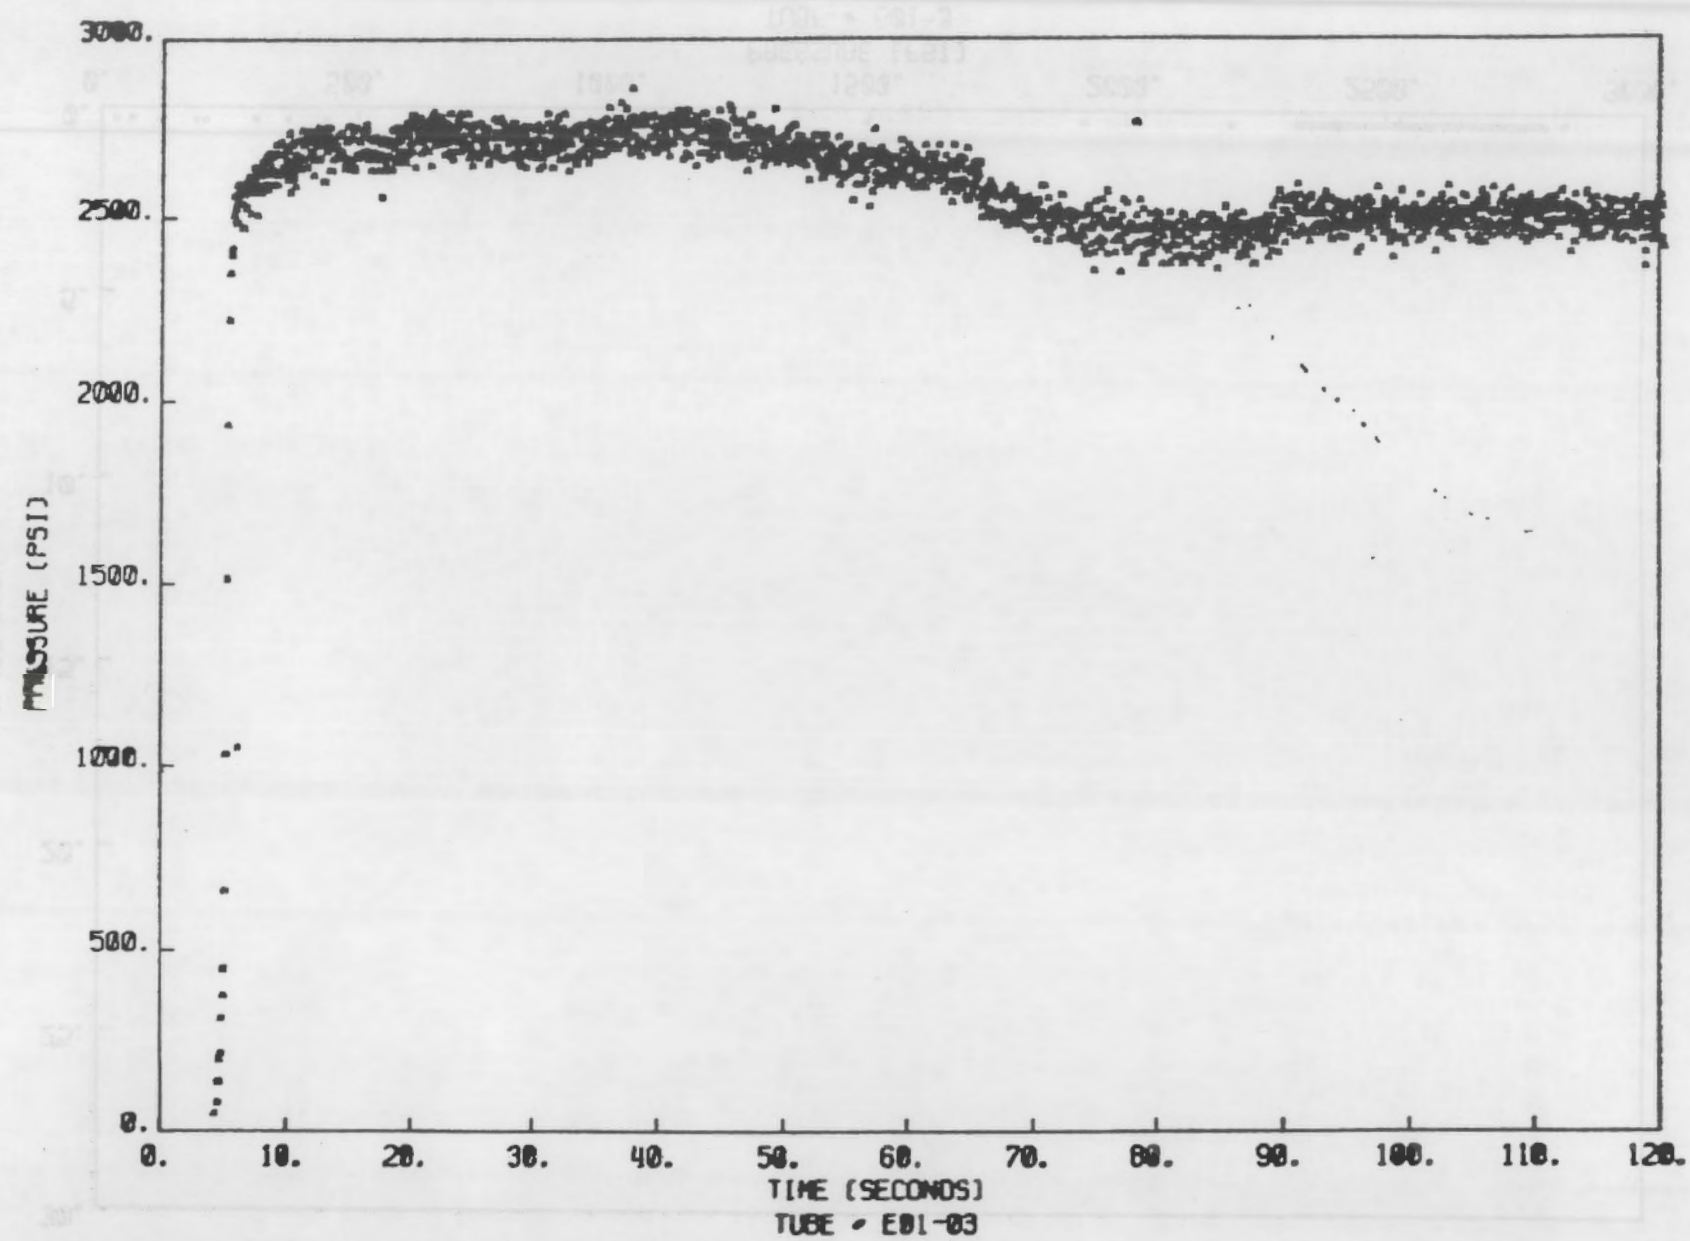
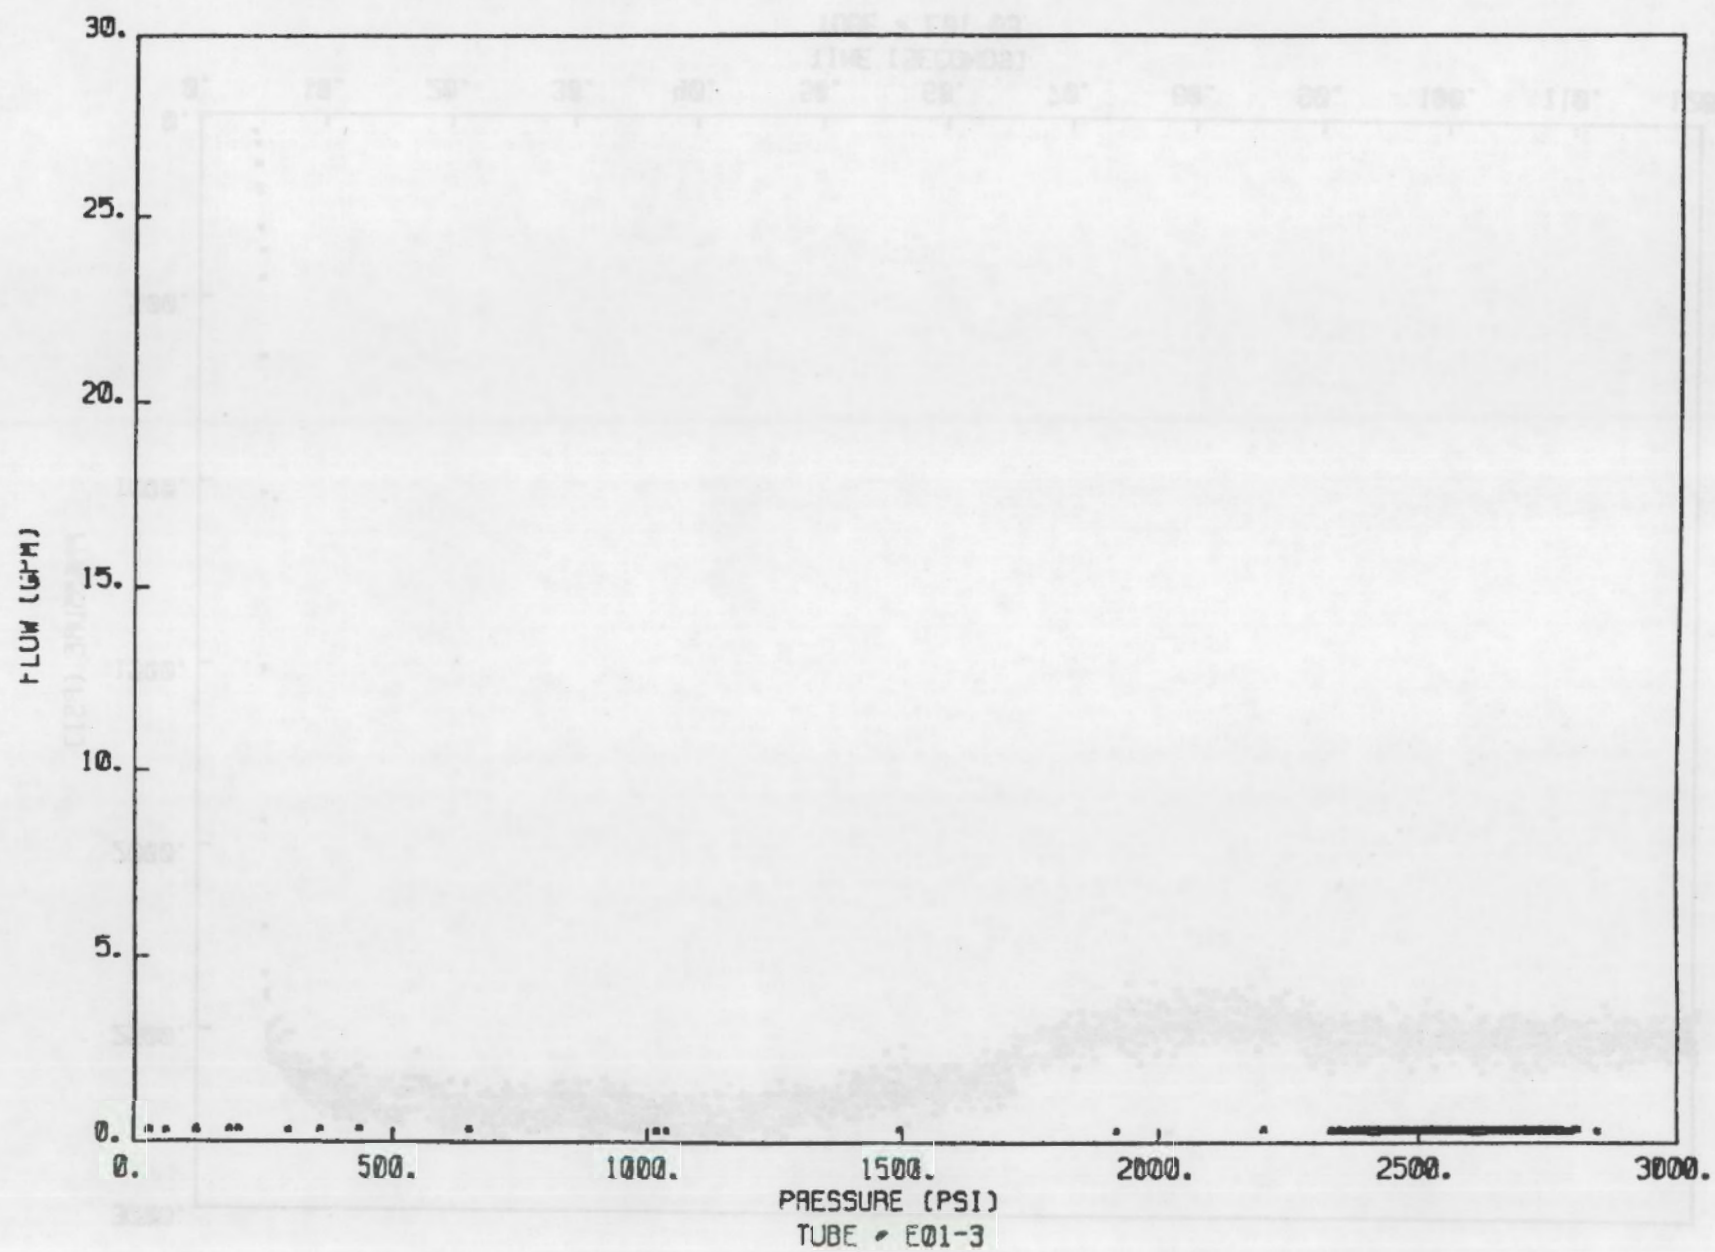
- Computer data: Figures 8, 9 and 10.
- After test photograph: Figure 35.
- Eddy current before test: 100% through-wall crack.
- Visual inspection: No thinning, 3/8" long crack in center of exposed area.
- Testing: Flow remained <2 gpm although pressure ranged between 2700 and 2500 psig. Test ran for slightly over 2 minutes.
- Test results: Major crack opened slightly and length increased to 1/2". No substantial crack growth noted on videotape.

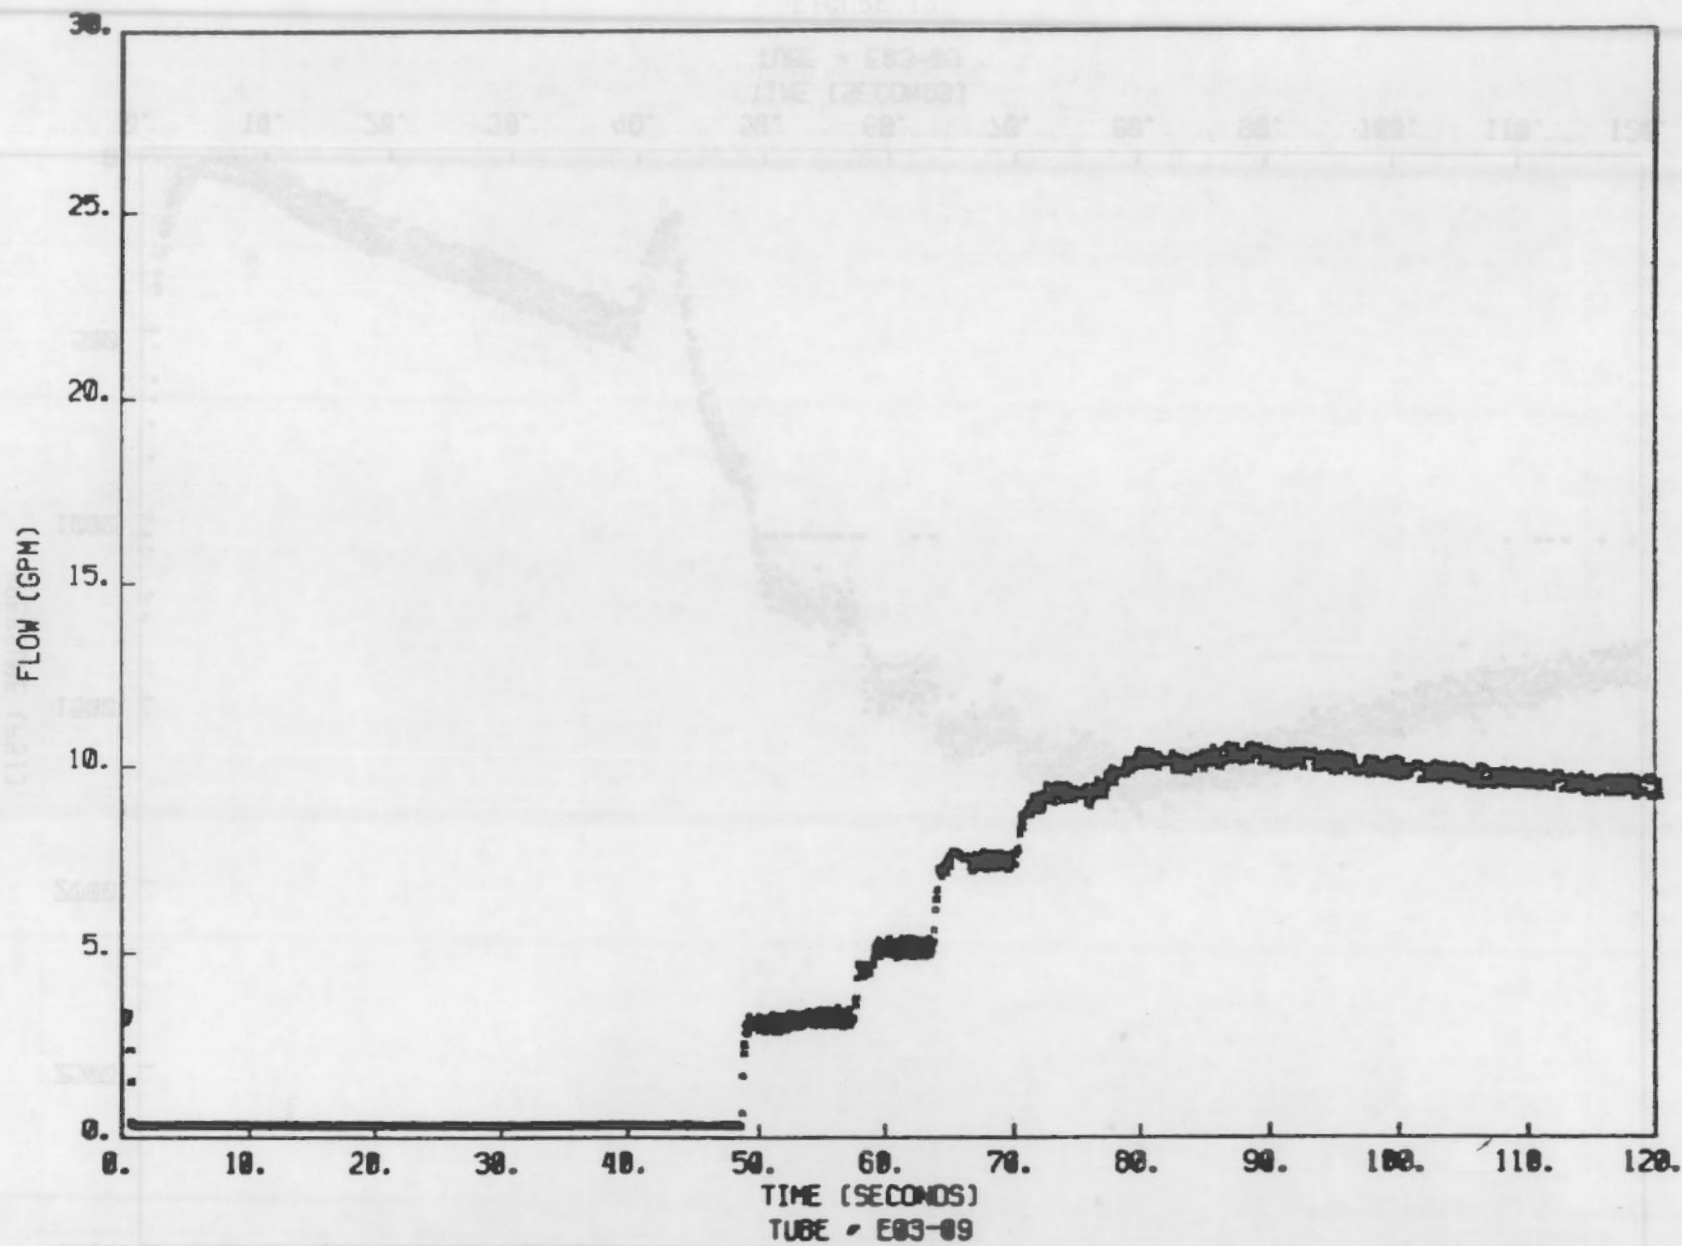
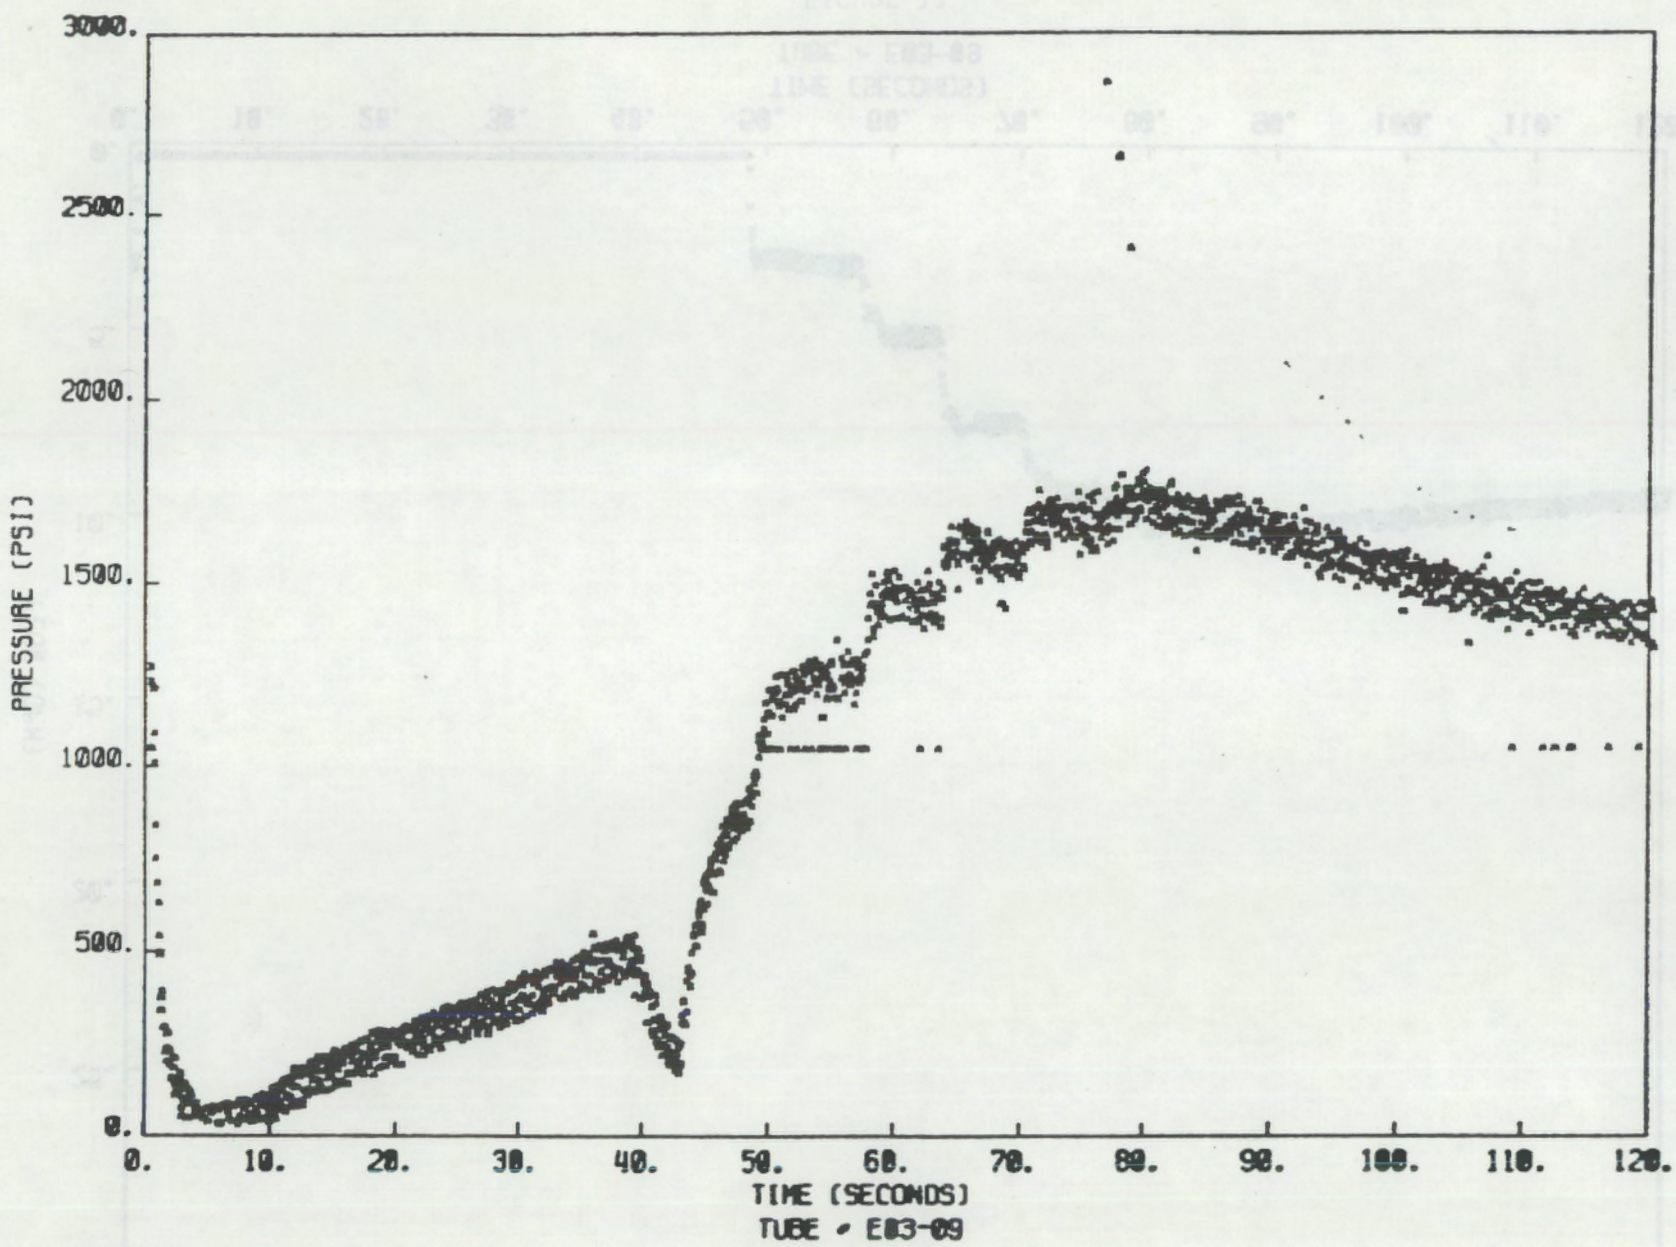
- Computer data: Figures 11, 12 and 13.
- After test photograph: Figure 36.
- Visual inspection: 1/2" long EDM notch.
- Testing: Pressure built up to 500 psi and flow remained at <2 gpm for first 50 seconds of test. Then pressure increased in steps to a maximum of ~1700 psi while flow increased in steps to 10 gpm.
- Test results: Notch bulged slightly at both edges.

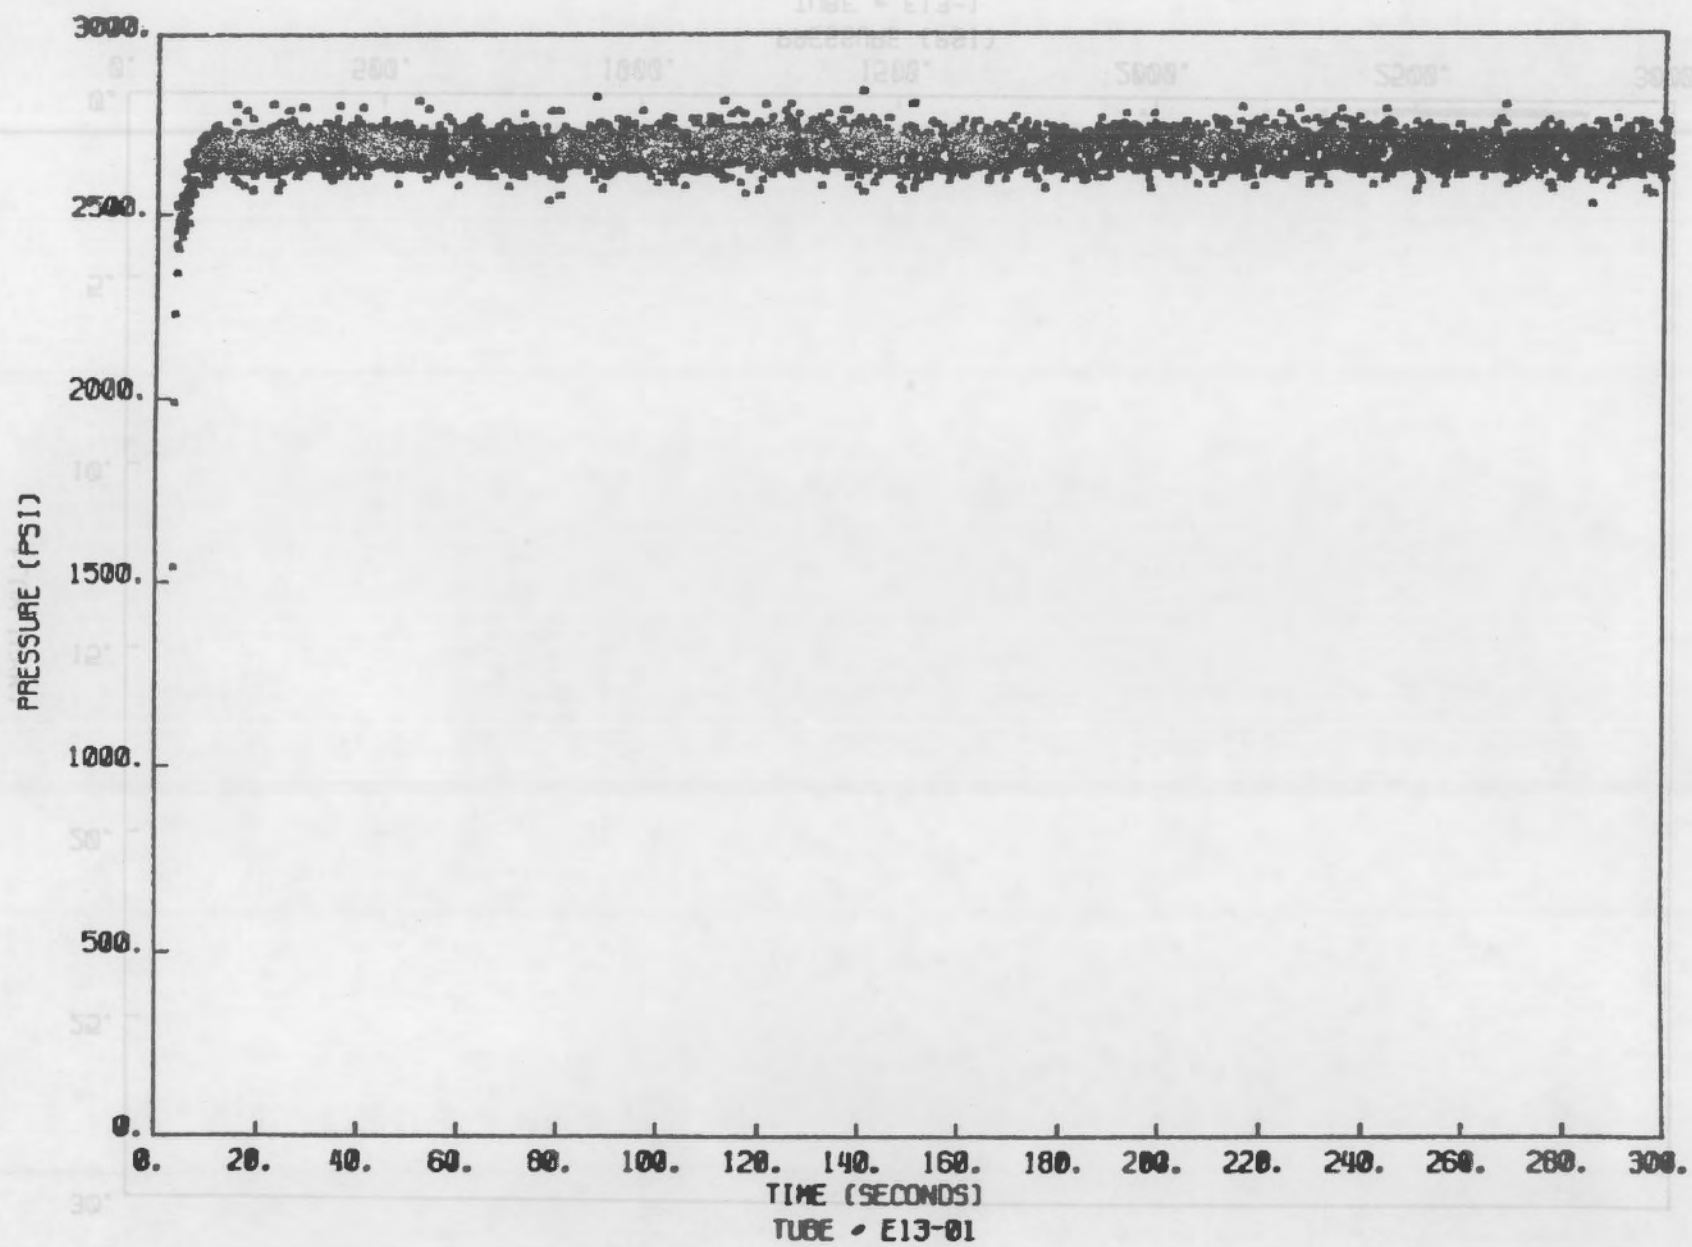
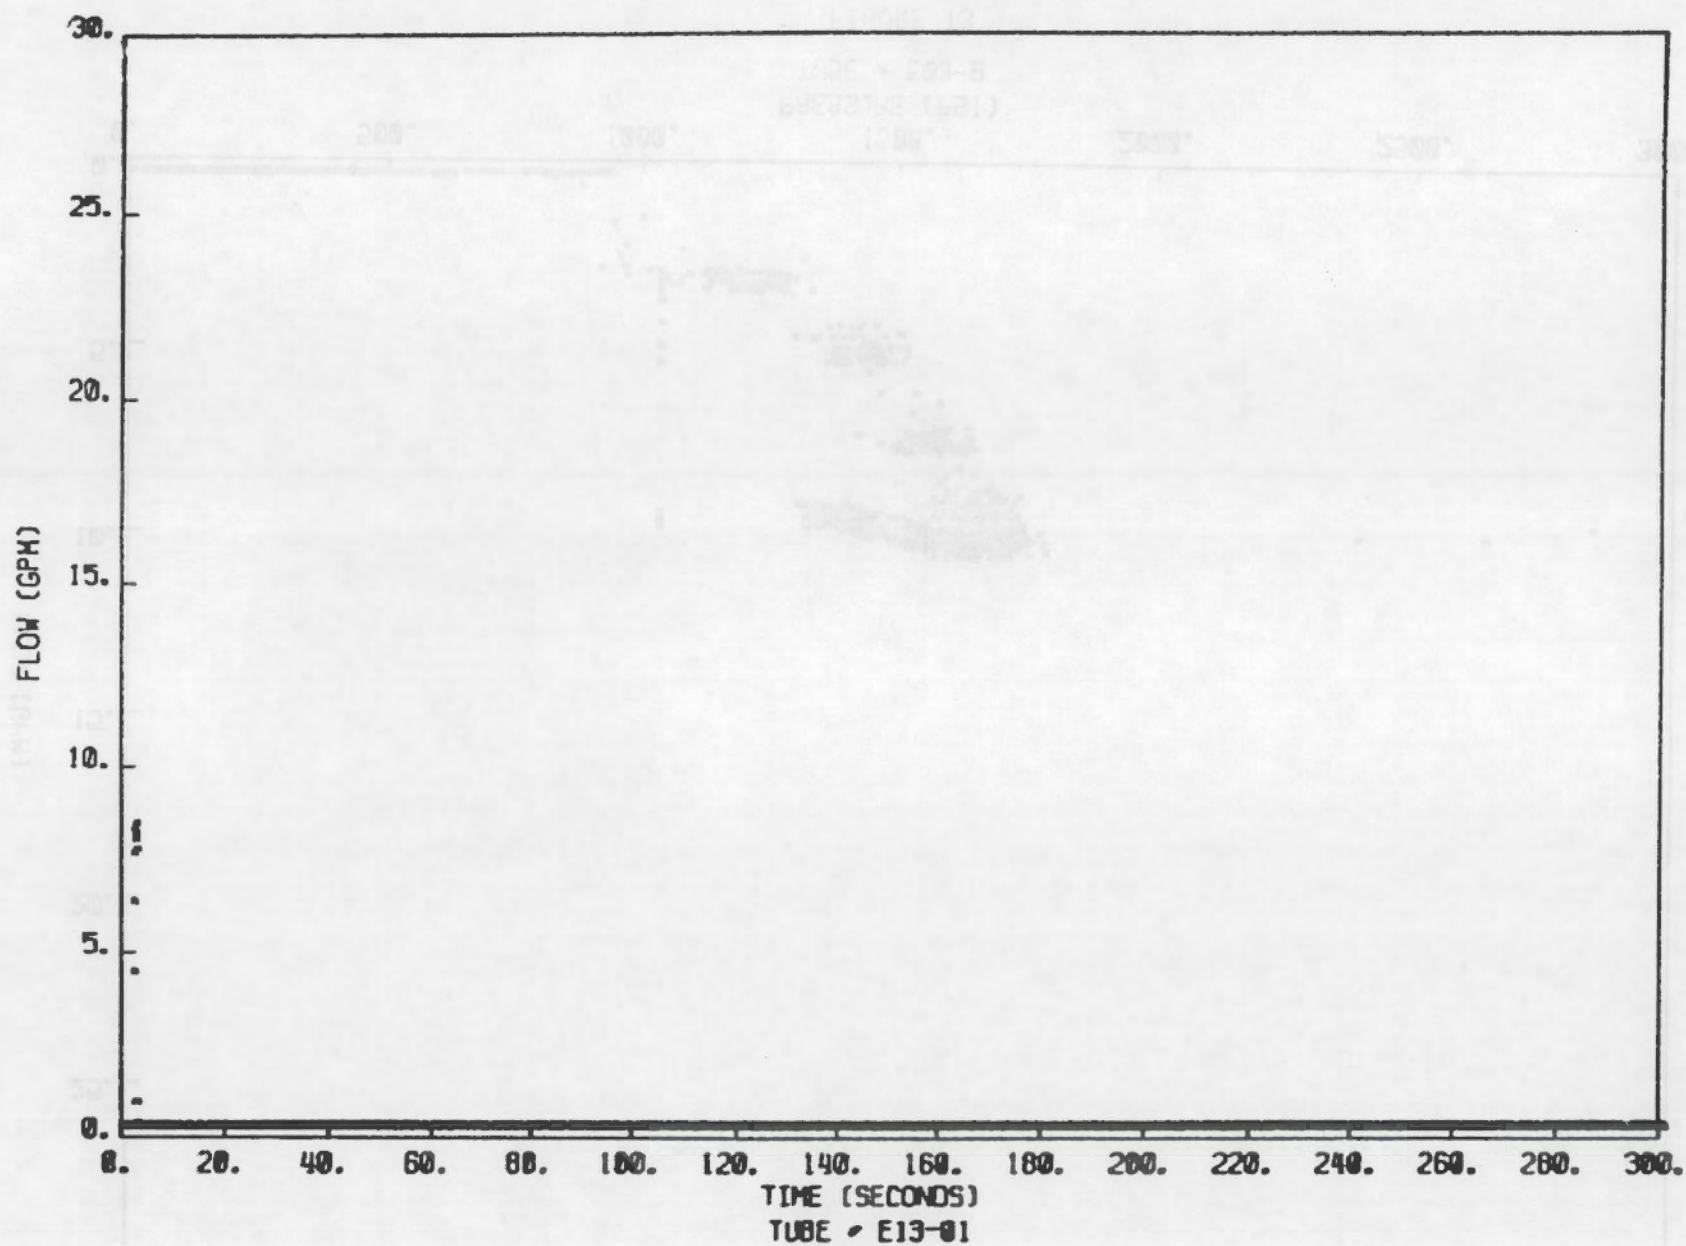
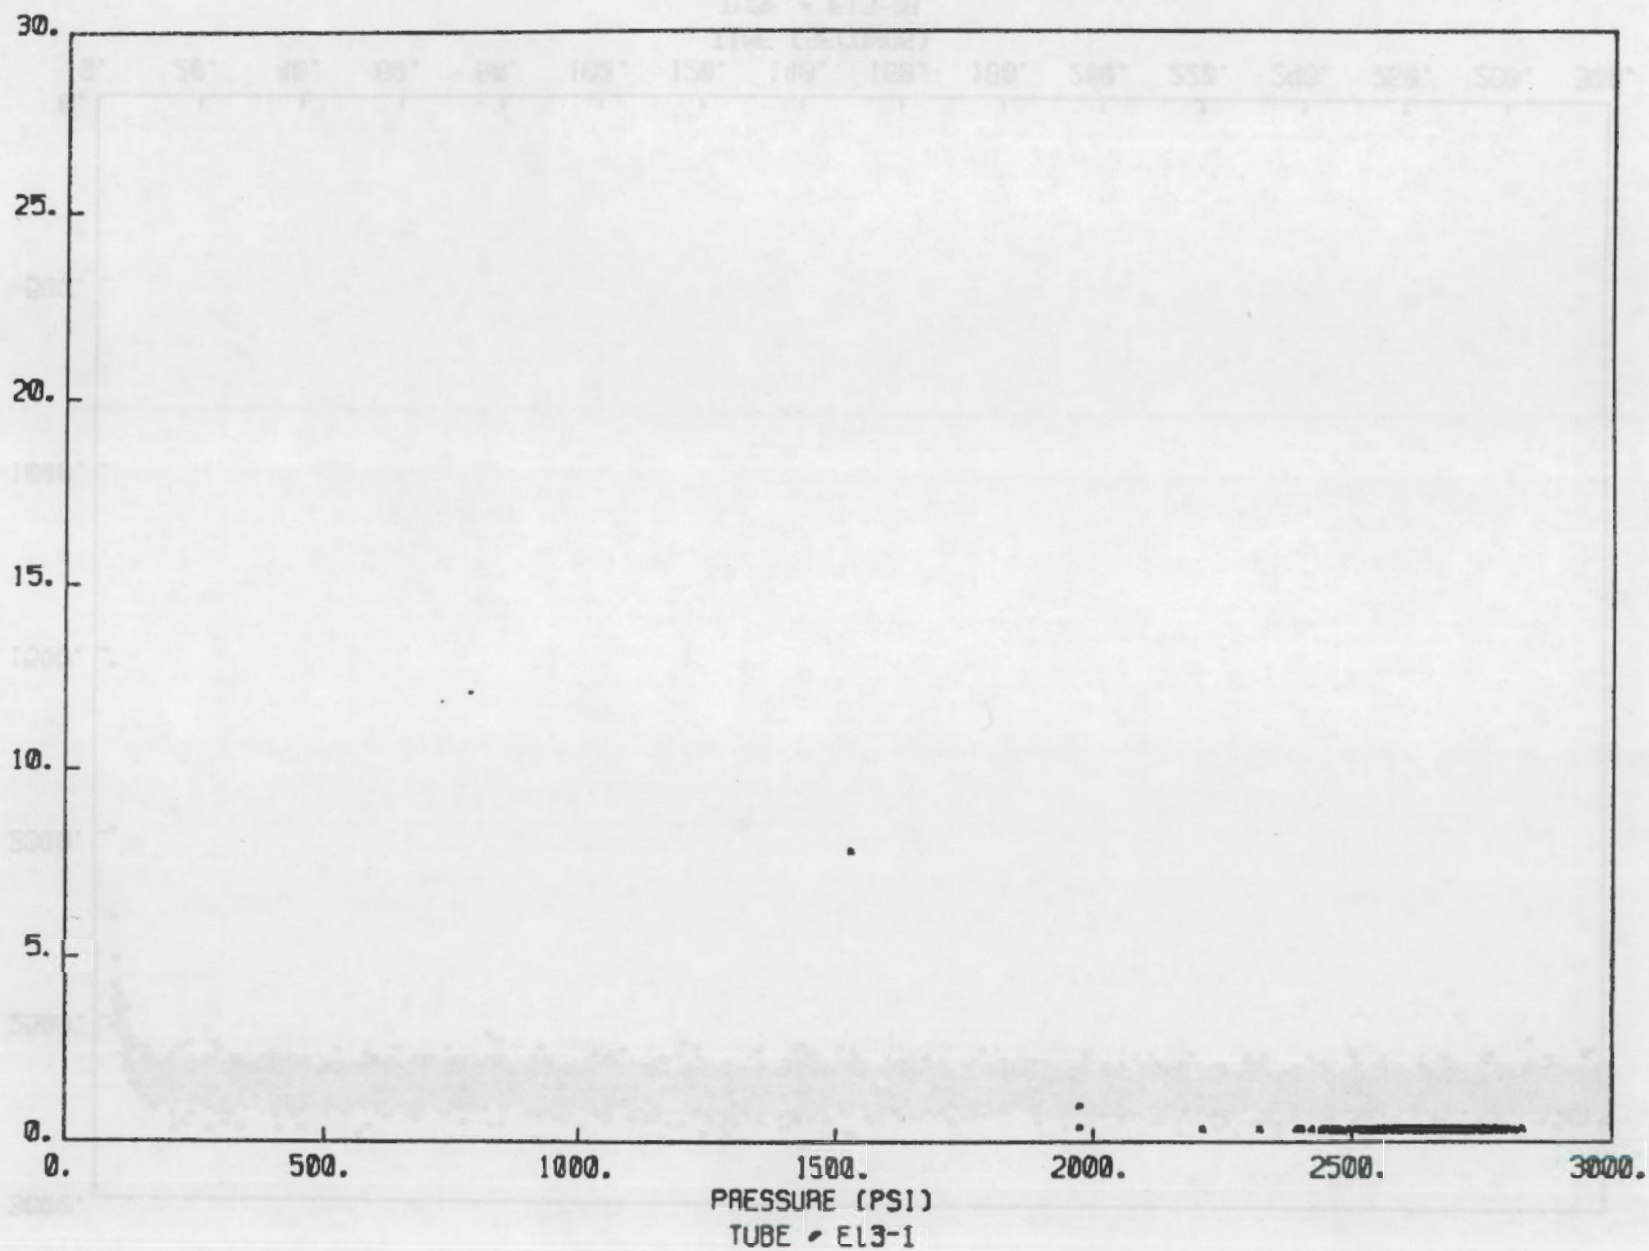
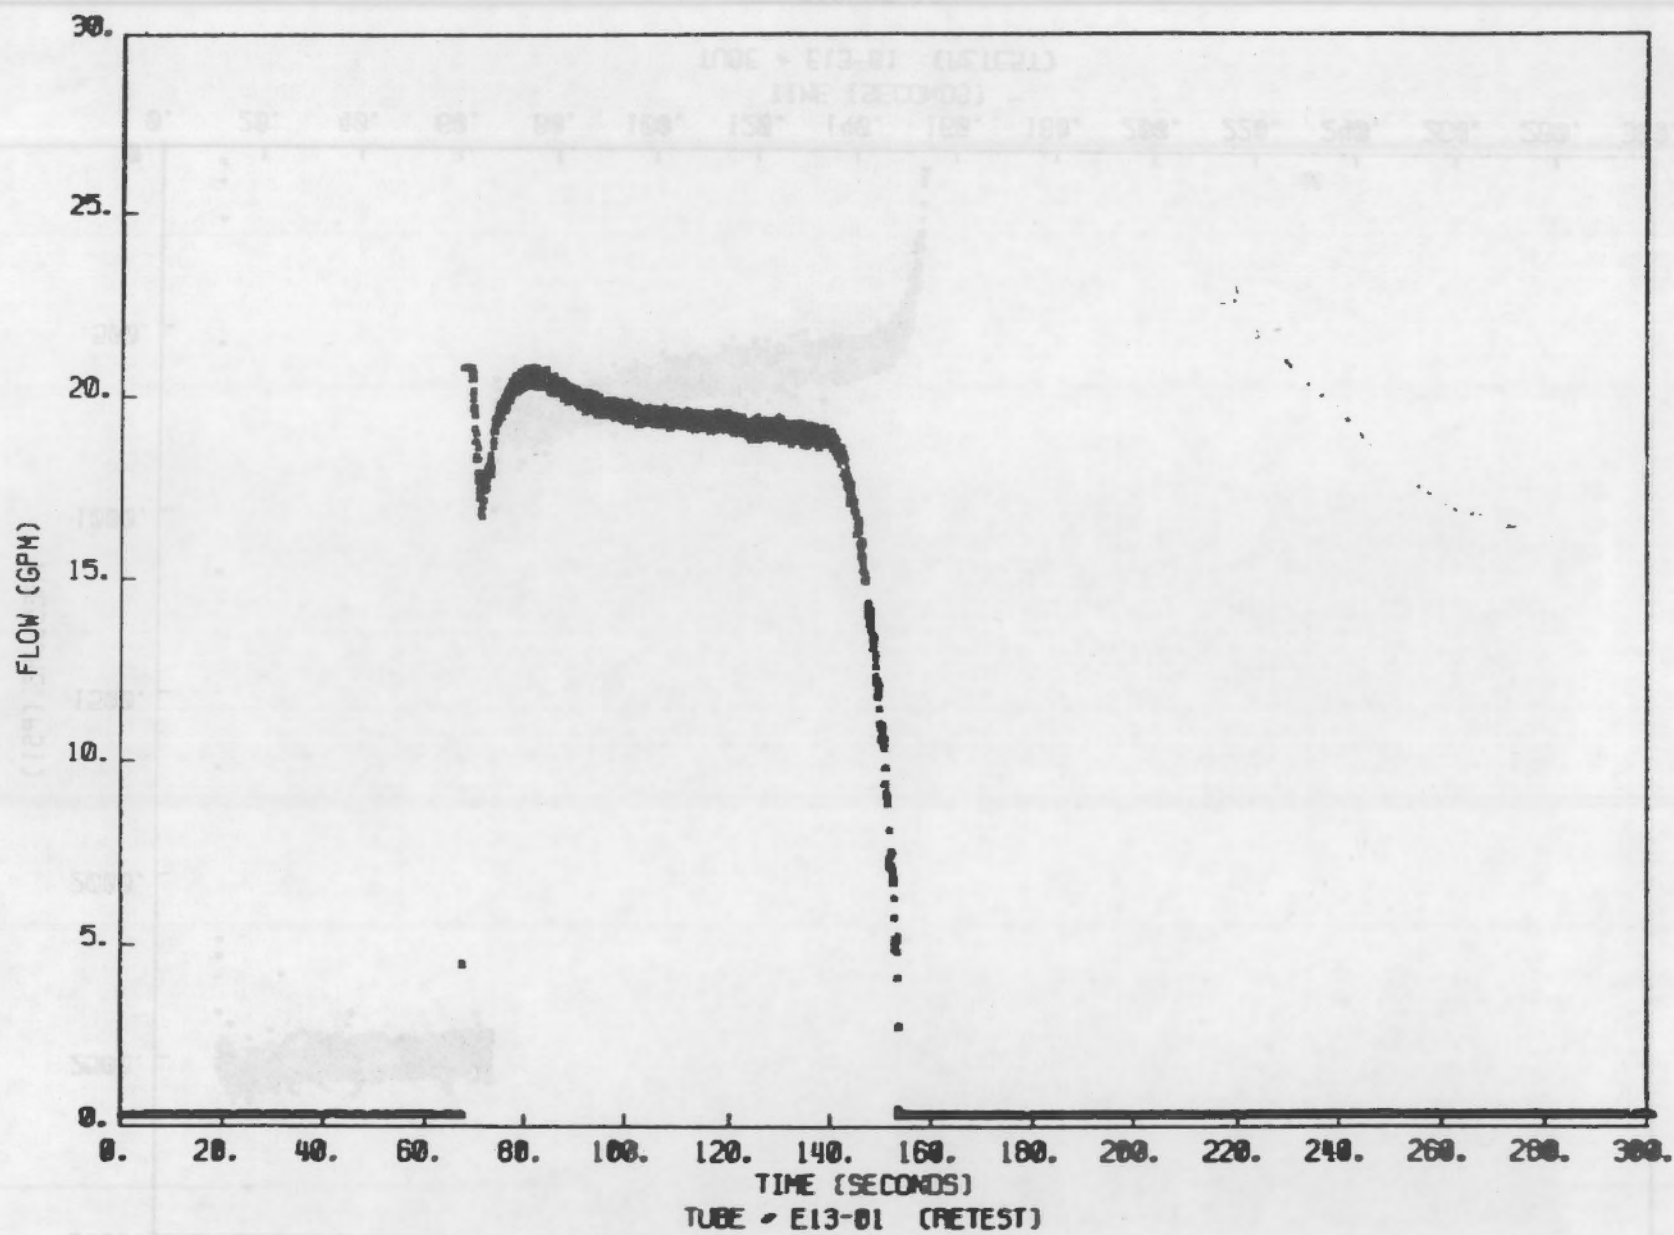
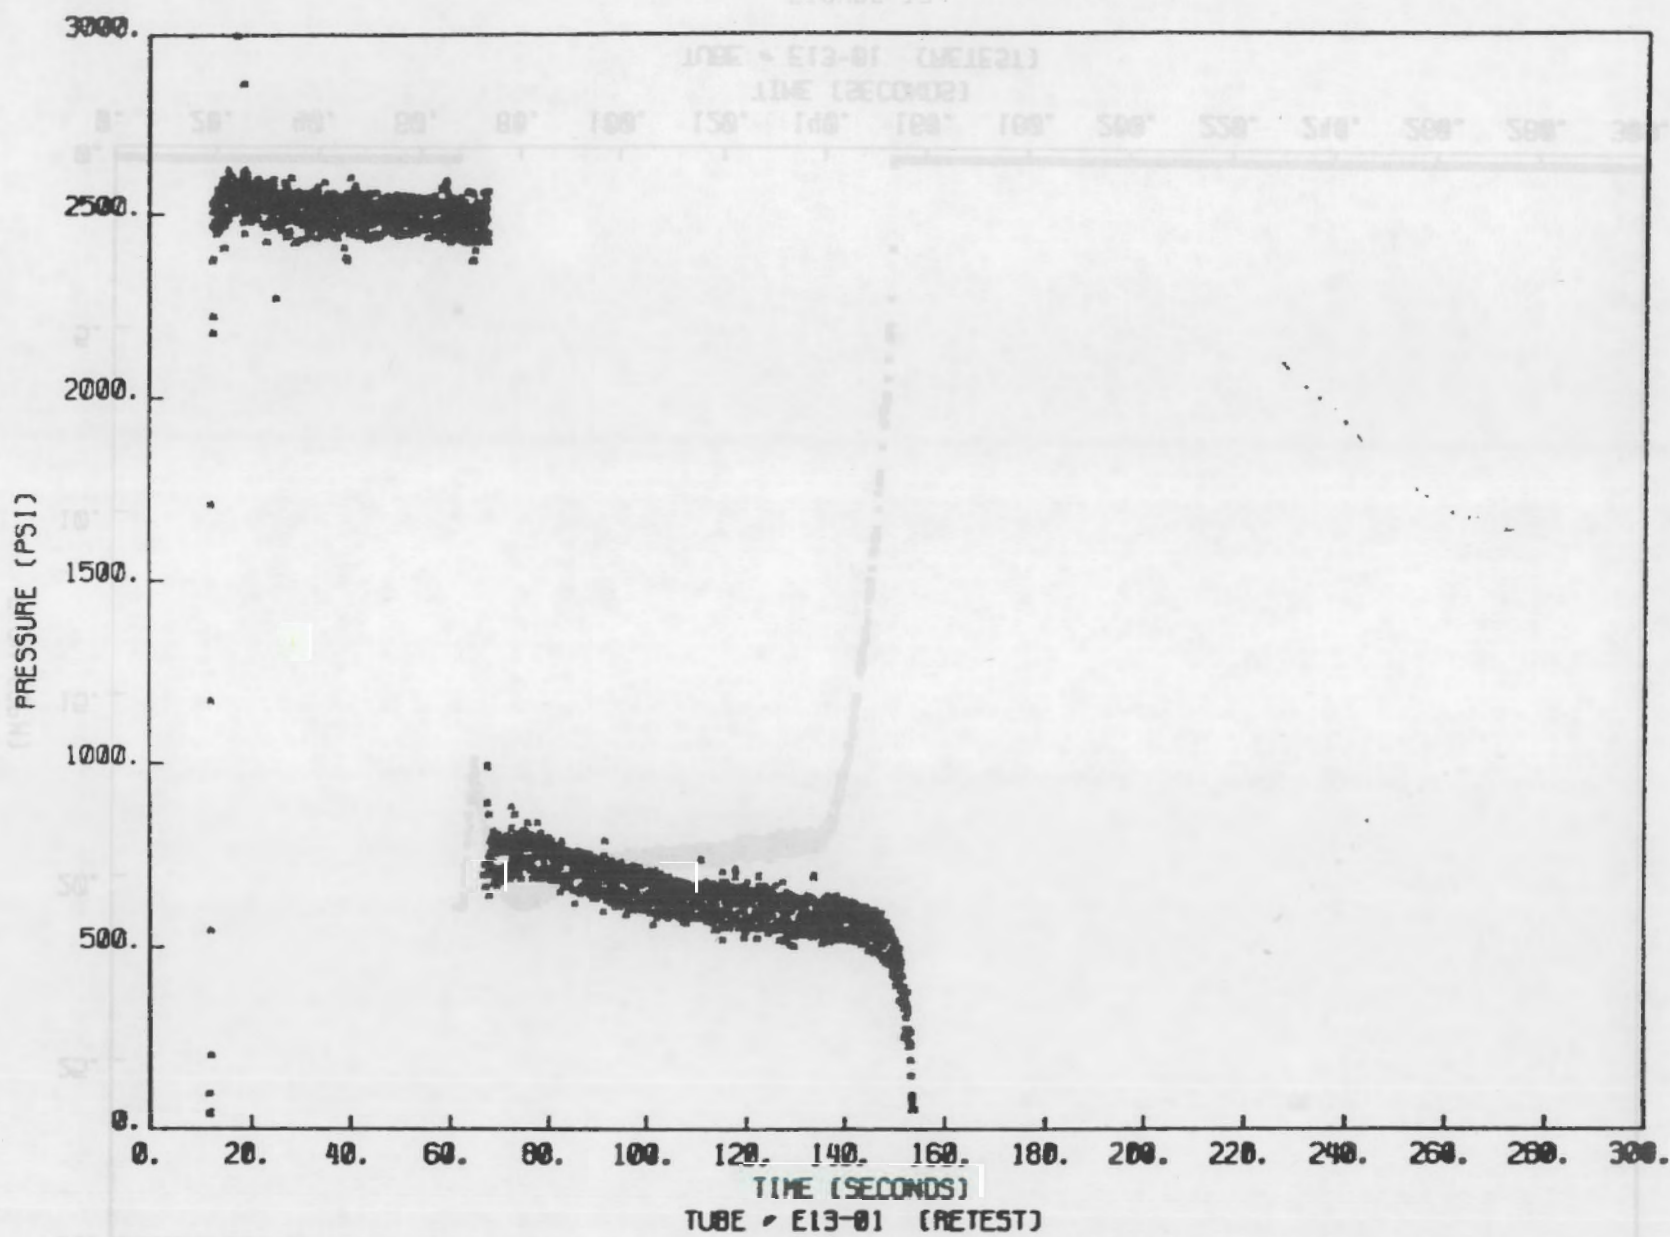
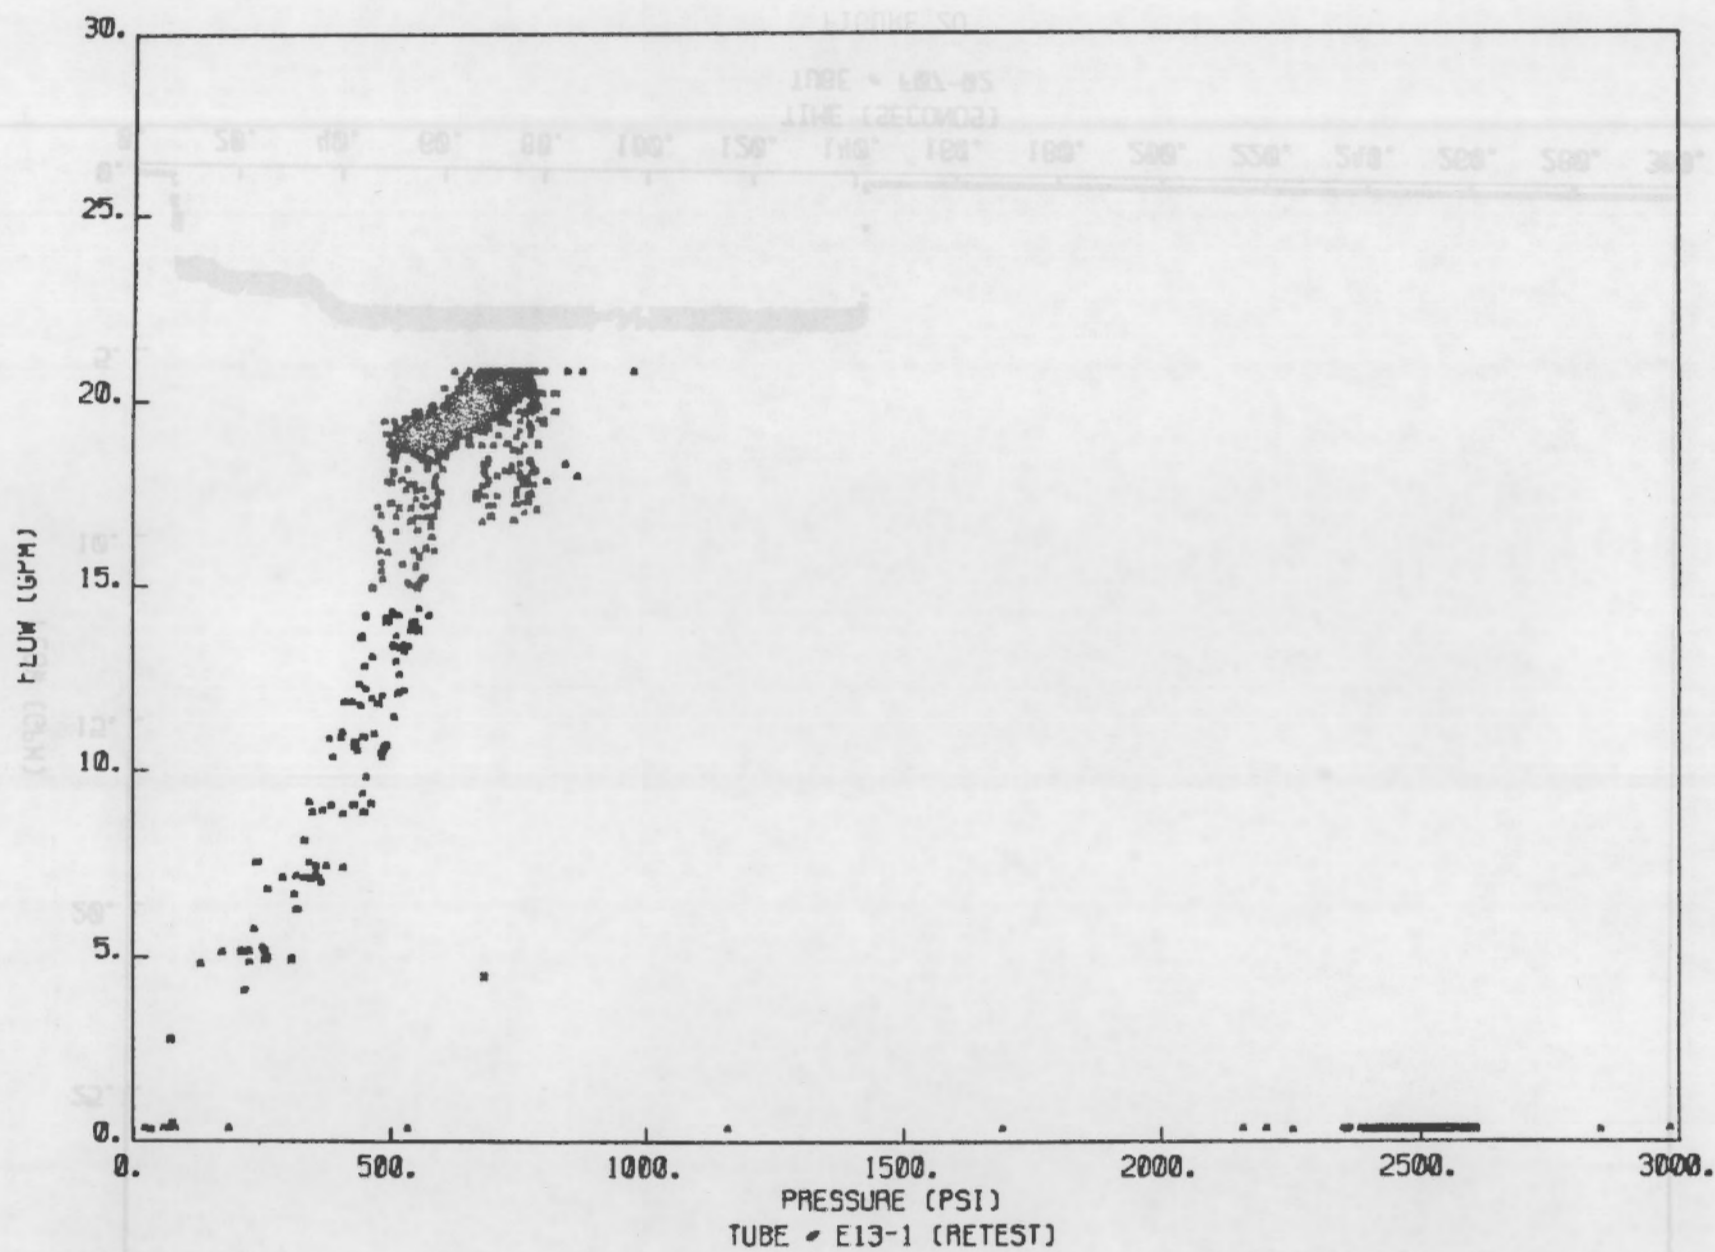
- Computer data: Figures 14, 15 and 16 - original test.  
Figures 17, 18 and 19 - retest.
- After test photograph: Figure 37.
- Eddy current before test: 100% through-wall crack.
