NUREG/CR-3562  
PNL-4629

# Steam Generator Tube Integrity Program Leak Rate Tests

## Progress Report

**Pacific Northwest Laboratory**  
Operated by  
Battelle Memorial Institute

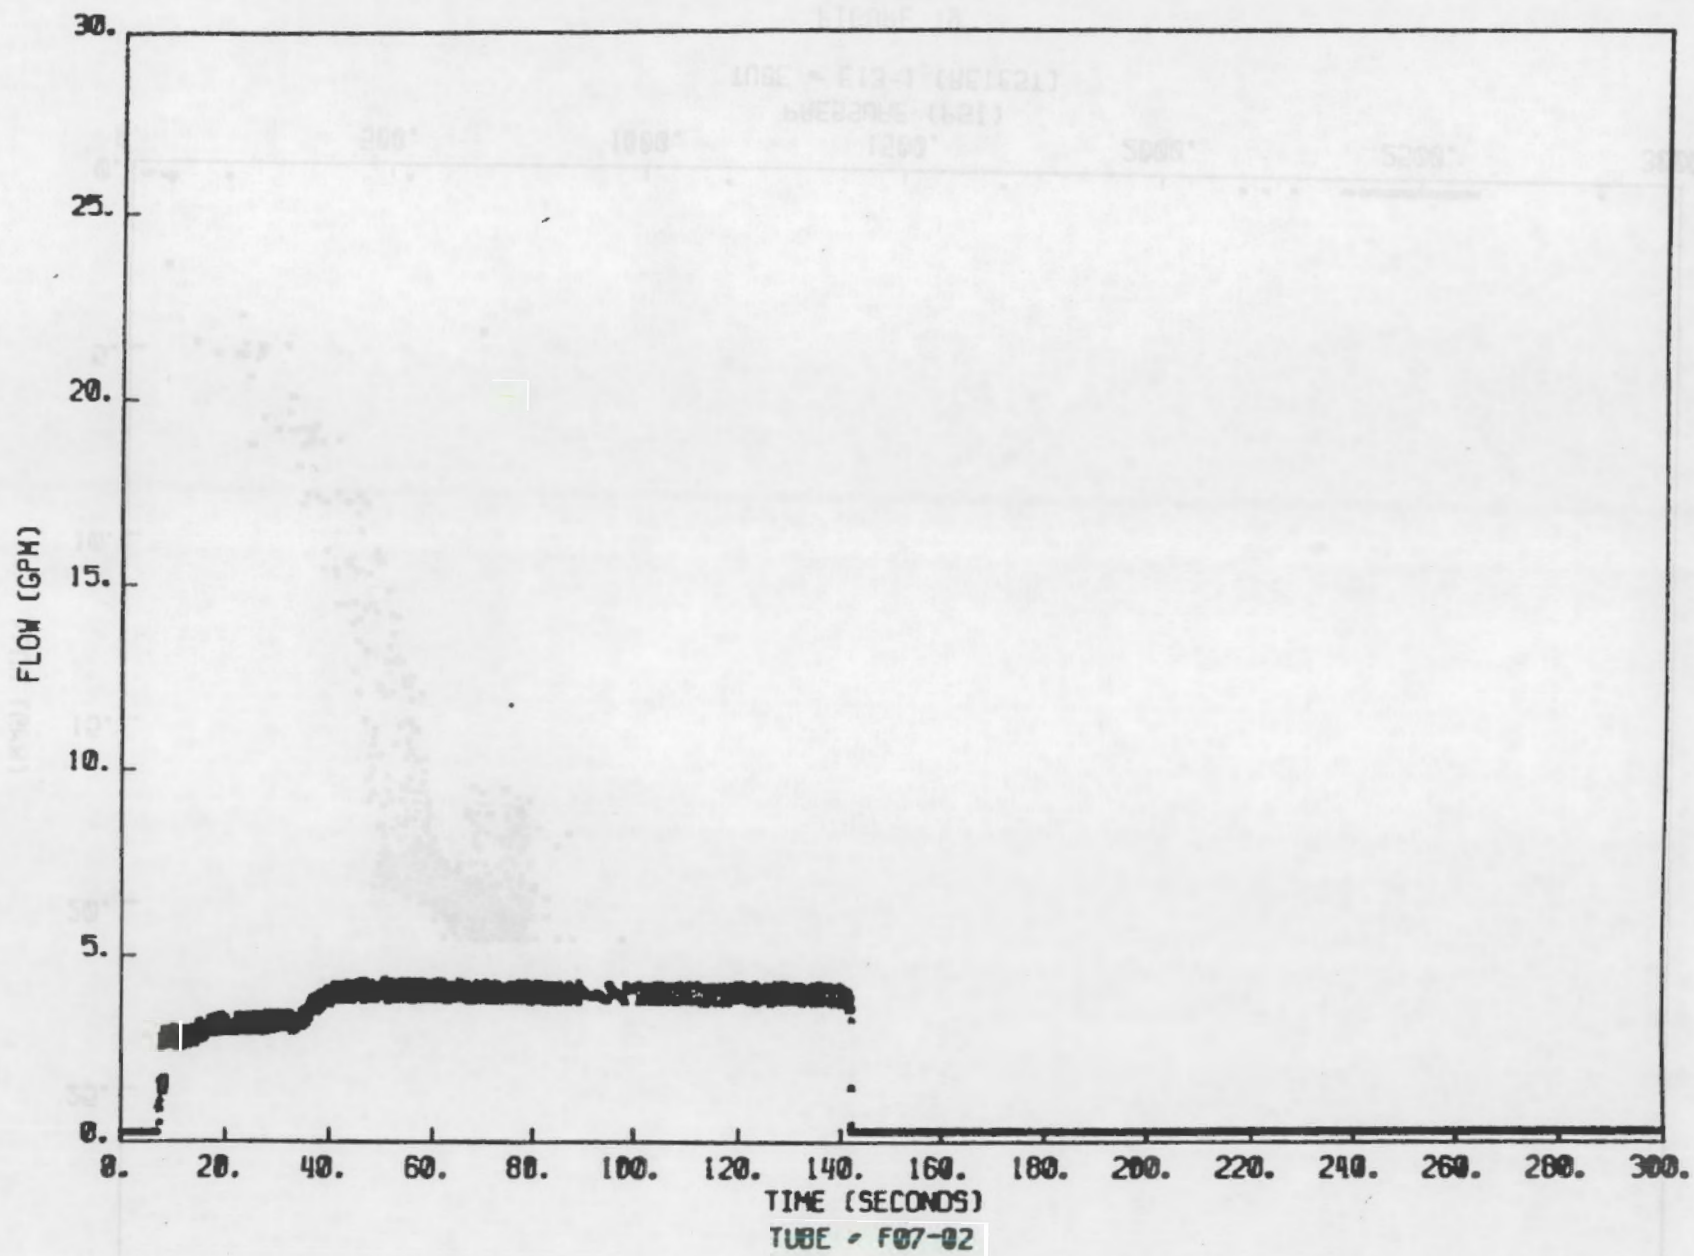
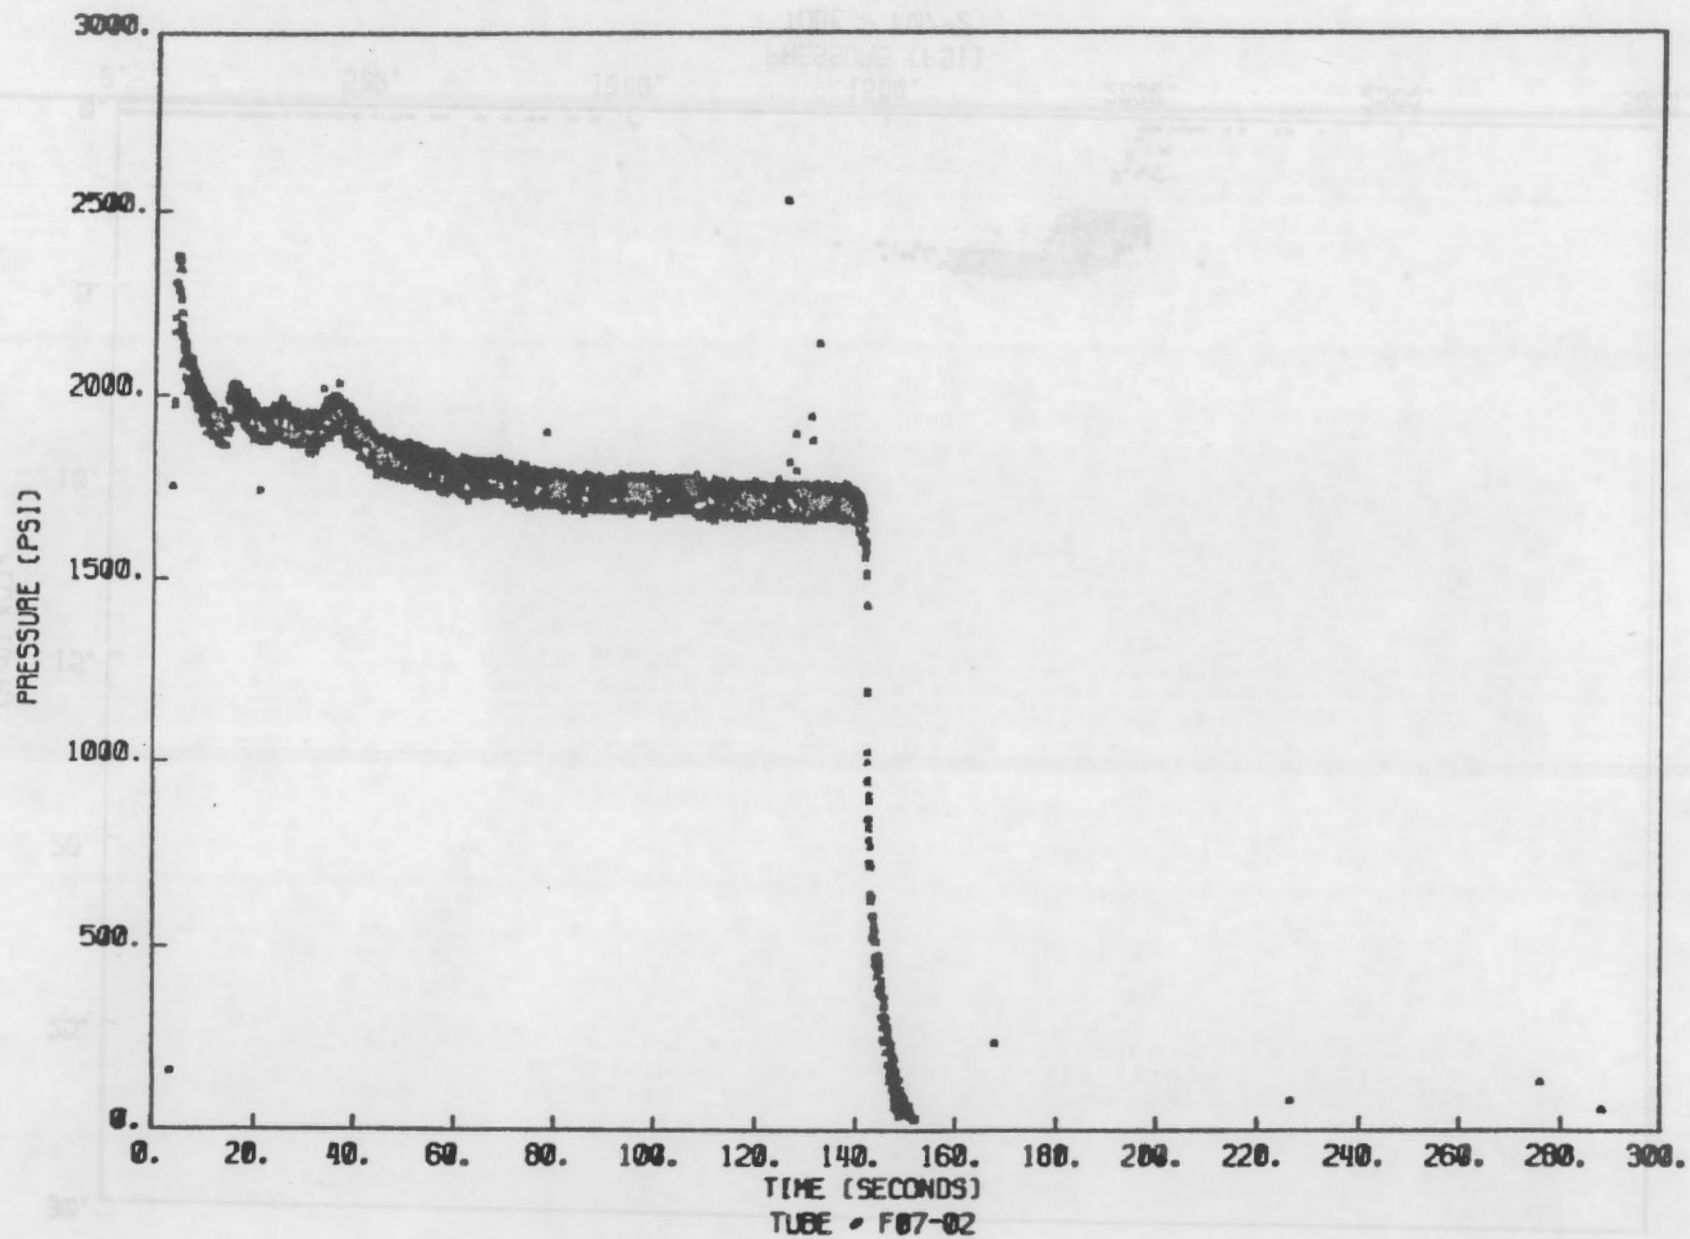
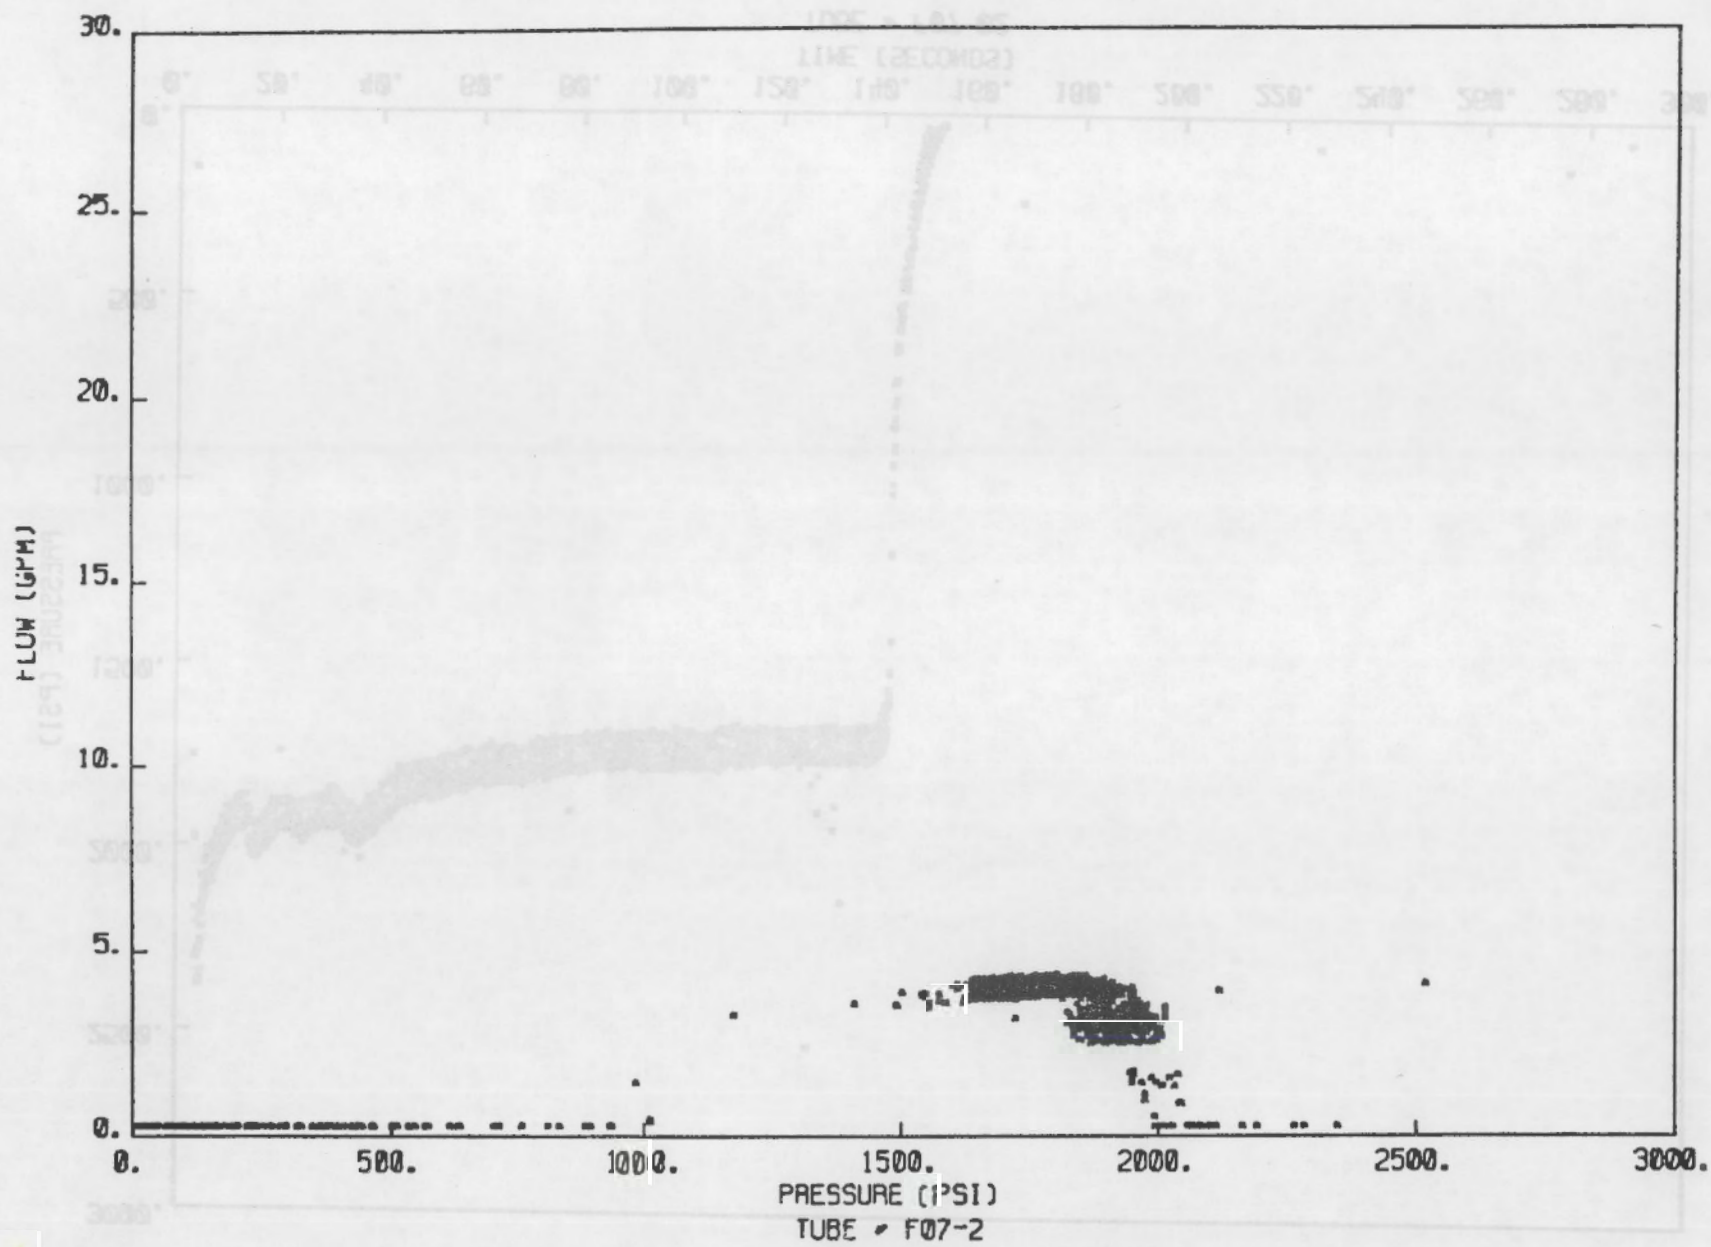
- Computer data: Figures 20, 21 and 22.
- After test photograph: Figure 38.
- Eddy current before test: Major crack ~90% through-wall.
- Visual inspection: 2" long thinned area, 40% thinning (60% of wall remaining), crack ~3/8" long - started at very edge of thinned area.
- Testing: Flow remained at <2 gpm for 10 seconds then increased to 4 gpm until test was terminated. Pressure started out at ~2300 and decreased to ~1750 psi when 4 gpm flow started. Test lasted for 150 seconds.
- Test results: Length of crack grew to 6/10" and opened up slightly.

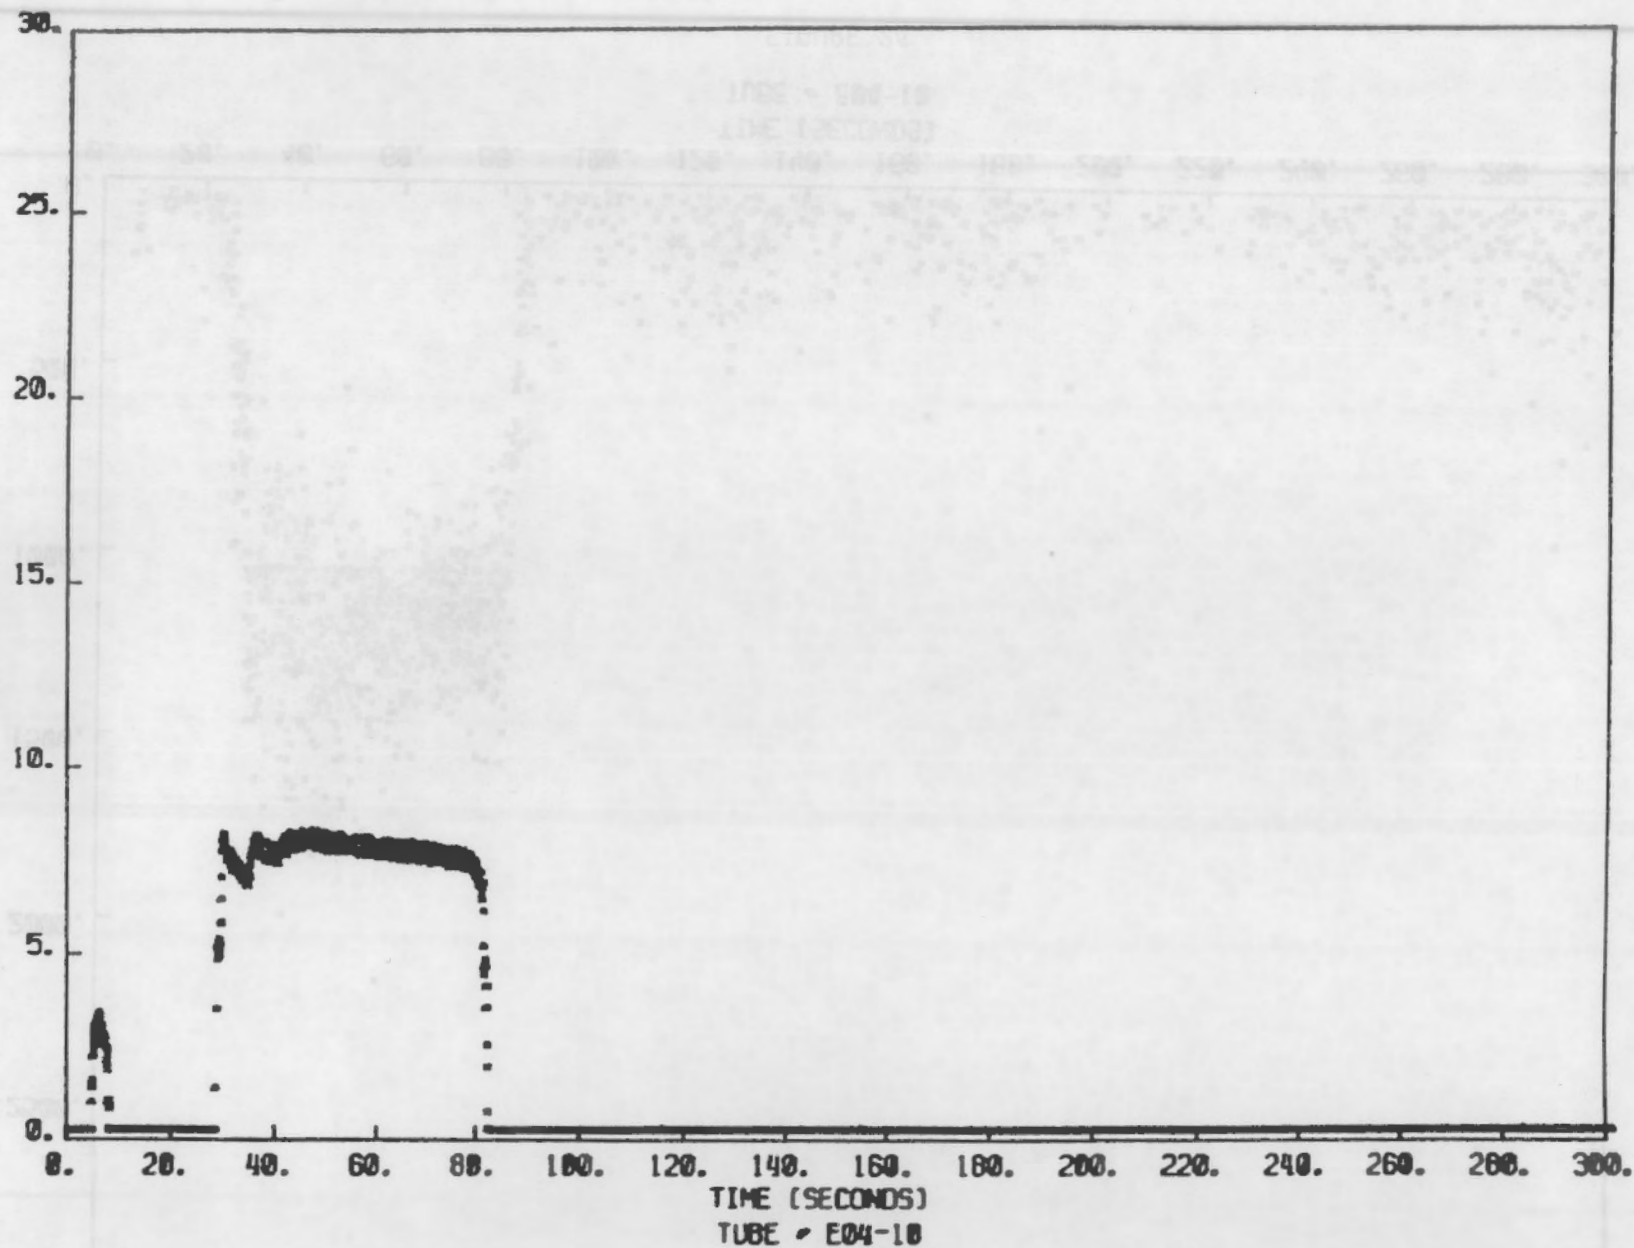
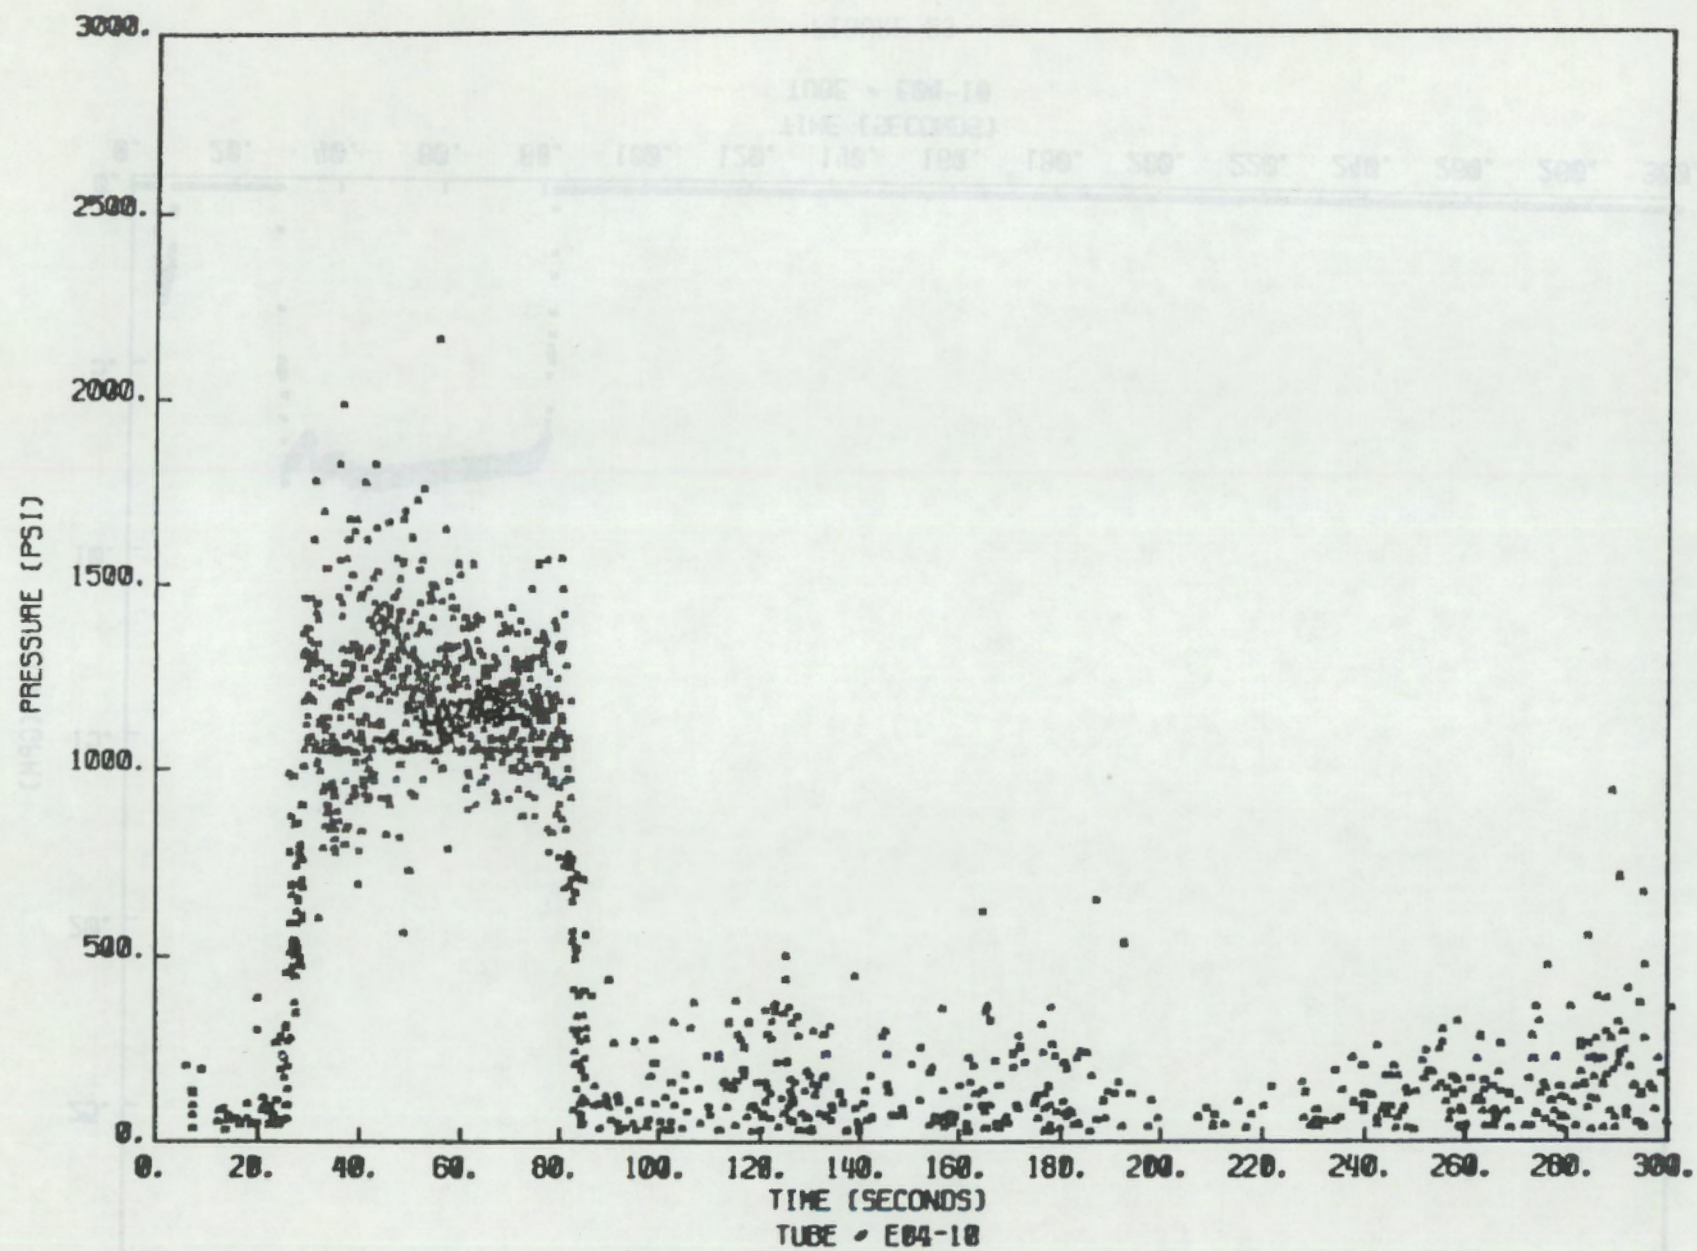
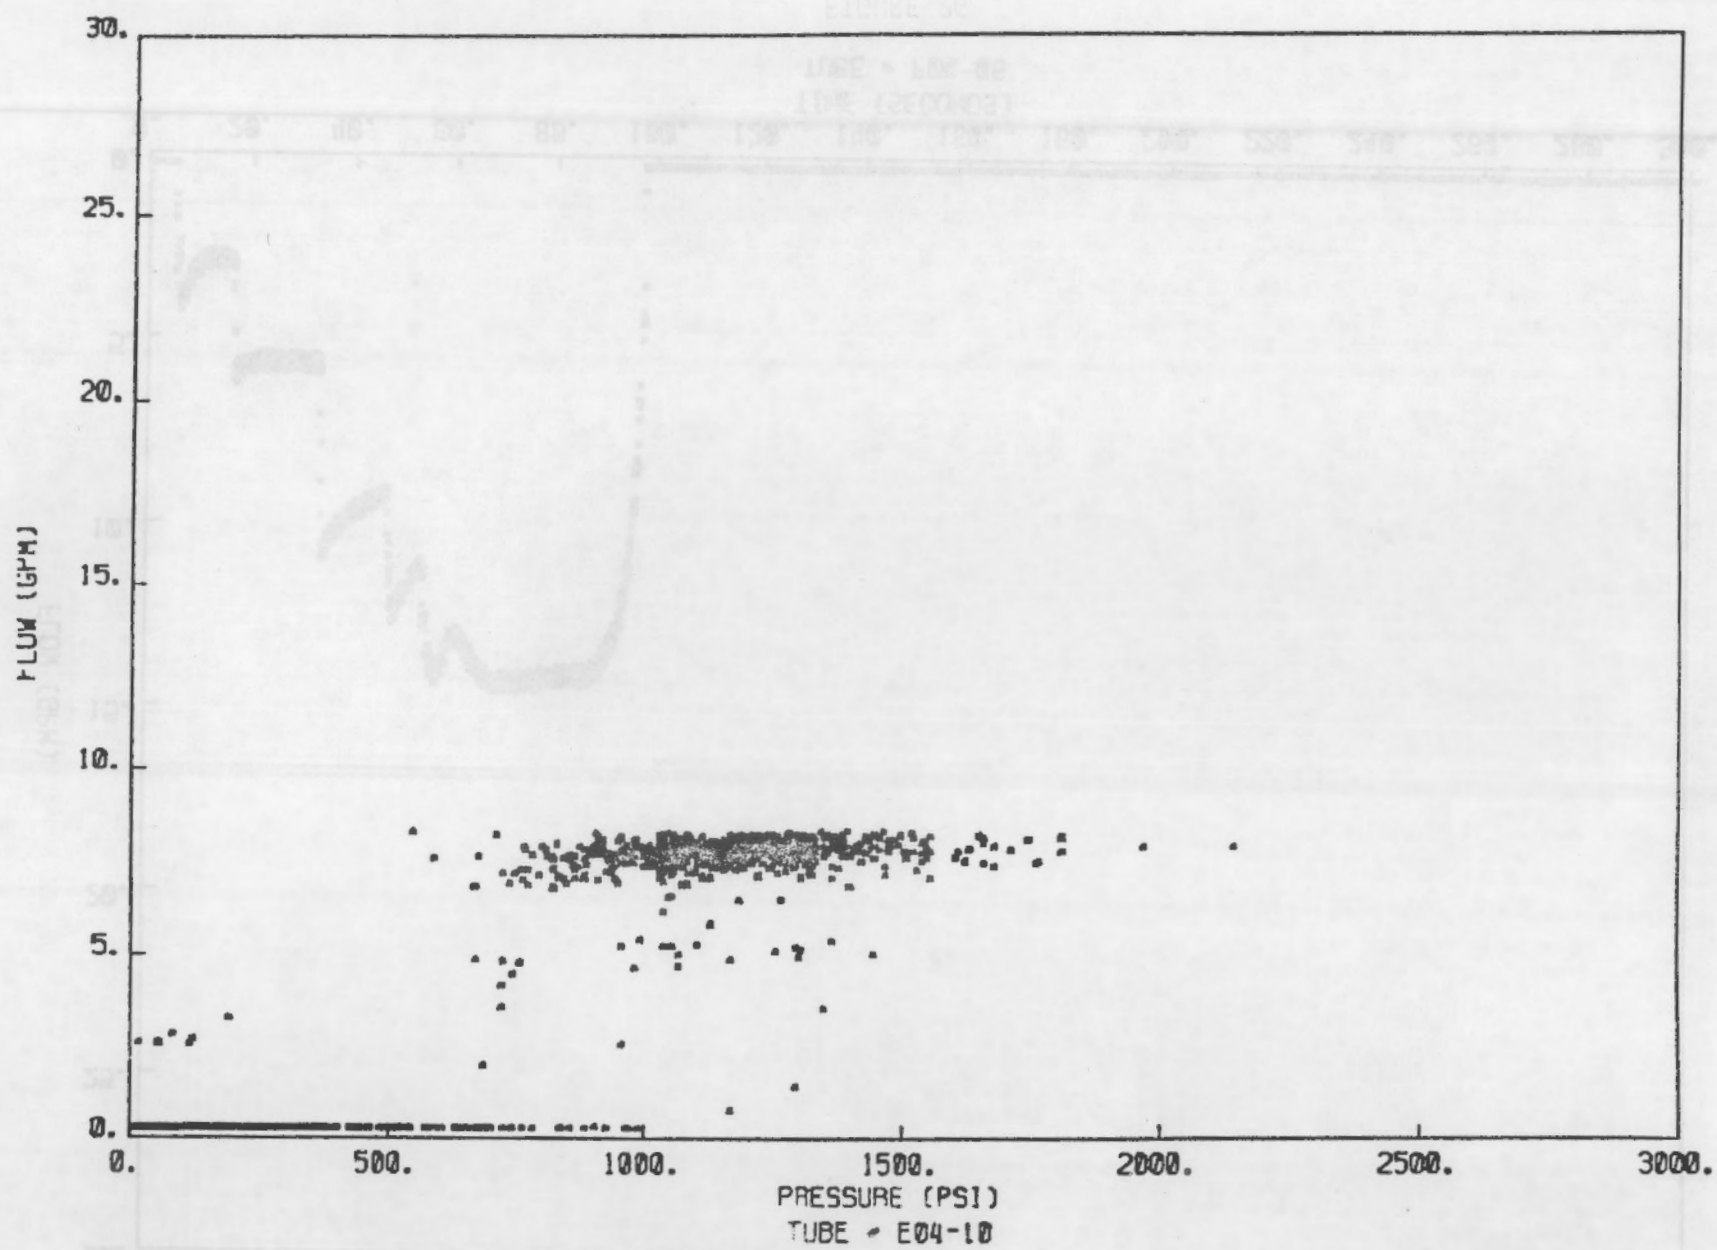
- Computer data: Figures 23, 24 and 25.
- Before and after photographs: Figures 40 and 41.
- Eddy current before test: 90% through-wall - 2 indications.
- Visual inspection: 1" long thinned area, 40% thinned (60% of wall remaining) 1/2" long crack running towards one side of thinned area.
- Testing: Pressure was not applied to specimen until ~25 seconds into the test. Pressure started out then to be 1000 psi and flow increased from <2 gpm to 7 gpm. Test ran for 60 seconds after maximum flow.
- Test results: Crack opened up over its entire length but did not burst.

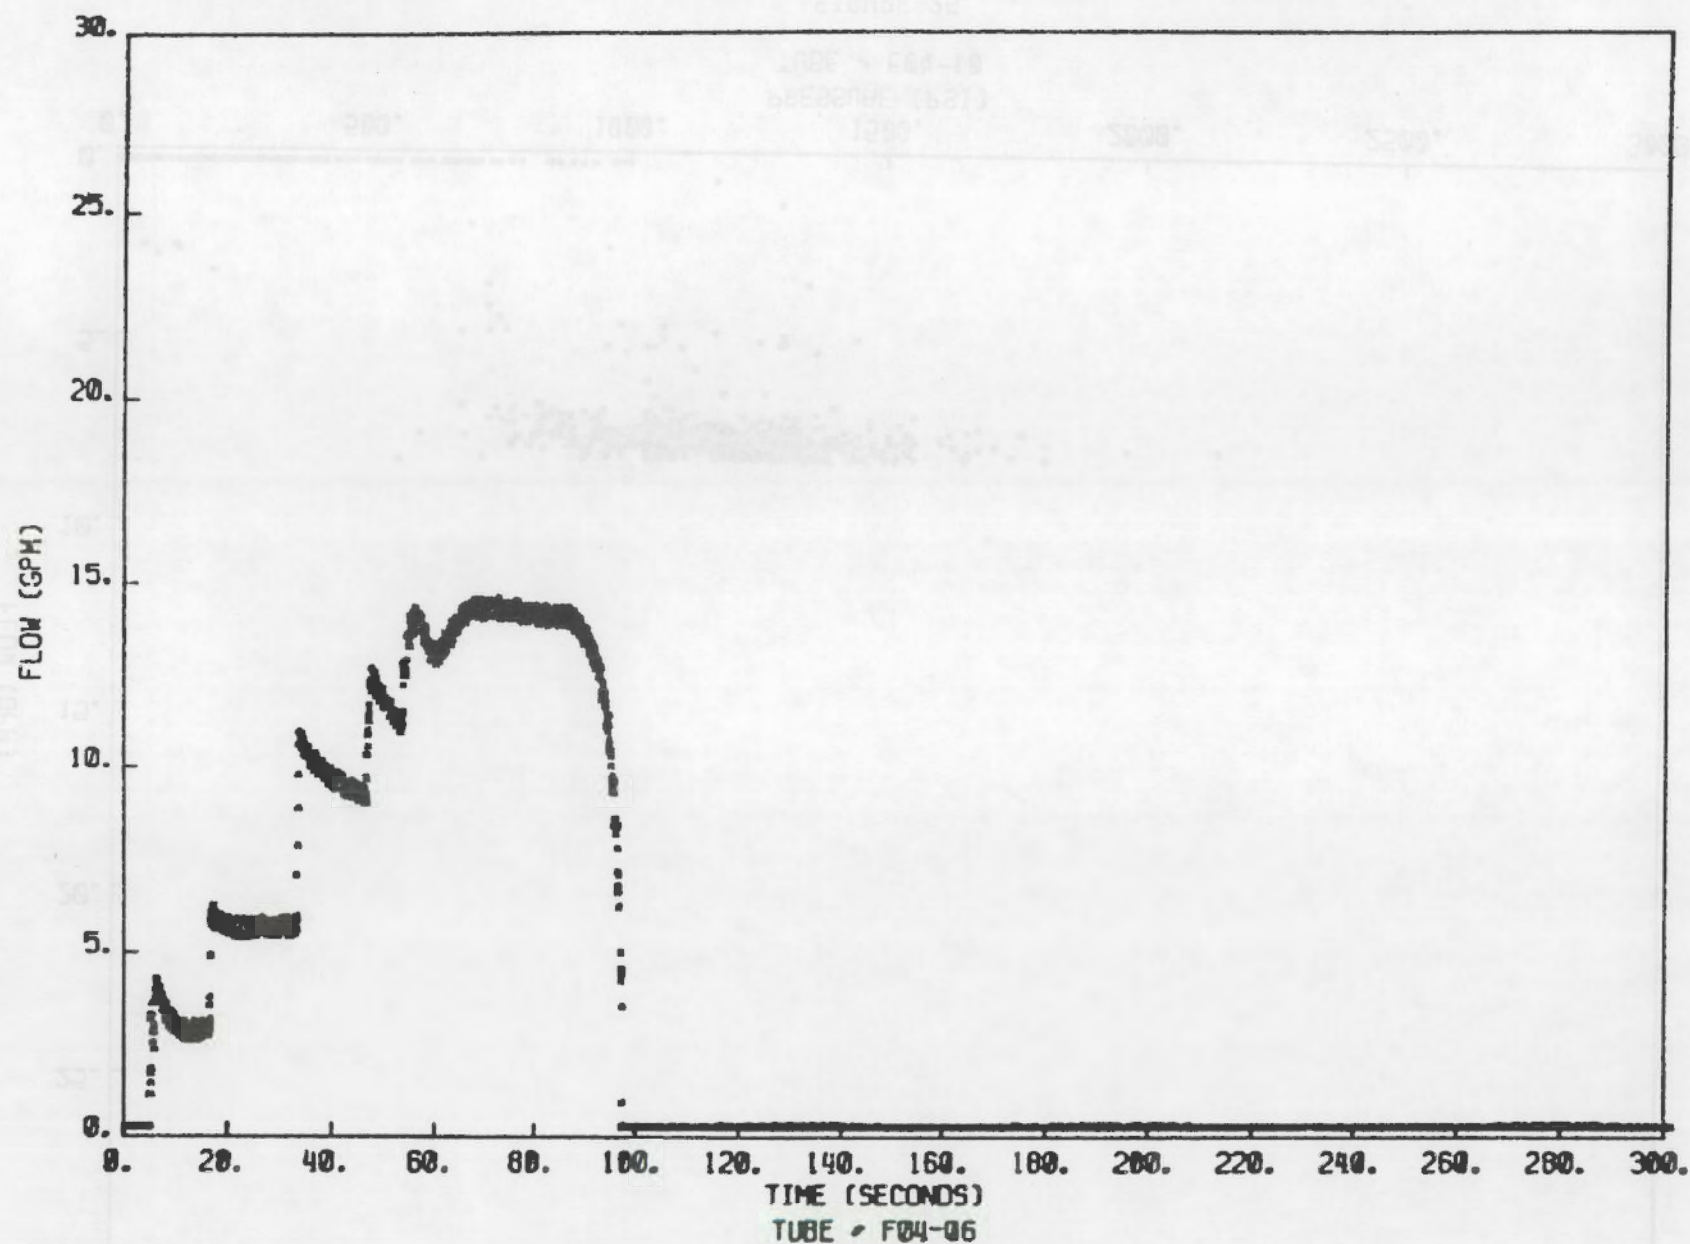
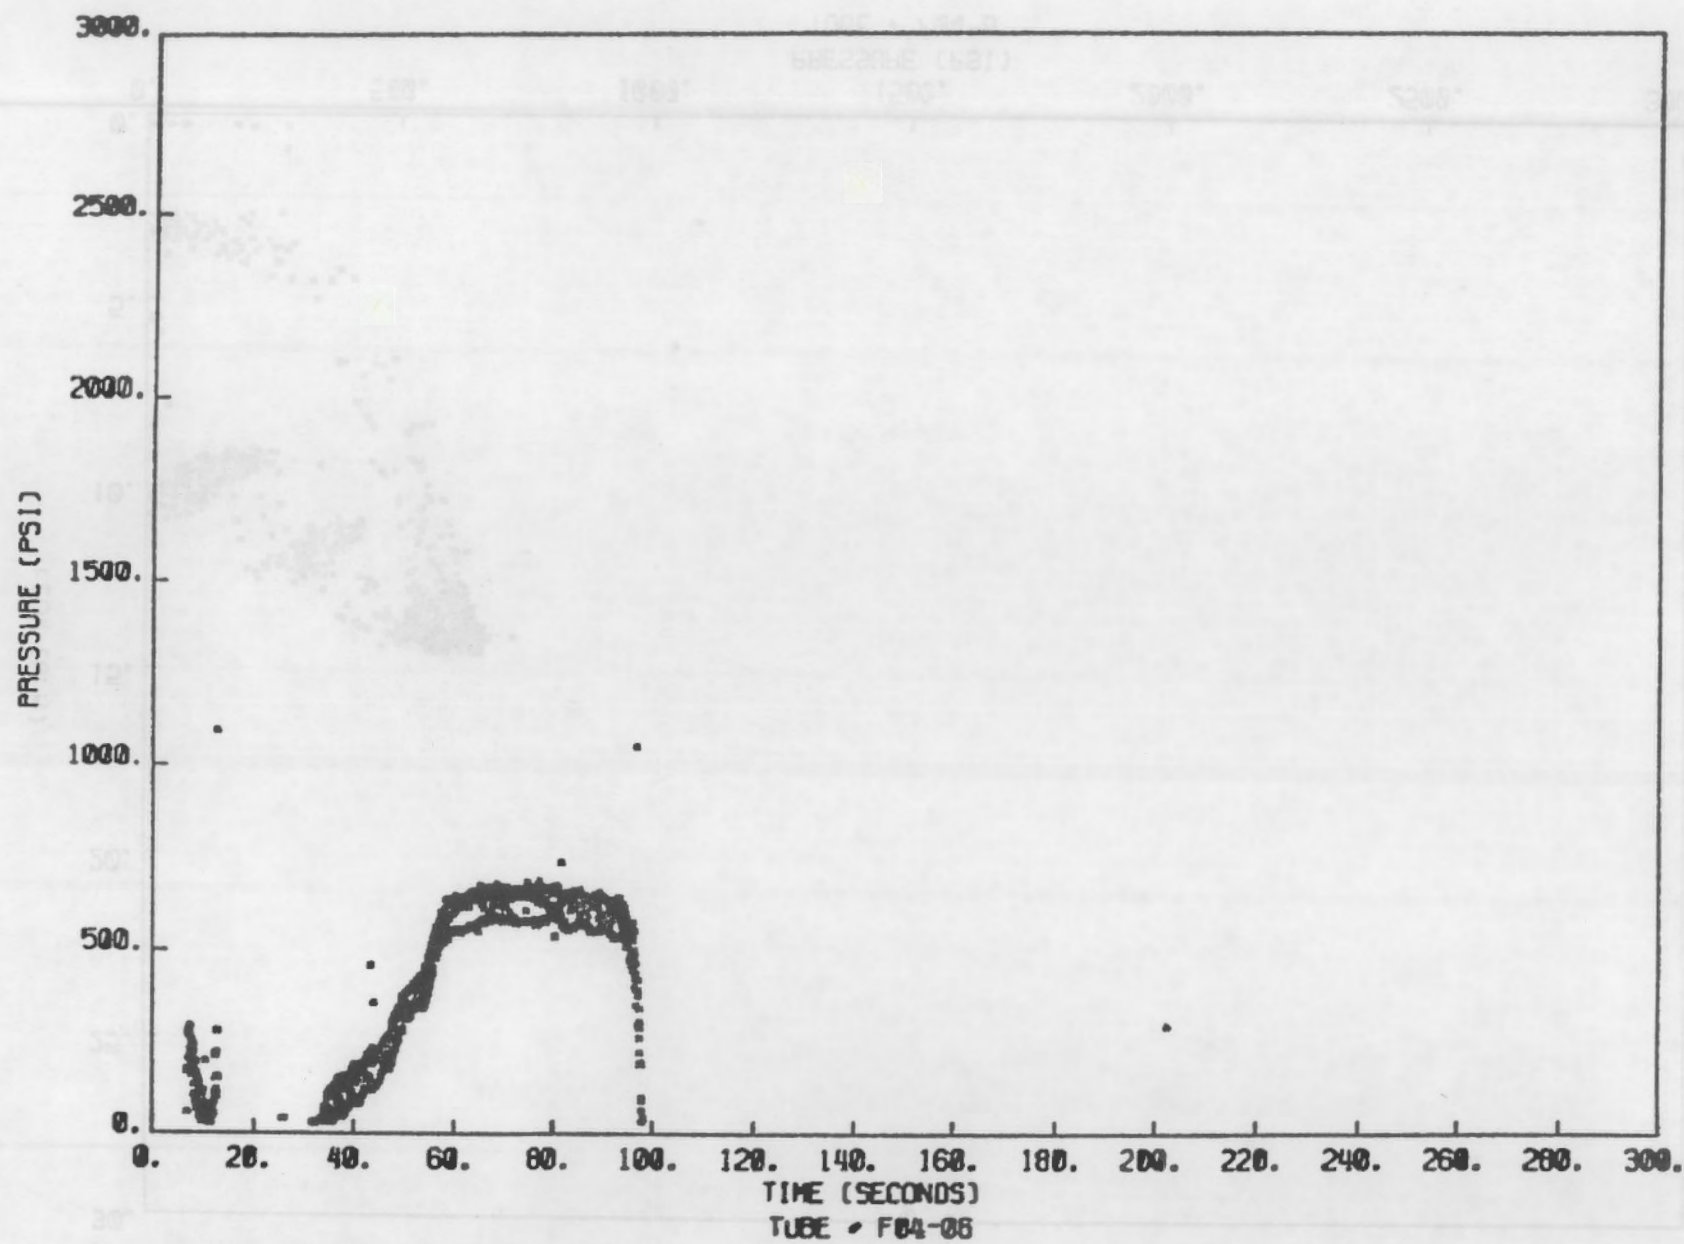
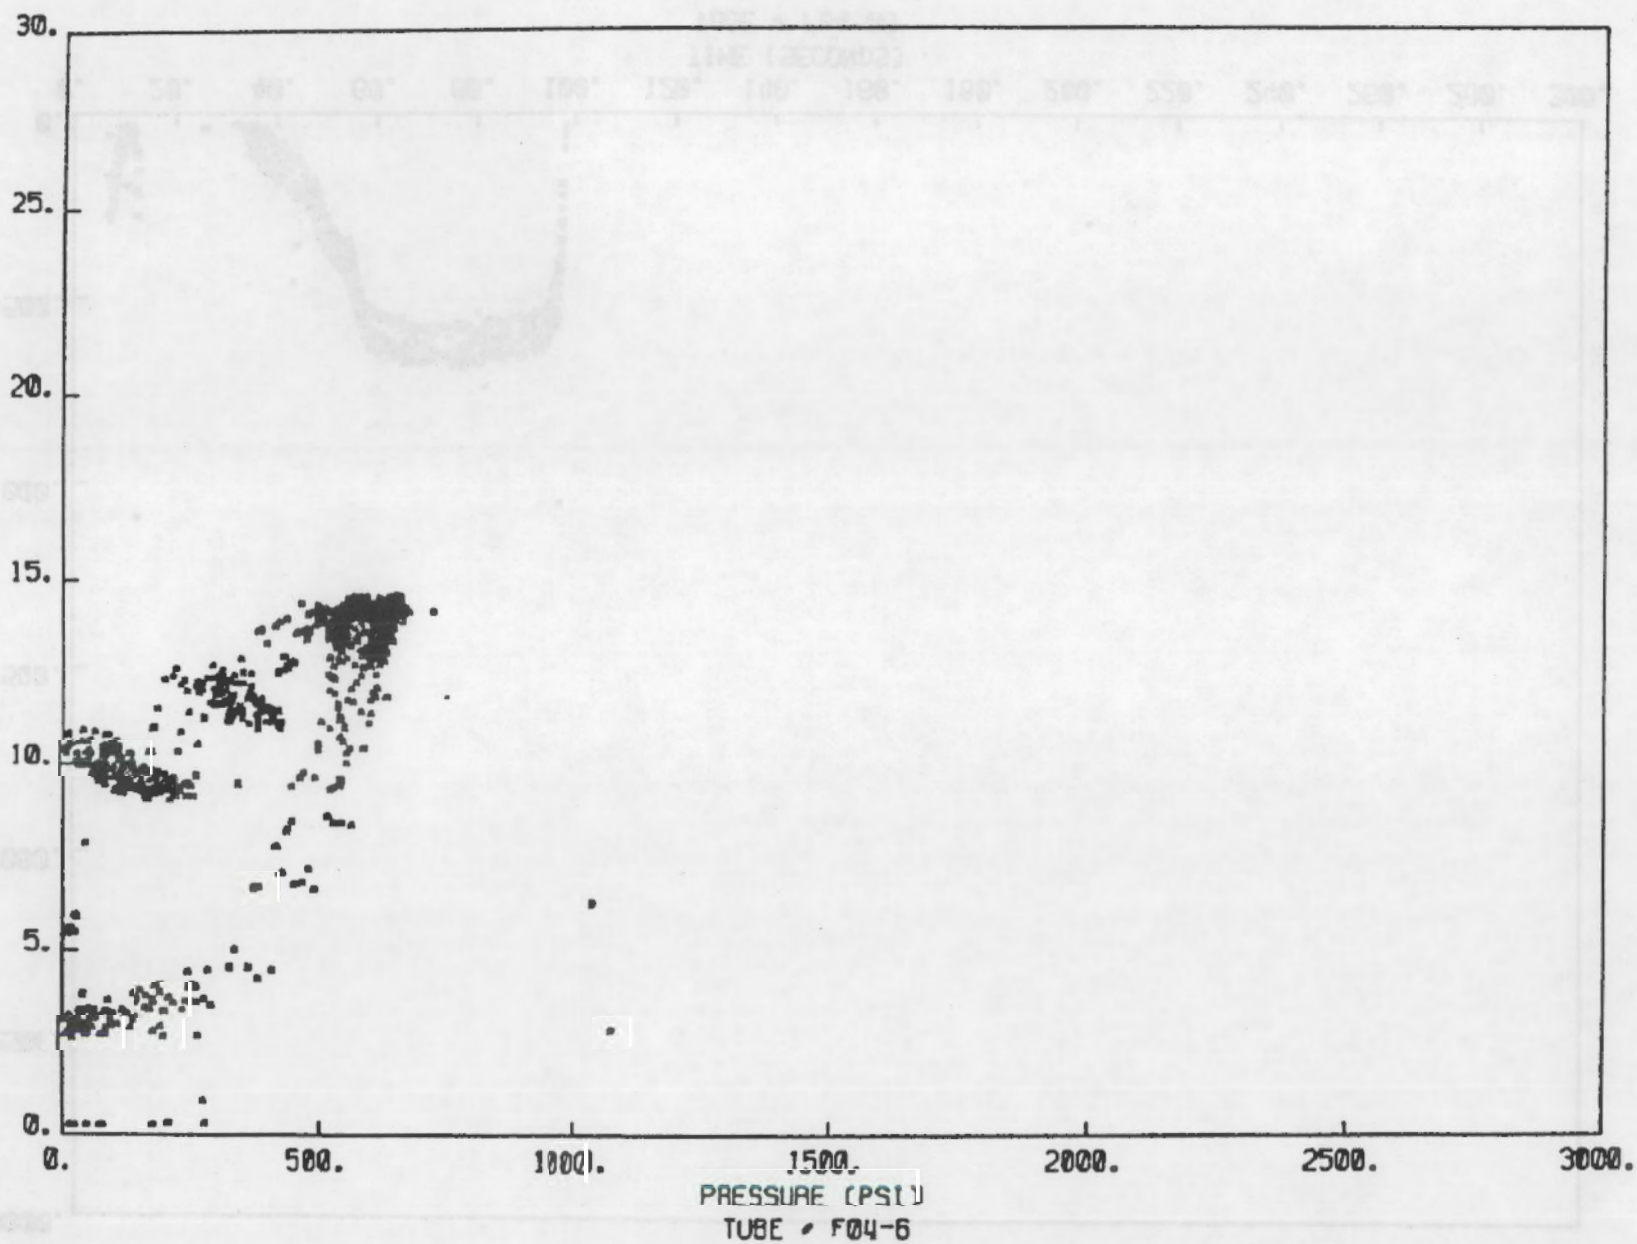
- Computer data: Figures 26, 27 and 28.
- Before and after photographs: Figures 44 and 45.
- Eddy current before test: One crack 90-100% through-wall.
- Visual inspection: 2" long thinned area, 60% thinning, 1/2" crack in center of thinned area.
- Testing: Flow was increased in steps to a maximum of ~14 gpm. This flow was held for 30 seconds. Pressure was increased slowly to a maximum of 600 psi during maximum flow.
- Test results: Crack burst open but its length did not increase significantly.
