NUREG/CR-3562  
PNL-4629

# Steam Generator Tube Integrity Program Leak Rate Tests

## Progress Report

**Pacific Northwest Laboratory**  
Operated by  
Battelle Memorial Institute

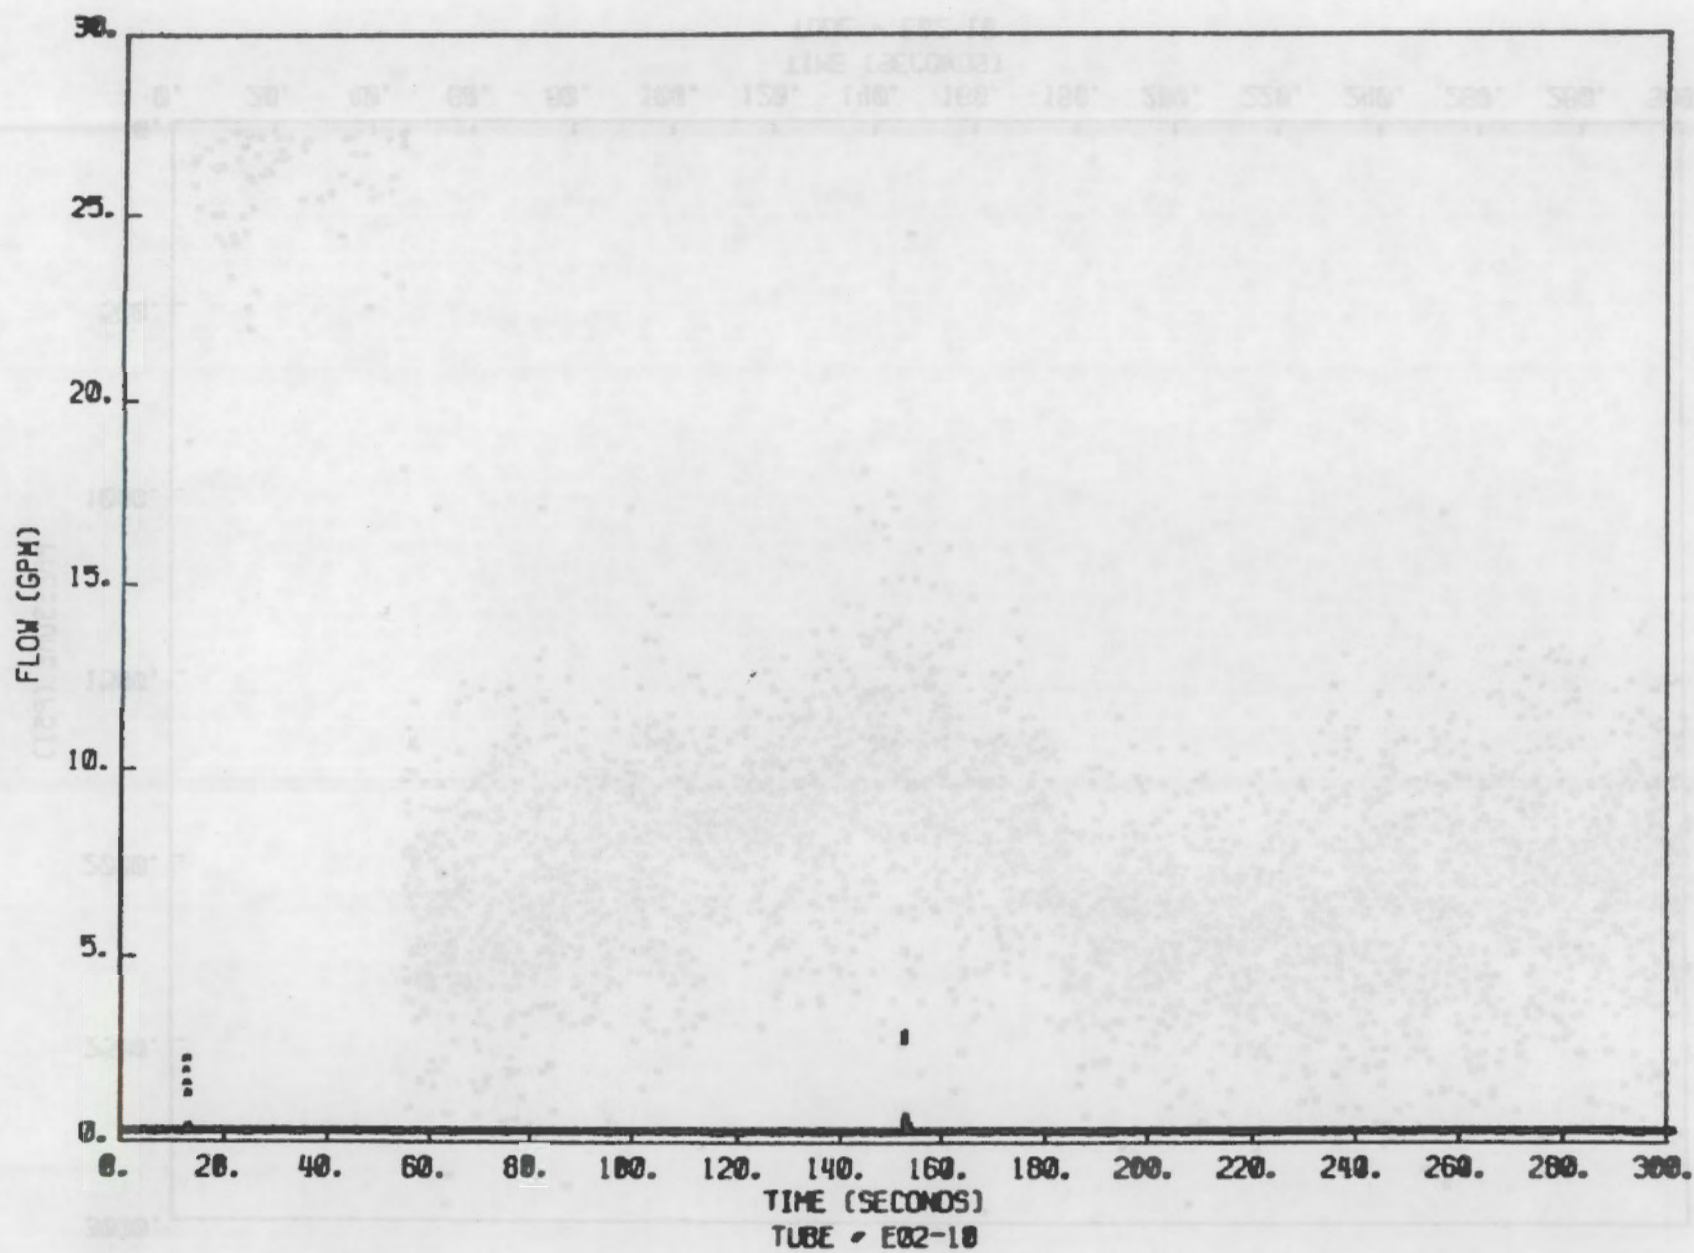
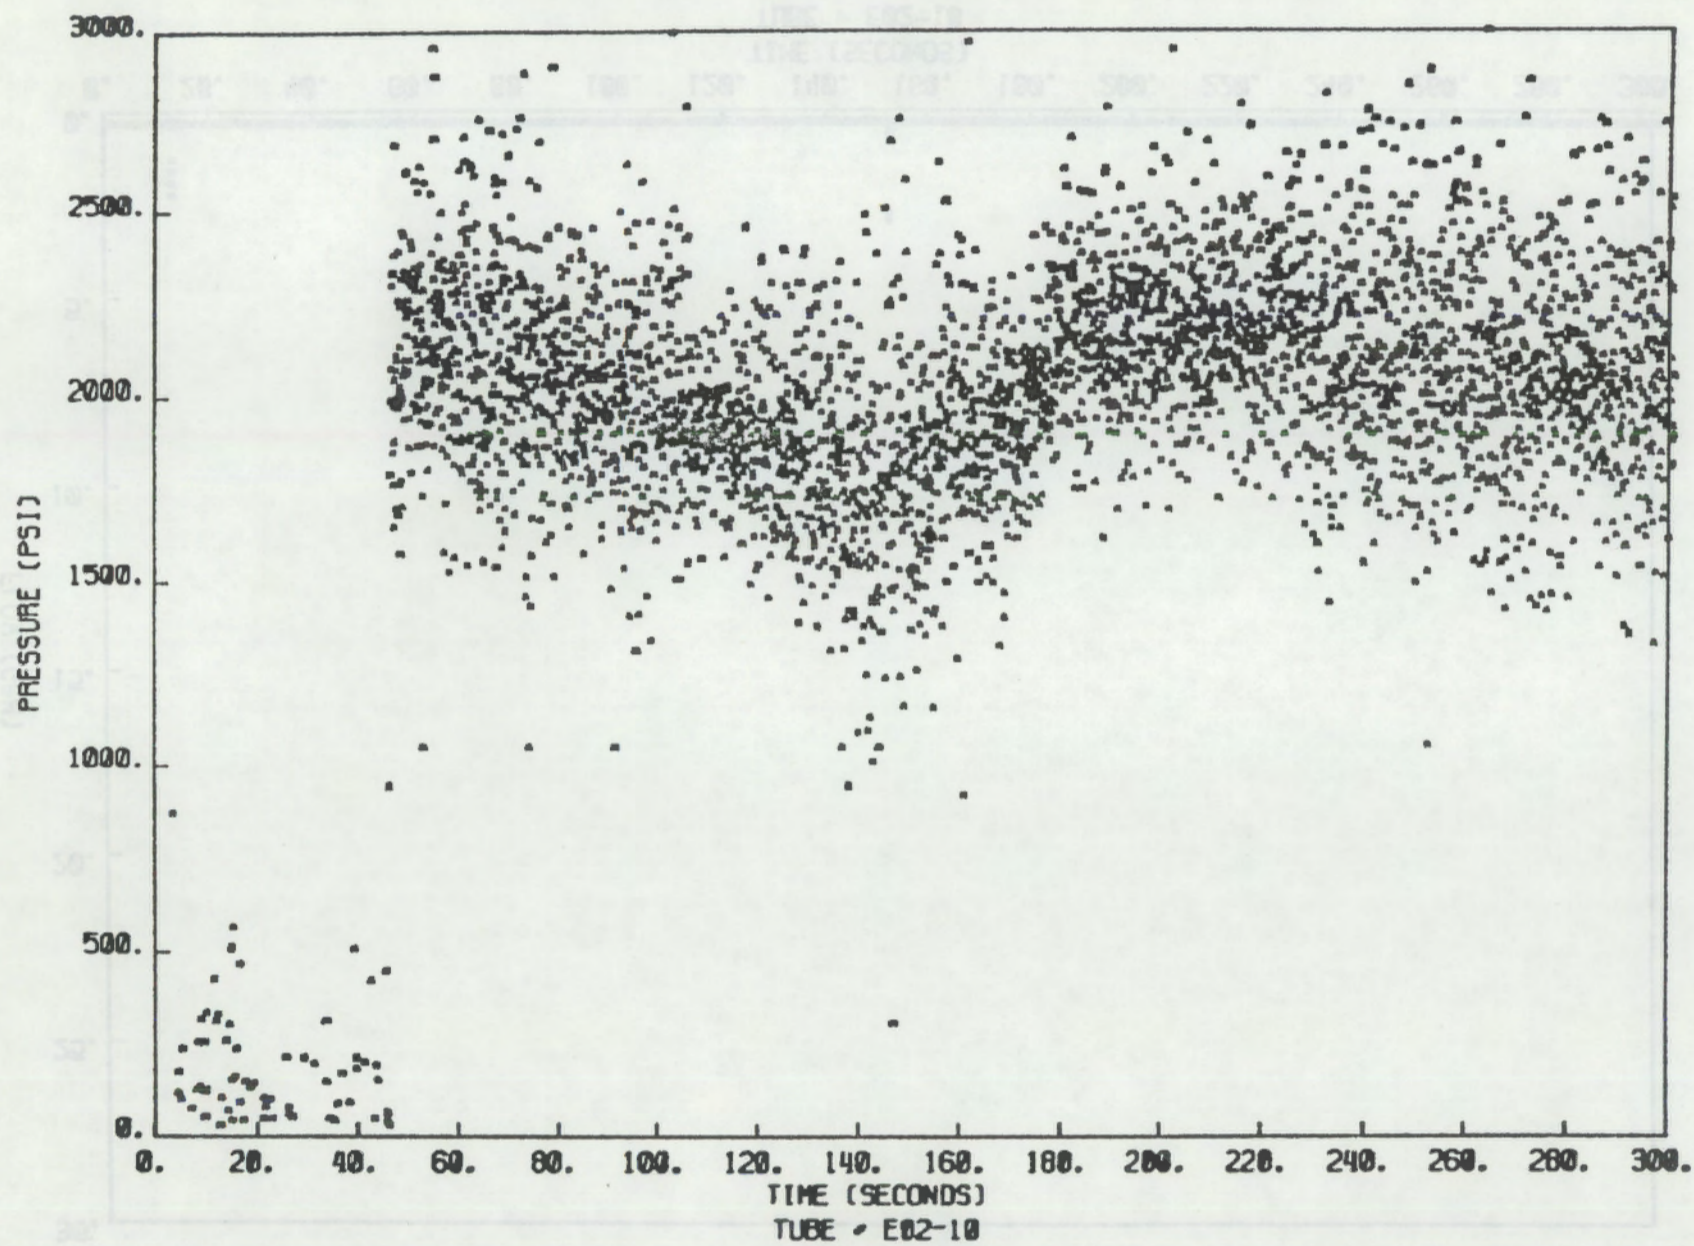
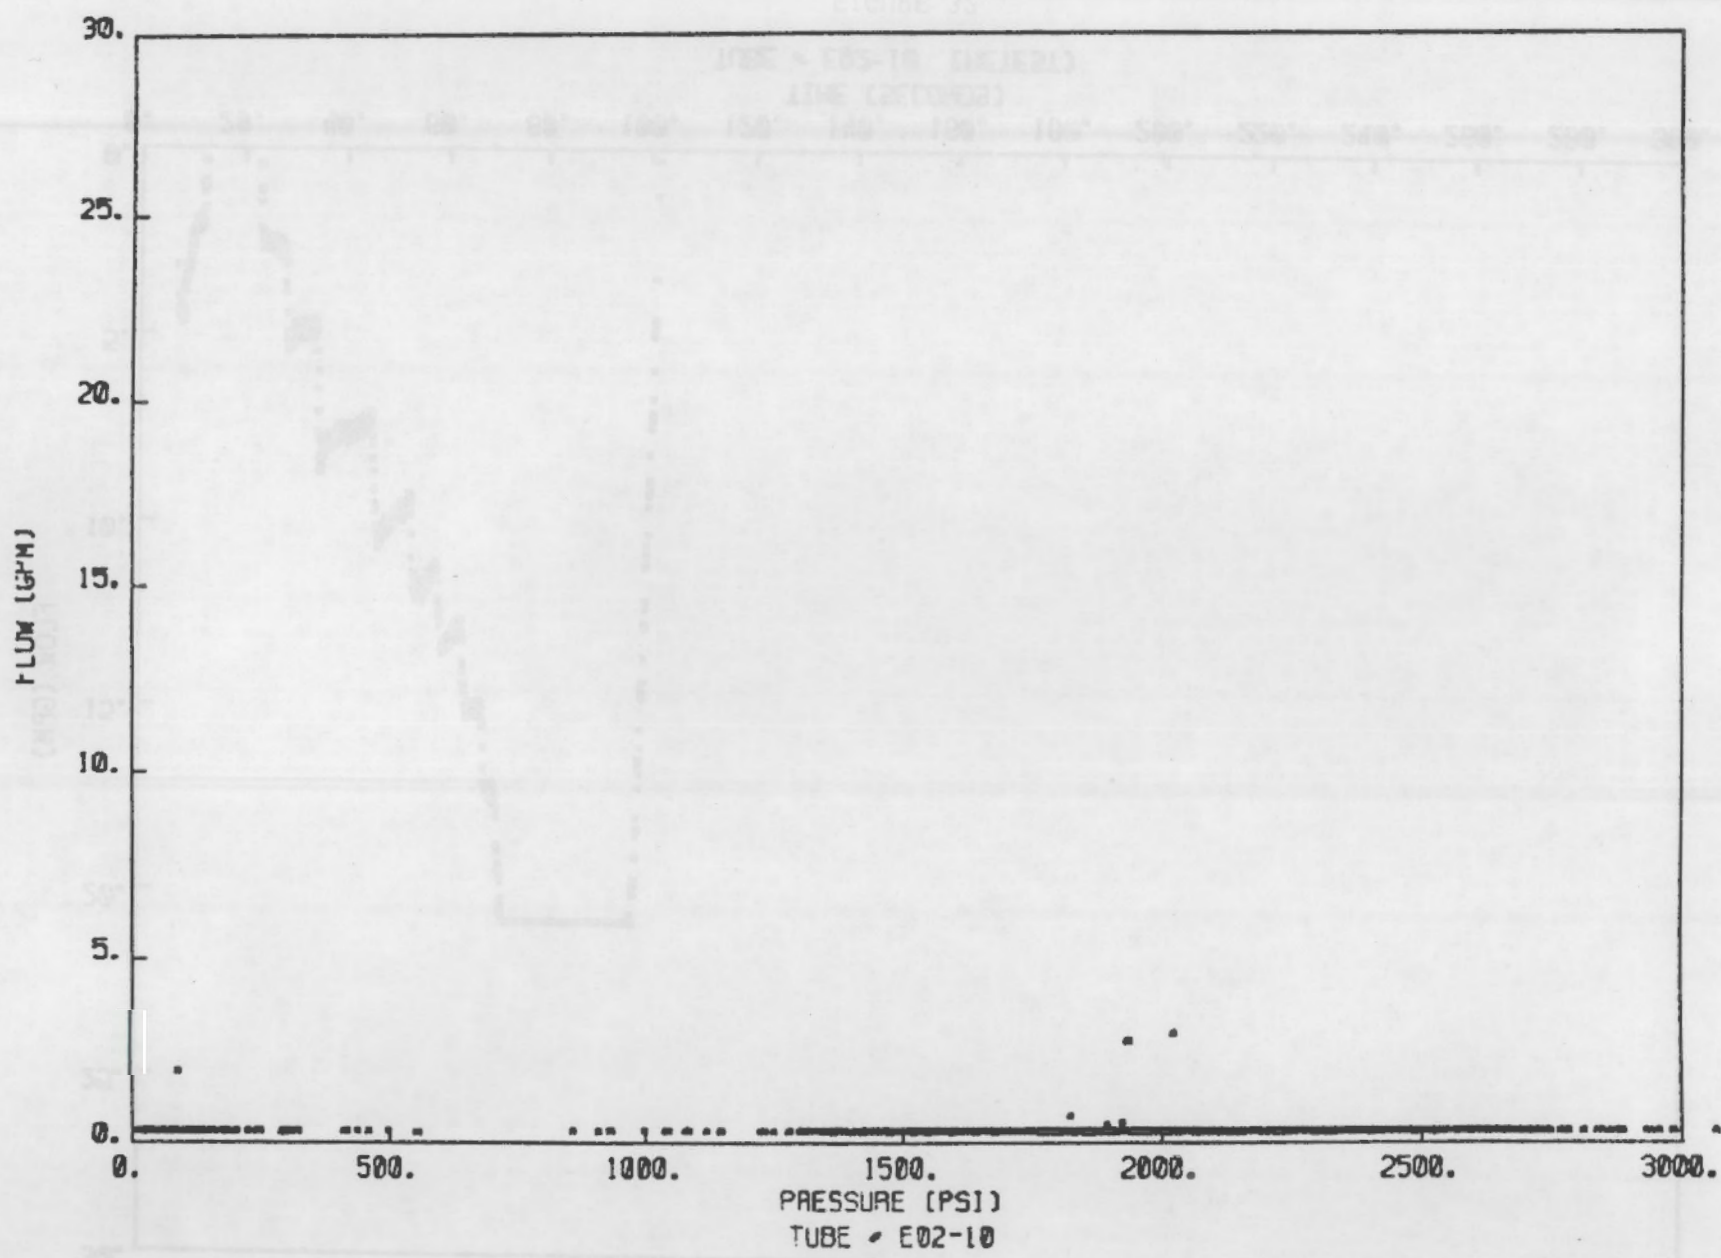
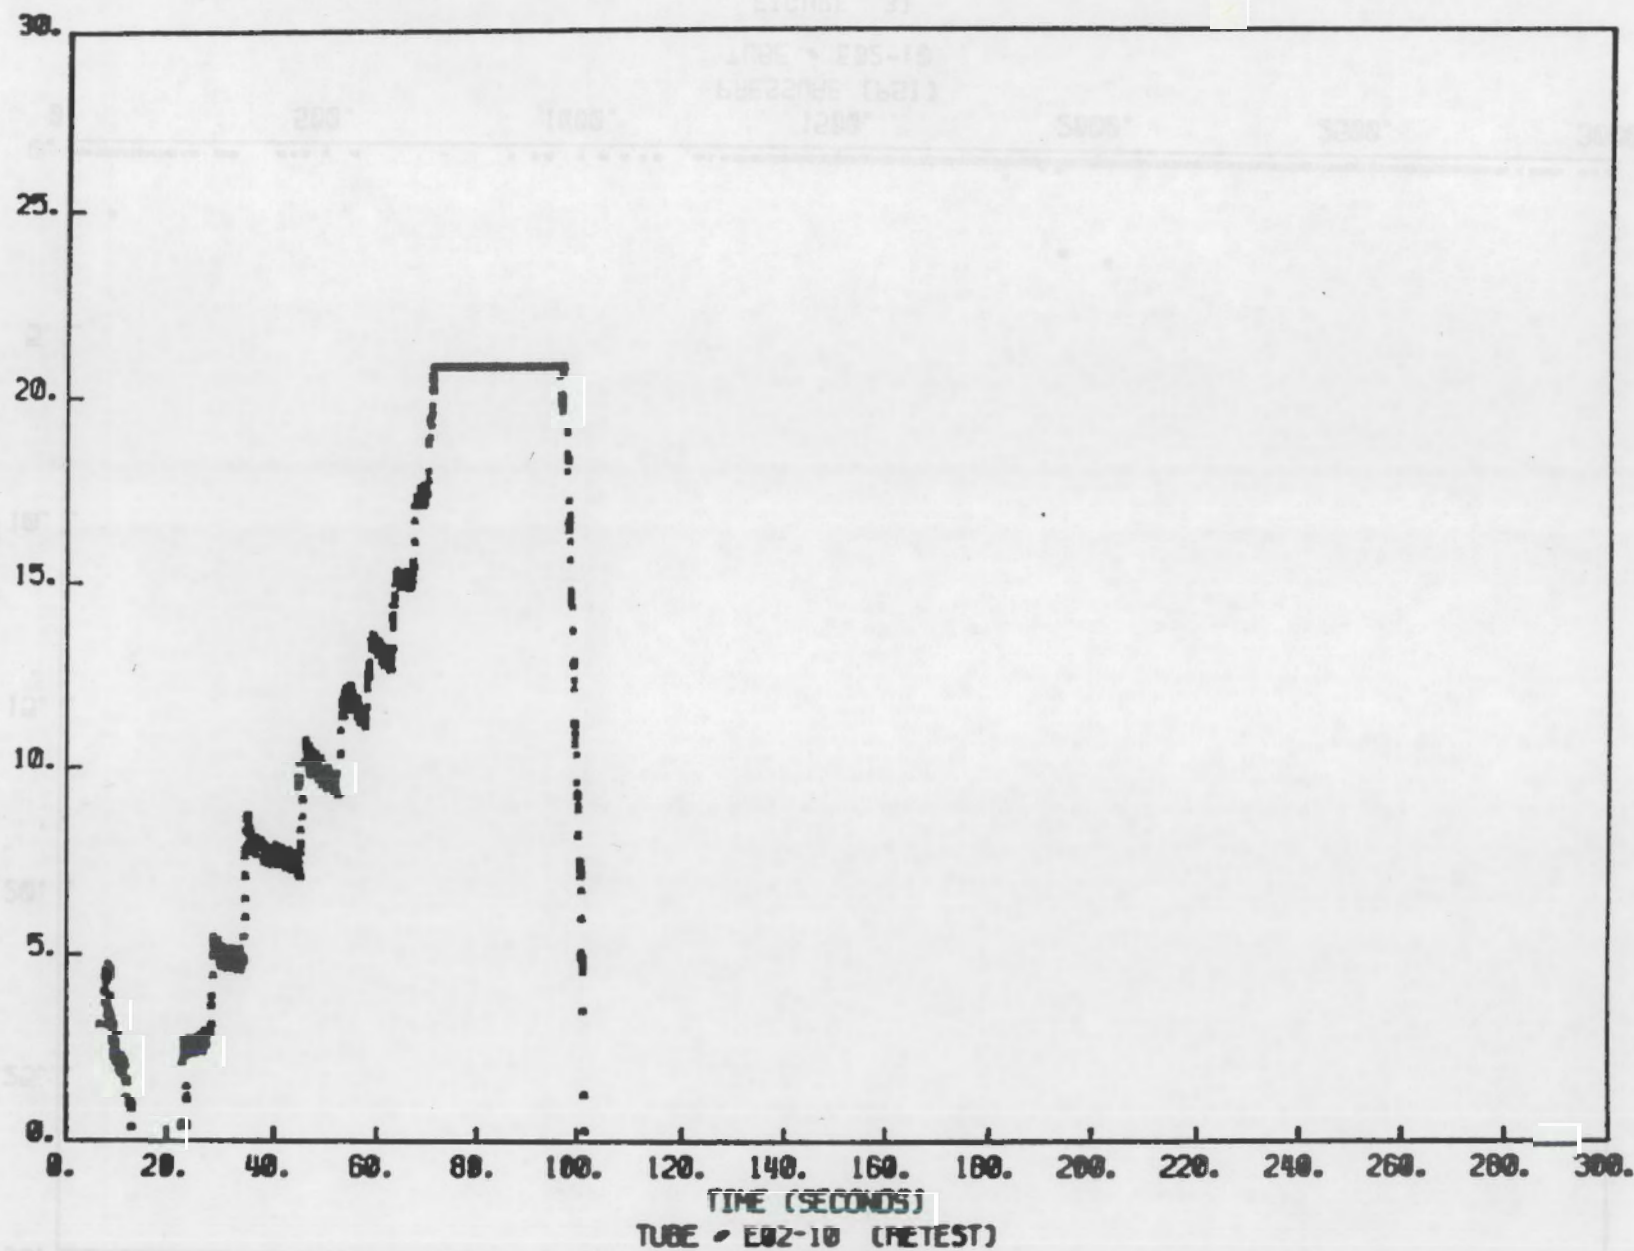
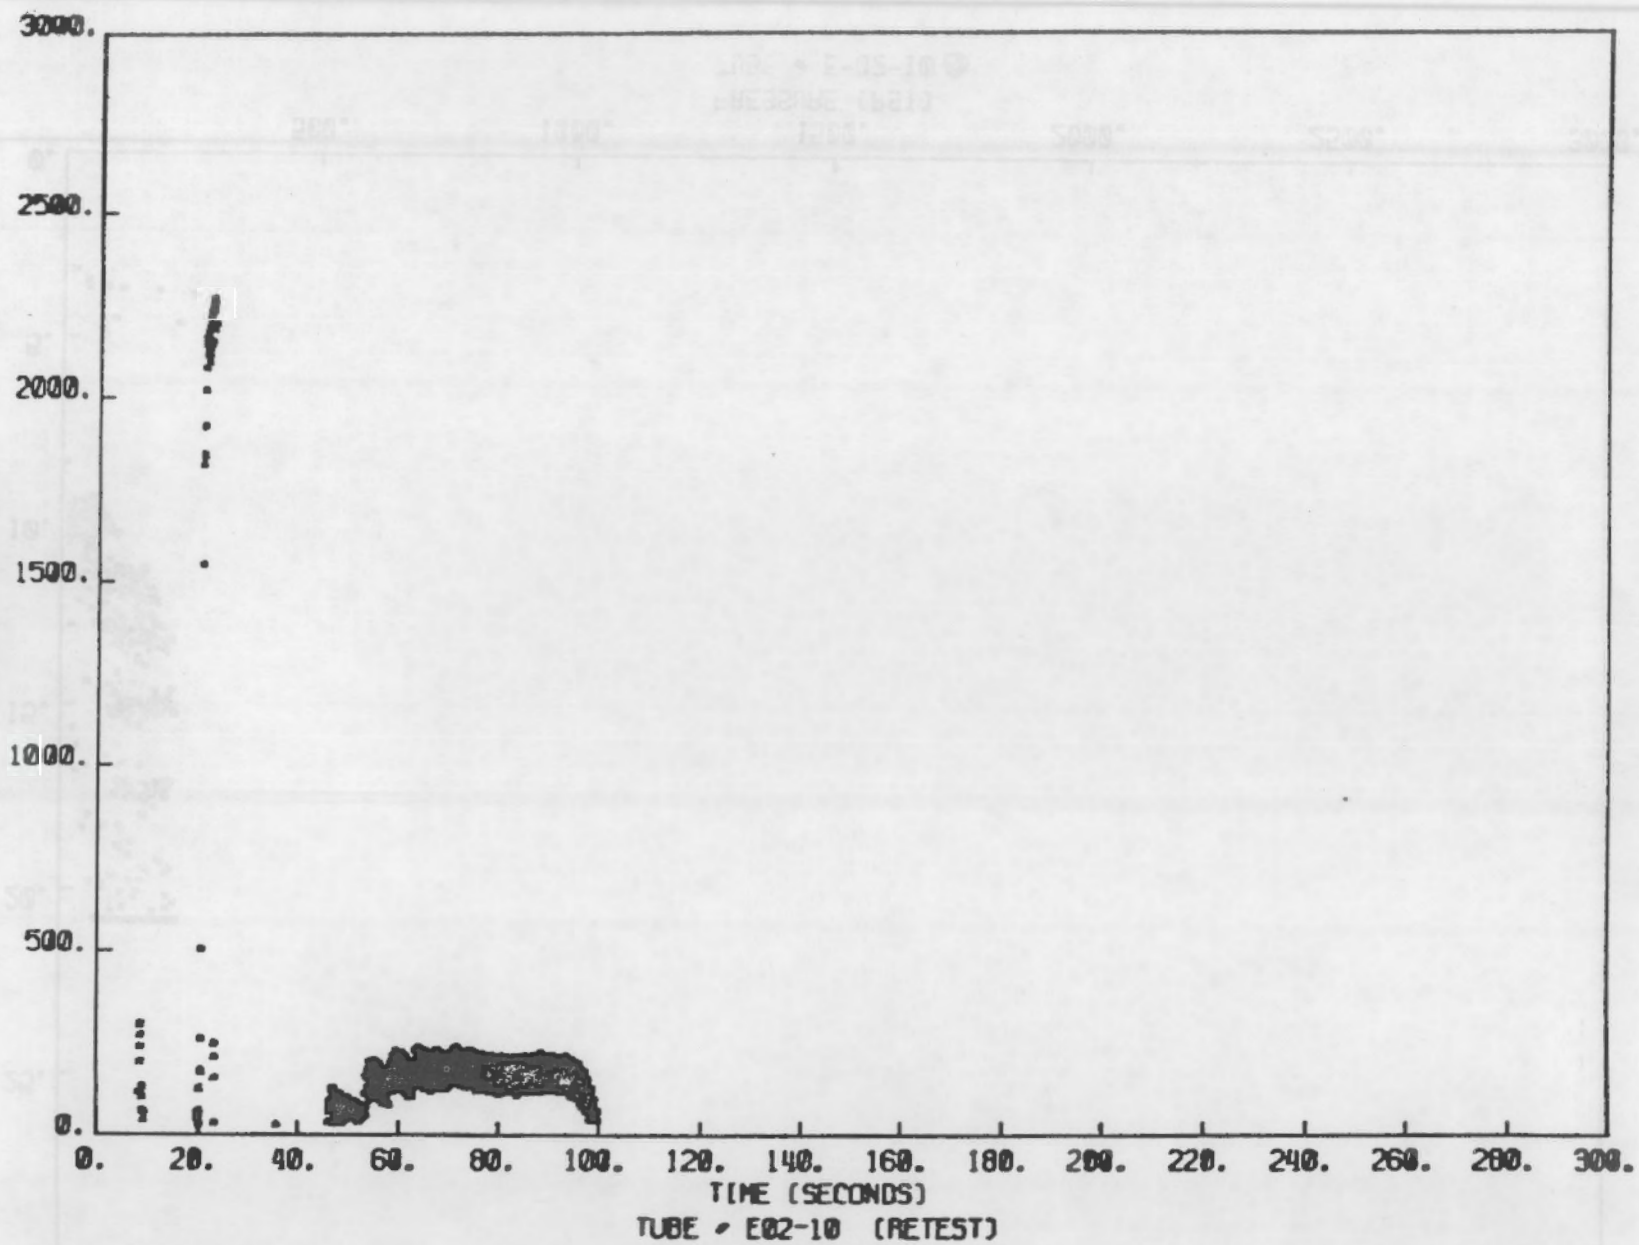
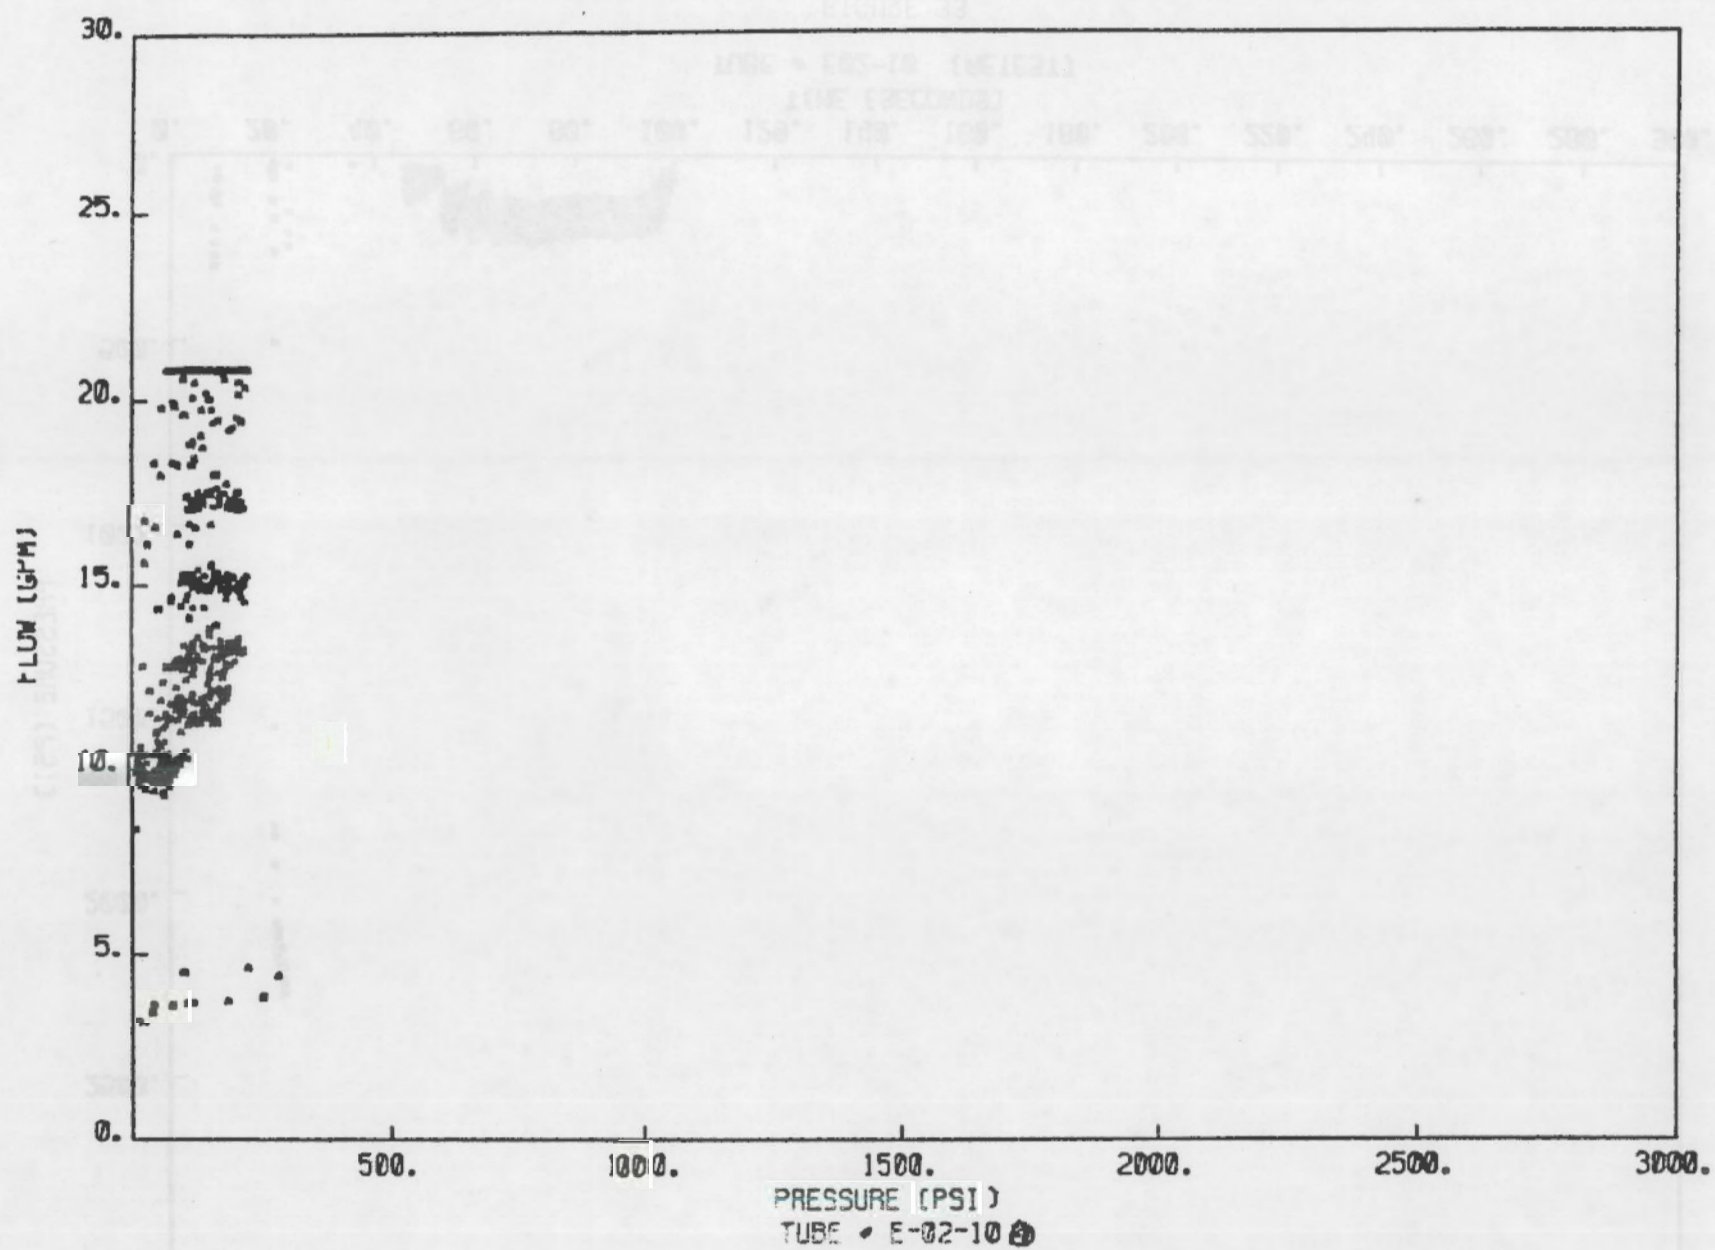
- Computer data: Figures 29, 30 and 31 - original test.  
Figures 32, 33 and 34 - retest.
- Before and after photographs: Figures 46 and 47.
- Eddy current before test: One crack 100% through-wall.
- Visual inspection: One major crack and several branching cracks, 1" long thinned area, 40% thinning.
- Testing: Original test produced no results due to water temperature problem in specimen. Test was run for 5 minutes but temperature never increased substantially. This problem was remedied by installation of a specimen vent valve. The retest was run for 100 seconds. The flow was increased in steps to a maximum of 20 gpm. Pressure remained at ~200 psi for most of test.
- Testing results: Crack burst open. Length 3/4".
