POST-TEST EXAMINATION OBSERVATIONS
FOR THE W-2 SLSF EXPERIMENT

A. L. Pitner
D. E. Smith
G. E. Culley

September, 1983

A. L. Pitner, D. E. Smith, G. E. Culley
Westinghouse Hanford Company
Hanford Engineering Development Laboratory, Richland, Washington

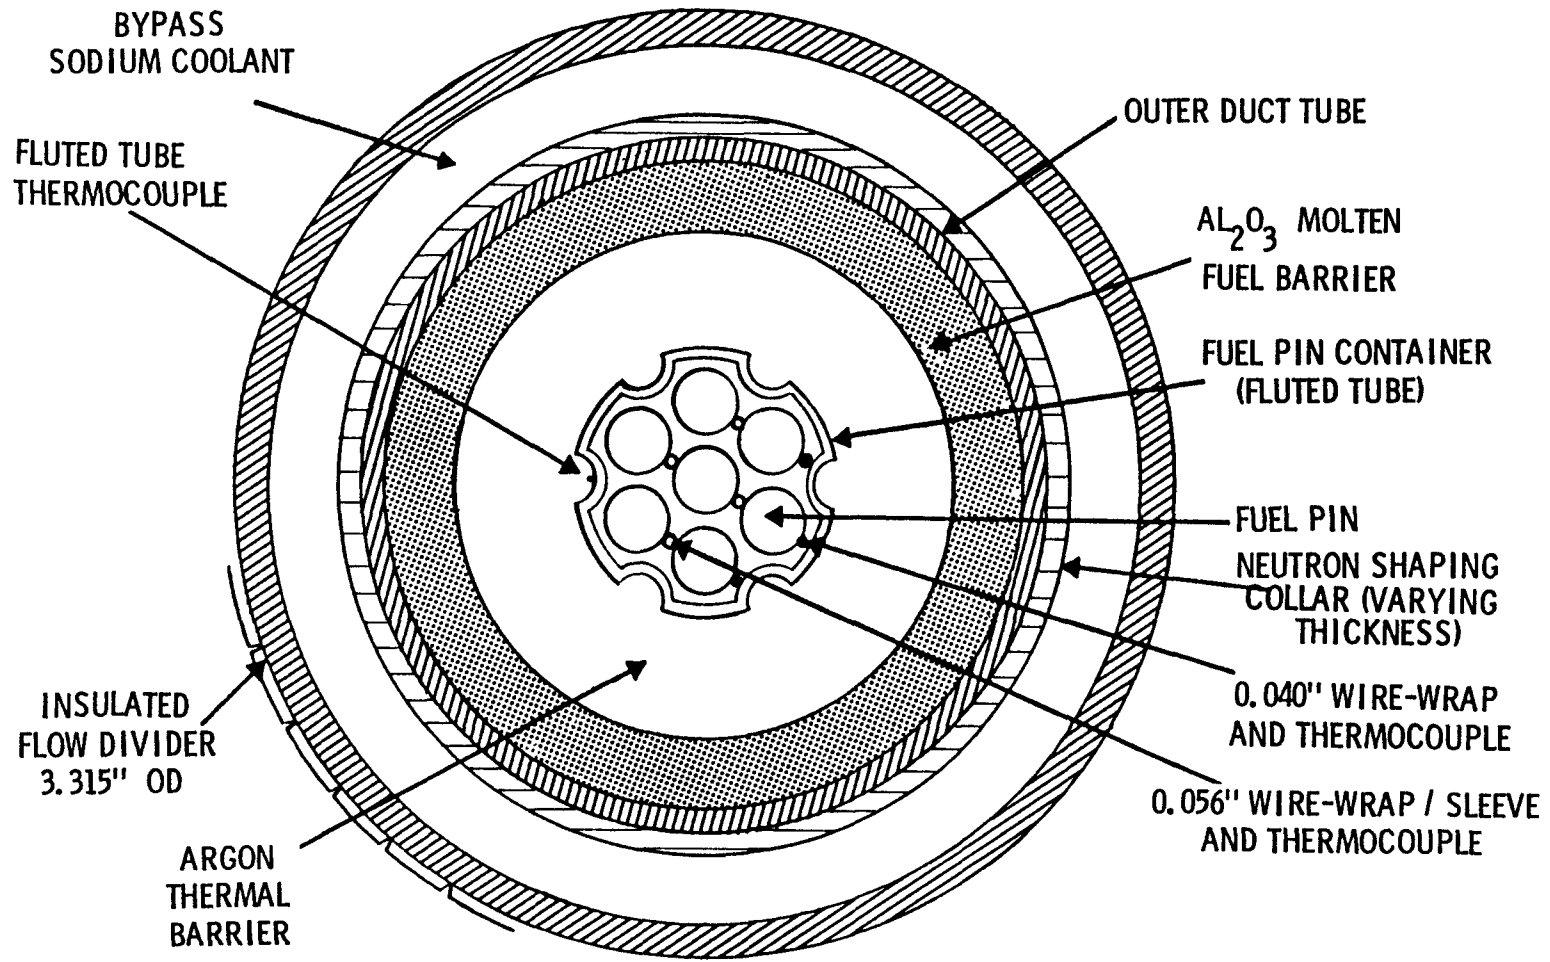
FIGURE 1. Cross-Section of W-2 Test Section.

A cross section of the W-2 test section is shown schematically in Figure 1. The seven-pin test bundle was contained in a fluted tube to reduce flow on the outside regions of the outer pins and thereby provide more prototypic thermal/hydraulic conditions for the center (design) pin. The center test pin contained higher enrichment fuel (91% ^{235}U) than the outer pins (43% ^{235}U) to compensate for the radial flux depression across the test assembly that occurs in the ETR. The experiment also provided for bypass coolant flow to better simulate true LMFBR hydraulic conditions. While the test was designed for and pretest calculations predicted an initial upper level failure in the center pin, test instrumentation indicated that failure first occurred in an outer fuel pin at the axial midplane.

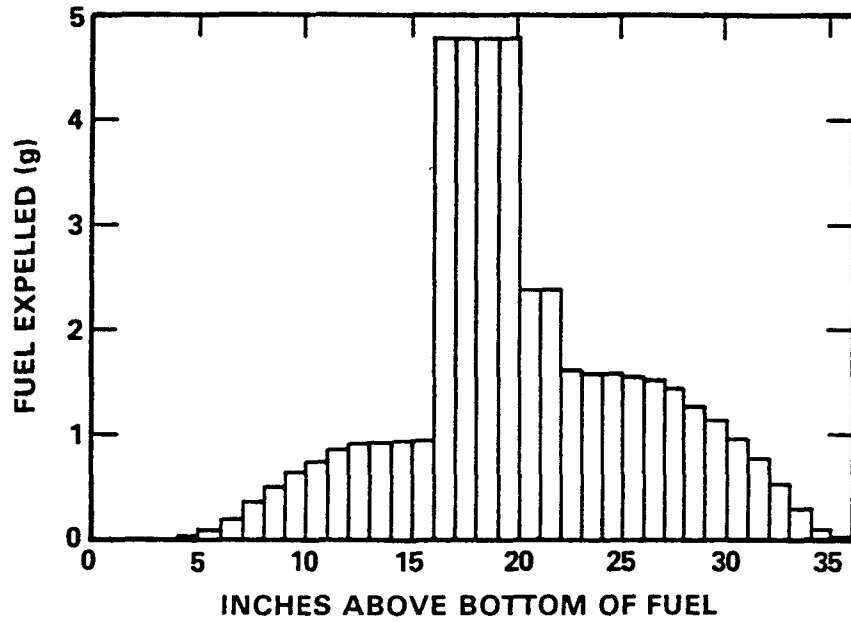
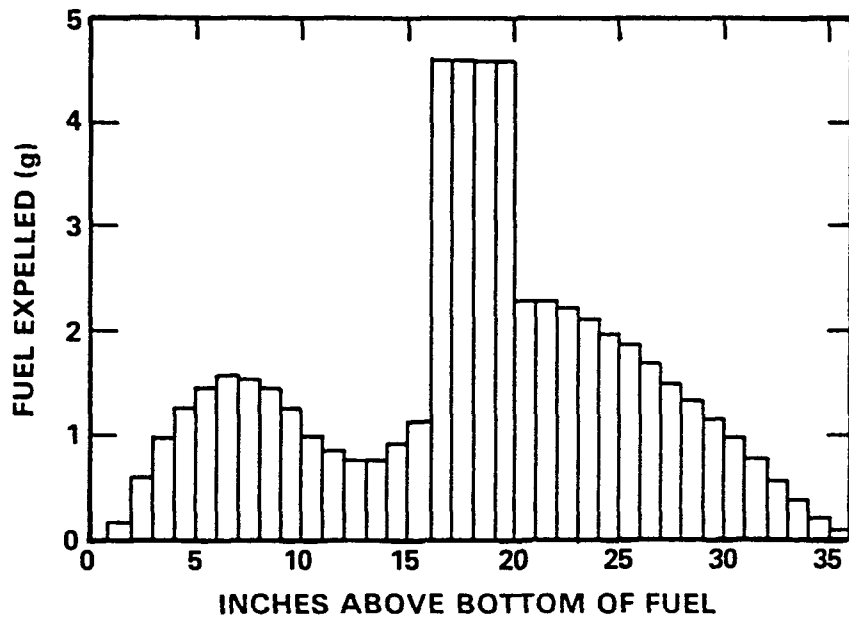
FIGURE 12. Estimated Fuel Expulsion from W-2 Pin Bundle.

Based on observations of residual fuel content at various levels in the test section, it was possible to estimate the amount of fuel expelled along the fueled length of the test assembly. Histograms constructed by interpolating between measured points are shown in Figure 12. The outer pin histogram represents the average of the six circumferential pins. These

distributions should represent an upper limit to actual fuel expulsion, since they do not acknowledge localized plugging of the central voids which was observed at several locations. The integrated distributions in Figure 12 indicate that 45.9 g of fuel was expelled from the center pin, and an average of 55.8 g of fuel was expelled from each of the outer pins. These quantities represent 27% and 34% of the fuel loading in the inner and outer pins, respectively. The total quantity of fuel expelled is thus inferred to be 380 g, or 33% of the test bundle fuel loading. This is an approximate estimate due to the basic inaccuracies involved in obtaining these values, but it should represent an upper limit to fuel expulsion as noted above. The 380 g value obtained here is a factor of 2.3 greater than the estimated fuel dispersion obtained from the Delayed Neutron Detection (DND) System (165 g). However, measurement of fission product activity (^{87}Br) in the SLSF after the transient test suggested that more than 165 g of fuel had been dispersed. In actuality, it is felt that the true fuel expulsion value lies somewhere between these two extremes of 14% and 33%. There was substantial upward sweep-out of the fuel expelled at the midplane failure site, as evidenced by fuel debris present in the coolant channels of upper level metallography sections, and fuel particulate matter above the fueled section detectable in the neutron radiographs.

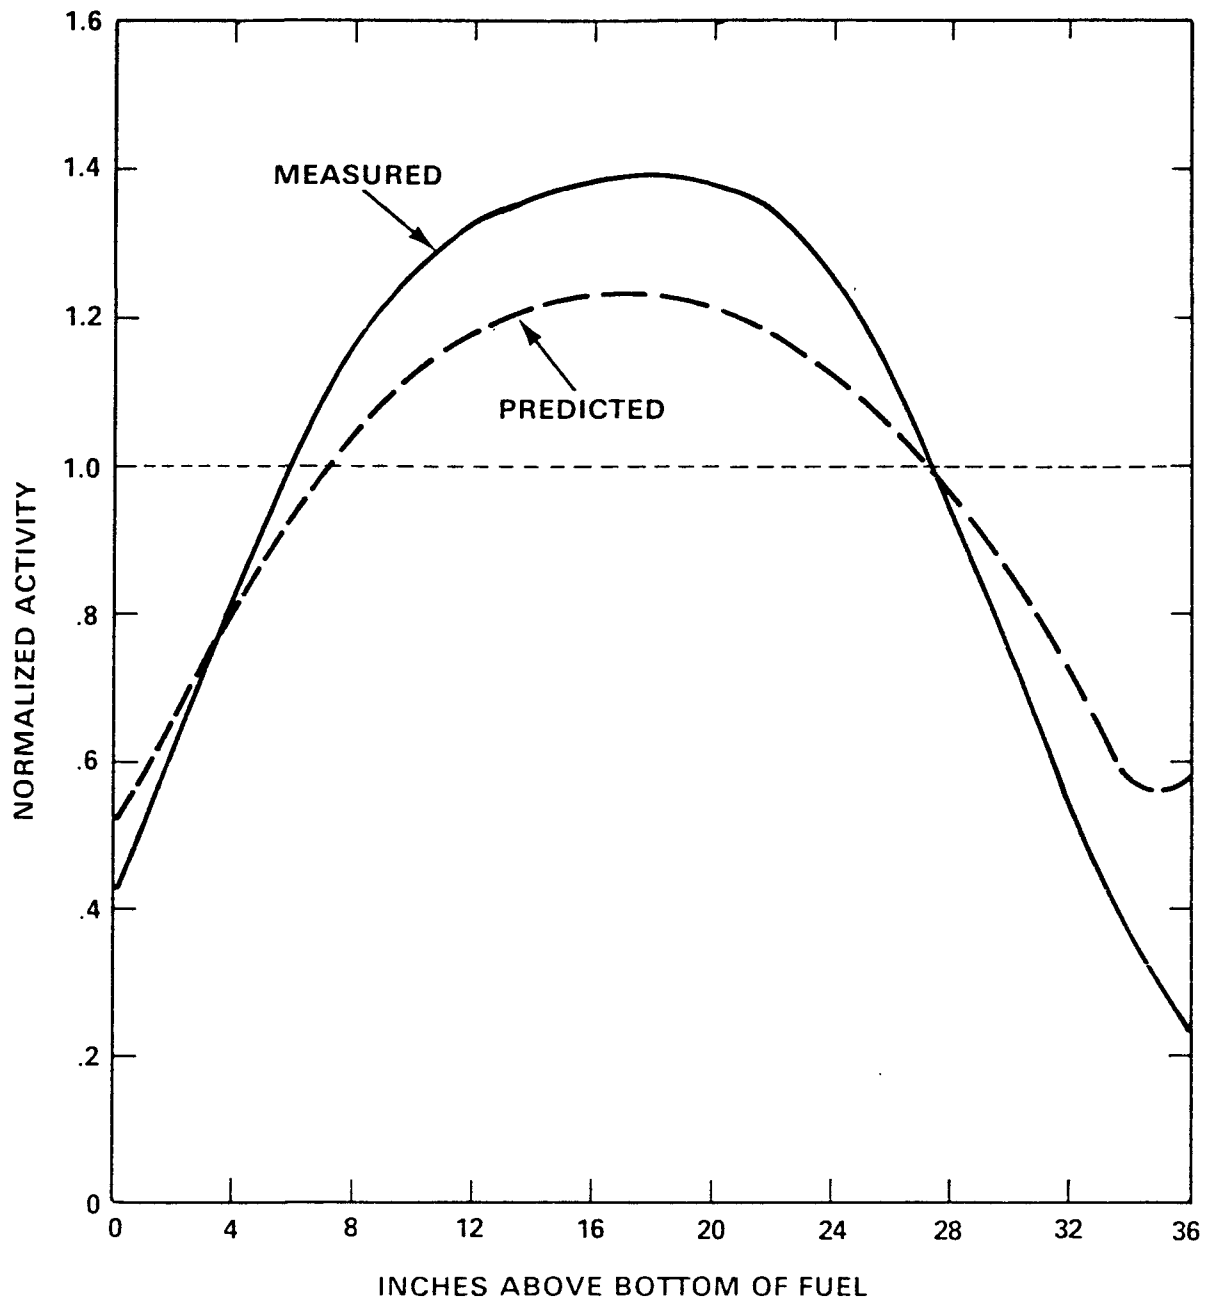
FIGURE 13. Measured Gamma Scan Profile vs. Predicted Profile.

The axial profiles determined from these two isotope activities agreed well (within ~5%) with one another, and their average is shown in Figure 13 along with the predicted axial power profile based on pretest critical facility (ETRC) measurements and neutronic calculations. Each curve has been normalized to an average value of unity over the length of the fuel column. The measured profile is considerably more peaked than the predicted profile, with a peak-to-average (P/A) value of 1.39 for the measured, versus 1.25 for the predicted profile. The measured profile is also seen to be skewed more toward the bottom of the core relative to the predicted profile.
