NUREG/CR-1603
UCRL-53000

Evaluation of Cracking in Feedwater Piping Adjacent to the Steam Generators in Nine Pressurized Water Reactor Plants

Alfred Goldberg, Ronald D. Streit, and Robert G. Scott

Lawrence Livermore Laboratory
7000 East Avenue
Livermore, CA 94550

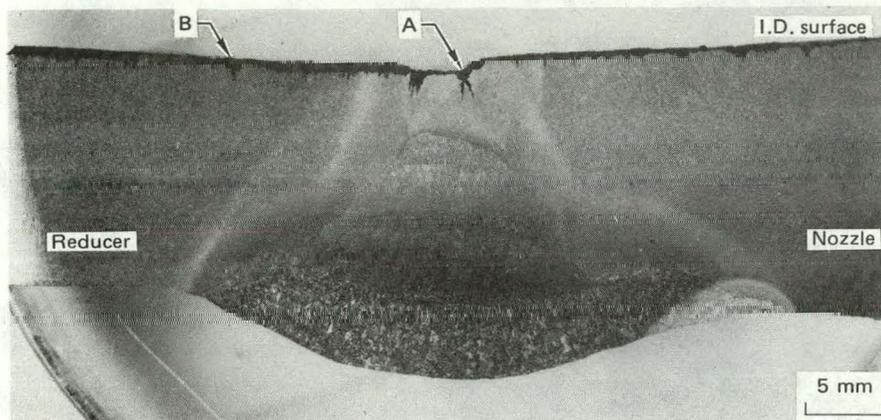
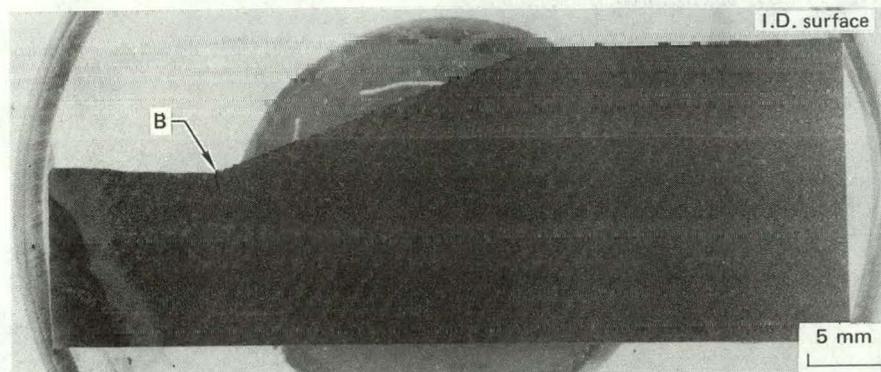
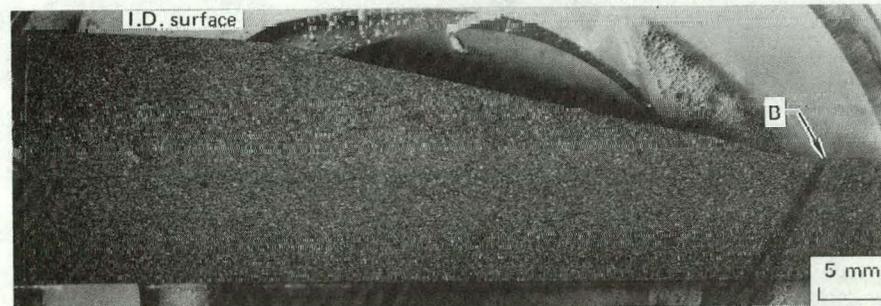
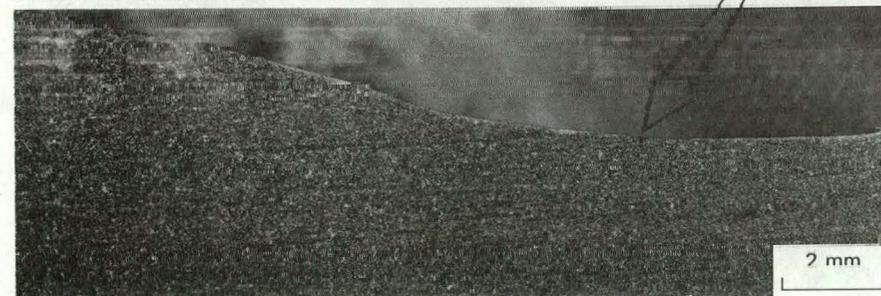
FIG. 3.4. Mounted cross sections from longitudinal slices used for light microscopy examination of San Onofre, Ginna, and H. B. Robinson material. Major cracks are indicated by arrows. Views are parallel to piping axis and wall thickness.

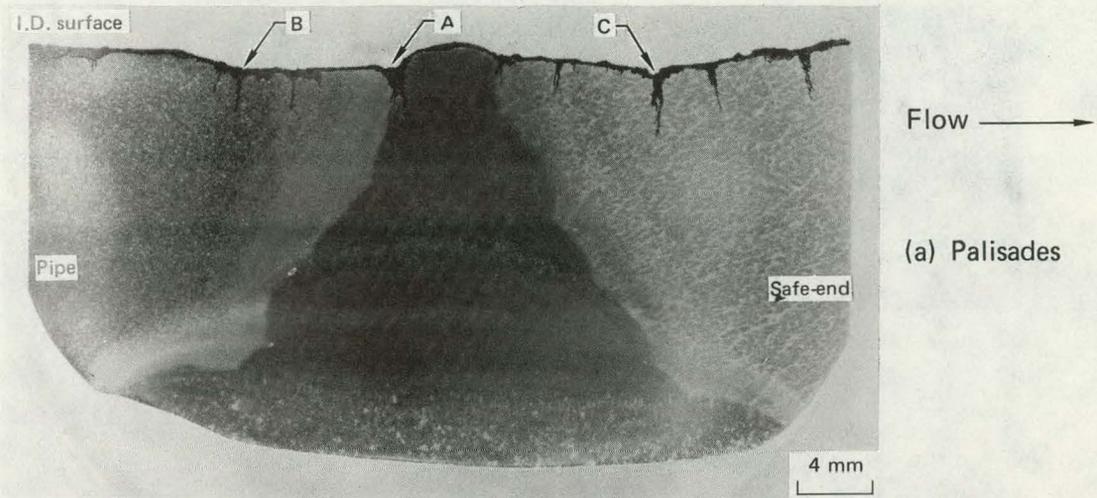
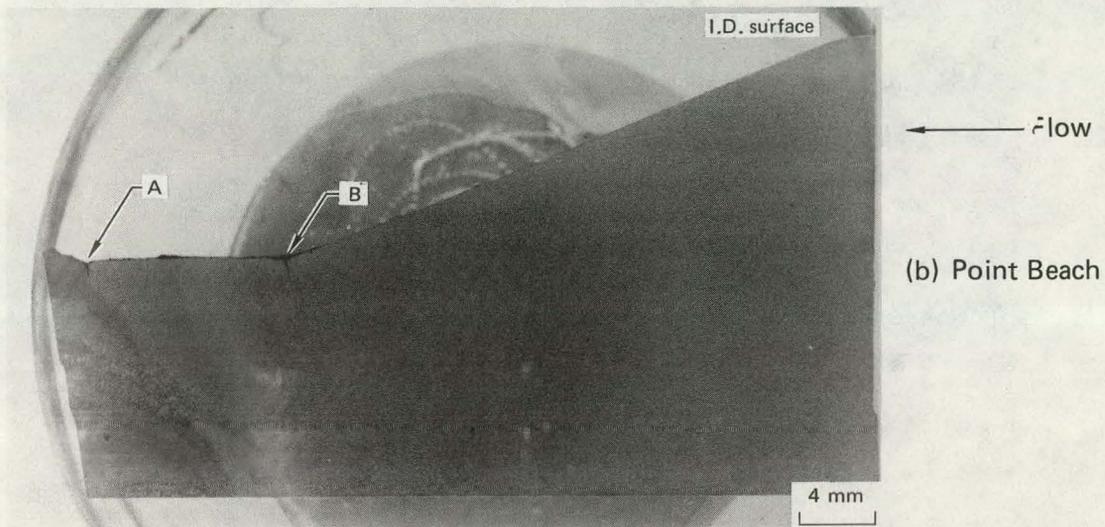
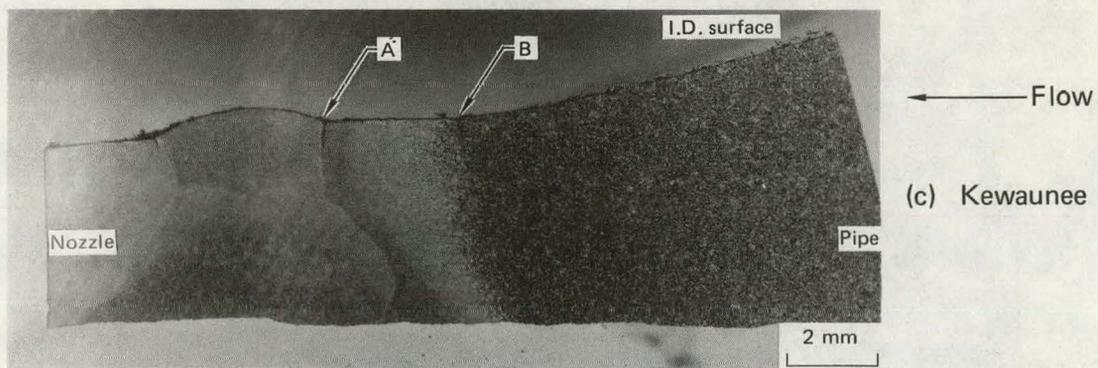
FIG. 3.5. Mounted cross sections from longitudinal slices used for light microscopy examination of Palisades, Point Beach, and Kewaunee material. Major cracks are indicated by arrows. Views are parallel to piping axis and wall thickness.

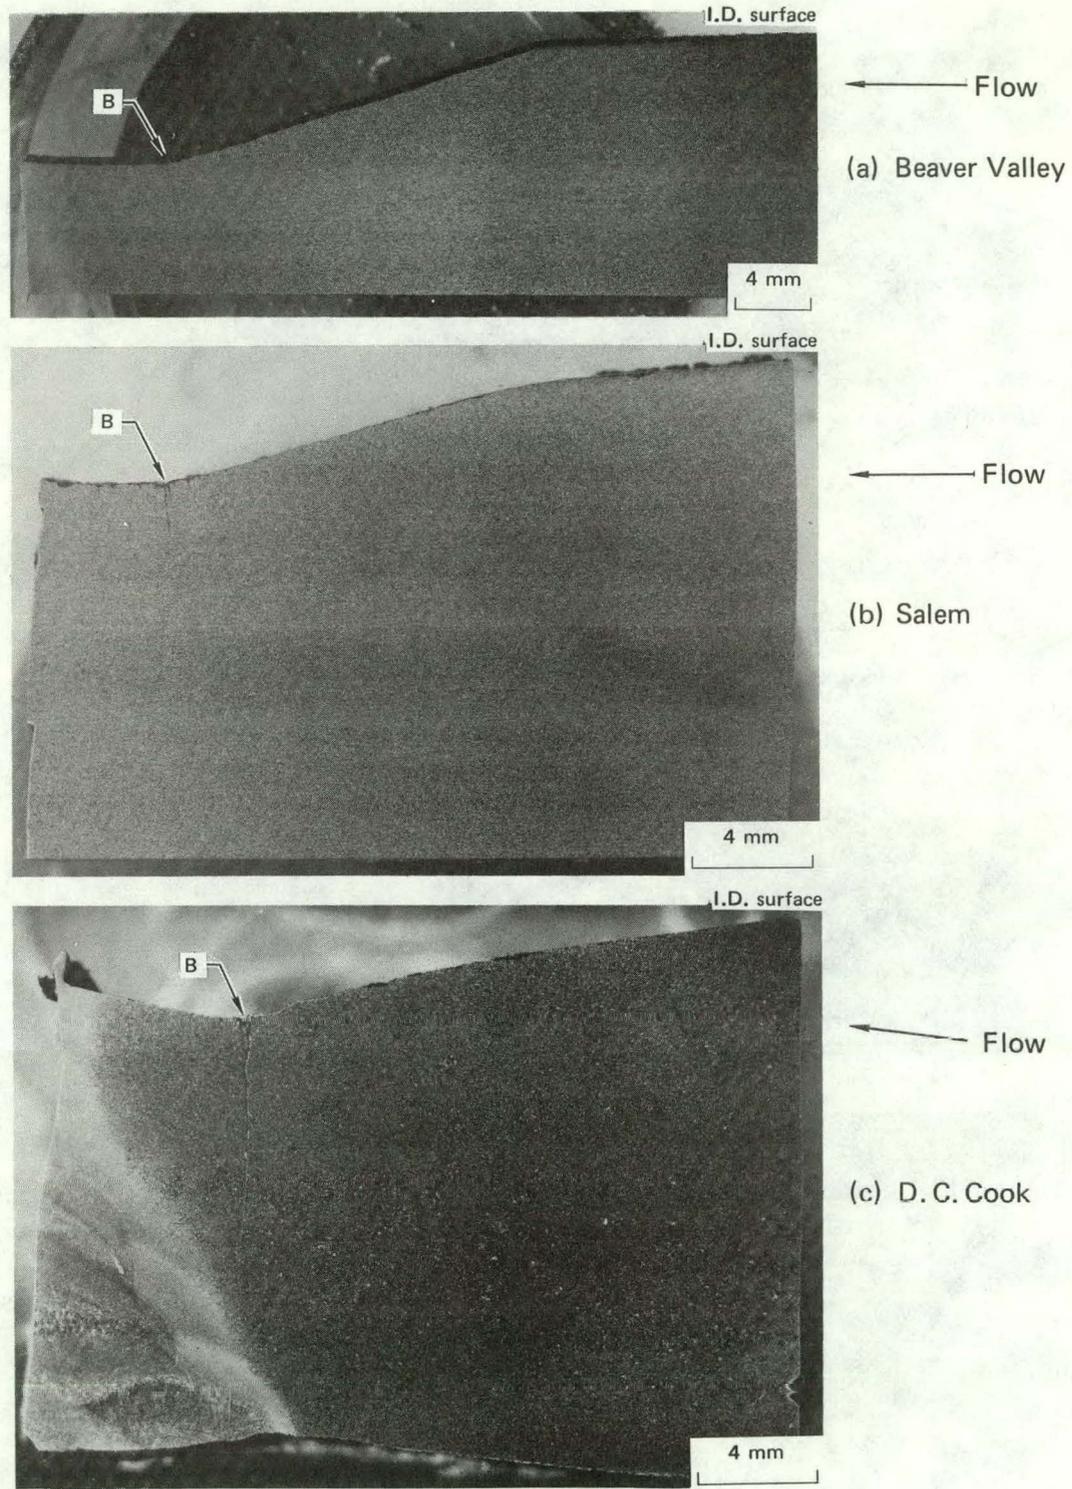
FIG. 3.6. Mounted cross sections from longitudinal slices used for light microscopy examination of Beaver Valley, Salem, and D. C. Cook material. Major cracks are indicated by arrows. Views are parallel to piping axis and wall thickness.

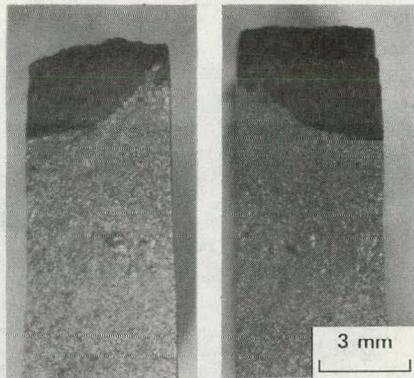
(a) San Onofre:
Crack A as-corroded
and fractured

FIG. 3.19. Macroscopic views of crack surfaces from San Onofre, Ginna, and H. B. Robinson sections showing arrest bands. In views (a) and (b), note differences between as-corroded and after cathodic cleaning of the San Onofre crack. Upper regions are plant cracks; lower regions are laboratory fractures. Crack propagation is from top to bottom.

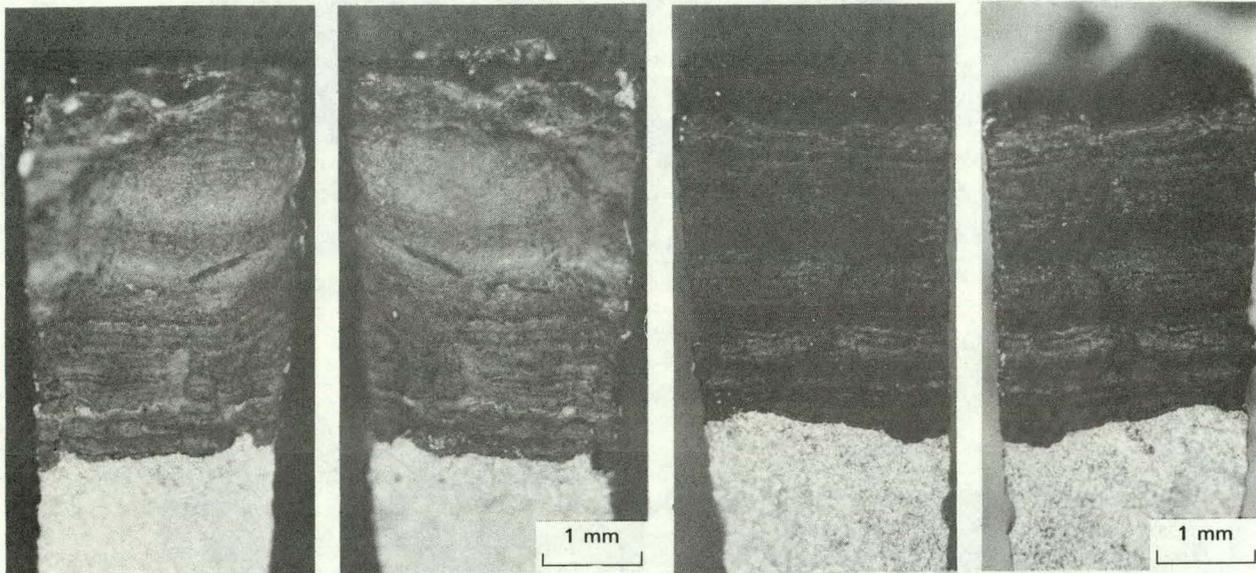
(a) Crack A:
at pipe to
weld interface

(b) Crack C:
at bottom of pipe
counterbore slope

FIG. 3.20. Macroscopic views of crack surfaces of three cracks along a Palisades section. Refer to Fig. 3.5(a). Note that the arrest bands are less distinct in Crack B than in Cracks A and C. The upper regions are plant cracks; the lower regions are laboratory fractures. Crack propagation is from top to bottom.

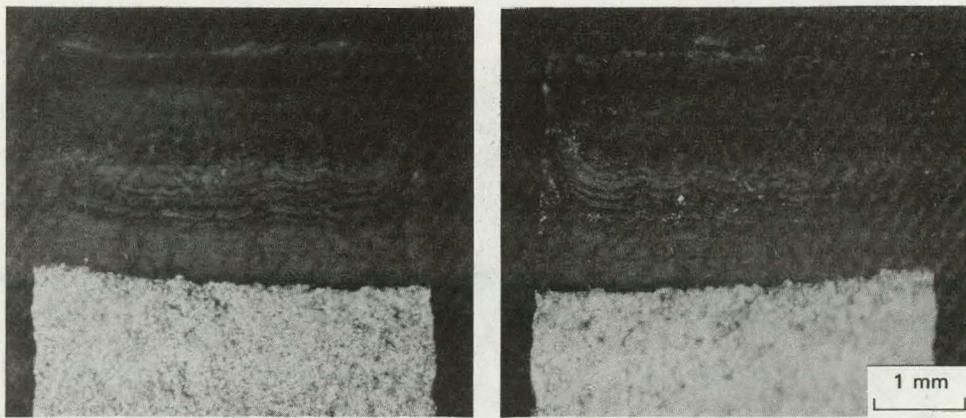
(a) At counterbore slope of safe-end

FIG. 3.21. Macroscopic views of crack surfaces of additional cracks along a Palisades section. Refer to Fig. 3.5(a). Note that the arrest bands are less distinct in pipe cracks than in safe-end cracks. The upper regions are plant cracks; the lower regions are laboratory fractures. Crack propagation is from top to bottom.

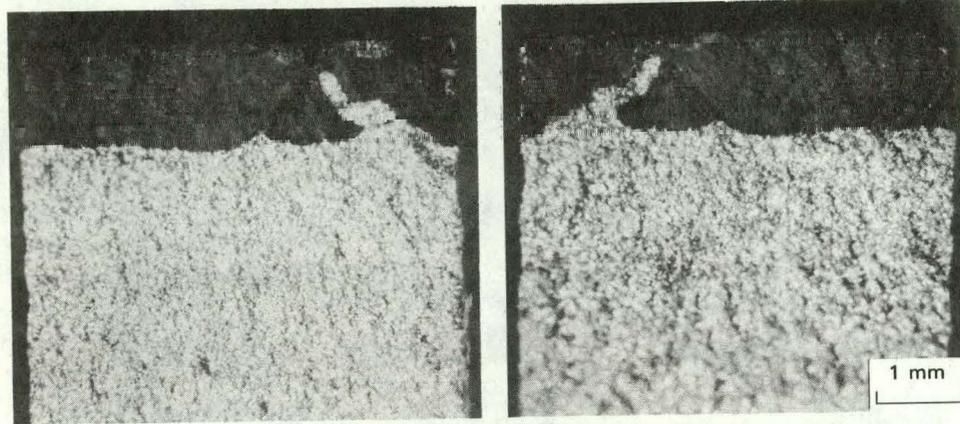
(a) Point Beach: Crack B

FIG. 3.22. Macroscopic views of crack surfaces from Point Beach, Kewaunee, and Beaver Valley sections showing arrest bands. Refer to Fig. 3.5(c) for Kewaunee cracks: Crack A is at weld-to-pipe interface; Crack B is at discontinuity at bottom of counterbore slope. Beaver Valley views are of surfaces from different sections of same crack. The upper regions are plant cracks; the lower regions are laboratory fractures. Crack propagation is from top to bottom.

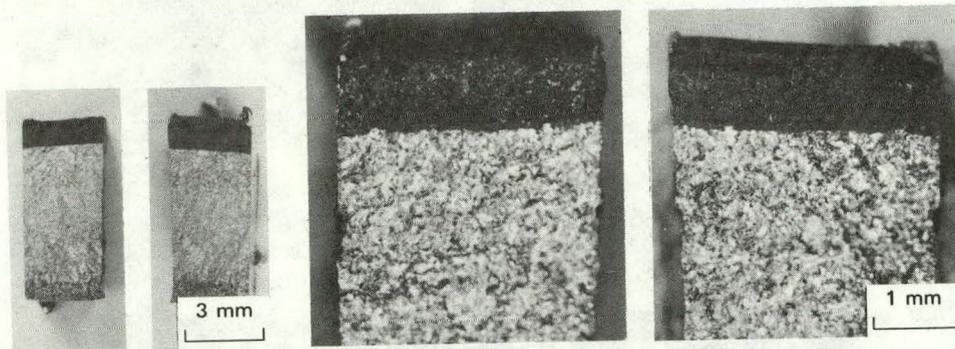
(b) Kewaunee: Crack A

(c) Kewaunee: Crack B

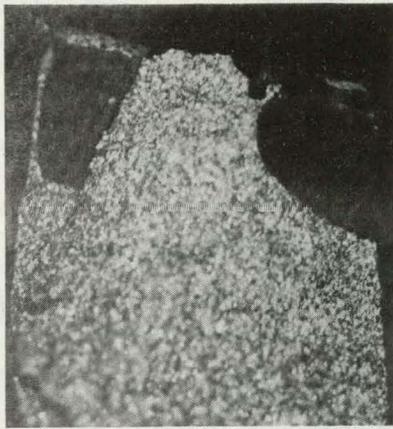
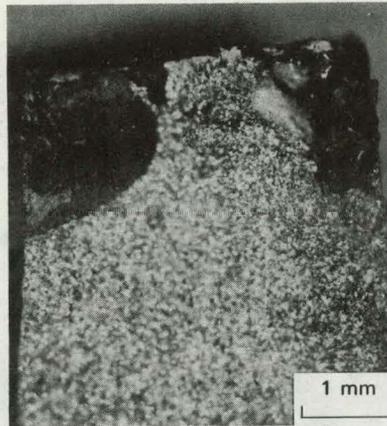
(a) Salem: Crack B

FIG. 3.23. Macroscopic views of crack surfaces from Salem and D. C. Cook sections showing arrest bands. In view (b), note that the arrest bands are not visible on the as-corroded surface of the D. C. Cook crack. After cathodic cleaning, numerous arrest bands become visible. Compare view (c) with view (d). Views (b) and (c) are of surfaces from adjacent sections of the same crack.

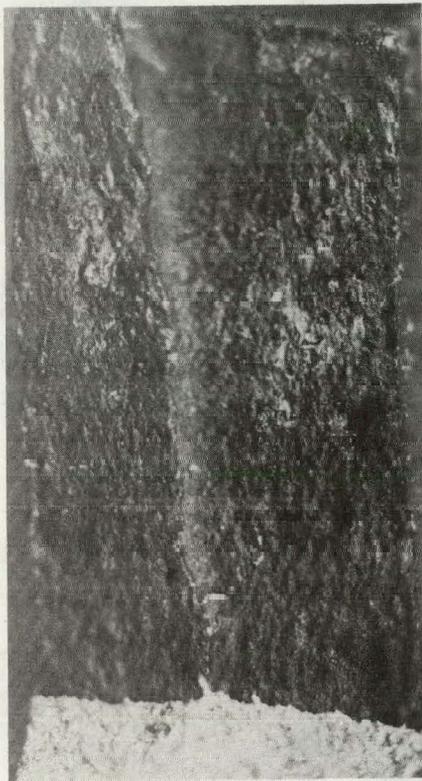
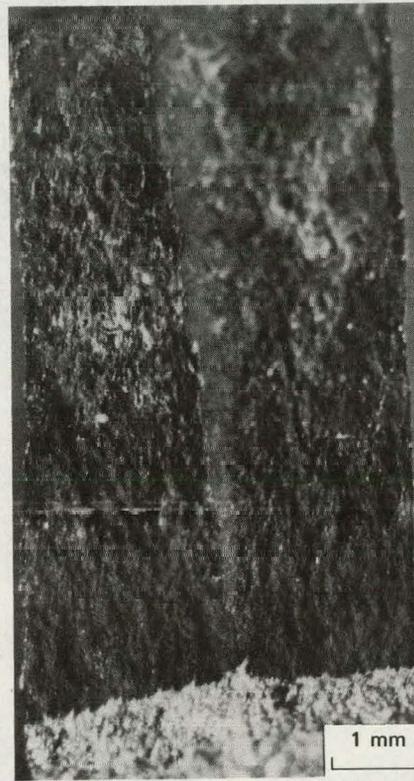
(b) D.C. Cook: Crack B as-corroded and fractured, before cathodic cleaning

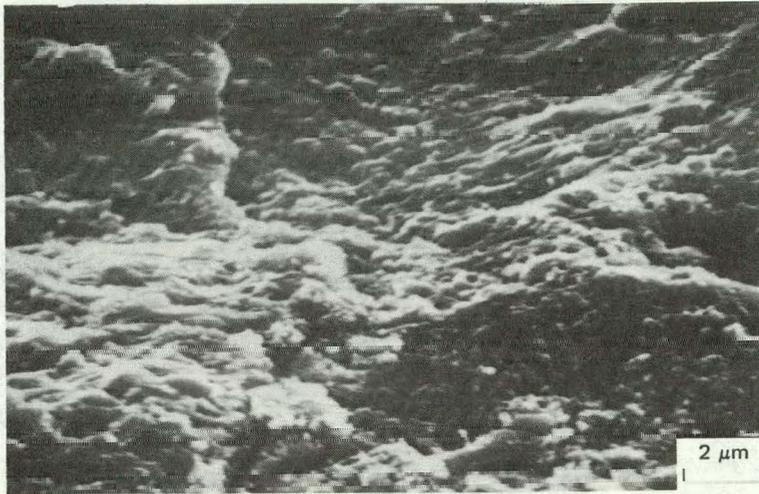
(a) H. B. Robinson

FIG. 3.24. SEM fractographs of as-corroded crack surfaces from H. B. Robinson, Beaver Valley, and D. C. Cook showing wavy striations suggesting cyclic events.

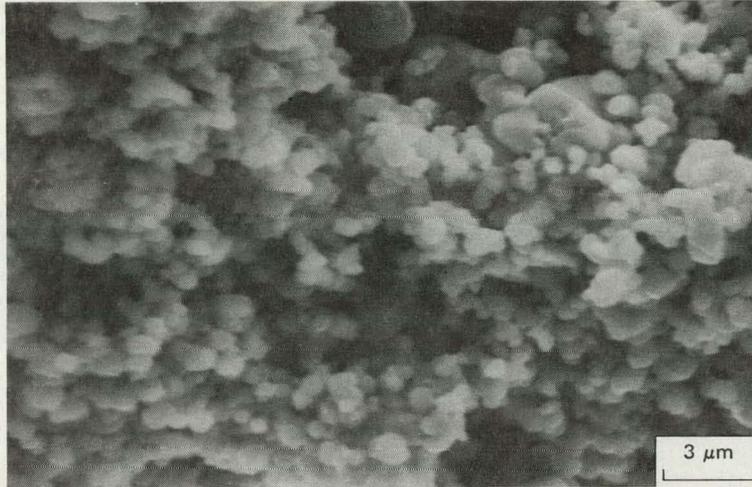
(a) San Onofre: globular

FIG. 3.27. SEM views showing typical morphology of corrosion nodules on crack surfaces for sections from San Onofre, H. B. Robinson, and D. C. Cook.

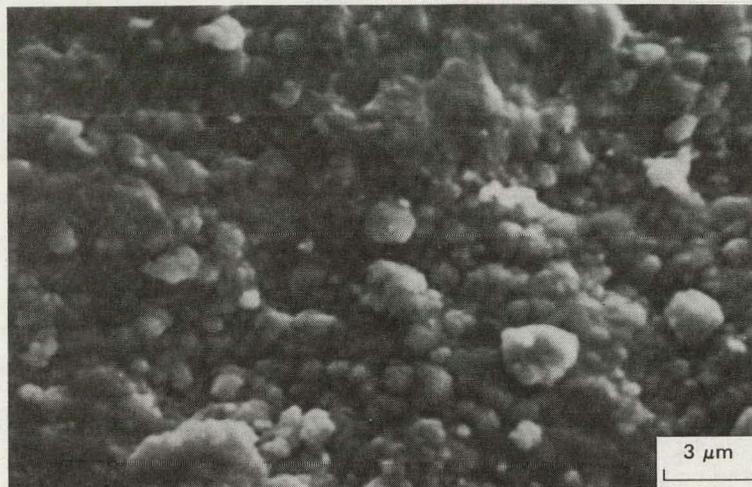
(b) H. B. Robinson: spongy

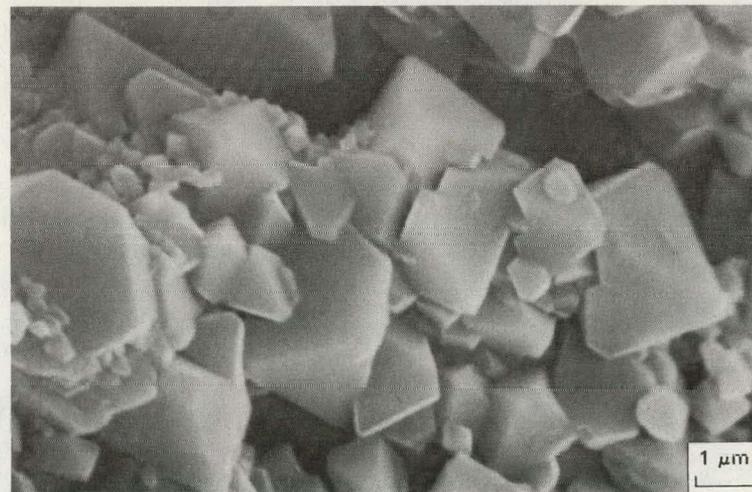
(c) D. C. Cook
(shallow crack):
faceted

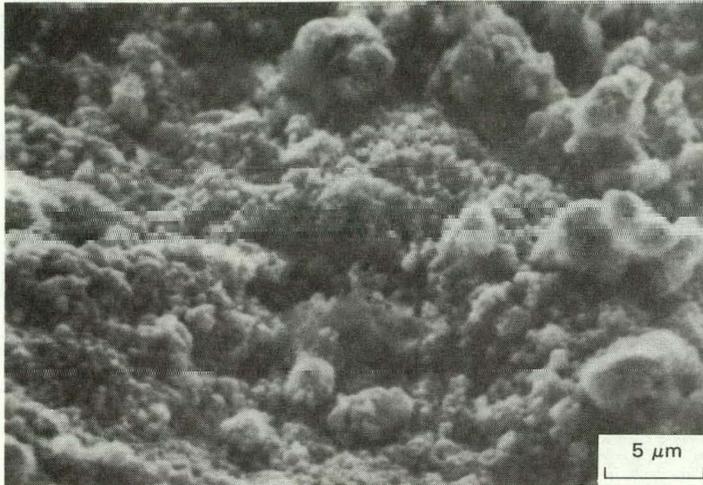
(a) Ginna: spongy

FIG. 3.28. SEM views showing typical morphology of corrosion nodules on crack surfaces for sections from Ginna, Palisades, and Kewaunee.

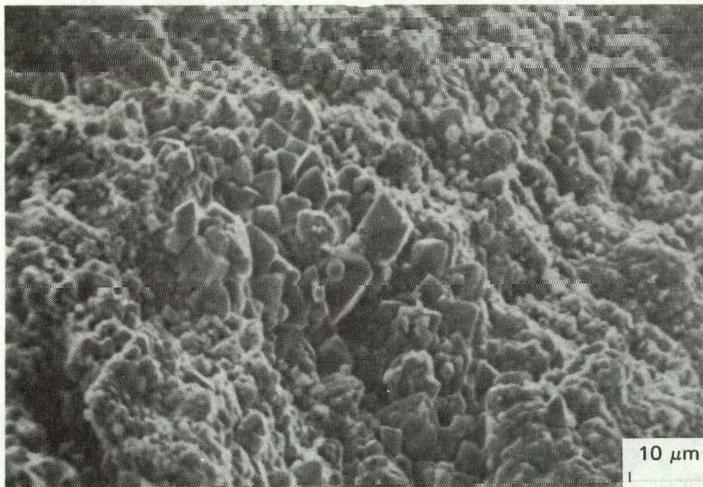
(b) Palisades: faceted,
globular, and spongy

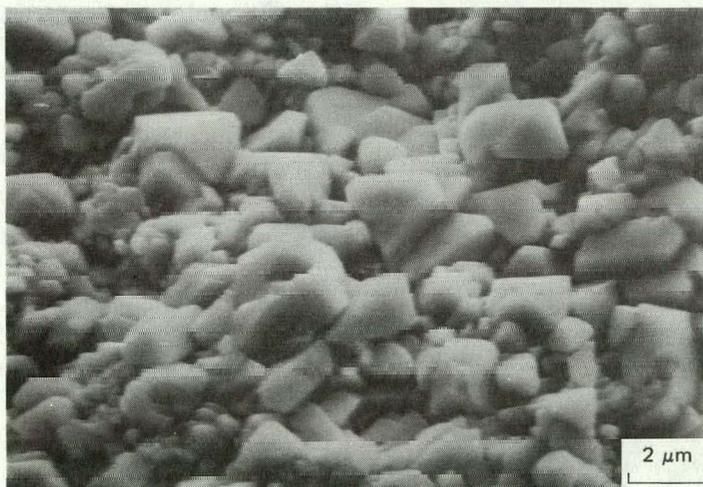
(c) Kewaunee: faceted
and globular

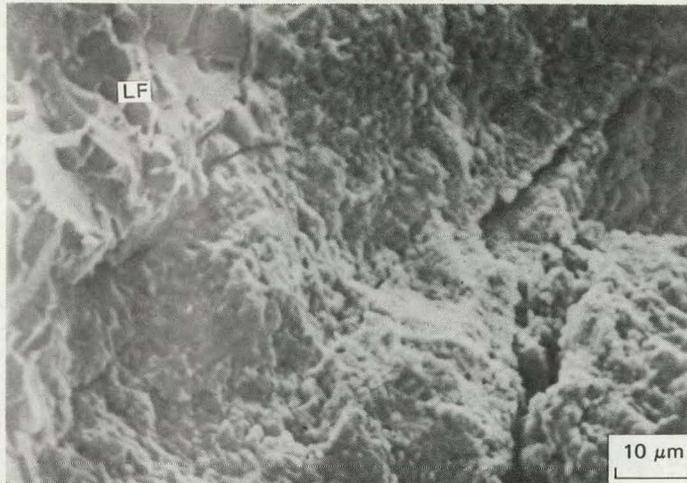
(a) Palisades

FIG. 3.29. SEM views taken across interface from plant crack to laboratory fracture of crack surfaces from sections from Palisades, Point Beach, and D. C. Cook. Note corrosion nodules at crack tips and crack-like appearance of corrosion product--probably an arrest band--especially at the tip in the Palisades section shown in view (a).

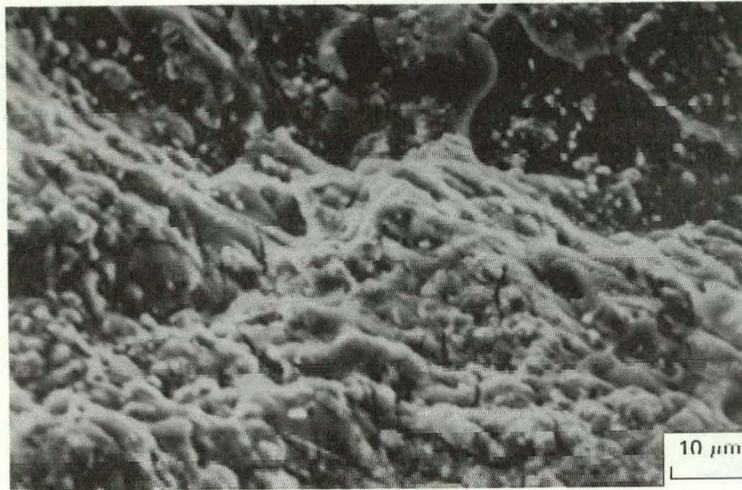
(a) Crack tip

FIG. 3.30. SEM fractographs of crack surface of D. C. Cook section showing crazed surface of corrosion product at crack tip and crack center. In view (c), note increased concentration of discrete corrosion nodules where part of surface had apparently flaked-off.

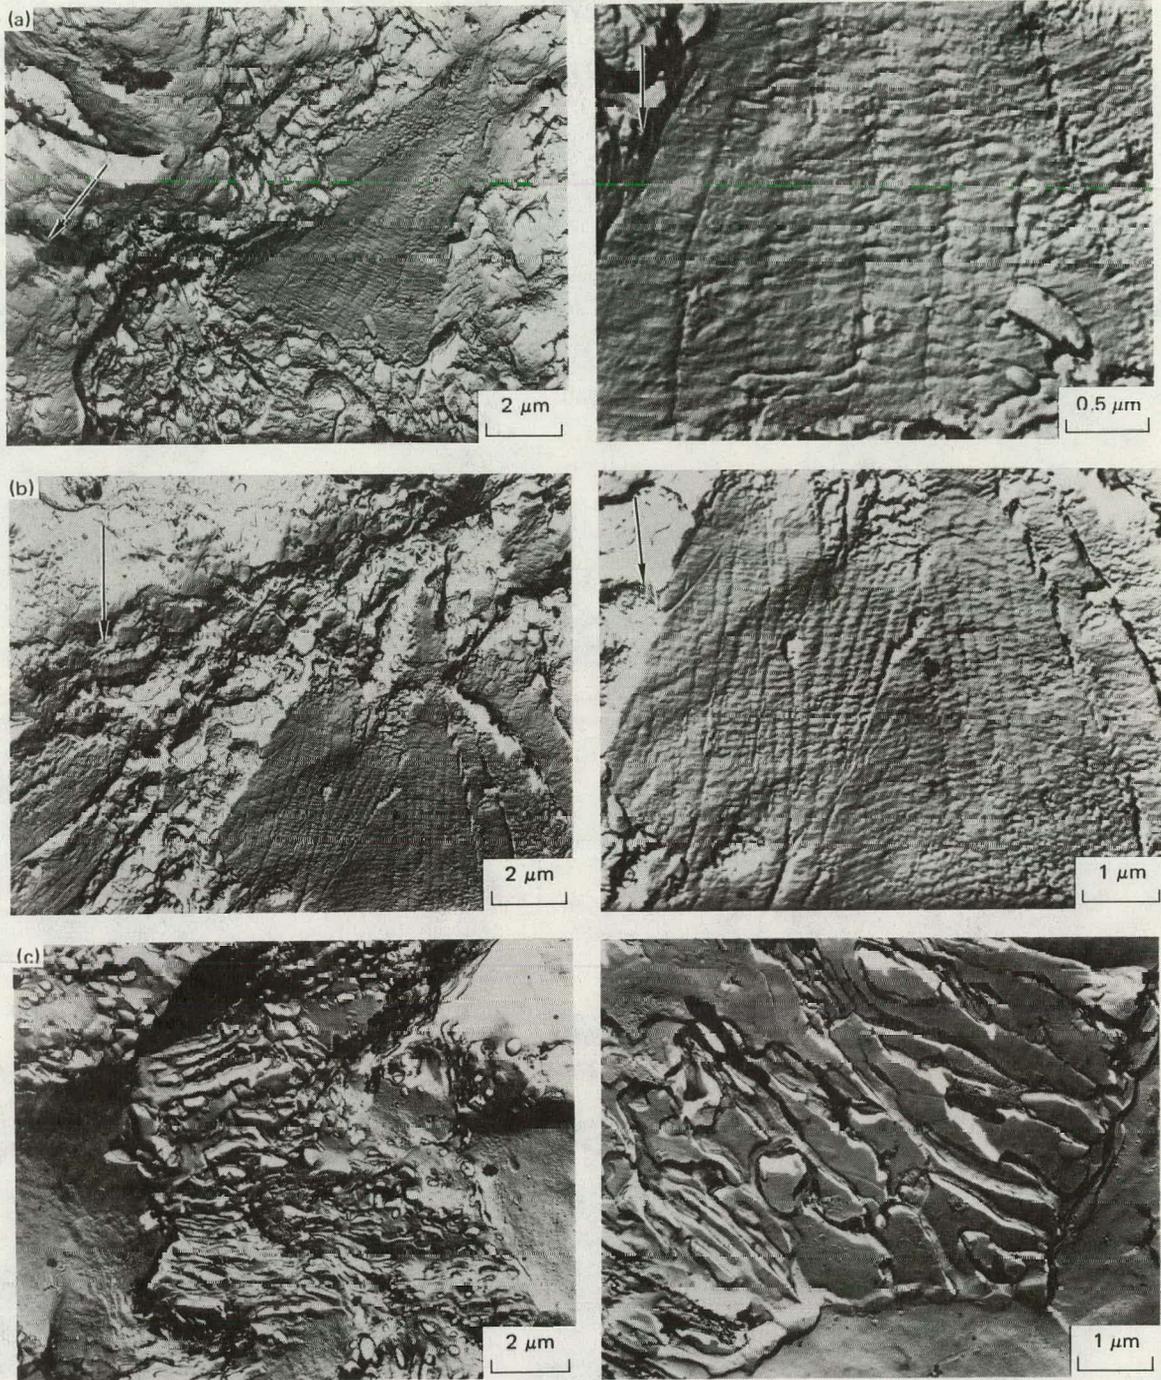
FIG. 3.31. TEM fractographs of replicas of a crack tip from the cleaned crack surface of a D. C. Cook section. Three areas, each at two magnifications, are shown. Note the classical fatigue striations and tear ridges in views (a) and (b). The arrows indicate the estimated direction of crack propagation. Note the pearlite lamellae in view (c).

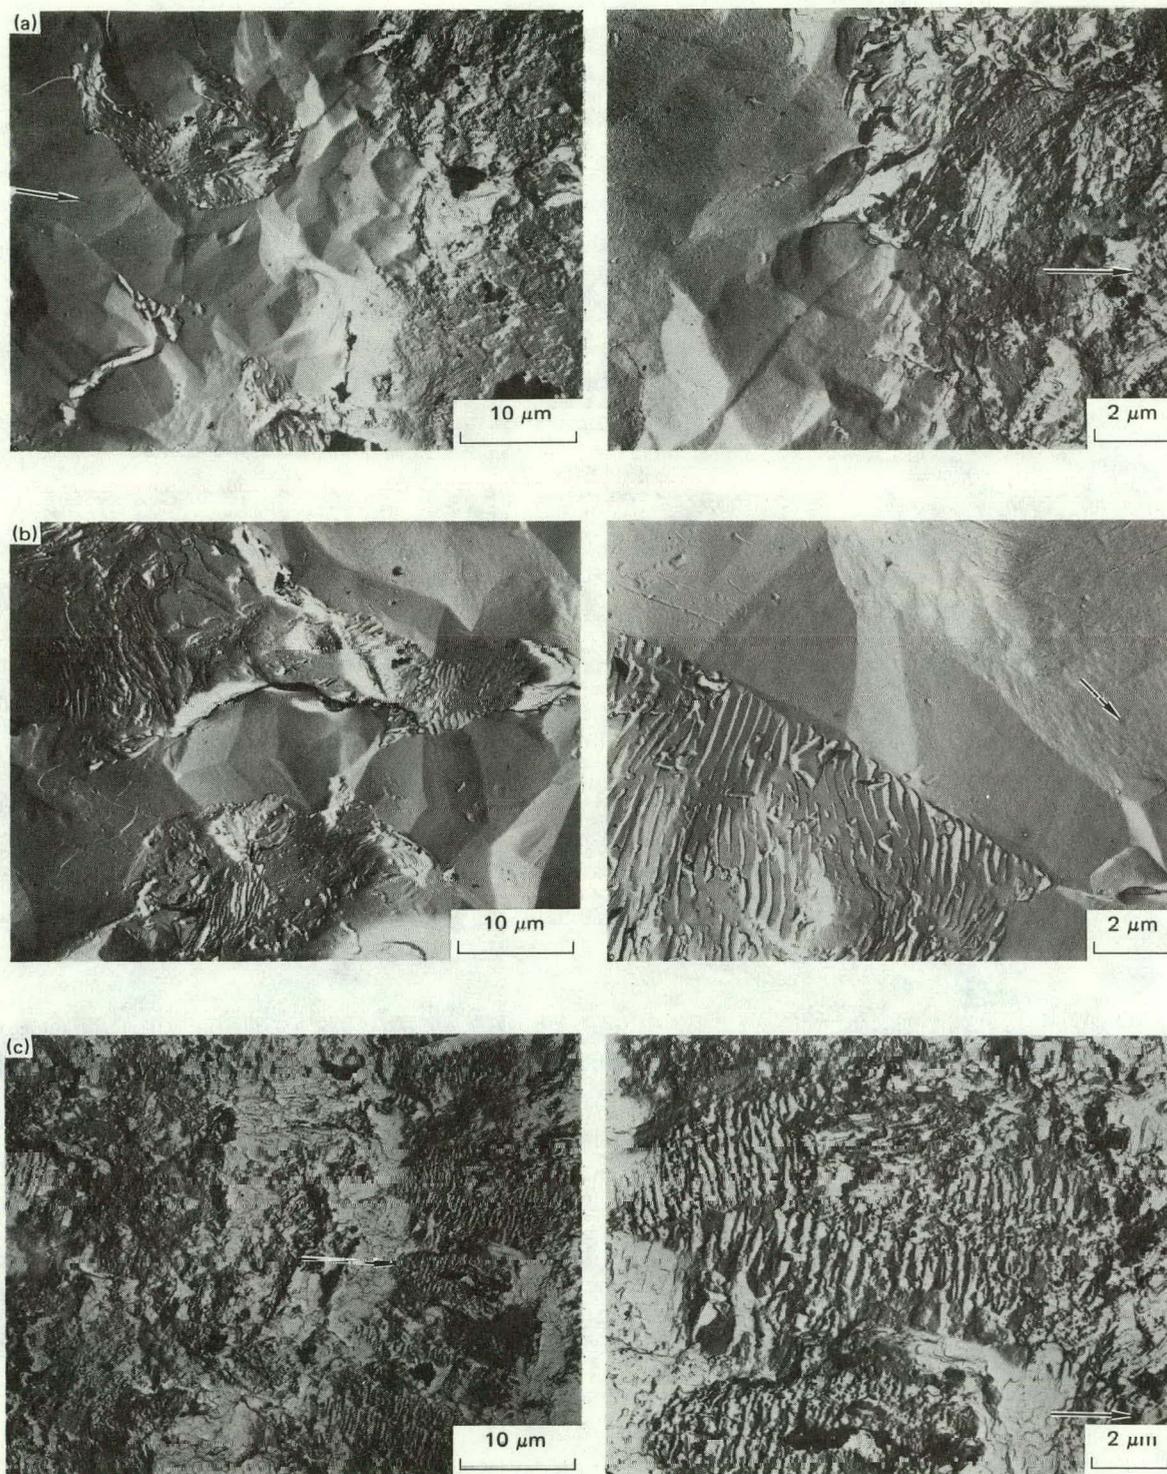
FIG. 3.32. TEM fractographs of replicas obtained near the crack origin of the cleaned crack surface of a D. C. Cook section. Three areas, each at two magnifications, are shown. Note the faceted grains between the distinct pearlite regions in views (a) and (b). Also note the corroded surface with striations and/or pearlite in views (a) and (c). Arrows indicate estimated direction of crack propagation.

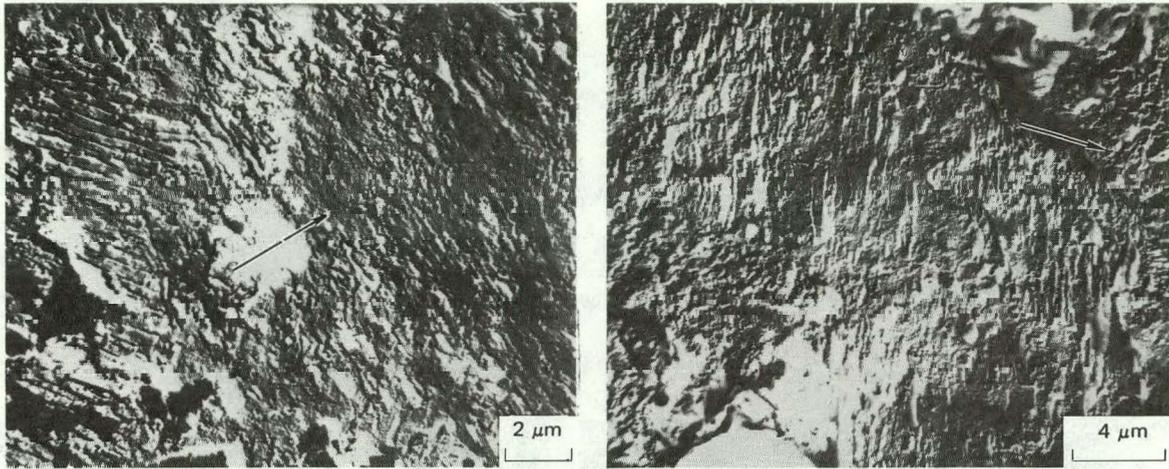
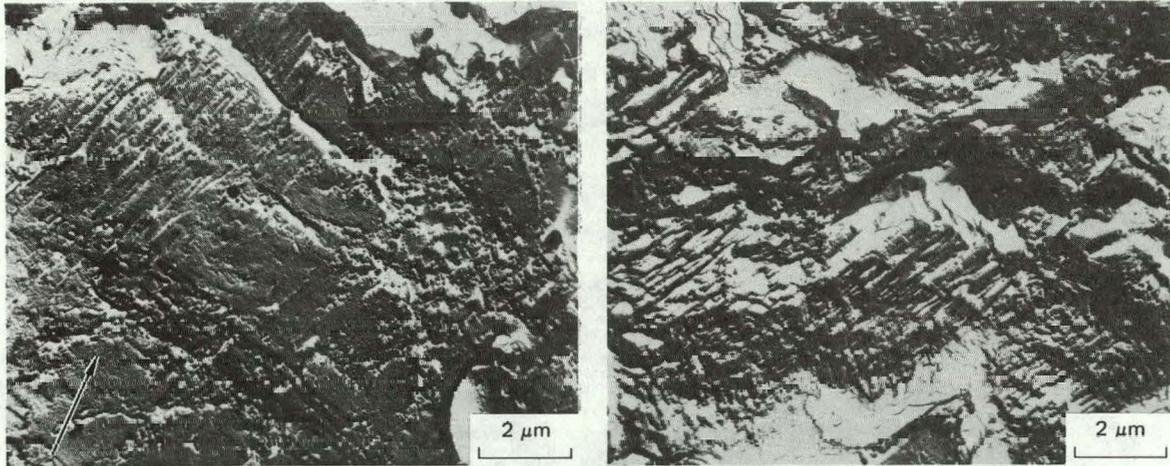
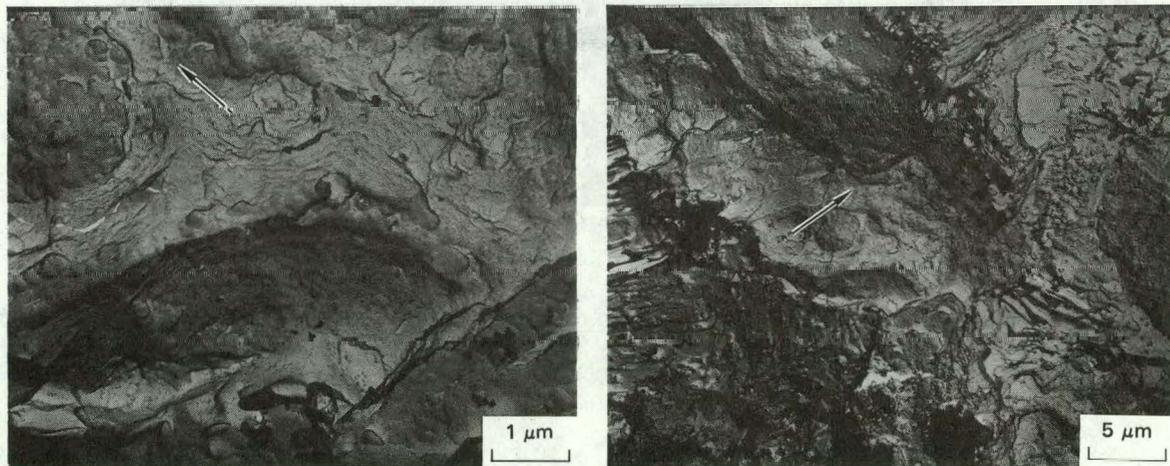
Figure 3.34 contains TEM fractographs typical of replicas from the cathodically cleaned crack tips from H. B. Robinson, Kewaunee, and Ginna. Indications of fatigue behavior decrease in this order. Figures 3.34(a) and 3.34(b) show numerous parallel striations that are appropriately oriented relative to the direction of crack propagation and these are most likely fatigue markings. Others, such as at the upper left-hand corner of Fig. 3.34(a), are likely to be pearlite. At the other extreme, the conical markings in the center of Fig. 3.34(e) may be fatigue striations. The top, center-right, of Fig. 3.34(f) shows some fine striations that do not appear to be related to pearlite and suggest fatigue. Most other striations in this view are likely to be pearlite.

FIG. 3.34. TEM fractographs typical of replicas of crack tip of cleaned crack surfaces from H. B. Robinson, Kewaunee, and Ginna. All fractographs contain markings that could possibly be interpreted as fatigue striations. Arrows indicate estimated direction of crack propagation.

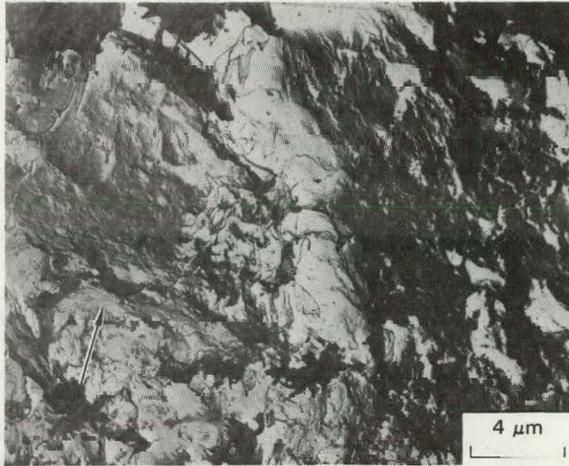
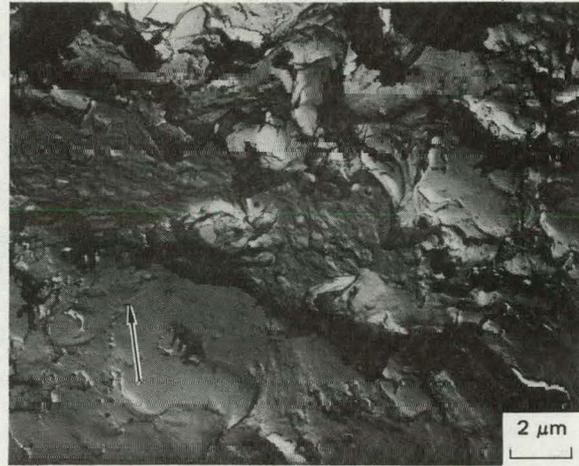
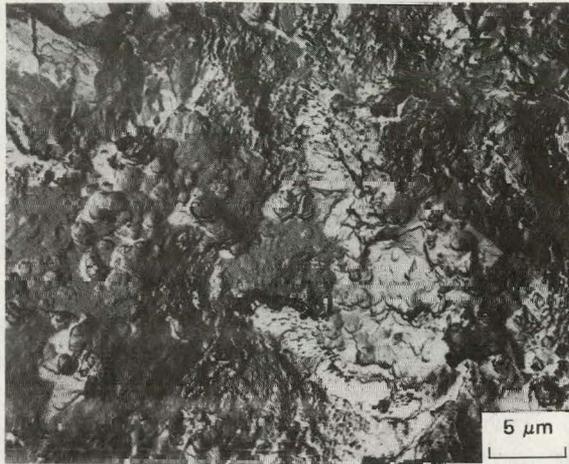
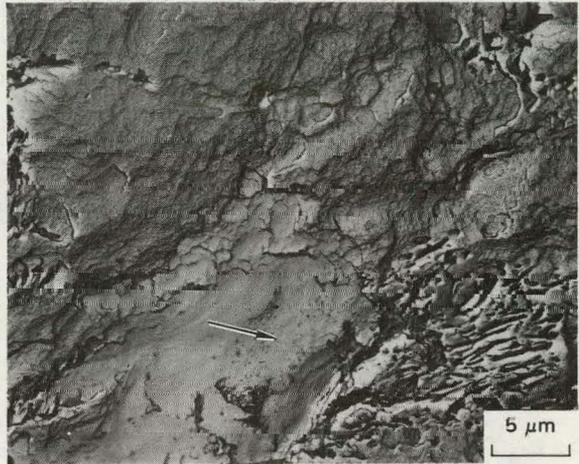
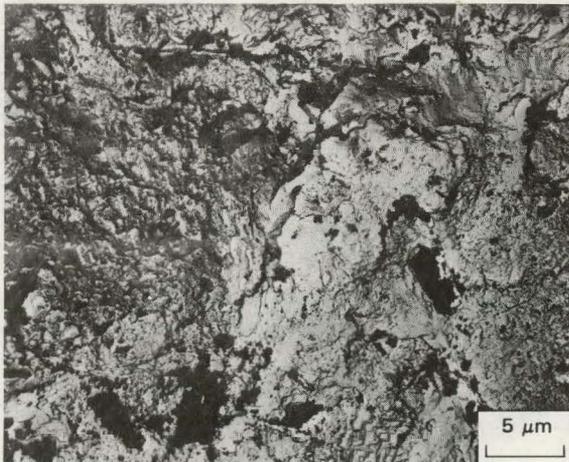
Figure 3.35 contains TEM fractographs typical of the replicas of the cleaned crack tips from each of the remaining plants: San Onofre, Palisades, Point Beach, Beaver Valley, and Salem. The TEM observations on fatigue striations are included in Table 3.4. There was no indication of fatigue striations in any of these replicas; some pearlite could be detected. Although wavy fatigue striations were most clearly seen on the as-corroded crack surfaces for Beaver Valley and H. B. Robinson, fatigue markings on replicas of cleaned surfaces were only seen for the deep crack from the D. C. Cook section.

FIG. 3.35. TEM fractographs typical of replicas of crack tips of cleaned crack surfaces from San Onofre, Palisades, Point Beach, Beaver Valley, and Salem. There are no indications of fatigue striations. Arrows indicate estimated direction of crack propagation.

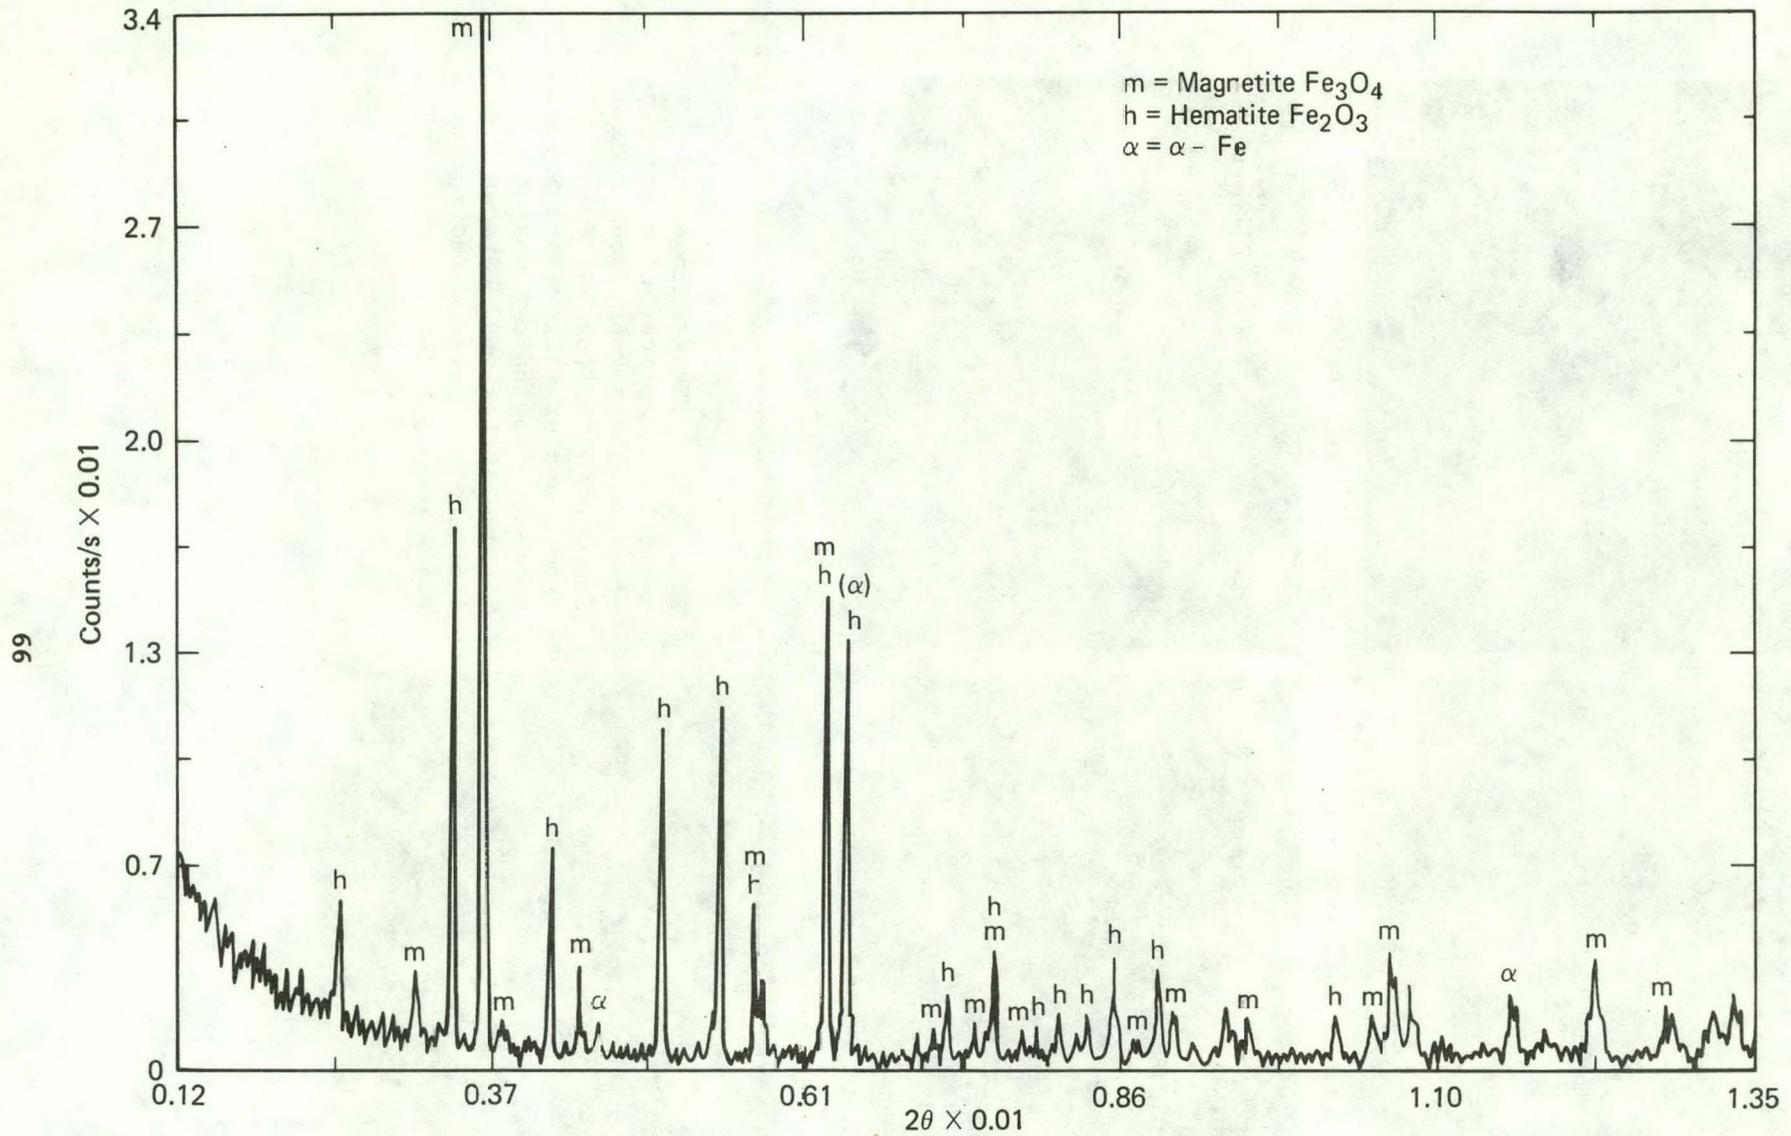
Diffraction patterns for crystal structure determinations were obtained on a Norelco diffractometer using a diffraction scan rate of 1 degree of 2θ per min over a range of 2θ from 12 to 135 degrees. Patterns were obtained on nine samples measuring 10 by 10 mm (0.4 by 0.4 in.), one from each plant. Figure 3.36 is an example of a typical pattern, which was obtained for the sample from Beaver Valley. Copper radiation, at 50 kV and 30 mA, was used. Peaks for Fe_3O_4 (m, magnetite), Fe_2O_3 (h, hematite), and Fe (α , alpha ferrite phase) are indicated. Several trace peaks that could not be identified are also present. Unidentified trace peaks were seen in all patterns; for the Palisades sample, one of these lines coincided with the major line for Cu_xS . The α -Fe lines were present on all patterns indicating that the entire thickness of the corrosion layer was sampled in each case.

FIG. 3.36. Tracing of raw data spectrum output from the x-ray diffractometer (using Cu radiation) for the corroded inside diameter surface of a Beaver Valley section.

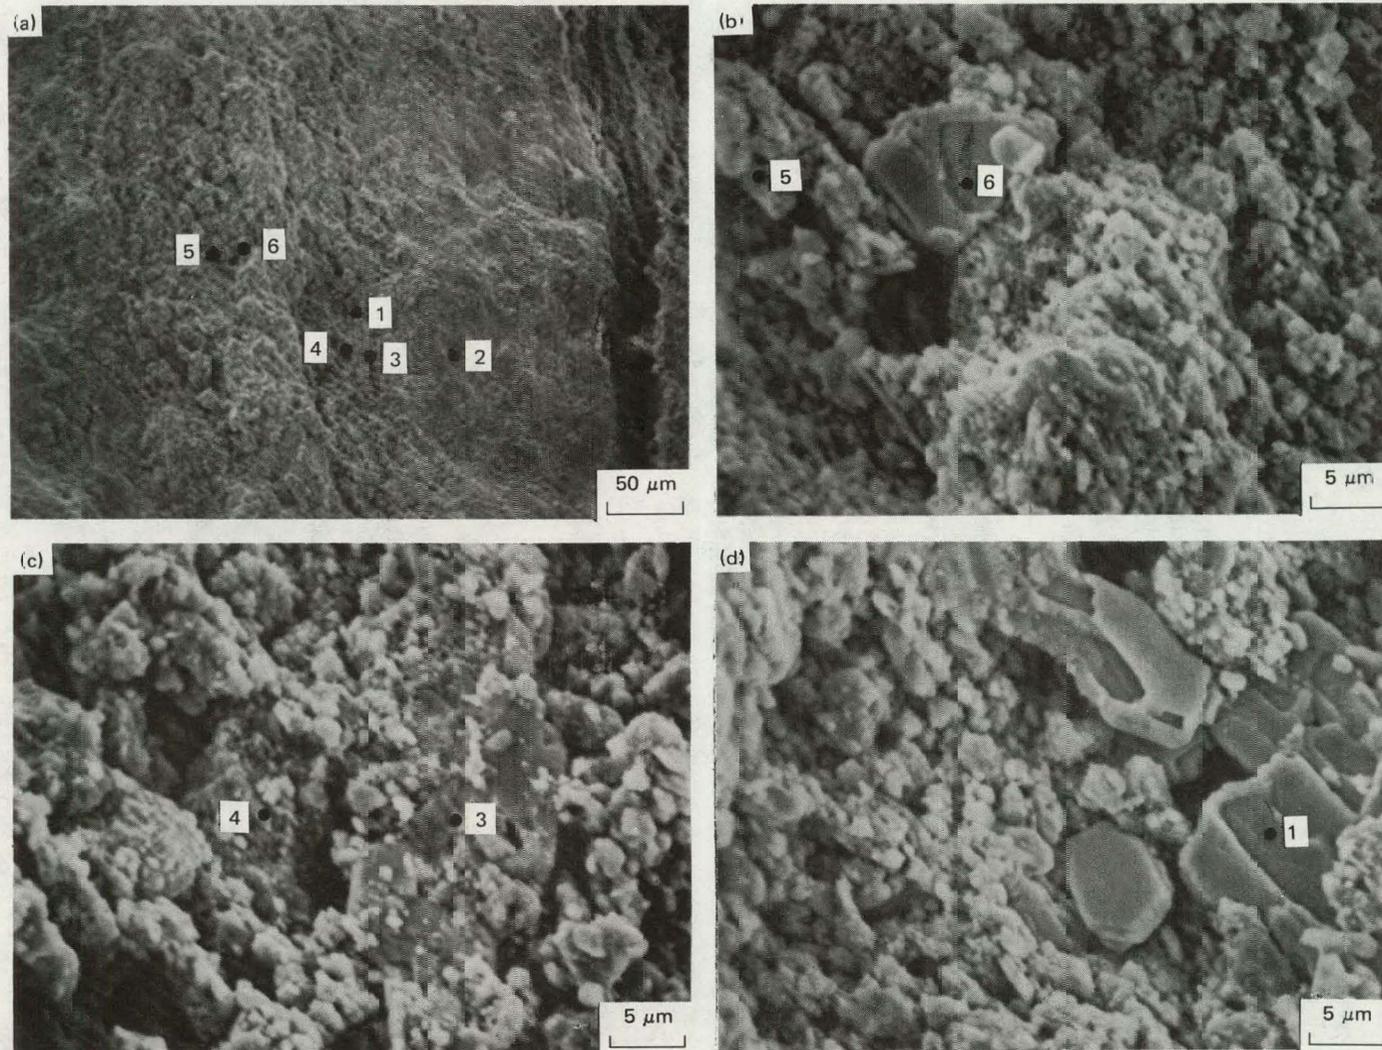
The following figures are examples of EDS spectra from some of the crack surfaces. Figure 3.37 shows an area near the crack origin on a Palisades crack that had a wide range of spectra. The spots are identified in Fig. 3.37(a) and

at a higher magnification again in Figs. 3.37(b), 3.37(c), and 3.37(d). The corresponding spectra are shown in Fig. 3.38. Both spots 1 and 6 consist of very similar faceted corrosion nodules. However, spot 6 indicates primarily Fe with only a trace of Cu and S. By contrast, spot 1 shows mainly Cu and S and, in fact, is similar to the spectra from spot 5. Yet, the morphology of the corrosion nodules is quite different at 1 and 5. We noted that Cu and S, and at times Ni and S, were usually present together, suggesting Cu_xS or Ni_xS deposits. The Cu and Ni probably originate from the tube wastage in the Monel condensers. Wastage of the Inconel 600 heat exchanger tubing in the steam generators can result in deposits containing Al, Cr, Ni, Si, P, Cu, and Mn. The Cr and Ni could also originate from alloy steel components such as the safe-end or nozzle. Sulfur was detected on crack surfaces for all plants and it likely originated from the steel piping.

FIG. 3.37. SEM fractographs near the crack origin for a crack along the safe-end of a Palisades section. The wide range of spectra obtained are independent of the type of corrosion-nodule morphology. The numbers refer to spots for spectra in Fig. 3.38.
