NUREG/CR-1603
UCRL-53000

Evaluation of Cracking in Feedwater Piping Adjacent to the Steam Generators in Nine Pressurized Water Reactor Plants

Alfred Goldberg, Ronald D. Streit, and Robert G. Scott

Lawrence Livermore Laboratory
7000 East Avenue
Livermore, CA 94550

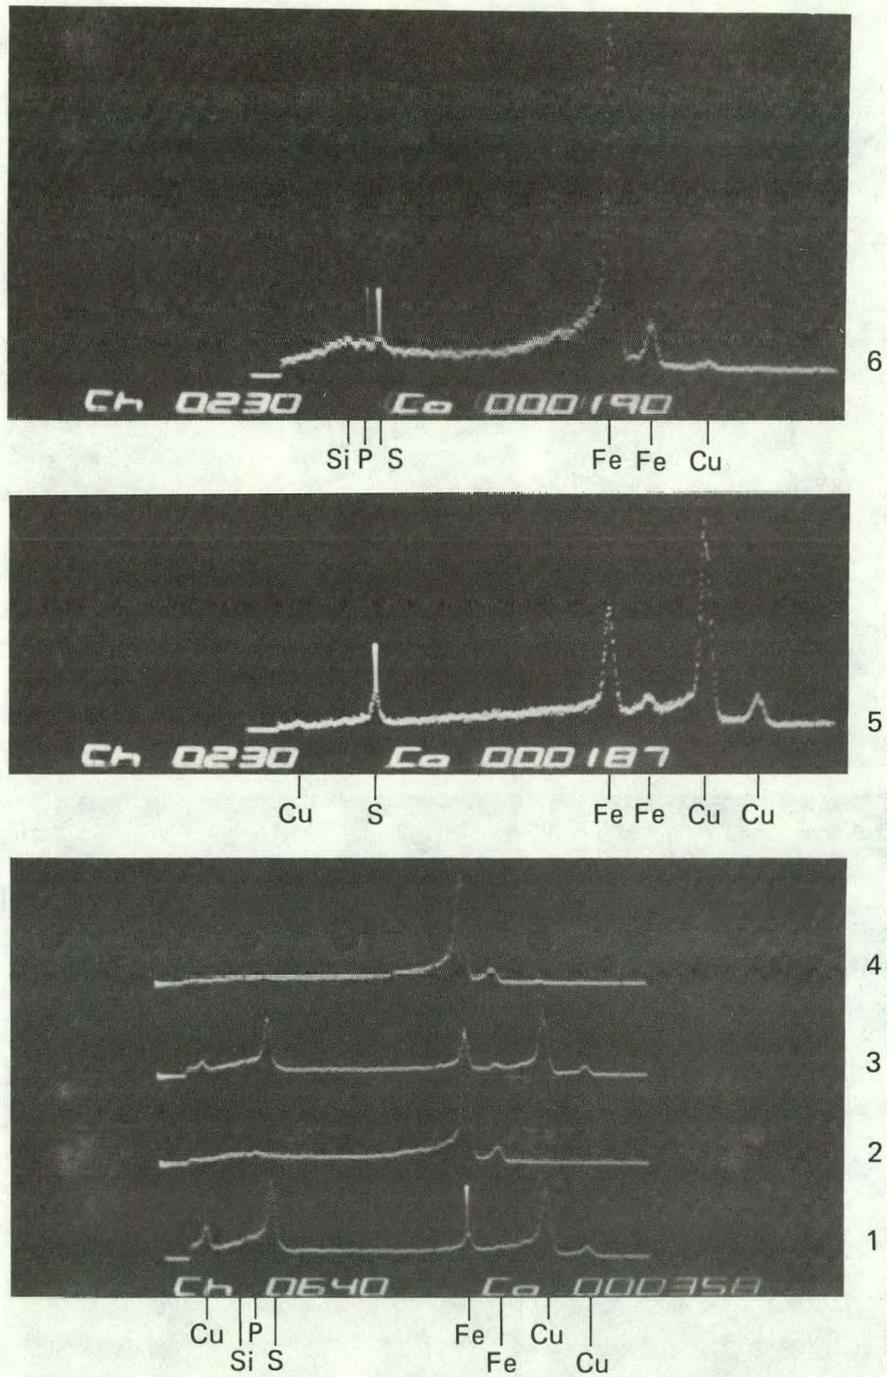
at a higher magnification again in Figs. 3.37(b), 3.37(c), and 3.37(d). The corresponding spectra are shown in Fig. 3.38. Both spots 1 and 6 consist of very similar faceted corrosion nodules. However, spot 6 indicates primarily Fe with only a trace of Cu and S. By contrast, spot 1 shows mainly Cu and S and, in fact, is similar to the spectra from spot 5. Yet, the morphology of the corrosion nodules is quite different at 1 and 5. We noted that Cu and S, and at times Ni and S, were usually present together, suggesting Cu_xS or Ni_xS deposits. The Cu and Ni probably originate from the tube wastage in the Monel condensers. Wastage of the Inconel 600 heat exchanger tubing in the steam generators can result in deposits containing Al, Cr, Ni, Si, P, Cu, and Mn. The Cr and Ni could also originate from alloy steel components such as the safe-end or nozzle. Sulfur was detected on crack surfaces for all plants and it likely originated from the steel piping.

FIG. 3.38. EDS spectra of spots identified in Fig. 3.37 for a Palisades crack.

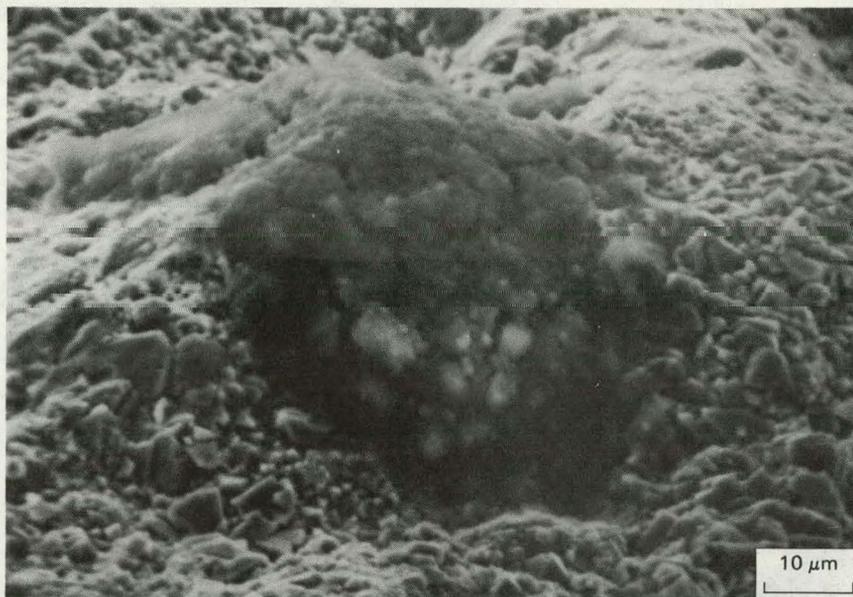
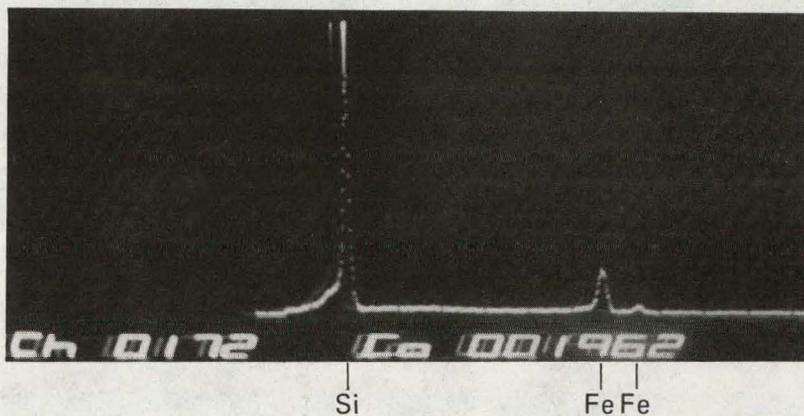
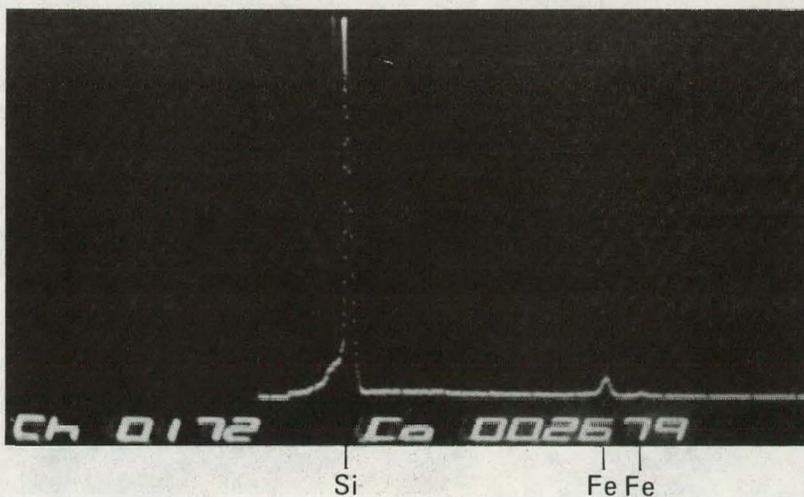
Figure 3.39(a) shows a region containing a high concentration of Si in the center of the crack surface from Salem. Strong Si lines were obtained in both the scan, Fig. 3.39(b), and spot, Fig. 3.39(c) modes. The Si, which was present in all plants, may here be the residue of a silicate slag particle in the steel. The presence of Si and S at a crack tip of Palisades is shown in Fig. 3.40. Here, these elements could only be detected in the spot mode.

FIG. 3.39. Large residual silicate inclusion from steel or corrosion deposit giving a strong Si line in both the scan and spot modes.

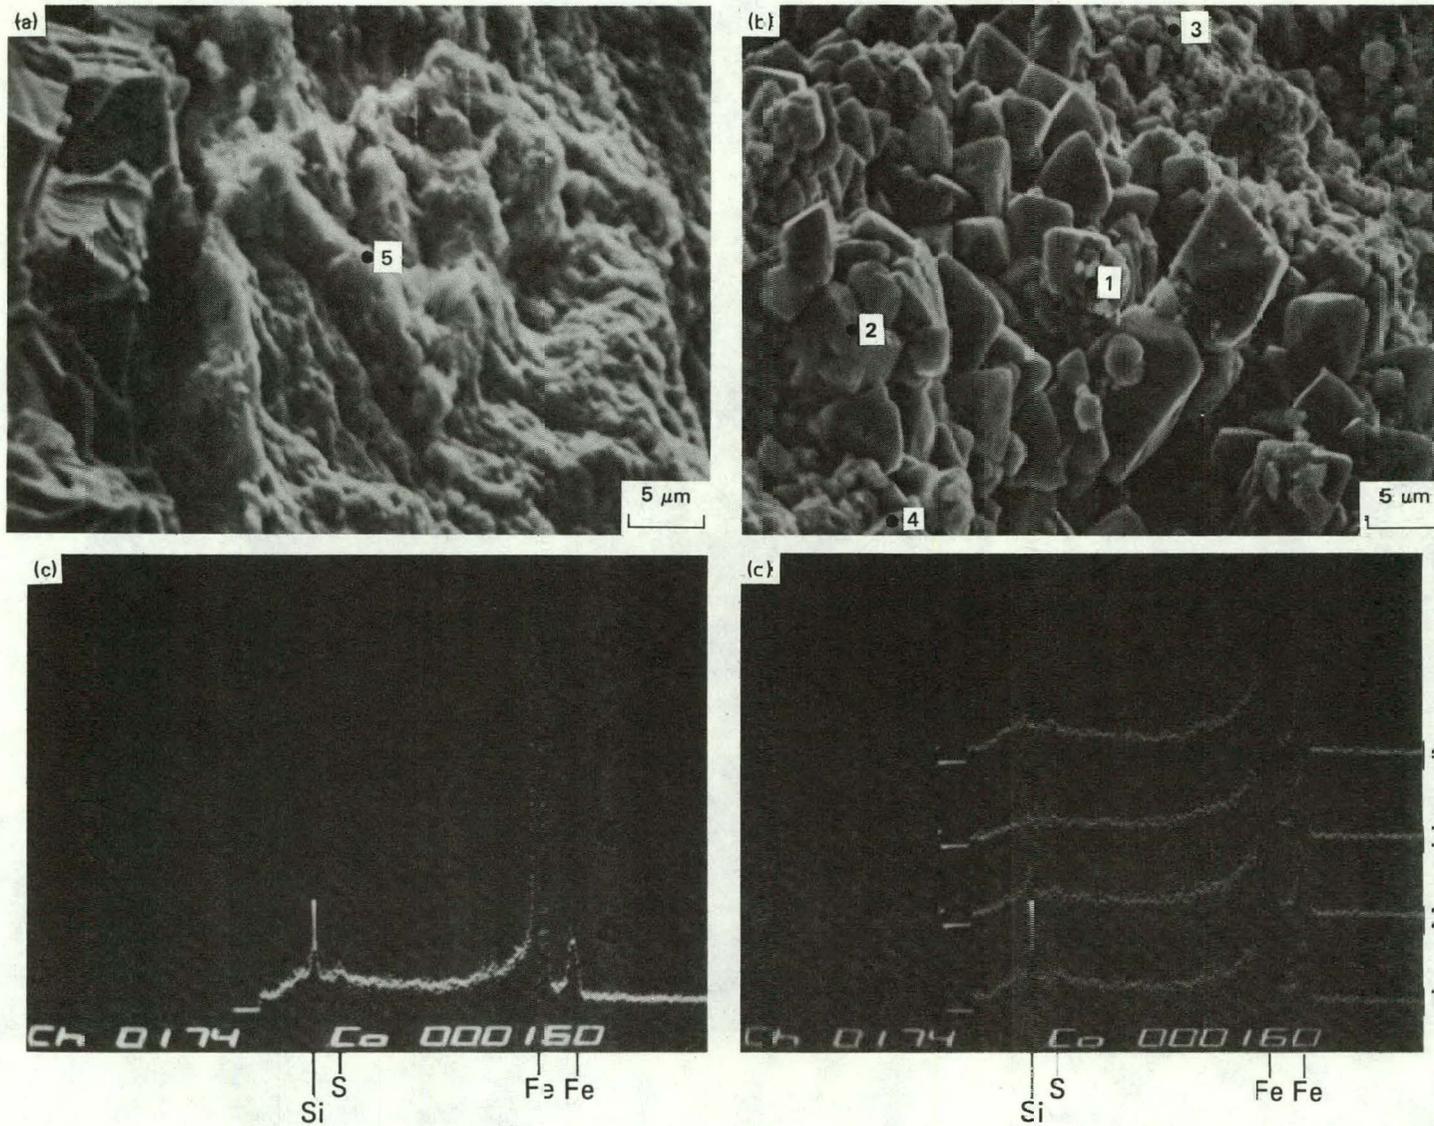
FIG. 3.40. Areas at crack tip and near crack tip that show similar EDS spot spectra of a Palisades crack. Traces of S and Si (with Fe and Mn) are only evident.

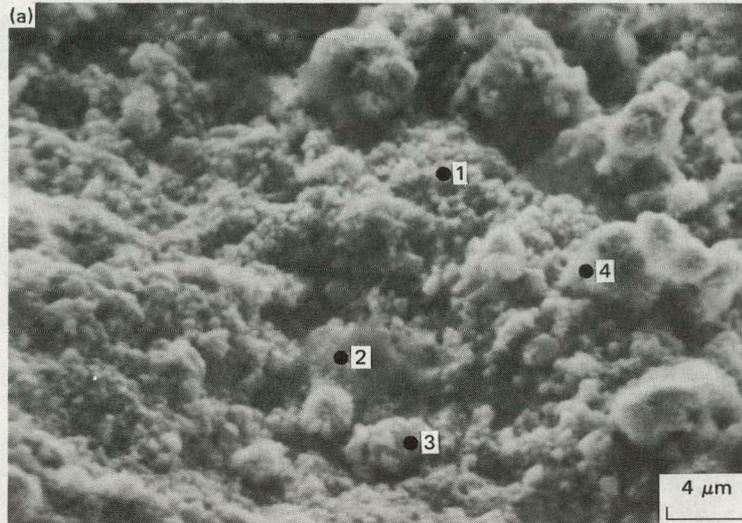
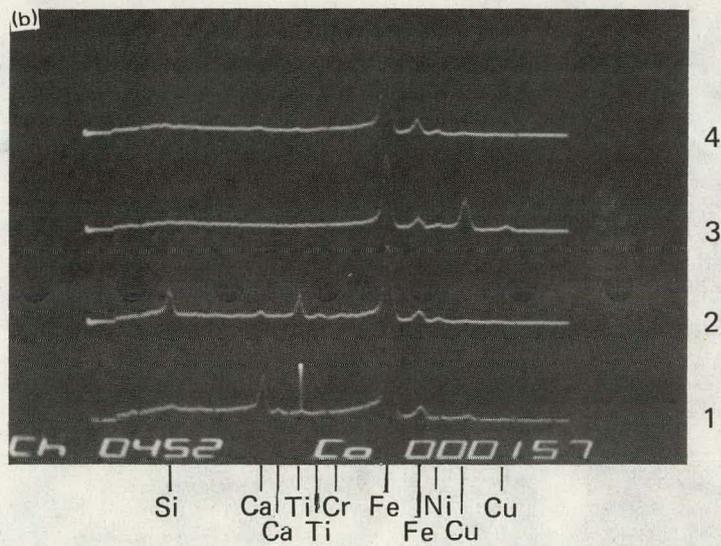
Figure 3.41 shows the spectra obtained from a number of spots in an area containing "spongy" corrosion nodules on a crack surface from Ginna. A number of elements are detected, Cu, Ni, Fe, Cr, Ti, Ca, and Si; however, S was not present in this area, despite the presence of Cu and Ni. Although the morphology of the corrosion nodules was virtually constant, the spectra were quite different from point to point in this small area. Another example of a high concentration of elements in a small area is shown in Fig. 3.42 for a crack surface from Beaver Valley. In addition to the elements listed above, Na, Mg, Al, P, K, and Cl are present. The presence of the strong Cl line as well as the Na and K lines suggests the possibility of contamination; however, we were careful in the handling of these fractographic samples to avoid such contamination. Nonetheless, Cl could only be detected in these two areas, which were close to the crack origin.

FIG. 3.41. Area near crack origin of a Ginna crack that shows a variety of EDS spectra. Note the small difference in morphology of corrosion nodules of different spots.

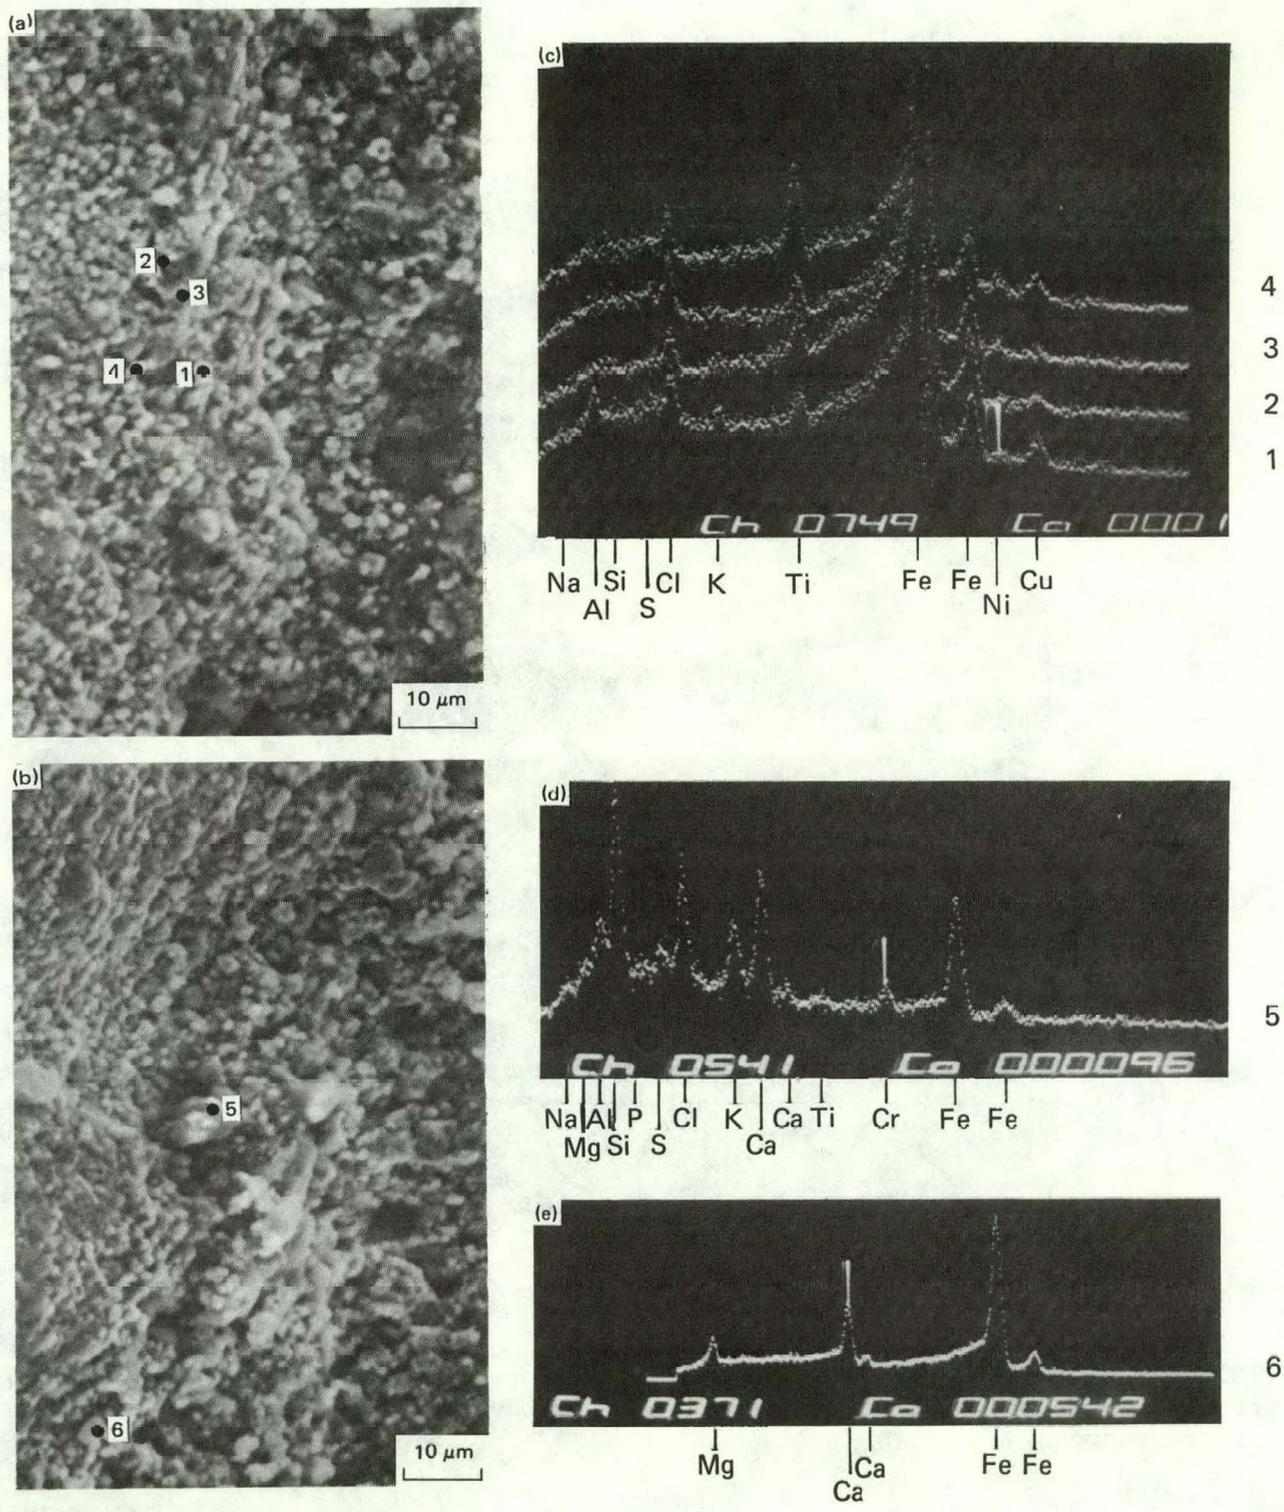
FIG. 3.42. SEM fractographs taken near the crack origin in a Beaver Valley specimen. Note the large range of elements detected in the EDS spectra.

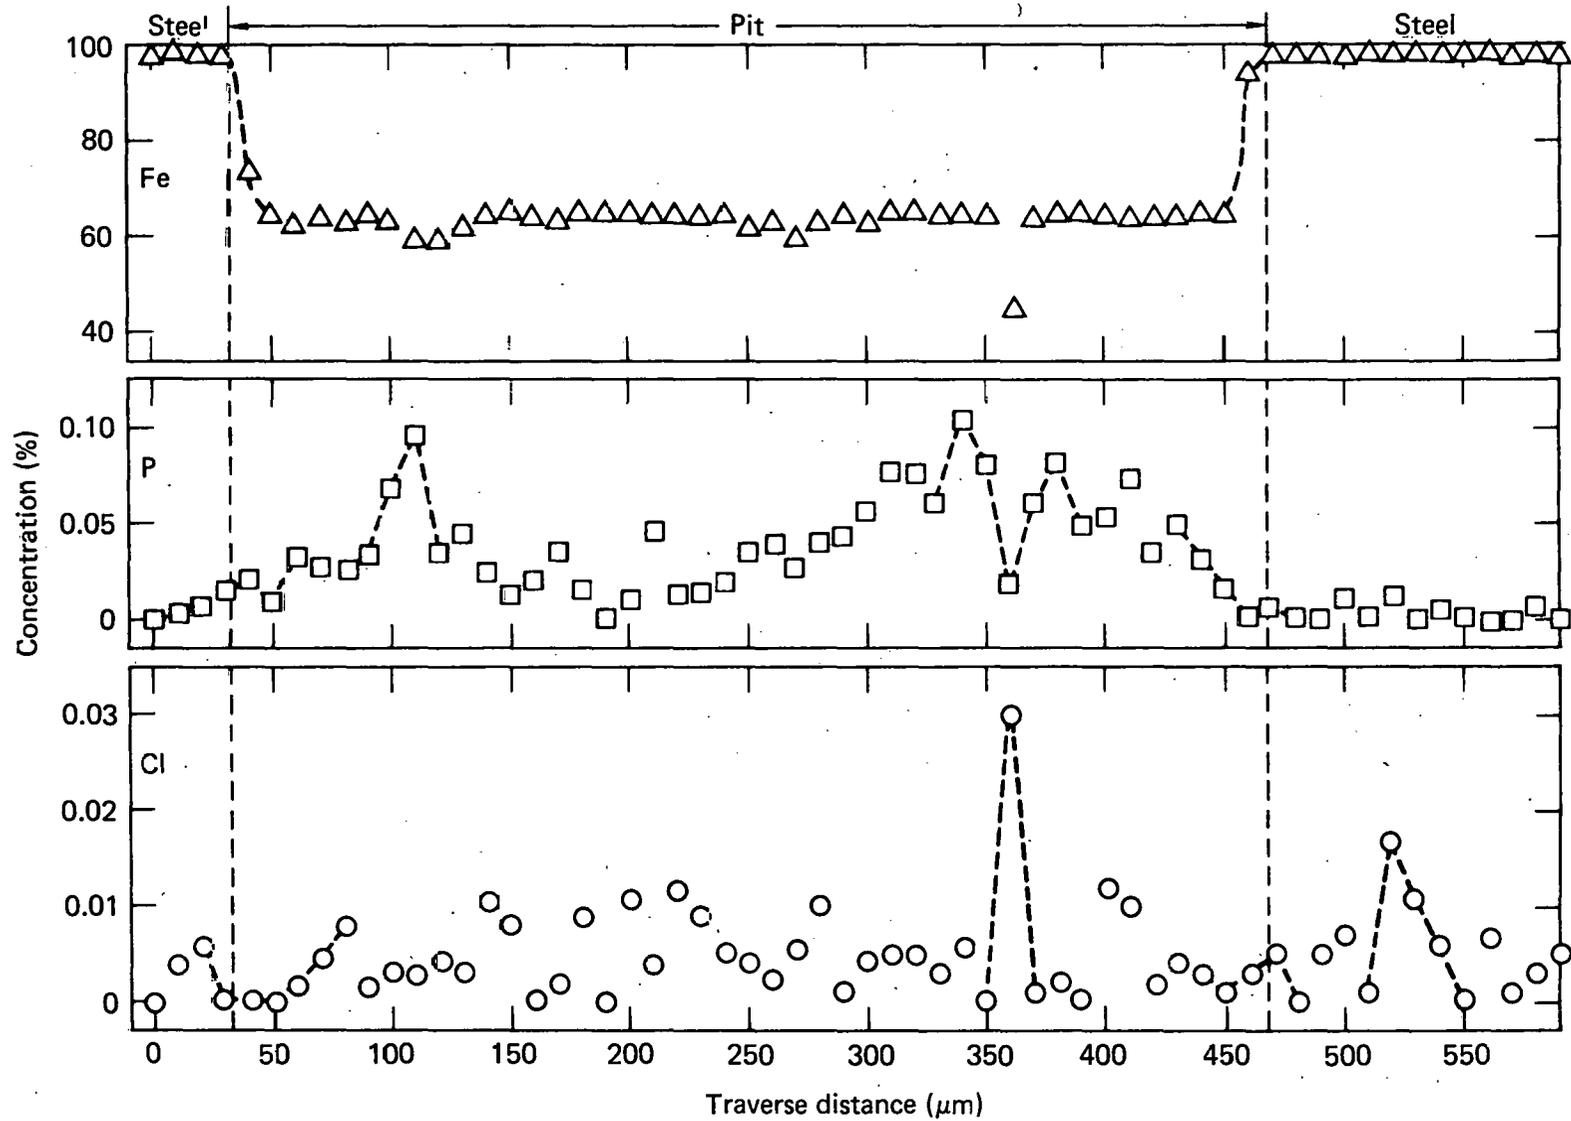
We selected one of the large pits along the counterbore slope of the safe-end of the Palisades section. We obtained analyses along 40 spots in the pit section and at least four spots on each side of the pit into the steel. We analyzed for nine elements in groups of three as follows: (Cl, P, and Fe), (Al, Si, and Cr), and (S, Ni, and Cu). The results are plotted in Figs. 3.43, 3.44 and 3.45, respectively, for each of these groups. The pit boundaries for the first series are indicated by the drop (98 to ~ 63 percent) and rise (63 to 98 percent), respectively, in the Fe content; for the third series they are indicated by the rise (~ 0.04 to 0.4 percent) and drop (~ 0.5 to 0.04 percent), respectively, of the S content. The boundaries are not clearly defined in the second series.

FIG. 3.43. Electron microprobe traces of Cl, P, and Fe made across the pit near the origin of a deep crack in the safe-end of a Palisades cross section. Traces start and terminate in steel.

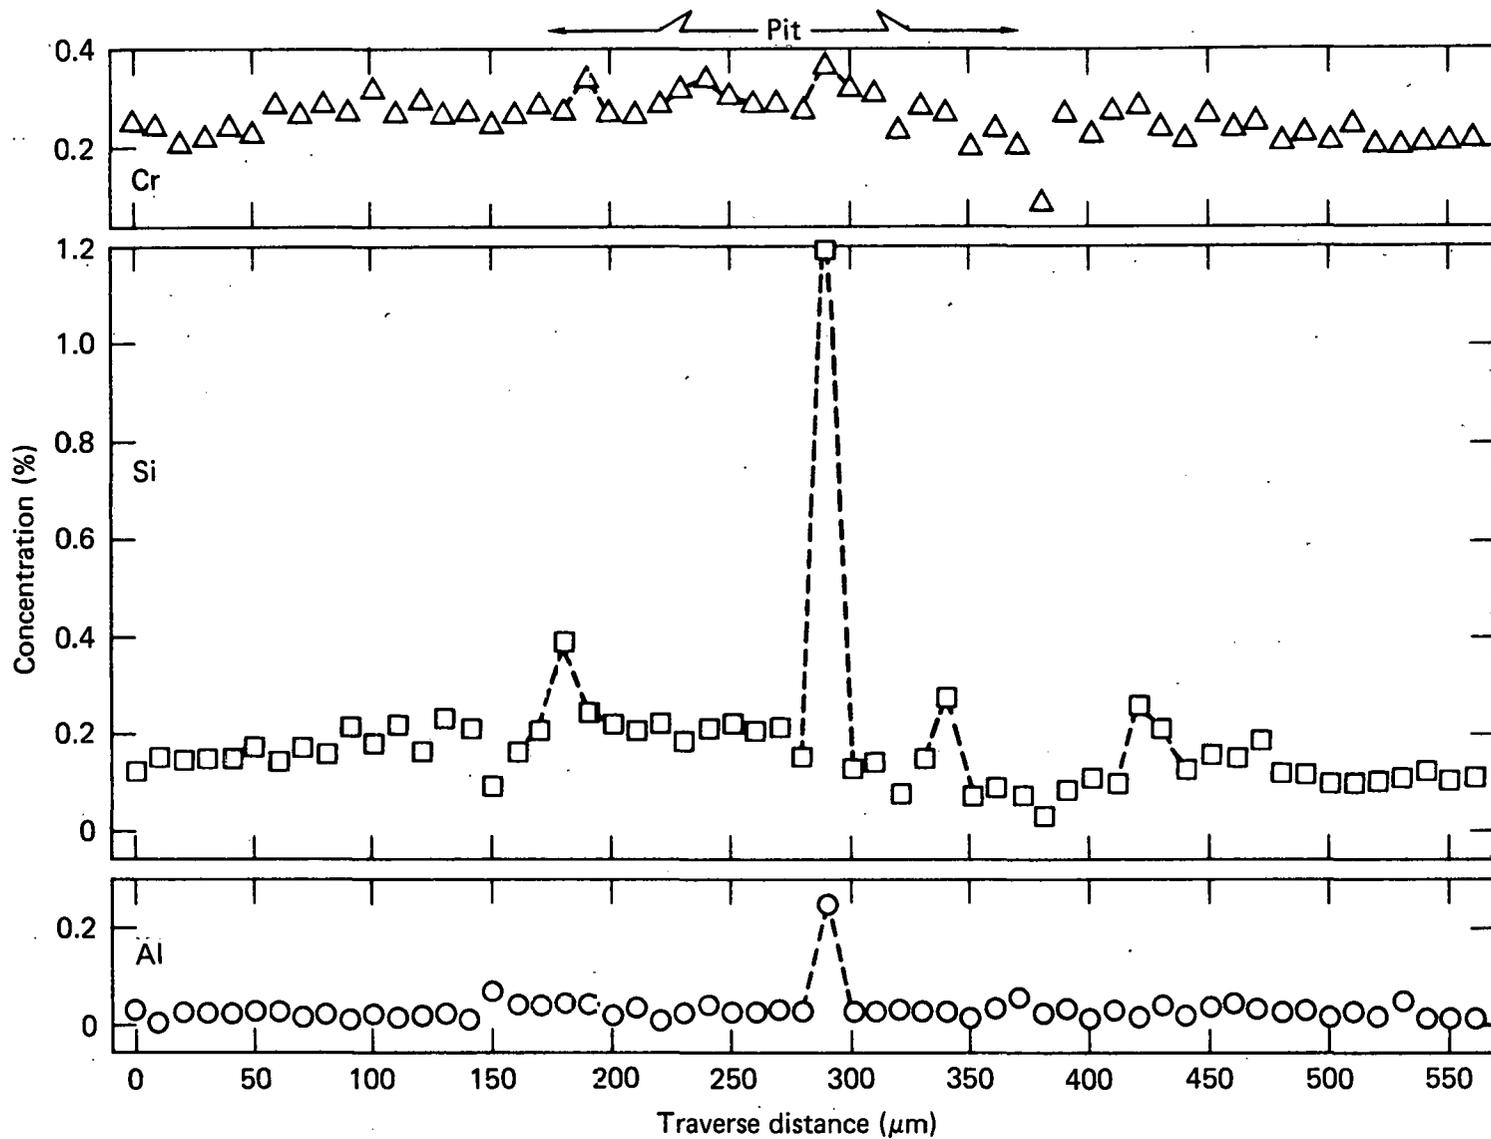
FIG. 3.44. Electron microprobe traces of Al, Si, and Cr made across the pit near the origin of a deep crack in the safe-end of Palisades cross section. Traces start and terminate in steel.

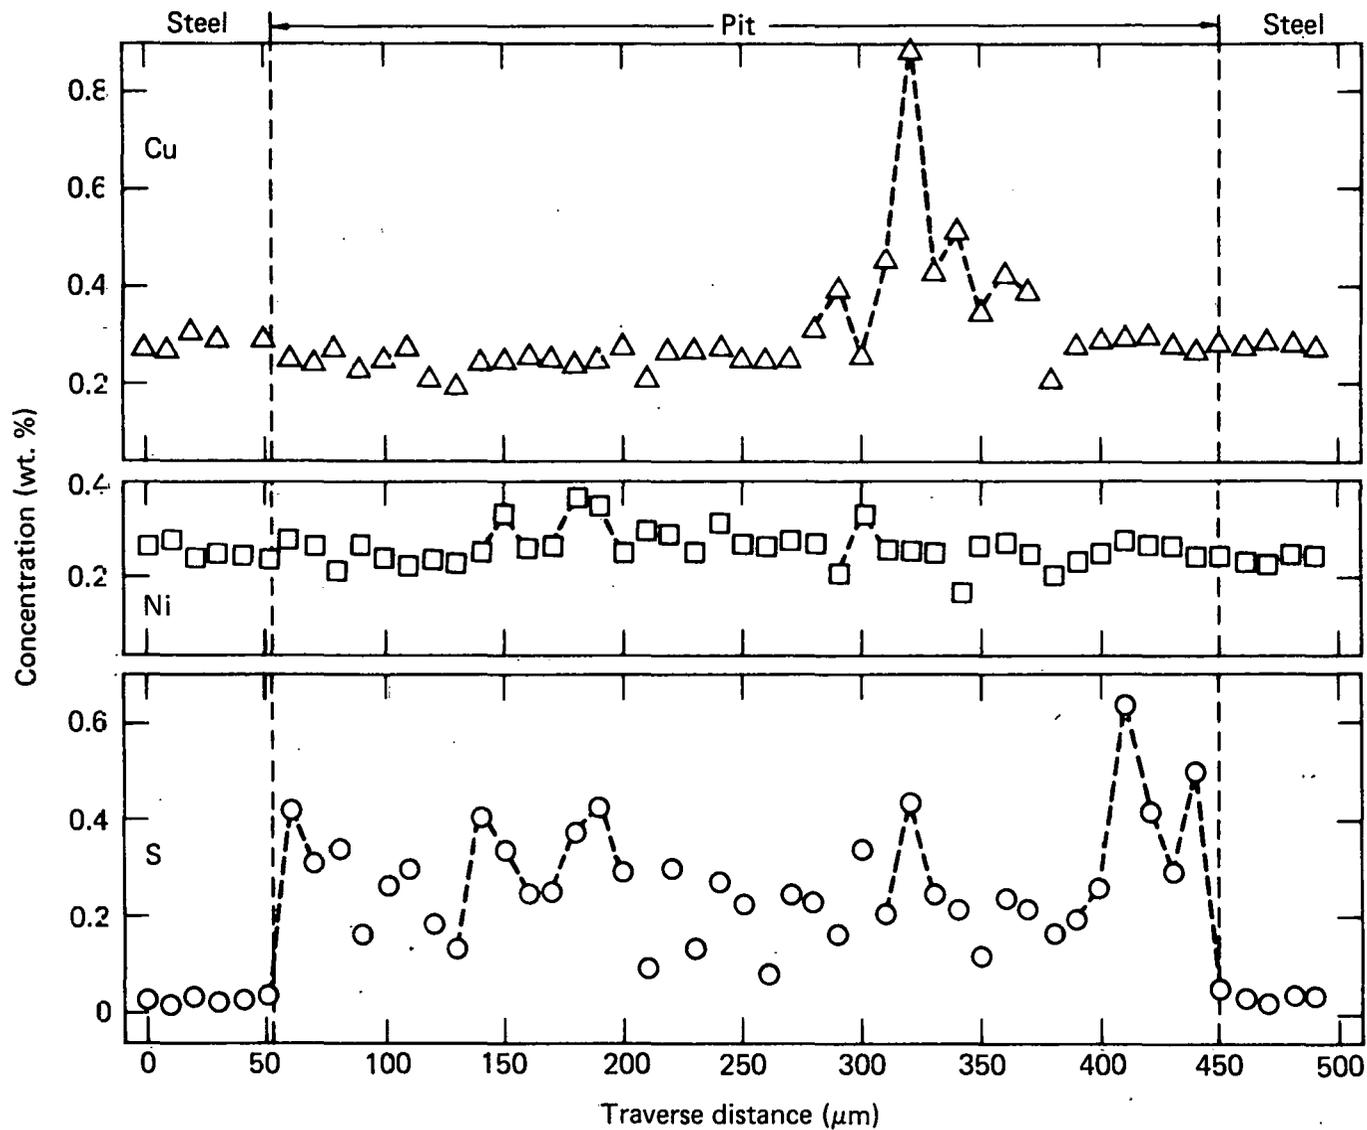
FIG. 3.45. Electron microprobe traces of S, Ni, and Cu made across the pit near the origin of a deep crack in the safe-end of a Palisades cross section. Traces start and terminate in steel.

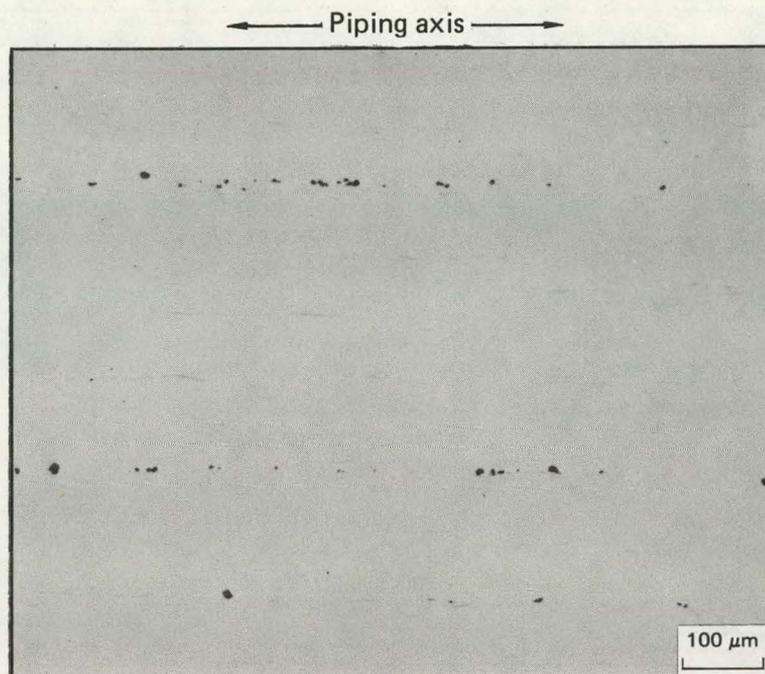
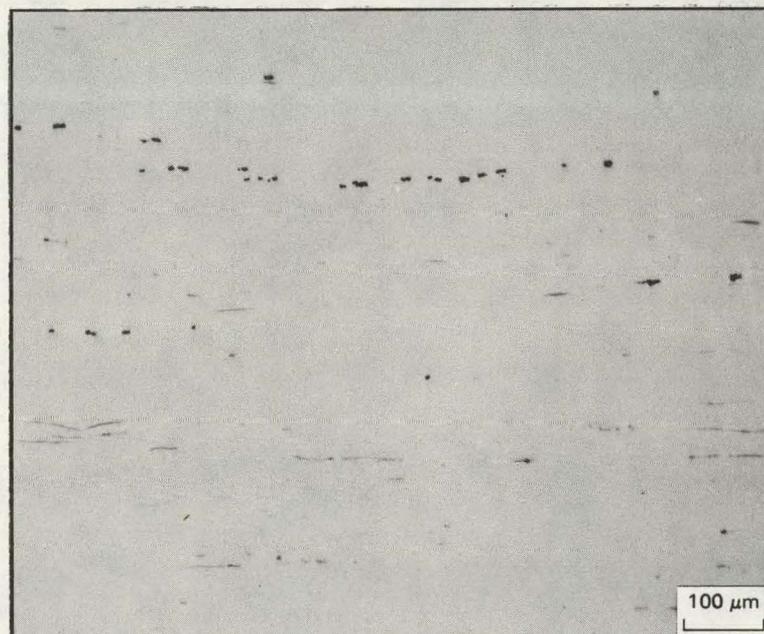
All the steels were relatively clean with respect to inclusions. Two examples are shown in Fig. 4.1, and we selected the dirtiest area in each case. Figure 4.1(a) is taken of the San Onofre section and is the dirtiest example for globular-type inclusions; stringers are also present. Figure 4.1(b) is from the Salem section and is the dirtiest example for stringer-type inclusions; globules are also present here to almost the same extent. All steels contained both types of inclusions. The morphologies of both the steel phases and the inclusions were different for the corresponding piping and nozzle (or safe-end). Figure 4.2(a) illustrates this for the inclusions observed in the Palisades pipe and Fig. 4.2(b) for the Palisades safe-end. Typical stringer and globular inclusions are seen in the pipe section with the stringers parallel to the pipe axis. The safe-end, by contrast, does not contain stringers, but instead exhibits a fine dispersion of spherical or globular inclusions. Such breaking up and spheroidization of inclusions suggest the use of a significant amount of redundant deformation in its fabrication.

FIG. 4.1. Examples of inclusions in sections from San Onofre and Salem. The dirtiest area in each material was selected. View (a) shows predominantly globular inclusions (dark) with stringers (light) in the San Onofre section. View (b) shows predominantly stringers (light) with globular inclusions (dark) in the Salem section.

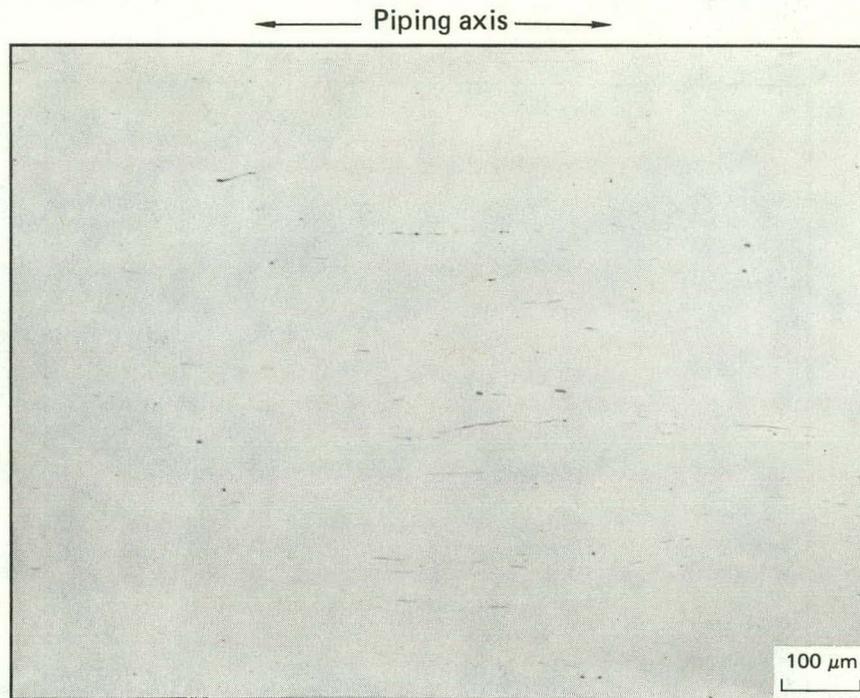
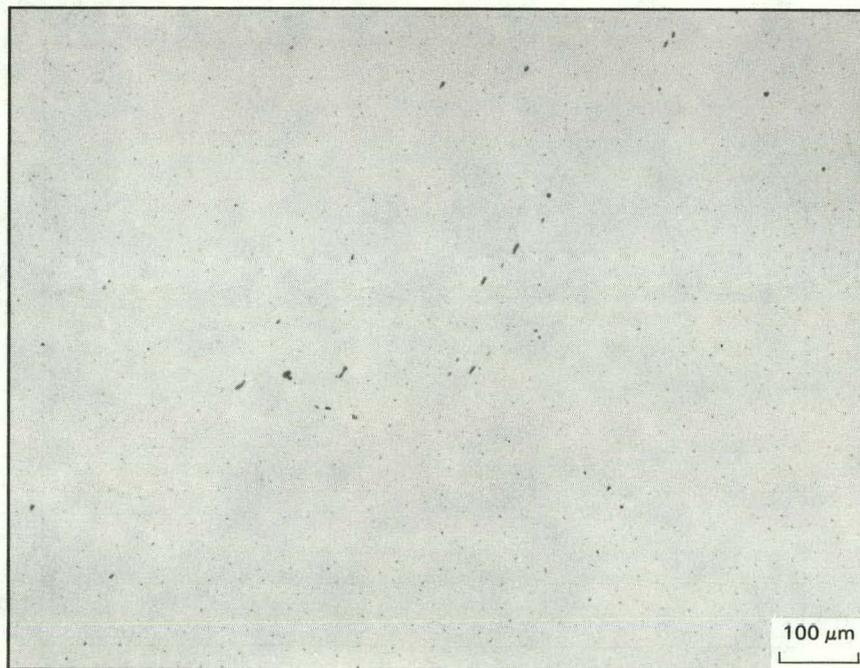
FIG. 4.2. Photomicrographs showing differences in the morphology of inclusions in the pipe and safe-end of a Palisades section. The pipe shows mostly stringers while safe-end shows globular or spheroidal morphology; both samples are parallel to the piping axis and wall thickness.

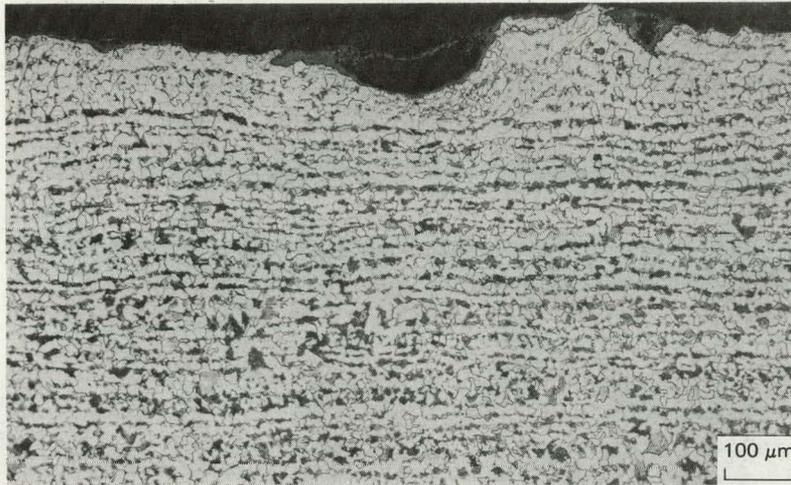
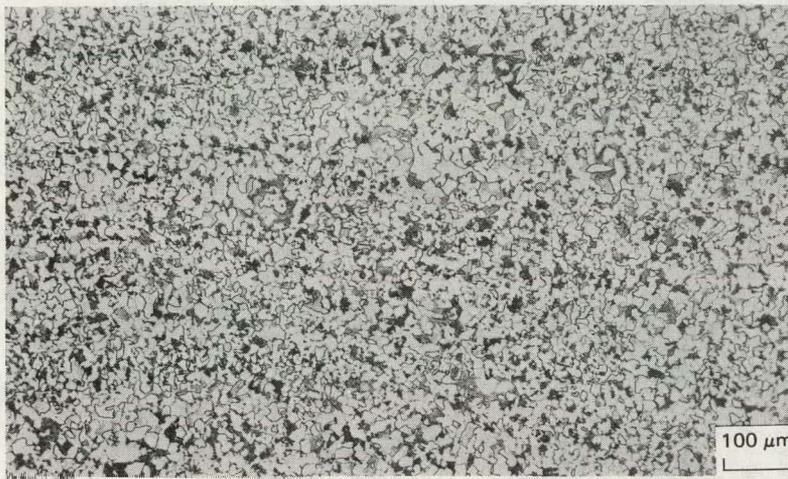
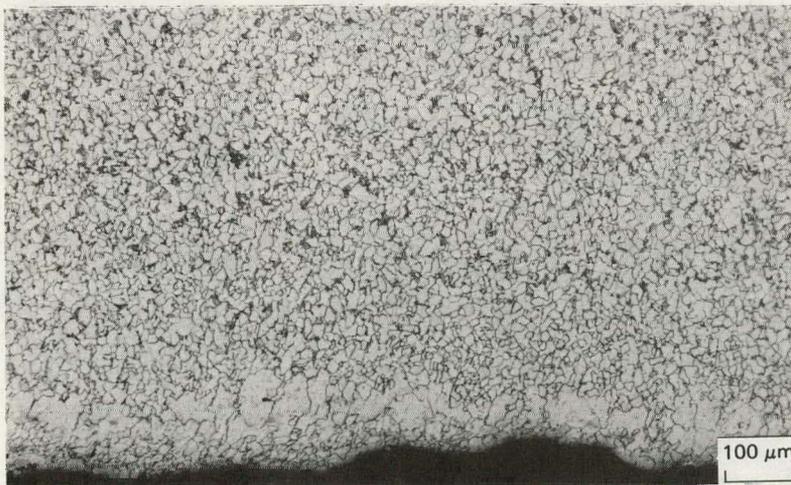
Examples of the microstructures of the steel phases are shown in Figs. 4.3 through 4.6. Figure 4.3(a) is an example of strongly banded ferrite and pearlite zones at the i.d. of the elbow from Beaver Valley. The deformation at the bottom of a pit seen in Fig. 4.3(a), suggests that it is likely to be a machining groove. Banding decreases through the wall thickness, virtually disappearing at almost midthickness, as shown in Fig. 4.3(b). Figure 4.3(c) shows the uniform structure at the o.d. of this elbow. This general change in morphology from i.d. to o.d. is seen in all banded sections. An example showing only a trace of banding at the i.d. with an equiaxed grain structure is shown in Fig. 4.4(a) for Salem. An example of Widmanstätten (oriented growth) ferrite is illustrated in Fig. 4.4(b) for Kewaunee; the structure, however, is uniform. In all cases, some decarburization can be seen; however, this decarburized layer is removed on counterboring. Examples of predominantly laminar and spheroidal pearlite are shown in Figs. 4.5(a) and 4.5(b), respectively, for H. B. Robinson and Kewaunee. At these high magnifications, the oriented ferrite structure (Widmanstätten pattern) in the Kewaunee section is more clearly revealed than at the lower magnification shown in Fig. 4.4(b). Another example of a predominantly spheroidized structure is shown in Fig. 4.5(c) for Beaver Valley which was also shown at a lower magnification in Fig. 4.3(a). The segregation is clearly evident. Figure 4.6 illustrates the contrasting morphology in the Palisades section between the pipe which contains laminar pearlite and the safe-end, which is strongly spheroidal, largely the result of different fabrication/heat treating procedures.

FIG. 4.3. Photomicrographs showing various degrees of banding across the wall thickness in a section from Beaver Valley. View (a) shows banding at the inside diameter; view (b) shows that banding virtually disappears at midthickness; and view (c) shows a uniform structure at the outside diameter. Note slight decarburization along both surfaces.

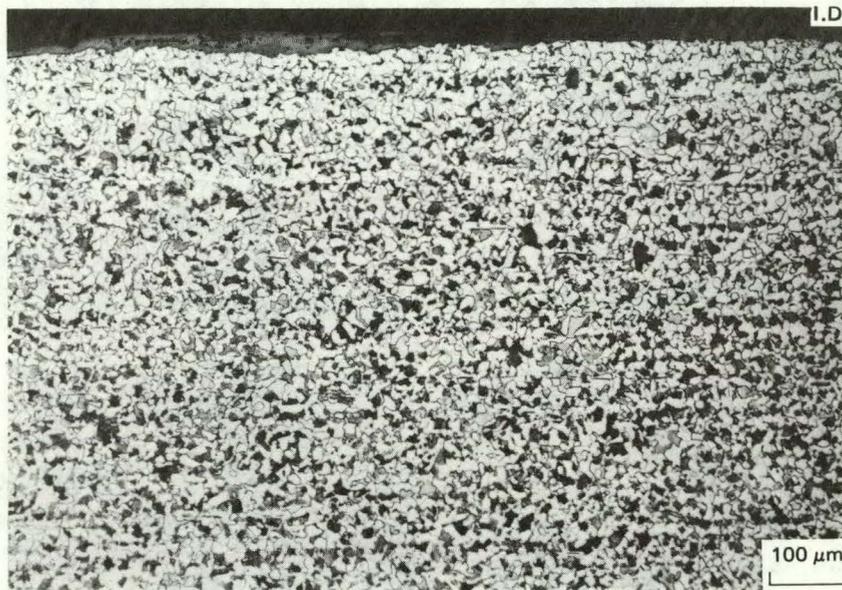
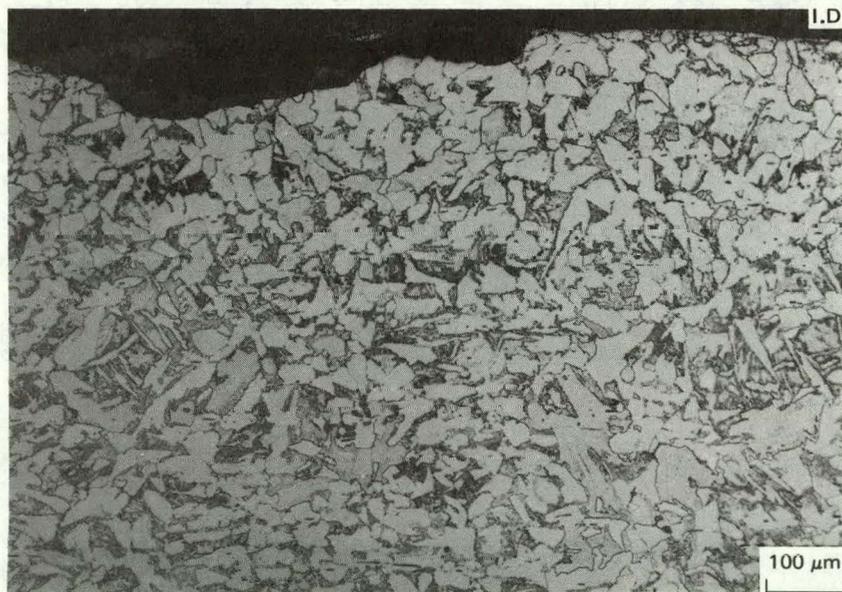
FIG. 4.4. Photomicrographs showing only a trace of banding near the inside diameter for a Salem section and Widmanstätten (oriented) ferrite and no banding for a corresponding Kewaunee section. Note decarburization.

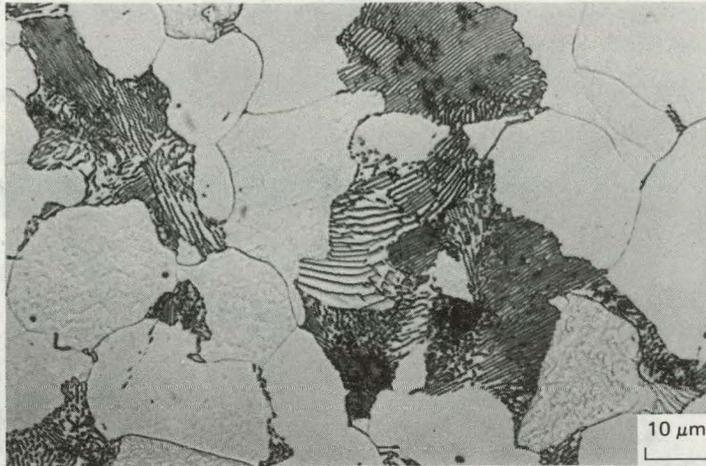
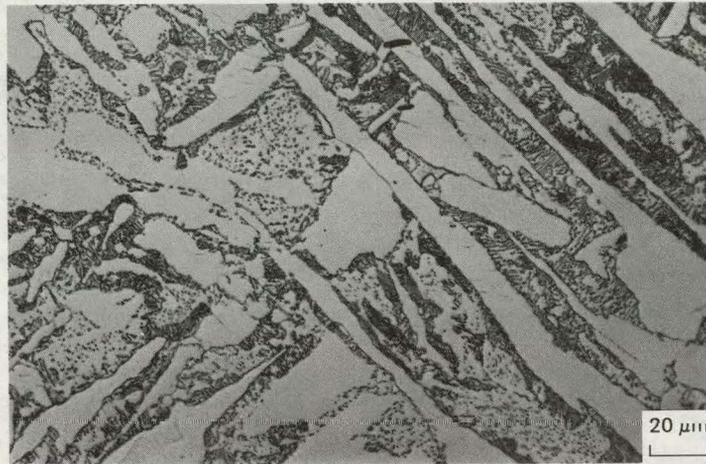
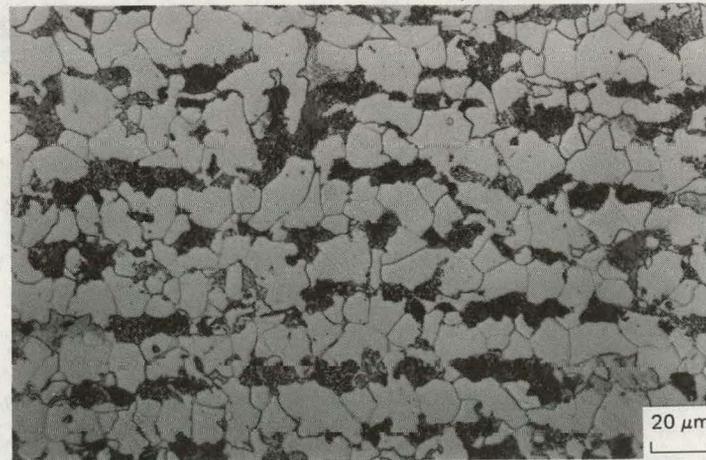
FIG. 4.5. Photomicrographs of lamellar and spheroidized pearlite. View (a) shows mostly lamellar pearlite in an H. B. Robinson section. View (b) shows mostly spheroidal pearlite in a Kewaunee section. View (c) shows mostly spheroidal pearlite in a Beaver Valley section. Note the Widmanstätten ferrite and occasional remnants of the pearlite lamellae in view (b). Note the banding in view (c).

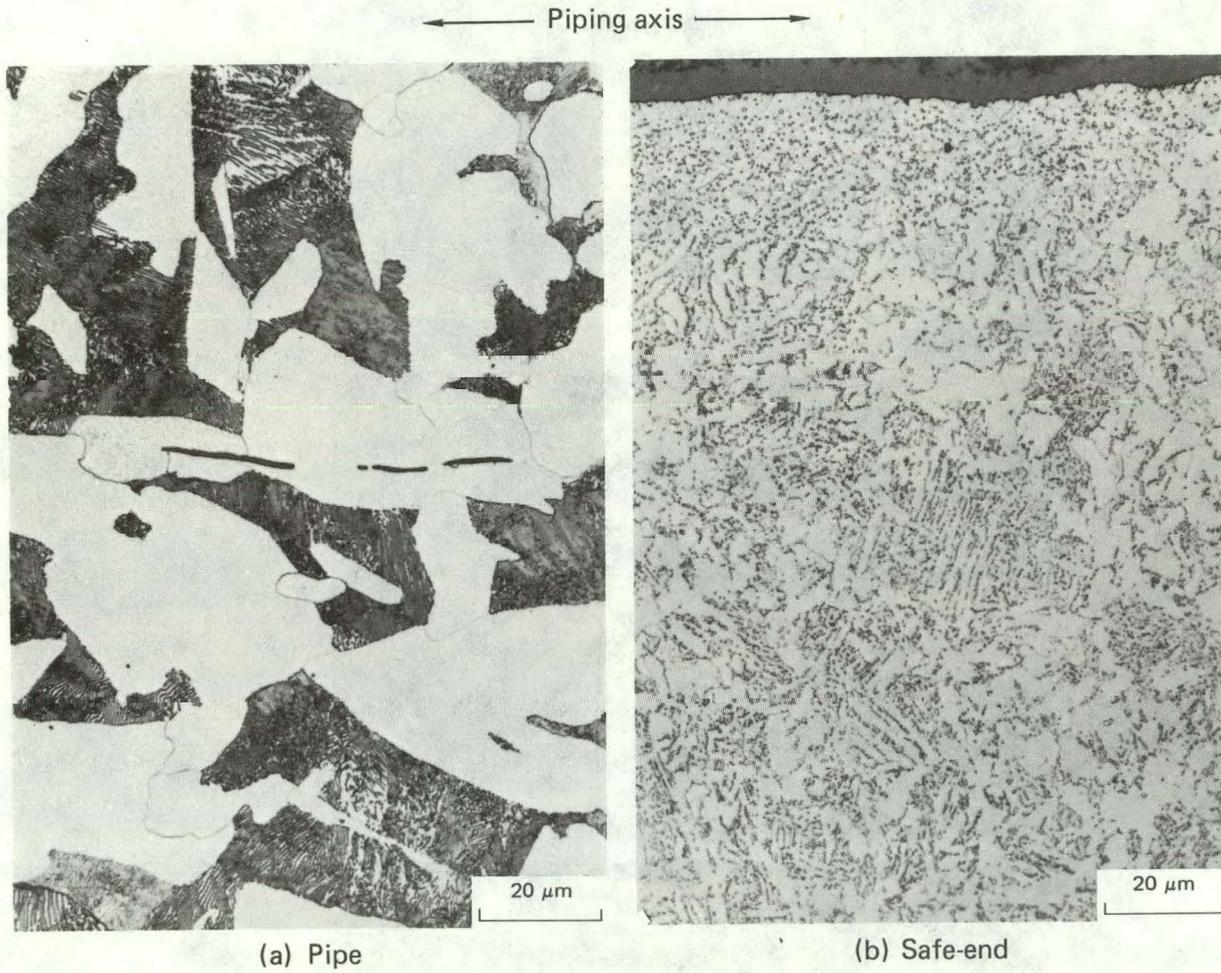
FIG. 4.6. Photomicrographs showing differences in morphology of the steel phases in the pipe and safe-end of a Palisades section. Note the predominantly lamellar pearlite in view (a) and the strongly spheroidal structure in view (b).

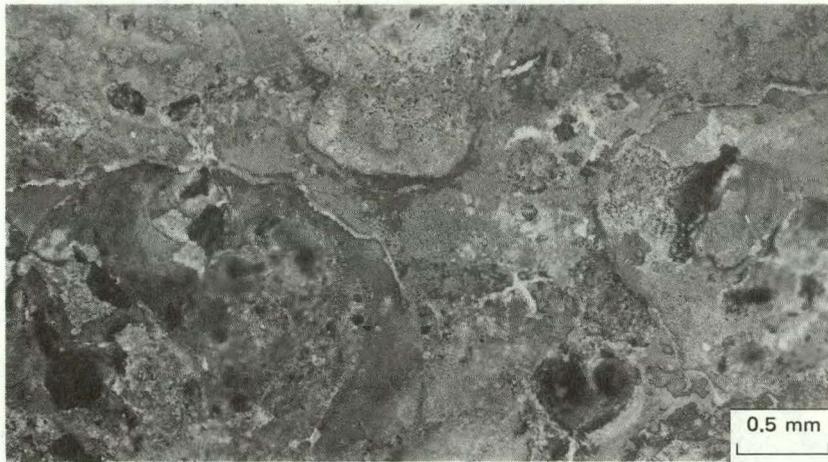
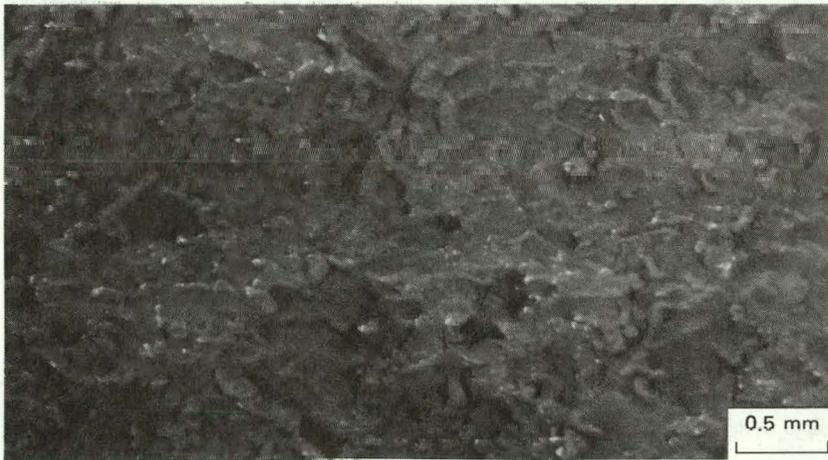
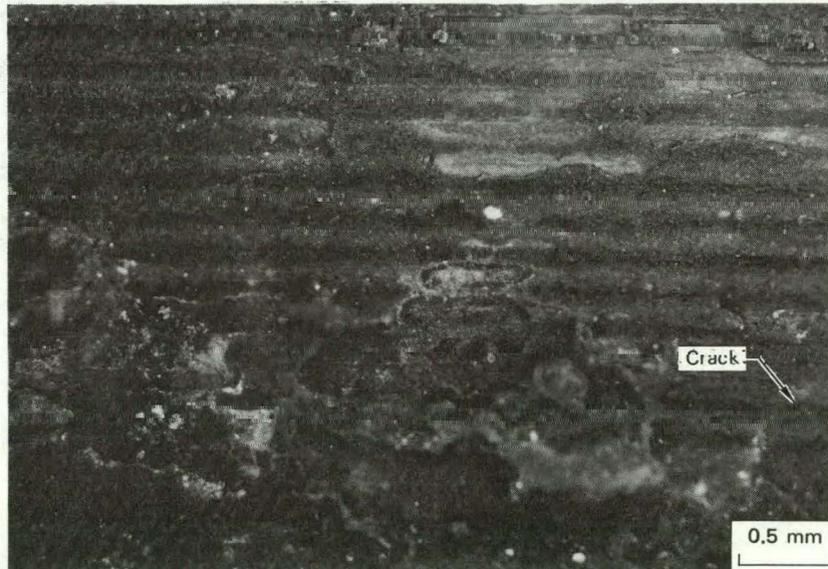
FIG. B.1. Photomicrographs (25X) showing the surface condition of as-received sections from San Onofre, Kewaunee, and Palisades. The areas along the counterbore were unavailable from the San Onofre and Kewaunee sections because the entire crack sections had been used for other analyses.
