NUREG/CR-1603
UCRL-53000

Evaluation of Cracking in Feedwater Piping Adjacent to the Steam Generators in Nine Pressurized Water Reactor Plants

Alfred Goldberg, Ronald D. Streit, and Robert G. Scott

Lawrence Livermore Laboratory
7000 East Avenue
Livermore, CA 94550

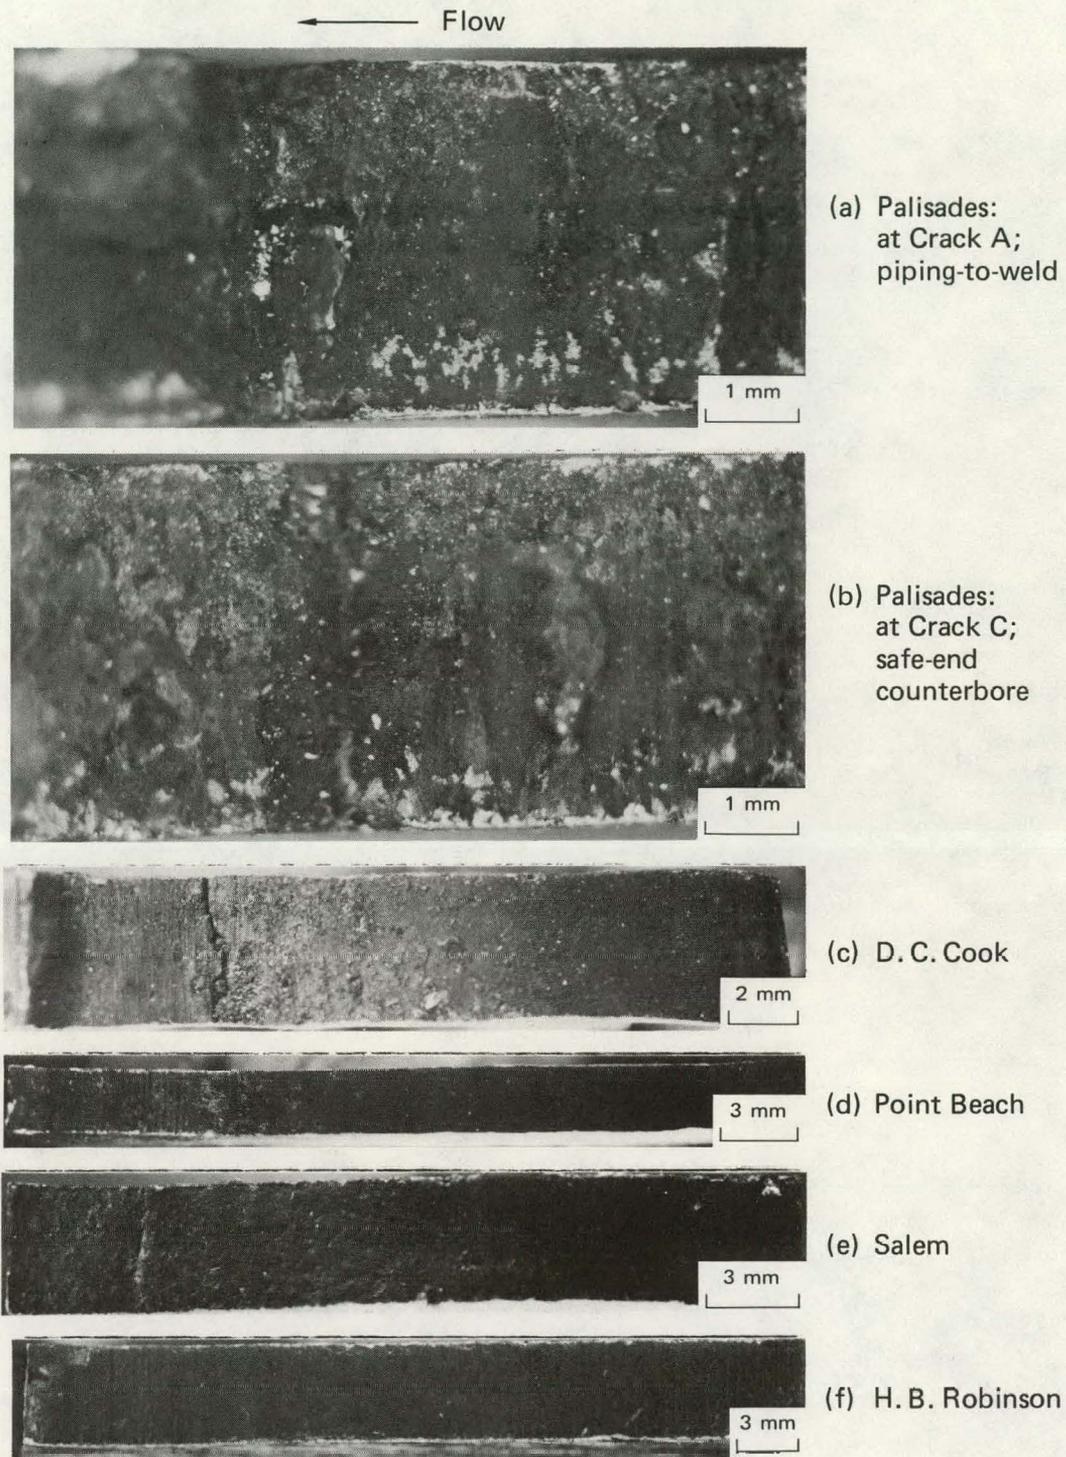
FIG. B.4. Photomicrographs showing typical original inside diameter surfaces of cut section slices used for analyses.

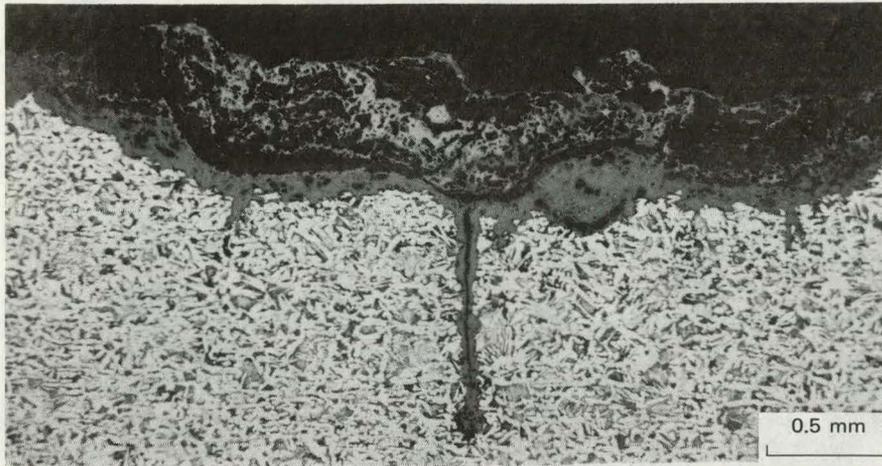
(a) Palisades

FIG. C.1. Examples of corrosion pits and corrosion spikes (most likely small corrosion-filled cracks) in Palisades, San Onofre, Beaver Valley, and Kewaunee sections. Views (a) and (b) show spikes (cracks) extending from the bottom of large pits. View (c) shows an example of small pits (and possibly machining grooves). View (d) shows spikes extending down directly from a uniformly corroding surface region.

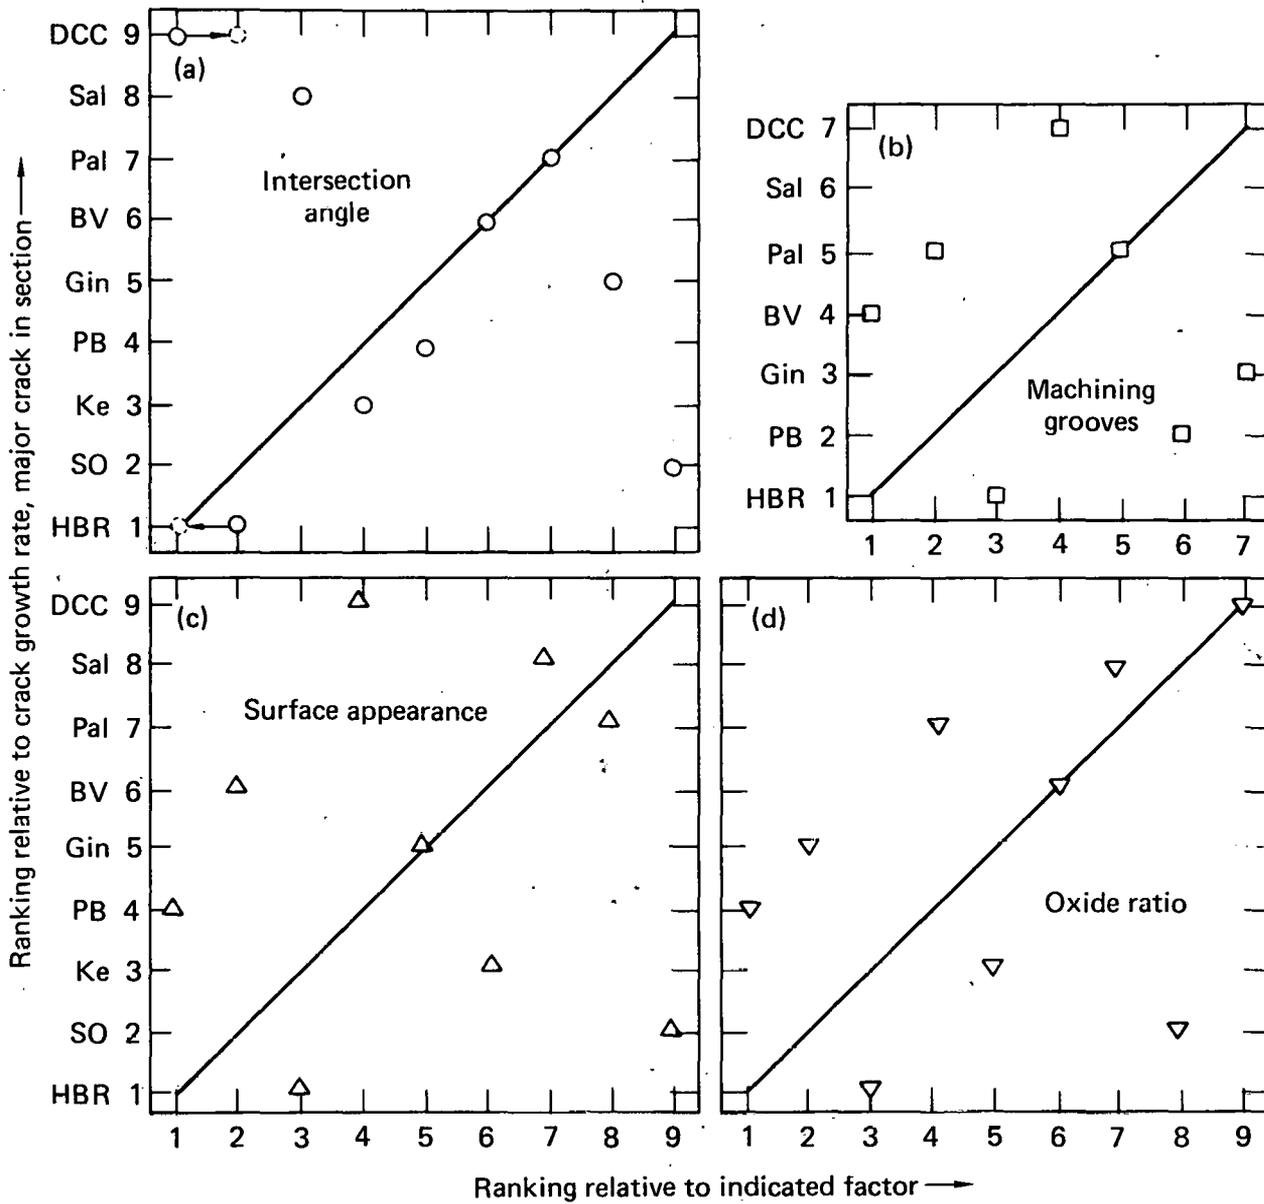
We attempted to see if any trends could be detected between crack length and the various factors listed in Tables C.1 to C.4. In Figs. C.3 and C.4, we plotted the ranking of crack growth rates for the major crack along the total section and along the piping, respectively, versus various factors reflecting surface conditions: the intersection angle of the contiguous i.d. surfaces at the crack origin, the extent of surface damage by machining grooves, the general surface appearance, and the $\text{Fe}_2\text{O}_3/\text{Fe}_3\text{O}_4$ ratio. The solid lines indicate a 1 to 1 relationship in each case. For both the total section and piping section alone there is a limited trend with intersection angle. In both cases, D. C. Cook presents a strong exception. There is an indication of a limited trend for oxide ratio with reference to the total section cracks. Taking into account the different operating periods, one can also see from Table C.2 some trend between oxide ratio and oxygen exposure, which in turn reflects a slight correlation between crack length and feedwater oxygen content. The data in the remaining plots are essentially random, although limited trends can be seen by isolating the plants into groups; however, such groupings are not always consistent either within these plots or with additional plots described below.

FIG. C.3. Ranking relative to (estimated) crack-growth rate of major crack in section versus ranking of various inside diameter surface observations (1 is best, 9 is worst). Note that only seven plants were used to rank machining grooves. The dashed data points in (a) refer to alternative ranking. See Table C.1.

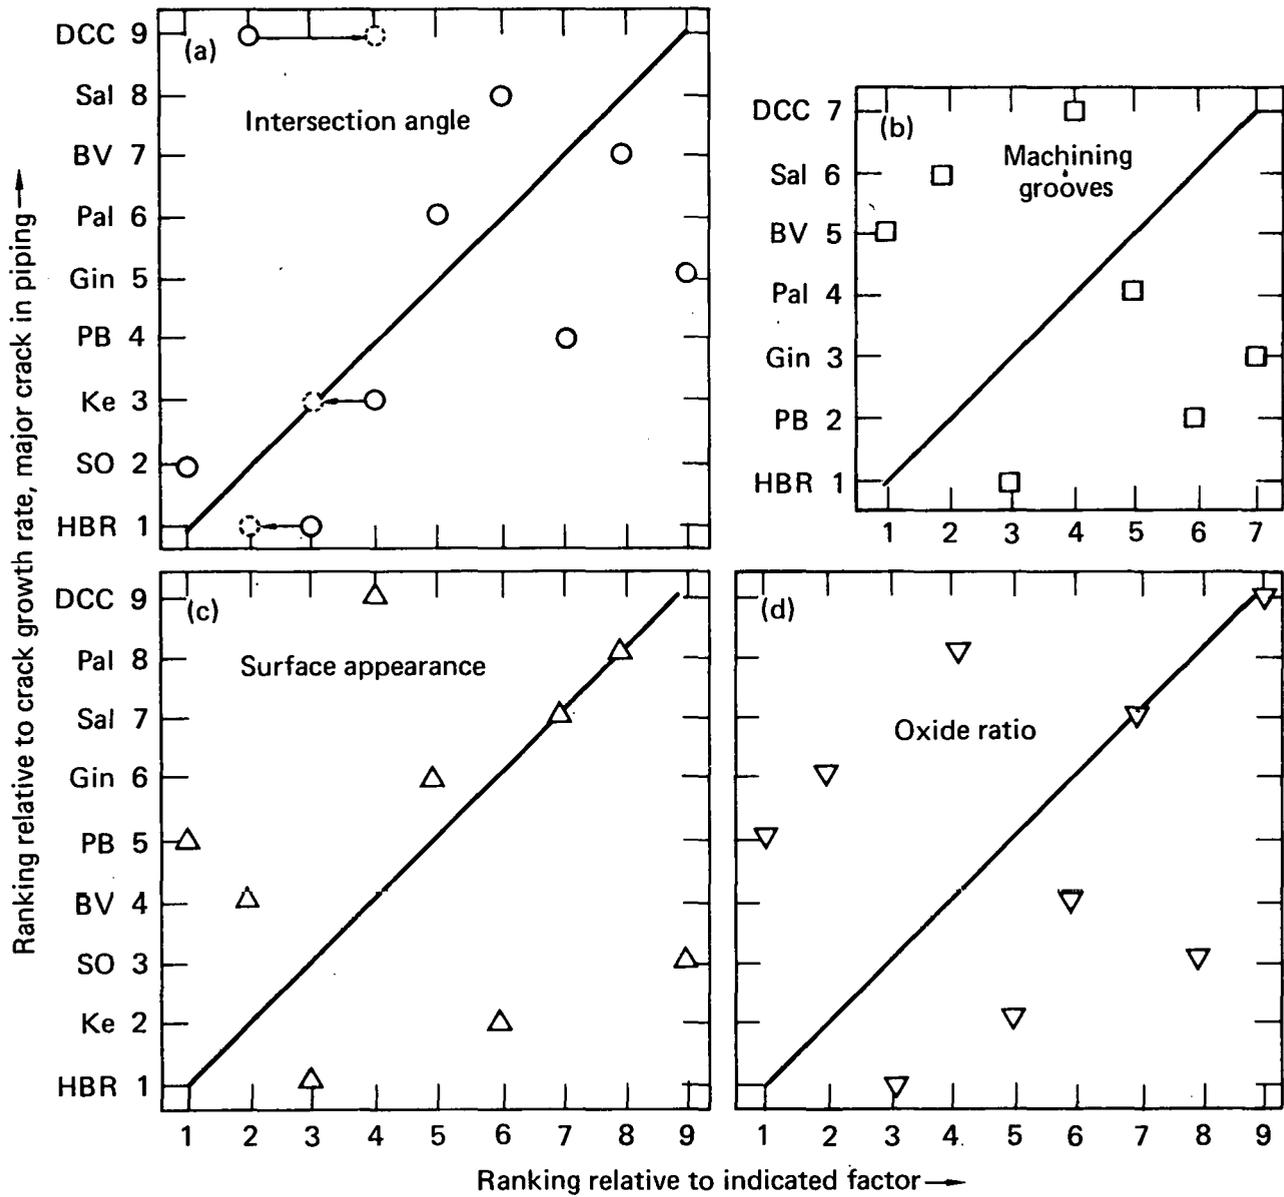
FIG. C.4. Ranking relative to (estimated) crack-growth rate of major crack in piping versus ranking of various inside diameter surface observations (1 is best, 9 is worst). Note that only seven plants were used to rank machining grooves. The dashed data points in (a) refer to alternative ranking. See Table C.1.

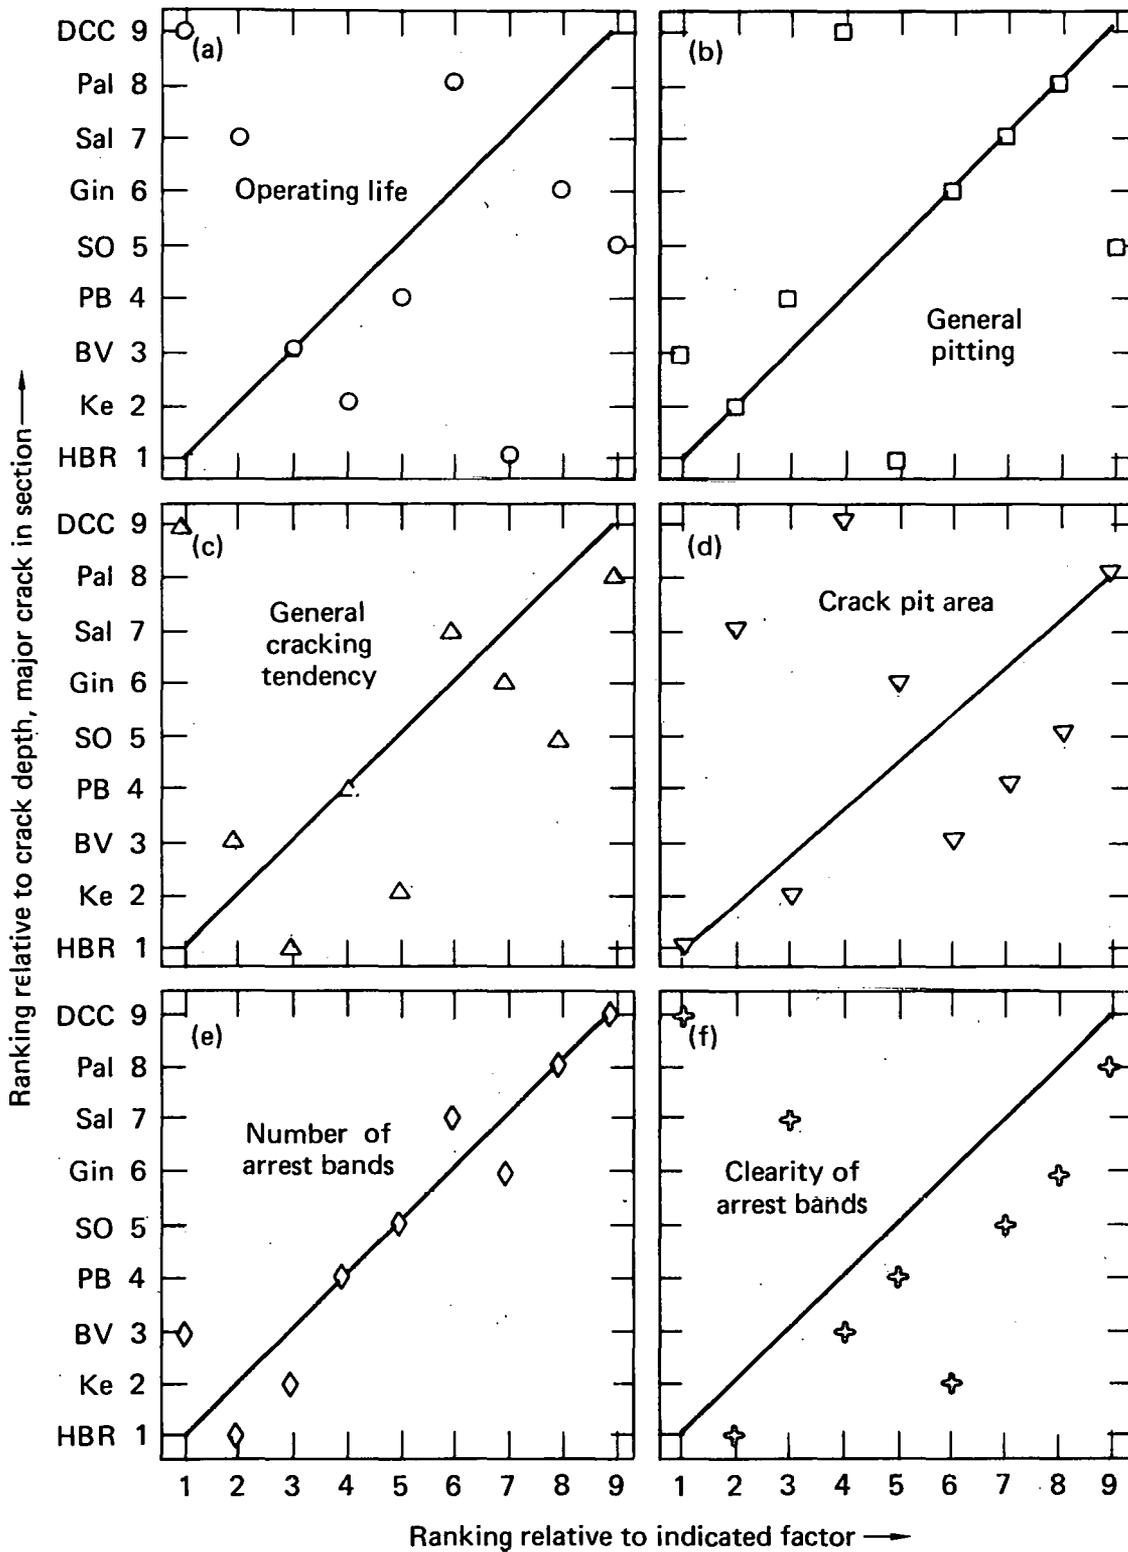
In Figs. C.5, C.6, and C.7, we plotted the ranking of crack length versus the ranking of a number of those factors or characteristics that could be ranked and, in general, may be expected to vary with crack length. Plots in most cases are made for both the total section and for the piping alone. The only definite trend that is obtained is that crack length increases with the number of arrest bands, Fig. C.5(e). The presence of arrest bands on crack surfaces is discussed in detail in the main body of the report. Again we note some limited trends: general pitting, general cracking tendency, and crack-pit area (Fig. C.5) for the total section, and possibly general pitting and general

FIG. C.5. Ranking relative to crack depth of major crack in section versus ranking of various factors that should relate to corrosion/cracking degradation (1 is best, 9 is worst).

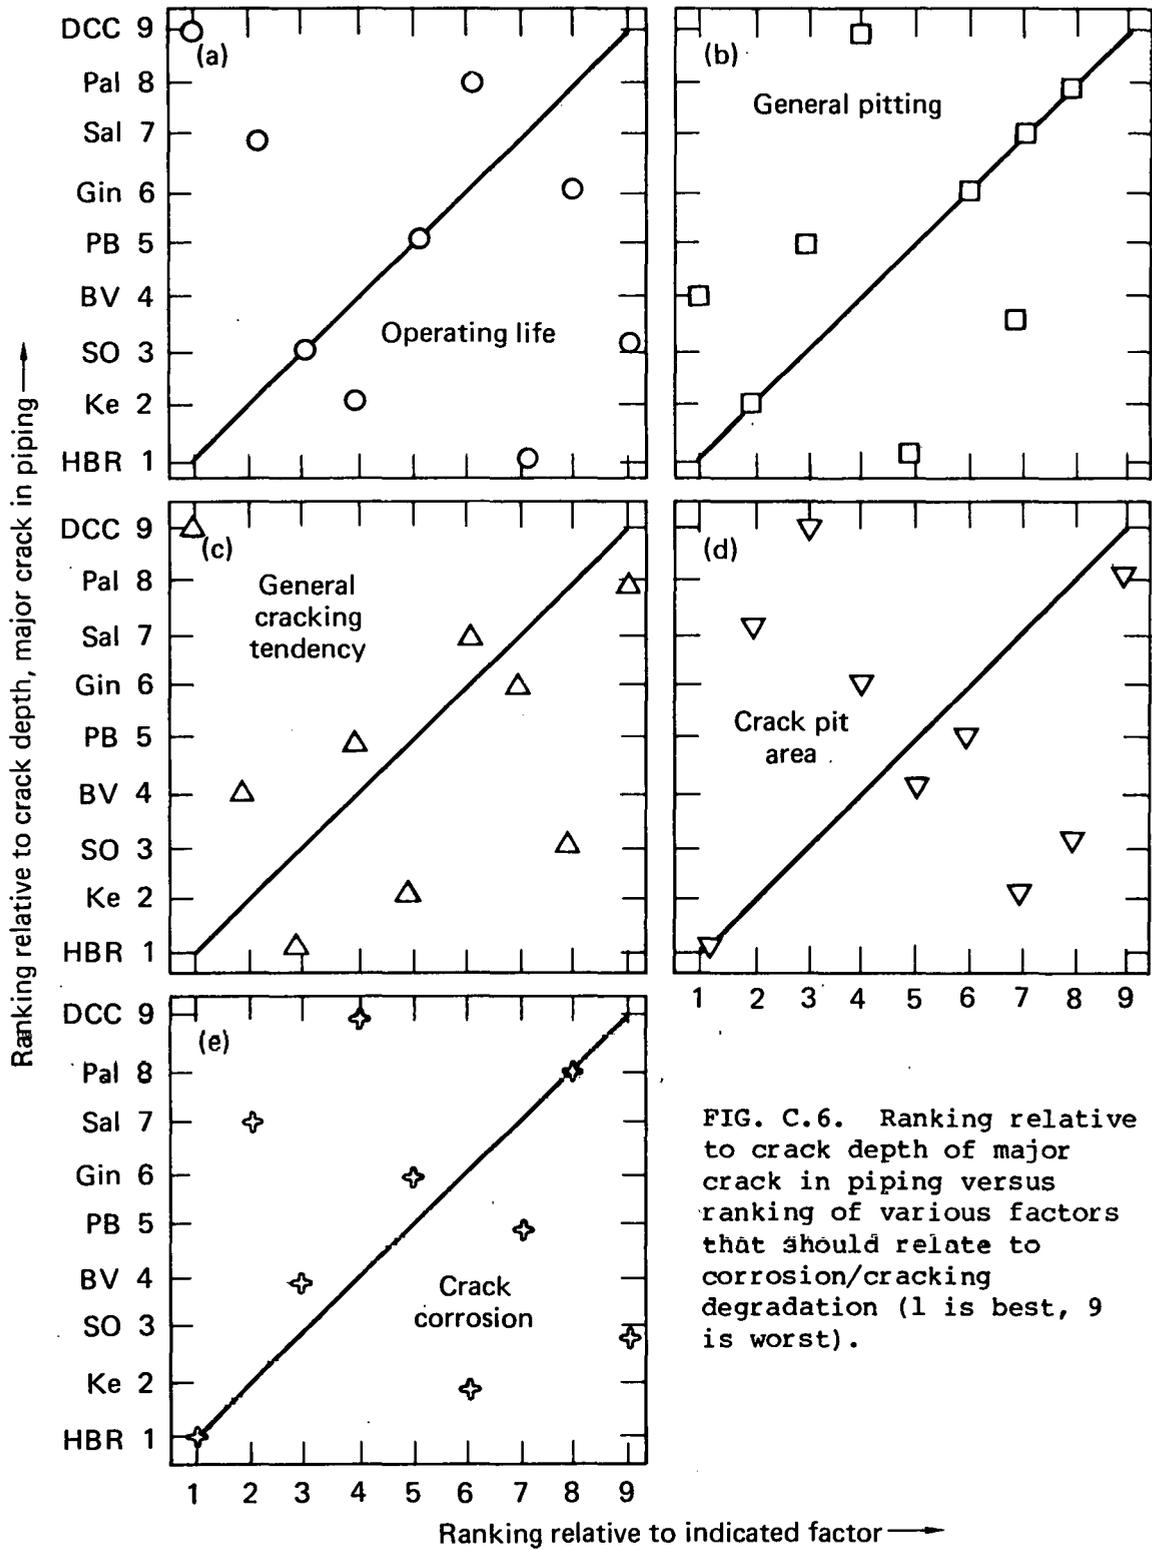
cracking tendency (Fig. C.6) for the piping. The data from D. C. Cook are invariably out of line for these factors.

FIG. C.6. Ranking relative to crack depth of major crack in piping versus ranking of various factors that should relate to corrosion/cracking degradation (1 is best, 9 is worst).

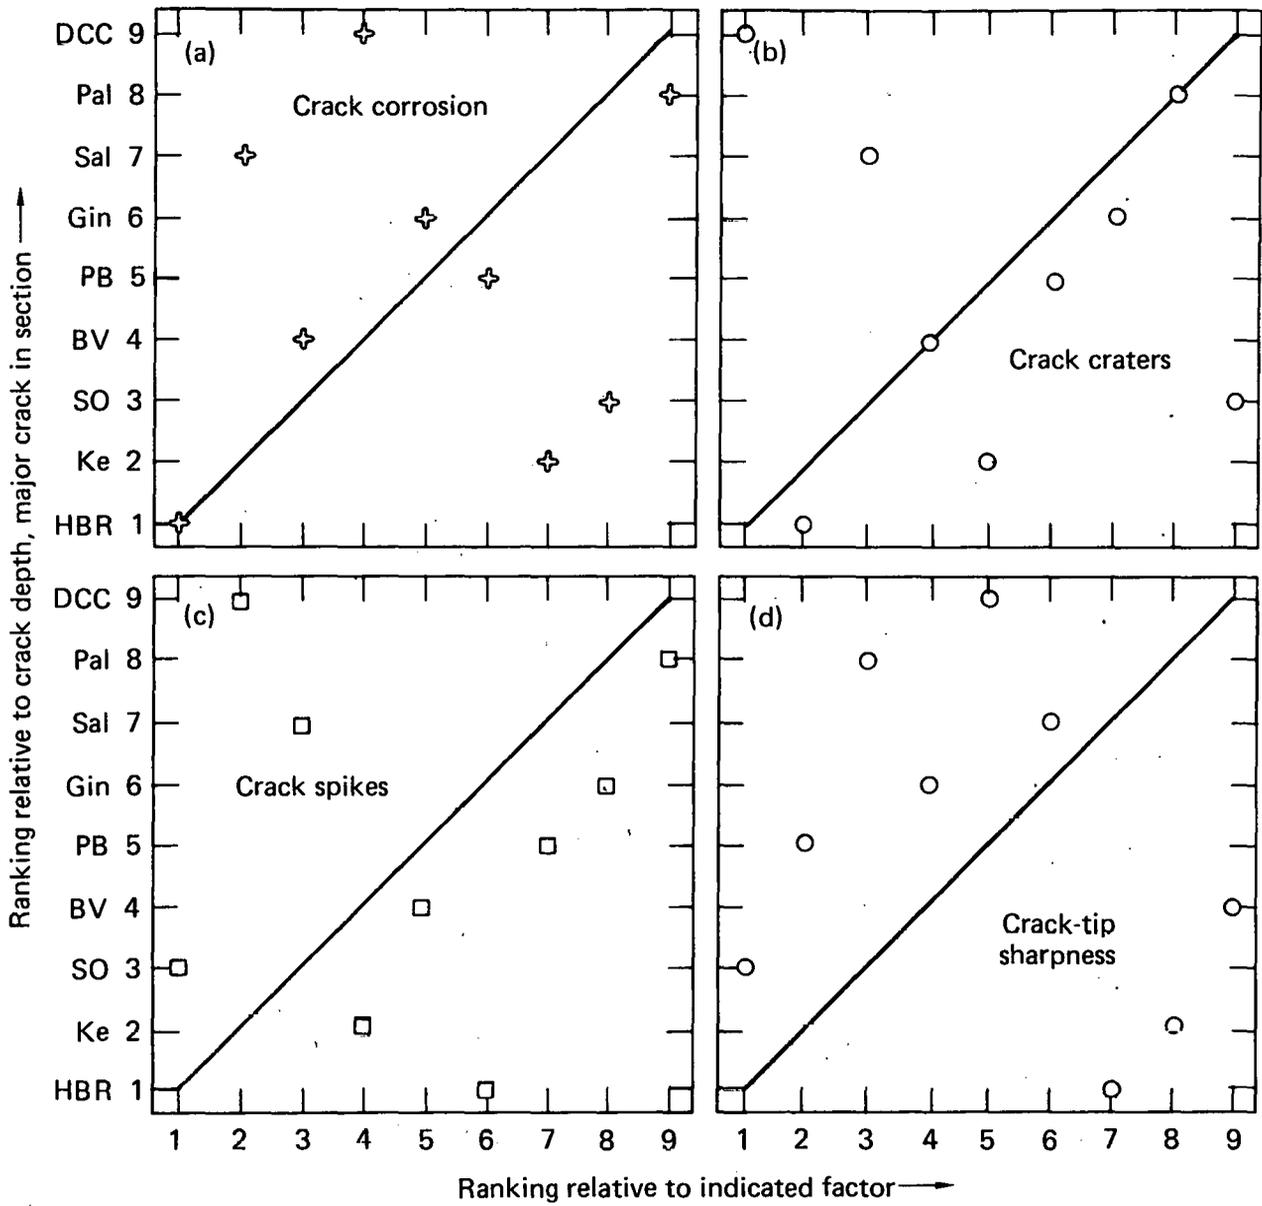
Figure C.7 contains plots of crack depth ranking versus ranking of observations on corrosion along cracks. The data are essentially all random, although limited trends can be detected in plots Figs. C.7(a), C.7(b), and C.7(c) between Beaver Valley, Point Beach, Ginna, and Palisades. The sharpness of the crack tip, Fig. C.7(d), should indicate whether corrosion or stresses were the predominant factor in the final stages of exposure of the pipe, i.e., whether the "cracking" was active at that time. Assuming that stress is the major factor in the cracking problem, we ranked the crack tips on the basis of their sharpness with the most blunt crack tip as 1 (San Onofre) and the sharpest crack tip as 9 (Beaver Valley). We considered, generally, the most advanced region of a crack. In some cases the relatively sharper tips have only propagated a short distance from the final corrosion crater, e.g., the Kewaunee crack, Fig. 3.14(d). In the case of the most blunted crack tips, Figs. 3.7(b) and 3.7(d), it is apparent that aggressive corrosion had played a major role in the degradation of the steel. However, the blunting may have actually delayed the propagation of the crack.

FIG. C.7. Ranking relative to crack depth of major crack in section versus ranking of various observations made along corresponding crack (1 is best, 9 is worst).

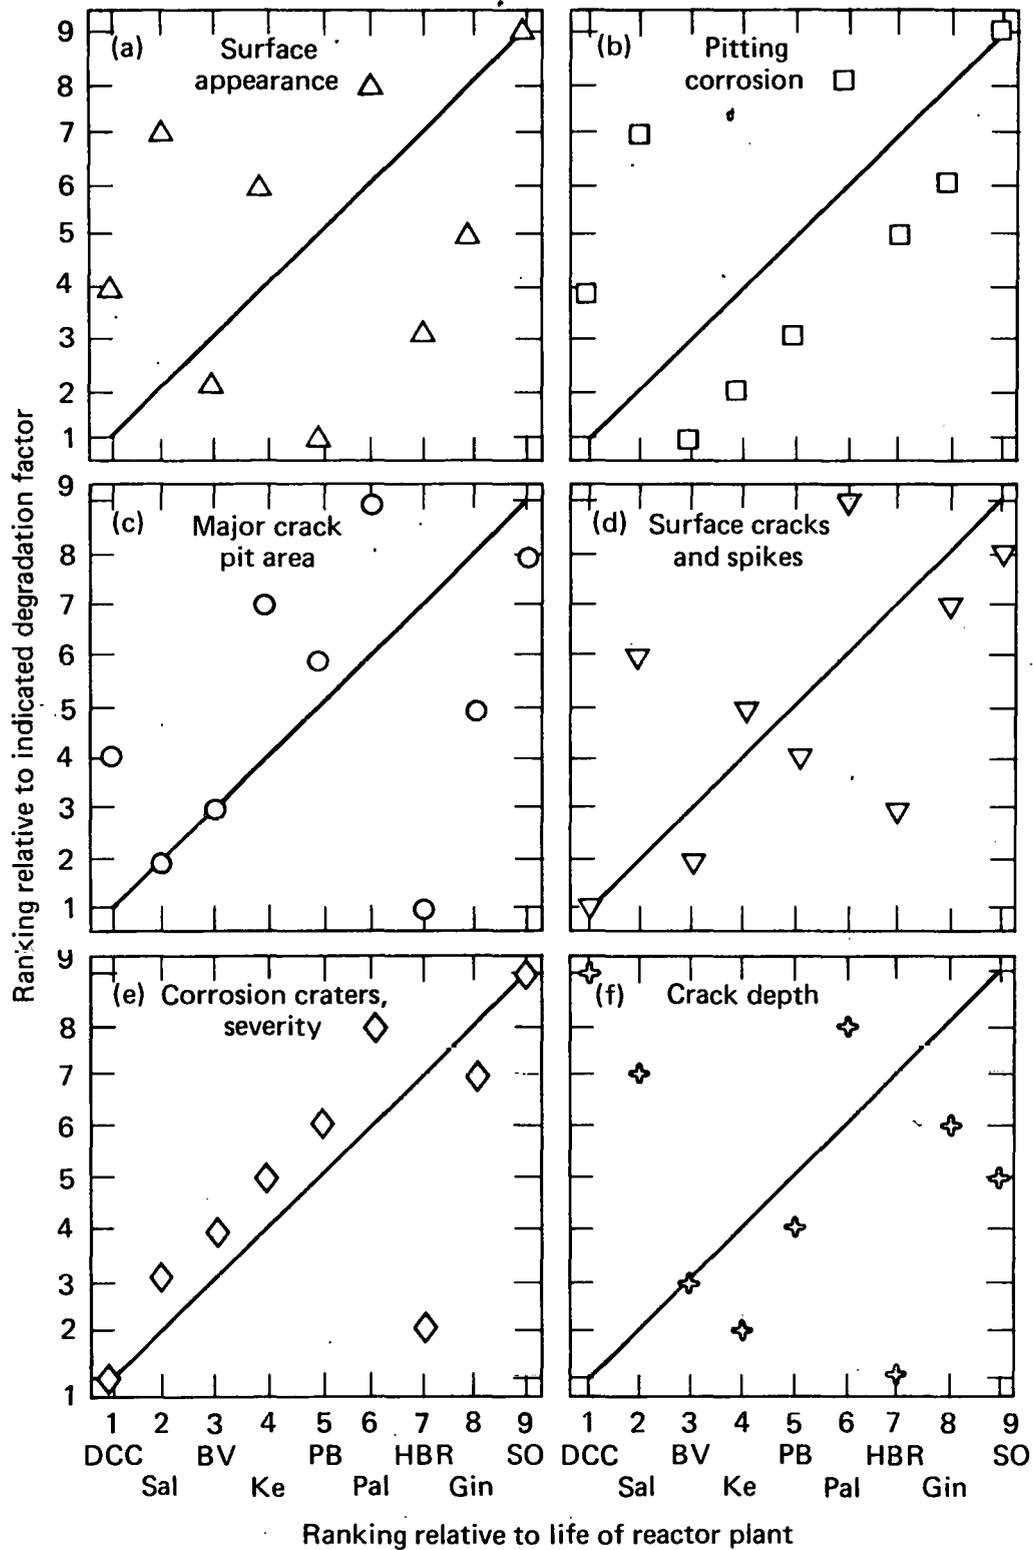
In Fig. C.8 are plotted the ranking of various factors that are related to corrosive attack versus ranking indicating relative operating life. We have also included crack depth ranking which shows high randomness relative to operating life. The plots for surface appearance and crack-pit area are also quite random; the former can be attributed to the added contribution of the initial conditions of the piping surfaces, the latter to the uncertainty as to when in the operation of the plant the cracks started to propagate. However, in contradiction to the uncertainty of crack initiation time, we do see a definite trend between the severity of corrosion craters and operating life. But, as indicated in Table C.4, there are only slight differences in the severity of these craters for six of the plants with greatly different operating periods. The plot for pitting corrosion, and possibly for surface cracks and spikes, shows some limited trends, and these factors do reflect the relative total operating times of the plants.

FIG. C.8. Ranking relative to extent of degradation seen on inside diameter surface along crack versus ranking relative to estimated corresponding reactor plant life (1 is best, 9 is worst).

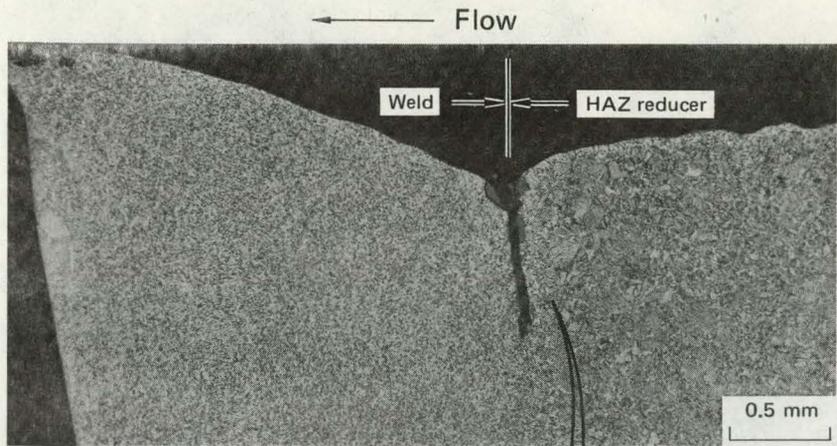
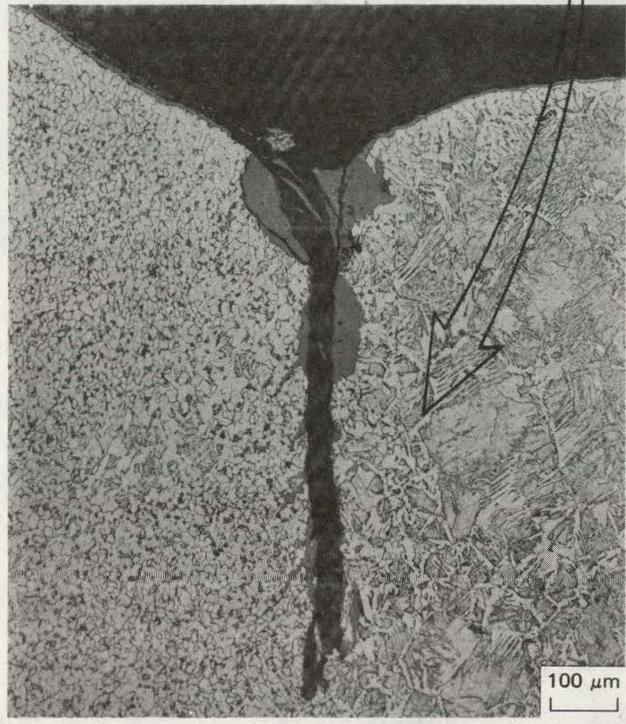
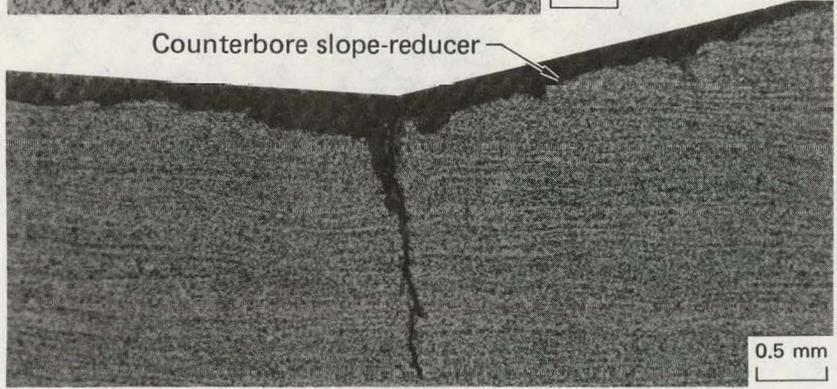
FIG. D.6. Photomicrographs showing cracks at discontinuous cross-sectional changes in a Point Beach section. Views (a) and (b) show the weld-HAZ interface, and view (c) shows the critical region of the counterbore.

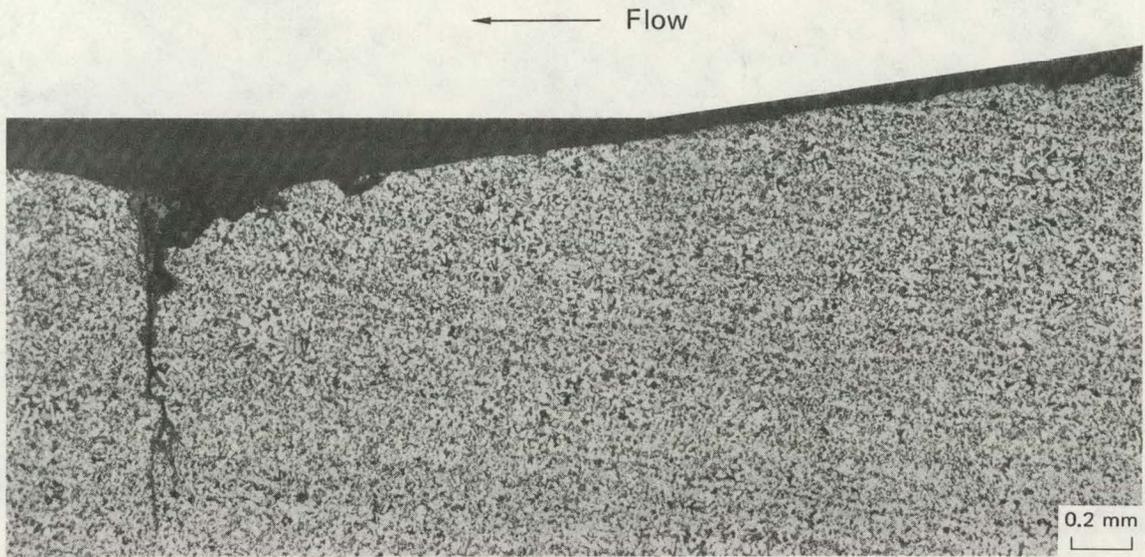
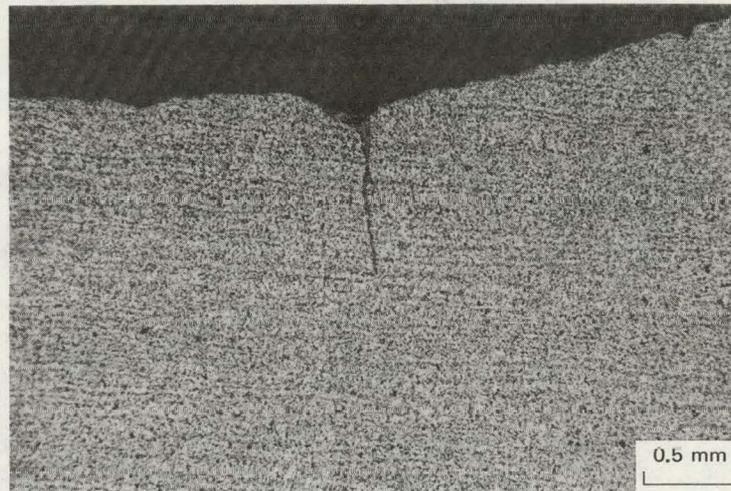
FIG. D.8. Photomicrographs showing a crack at the bottom of the counterbore slope in two longitudinal sections taken from two different regions along the circumference of the elbow from Beaver Valley.

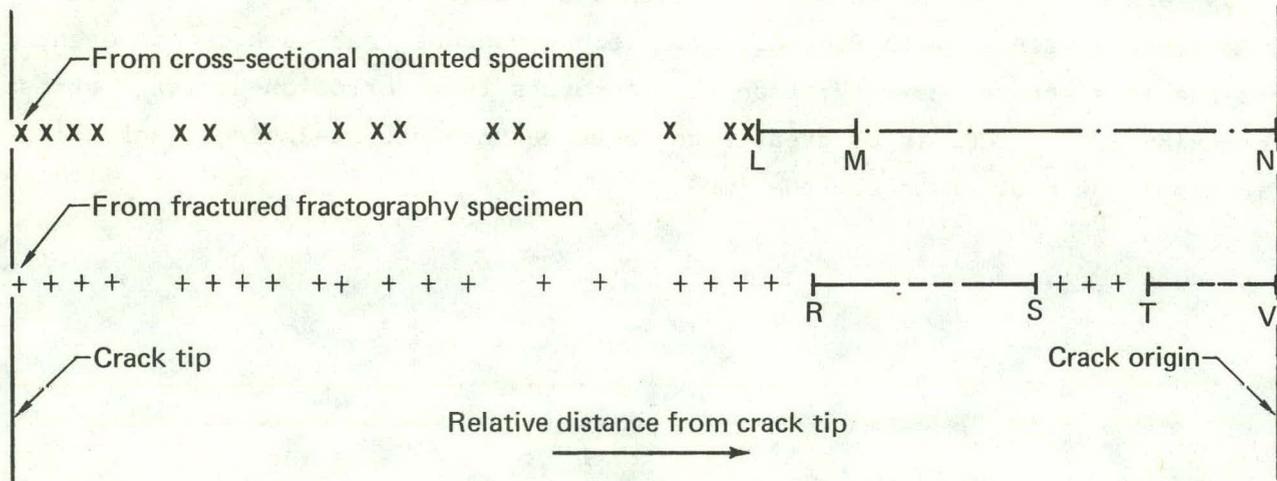
It is to be expected that the craters and arrest bands are at the same locations along a crack; but, they are viewed along surfaces differently prepared, normal to each other, and on different longitudinal slices taken from the same section. The ease with which the bands are detected follow closely the severity of the craters (Table C.4). Furthermore, we attempted with reasonable success to show a 1 to 1 correlation between the distances from the crack origin of the craters seen in cross section and the arrest bands on the crack surfaces for cracks A and C in the Palisades section. Figure E.1 illustrates this for crack A. Although there is a definite trend between crack depth and the number of crater events (arrest bands), there is much less of a trend between crack depth and the severity of the craters. Compare Fig. C.5(e) with Fig. C.7(b). If one assumes that each cyclic event is due to a stress activity, then this suggests that corrosion-assisted stress cracking (CF or SCC) is of greater consequence than stress-assisted corrosion in causing the observed degradations.

FIG. E.1. Correlations between distribution of craters and corrosion irregularities in a polished-and-etched specimen and of arrest bands in a fractured fractography specimen for Crack A of Palisades section. Refer to Fig. 3.10.

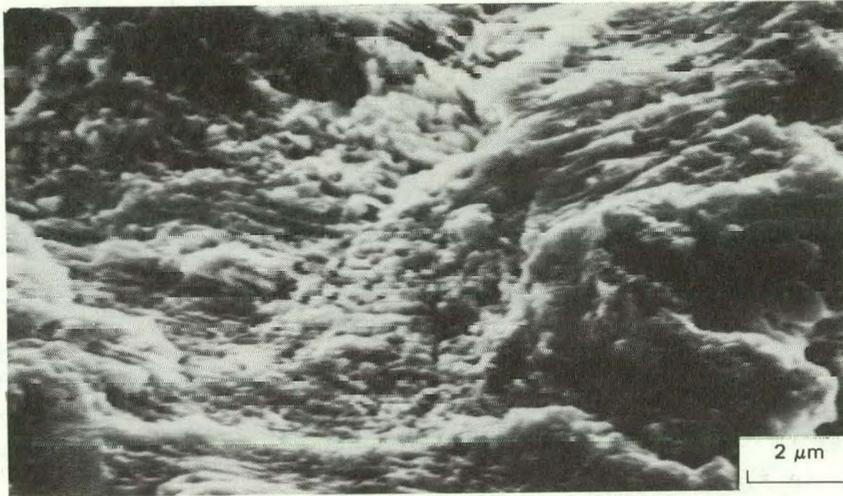
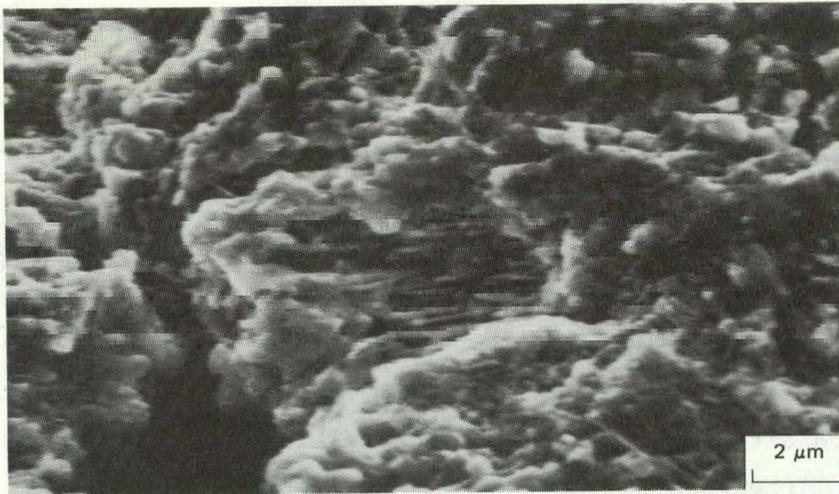
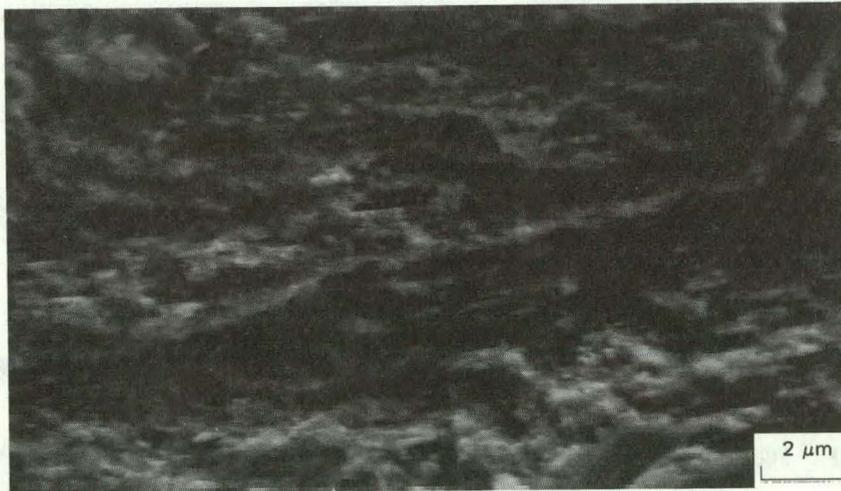
FIG. F.1. SEM fractographs of a cathodically cleaned crack surface of an H. B. Robinson section. In view (a) and possibly (c), note the parallel markings that suggest fatigue striations. Note the pearlite in view (b). Compare view (a) with Fig. 3.24(a).

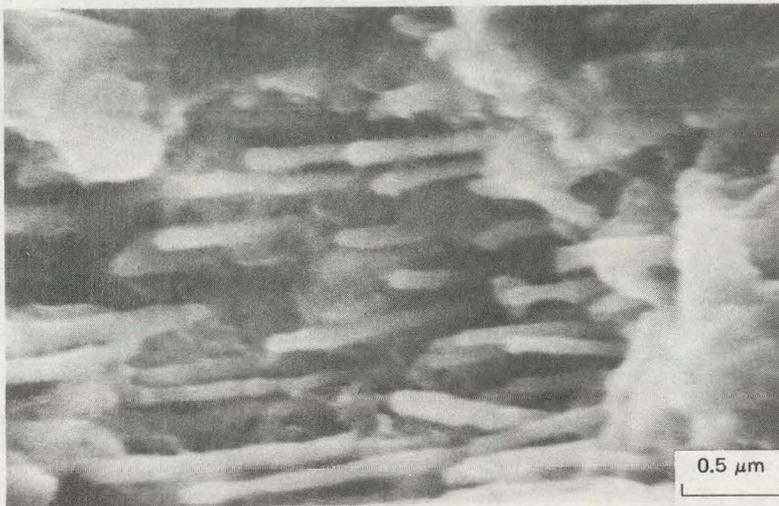
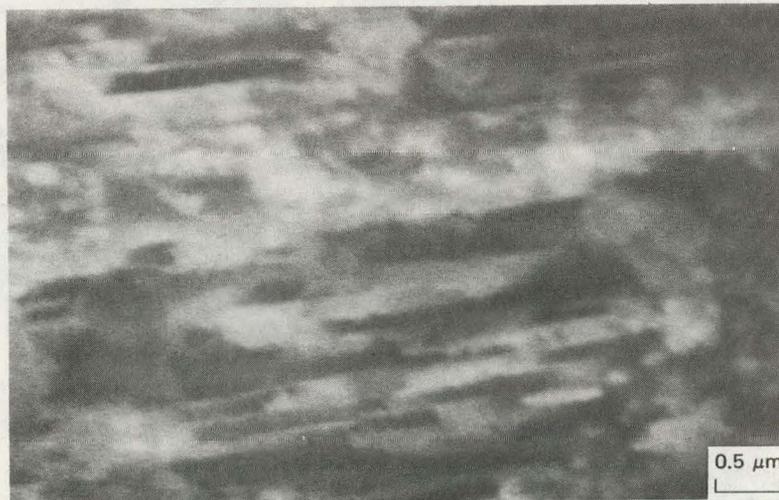
FIG. F.2. SEM fractographs of areas in Fig. F.1 showing distinct pearlite at higher magnifications in an H. B. Robinson section.

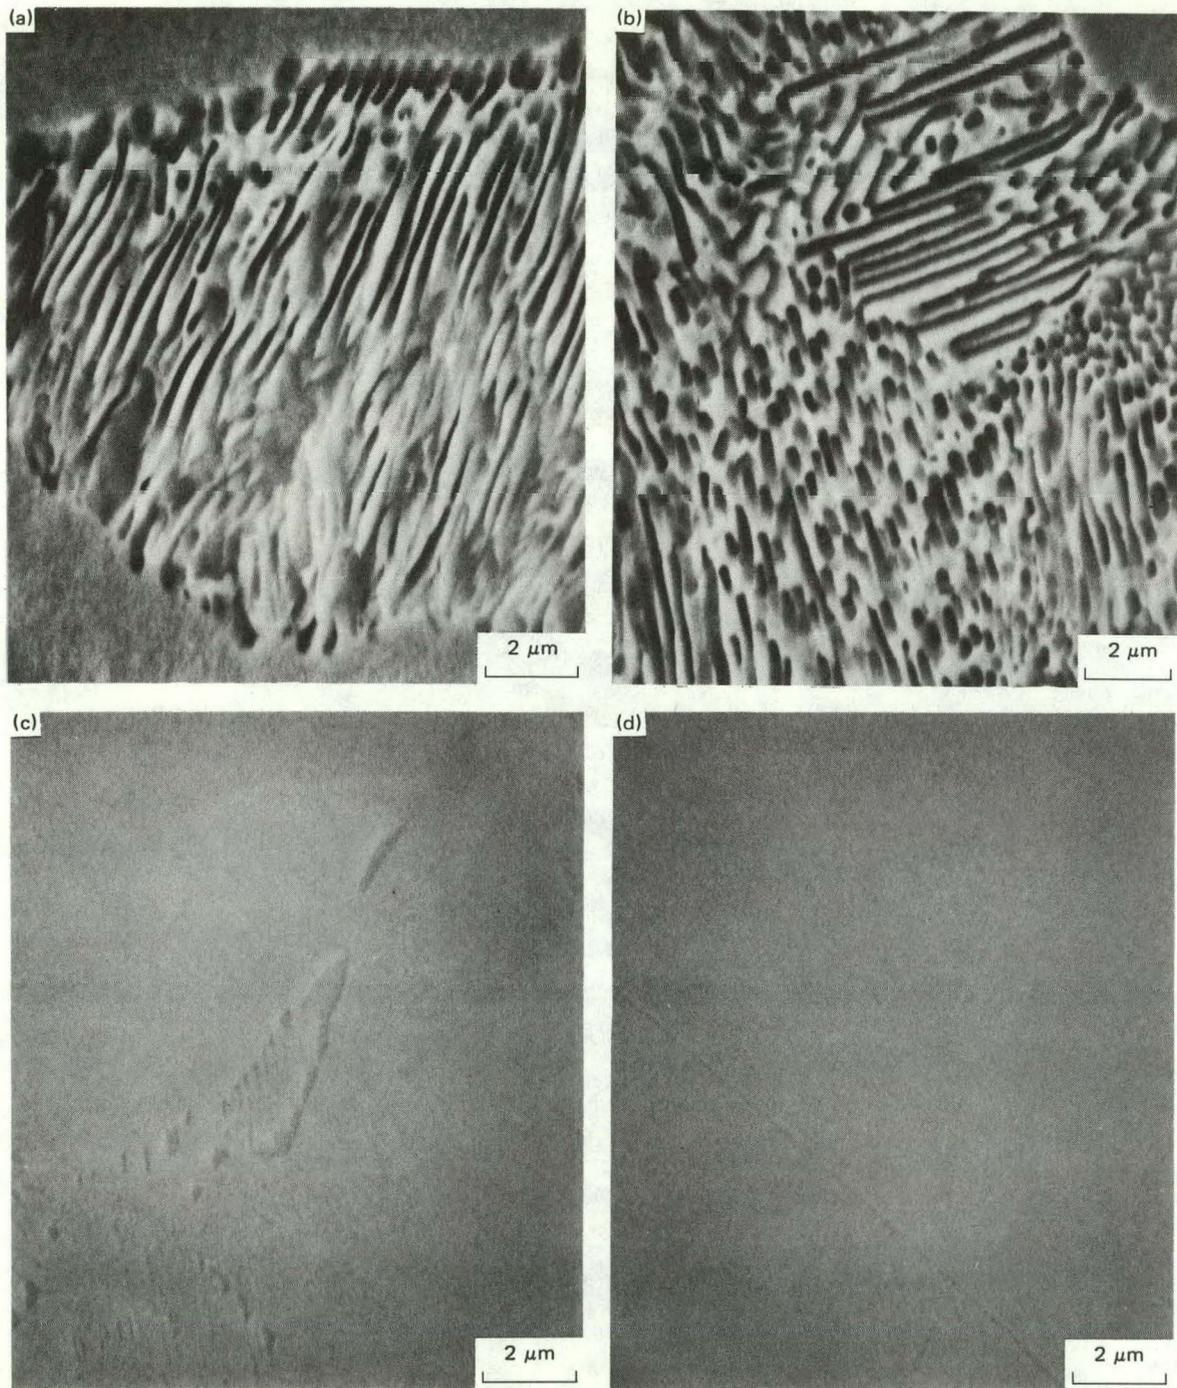
Figure F.3 shows SEM views of a specimen that was removed from a region just below the crack tip from the H. B. Robinson section. It was then polished and cathodically cleaned. A portion of the specimen was masked; the exposed surface was then anodically cleaned. Figures F.3(a) and F.3(b) reveal pearlite on the anodically attacked surface; Fig. F.3(c) is a transition region at the edge of the masking, and Fig. F.3(d) is the cathodically cleaned surface. The fact that the cathodic cleaning did not attack the steel surface indicates that the morphology of the cleaned steel surface is indeed that caused by the corrosive attack of the environment. This is further illustrated in Fig. F.4(a) for the interface region between the laboratory fracture and plant crack from H. B. Robinson. Figure F.4(b) shows the unattacked laboratory fracture, while Fig. F.4(c) shows the corrosive attack of the steel which is revealed by the removal of the oxide had been removed by the cathodic cleaning. Again, we see here a periodic-type pattern, but we question as to whether these markings are actually due to a cyclic event or due to selective attack of the pearlite phases. Furthermore, are the wavy striations on the as-corroded surfaces the result of retention of the pearlite-developed corrosion pattern throughout the growth of the corrosion deposits? The observations indicated to us that the use of SEM to detect evidence of fatigue in our samples is very limited and, in fact, may lead to erroneous conclusions.

FIG. F.3. SEM fractographs of a polished-and-cleaned surface of an H. B. Robinson section. In views (a) and (b), note the pearlite etched by anodic cleaning. View (d) shows the surface unattacked by cathodic cleaning. The transition region is shown in view (c).

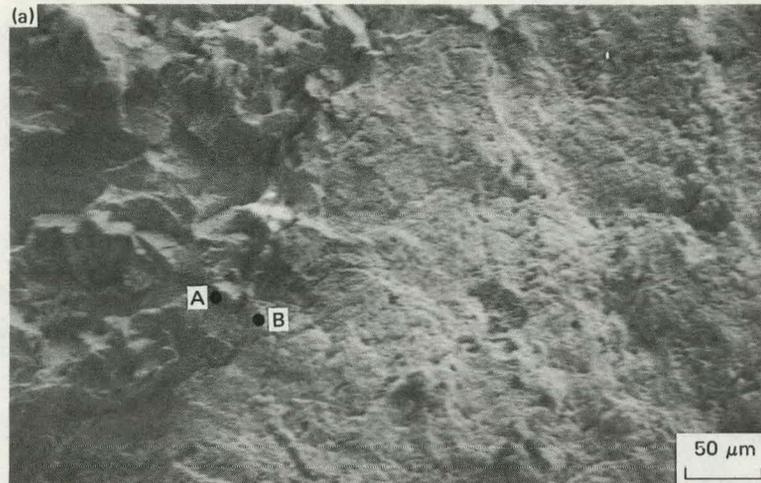
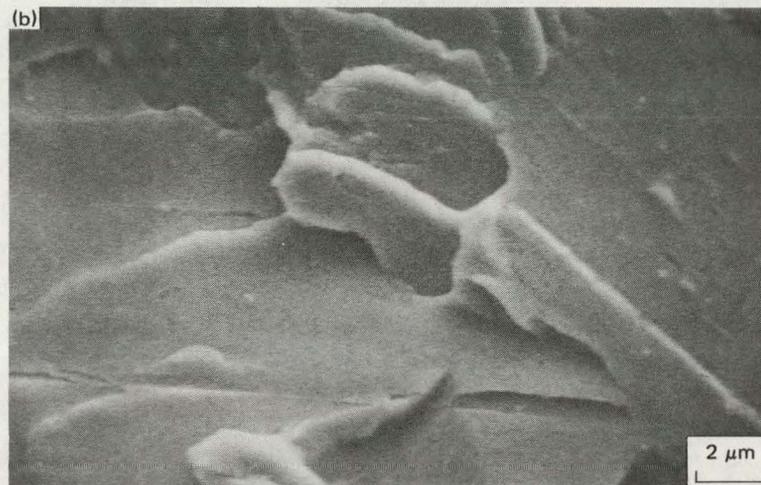
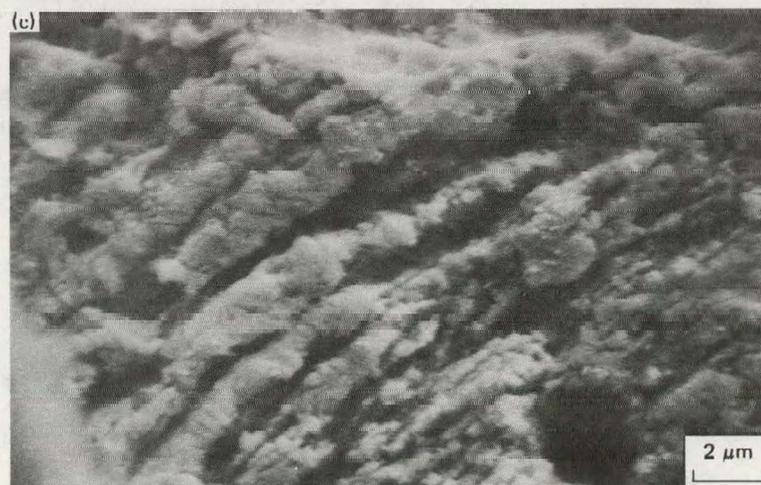
FIG. F.4. SEM fractographs across the interface from a plant crack to the laboratory fracture of a cathodically cleaned crack surface from an H. B. Robinson section. In view (b), note that the laboratory fracture was unattacked while the corrosion product was removed (attacked) revealing, in view (c), a series of ridges on the exposed steel surface suggestive of cyclic events. Views (b) and (c), respectively, are taken at A and B in view (a).
