NUREG/CR-1603
UCRL-53000

Evaluation of Cracking in Feedwater Piping Adjacent to the Steam Generators in Nine Pressurized Water Reactor Plants

Alfred Goldberg, Ronald D. Streit, and Robert G. Scott

Lawrence Livermore Laboratory
7000 East Avenue
Livermore, CA 94550

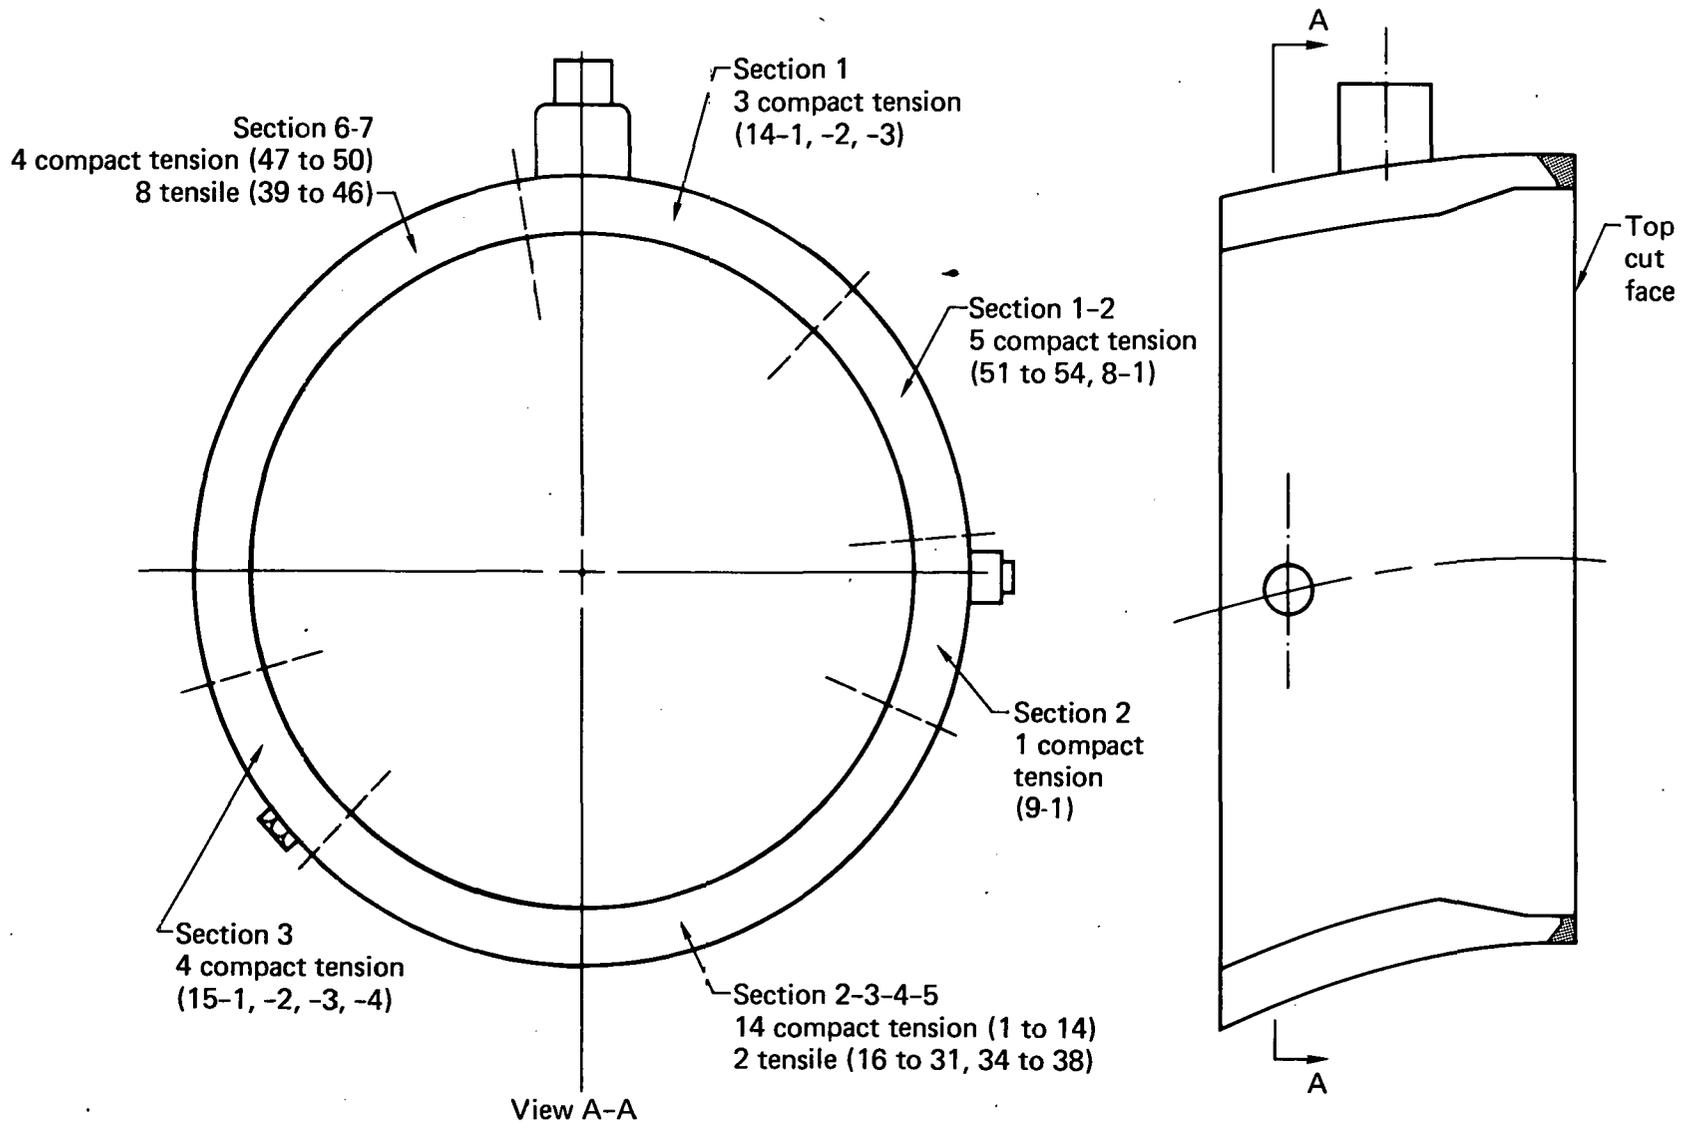
FIG. G.1. D. C. Cook feedwater piping elbow section indicating the general location of compact-tension fracture toughness specimens and tensile specimens.

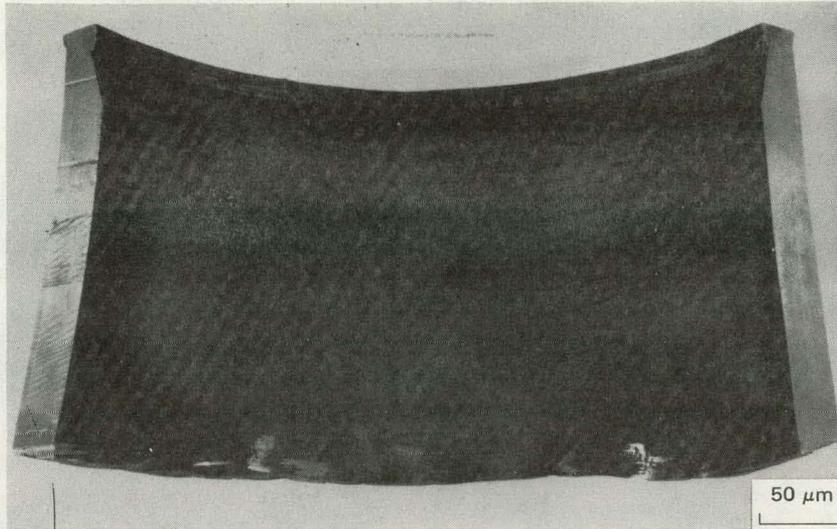
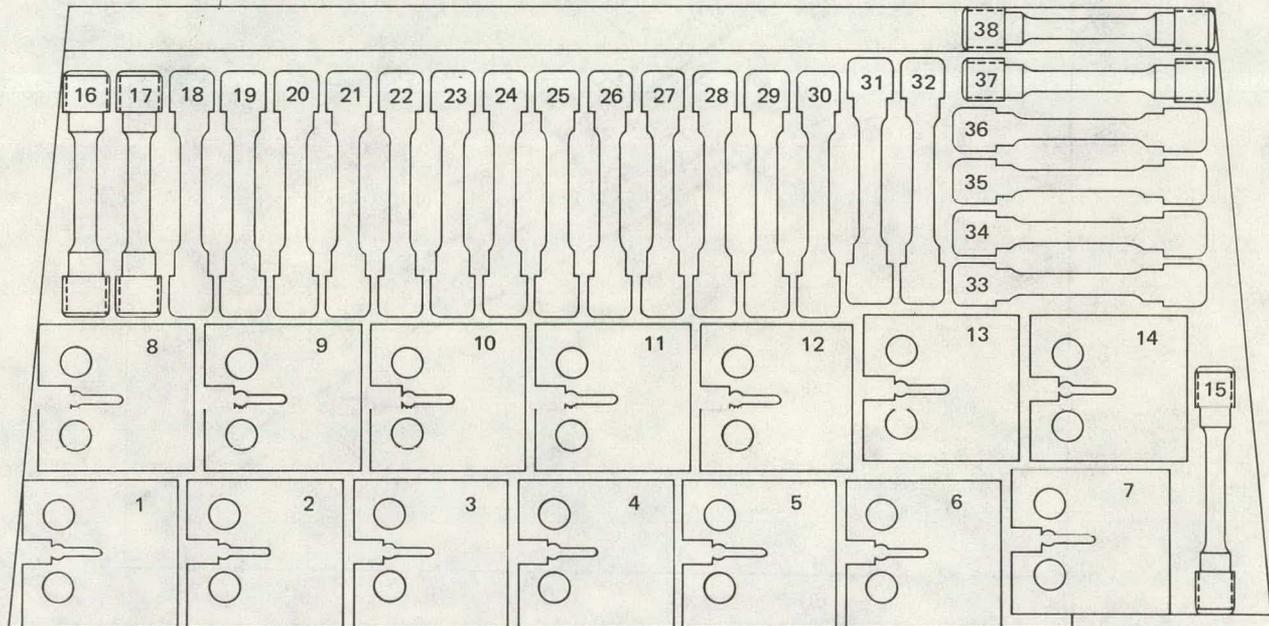
(a) Section 2-3-4-5
(113 to 225°);
as-received

FIG. G.2. Photograph of as-received D. C. Cook elbow section (2-3-4-5 of Fig. G.1) and drawing of layout of specimens for mechanical properties characterization. Specimens 15, 32, and 33 were not machined. Note that the circumferential direction of the elbow is normal to the tensile axis for all specimens except 33 through 38.

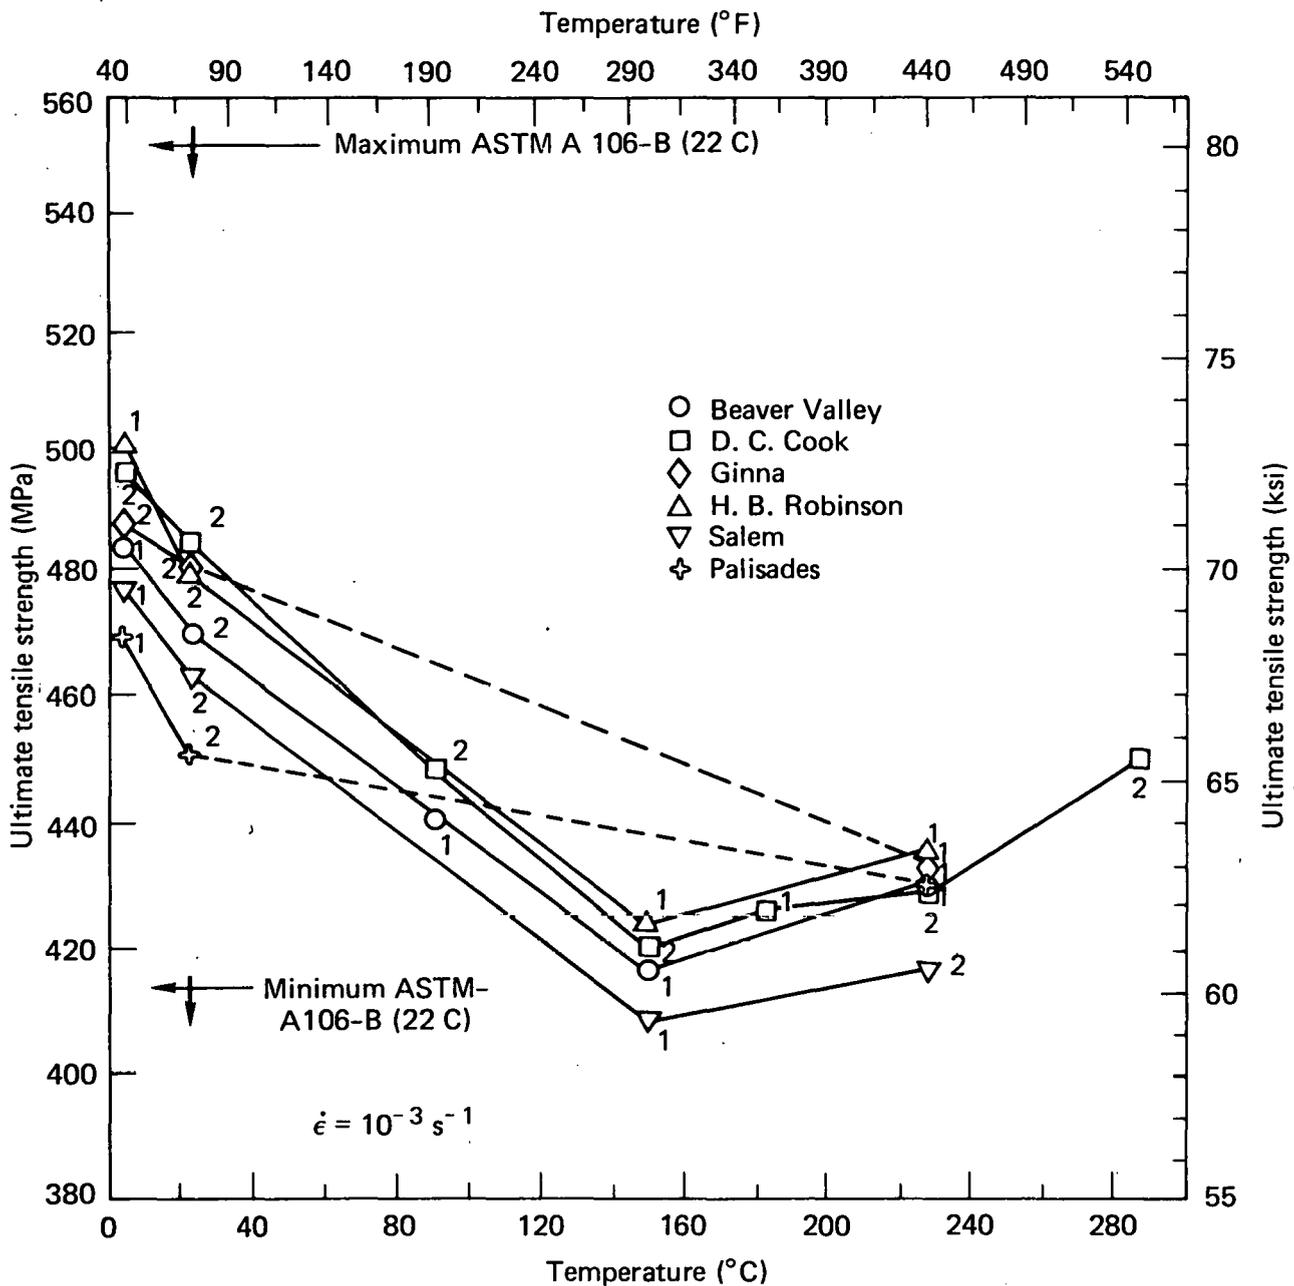
Changes in ultimate tensile strengths (UTS) with temperature are plotted in Fig. G.5. All the data fall well within the ASTM limits specified for A106-B at 22 C (72 F). A distinct minimum in UTS is observed at about 149 C (300 F) for the four plants tested at this temperature. The increase in UTS (and work hardening) at temperatures above this minimum is likely due to solute-dislocation interactions or carbon-vacancy interactions. Similar trends were not obtained for any of the other tensile properties. The corresponding elongation data are shown in Fig. G.6. We note a drop in ductility from 22 C to 4 C (39 F) in several cases, especially for Beaver Valley, and this is probably indicative of being within the ductile-to-brittle transition temperature region. The data show a general drop in elongation with increase in temperature. It should be noted that the elongation axis is a greatly expanded scale, and with the exception of three points, all the data fall between 30 and 39 percent elongation. The rapid drop off from nearly 43 percent at 22 C to 30 percent at 149 C for Beaver Valley is unusual. It is also the only plant that shows an elongation minimum corresponding with the UTS minimum. Of the six plants investigated, Ginna exhibited the lowest elongation to failure: 34 percent at 22 C (72 F) and 25 percent at 227 C (440 F).

FIG. G.5. Tensile strengths as a function of temperature for piping material from six plants tested at the standard strain rate. All data at ambient temperature fall within the limits of A106-B. All materials except from Salem (A106-C) are A106-B. Note the minimum in data from four plants at 149 C (300 F). If more than one test was conducted, average values are plotted. Numbers indicate tests.

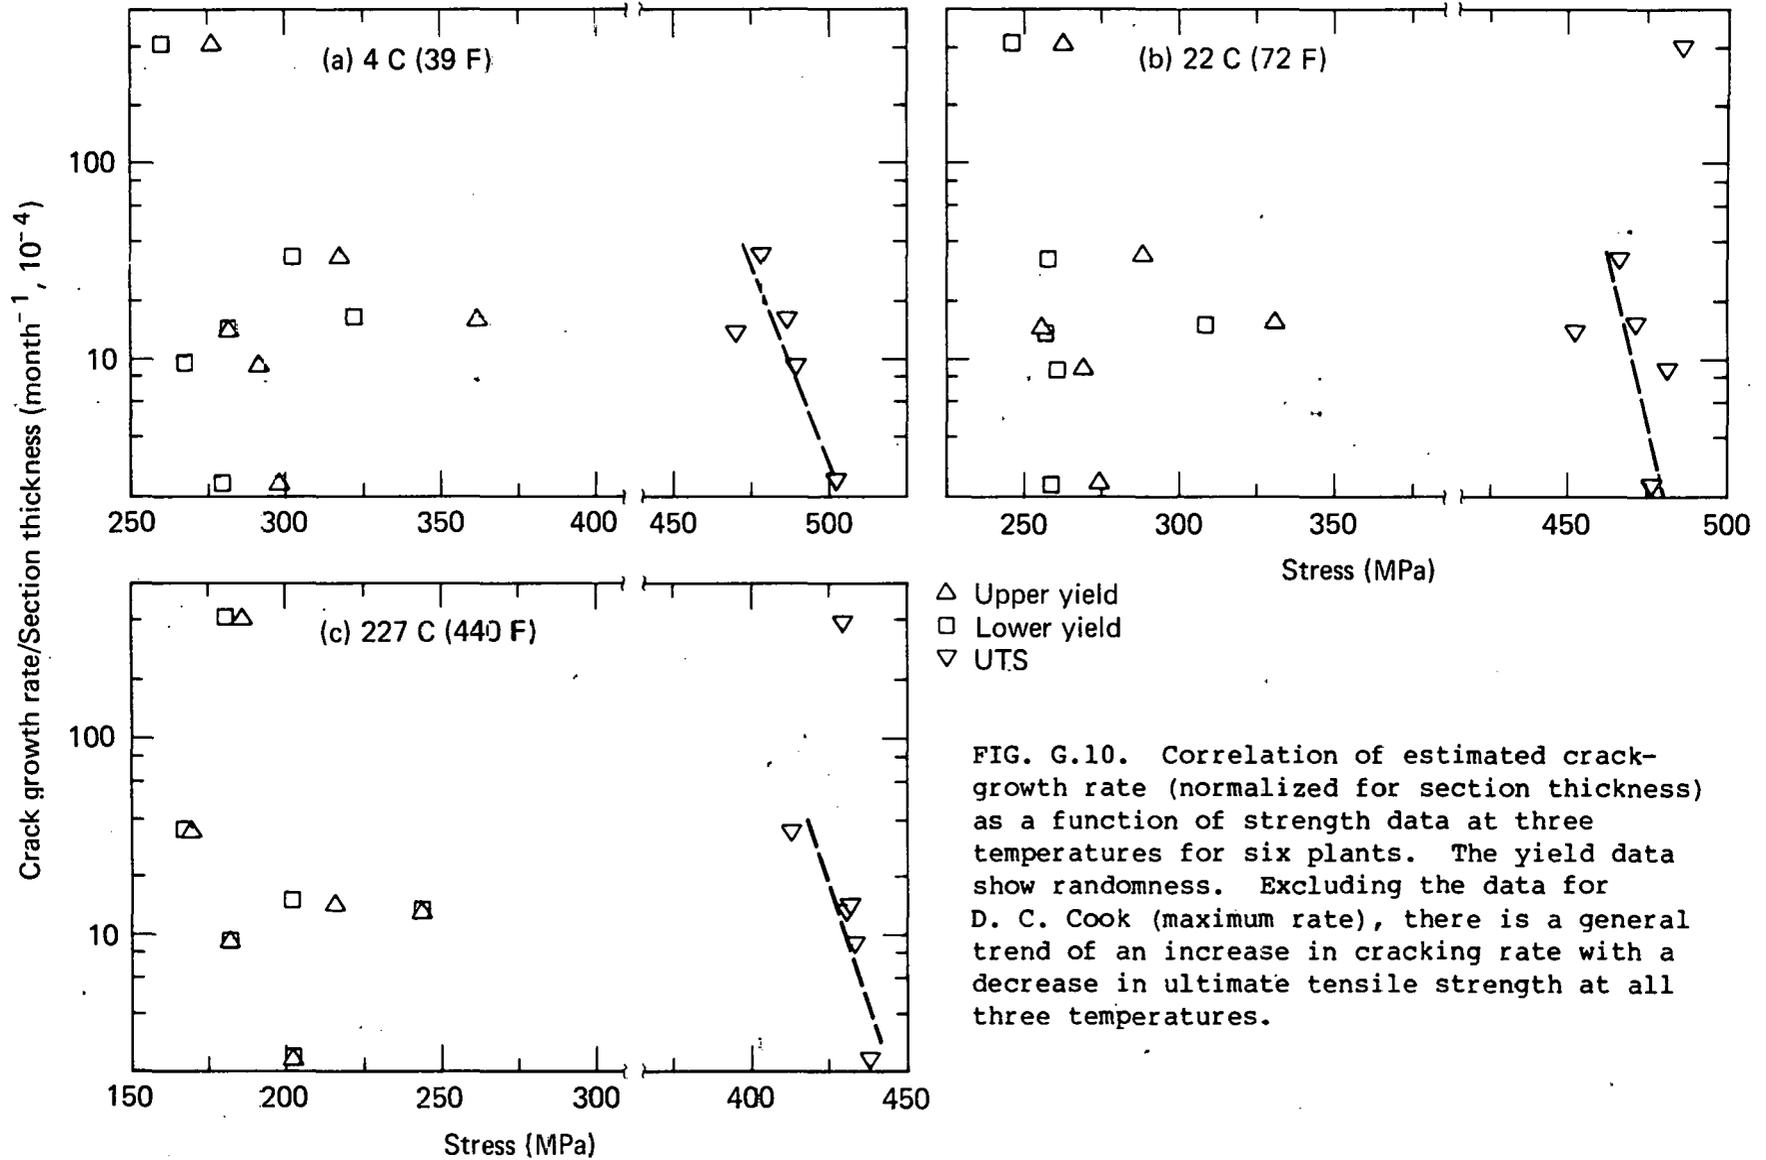
We attempted to relate the yield strengths and UTS to either crack length or crack growth rate with and without corrections for section thickness at the major cracks. Figures G.10(a), G.10(b), and G.10(c) are plots of crack growth versus upper and lower yield strengths and UTS at 4 C (39 F), 22 C (72 F), and 227 C (440 F), respectively. The crack growth rates are divided by the corresponding section thicknesses. Figures G.11(a), G.11(b), and G.11(c) are corresponding plots of crack length versus the same strength values. Correction for section thickness has a negligible effect on the results. As expected, the D. C. Cook data are greatly displaced from the remaining data. The yield data are quite random. However, a rough trend can be detected for the UTS relative to both crack length and crack propagation rate at all three temperatures, in that an increase in UTS roughly results in an apparent increase in resistance to cracking. We question the significance of this trend with UTS as one normally would expect instead a trend with yield strength for either SCC, CF, or fatigue.

FIG. G.10. Correlation of estimated crack-growth rate (normalized for section thickness) as a function of strength data at three temperatures for six plants. The yield data show randomness. Excluding the data for D. C. Cook (maximum rate), there is a general trend of an increase in cracking rate with a decrease in ultimate tensile strength at all three temperatures.
