**INSPECTION OF ALUMINUM COMPONENTS
FROM FREEZE DESALTING FACILITY
AT WRIGHTSVILLE BEACH, NC**

D. G. Melton and T. S. Lee

ANL/OTEC-BCM-007

February 1980

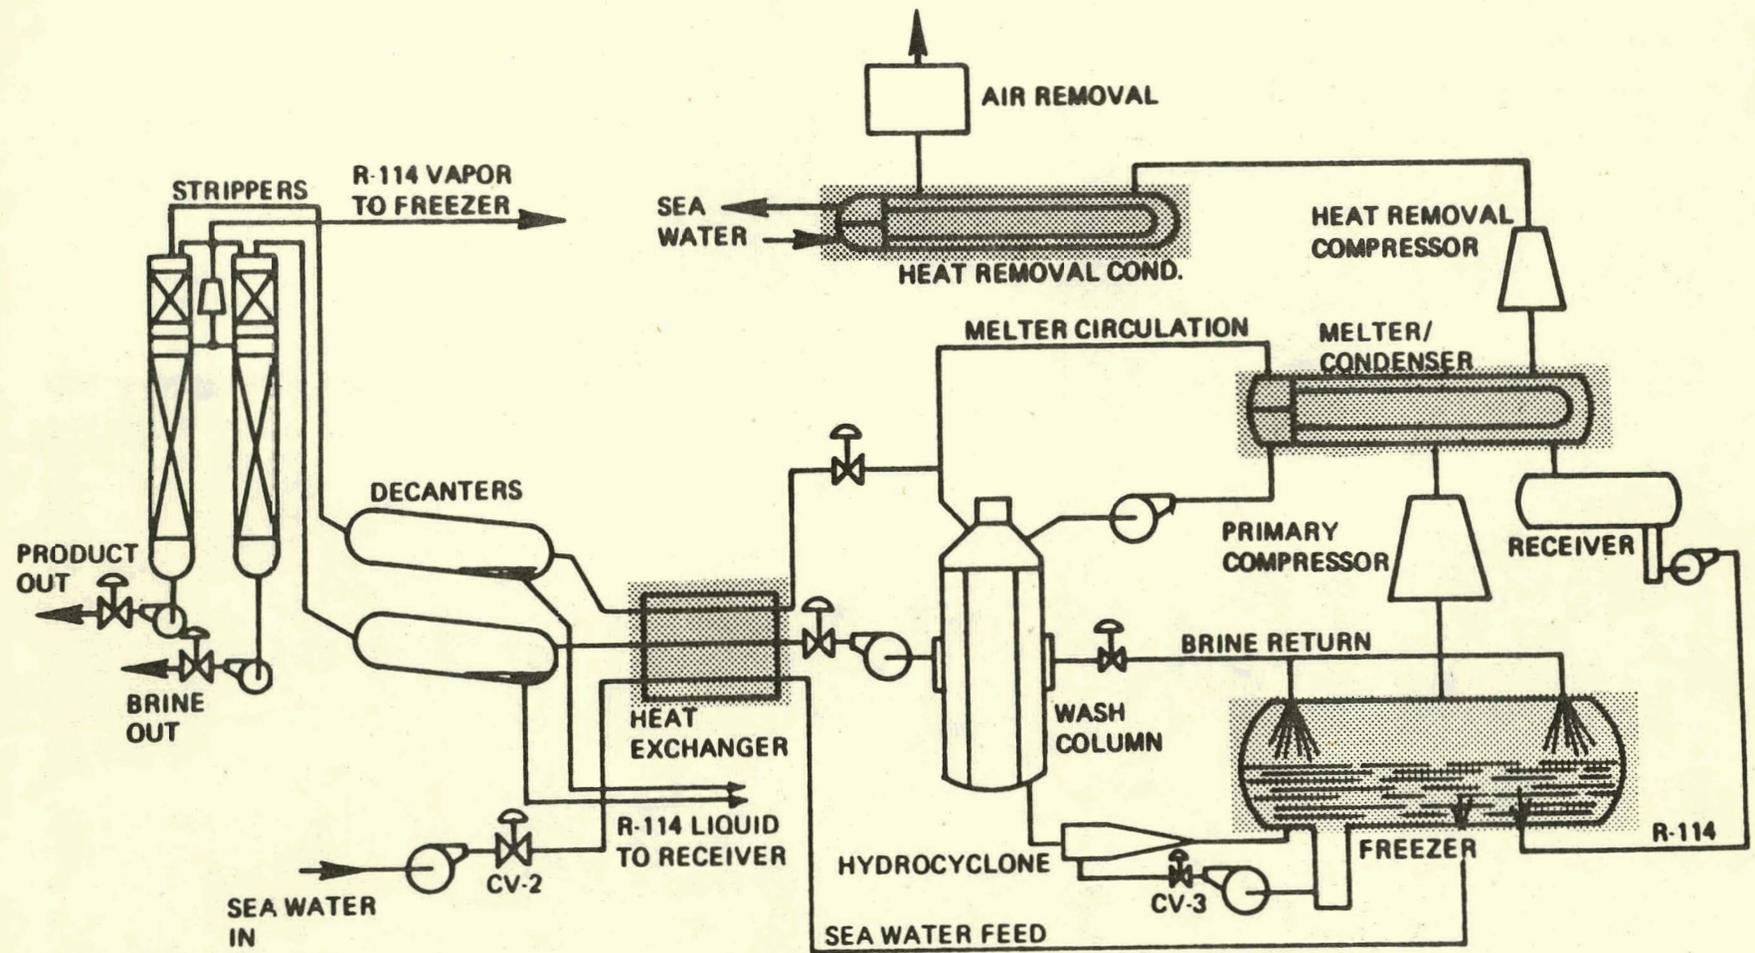
Figure 1. Pilot-plant System

The 240,000-liter-per-day pilot plant constructed by AVCO Systems Division is a direct-contact secondary refrigerant freeze desalting plant utilizing refrigerant R-114 (Dichlorotetrafluoroethane) as the working fluid. The performance of this plant is documented in two AVCO reports.^{1,2} The simplified operation of this process¹ is shown schematically in Figure 1, with the inspected components shaded for clarity. An overview of the facility is shown in Figure 2.

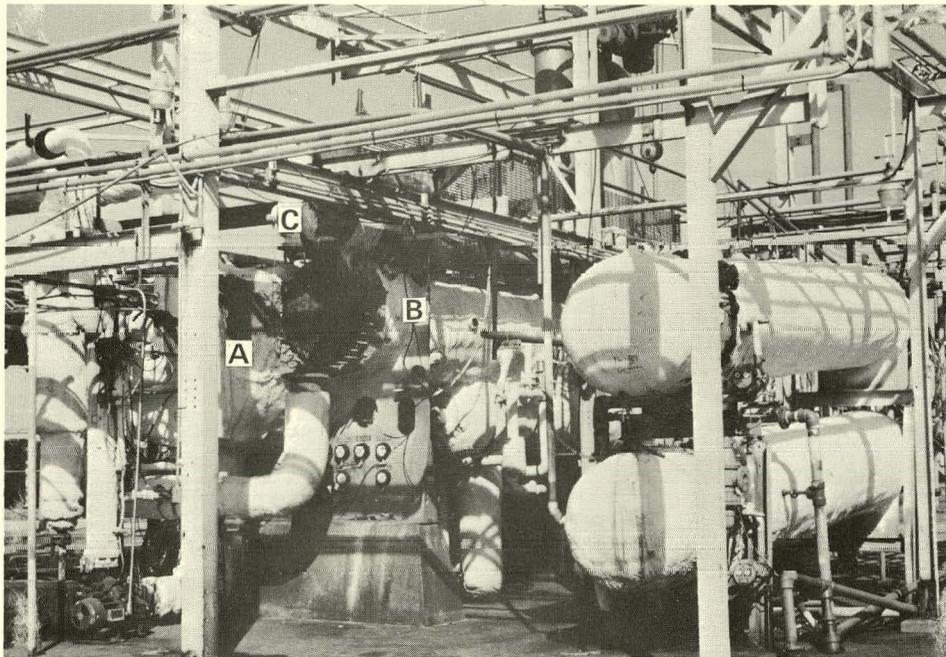
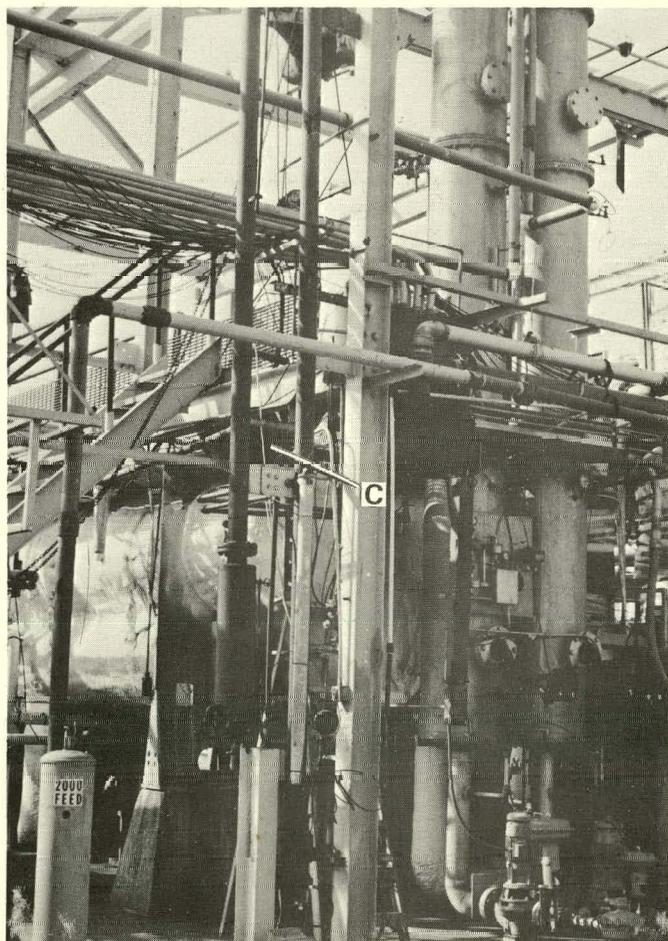
Figure 2. Overview of AVCO Desalting Pilot Plant. (A) Freezer, (B) melter-condenser, and (C) heat-removal condenser.

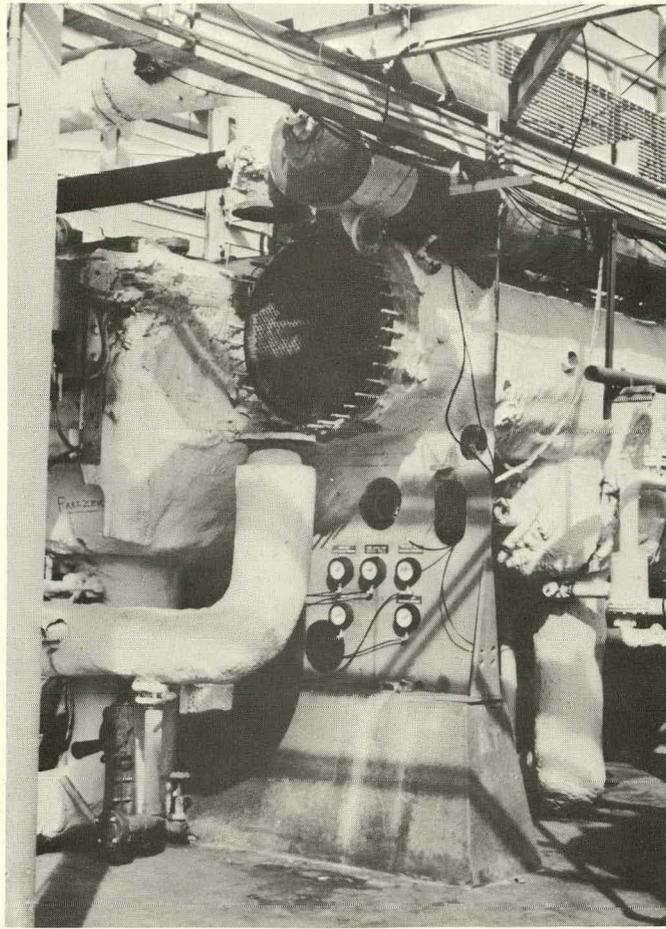
The melter-condenser condensed refrigerant vapor on the shell side while melting an ice slurry from the freezer on the tube side. This unit, as originally constructed, was a 1-meter-OD by 8-meter-long heat exchanger with a U-tube configuration. The tube sheet (Figure 11) and water box (Figure 12) were fabricated from aluminum alloy 5083 and the U-tubes of aluminum alloy 3003 with external fins.¹ Due to many failures attributed to vibration, gas impingement, and corrosion,² the melter-condenser was retubed in January 1977 with straight tubes of aluminum alloy 5052.² In order to use the straight tubes, a floating head had to be installed, and a row of tube holes in the tube sheet was plugged as shown in Figure 13.

Figure 11. Overall View of Melter-Condenser
with Water Box Removed.

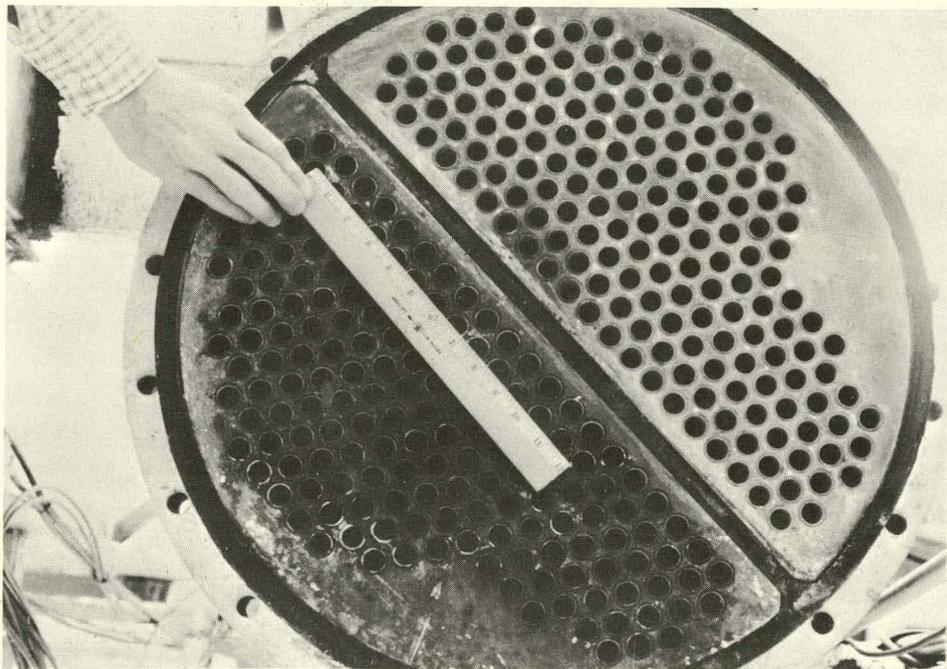
The heat-removal condenser, a 0.6-meter-diameter by 8-meter-long unit, used seawater on the tube side to condense the remaining refrigerant vapor from the melter-condenser. Originally this unit, a two-pass U-tube heat exchanger, was constructed with aluminum alloy 6061 for the shell and water box and aluminum alloy 3003 for the tubes.¹ Several very small leaks developed between 1974 and 1976 and were reported as being due to corrosion or erosion of the tubes.² Therefore, in January 1977, the heat-removal condenser was retubed with aluminum alloy 5052-0.^{2,3} This heat exchanger and its water box, as shown in Figures 17 and 18, have been in operation with the pilot plant since 1974.

Figure 17. Overall Appearance of Tube Sheet
on Heat-removal Condenser

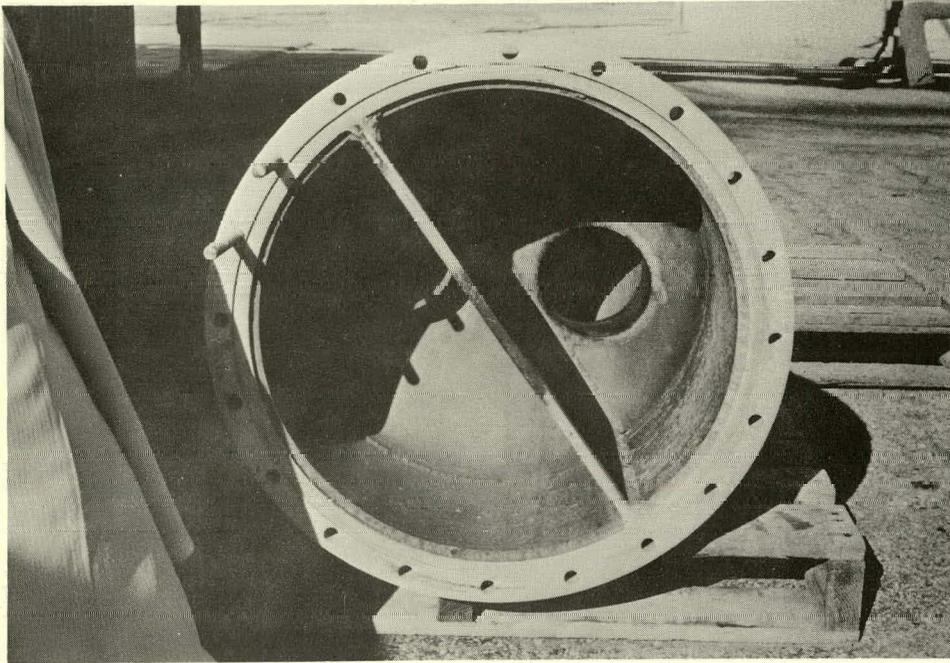
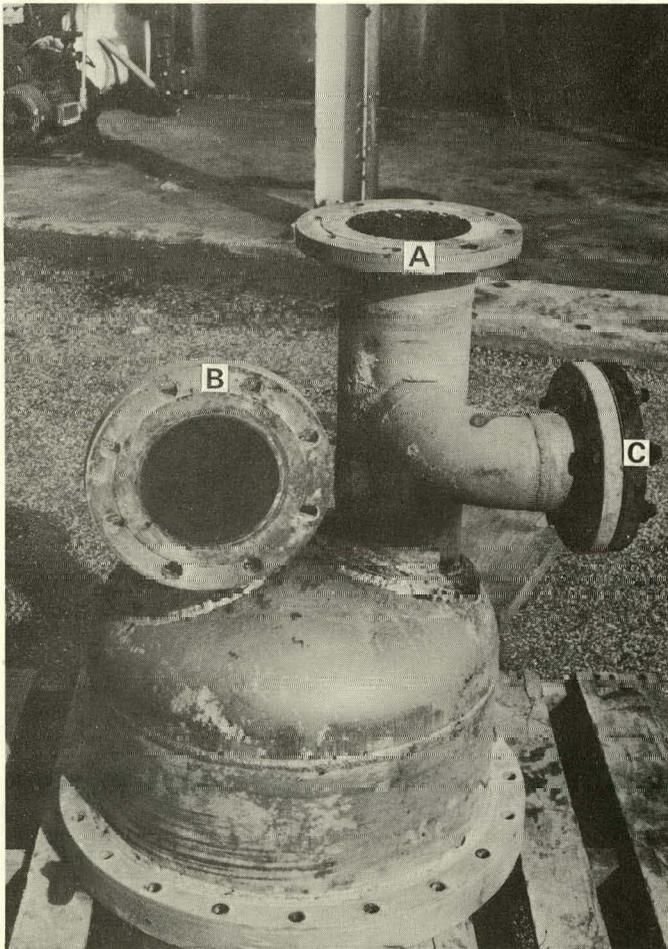
Figure 18. Appearance of Heat-removal Condenser Water Box. (A) Inlet, (B) discharge, and (C) steel blank and bolts.
