GEAP-4360
AEC RESEARCH AND
DEVELOPMENT REPORT
SEPTEMBER 16, 1963

FUEL FAILURE EXAMINATIONS AND ANALYSES IN THE HIGH POWER DENSITY PROGRAM

By
W.H. ARLT
S.R. VANDENBERG

VALLECITOS ATOMIC LABORATORY

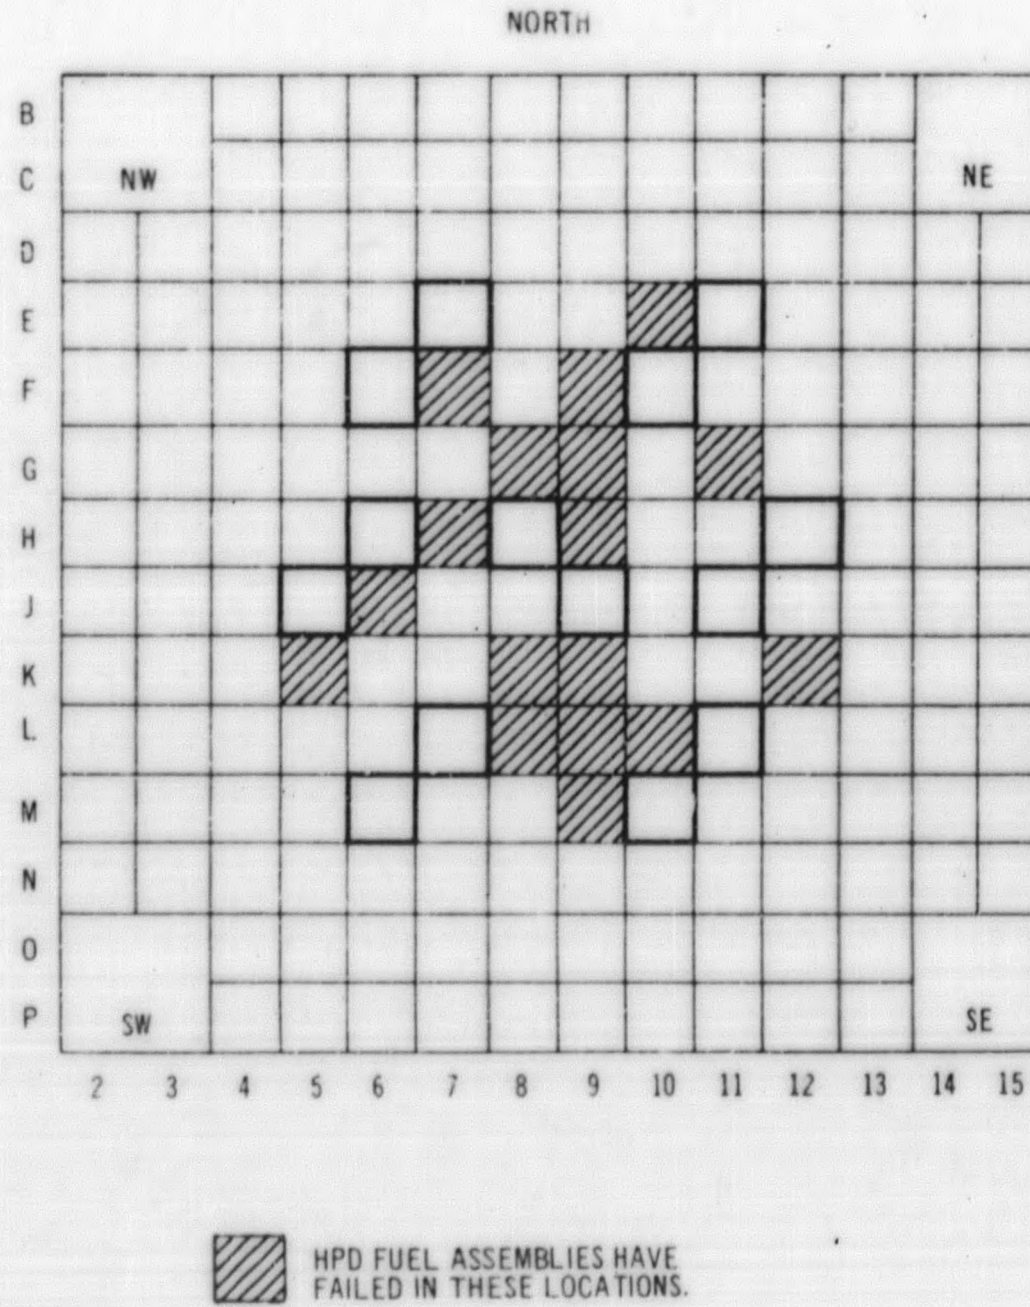
Figure 2. VBWR Core Plot: Locations Where Failures Have Occurred

Table IV tabulates the operating history of all assemblies in the Task 1B group. During the months of February, April, July, August, and September, 1962, seven fuel assemblies were removed from VBWR because of indications of high activity release as measured by flux tilting and sipping techniques. Subsequent to this in the early part of 1963 through June additional failures have occurred in both Task 1A and 1B. Table V lists the core position at the time of failure and the approximate date of failure. Figure 2 shows in schematic form where the above failures occurred in-core.

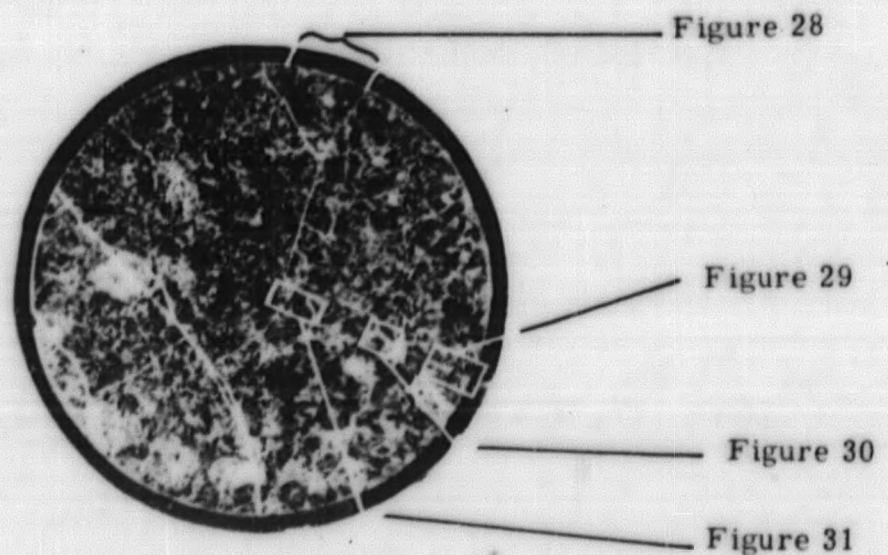
Figure 25. Metallographic Specimen from HPD 1G, Rod B

The cross section of the clad and fuel is shown in Figure 25 with typical photomicrographs indicated.

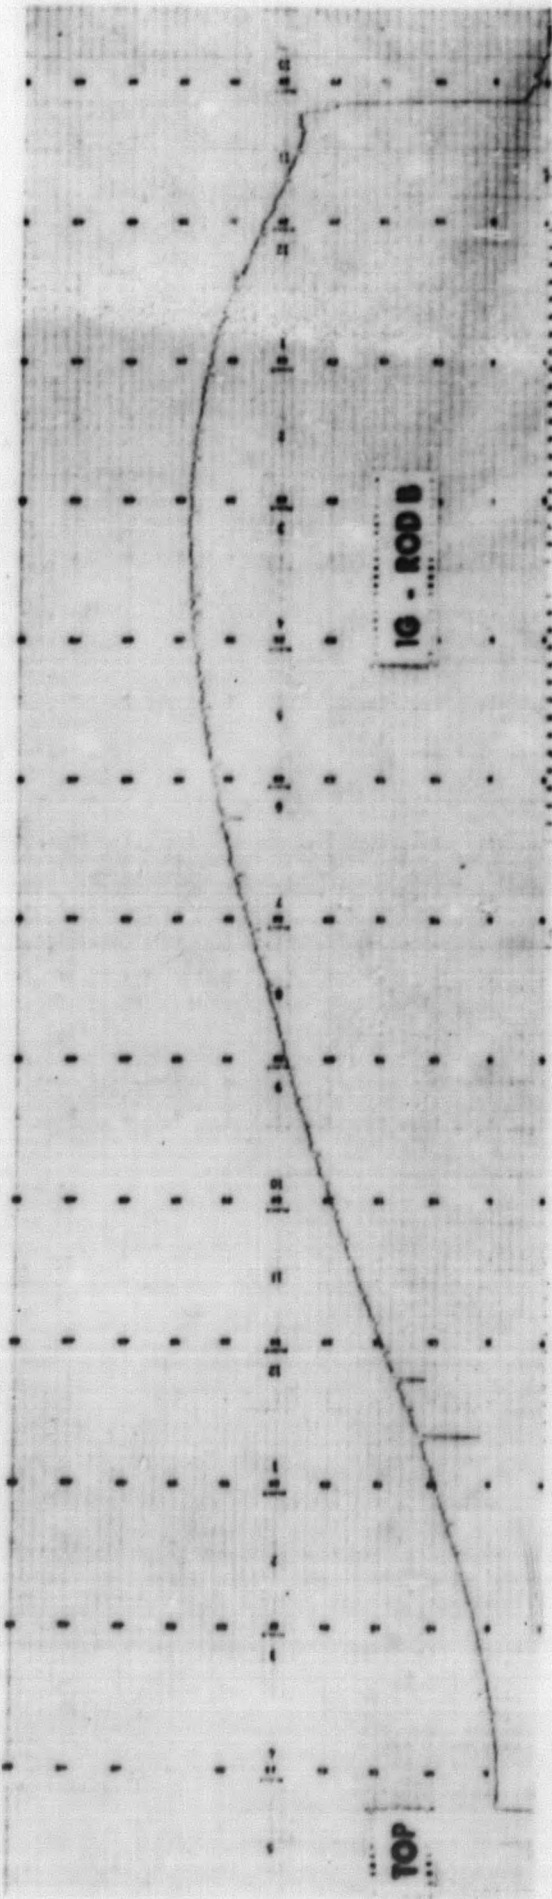
Figure 26. Gamma Scan of HPD 1G, Rod B

A gamma scan, Figure 26, was run on the rod to determine the exact location of the peak flux zone. The rod was then sectioned at this zone for a metallographic sample.

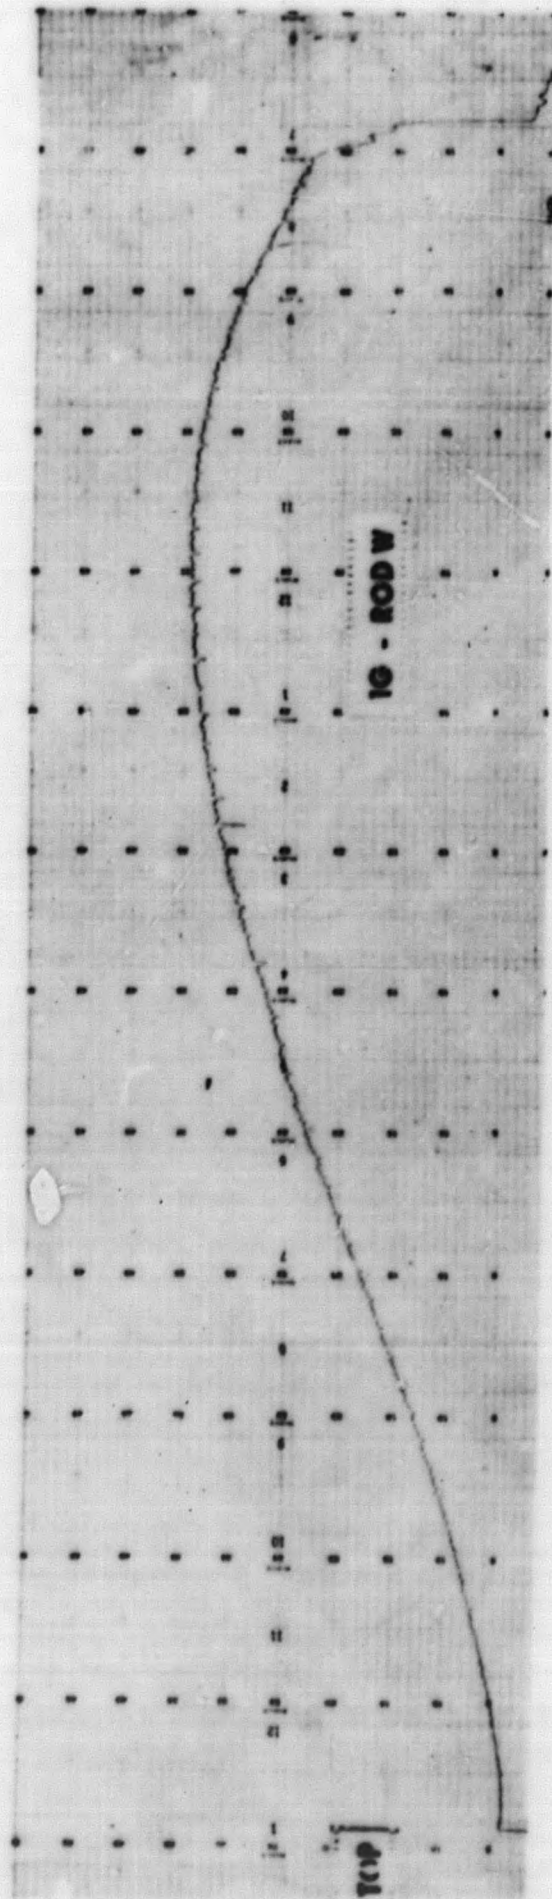
Figure 27. Gamma Scan of HPD 1G, Rod W

Rod W exhibited the same appearance metallographically as Rod B. A gamma scan of Rod W is shown in Figure 27.

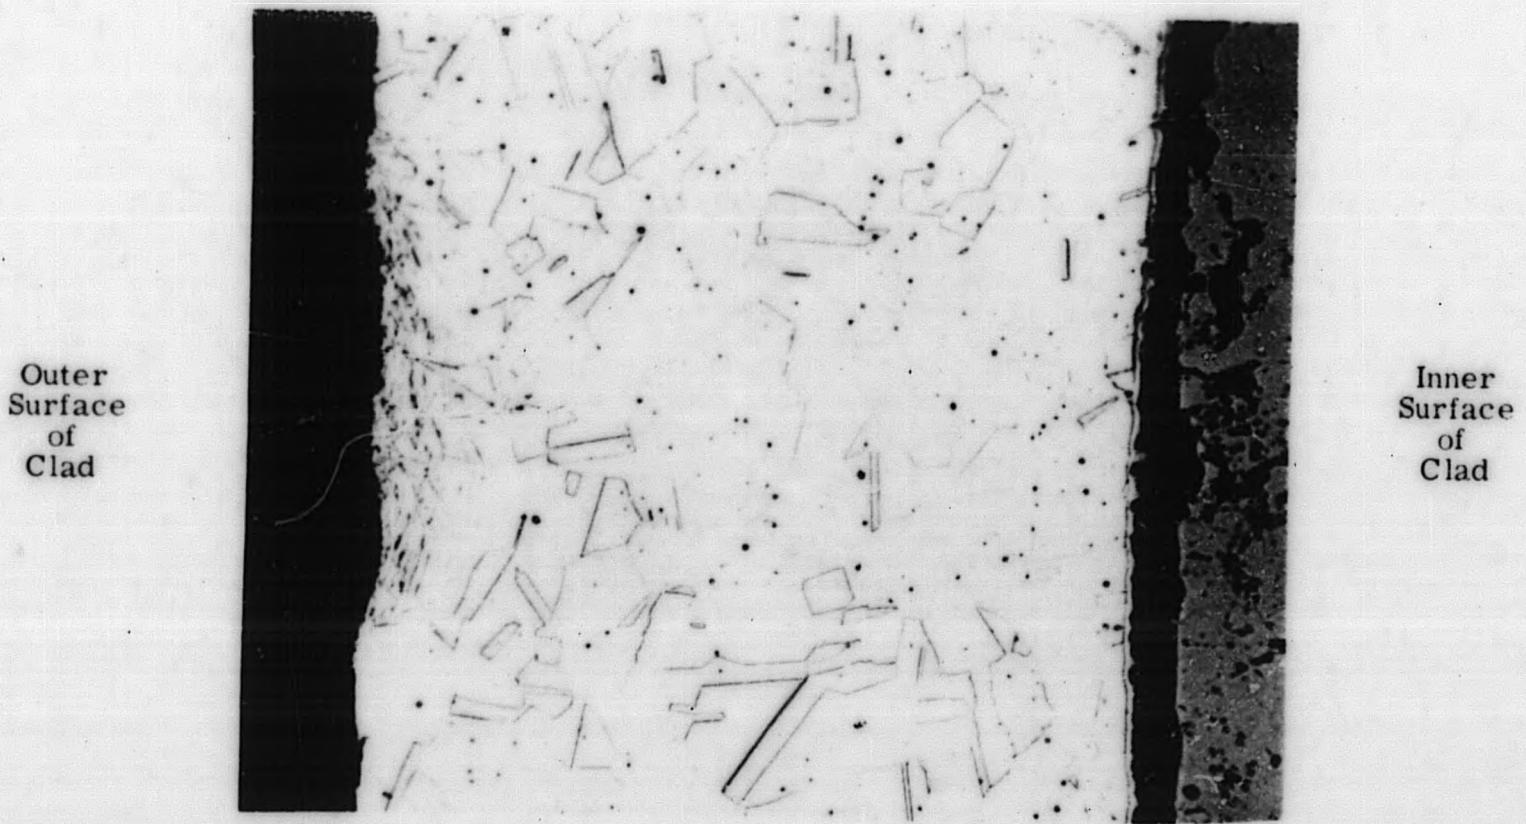
Figure 28. Cross Section of Clad from HPD 1G, Rod B

The cladding, prior to irradiation, was in the commercially annealed condition. The absence of slip-lines in the microstructure shown in Figure 28 is typical of annealed material. The narrow zone observable at the inner surface of the clad is believed due to fission fragments and is typical of stainless steel cladding studied in the HPD program. The metallographic investigations with the optical microscope thus far have been unable to detect any significant sensitization of the clad structure. The small cold-worked dent at the surface of the section shown in Figure 28 is of unknown origin.

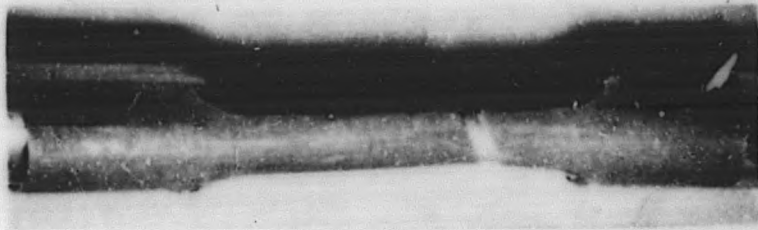
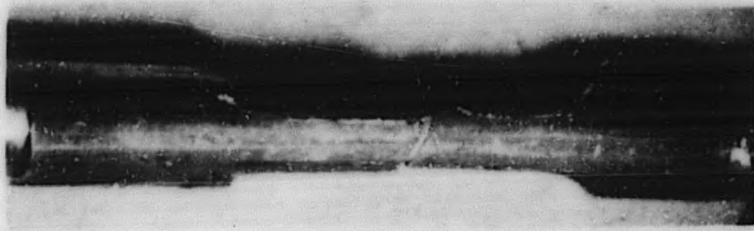
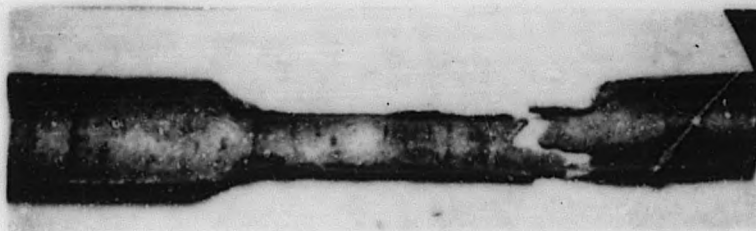
Figure 38. Photographs of Tensile Specimens After Testing at 625 F

(c) Samples contained longitudinal cracks

Irradiated ($\times 10^{21}$ nvt)
Initially Cold Work Clad (Rod R)
Sample Contained Longitudinal Cracks

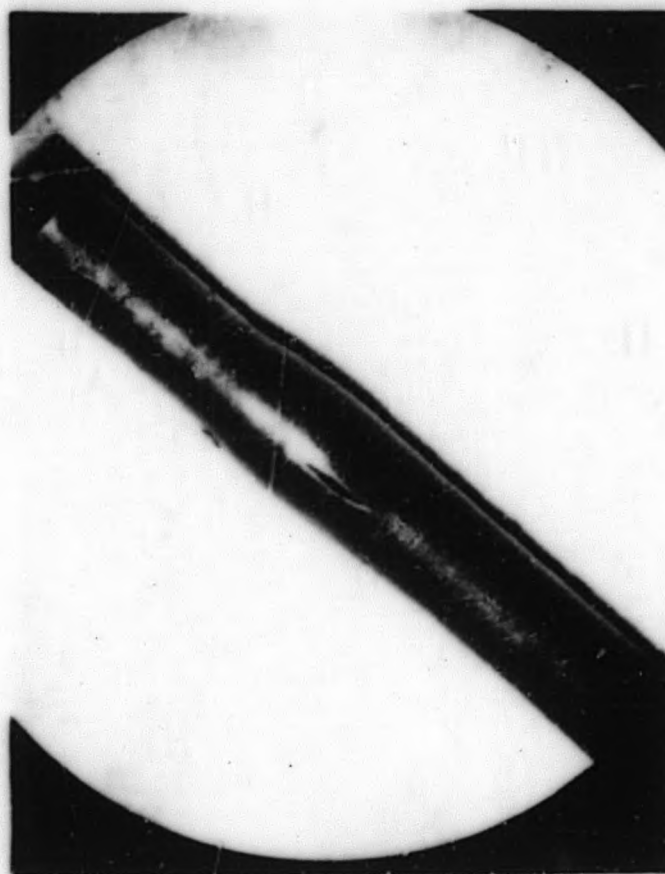
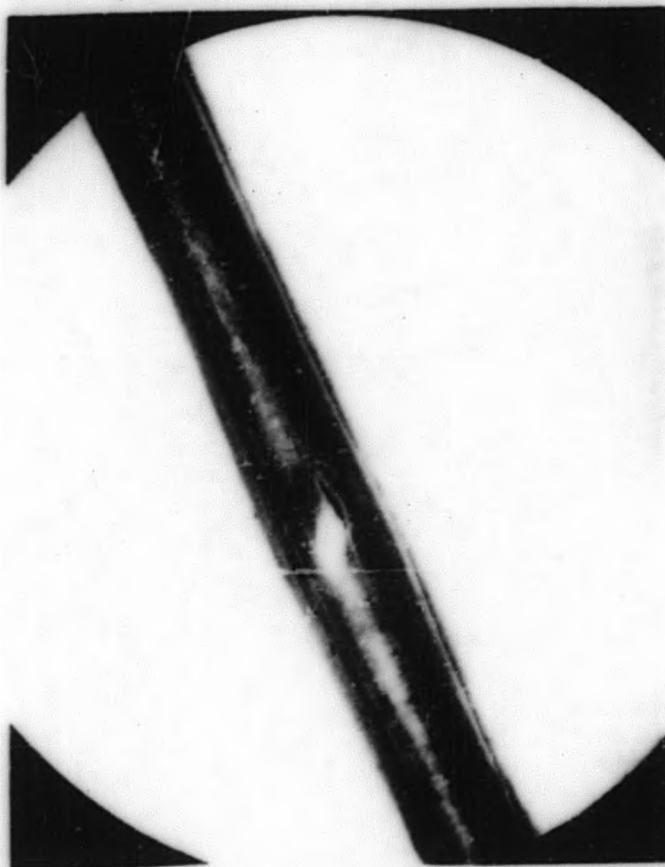
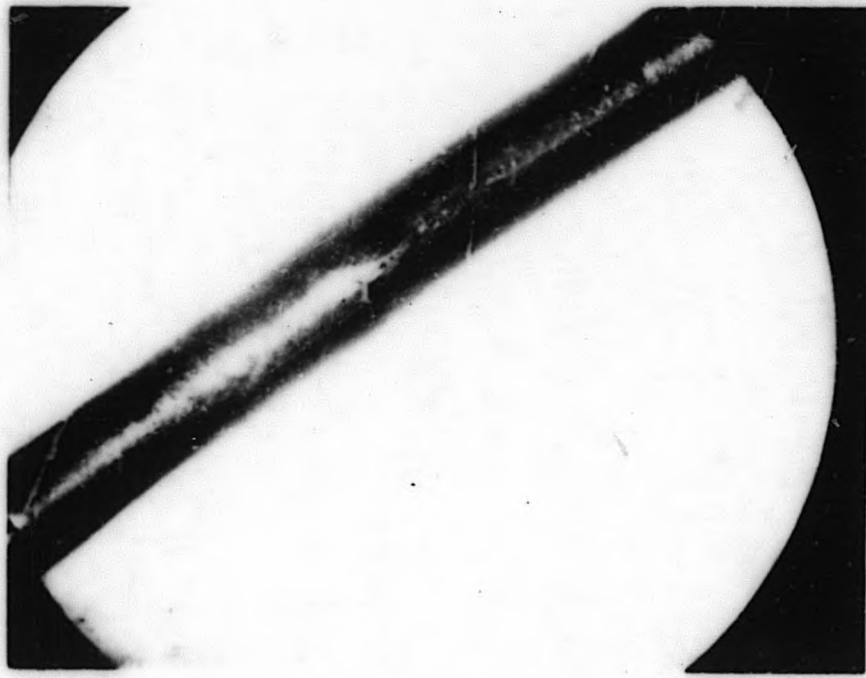
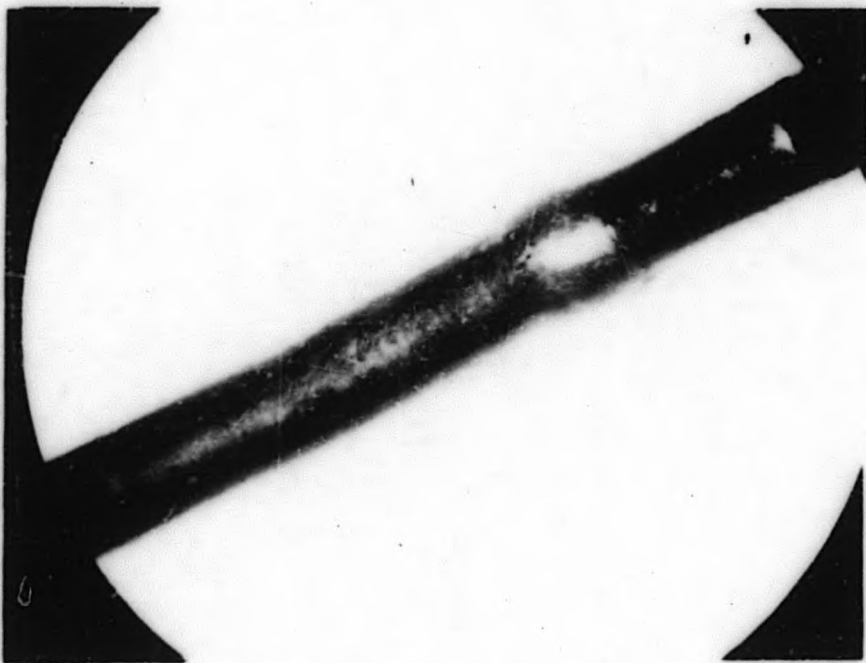
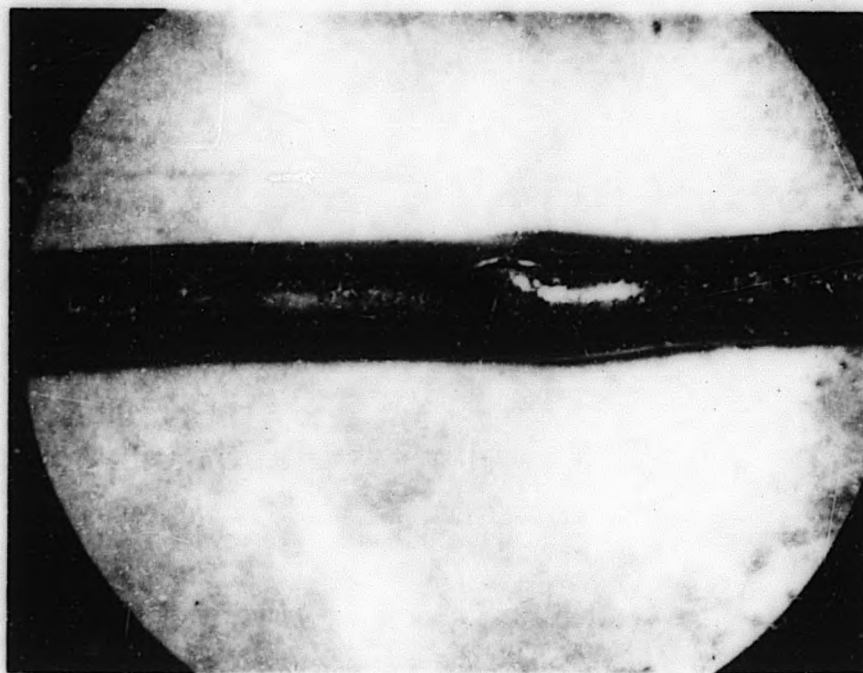
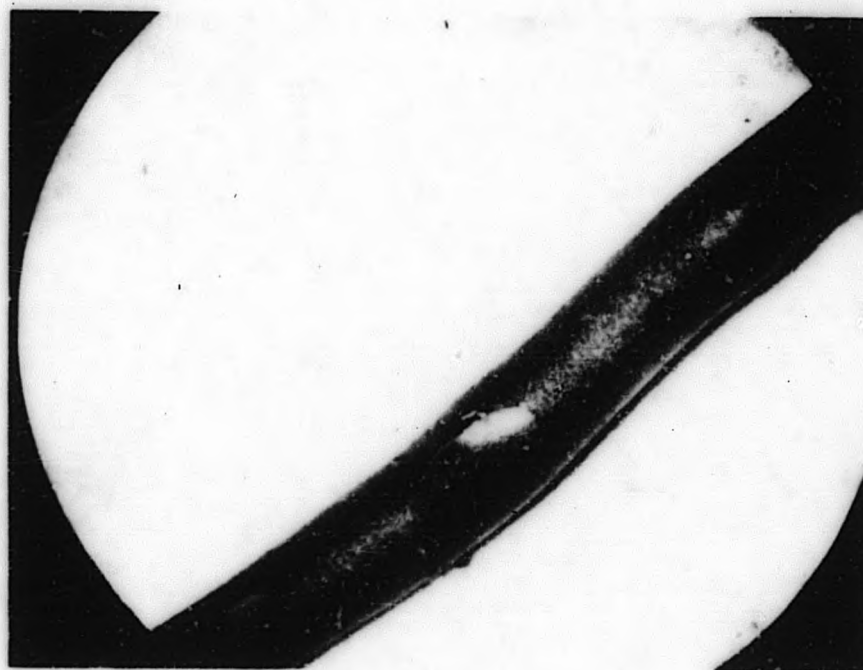
Figures 44 through 49 reveal that appreciable ductility is present in the irradiated cladding (average exposure $\sim 6,000$ MWD/t and maximum exposure $\sim 9,600$ MWD/t).

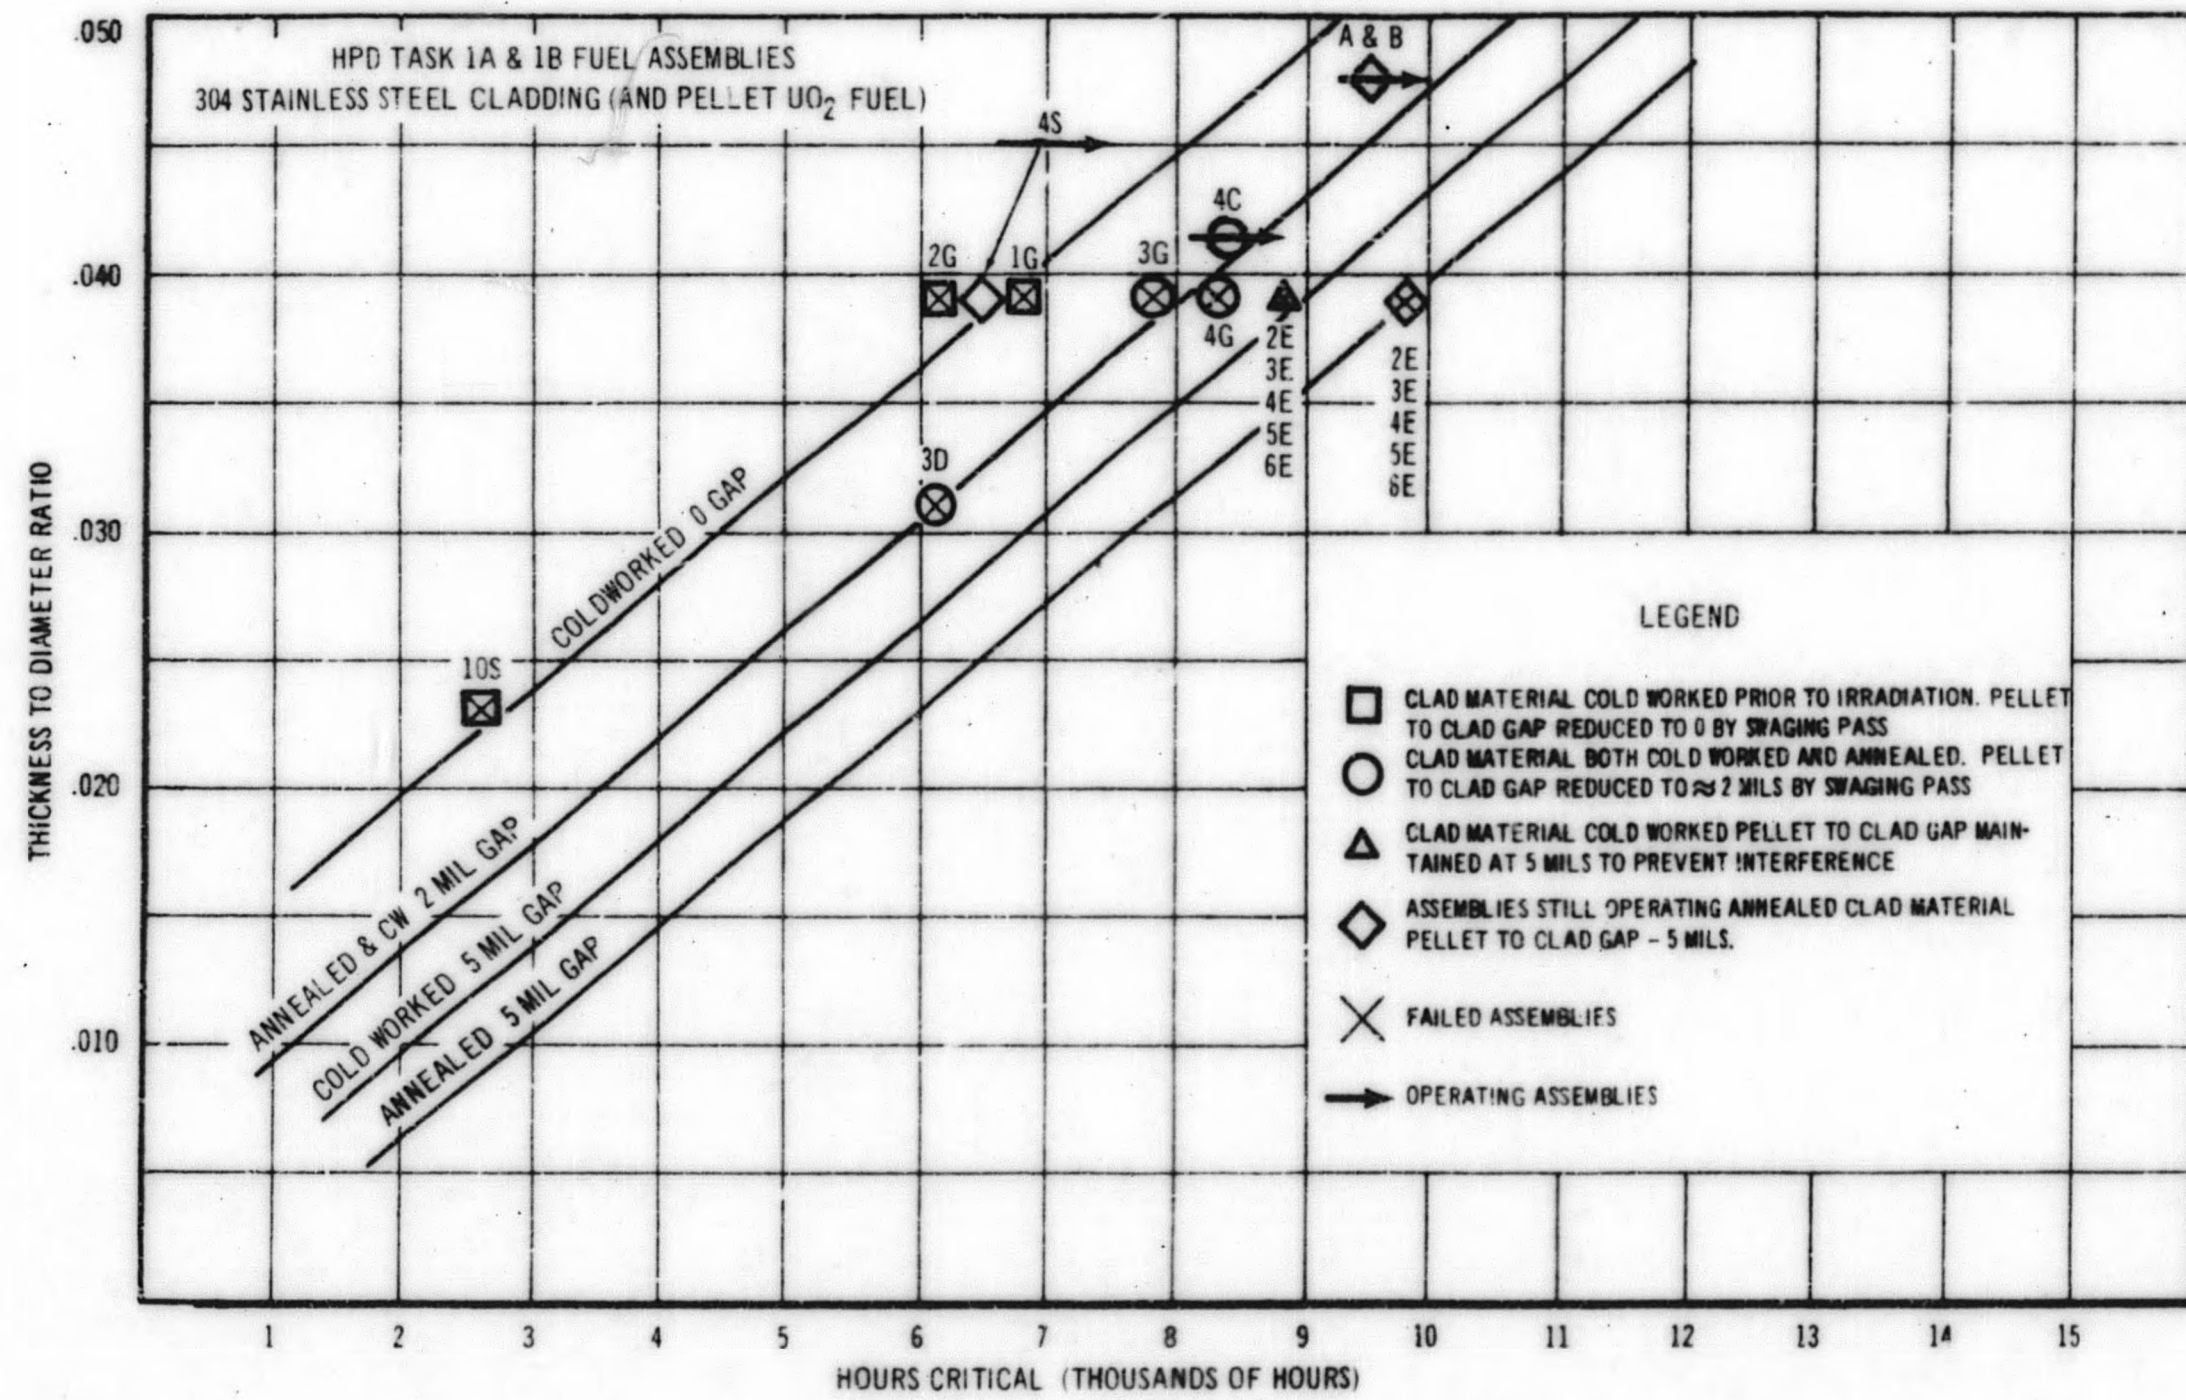
Figure 50. Fuel Lifetime (hours critical) vs t/D for Operating Fuel and Failed Fuel

It appears that the chemical environment, peculiar to the reactor coolant and the effects of irradiation, is a significant factor in initiating and propagating corrosion attack. The intergranular nature of the clad cracks indicates preferential corrosion attack with the presence of high stresses being a necessary or accelerating effect. A tentative correlation is proposed as shown in Figure 50 combining the effects of stress, corrosion and time. The variables in Figure 50 represent:

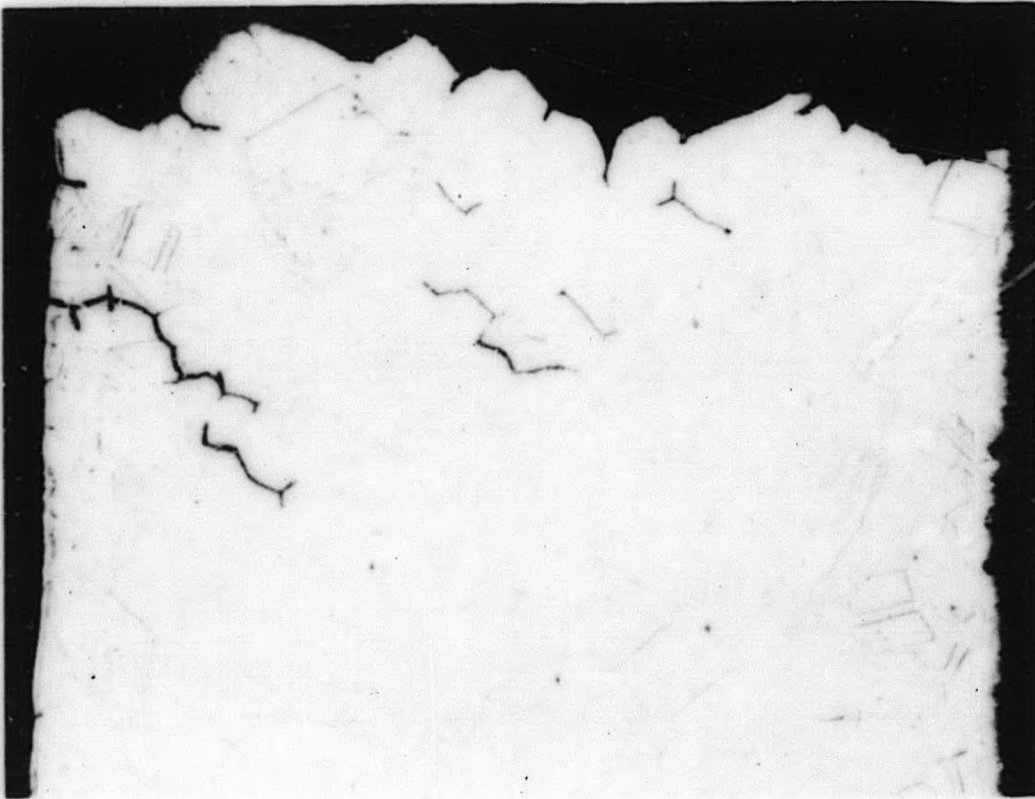
Figure 53. Circumferential Cracks in Rod C, HPD 4E

A metallographic section revealed that the cracks are intergranular. See Figures 52, 53, 54, 55 and 56.

Complete destructive exam in progress.

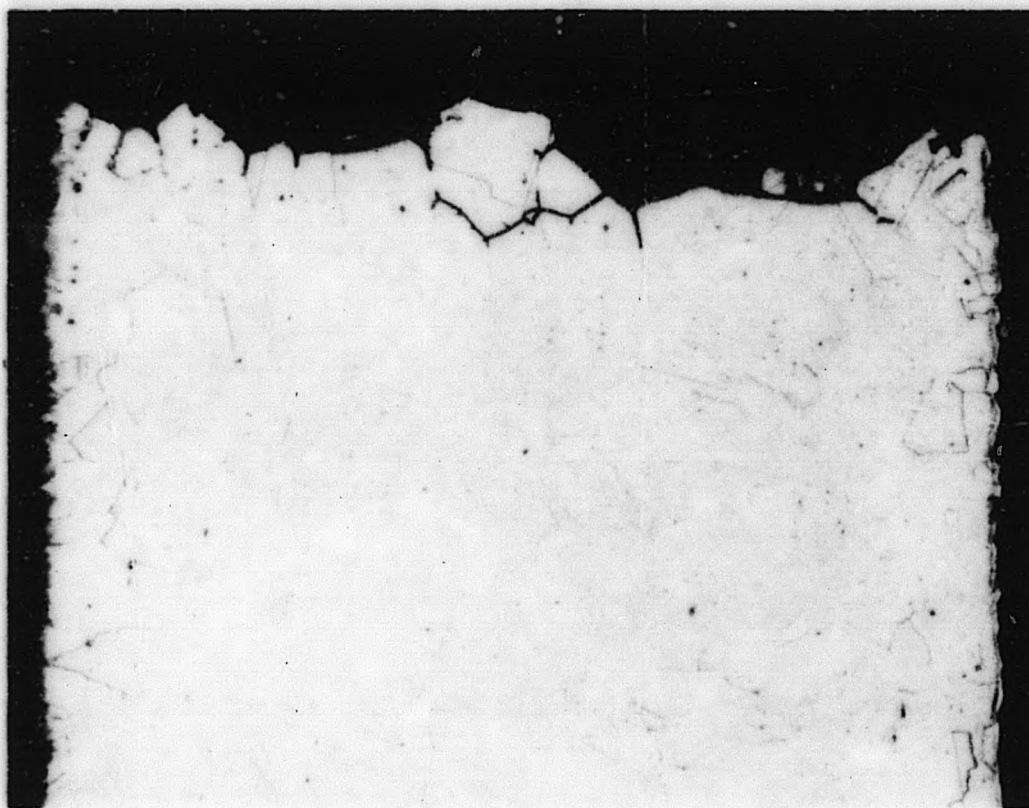
Figure 54. Circumferential Cracks in Rod C, HPD 4E

Complete destructive exam in progress.

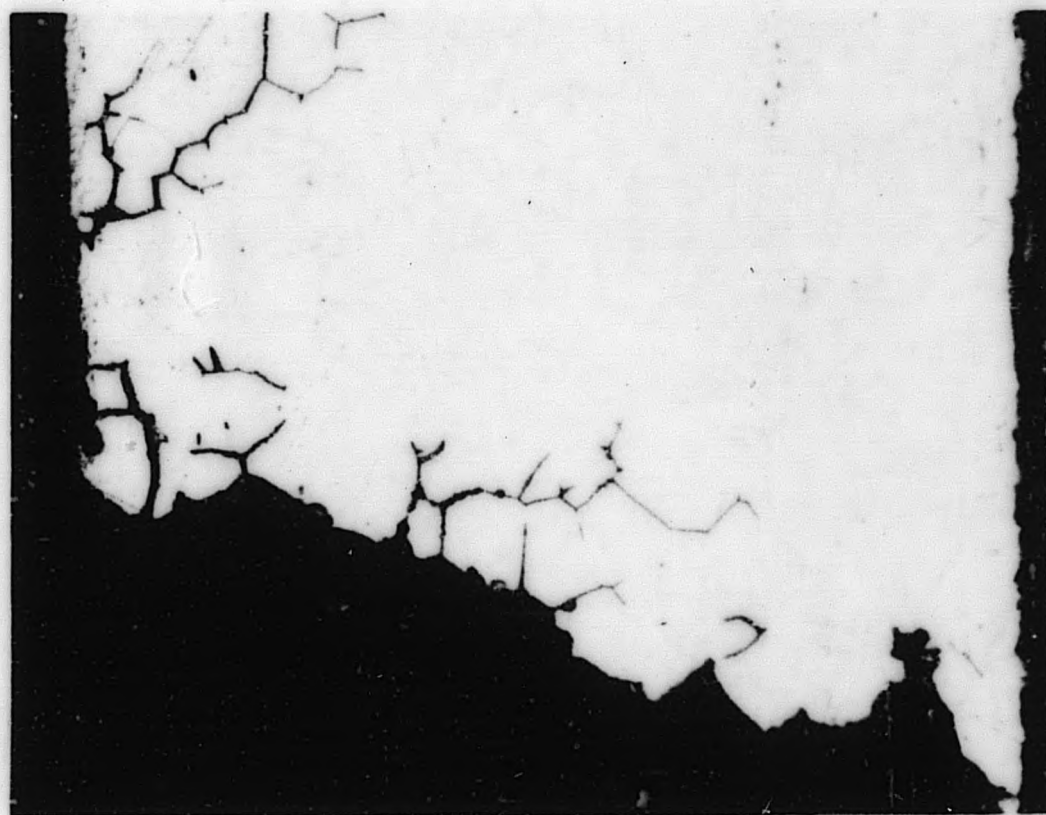
Figure 55. Circumferential Cracks in Rod C, HPD 4E

Complete destructive exam in progress.
