NUREG/CR-1715
EGG-2061

Fuel Rod Behavior During Tests PCM 8-1 RS, CHF Scoping, and PCM 8-1 RF

November 1980

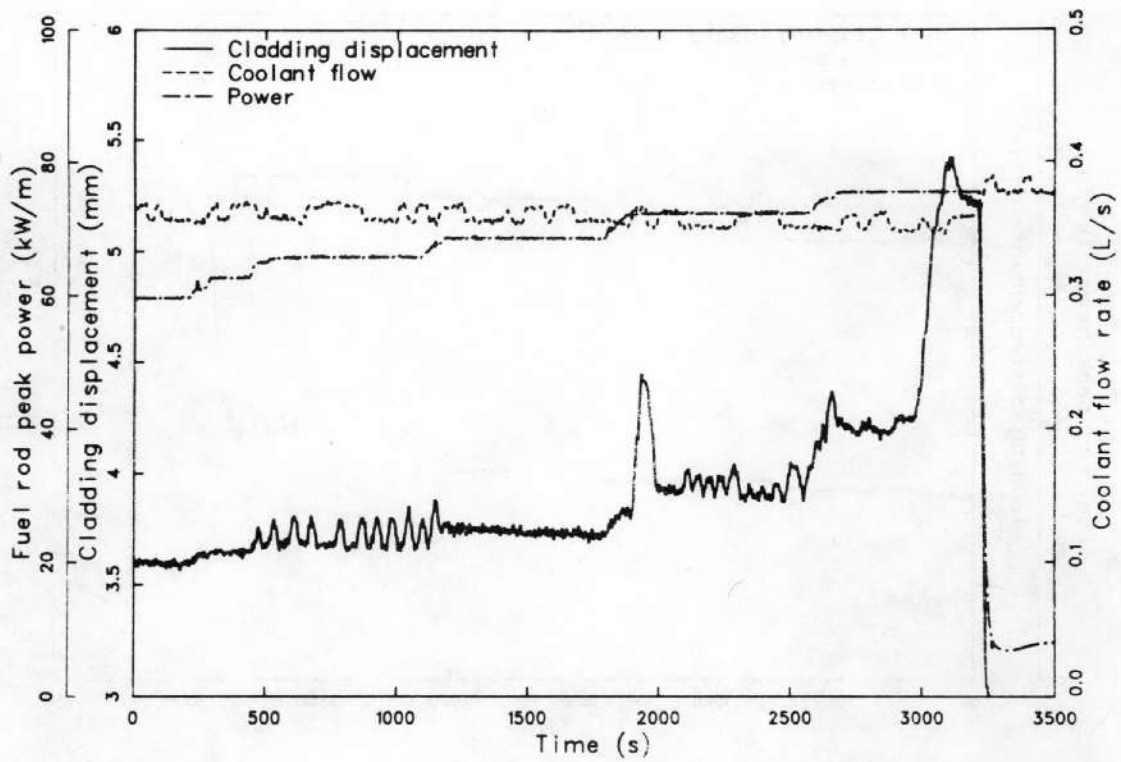
Figure 6. Fuel rod peak power, cladding displacement, and coolant flow rate versus time during Test 8-1 RS (DNB Cycle 3).

Departure from nucleate boiling Cycles 1 and 3 were terminated by manually decreasing the reactor power. No film boiling was apparent when Cycle 1 was terminated. Film boiling had occurred for about 200 s before termination of Cycle 3 (see Figure 6). Cladding surface thermocouples indicated that rewet occurred within a few seconds after the power decrease was initiated. A rapid recovery was also indicated by the fuel rod elongation measurement.

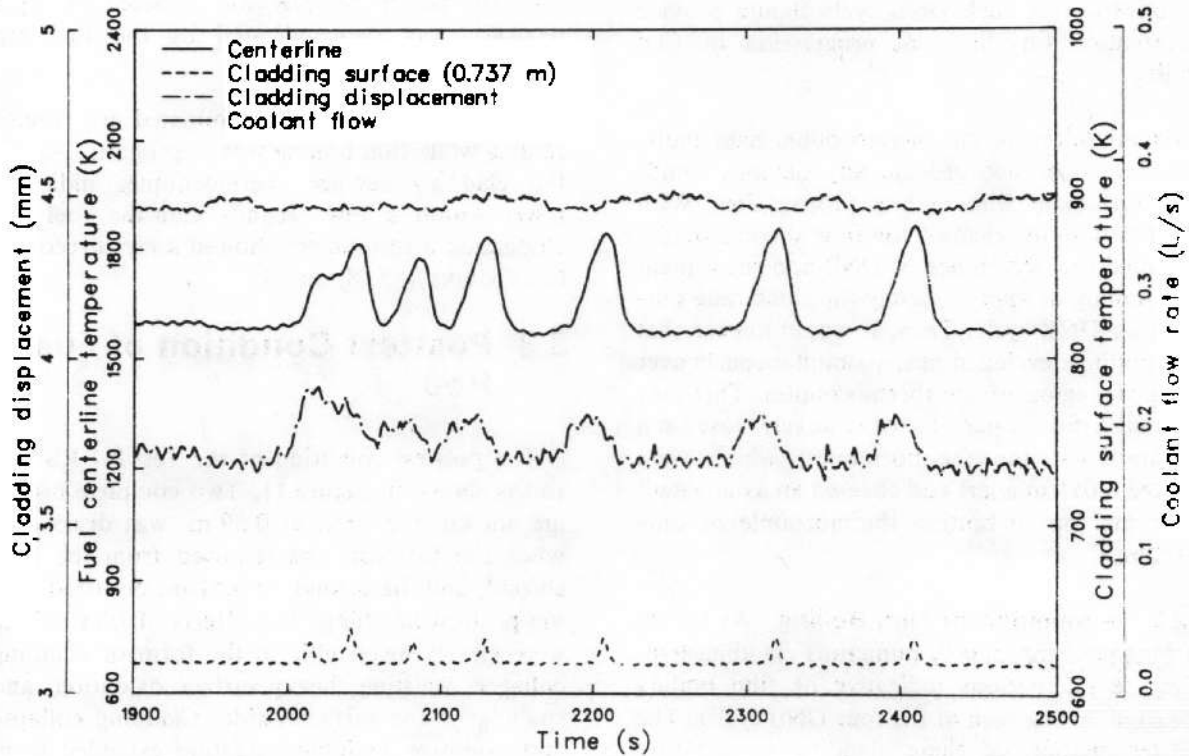
sheaths act as cooling fins and may have contributed to intermittent wetting and film boiling in the vicinity of the sheaths. Variations in the inlet coolant flow rate were about $\pm 7\%$ and may also have contributed to the observed oscillatory behavior. Figure 10 presents a composite plot of the measured cladding surface temperature, inlet coolant flow, cladding axial length change, and fuel centerline temperature for the six temperature fluctuations observed at 65.3 kW/m rod peak power during Cycle 2. Although the data in Figure 10 do not show a correlation between film boiling and coolant flow rate variations, the cladding surface temperature is clearly related to changes in axial fuel rod length and fuel centerline temperature. This correlation indicates that the cladding surface temperature oscillations were indicative of actual fuel rod temperature increases during film boiling and not just local fluctuations at the thermocouple locations.

Figure 10. Measured fuel centerline temperature, cladding axial length change, inlet coolant flow rate, and cladding surface temperature versus time during Test 8-1 RS (DNB Cycle 2).

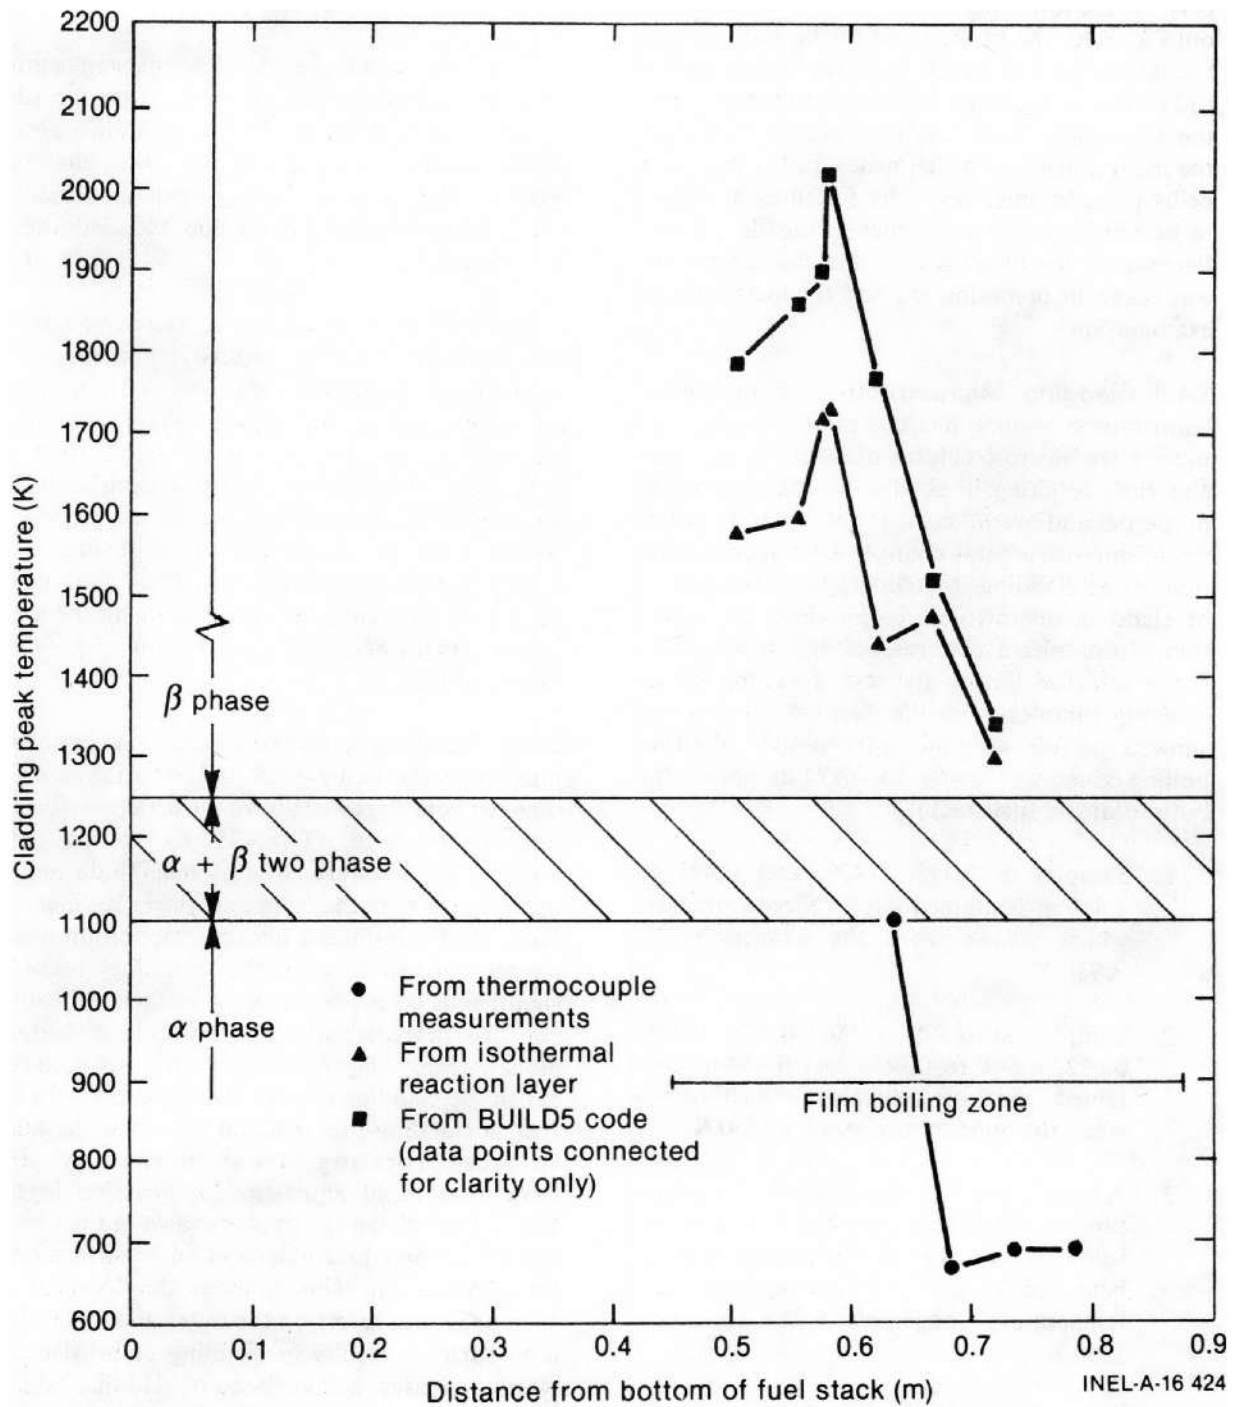
Figure 12. Cladding peak temperatures during Test 8-1 RS.

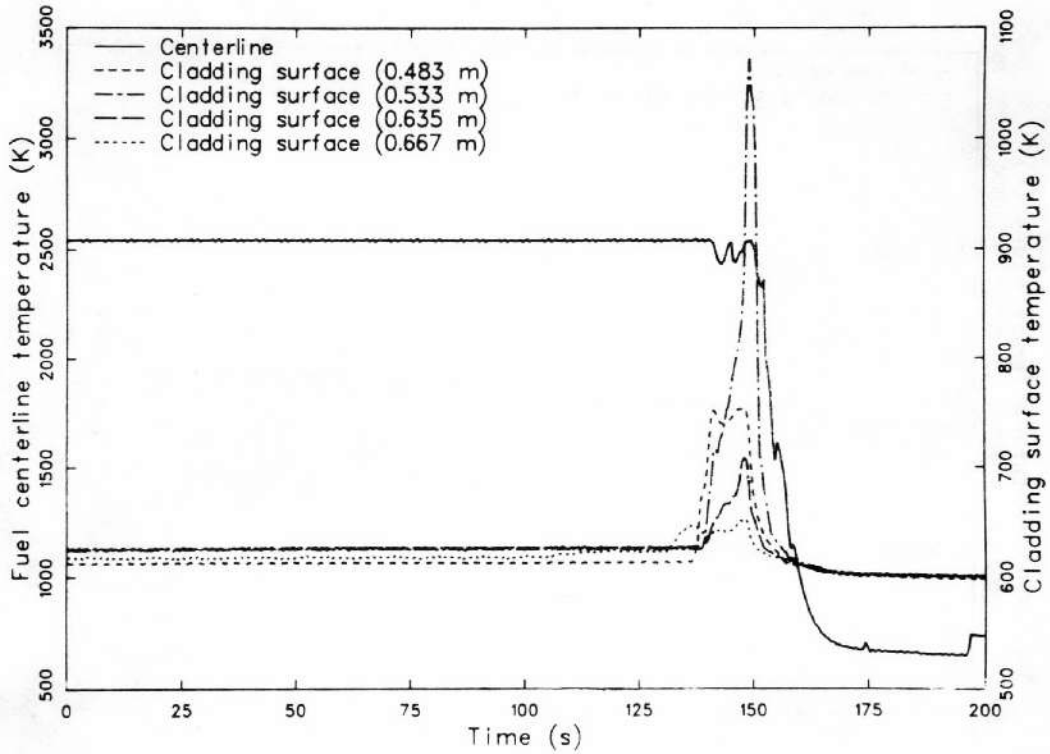
Figure 24. Fuel centerline temperature and cladding surface temperature versus time during Test CHF Scoping (DNB Cycle 3).

During Cycle 3 (Figure 24), DNB again occurred first at the 0.667-m location, followed by the 0.483-m location about 15 s later, and the 0.533- and 0.635-m locations after another 5 s. As during Cycle 1, these data may indicate independent occurrences of film boiling or may indicate a spreading of film boiling that bypassed intermediate thermocouple locations by passing down uninstrumented sides of the fuel rod.

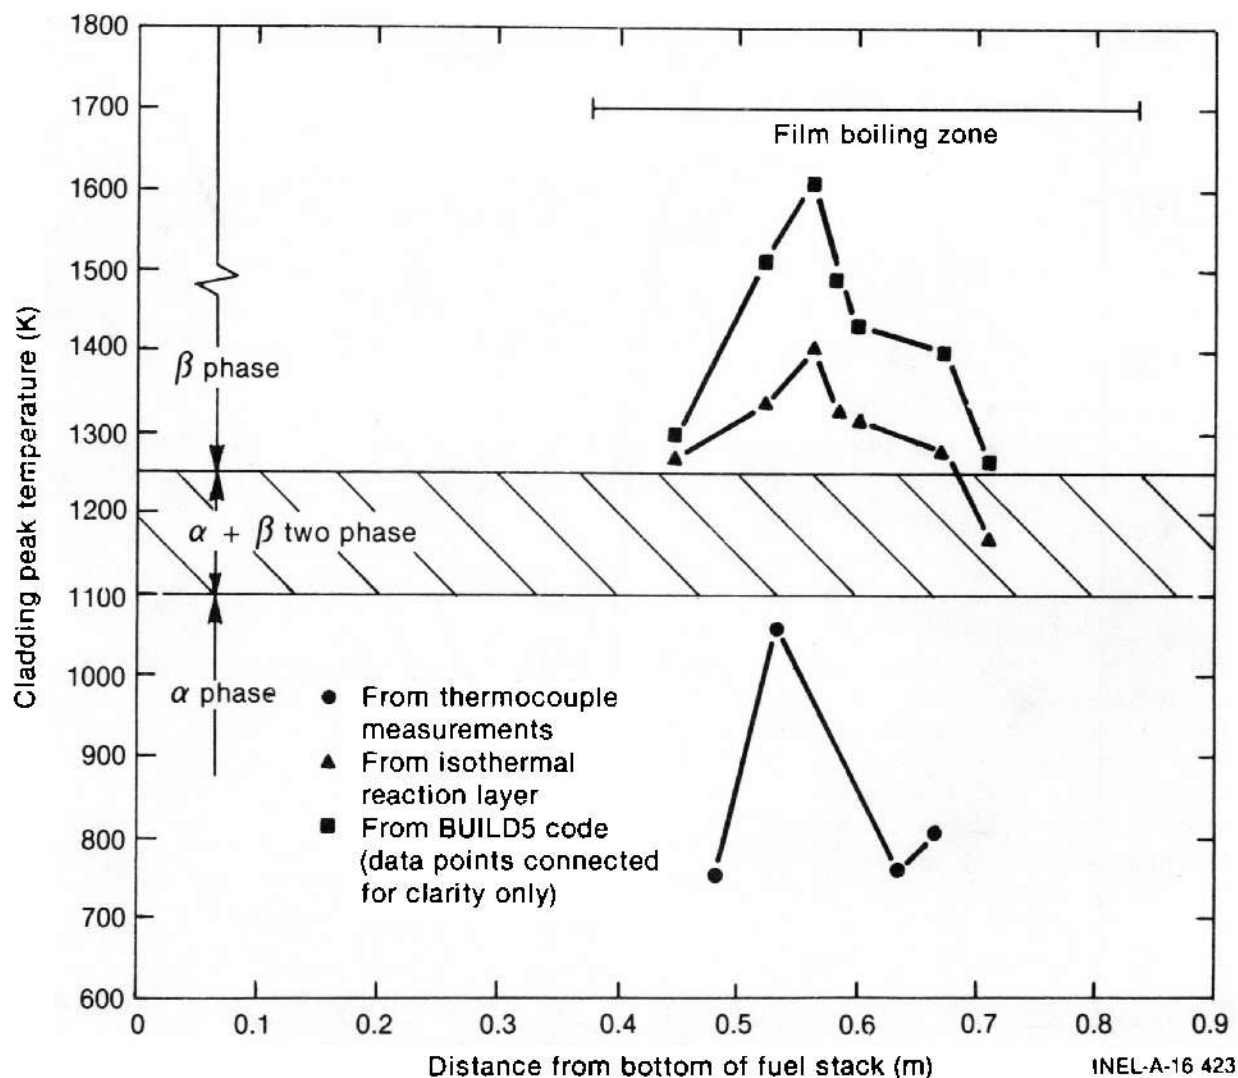
Figure 34 shows the cladding peak temperatures at various axial locations estimated from the isothermal reaction rate correlations and the BUILD5 code; thermocouple measurements are also shown for comparison. The BUILD5-calculated temperatures are the best-estimate values of the cladding peak temperatures attained during the test. The thermocouple-indicated temperatures are consistently low because of fin-cooling effects. Note that the best-estimate peak temperatures from the BUILD5 code at locations unperturbed by thermocouple sheaths are as much as 550 K greater than those determined from thermocouples at nearby axial locations. As expected, the cladding peak temperatures occurred in the lower part of the film boiling zone.

Figure 34. Cladding peak temperatures during Test CHF Scoping.

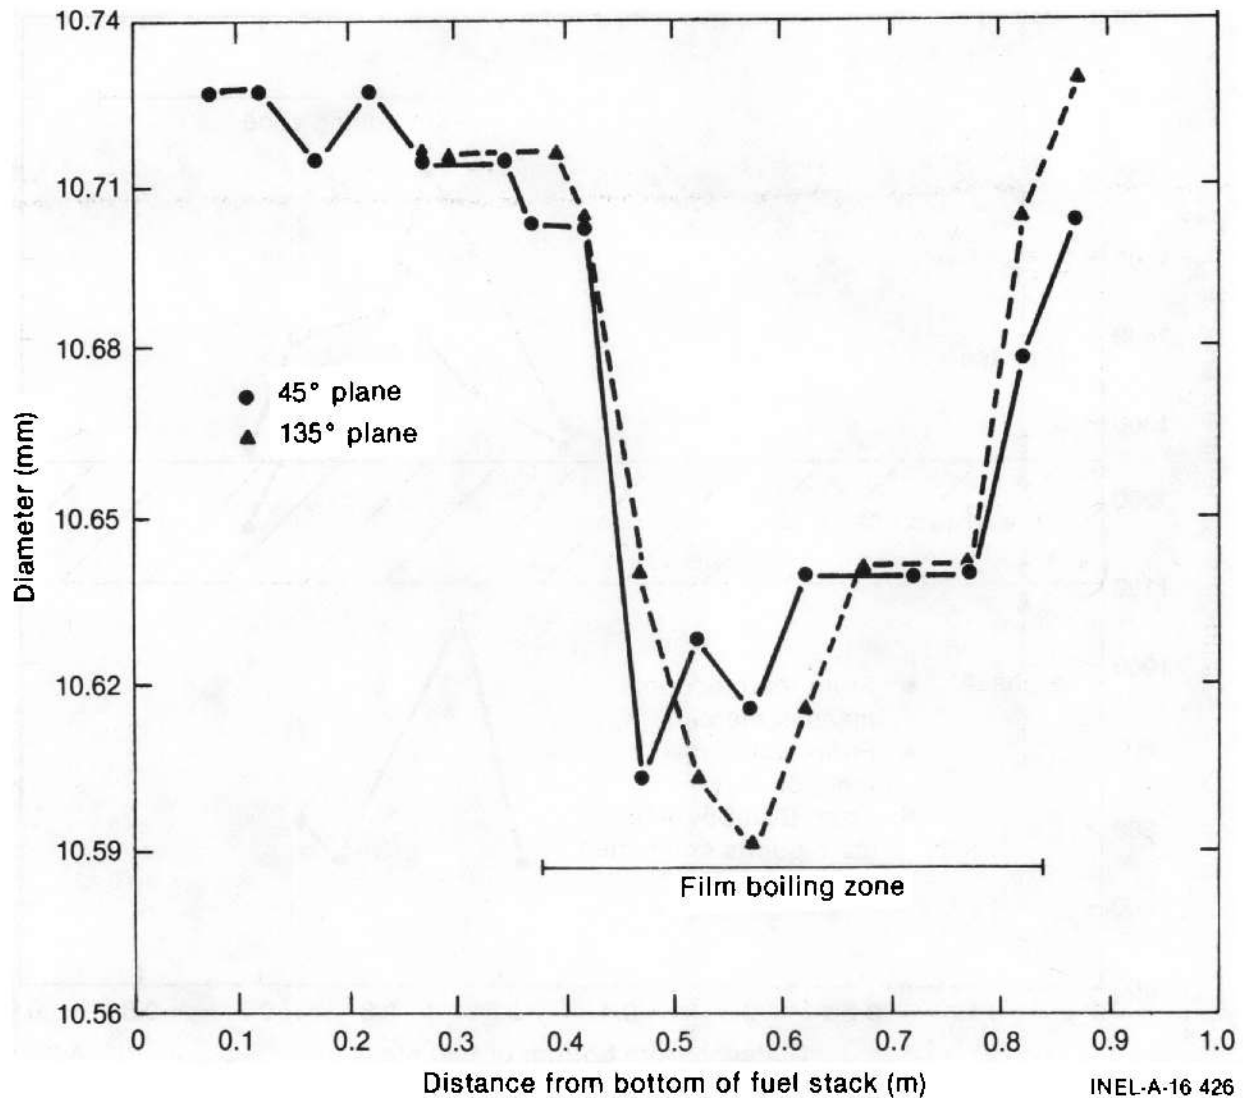
Radial cladding deformation in the form of cladding collapse and waisting occurred within the film boiling zone of the test rod. These deformations result from high cladding temperatures combined with high differential pressures across the cladding (system pressure greater than fuel rod internal pressure). Cladding collapse likely occurred during the initial film boiling cycle. The extent of cladding collapse is illustrated in Figure 35, which shows postirradiation outside diameter measurements versus axial location. Cladding collapse occurred over the range of 0.381 to 0.838 m above the bottom of the fuel stack, which is considered to be the film boiling zone. The maximum diametral reduction was 0.13 mm at 0.580 m from the bottom of the fuel stack, which corresponds to a 71% closure of the fuel-cladding cold gap.

Figure 35. Diametral measurements of Test CHF Scoping fuel rod.

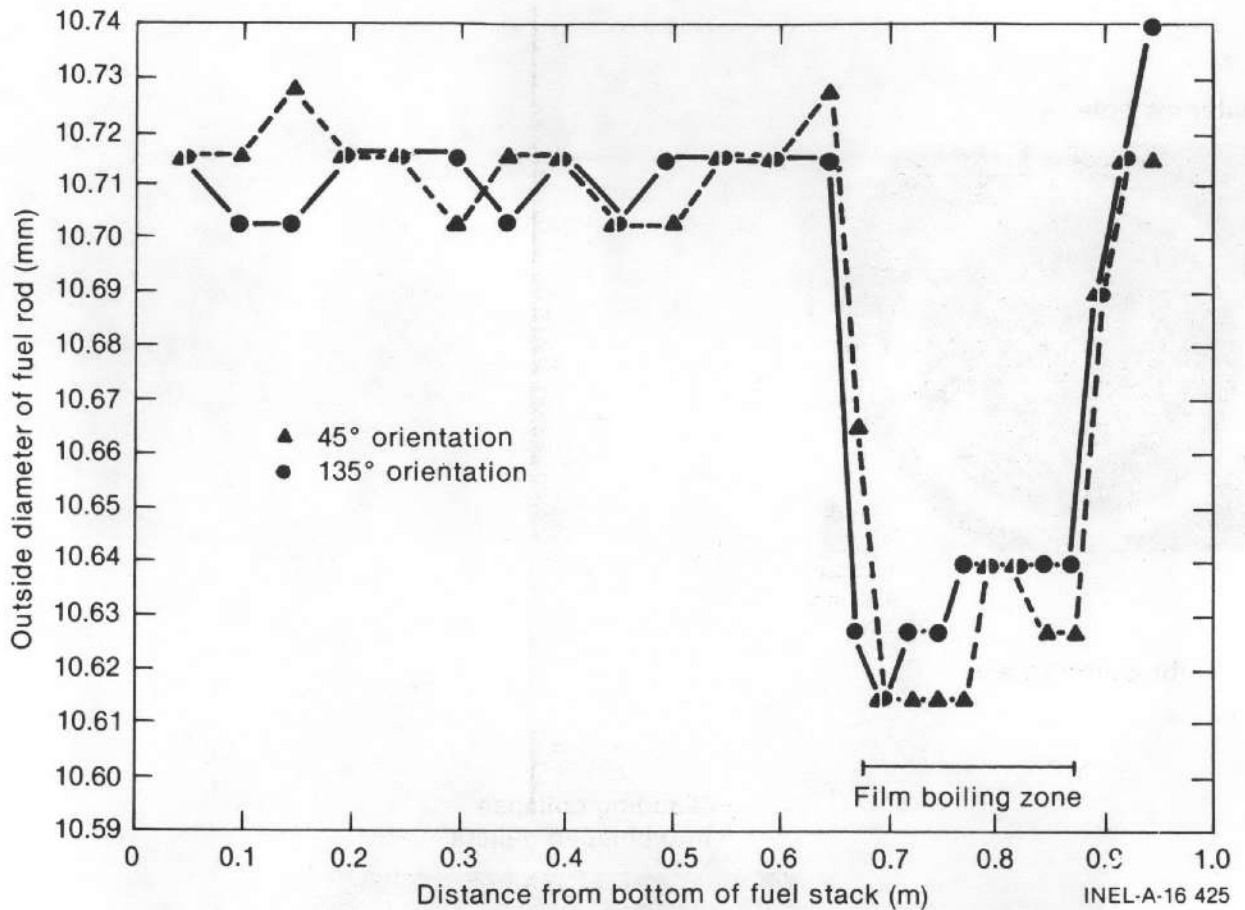
5.4.2 Cladding Deformation. Radial cladding collapse and waisting result from high cladding temperatures combined with high differential pressure across the cladding (system pressure greater than fuel rod internal pressure). Cladding collapse likely occurred within a few seconds after the beginning of film boiling. The extent of cladding collapse is illustrated in Figure 45, which shows postirradiation outside diameter measurements versus axial position. Cladding collapse occurred over the range of 0.673 to 0.868 m above the bottom of the fuel stack, which is considered to be the film boiling zone. The maximum diametral reduction was 0.10 mm, extending from 0.699 to 0.787 m above the bottom of the fuel stack. This diametral reduction corresponds to a 57% closure of the fuel-cladding cold gap.

Figure 45. Postirradiation diametral measurements of Test 8-1 RF fuel rod.

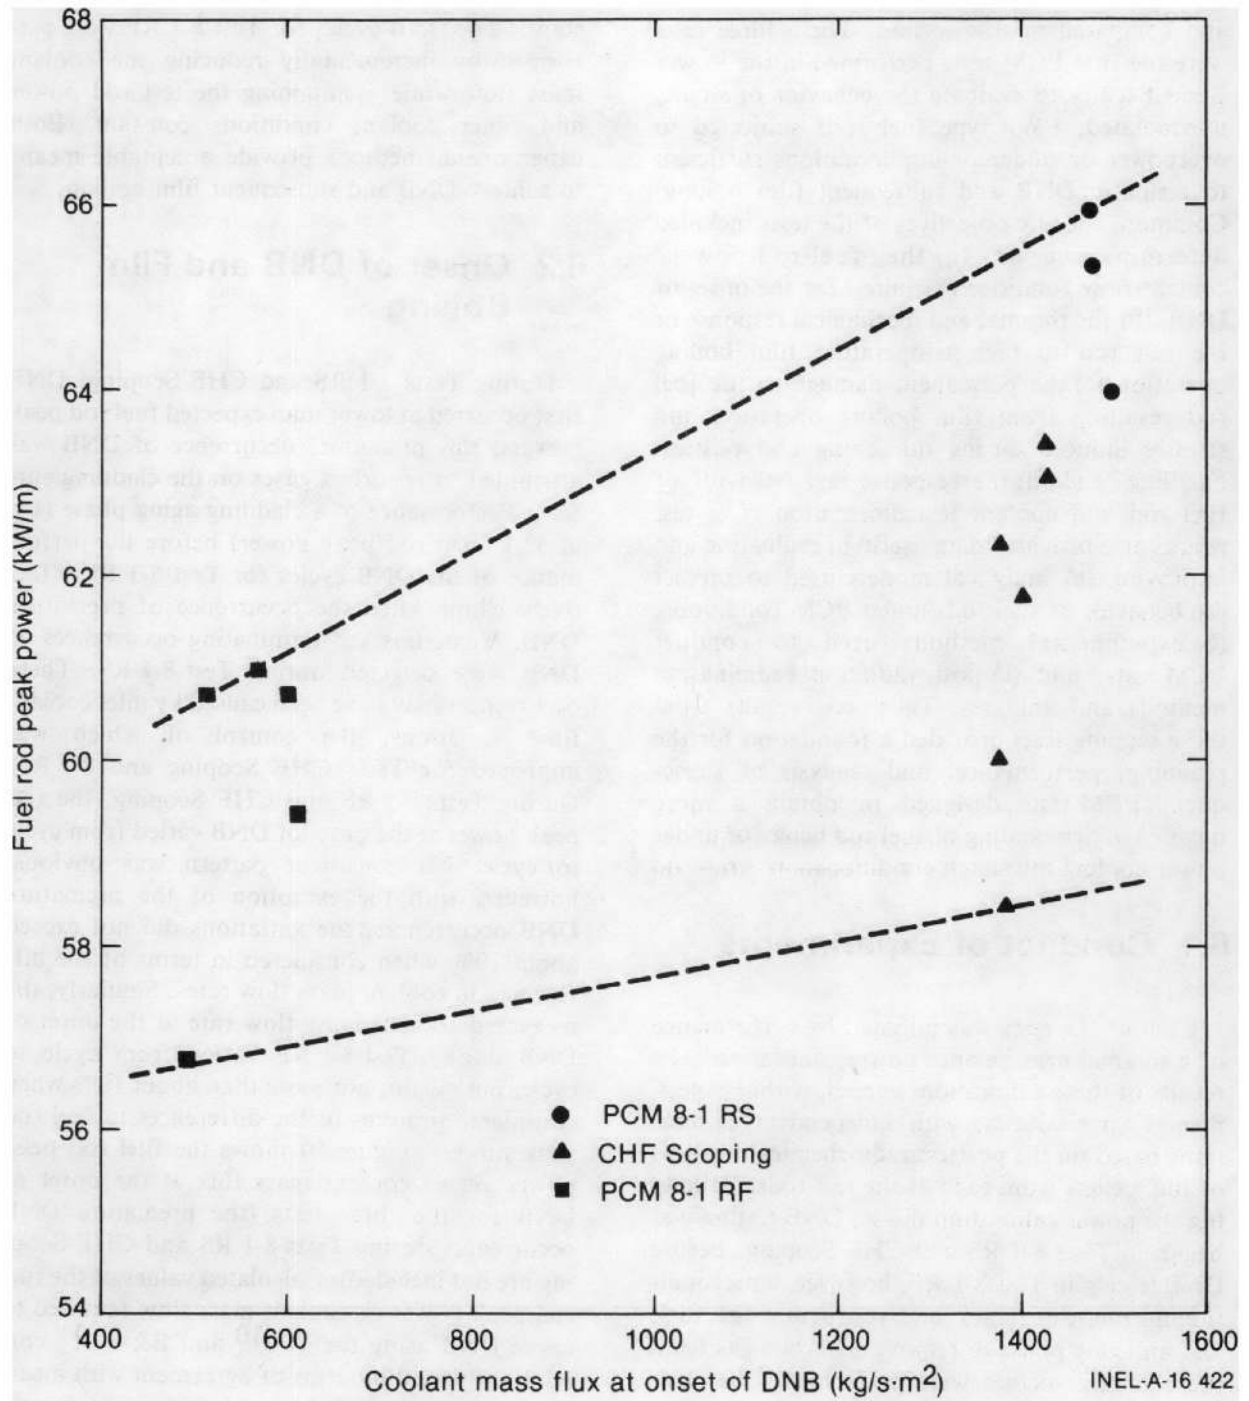
During Tests 8-1 RS and CHF Scoping, DNB first occurred at lower than expected fuel rod peak powers; this premature occurrence of DNB was attributed to adsorbed gases on the cladding surface. Performance of a cladding aging phase (1 h at 53 kW/m rod peak power) before the performance of the DNB cycles for Test 8-1 RF effectively eliminated the occurrence of premature DNB. Numerous self-terminating occurrences of DNB were detected during Test 8-1 RS. These occurrences may have been caused by inlet coolant flow variations, the control of which was improved for Tests CHF Scoping and 8-1 RF. During Tests 8-1 RS and CHF Scoping, the rod peak power at the onset of DNB varied from cycle to cycle. No consistent pattern was obvious; however, with the exception of the premature DNB occurrences, the variations did not exceed about 10% when considered in terms of the differences in coolant mass flow rates. Similarly, the measured coolant mass flow rate at the onset of DNB during Test 8-1 RF varied from cycle to cycle, but, again, not more than about 10% when considered in terms of the differences in fuel rod peak powers. Figure 50 shows the fuel rod peak power versus coolant mass flux at the onset of DNB for the three tests (the premature DNB occurrences during Tests 8-1 RS and CHF Scoping are not included). Calculated values of the fuel rod peak power or coolant mass flow required to cause DNB using the W-3¹⁰ and B&W-2¹¹ correlations varied in terms of agreement with measured values. The W-3 correlation more closely predicted the experimental measurements; the calculated fuel rod peak powers at the onset of DNB were within 10% of measurements during Tests 8-1 RS and CHF Scoping, and the calculated coolant mass flow rates at the onset of DNB were within 40% for Test 8-1 RF.

Figure 50. Power/flow at onset of DNB for Tests PCM 8-1 RS, CHF Scoping, and PCM 8-1 RF.
