Atomics International North American Rockwell		SUPPORTING DOCUMENT		NUMBER TR-097-330-007	REV LTR/CHG NO. SEE SUMMARY OF CHG																																																								
PROGRAM TITLE Fast Reactors (Central Station)				DOCUMENT TYPE Test Report																																																									
DOCUMENT TITLE MSG Test Report - Removal of Residual Sodium				KEY NOUNS MSG, Cleaning																																																									
PREPARED BY/DATE R. B. Harty <i>R. B. Harty</i>				ORIGINAL ISSUE DATE																																																									
DEPT		MAIL ADDR		GO NO. 41001	S/A NO. 33000																																																								
IR&D PROGRAM? YES <input checked="" type="checkbox"/> NO <input type="checkbox"/> IF YES, ENTER TPA NO. _____				PAGE 1 OF TOTAL PAGES 53																																																									
APPROVALS				REL. DATE <i>3-8-74 sm</i>																																																									
E. B. Baumeister <i>EBS</i>		DATE 3/8/74		SECURITY CLASSIFICATION																																																									
J. S. McDonald <i>JSM</i>		DATE 3/8/74		(CHECK ONE BOX ONLY)

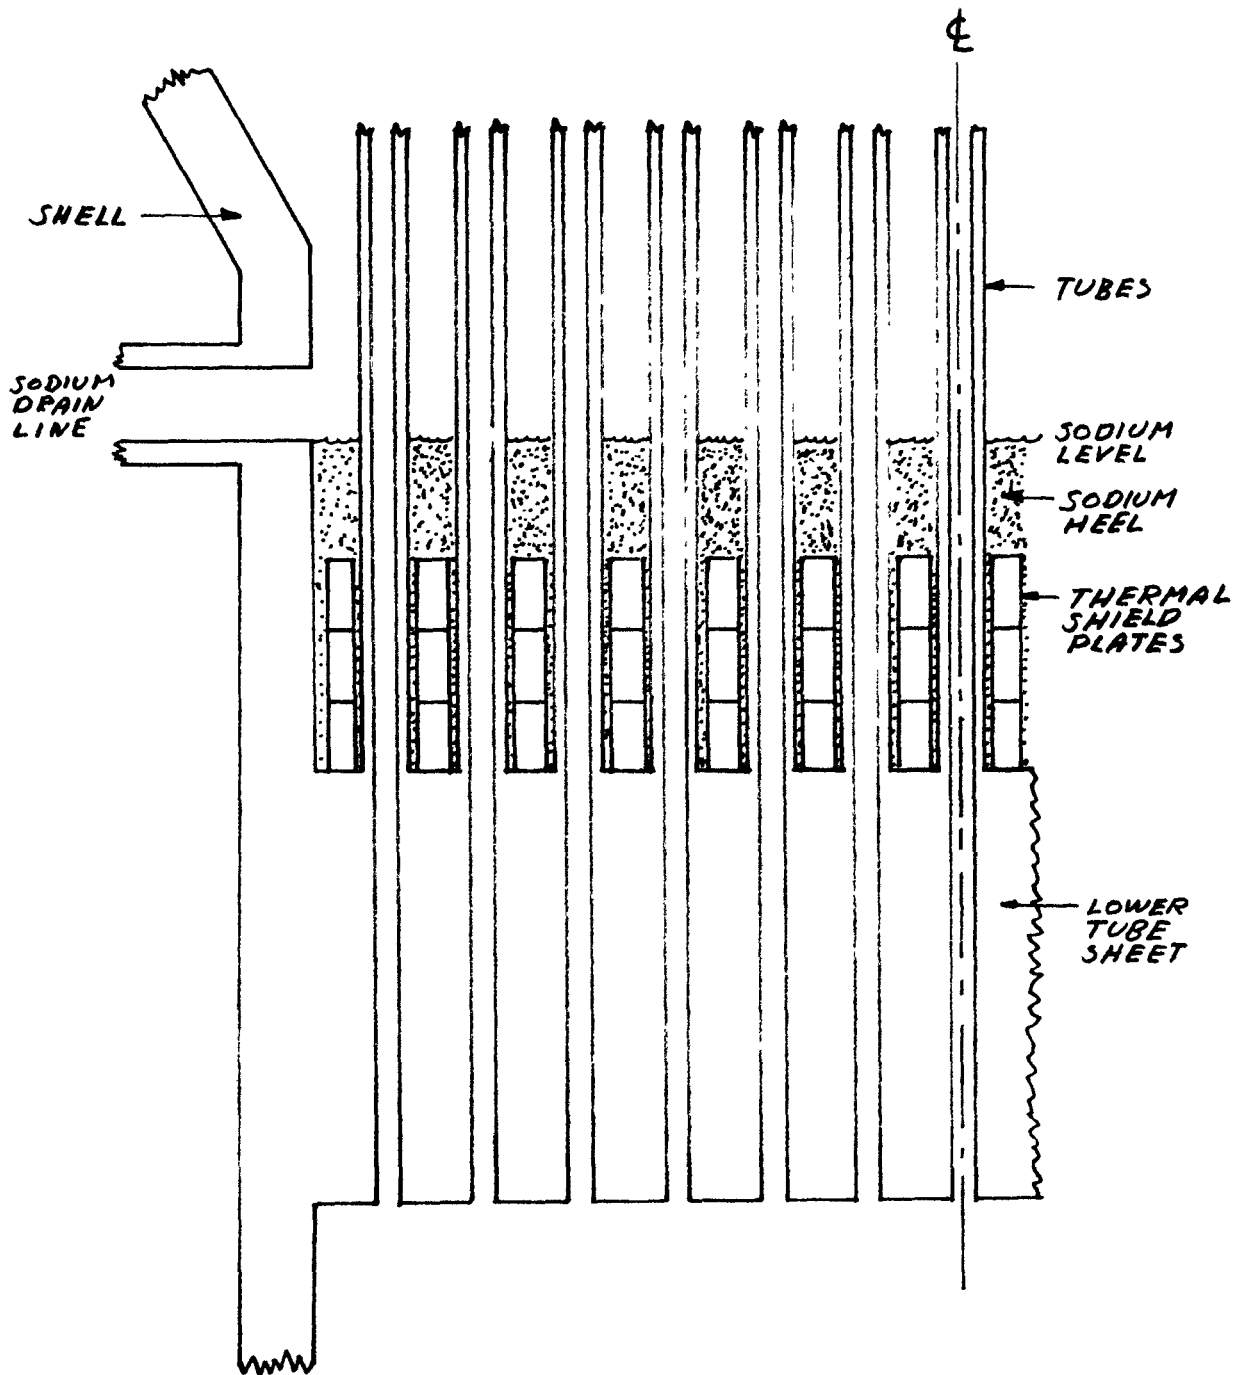
FIG IV-1
SCHEMATIC-LOWER END GEOMETRY

A sodium heel remains at the lower end of the MSG because the drain line is above the elevation of the lower tube sheet. A schematic of the lower end geometry is shown in Figure IV-1. It can be noted that there are thermal baffles resting on top of the tube sheet, resulting in a small annular gap between the tubes and thermal baffles. Based on the total free volume below the lower opening of the drain line nozzle, the sodium remaining in the heel was estimated to be 12.9 lb.

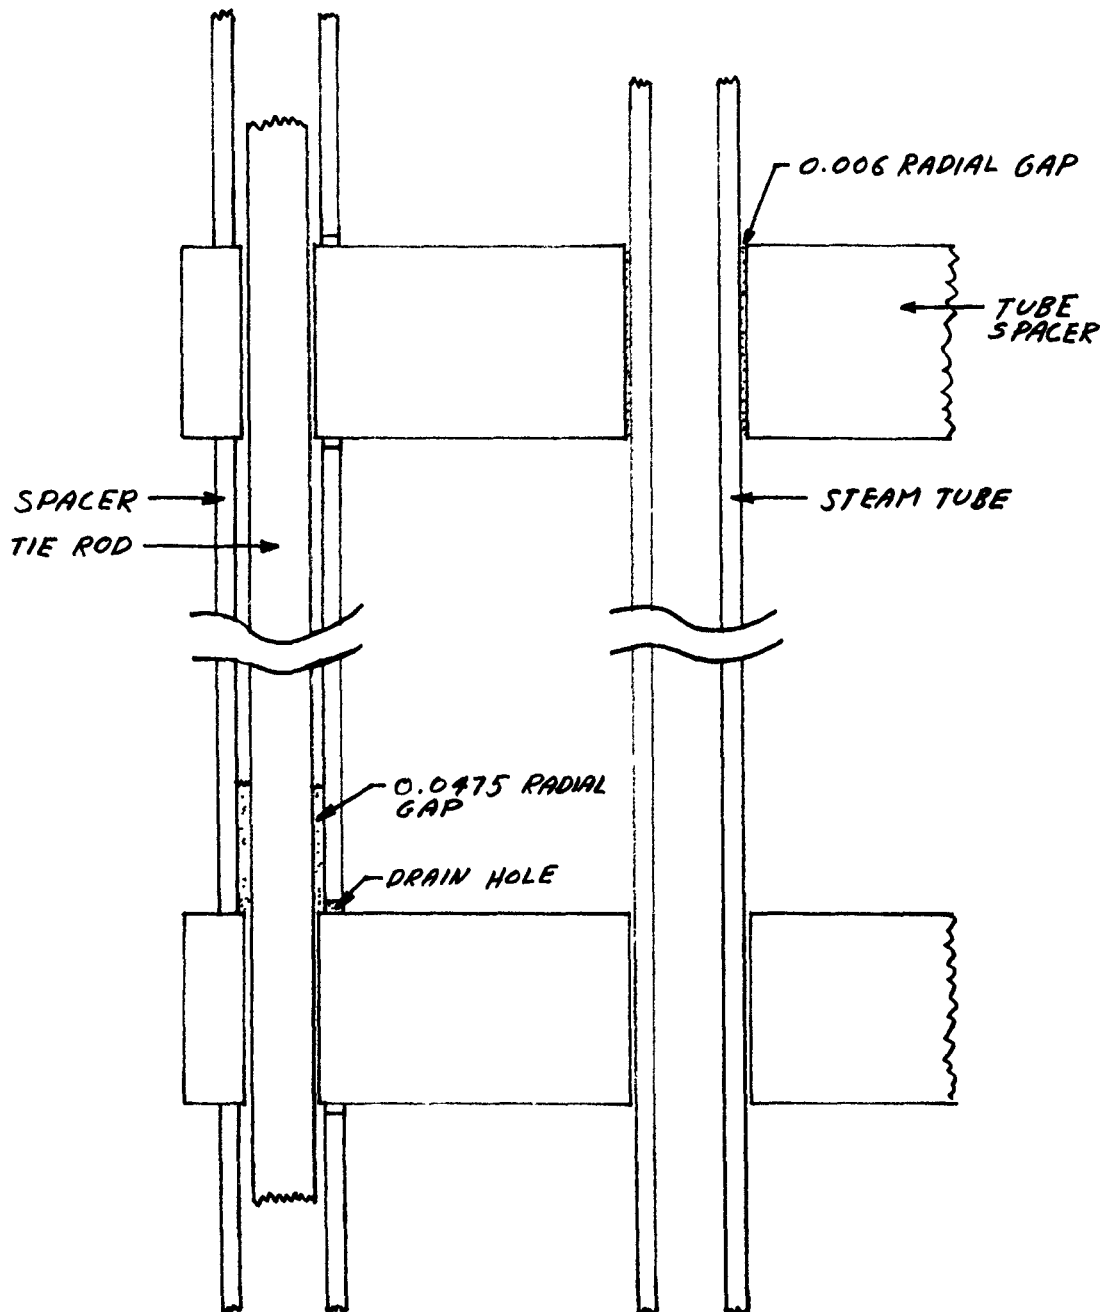
FIG. IV-2
SCHEMATIC - HOLDUP OF SODIUM IN CREVICES

that there can be a considerable tolerance in estimating the mass of sodium remaining on vertical surfaces and in crevices.

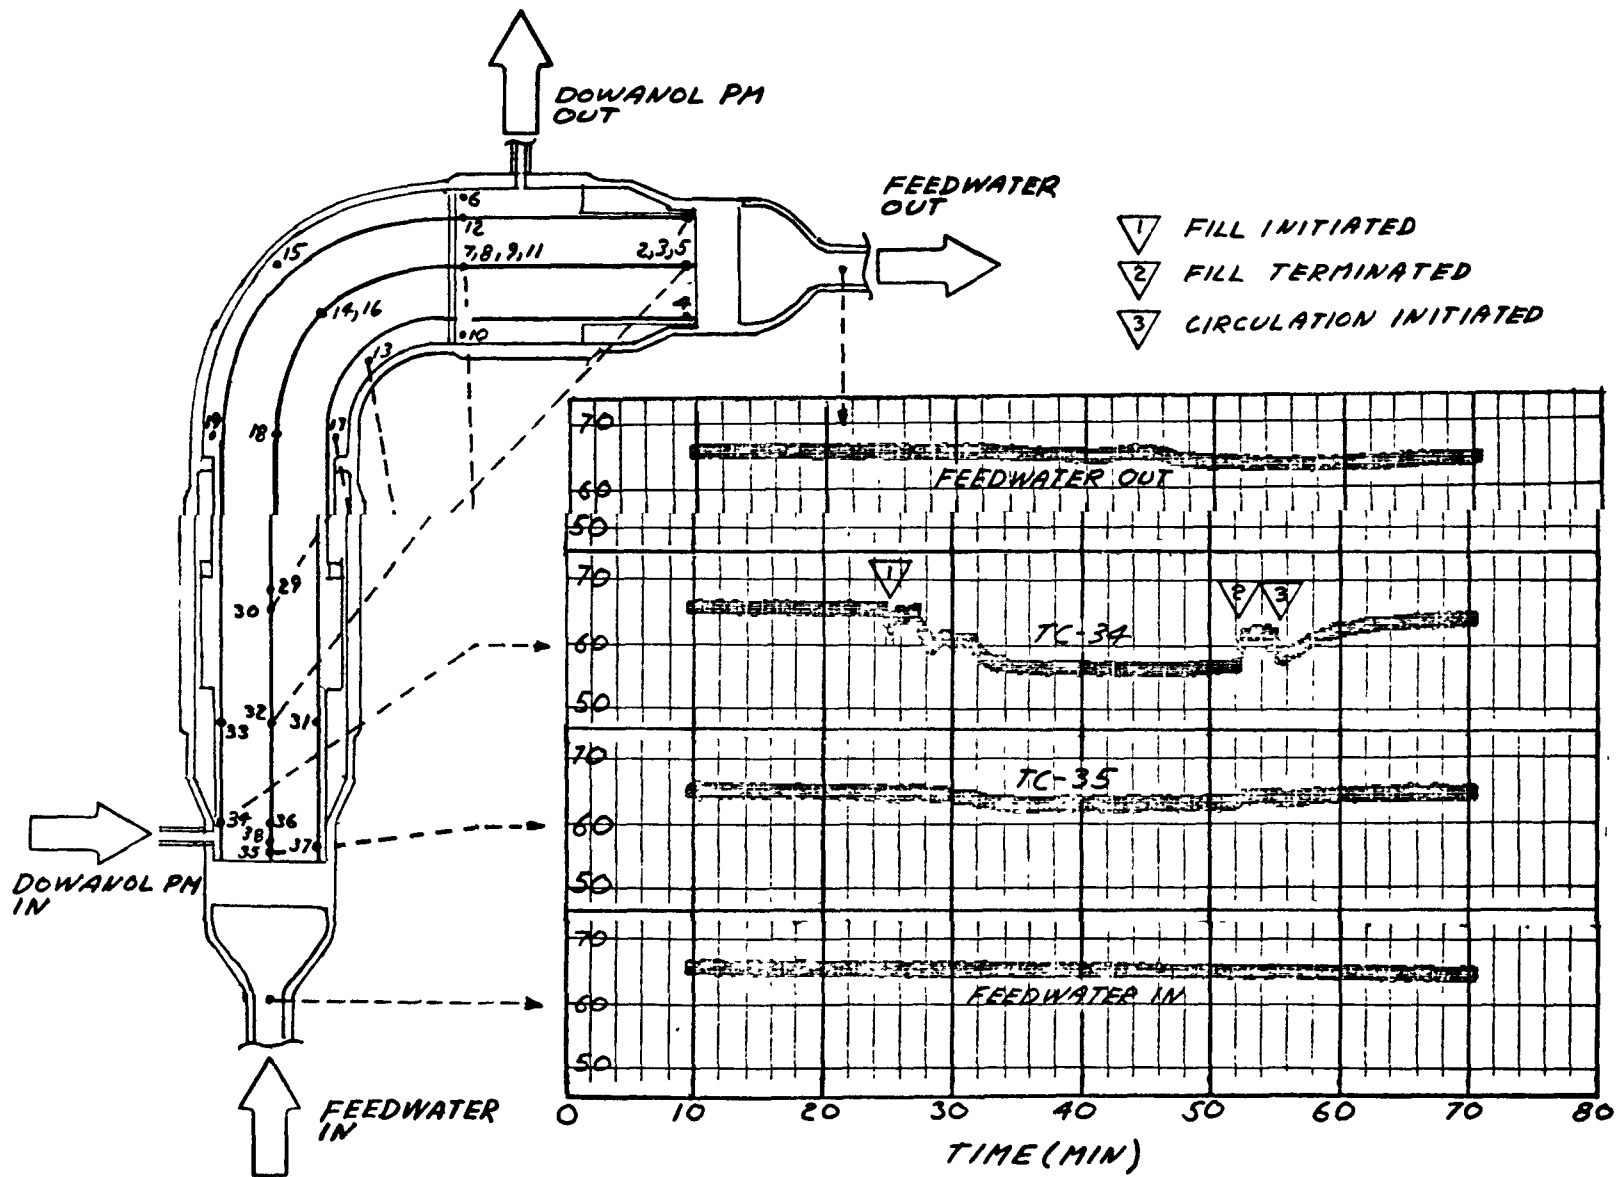
FIG. VI-1
INTERNAL TEMPERATURES DURING DOWANOL PM FILLING

During the initial filling of the MSG with Dowanol PM, internal temperatures and the effluent hydrogen concentration were monitored. Figure VI-1 presents selected internal temperatures at various elevations during filling. The fill time history can be noted from the temperatures recorded from TC-34, which was located adjacent to the MSG drain line (Dowanol PM fill line). Prior to filling, the unit was at a uniform temperature of about 66°F, the temperature of the circulating feedwater. Only slight differences can be noted among the different TC's. The entering Dowanol PM was at a temperature of about 56°F as noted from TC-34. Total filling of the MSG took about 27 minutes, and circulation was initiated about 4 minutes later. The initiation of filling can be noted from TC-34 by a sharp drop in temperature of about 5°F. The temperature increased followed by an erratic decrease to the Dowanol PM temperature. This behavior is felt to have been caused by a combination of valve sequencing during the initiation of fill and the reaction of sodium in the heel area and on the surface of the thermocouple. The termination of filling can be noted by the sharp increase in temperature of TC-34, occurring from the heat of reaction of the sodium in the heel region and from heat being transferred from the feedwater. The initiation of solvent circulation can be noted from the sharp decrease in temperature occurring when the cooler solvent immerses the thermocouple. Temperatures then gradually increased to the feedwater temperature. The temperatures indicated by TC-35, located in the solid heel region, were affected very little during filling. A decrease of only a few degrees was observed, resulting from the cooler solvent absorbing some of the heat from the sodium heel.

The time at which the solvent contacted a thermocouple at a given elevation can be noted from Figure VI-1. At the lower thermocouples (TC-32, 30), a temperature drop was noted when the solvent reached the TC. This drop was apparently the result of the cooler solvent overpowering the heat of reaction of the sodium on the thermocouple surface. As filling progressed, a temperature increase was noted (starting with TC-28). This is the result of the upper surface of the solvent being heated by the reaction

of sodium on vertical surfaces. The maximum temperature increase (on TC-6) was only 10°F. After the temperature increase, temperatures dropped as the upper heated solvent zone passed the thermocouple elevation. The temperature level after the drop increased with elevation as the solvent was heated by the feedwater. During the entire filling period the maximum temperature observed was only 72°F.

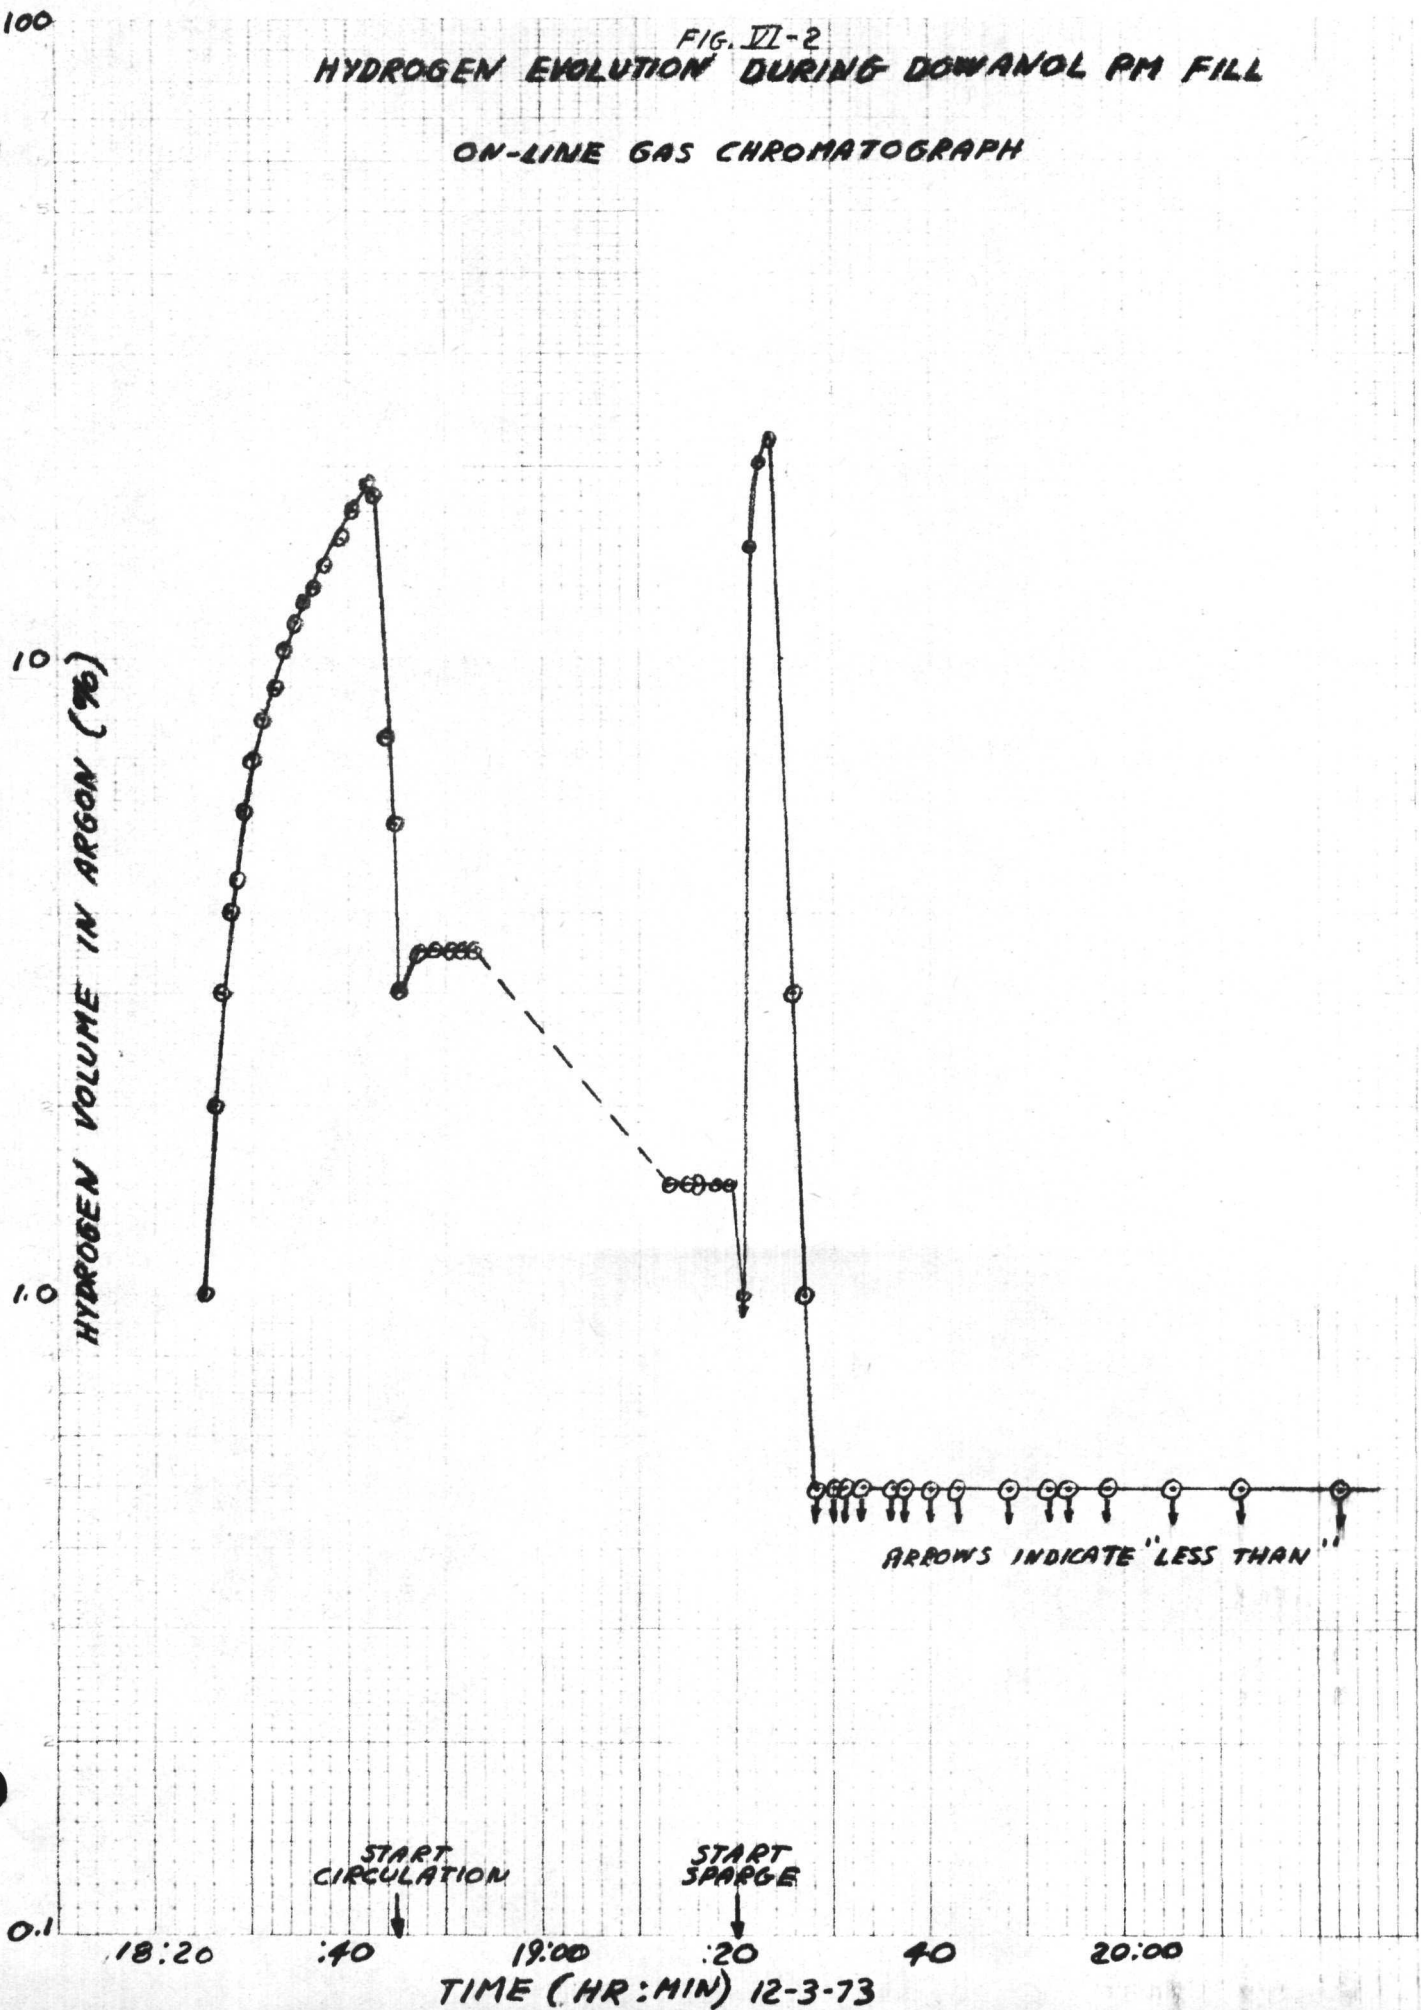
FIG. VII-2
HYDROGEN EVOLUTION DURING DOWANOL PM FILL
ON-LINE GAS CHROMATOGRAPH

The results of hydrogen gas concentration, as obtained from the on-line gas chromatograph, are presented in Figure VI-2. During fill, the hydrogen gas evolution increased to a peak level of 19% and then dropped rapidly. This peak value agrees reasonably well with the predicted value of 35% (section IV-C) considering the dilution of the hydrogen with the argon gas in the MSG and surge tank free volumes. A sudden increase in the hydrogen concentration occurred when the sparge gas flow (at the MSG drain line) was initiated. This increase apparently resulted from sweeping the hydrogen from small pockets in the MSG and that accumulated at the top of the surge tank. The level quickly dropped to below 0.5%, the lower limit of the gas chromatograph.

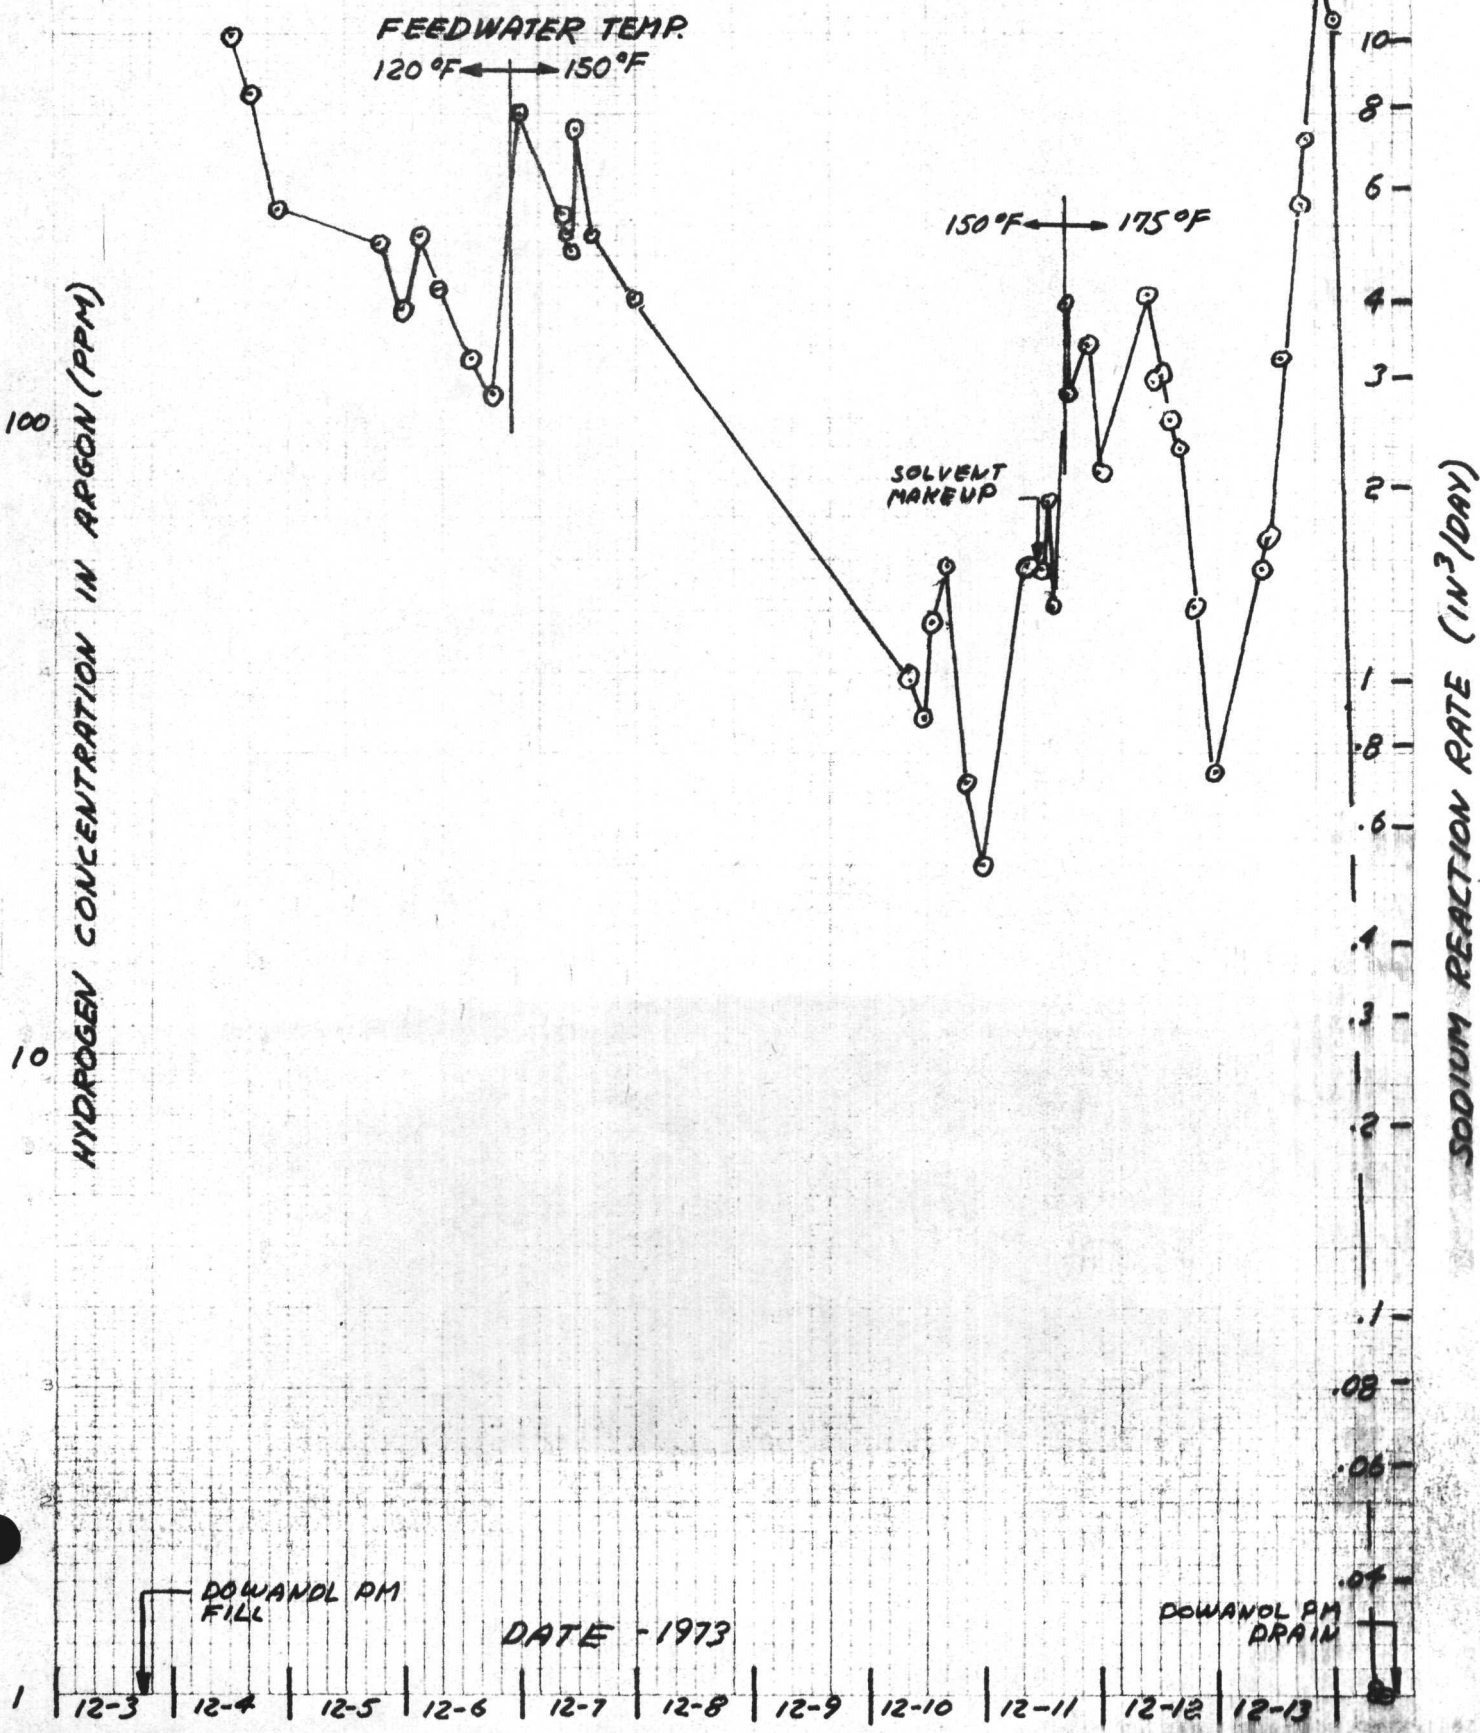
FIG. VI-3
MSG CLEANING
HYDROGEN SAMPLE RESULTS

To provide a more accurate evaluation of the reaction rate, samples of the effluent gas were taken and analyzed in the laboratory for hydrogen content. The results of these analyses obtained during the Dowanol PM flush are given in Figure VI-3. The left hand scale shows the hydrogen content in ppm and the right hand scale gives the equivalent reaction rate in cubic inches of sodium per day. The concentration showed somewhat of an erratic behavior, possibly as the result of crevices opening up and being exposed to the solvent.

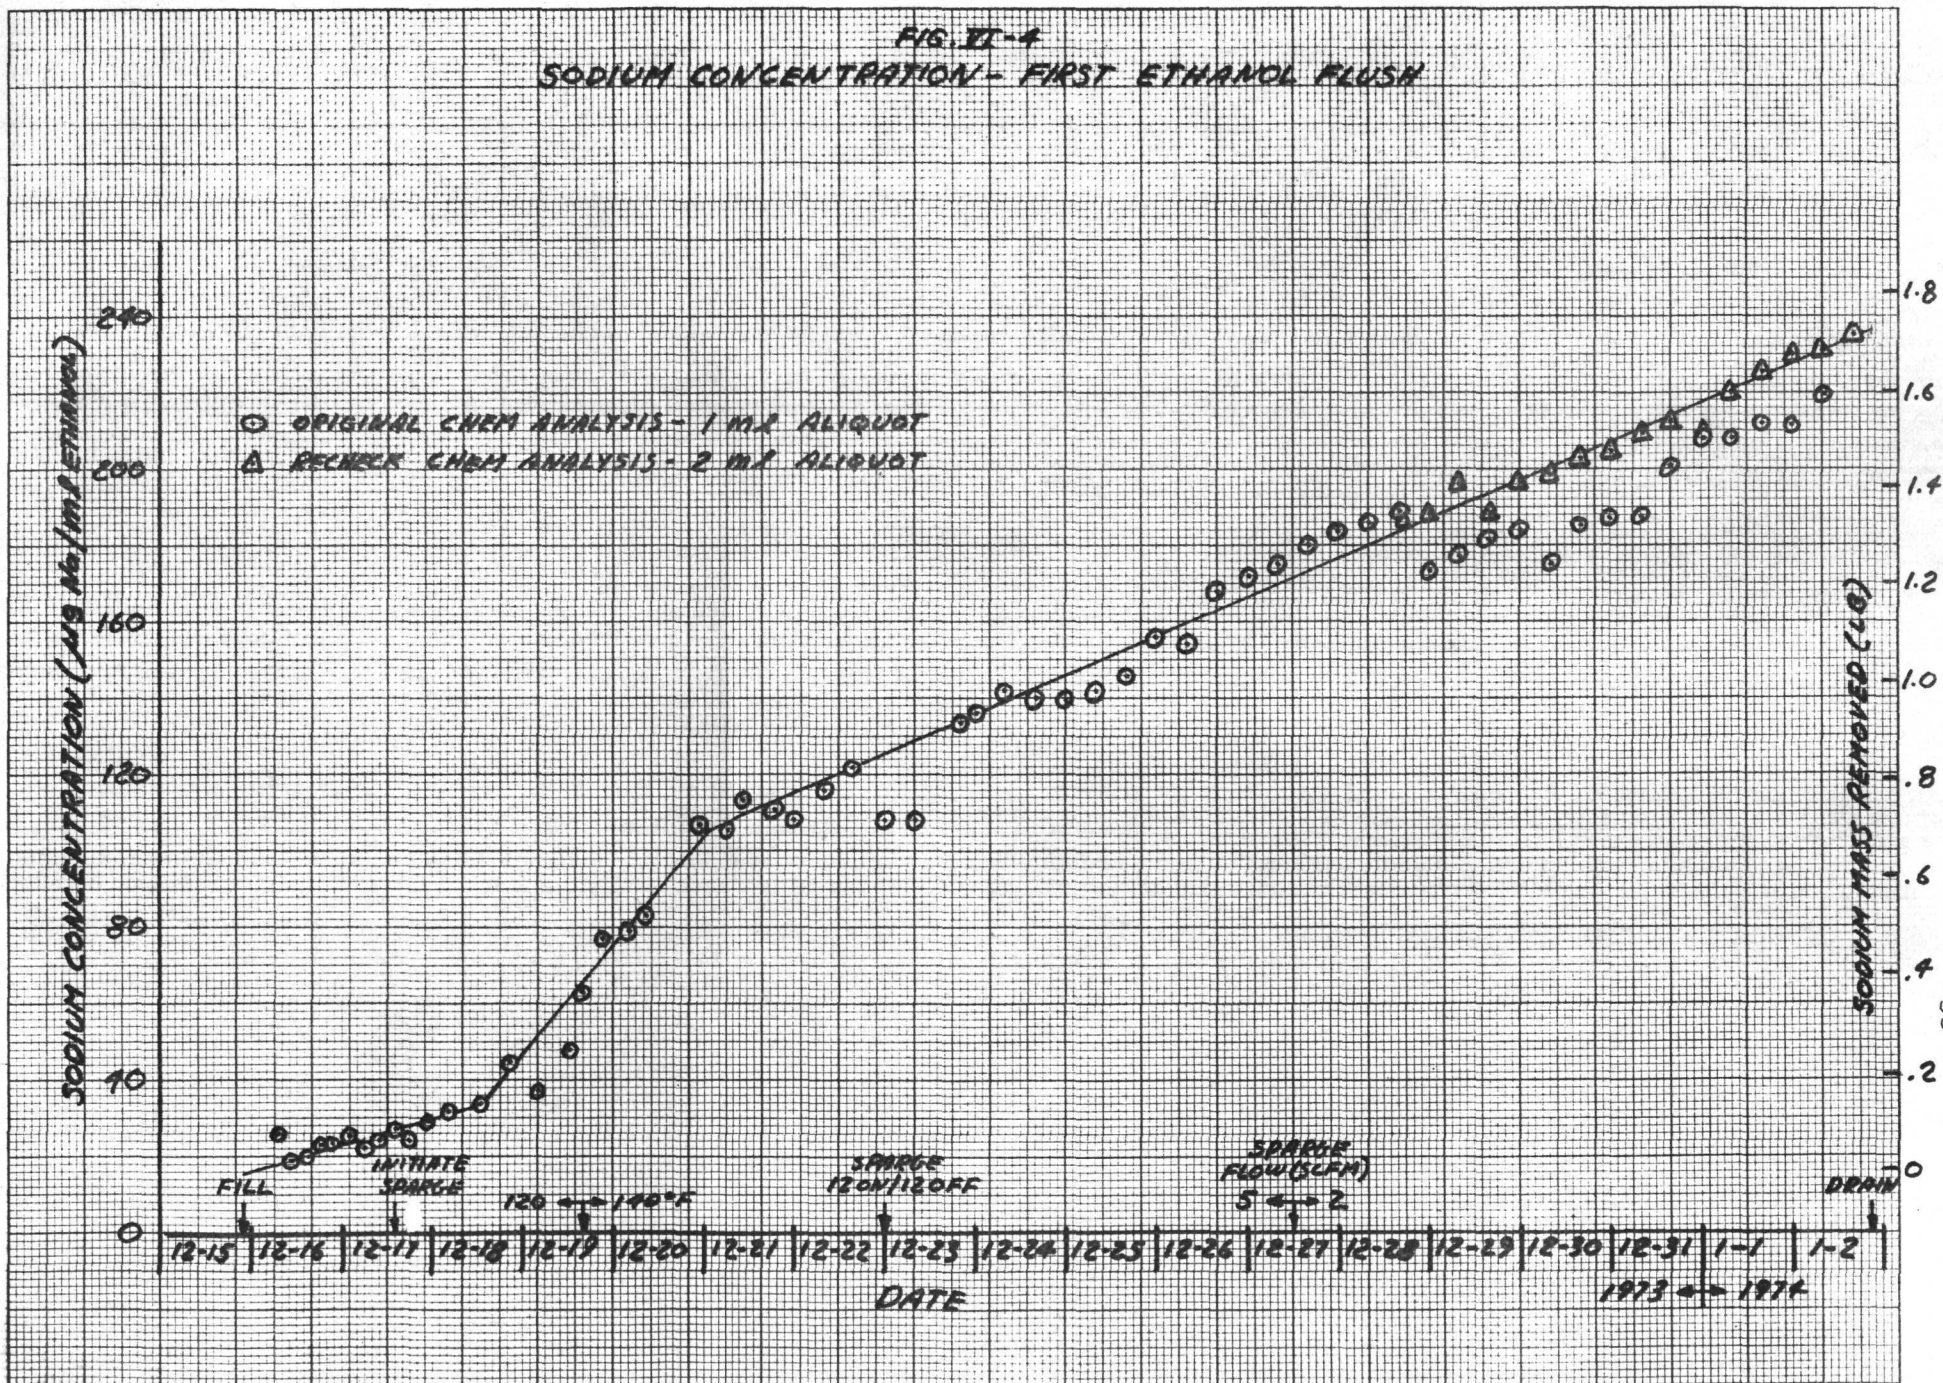
FIG. VI-4
 SODIUM CONCENTRATION - FIRST ETHANOL FLUSH

Cleaning was continued using ethanol in order to provide a better resolution of the reaction rate from sodium concentration analysis. The results of the sodium concentration analysis are presented in Figure VI-4. The left hand scale gives the actual sodium concentration in μg of sodium per ml of ethanol. The right hand scale gives the equivalent mass of sodium reacted. Sparge gas flow was initiated after two days of ethanol circulation, and after an additional two days, the feedwater temperature was increased from 120°F to 140°F . Eliminating sparging for the first two days was performed to determine the effect of sparging on reaction rate. During the ethanol flush, evaporation of the ethanol reduced the available makeup supply at an alarming rate (a fresh supply was not available at that time). To conserve the available supply, the sparge gas flow was changed from continuous to a 12-hr on and 12-hr off cycle. In addition, the sparge gas flow was reduced from 5 scfm to 2 scfm. The ethanol condensate was also collected and recycled back to the loop. Water content was shown to be acceptably low as indicated in Table VI-1. In addition, a condensate sample was analyzed for sodium content. Results of this analysis showed the sodium concentration to be less than one $\mu\text{g}/\text{ml}$, indicating that the sodium ethoxide formed is not evaporated along with the ethanol at the operating temperature.

It can be noted from Figure VI-4 that there appears to have been three distinct reaction rates that occurred during the ethanol flush (The slope of the concentration curve is proportional to the sodium reaction rate.). The initial slope changes are postulated to be the result of the initiation of the sparge gas flow. Since the reaction is primarily in crevice regions and, therefore, controlled by diffusion, the reaction products formed take a period of time to reach the main solvent stream where samples are obtained. Sparging would tend to decrease this time, thus initially increasing the apparent reaction rate.

from batch-to-batch. To evaluate this effect, several batches were reanalyzed using a 2 ml aliquot. The recheck of the chemical analyses are shown by the triangles in Figure VI-4, indicating a more consistent trend. It should be noted that all chemical analysis data points are within plus or minus 5%, the estimated precision of the process.

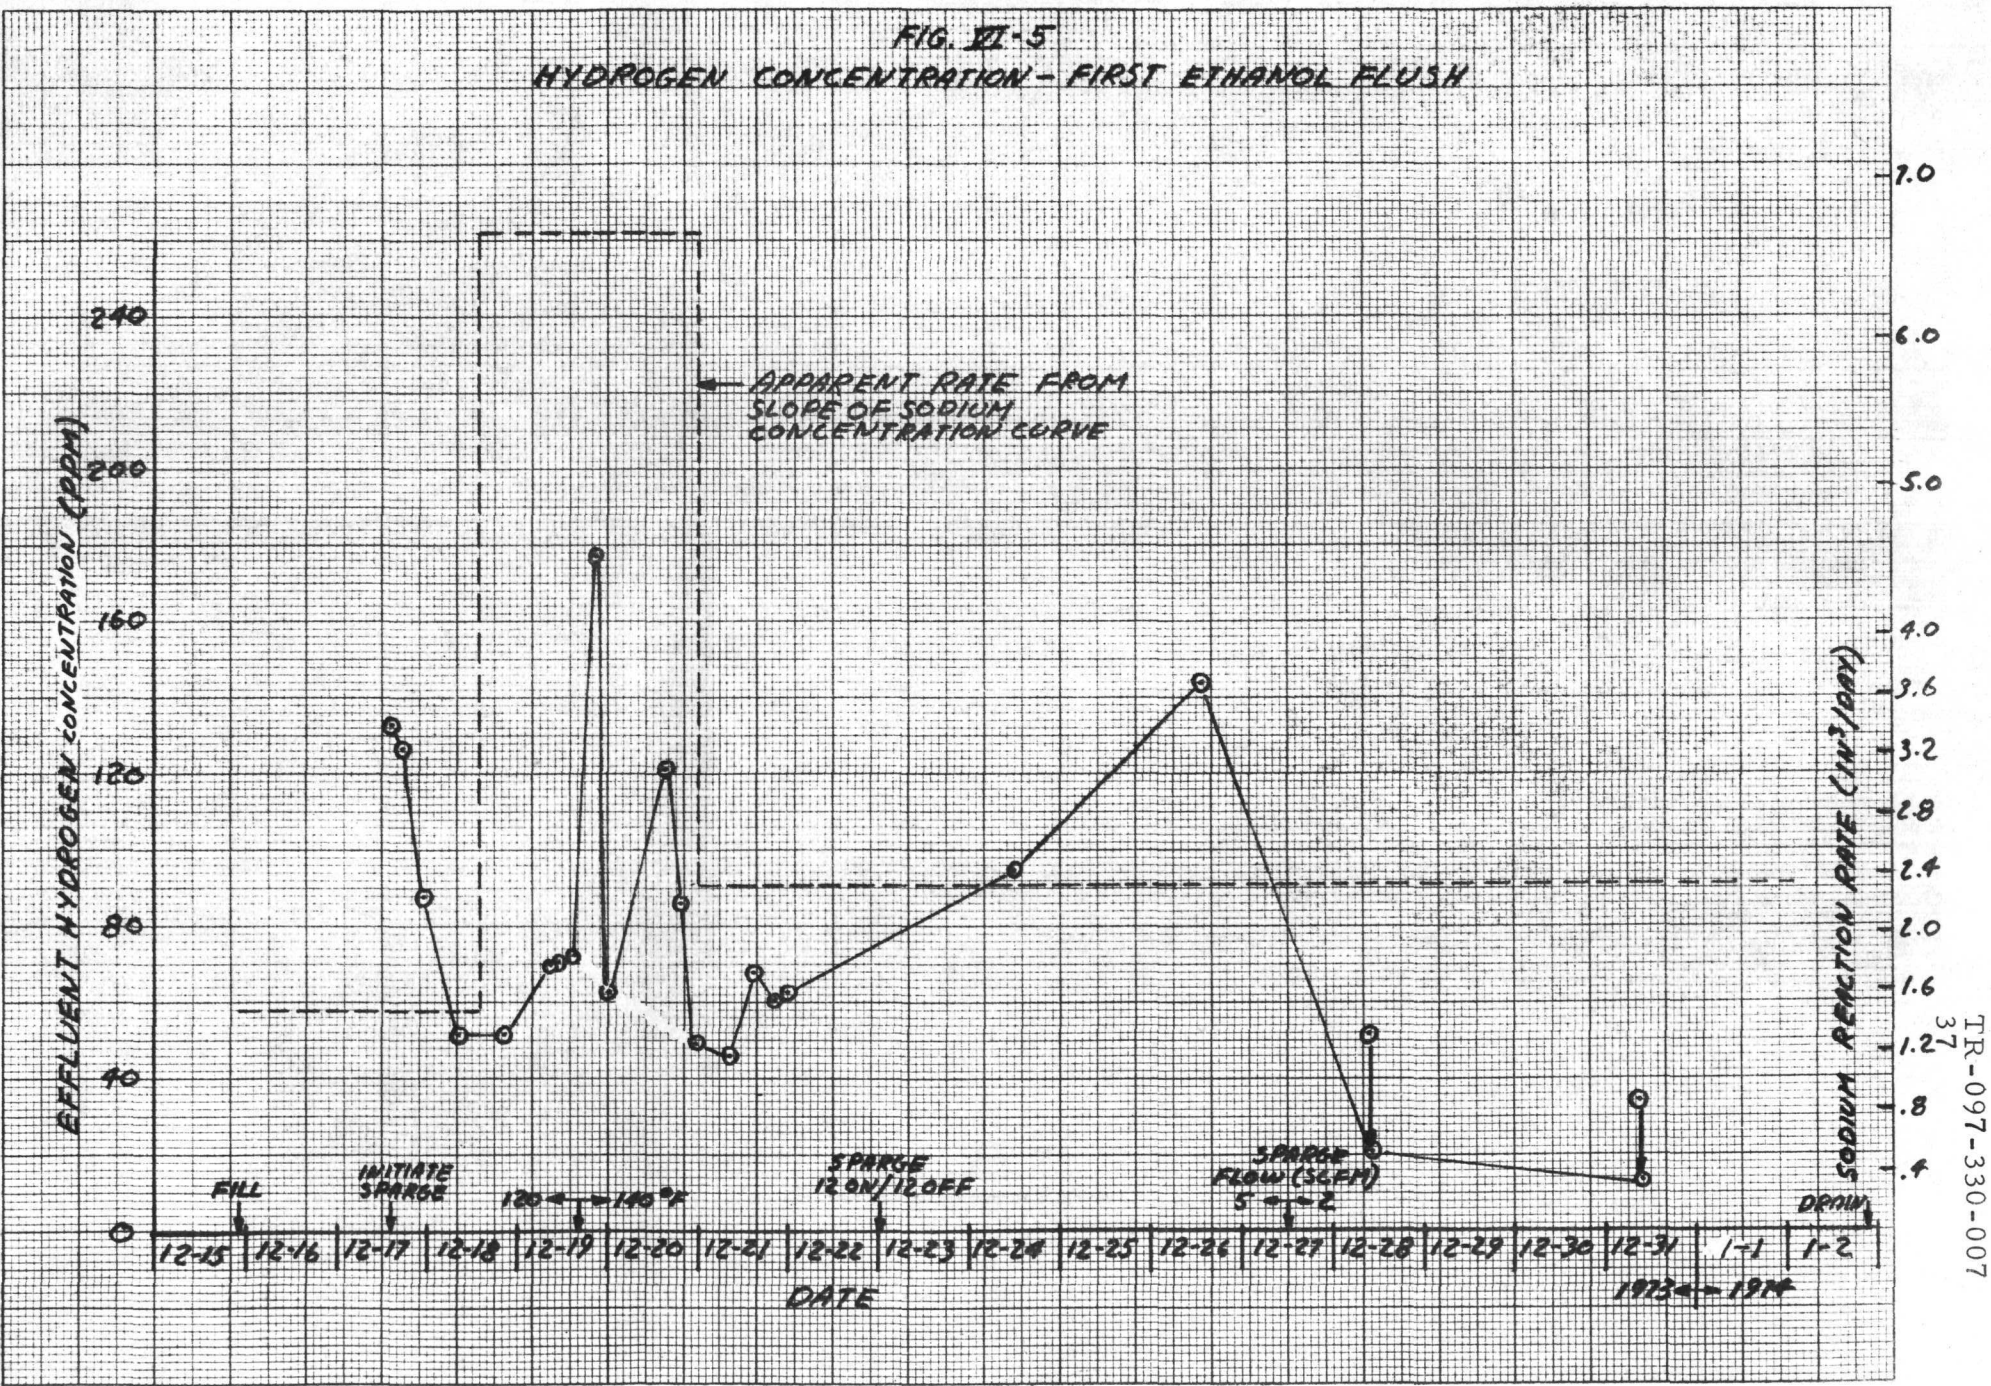
FIG. VI-5
 HYDROGEN CONCENTRATION - FIRST ETHANOL FLUSH

Gas samples were also taken during the ethanol flush and analyzed for hydrogen concentration. The results of these analysis are presented in Figure VI-5. The left hand scale gives the actual hydrogen concentration in ppm, and the right hand scale the equivalent reaction rate. The last two data points were obtained during a sparge gas flow of 2 scfm, and were corrected to equivalent values at a flow of 5 scfm. The dashed line shows the apparent reaction rate obtained from the slope of the sodium concentration curve (Figure VI-4). Several gas samples were taken during a period of no sparging (not shown in Figure VI-5). These show an extremely erratic behavior, giving either very high or very low readings. As can be noted from Figure VI-5, there was a marked increase in the apparent reaction rate when the temperature was increased. Again, as with the Dowanol PM flush, this behavior is thought to be caused by hydrogen gas solubility effects.

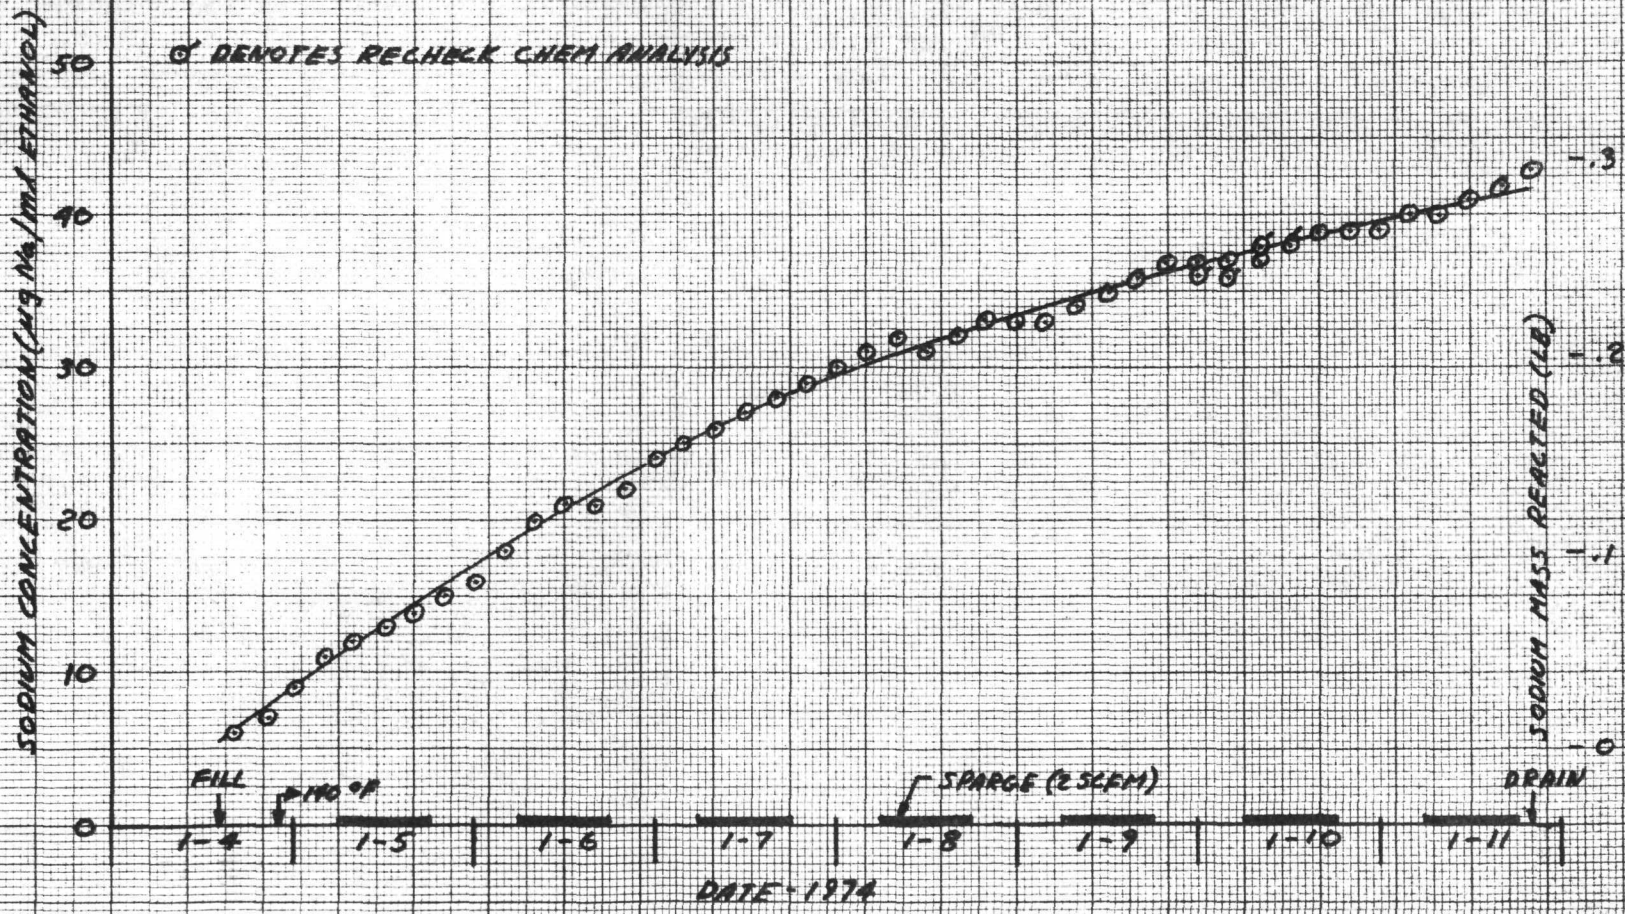
FIG. VI-6
SODIUM CONCENTRATION - SECOND ETHANOL FLUSH

was monitored as before by means of sodium concentration analysis and effluent hydrogen gas analysis. Figure VI-6 shows the results of the sodium concentration analysis. It can be noted that there was a gradual, but significant reduction in the reaction rate. A similar, but more dramatic trend was noted from the effluent hydrogen gas analysis. As shown in Figure VI-7, hydrogen gas evolution decreased to a negligible rate after about 5 days of circulation. The dashed line in Figure VI-7 represents the apparent rate obtained from the slope of the sodium concentration curve (Figure VI-6). The agreement between these two methods of reaction rate determination is better than that obtained during the previous ethanol flush. There appears to be a several day delay in the reaction rate as determined from sodium concentration and that determined from the gas sample data. This is postulated to be because of the hydrogen gas that is released from the sodium reaction enters the main flow stream and is swept to the effluent by the sparge gas in a very short time period. The sodium ethoxide formed in small crevices, however, takes a much longer time to diffuse into the main solvent stream.

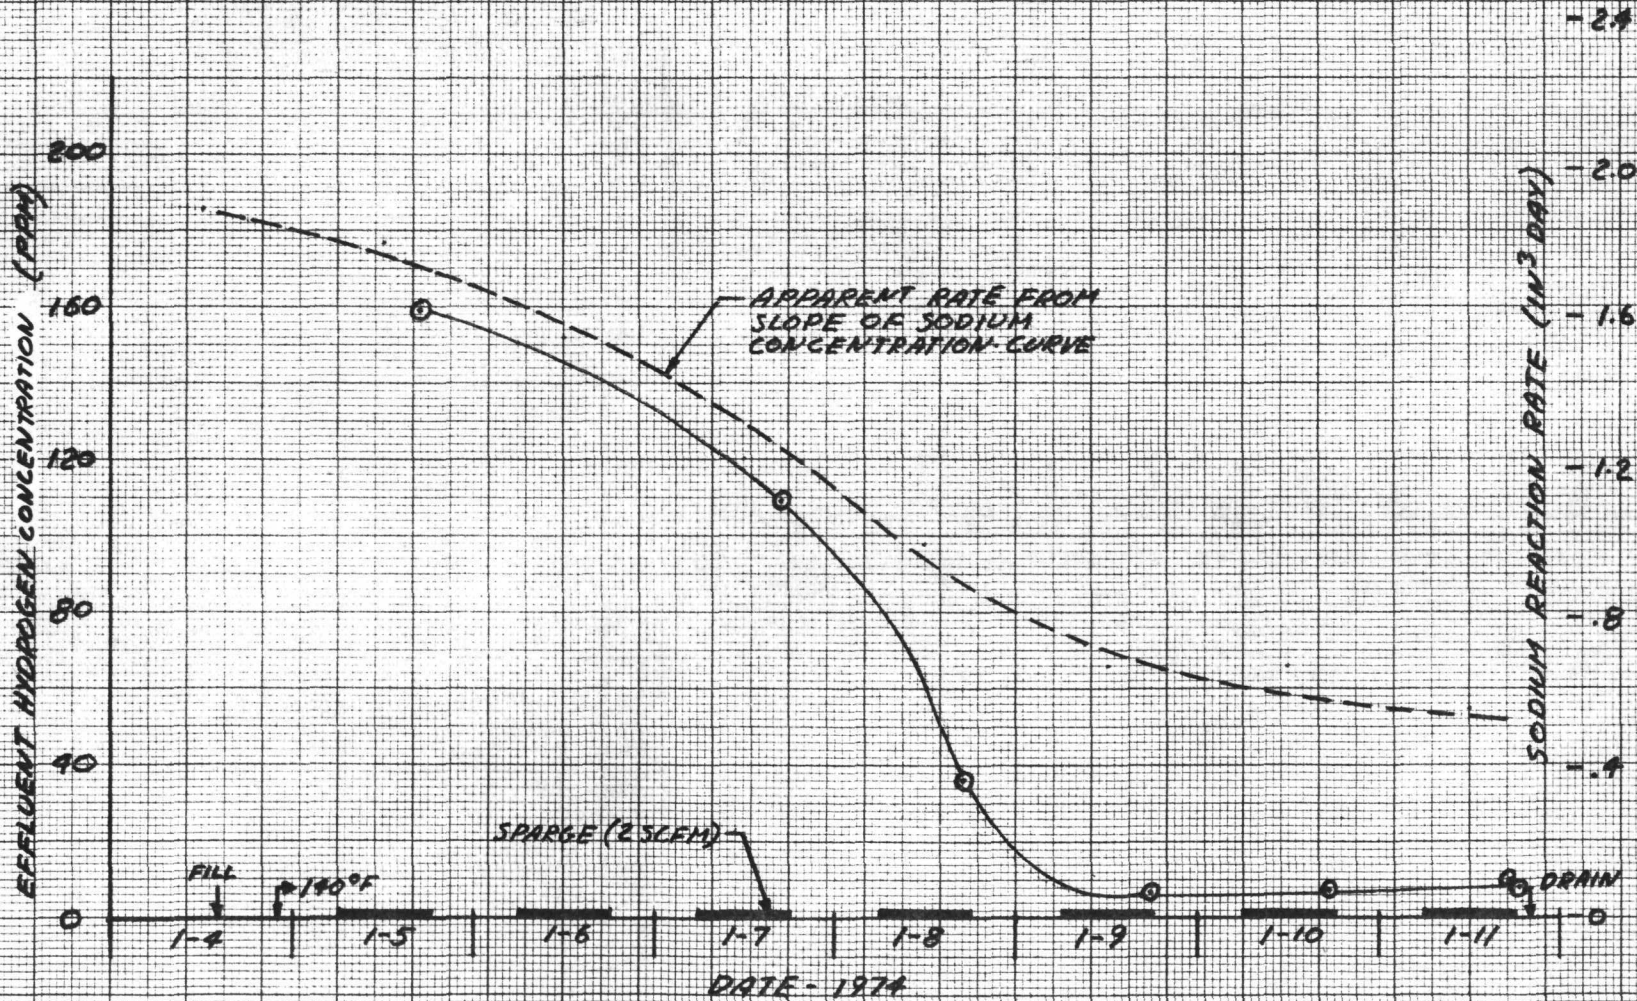
FIG. VI-7
 HYDROGEN CONCENTRATION - SECOND ETHANOL FLUSH

Based upon the low reaction rate observed from the sodium concentration analysis and the negligible rate from the hydrogen concentration, the decision was made to terminate the cleaning. The second ethanol charge was drained and the MSG dried at a temperature of 180°F (later reduced to 150°F to preclude any caustic stress corrosion problems).
