Atomics International North American Rockwell		SUPPORTING DOCUMENT		NUMBER TR-097-330-007	REV LTR/CHG NO. SEE SUMMARY OF CHG																																																								
PROGRAM TITLE Fast Reactors (Central Station)				DOCUMENT TYPE Test Report																																																									
DOCUMENT TITLE MSG Test Report - Removal of Residual Sodium				KEY NOUNS MSG, Cleaning																																																									
PREPARED BY/DATE R. B. Harty <i>R. B. Harty</i>				ORIGINAL ISSUE DATE																																																									
DEPT		MAIL ADDR		GO NO. 41001	S/A NO. 33000																																																								
IR&D PROGRAM? YES <input checked="" type="checkbox"/> NO <input type="checkbox"/> IF YES, ENTER TPA NO. _____				PAGE 1 OF TOTAL PAGES 53																																																									
APPROVALS				REL. DATE <i>3-8-74 sm</i>																																																									
E. B. Baumeister <i>EBS</i>		DATE 3/8/74		SECURITY CLASSIFICATION																																																									
J. S. McDonald <i>JSM</i>		DATE 3/8/74		(CHECK ONE BOX ONLY)

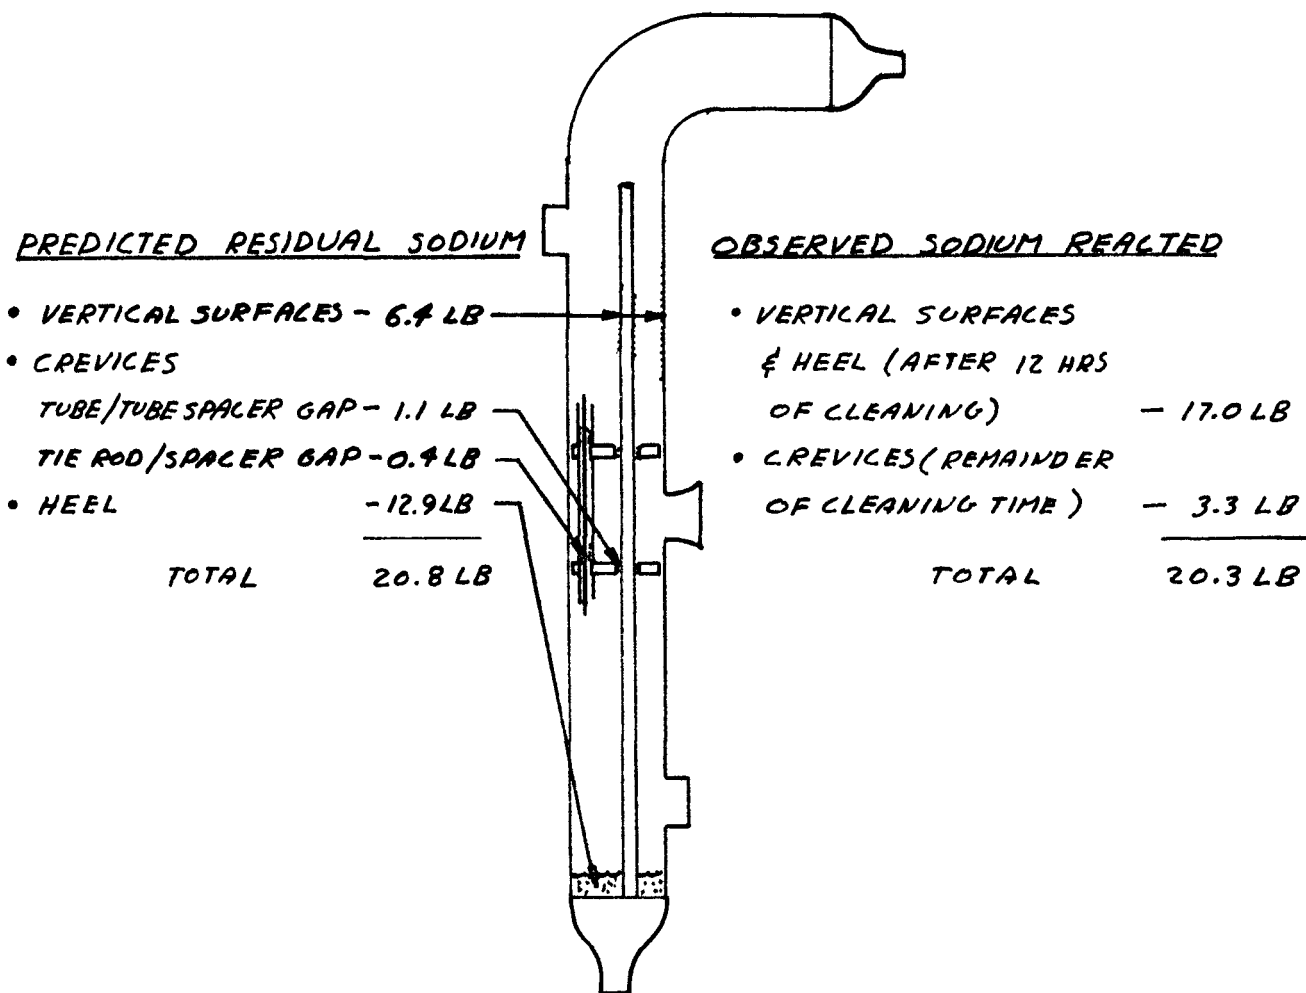
FIG. VI-12
MSG CLEANING SUMMARY

The alcohol process used for cleaning the MSG proved to be very safe and highly effective in removing the residual sodium from sodium coated surfaces. The long cleaning time required to remove the sodium remaining after draining was caused by the many small crevices within the MSG, which resulted in diffusion controlled reaction rates. The design of the steam generators for the demonstration plate incorporates features that minimizes the crevices, and should result in a significantly reduced cleaning time.

<u>SOLVENT</u>	<u>CLEANING TIME (DAYS)</u>	<u>SODIUM REACTED (LB)</u>
DOWANOL PM		
INITIAL	0.5	17.0
REMAINDER	10.5	1.3
FIRST ETHANOL	18	1.7
SECOND ETHANOL	7	0.3
TOTAL	36	20.3
